Expertise

Protocol number: 45808773
Order No. / Reference: 26321714
Inspection date: 22 May 2026

Model: Tiguan 2.0 TDI SCR 4MOTION DSG Elegance

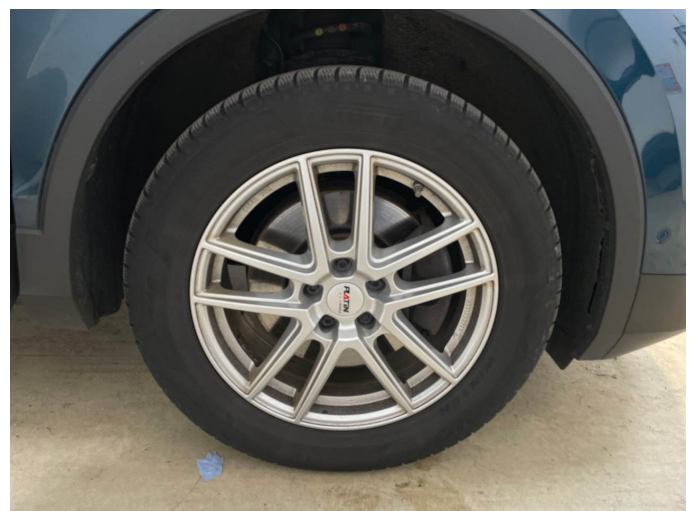
Figure 12: Mounted tyres

#	Tyre size	Type of tyre	Manufacturer	Tread depth
1)	235/55 R18 104H	Winter tires (with run-flat tires) on Light alloy	Pirelli	4mm / 4mm
2)	235/55 R18 104H	Winter tires (with run-flat tires) on Light alloy	Pirelli	6mm / 6mm

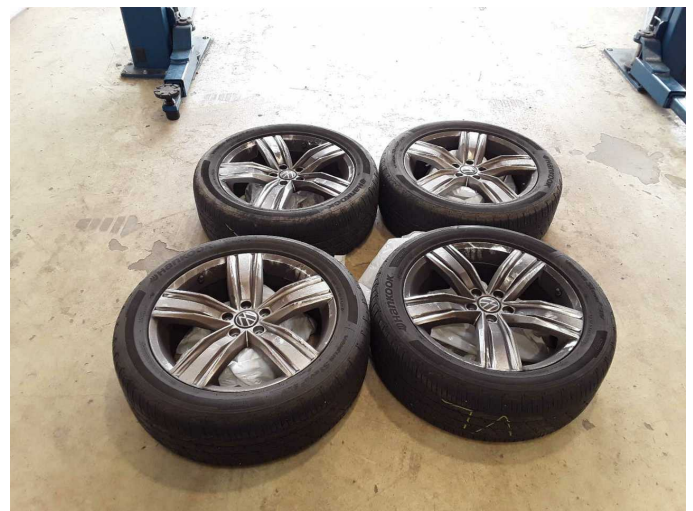
Figure 16: Additional tyres

#	Tyre size	Type of tyre	Manufacturer	Tread depth
1)	235/50 R19 99V	Summer tyres on Light alloy	Hankook	5mm / 5mm
2)	235/50 R19 99V	Summer tyres on Light alloy	Hankook	7mm / 7mm

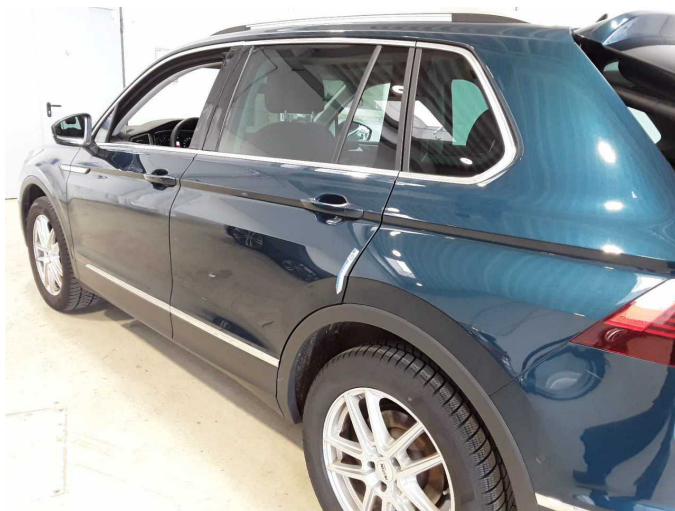
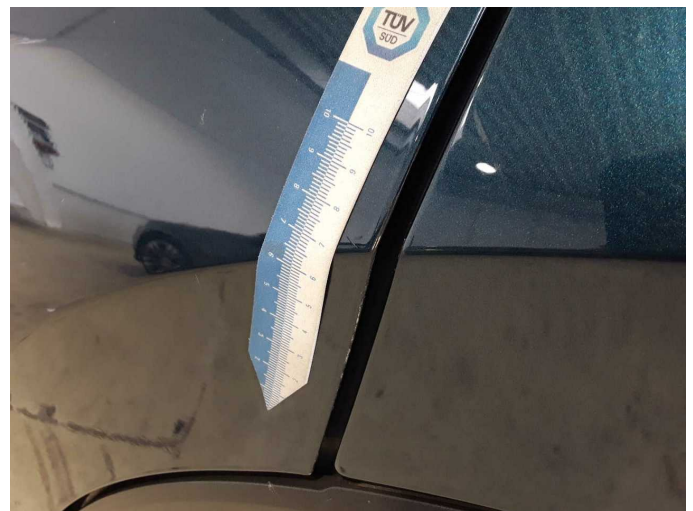
Damage 2: Door - rear left side: Door edge - Scratch(es) - Smart repair

No.	Component group	Description
1	Documents	Service book (30000er überzogen) - Incomplete
2	Door - rear left side	Door edge - Scratch(es) - Smart repair
3	Roof	Roof rail - left side - dent(s) - Smart repair
4	Door - front right side	Door - Dent / paintcoat damage - Smart repair
5	Rear bumper	Rear bumper (Inkl Spoiler und Zierleiste erneuern) - Deformed - Replace

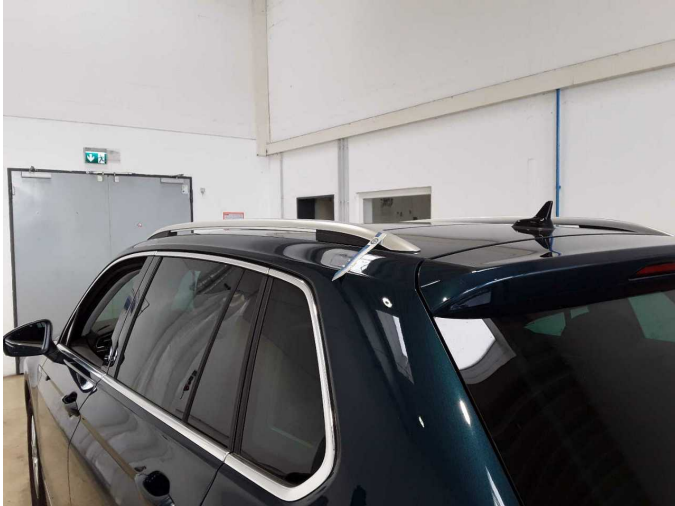
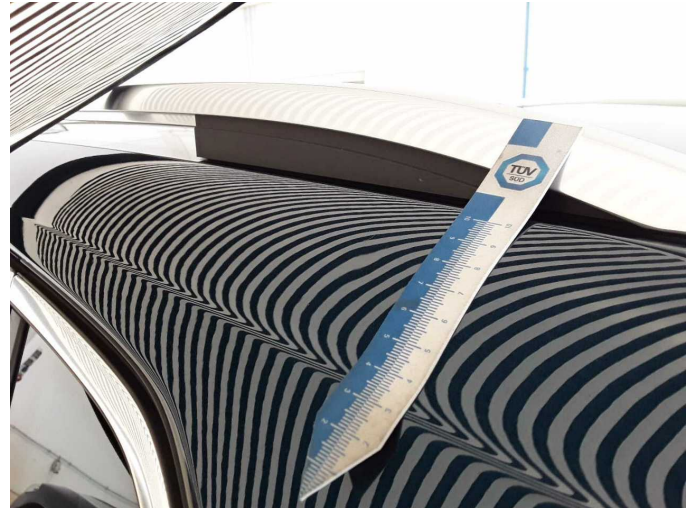
Damage 3: Roof: Roof rail - left side - dent(s) - Smart repair

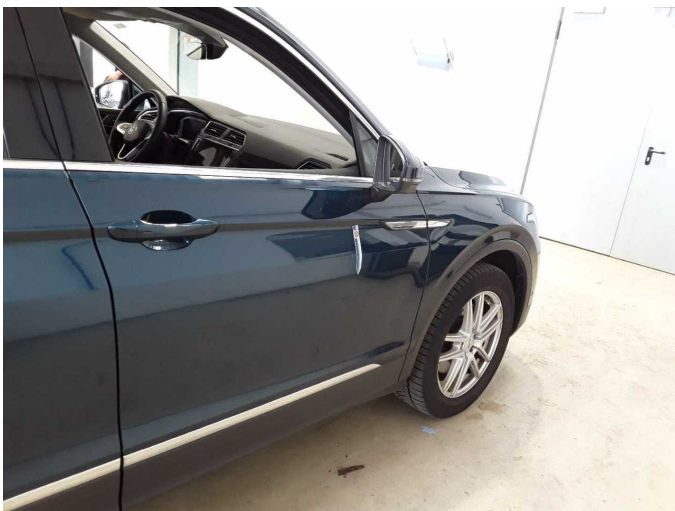
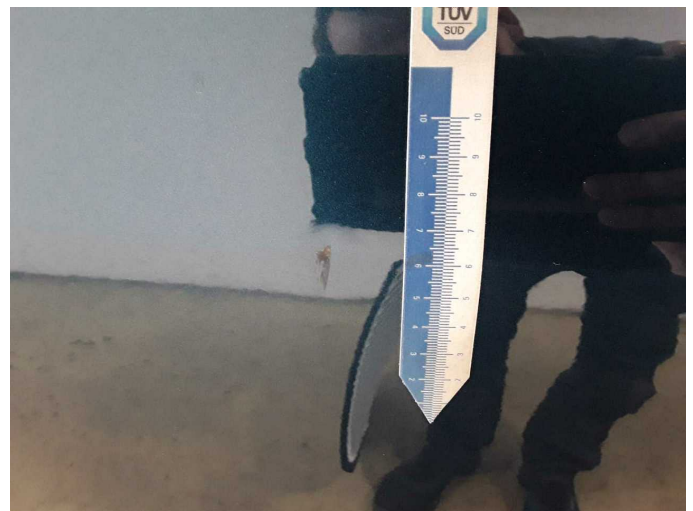
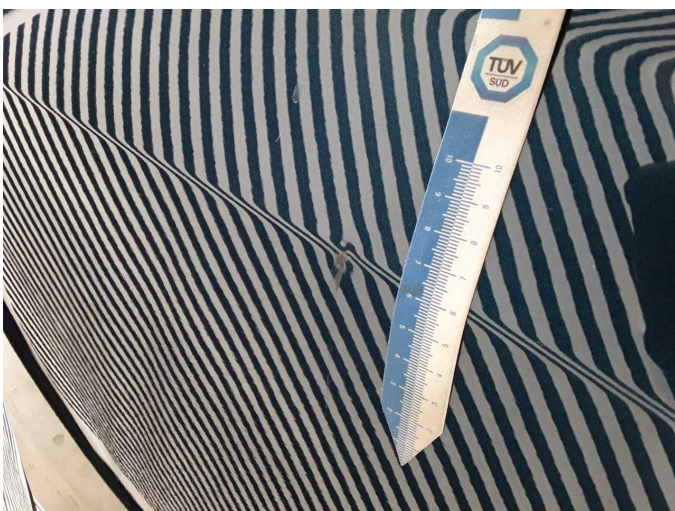
Damage 4: Door - front right side: Door - Dent / paintcoat damage - Smart repair

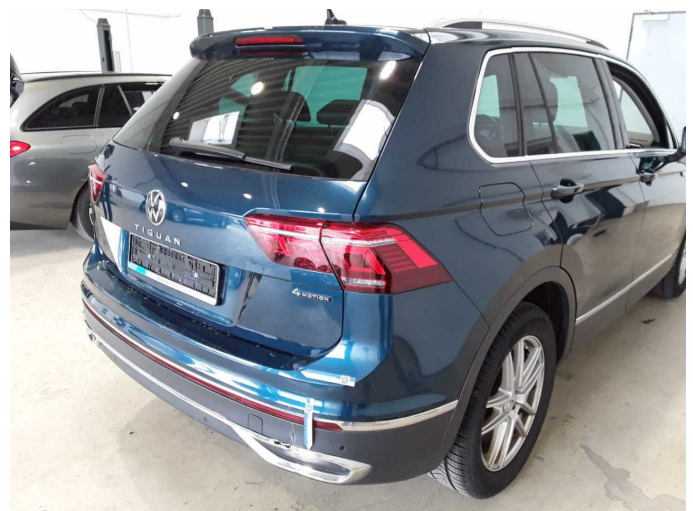
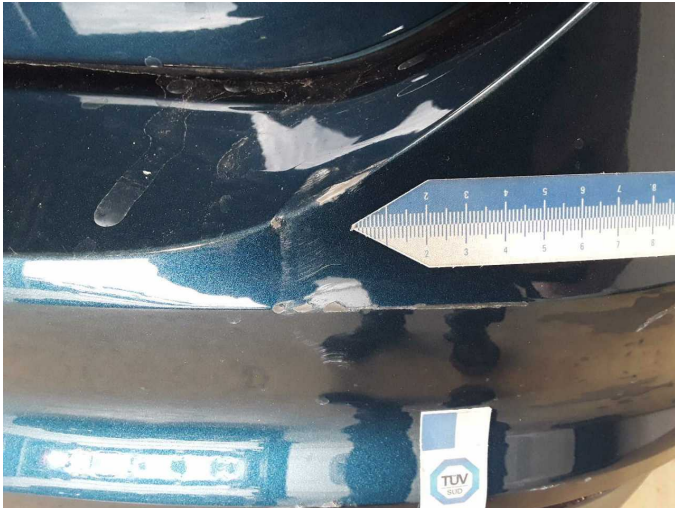
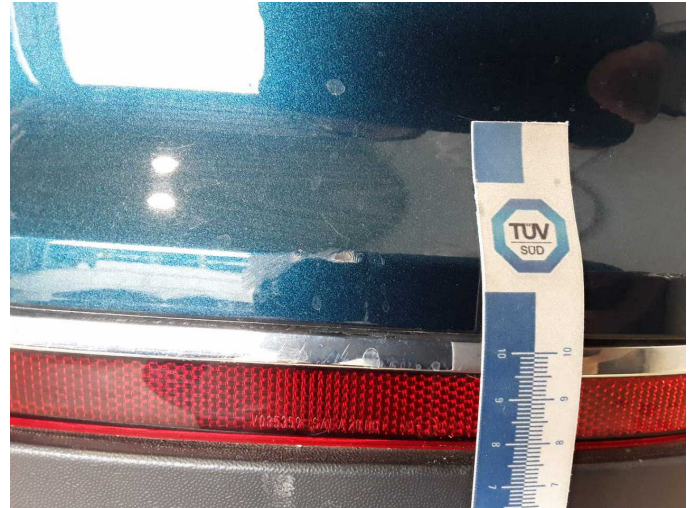
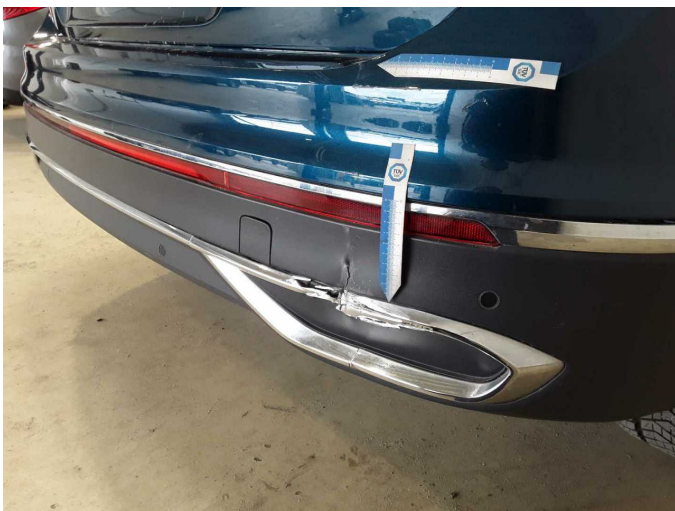
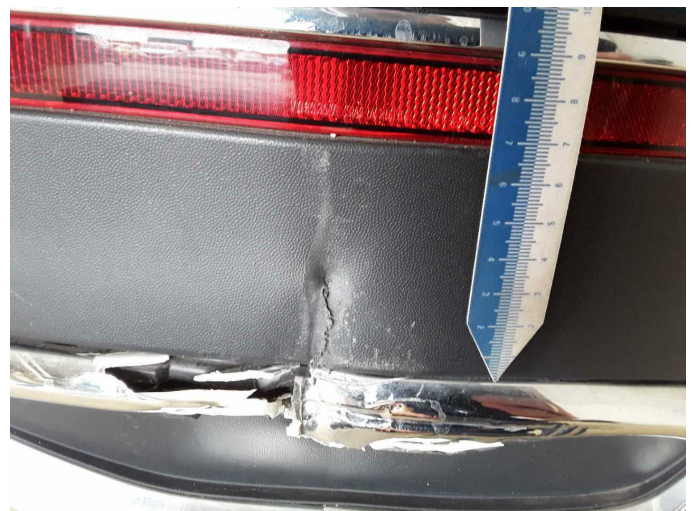
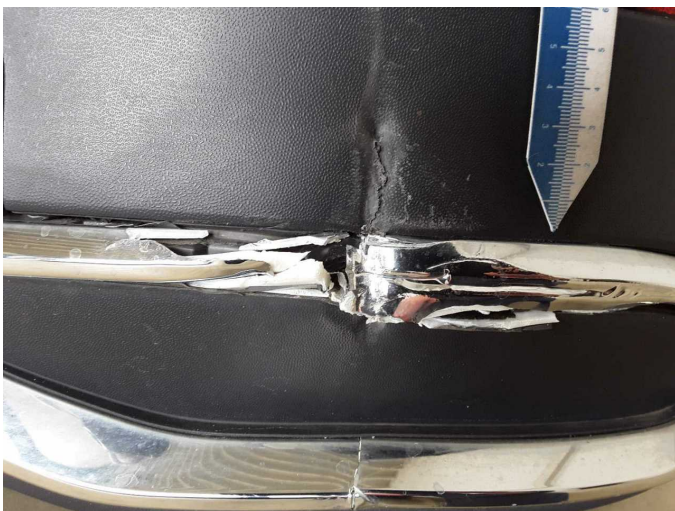
No.	Previous damage	Extent of damage (Net)
1	Side right, Professionally repaired, Invoice of repair done Non-existent, from 16 Sept 2022	3.999,49 €
2	Rear, not professionally repaired

Damage 5: Rear bumper: Rear bumper (Inkl Spoiler und Zierleiste erneuern) - Deformed - Replace

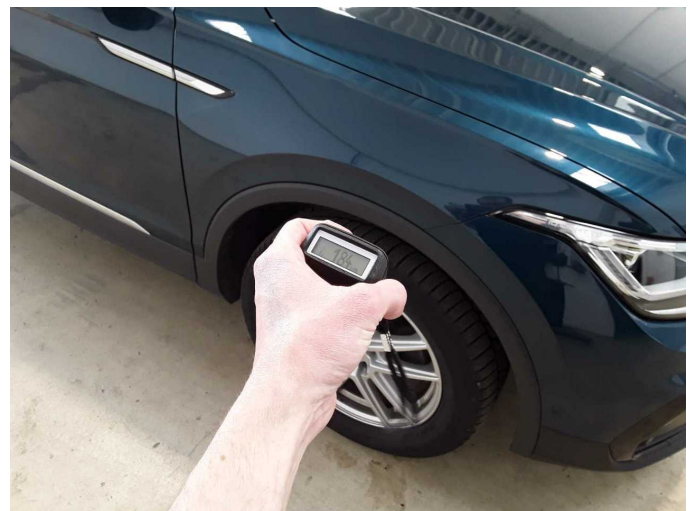
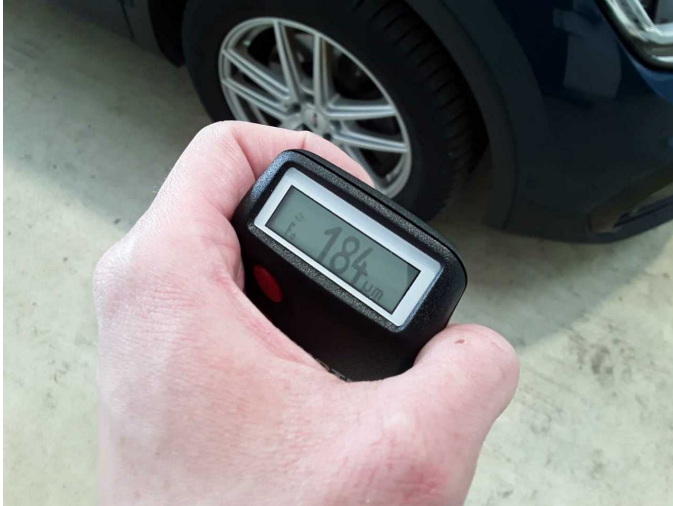
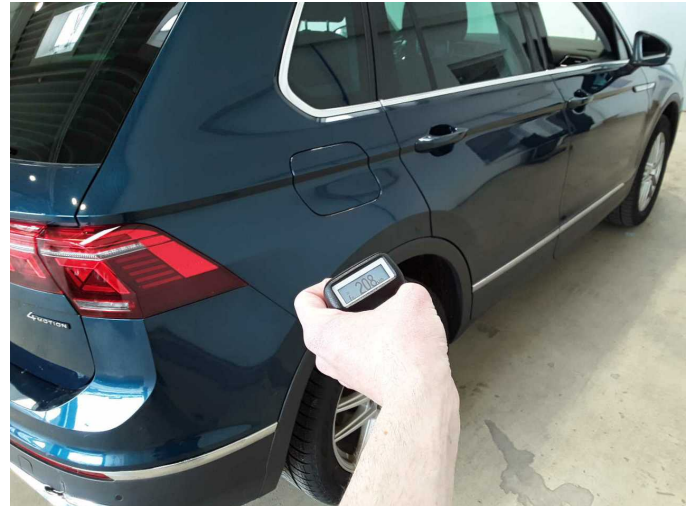
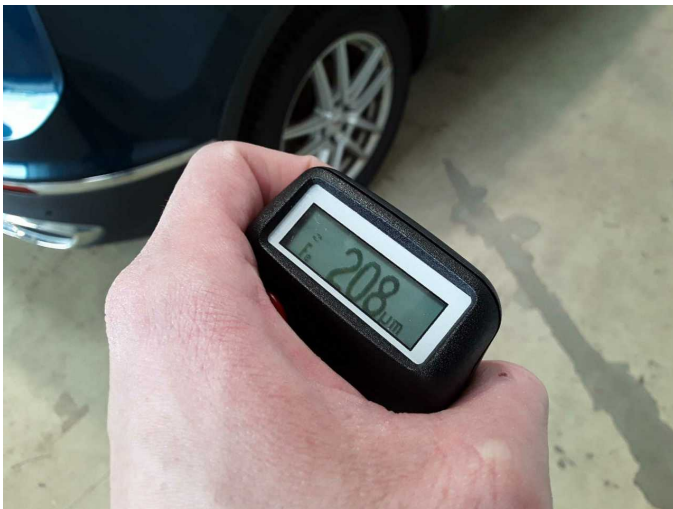
No.	Repainting
1	Mudguard - right side, Side panel - rear right side, Professionally carried out, Invoice of repair done Non-existent

Mudguard - right side	184 µm	Side panel - rear right side	208 µm
-----------------------	--------	------------------------------	--------

Repainting 1: Mudguard - right side, Side panel - rear right side
