Expertise

Protocol number: 46797815  
Order No. / Reference: 26605984  
Inspection date: 28 Jul 2026

Manufacturer: Mercedes-Benz

Model: E 300 de 4Matic T 9G-TRONIC Exclusive

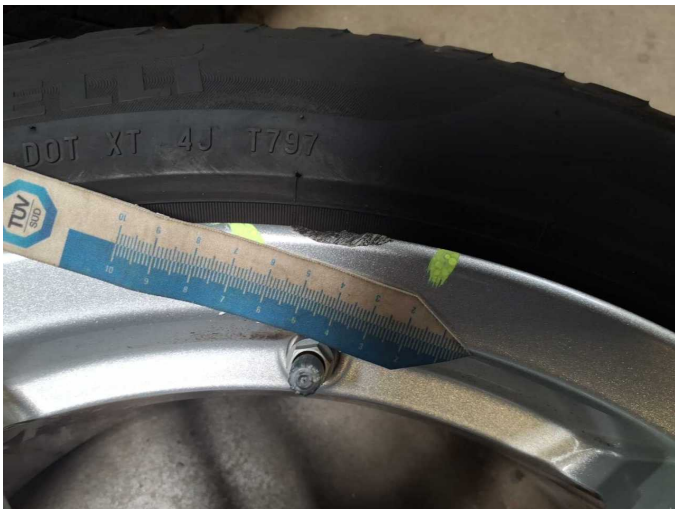
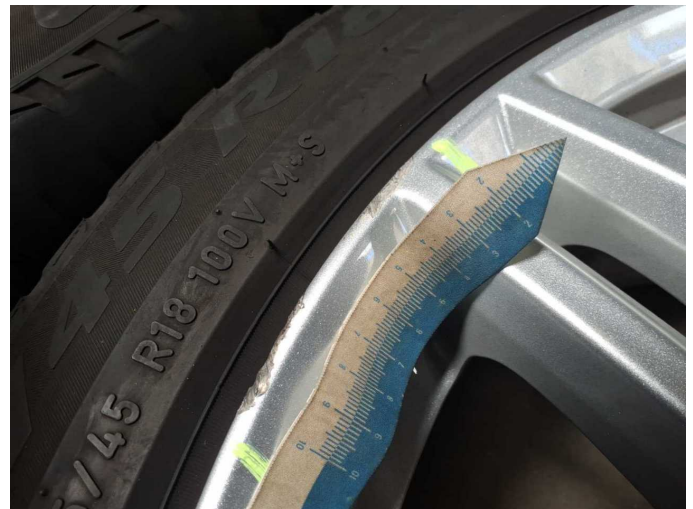
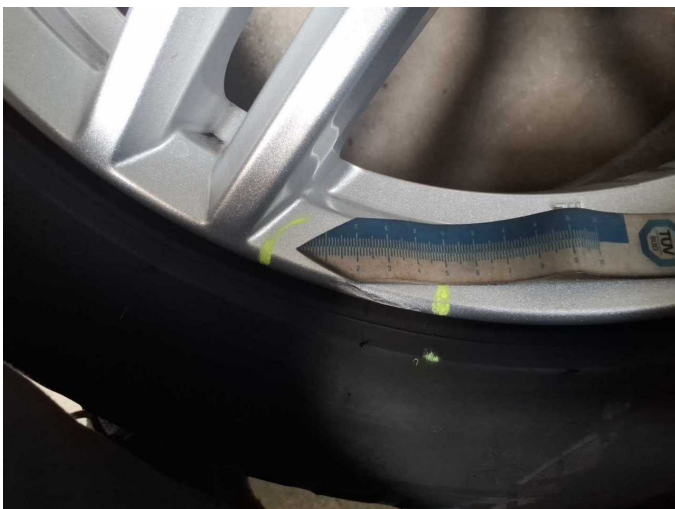
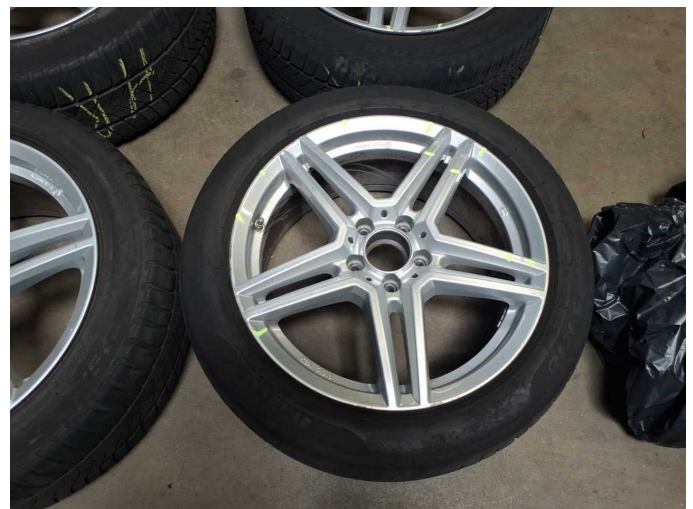
| No. | Component group | Description |
|---|---|---|
| 1 | 2nd wheel set | 1 alloy rim (nicht bestandteil der Serienausstattung) - Scratched - No deduction |

**Damage 1:** 2nd wheel set: 1 alloy rim (nicht bestandteil der Serienausstattung) - Scratched - No deduction

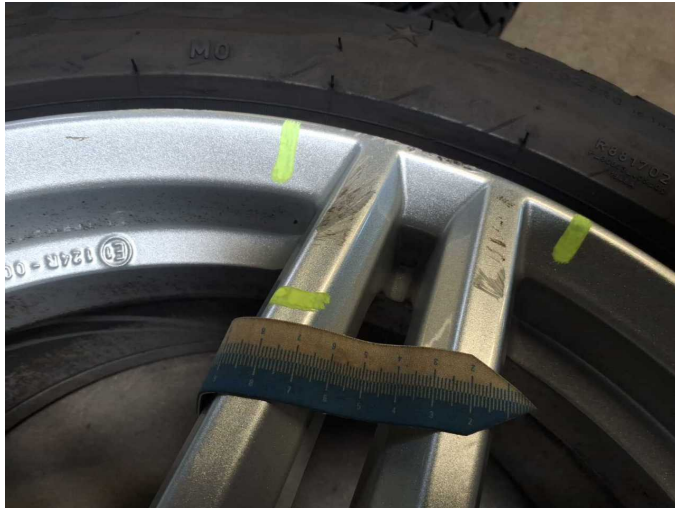
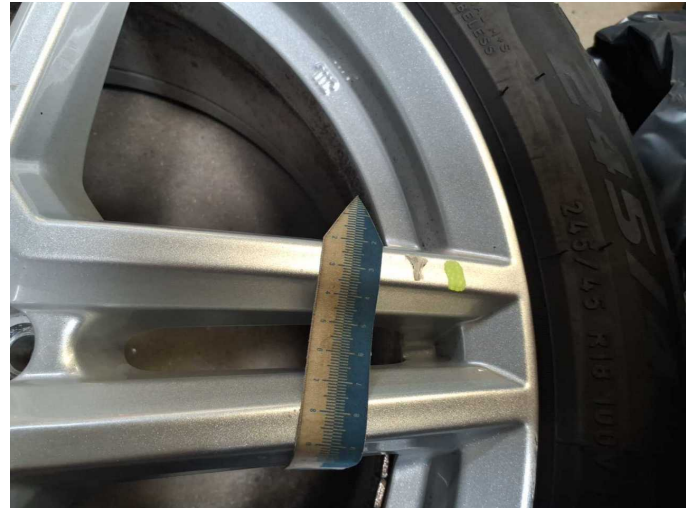
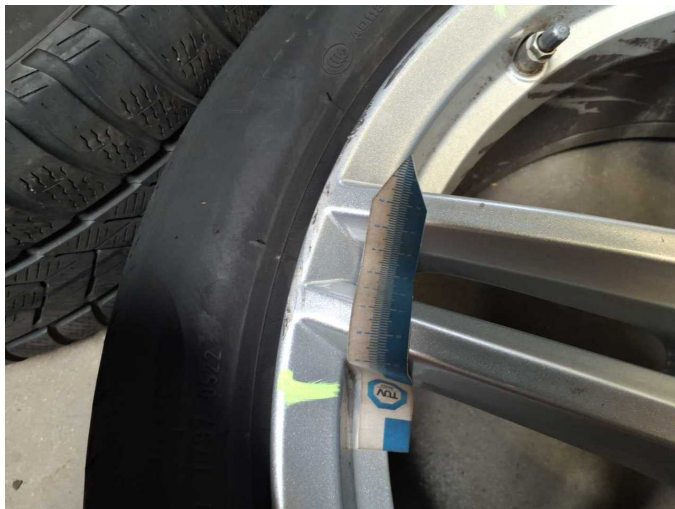
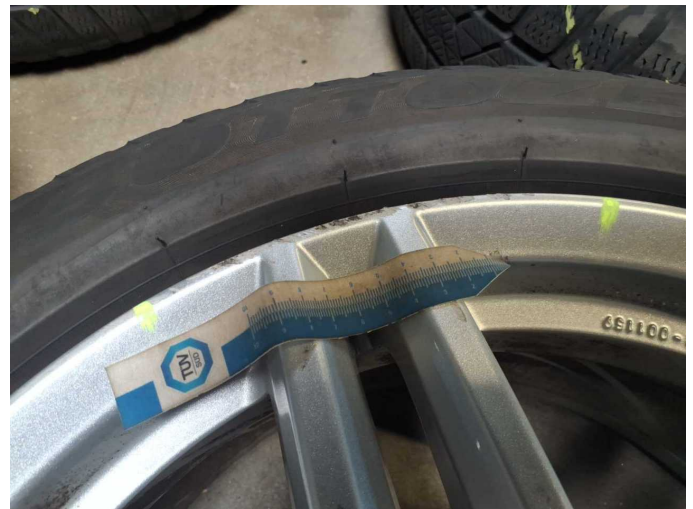
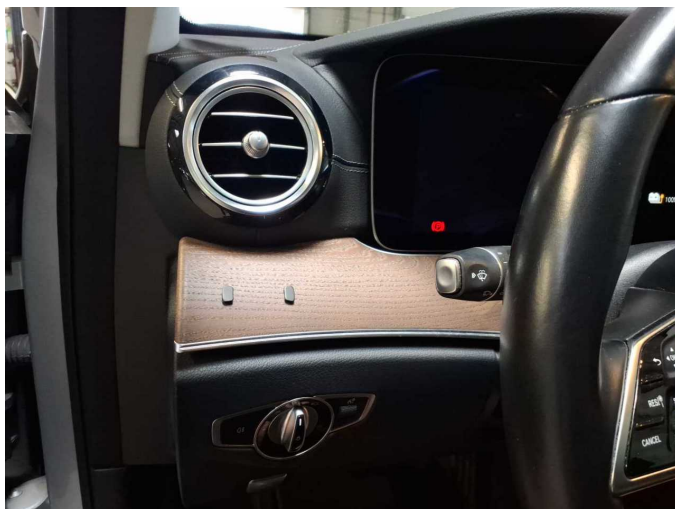
| No. | Component group | Description |
|---|---|---|
| 2 | 2nd wheel set | 1 alloy rim (nicht bestandteil der Serienausstattung) - Scratched - No deduction |

**Damage 2:** 2nd wheel set: 1 alloy rim (nicht bestandteil der Serienausstattung) - Scratched - No deduction

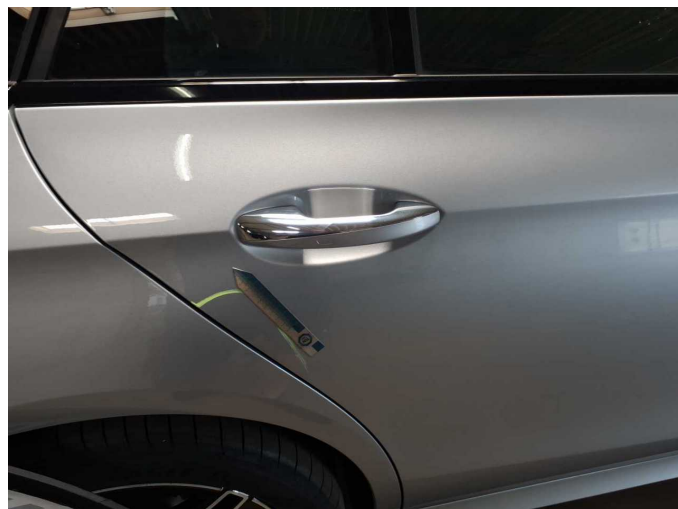
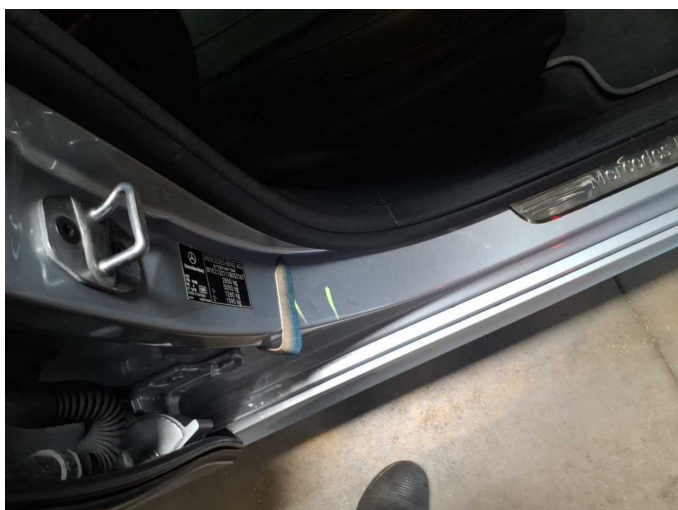
| No. | Component group | Description |
|---|---|---|
| 4 | Door - rear right side | Door - dent(s) - Smooth repair work |

**Damage 4:** Door - rear right side: Door - dent(s) - Smooth repair work

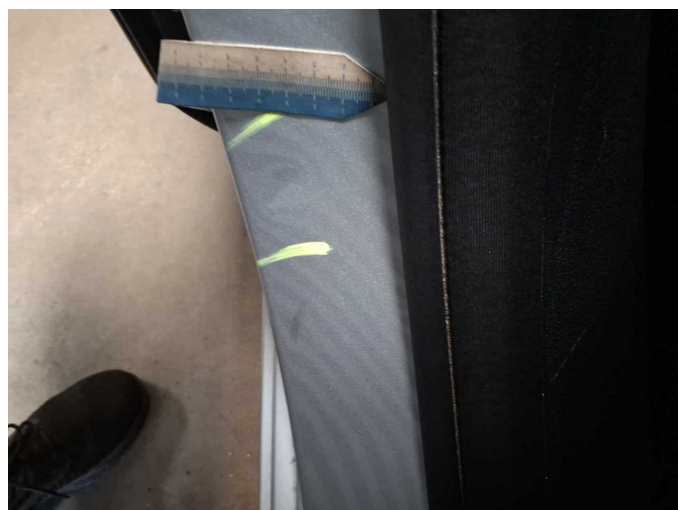
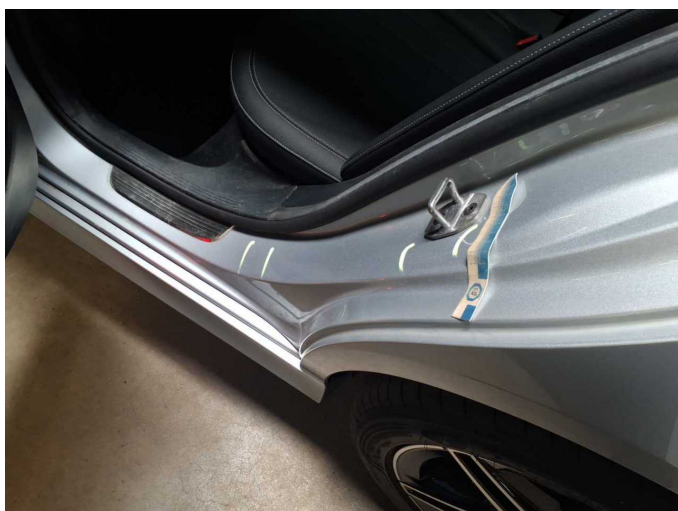
| No. | Component group | Description |
|---|---|---|
| 5 | Sill - right side | Sill - dent(s) - Smart repair |

**Damage 5:** Sill - right side: Sill - dent(s) - Smart repair

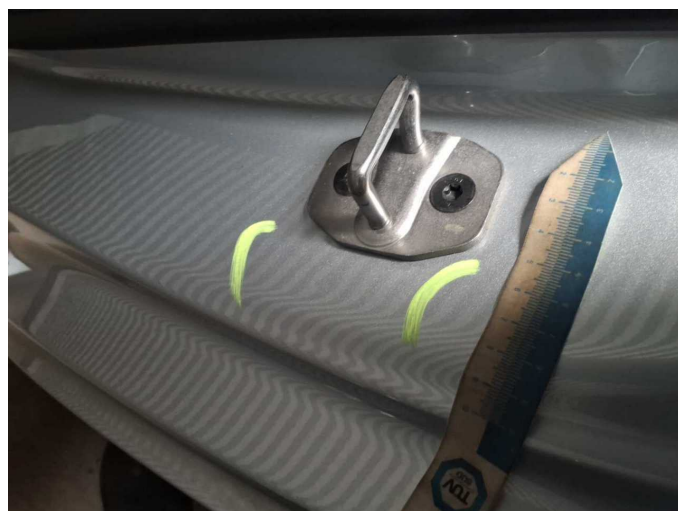
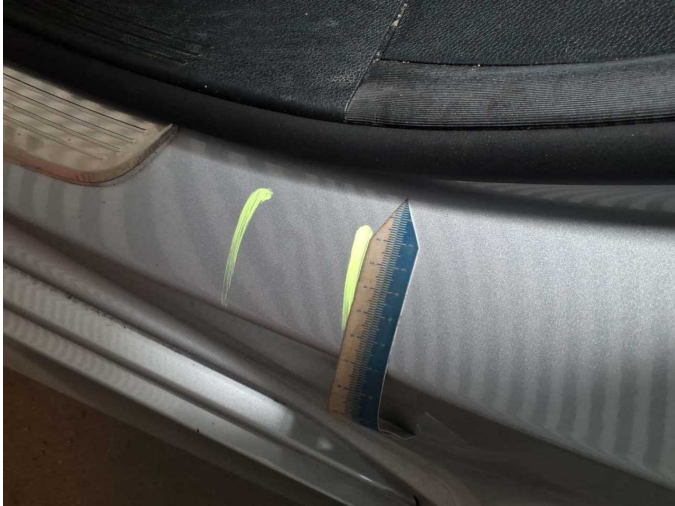
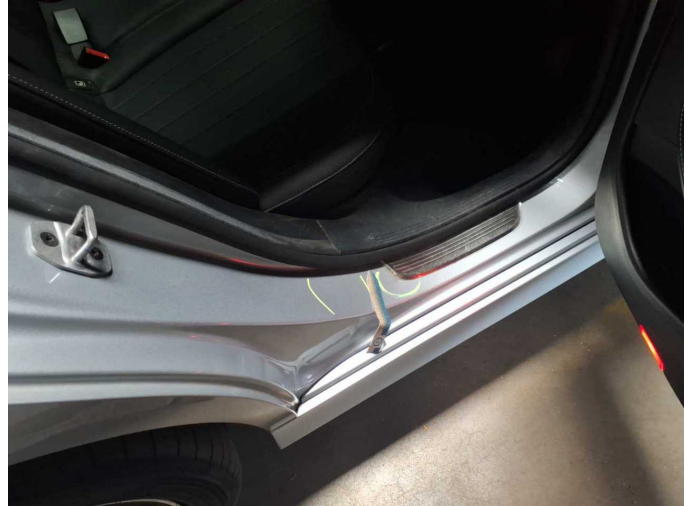
| No. | Component group | Description |
|---|---|---|
| 6 | Side panel - rear left side | Sill - dent(s) - Smart repair |

**Damage 6:** Side panel - rear left side: Sill - dent(s) - Smart repair

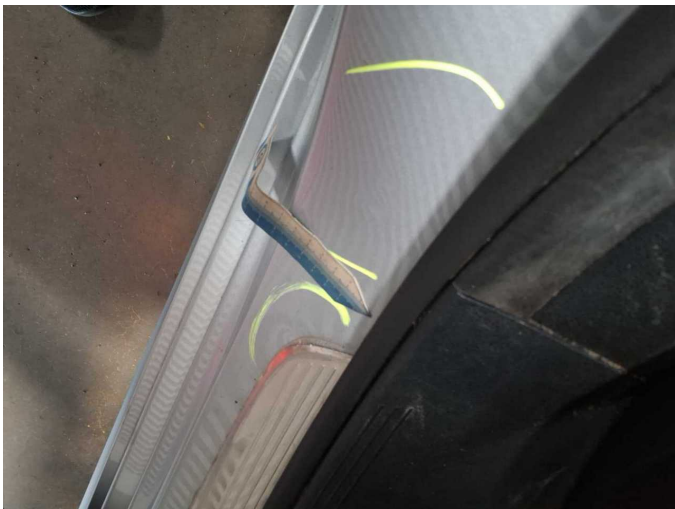
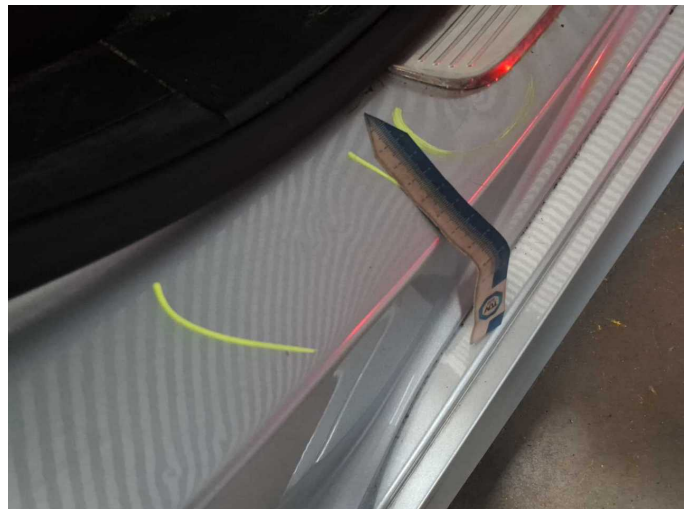
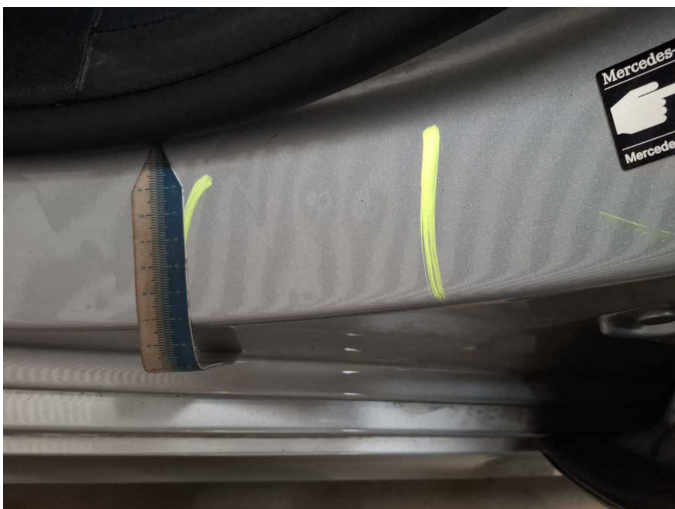
| No. | Component group | Description |
|---|---|---|
| 7 | Side panel - rear right side | Sill - dent(s) - Smart repair |

**Damage 7:** Side panel - rear right side: Sill - dent(s) - Smart repair

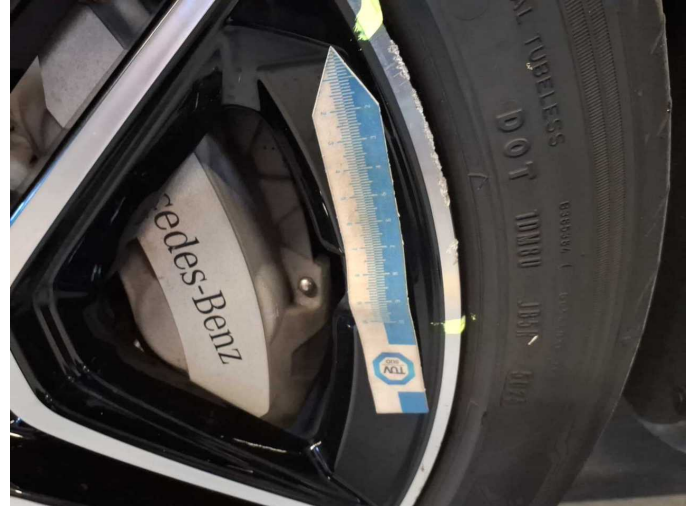
| No. | Component group | Description |
|---|---|---|
| 9 | Wheel / tyres | Alloy rim - front left side - Scratched - Loss in value |

**Damage 9:** Wheel / tyres: Alloy rim - front left side - Scratched - Loss in value

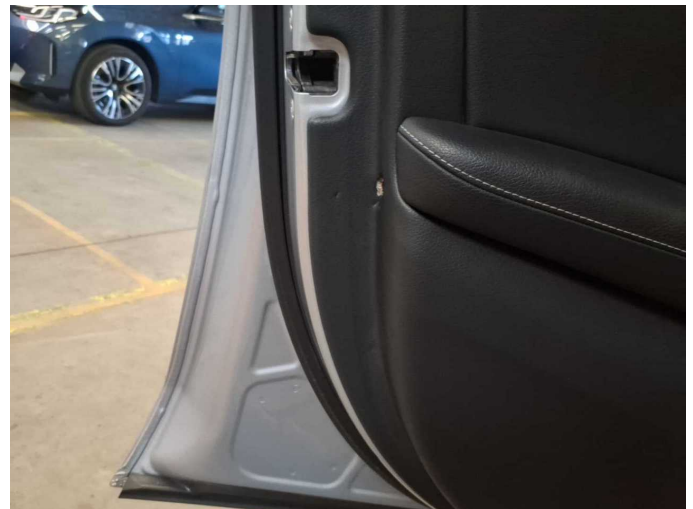
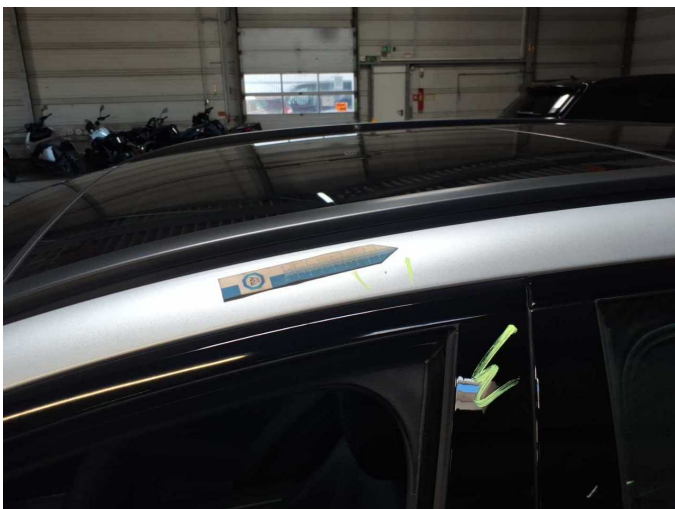
| No. | Component group | Description |
|---|---|---|
| 10 | Trim / covers | Door trim - front left side - Broken / torn - Loss in value |

**Damage 10:** Trim / covers: Door trim - front left side - Broken / torn - Loss in value

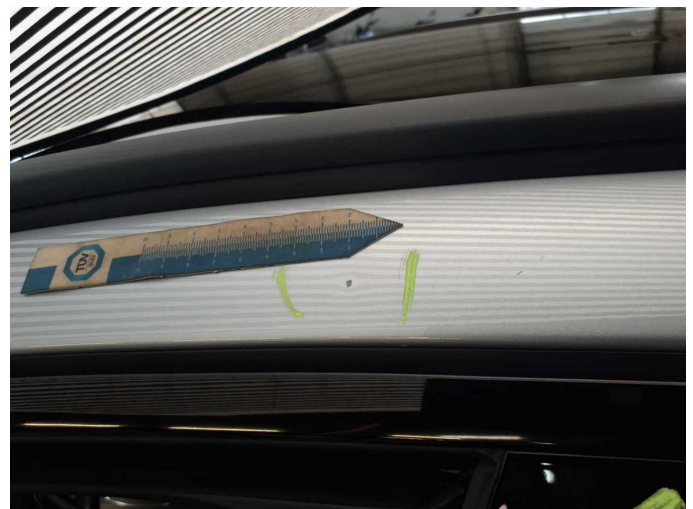
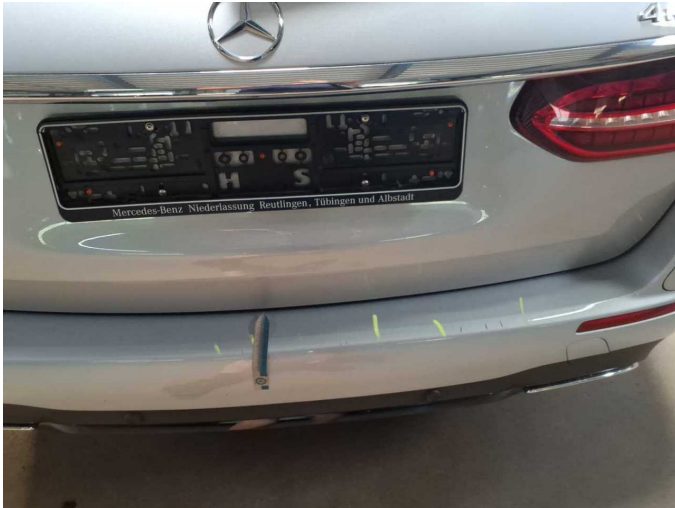
| No. | Component group | Description |
|---|---|---|
| 11 | Roof | Roof rail - left side - Dent / paintcoat damage - Repair and paint |

**Damage 11:** Roof: Roof rail - left side - Dent / paintcoat damage - Repair and paint

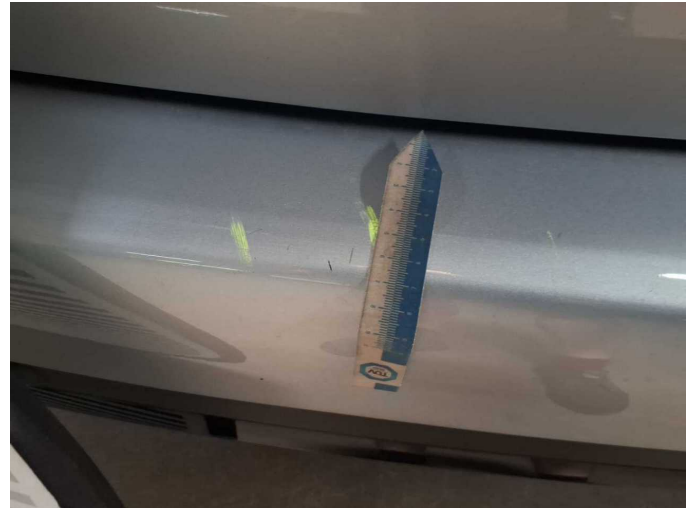
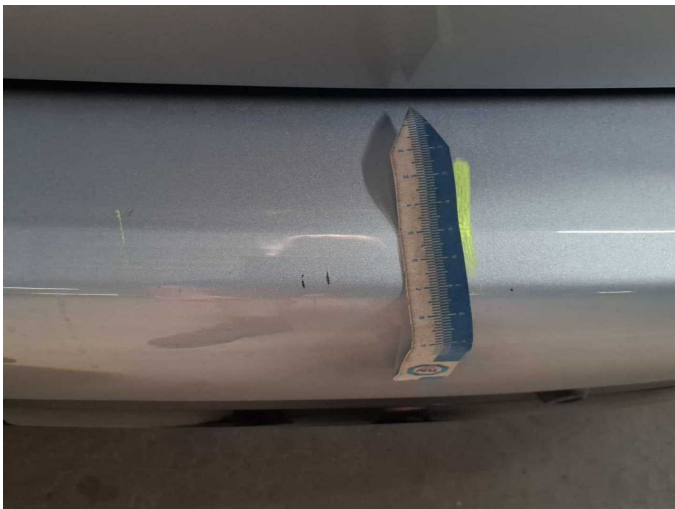
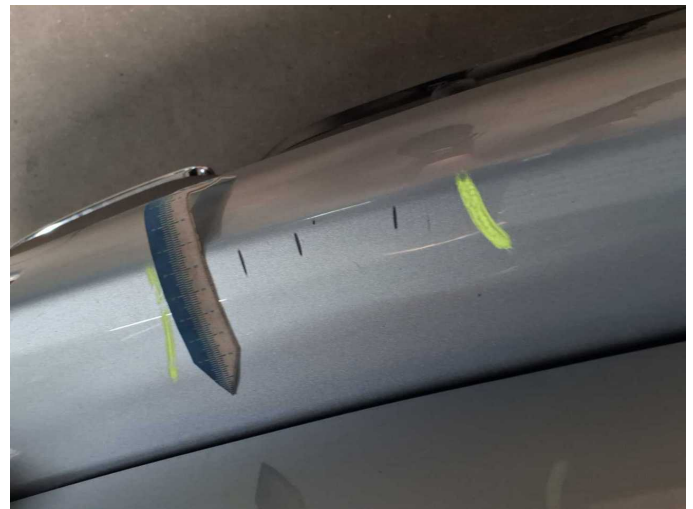
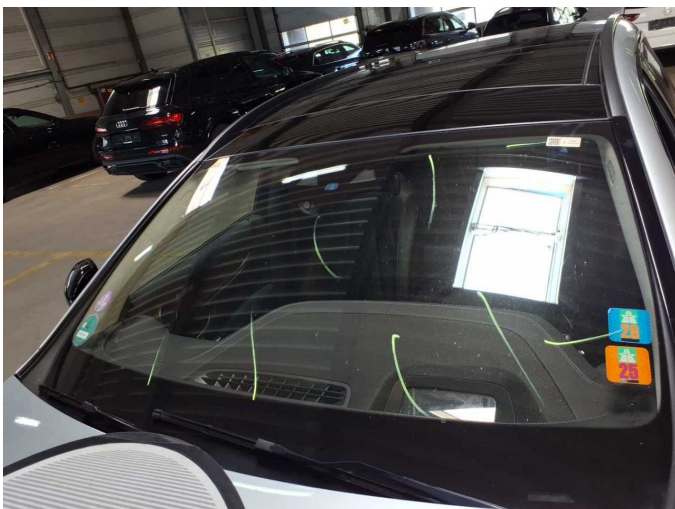
| No. | Component group | Description |
|---|---|---|
| 12 | Rear bumper | Rear bumper - Scratched - Paint |

**Damage 12:** Rear bumper: Rear bumper - Scratched - Paint

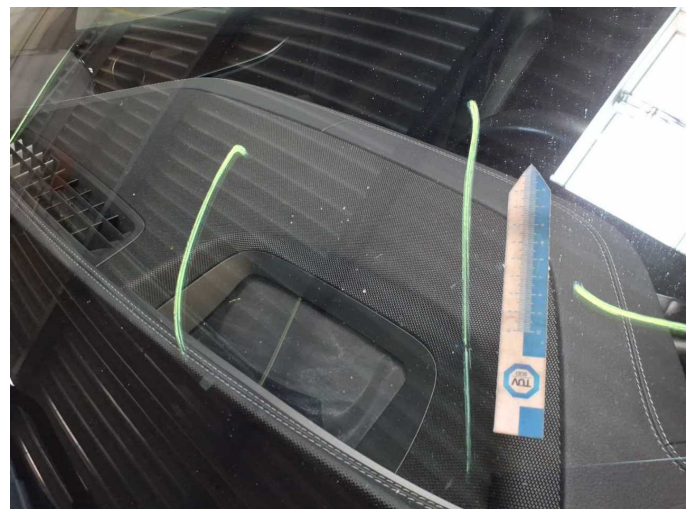
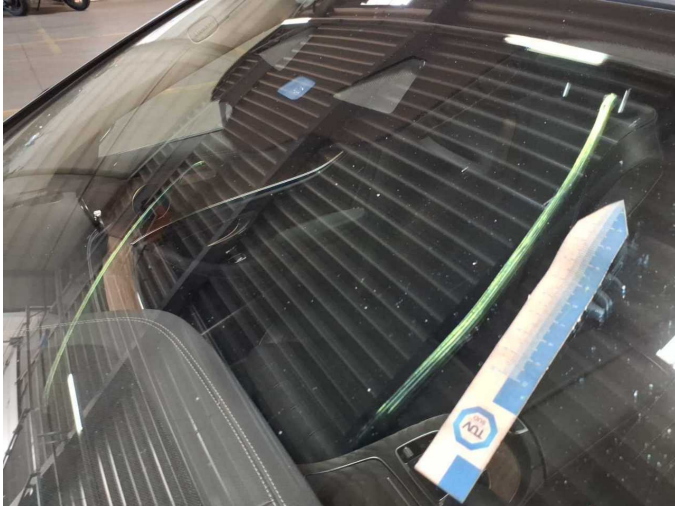
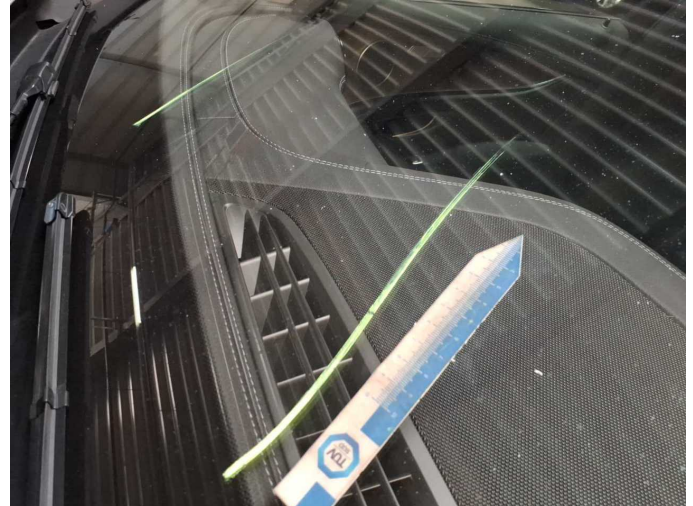
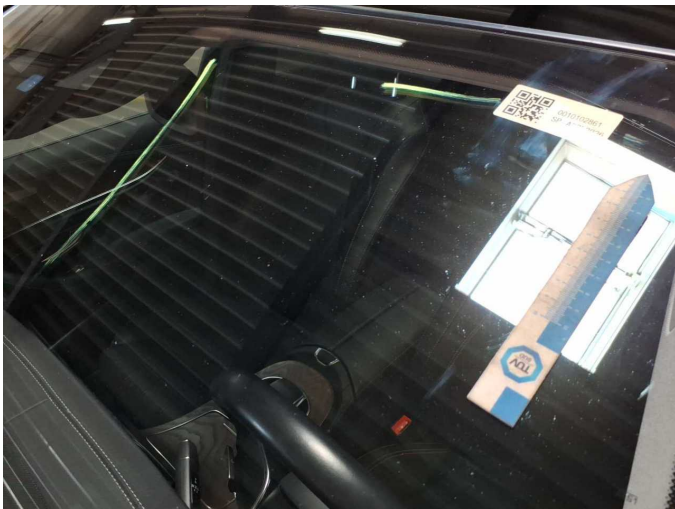
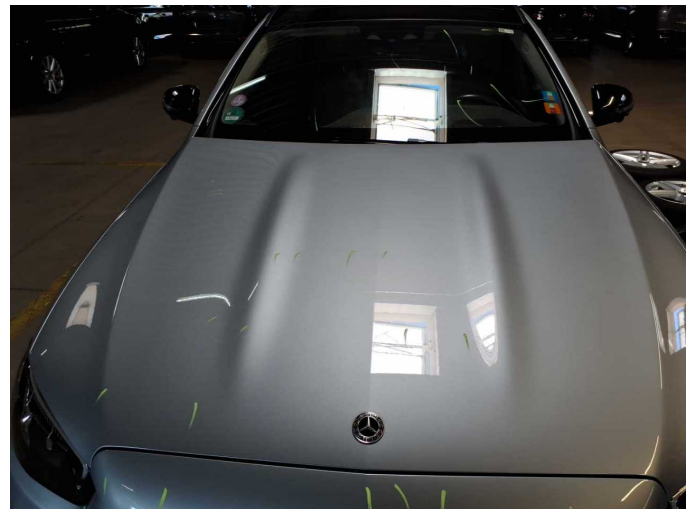
| No. | Component group | Description |
|---|---|---|
| 13 | Vehicle glazing | Windscreen (Sandstrahleffekt) - Stone chips - Replace |

**Damage 13:** Vehicle glazing: Windscreen (Sandstrahleffekt) - Stone chips - Replace

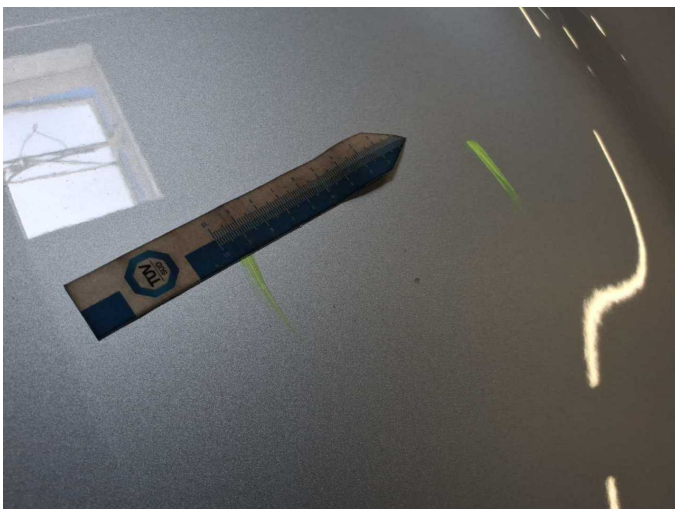
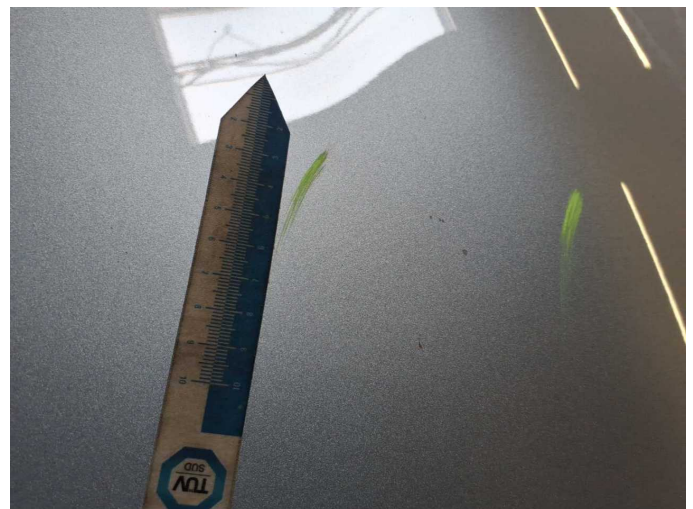
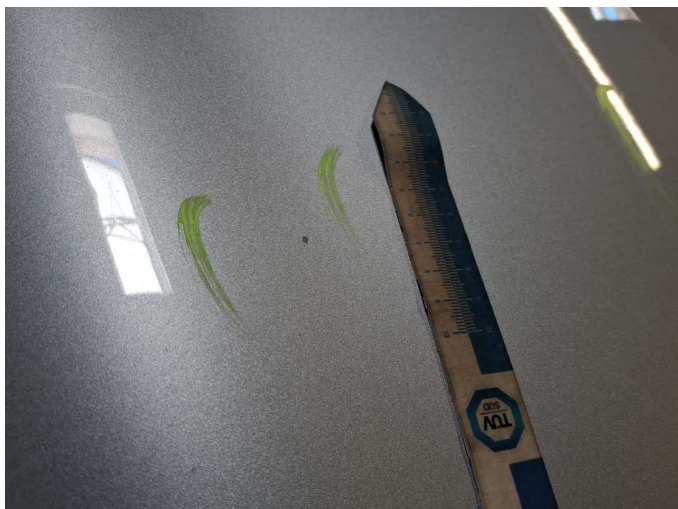
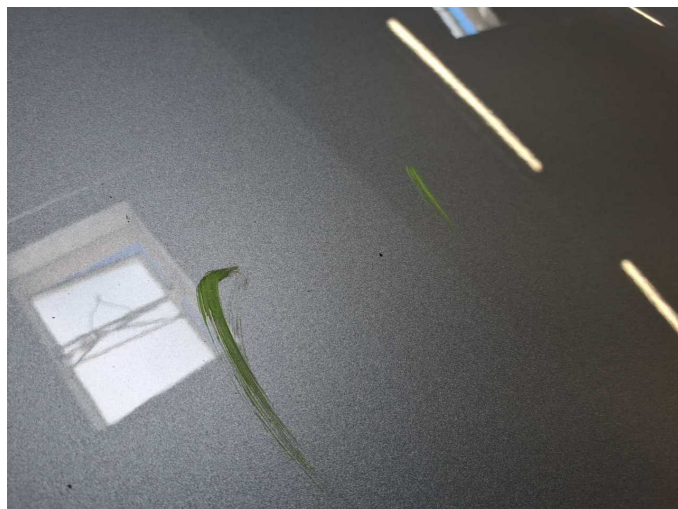
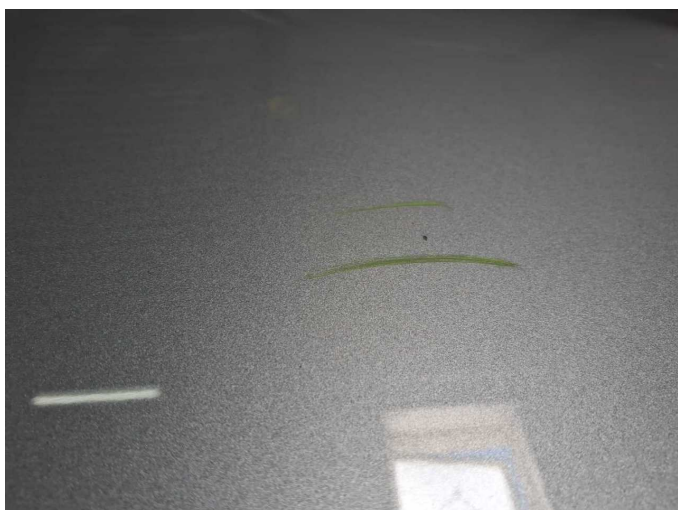
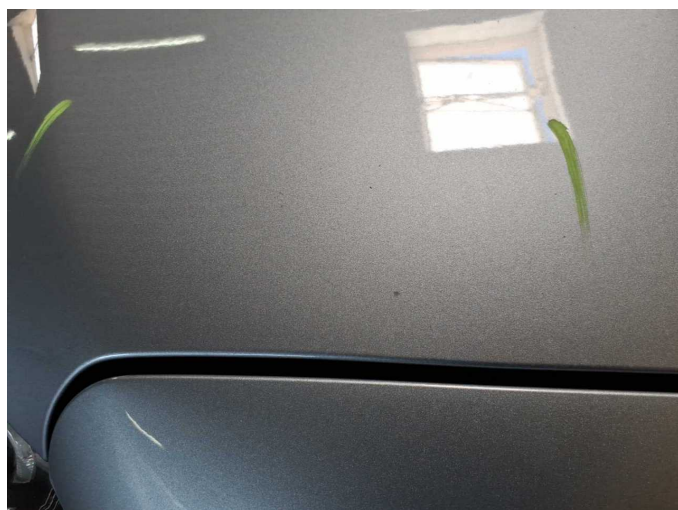
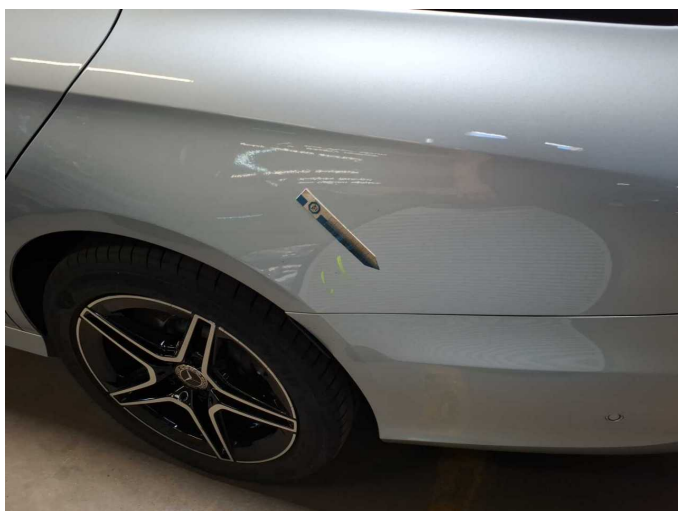
| No. | Component group | Description |
|---|---|---|
| 14 | Bonnet | Bonnet (Sandstrahleffekt) - Stone chips - Paint |

**Damage 14:** Bonnet: Bonnet (Sandstrahleffekt) - Stone chips - Paint

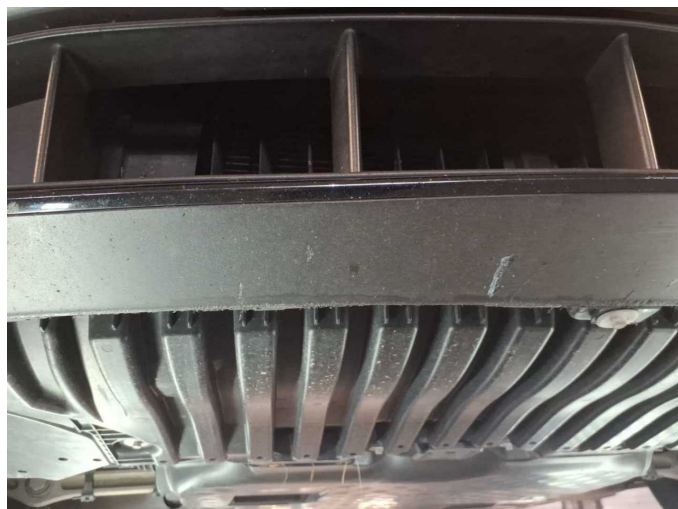
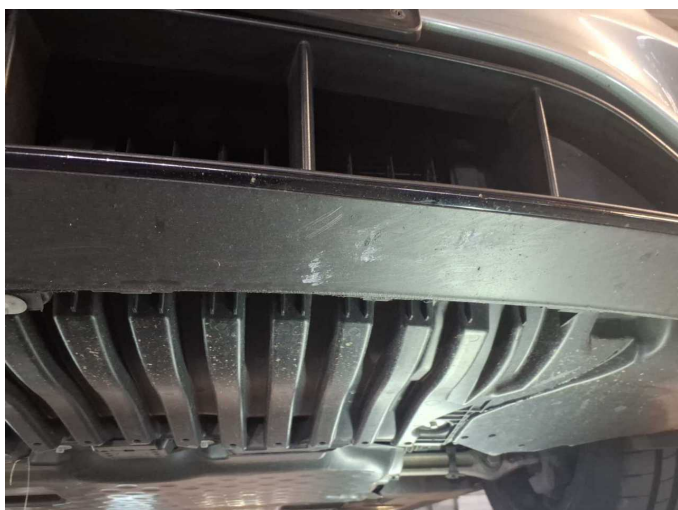
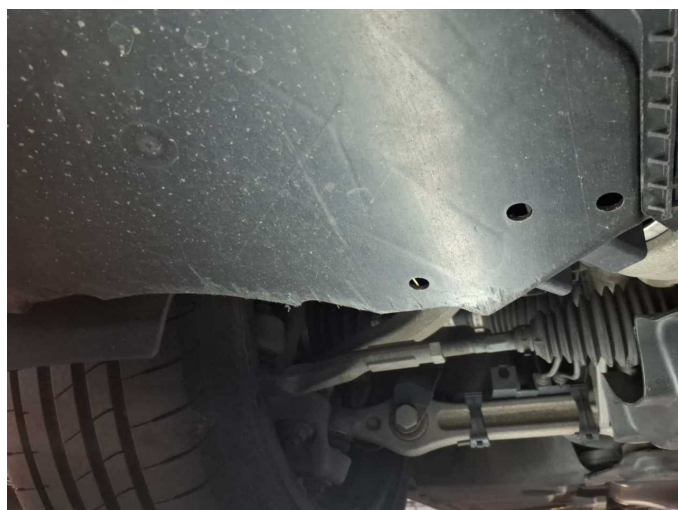
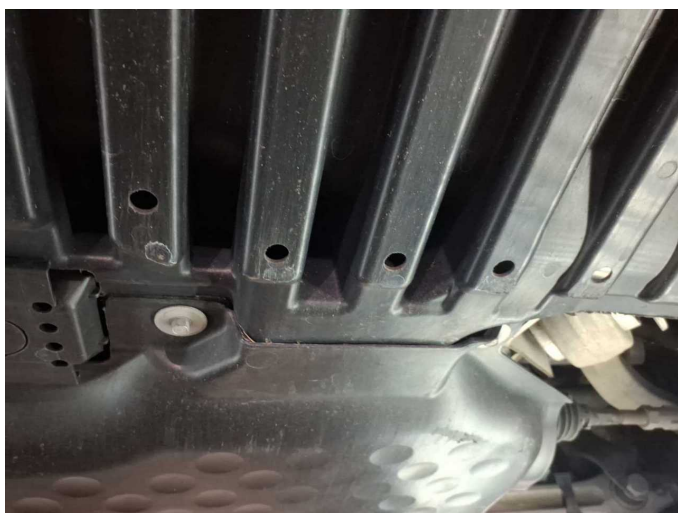
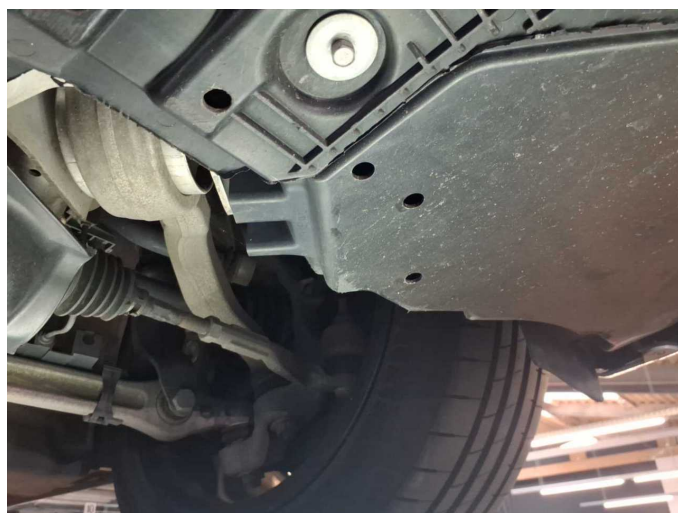
- 1 Front, Underbody

**Accident 1: Front, Underbody**
