Expertise

Protocol number: 45925257
Order No. / Reference: 26479130
Inspection date: 12 Jun 2026

Model: Passat Variant 2.0 TDI SCR DSG Business

An order was placed to prepare a sales report for the described vehicle. This report includes the following:

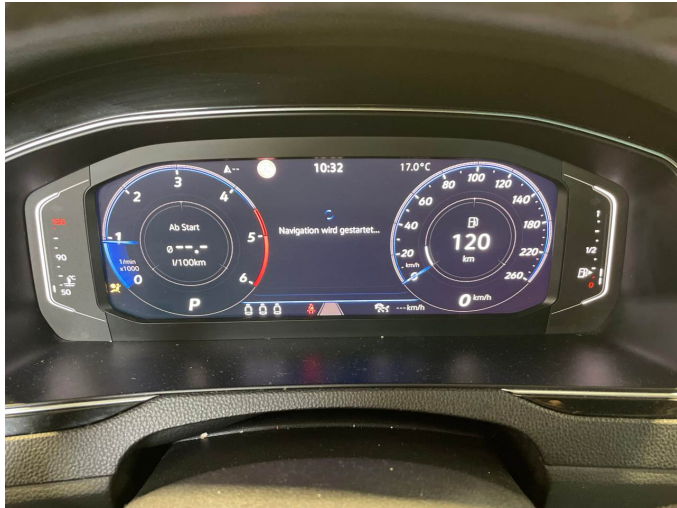
Figure 7: Instrument cluster

Mileage (Read) 145,567 km

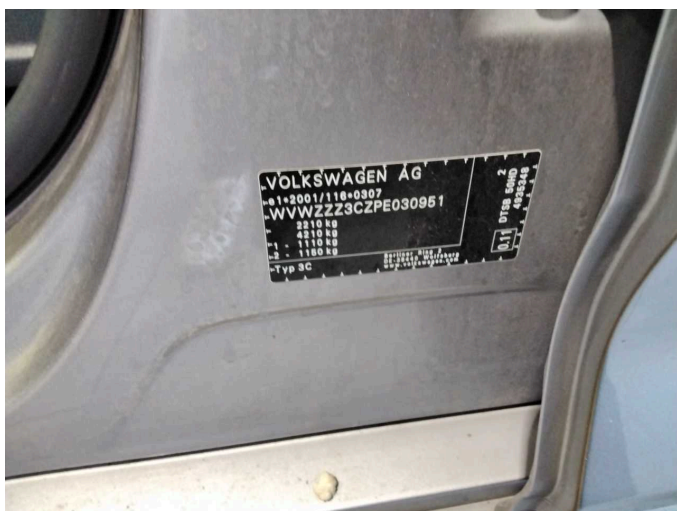
Figure 11: VIN

| VIN comparison | The vehicle identification number (VIN) was read from the vehicle and its conformity with the submitted documents was confirmed by the undersigned during the inspection. |

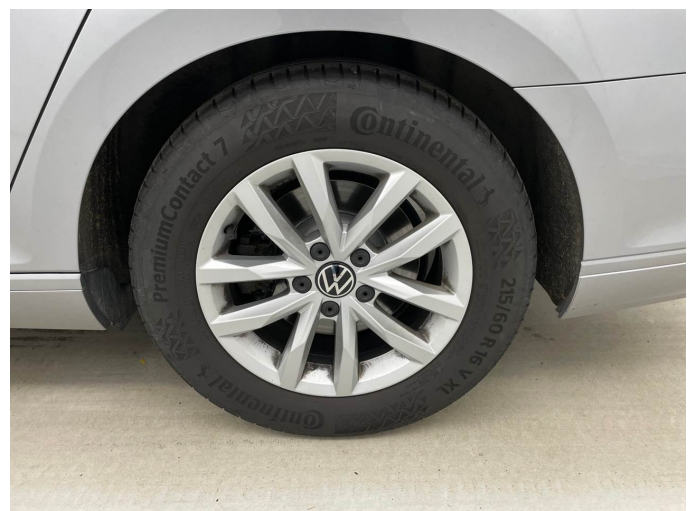
Figure 12: Mounted tyres

| Mounted tyres | | | | |
|---|---|--|---|---|
| 1) | 215/60 R16 99V | Summer tyres on Light alloy | Pirelli | 6mm / 6mm |
| 2) | 215/60 R16 99V | Summer tyres on Light alloy | Continental | 6mm / 6mm |

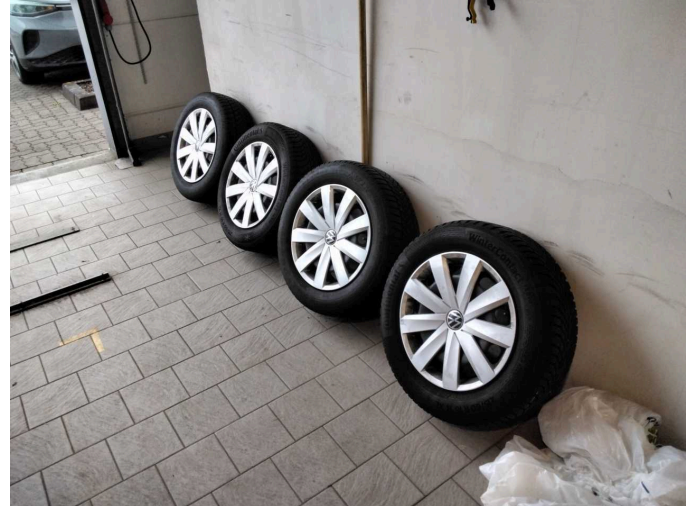
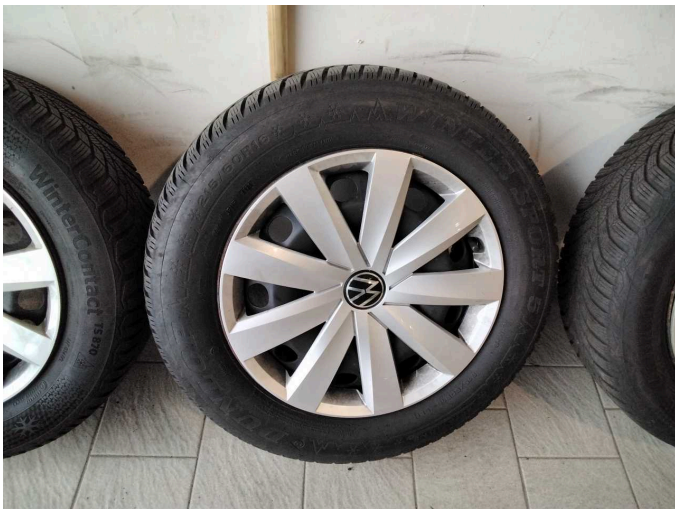
| Mounted tyres | | | | |
|---|---|--|---|---|
| 1) | 215/60 R16 99H | Winter tyres on Steel rim with wheel cover | Continental | 6mm / 6mm |
| 2) | 215/60 R16 99H | Winter tyres on Steel rim with wheel cover | Continental | 6mm / 6mm |

Figure 14: Additional tyres

Figure 15: Additional tyres

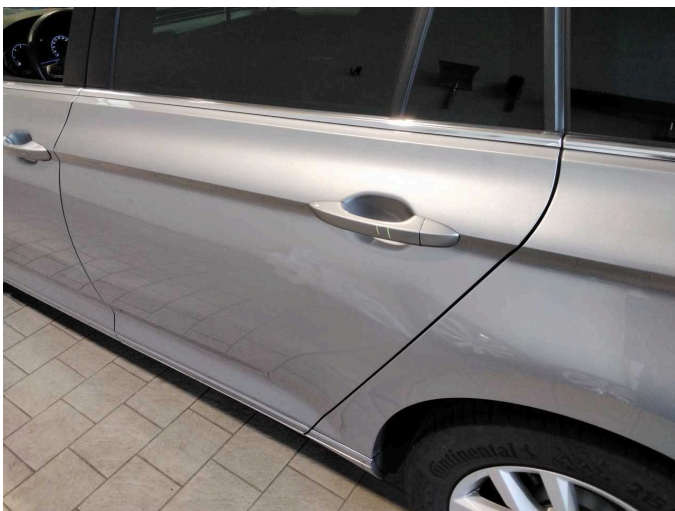
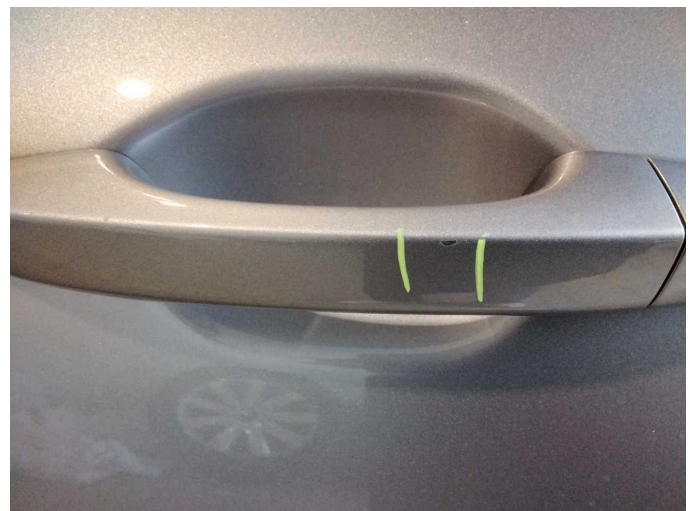
| No. | Component group | Description |
|---|---|---|
| 1 | Door - rear left side | Door handle - outside - Scratch(es) - Smart repair |

Damage 1: Door - rear left side: Door handle - outside - Scratch(es) - Smart repair

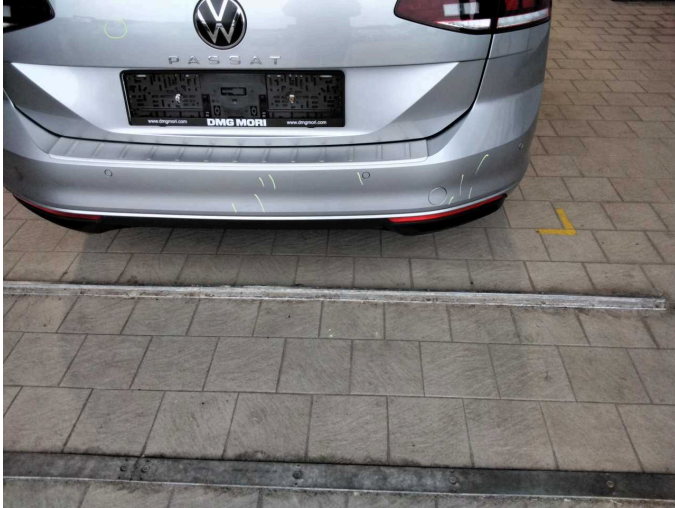
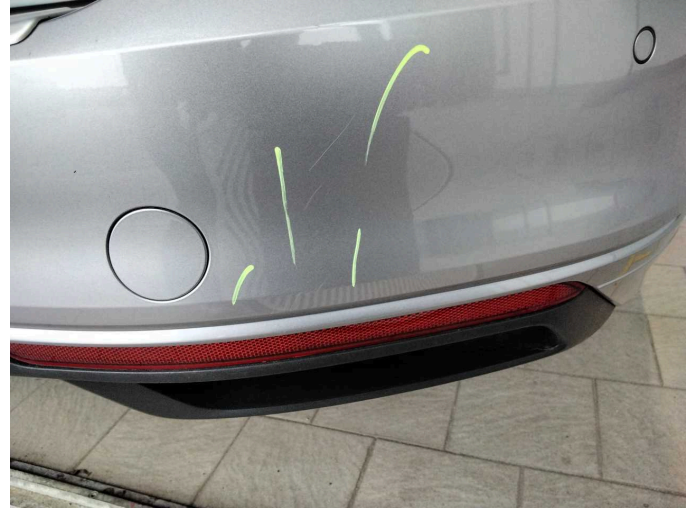
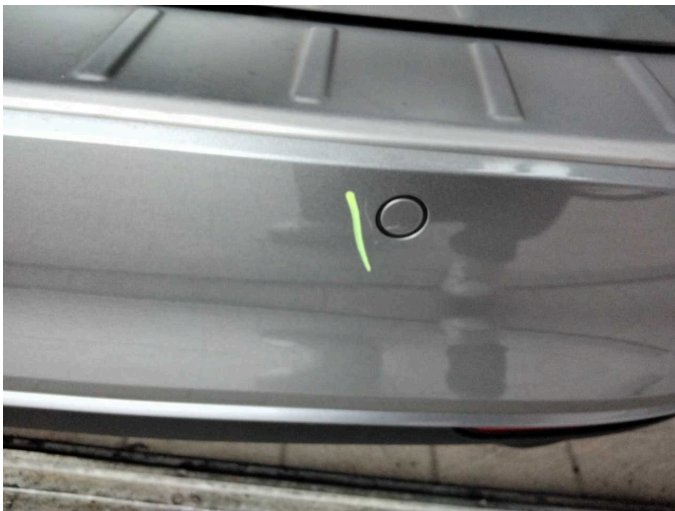
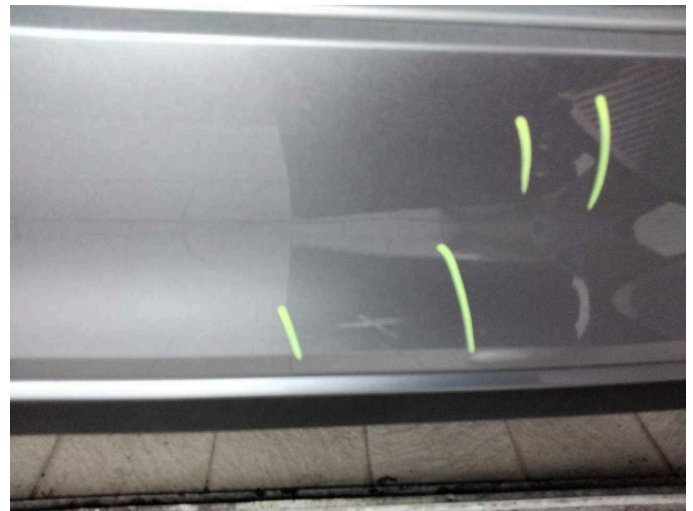
| No. | Component group | Description |
|---|---|---|
| 2 | Rear bumper | Rear bumper - Scratch(es) - Paint |

Damage 2: Rear bumper: Rear bumper - Scratch(es) - Paint

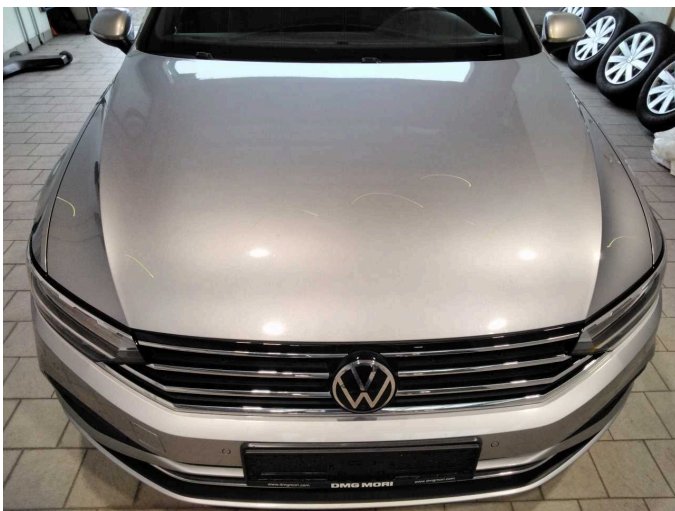
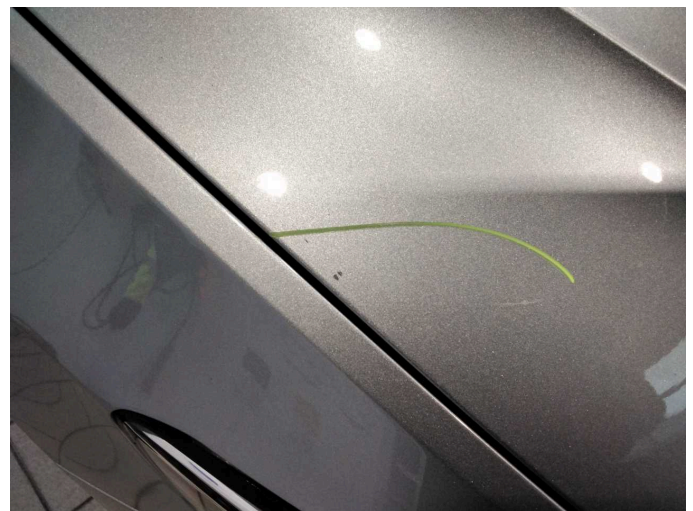
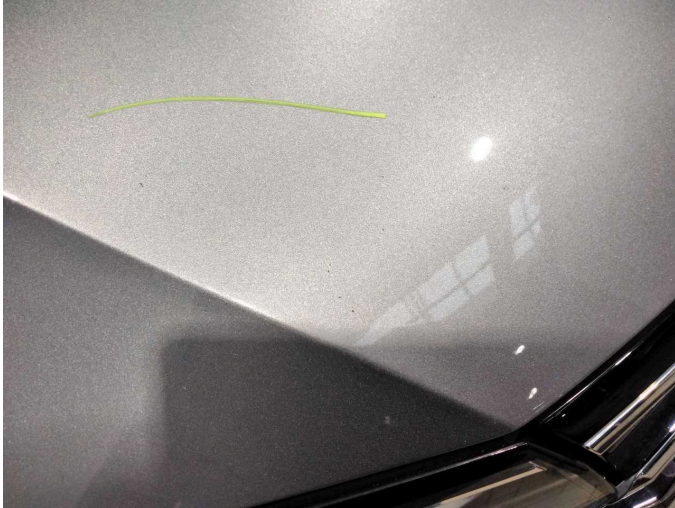
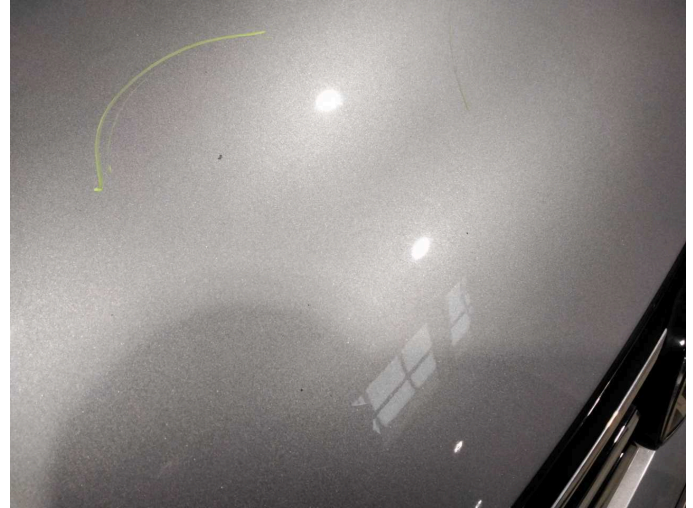
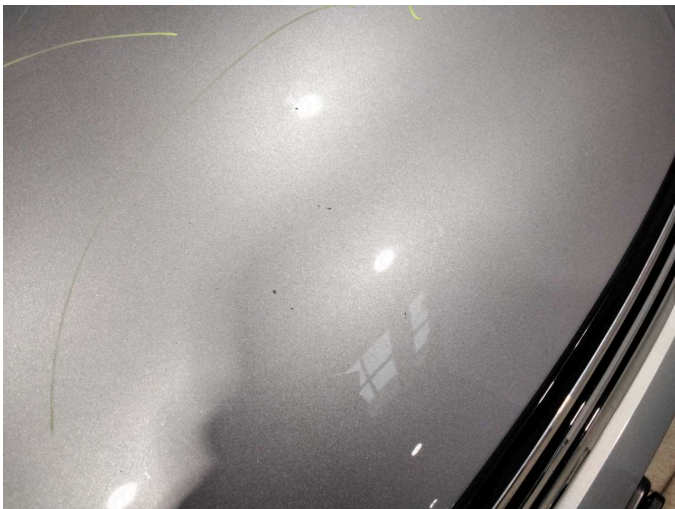
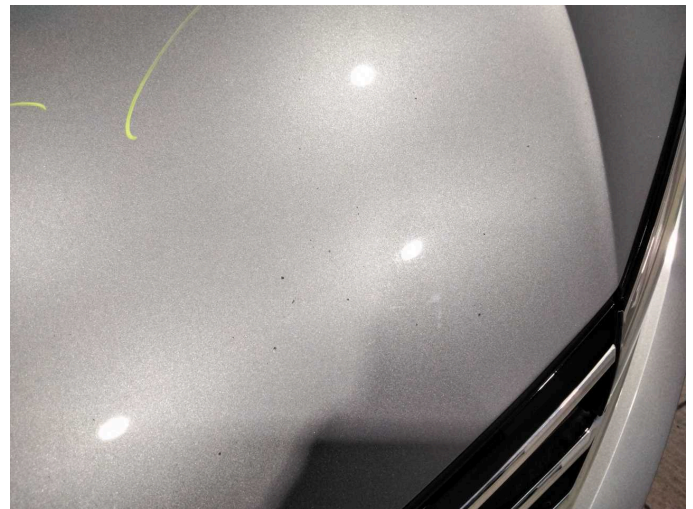
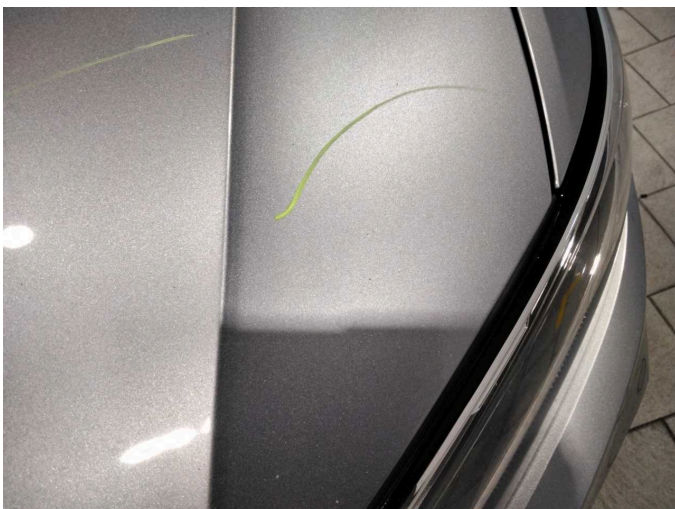
| No. | Component group | Description |
|---|---|---|
| 3 | Bonnet | Bonnet - Stone chips - Paint |

Damage 3: Bonnet: Bonnet - Stone chips - Paint

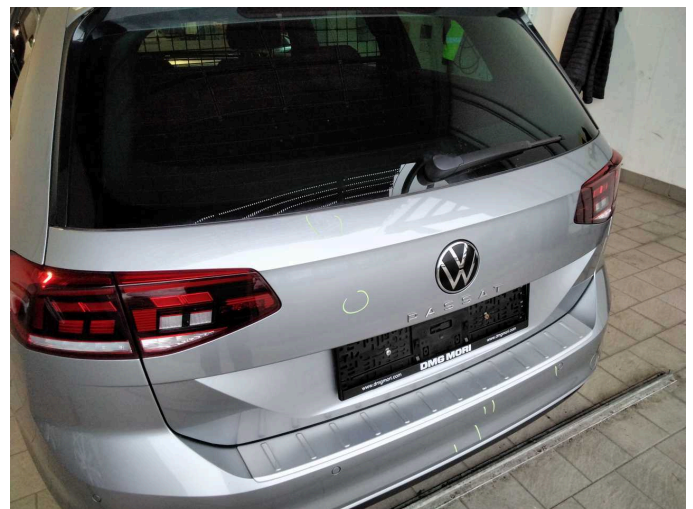
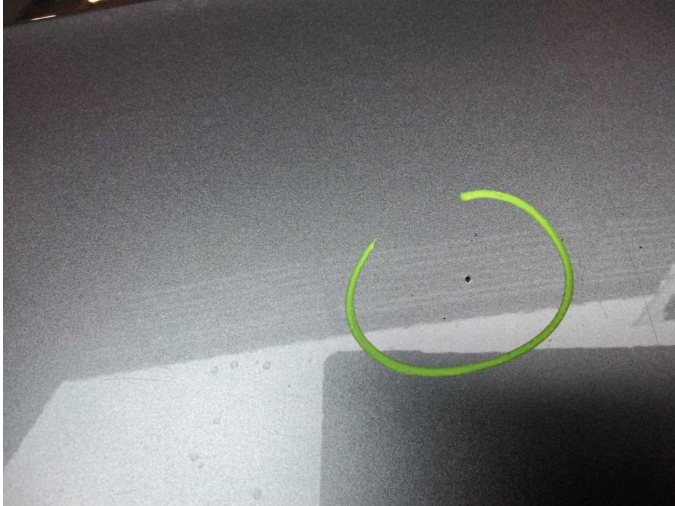
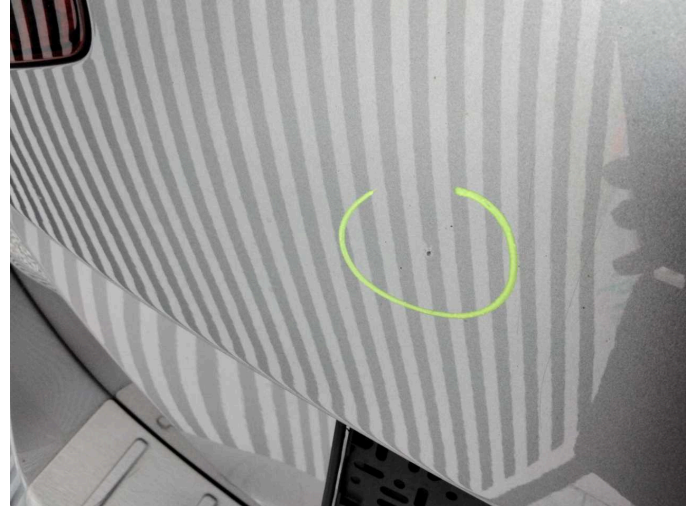
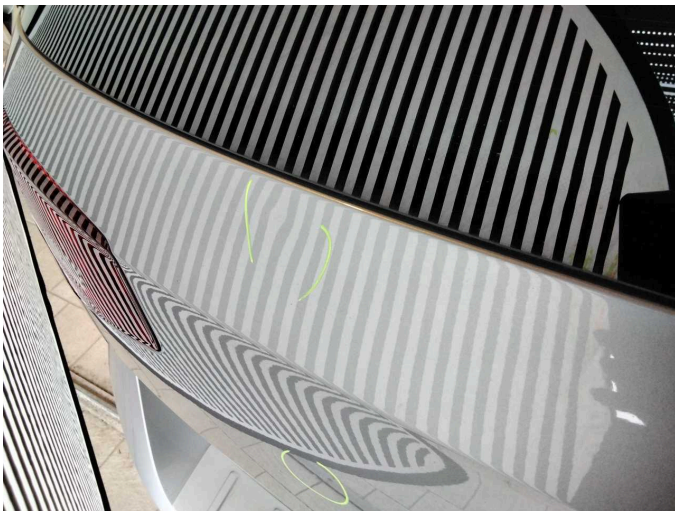
| No. | Component group | Description |
|---|---|---|
| 4 | Boot lid / rear door | Boot lid - Dent / paintcoat damage - Repair and paint |

Damage 4: Boot lid / rear door: Boot lid - Dent / paintcoat damage - Repair and paint

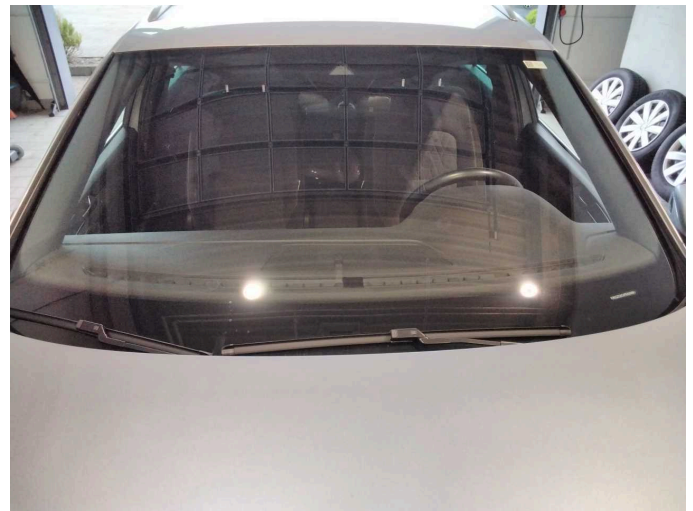
| No. | Component group | Description |
|---|---|---|
| 1 | Vehicle glazing | Windscreen - Stone chips - No deduction |

Wear and tear 1: Vehicle glazing: Windscreen - Stone chips - No deduction

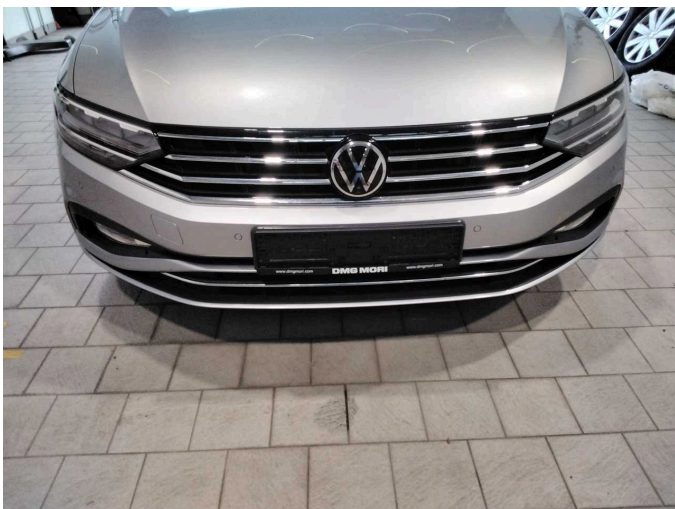
| No. | Component group | Description |
|---|---|---|
| 2 | Front bumper | Front bumper - Stone chips - No deduction |

Wear and tear 2: Front bumper: Front bumper - Stone chips - No deduction

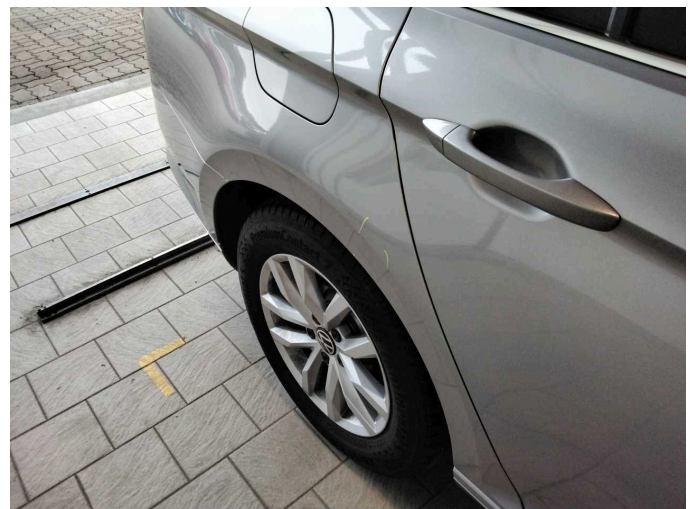
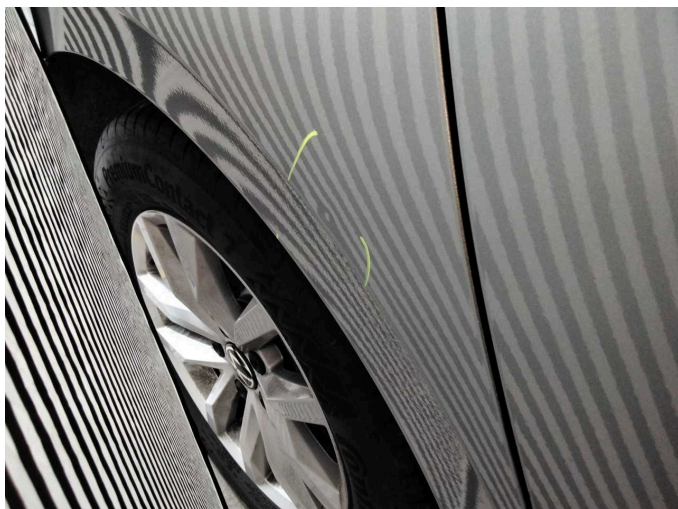
| No. | Component group | Description |
|---|---|---|
| 3 | Side panel - rear right side | Side panel - dent(s) - No deduction |

Wear and tear 3: Side panel - rear right side: Side panel - dent(s) - No deduction
