Expertise

Protocol number: 46458711  
Order No. / Reference: 26550817  
Inspection date: 10 Jul 2026

Manufacturer: Mercedes-Benz  
VIN: W1KAH0GB5PF109894

Model: C 300 d T 9G-TRONIC AMG Line

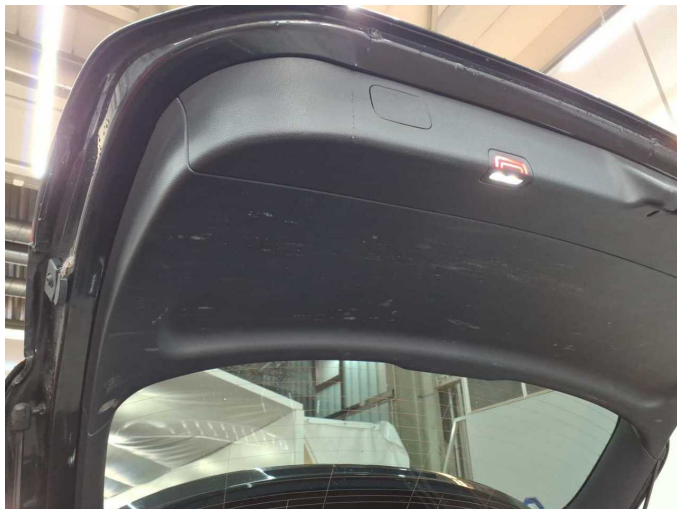
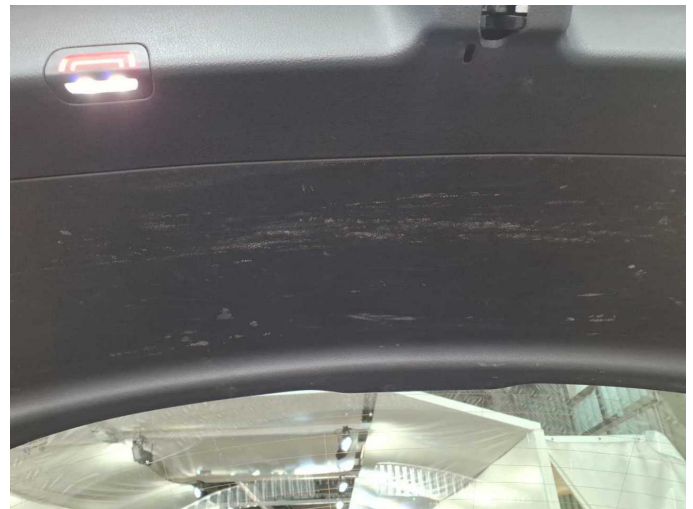
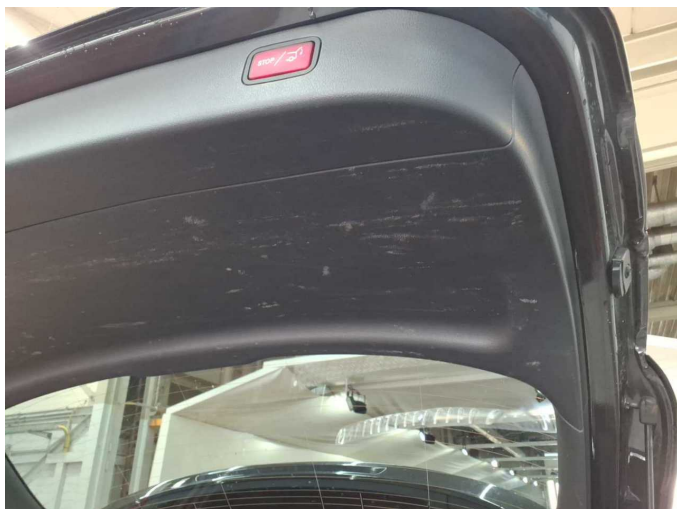
| No. | Component group | Description |
|---|---|---|
| 2 | Trim / covers | Boot lid - interior trim - Scratch(es) - Loss in value |

**Damage 2:** Trim / covers: Boot lid - interior trim - Scratch(es) - Loss in value

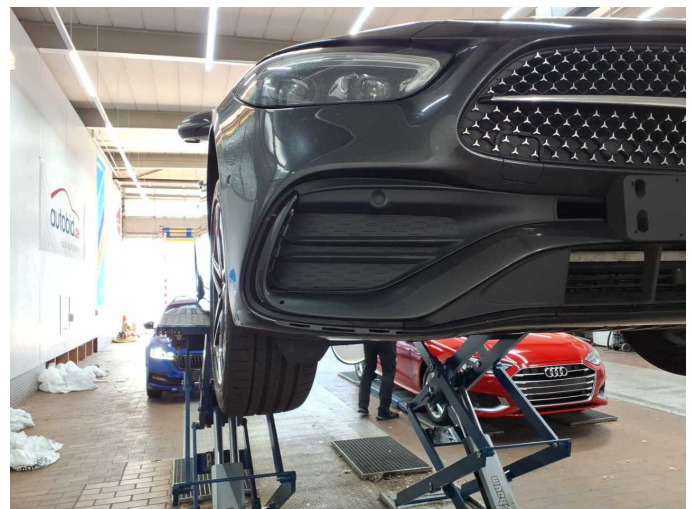
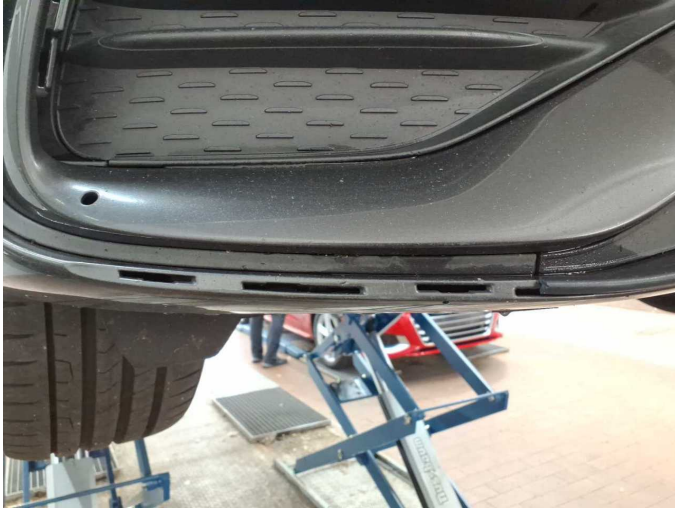
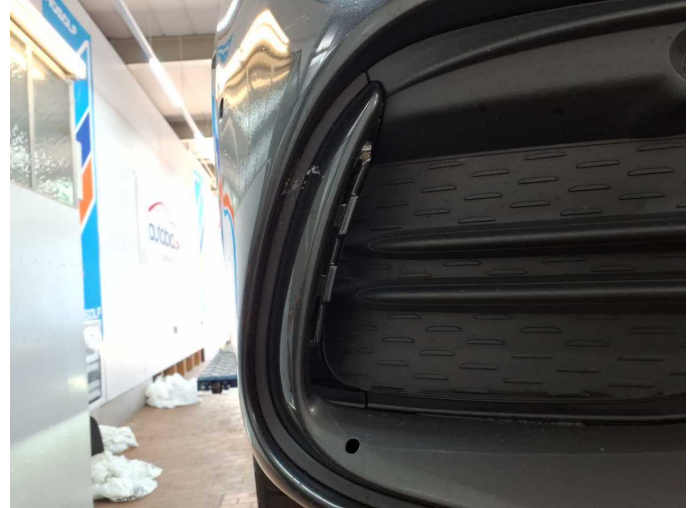
| No. | Component group | Description |
|---|---|---|
| 3 | Front bumper | Front bumper (Blende) - Broken / torn - Replace |

**Damage 3:** Front bumper: Front bumper (Blende) - Broken / torn - Replace

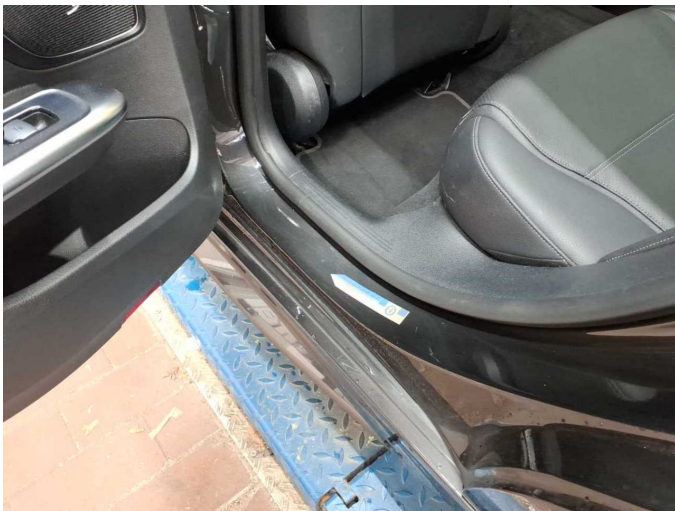
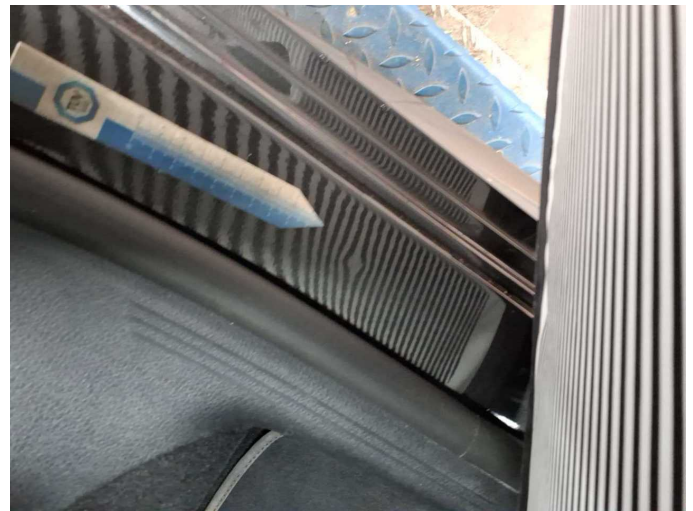
| No. | Component group | Description |
|---|---|---|
| 4 | Side panel - rear left side | Sill - dent(s) - Smart repair |

**Damage 4:** Side panel - rear left side: Sill - dent(s) - Smart repair

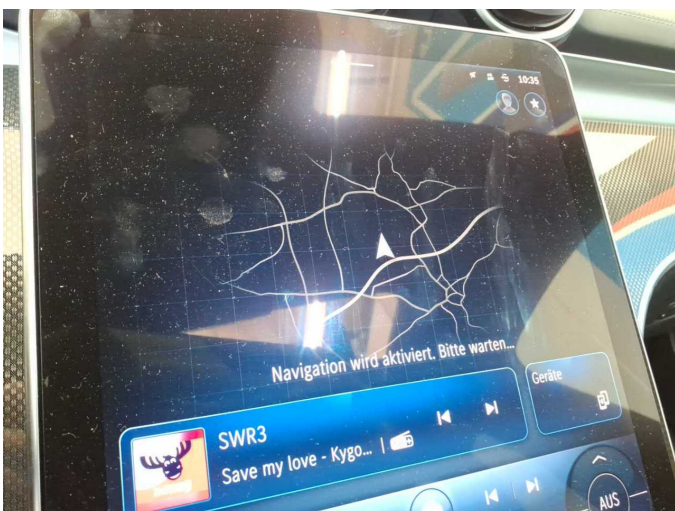
| No. | Component group | Description |
|---|---|---|
| 5 | Multimedia system | Navigation system - Non-operational - Perform diagnosis |

**Damage 5:** Multimedia system: Navigation system - Non-operational - Perform diagnosis

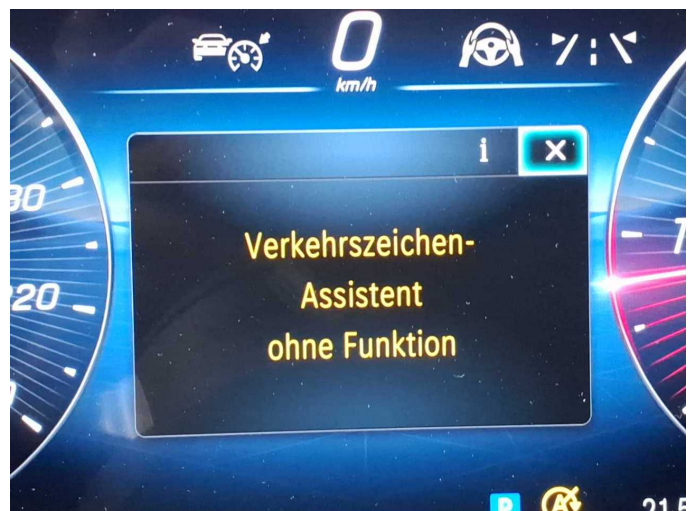
| No. | Component group | Description |
|---|---|---|
| 6 | Instrument panel | Indicator light (Verkehrszeichen Erkennung) - Non-operational - Perform diagnosis |

**Damage 6:** Instrument panel: Indicator light (Verkehrszeichen Erkennung) - Non-operational - Perform diagnosis

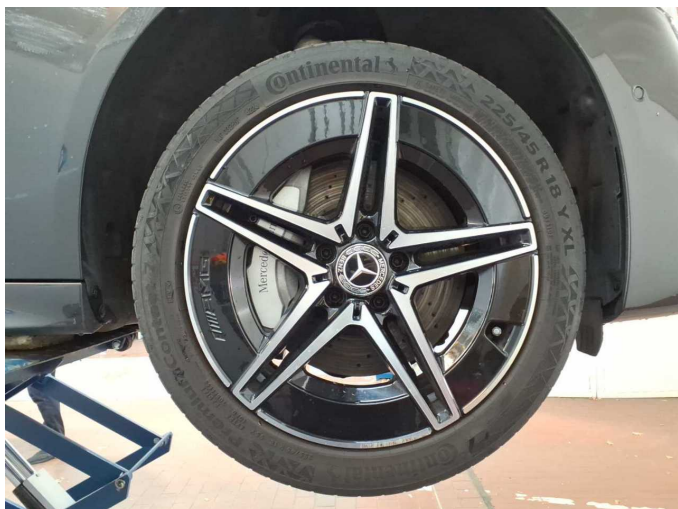
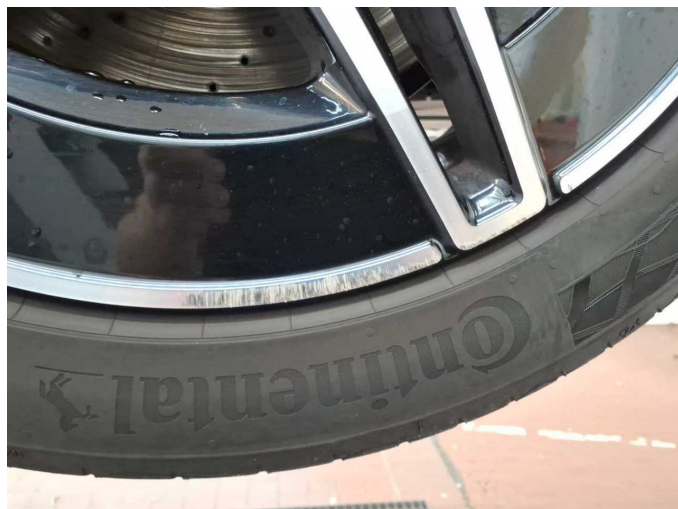
| No. | Component group | Description |
|---|---|---|
| 7 | Wheel / tyres | Alloy rim - front right side - Scratch(es) - Loss in value |

**Damage 7:** Wheel / tyres: Alloy rim - front right side - Scratch(es) - Loss in value

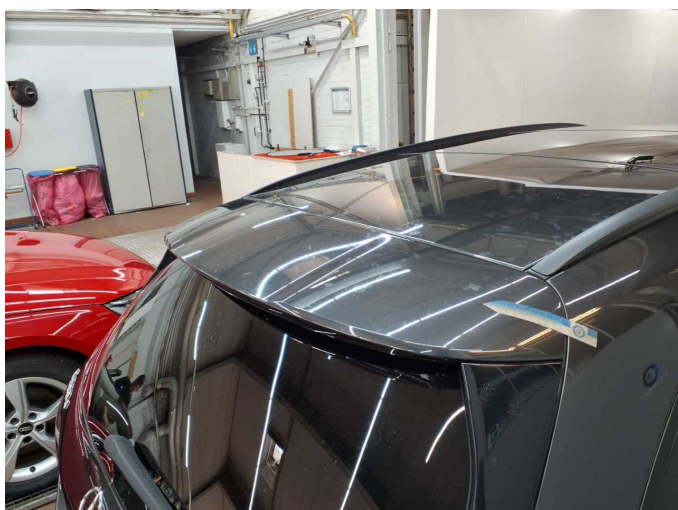
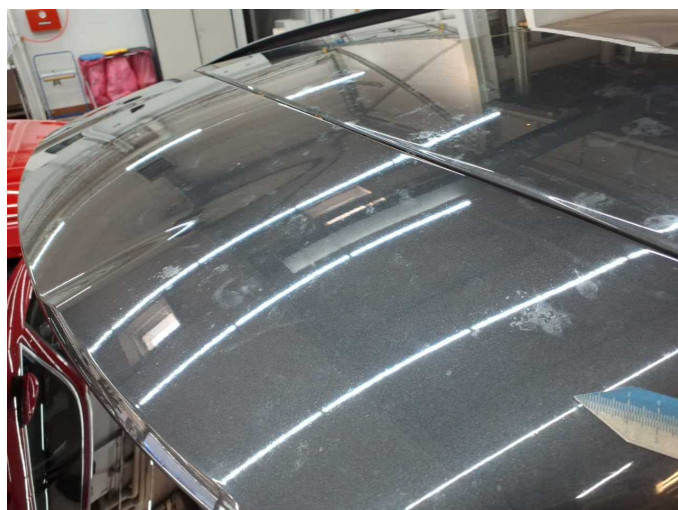
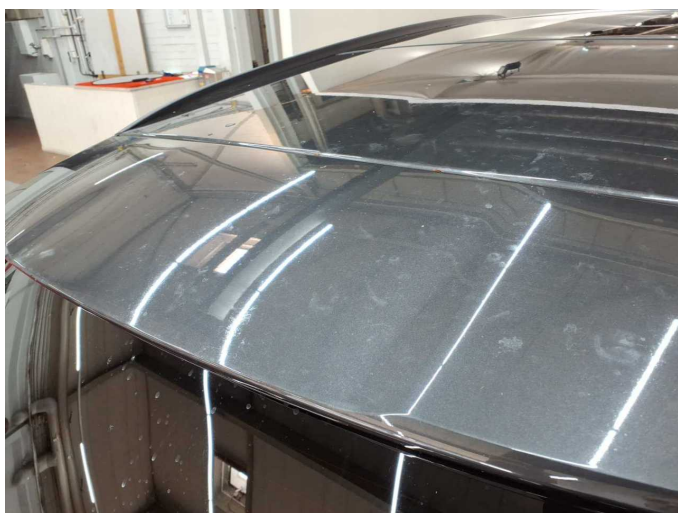
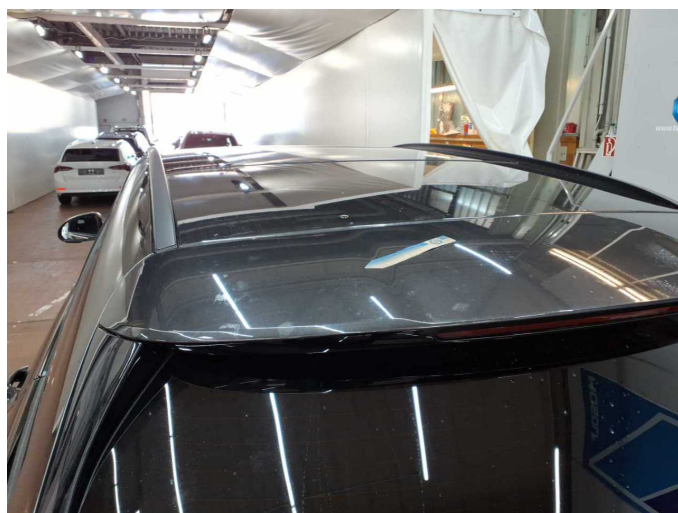
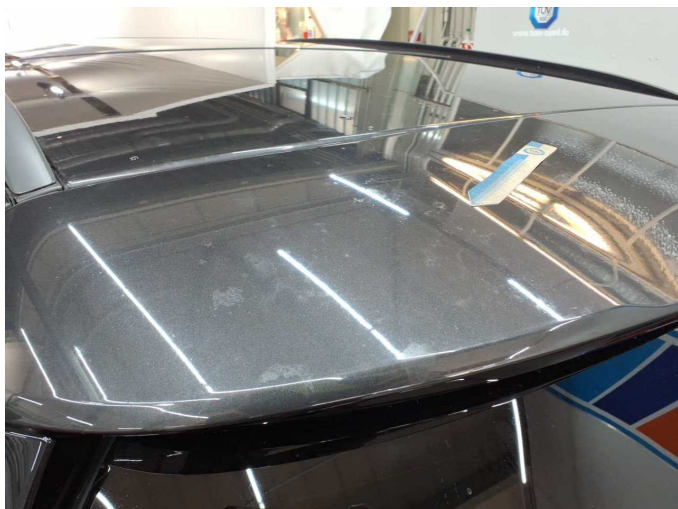
| No. | Component group | Description |
|---|---|---|
| 8 | Boot lid / rear door | Rear spoiler (Verätzungen) - Paint defect - Paint |

**Damage 8:** Boot lid / rear door: Rear spoiler (Verätzungen) - Paint defect - Paint

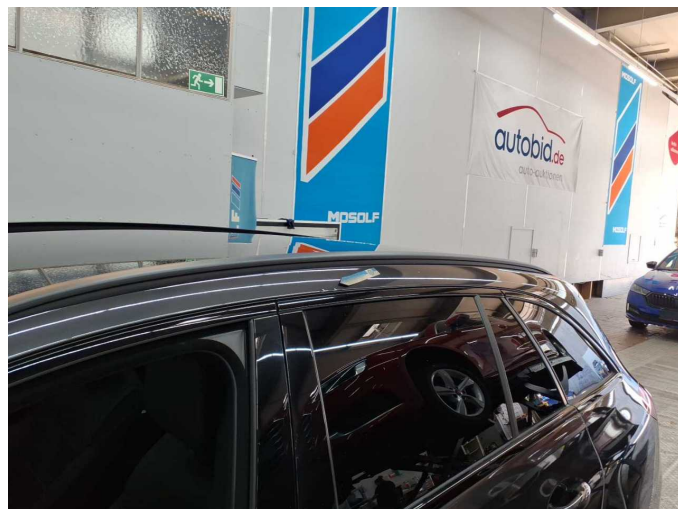
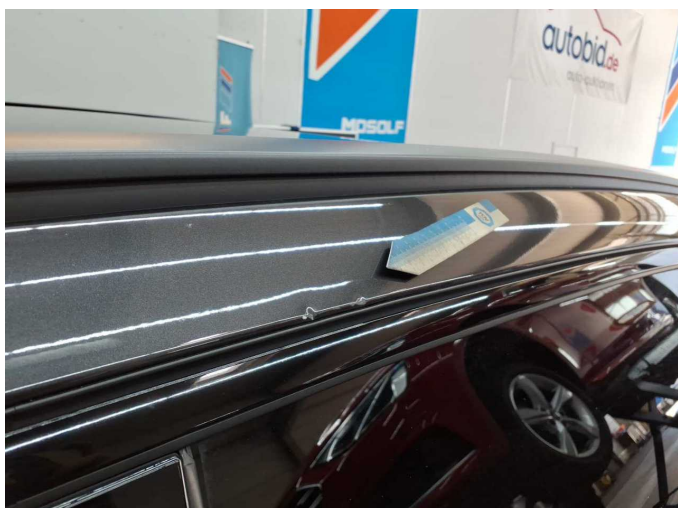
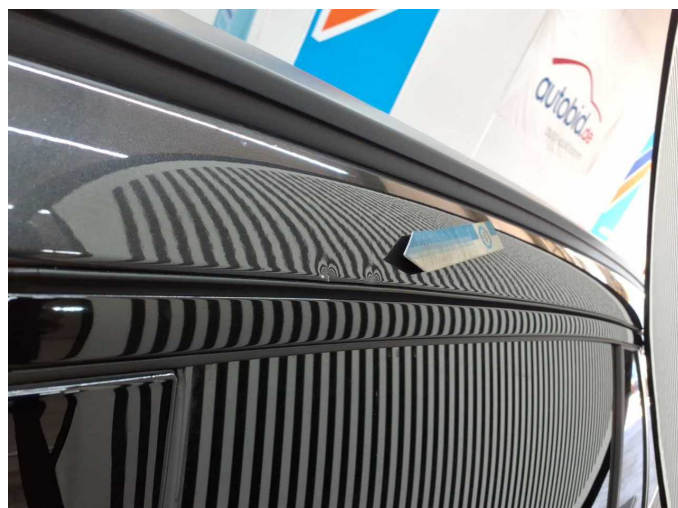
| No. | Component group | Description |
|---|---|---|
| 9 | Roof | Roof rail - left side - Dent / paintcoat damage - Repair and paint |

**Damage 9:** Roof: Roof rail - left side - Dent / paintcoat damage - Repair and paint

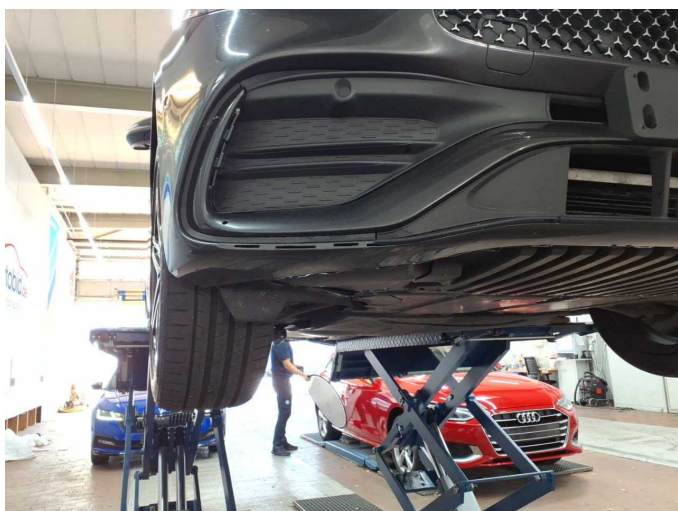
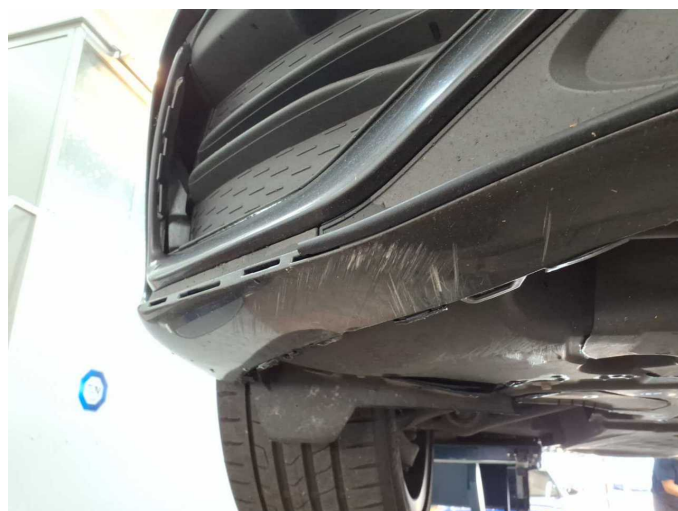
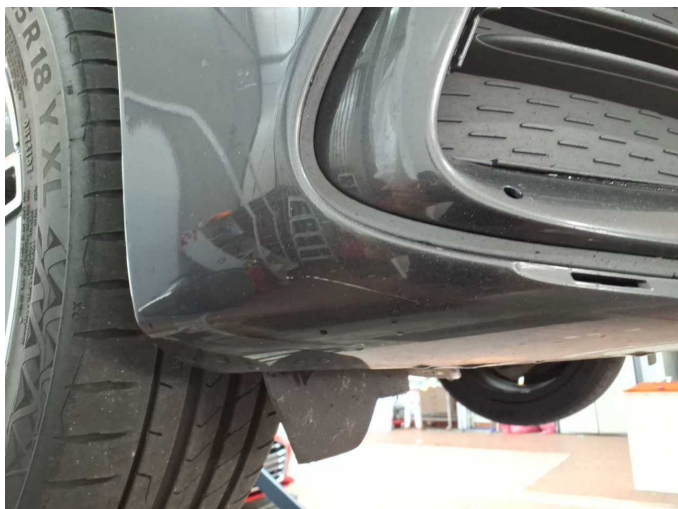
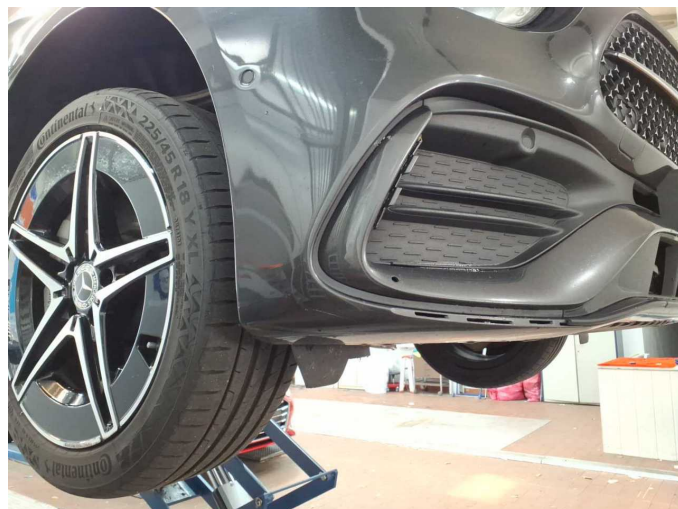
| No. | Component group | Description |
|---|---|---|
| 10 | Front bumper | Front bumper - Scratch(es) - Paint |

**Damage 10:** Front bumper: Front bumper - Scratch(es) - Paint

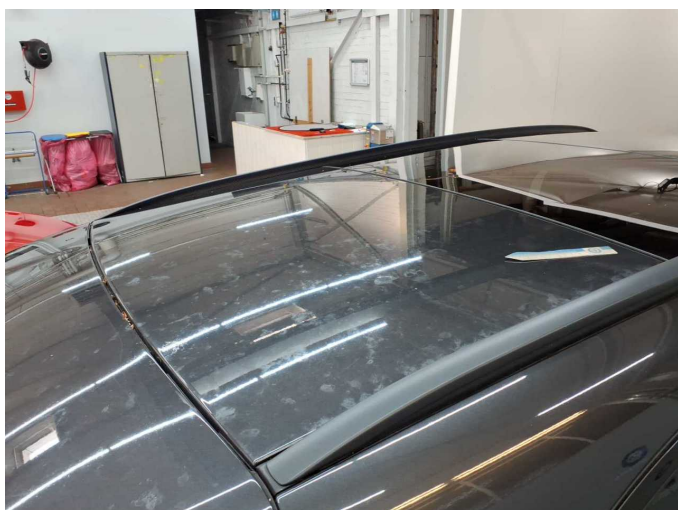
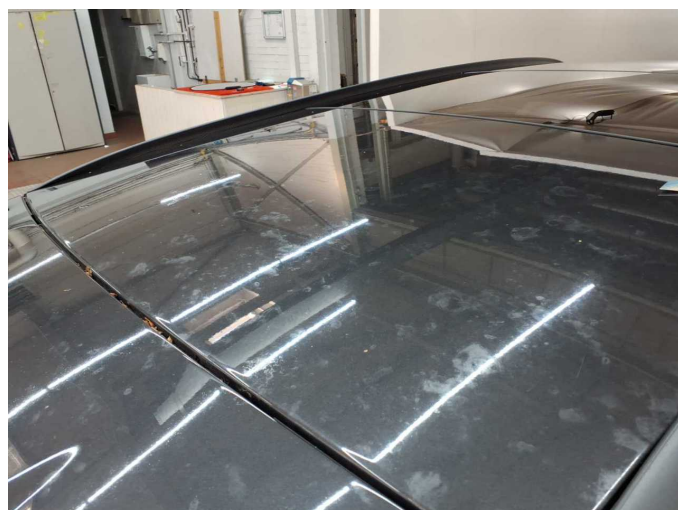
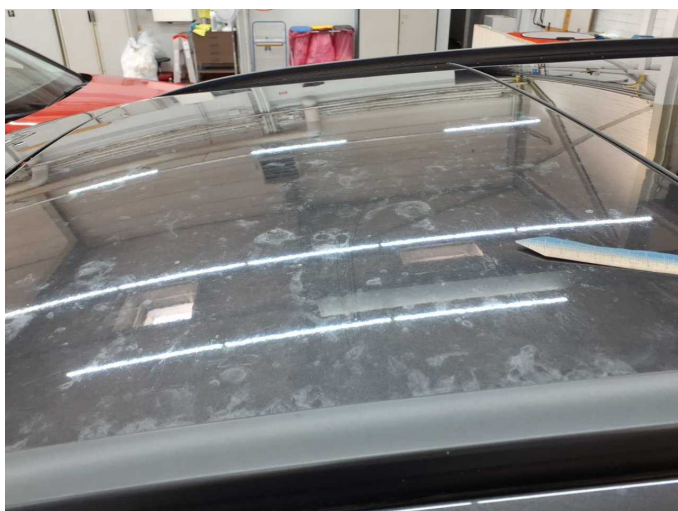
| No. | Component group | Description |
|---|---|---|
| 11 | Roof | Roof (Verätzungen) - Paint defect - Paint |

**Damage 11:** Roof: Roof (Verätzungen) - Paint defect - Paint

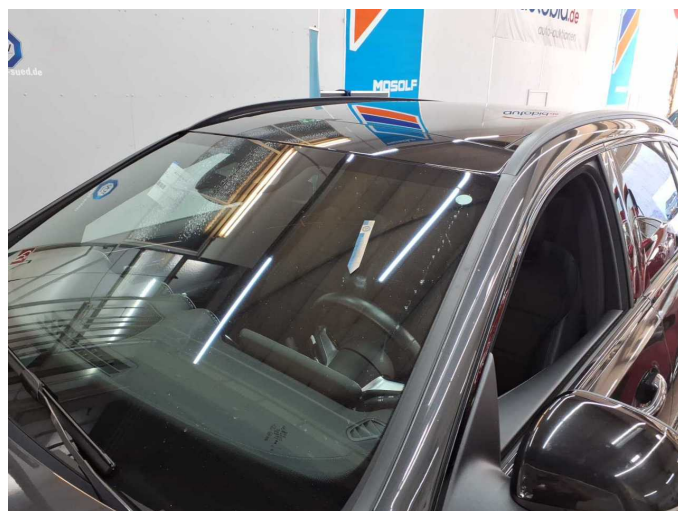
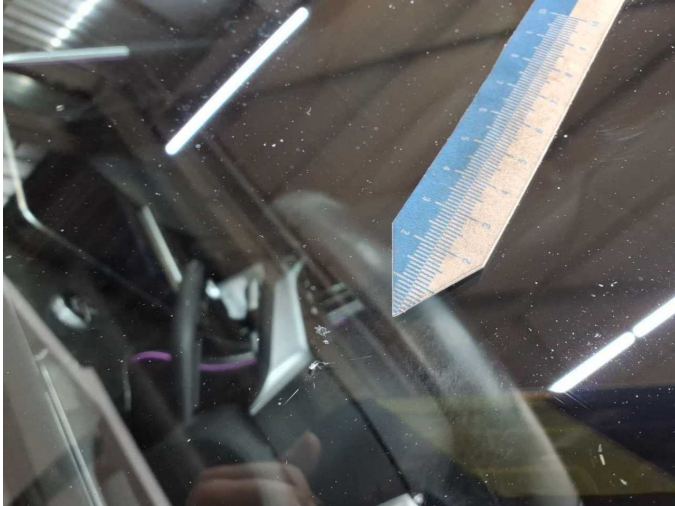
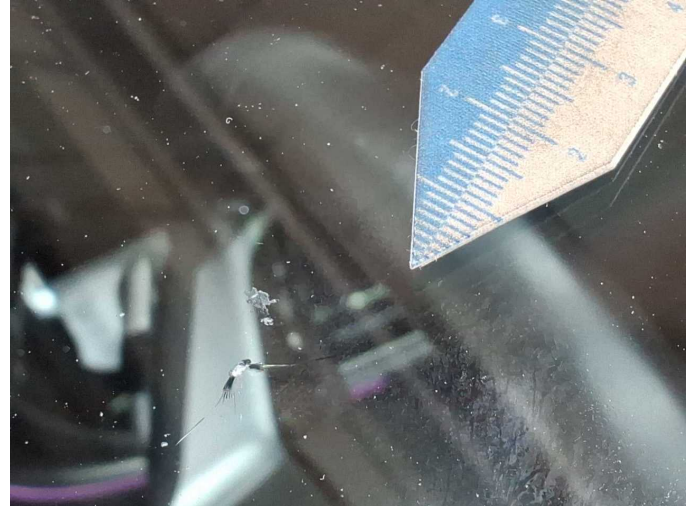
| No. | Component group | Description |
|---|---|---|
| 12 | Vehicle glazing | Windscreen - Stone chips - Replace |

**Damage 12:** Vehicle glazing: Windscreen - Stone chips - Replace

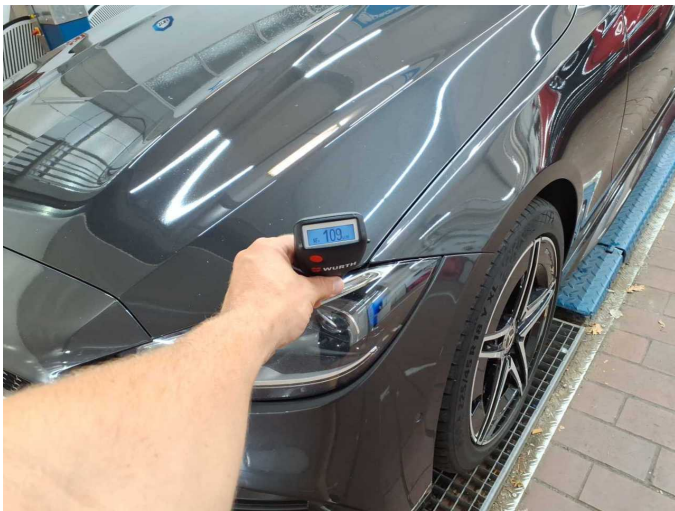
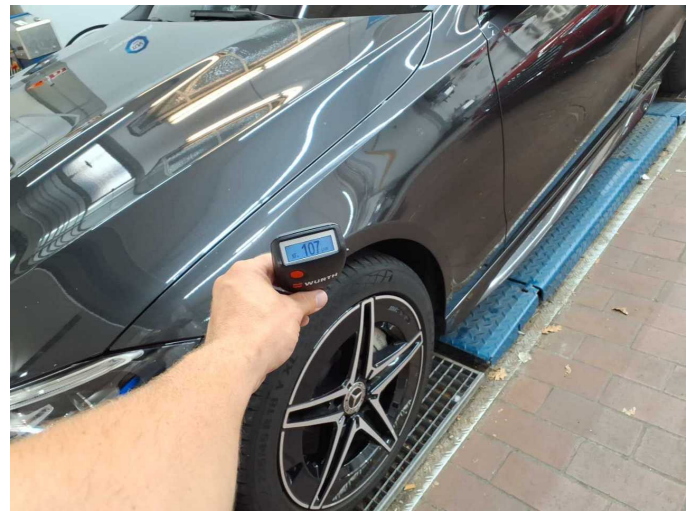
| No. | Previous damage | Extent of damage (Net) |
|---|---|---|
| 1 | Front, Side - left, Provided by user / customer, from 18 Oct 2024 | 1.272,44 € |

**Previous damage 1:** Front, Side - left

According to available information previous damages were repaired at the vehicle. Traces of repairs, which allow conclusions about the area of repair, were not recognizable during the inspection.
