Expertise

Protocol number: 46025641
Order No. / Reference: 26460897
Inspection date: 18 Jun 2026

Model: Superb Combi 1.4 TSI iV DSG Sportline

VIN: TMBJW7NP2N7017348

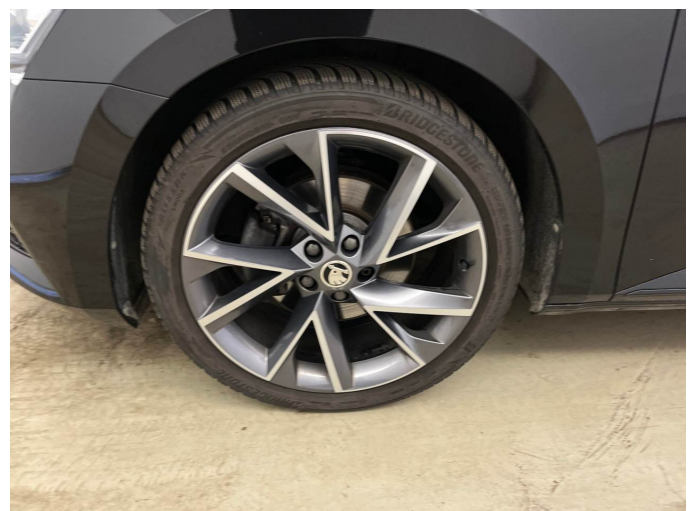
Figure 12: Mounted tyres

Mounted tyres				
#	Tyre size	Type of tyre	Manufacturer	Tread depth
1)	235/40 R19 96V	Winter tyres on Light alloy	Bridgestone	6mm / 6mm
2)	235/40 R19 96V	Winter tyres on Light alloy	Bridgestone	6mm / 6mm
Additional tyres				
#	Tyre size	Type of tyre	Manufacturer	Tread depth
1)	235/40 R19 96W	Summer tyres on Light alloy	Bridgestone	4mm / 4mm
2)	235/40 R19 96W	Summer tyres on Light alloy	Bridgestone	5mm / 5mm
Replacement				
Typ	Tyre size	Type of tyre	Manufacturer	Tread depth
	Tirefit	Expiration date 07/2025

- Für den montierten Radsatz wurde kein Nachweis erbracht.
- Winterradsatz ist kein Bestandteil des Auslieferungsumfangs.

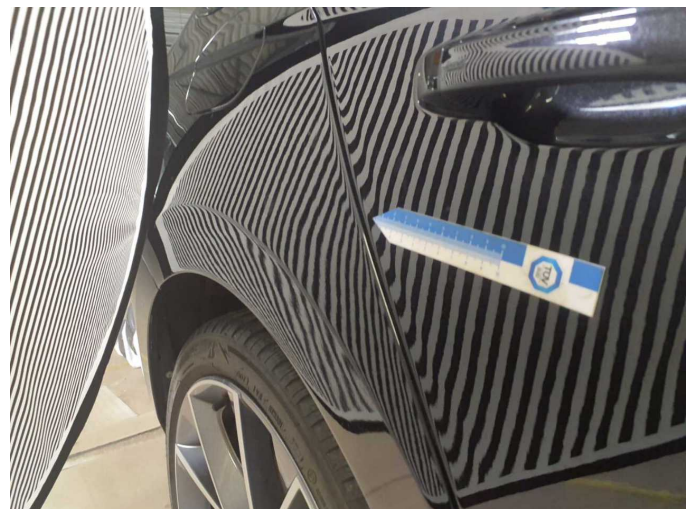
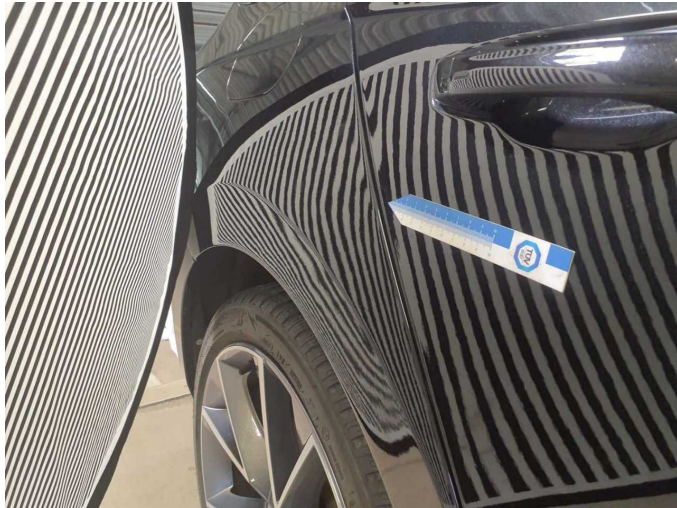
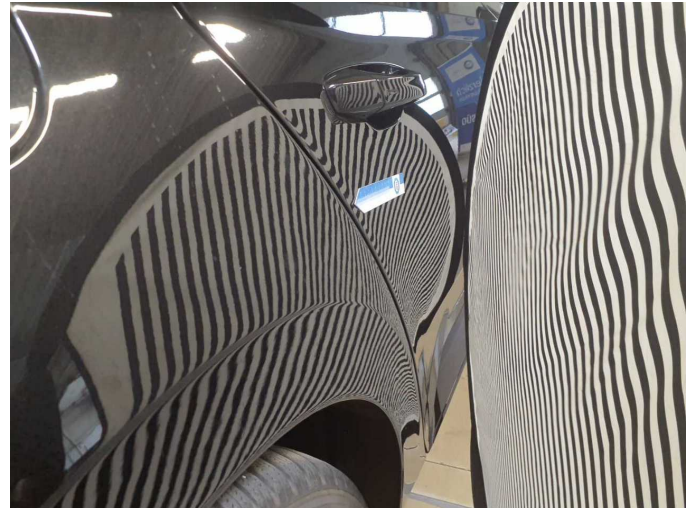
Damage 2: Side panel - rear right side: Side panel (Welliger Untergrund)
- Unprofessionally repaired - Repair and paint

No.	Component group	Description
1	Equipment	Tirefit filler - Expired - Replace
2	Side panel - rear right side	Side panel (Welliger Untergrund) - Unprofessionally repaired - Repair and paint

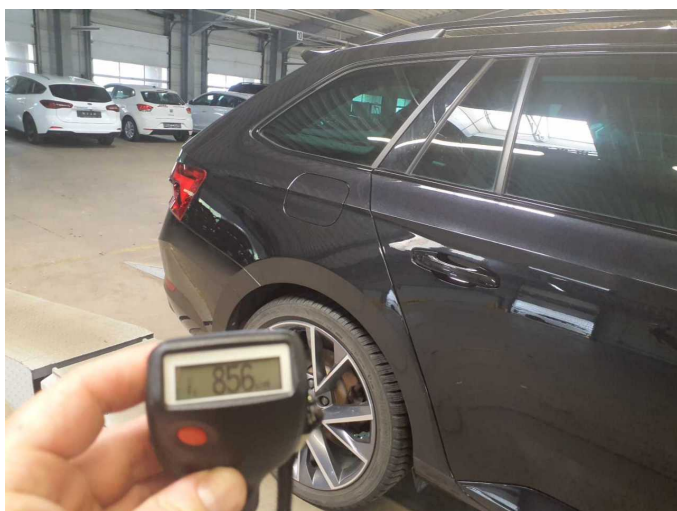
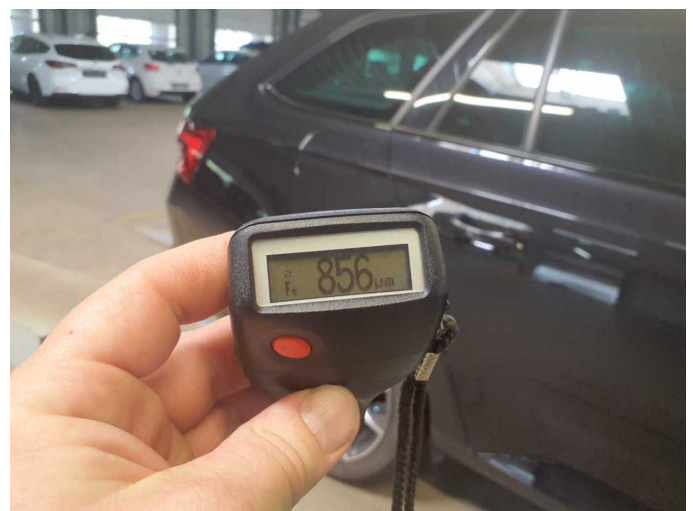
1	Side panel - rear right side, Unprofessionally carried out, Invoice of repair done Non-existent
---	---

Side panel - rear right side	856 µm
------------------------------	--------

Repainting 1: Side panel - rear right side
