Expertise

Protocol number: 46568236  
Order No. / Reference: 26664891  
Inspection date: 16 Jul 2026

Manufacturer: Mercedes-Benz  
VIN: W1N4M1CB8PW284437

Model: GLB 200 d 8G-DCT EDITION 2022

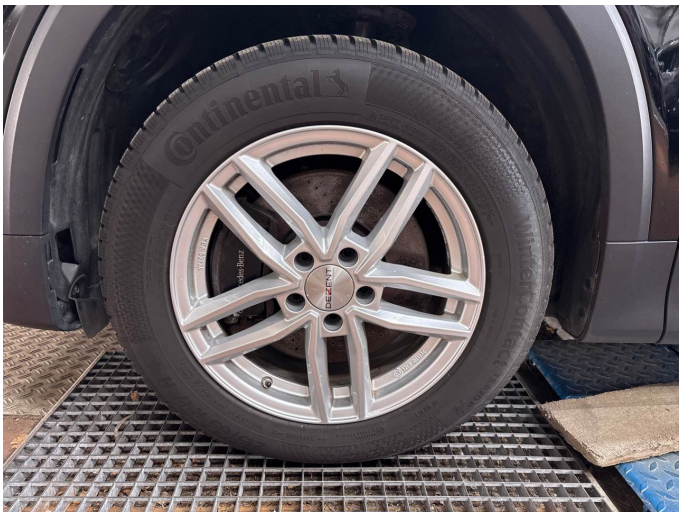
| # | Tyre size | Type of tyre | Manufacturer | Tread depth |
|---|---|---|---|---|
| 1) | 215/65 R17 99H | Winter tyres on Light alloy | Continental | 7mm / 7mm |
| 2) | 215/65 R17 99H | Winter tires (with run-flat tires) on Light alloy | Pirelli | 3mm / 3mm |

Figure 12: Mounted tyres

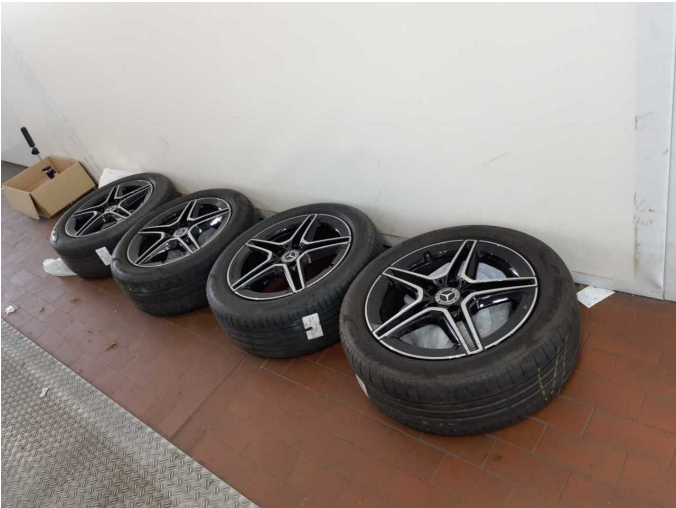
| # | Tyre size | Type of tyre | Manufacturer | Tread depth |
|---|---|---|---|---|
| 1) | 235/50 R19 99W | Summer tyres on Light alloy | Pirelli | 3mm / 3mm |
| 2) | 235/50 R19 99W | Summer tyres on Light alloy | Pirelli | 6mm / 6mm |

Figure 15: Additional tyres

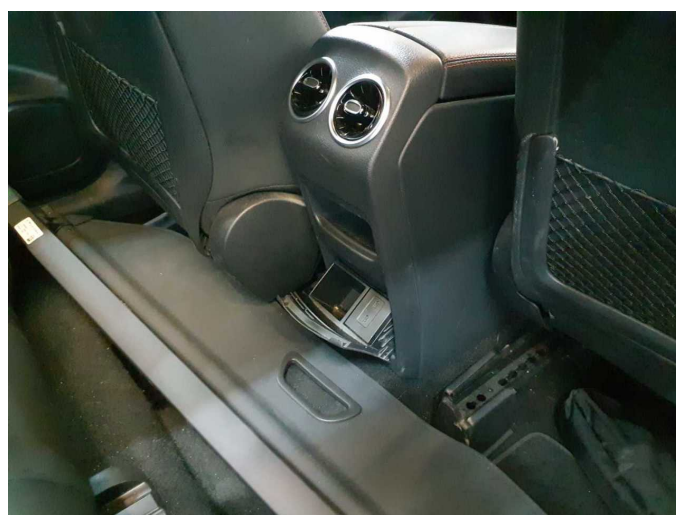
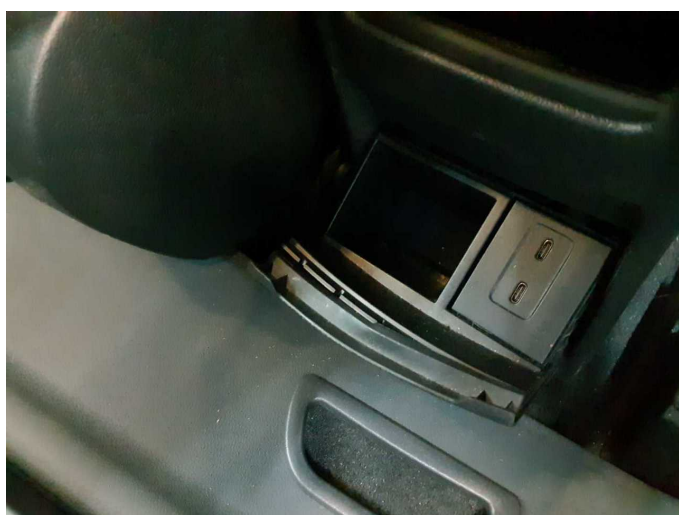
Damage 2: Instrument panel: Centre console - rear - Damaged - Replace

| No. | Component group | Description |
|---|---|---|
| 2 | Instrument panel | Centre console - rear - Damaged - Replace |

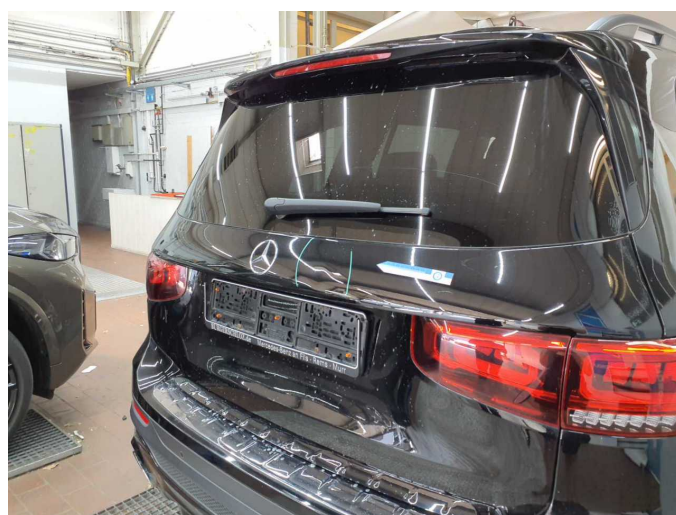
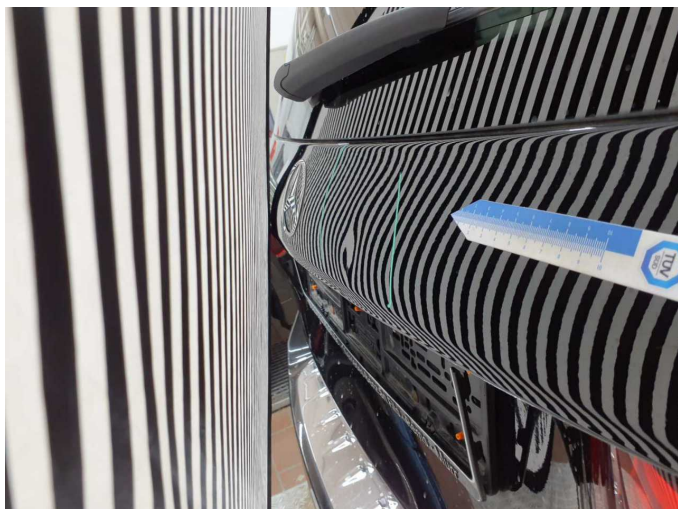
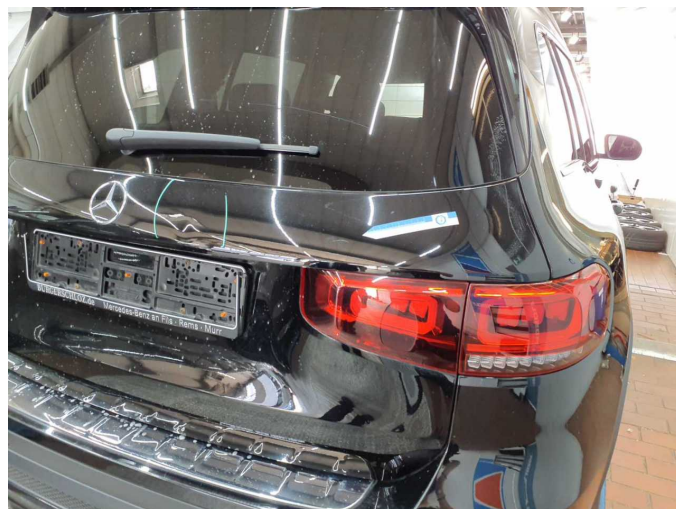
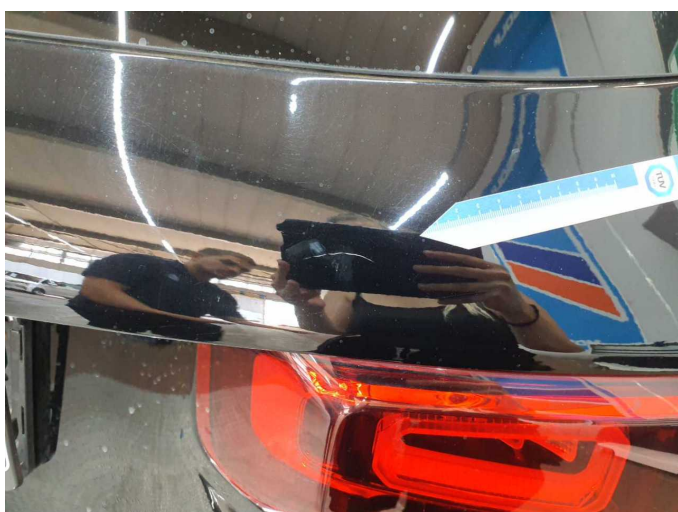
Damage 3: Boot lid / rear door: Boot lid (Mit Kratzer) - dent(s) - Smooth repair work

**Damage 3:** Boot lid / rear door: Boot lid (Mit Kratzer) - dent(s) - Smooth repair work

| No. | Component group | Description |
|---|---|---|
| 3 | Boot lid / rear door | Boot lid (Mit Kratzer) - dent(s) - Smooth repair work |

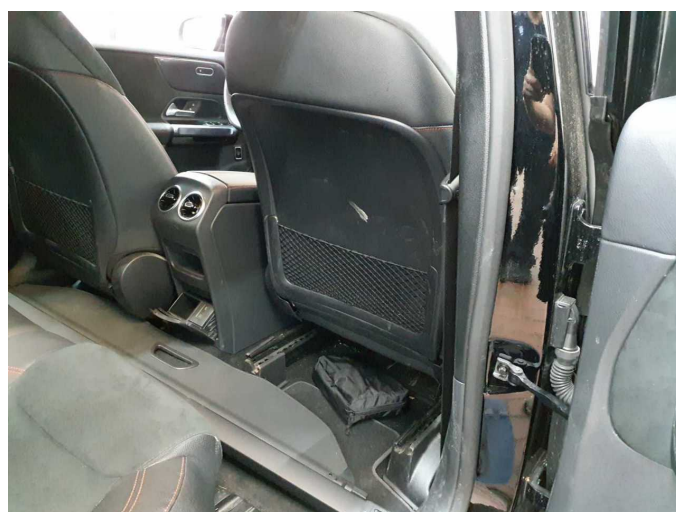
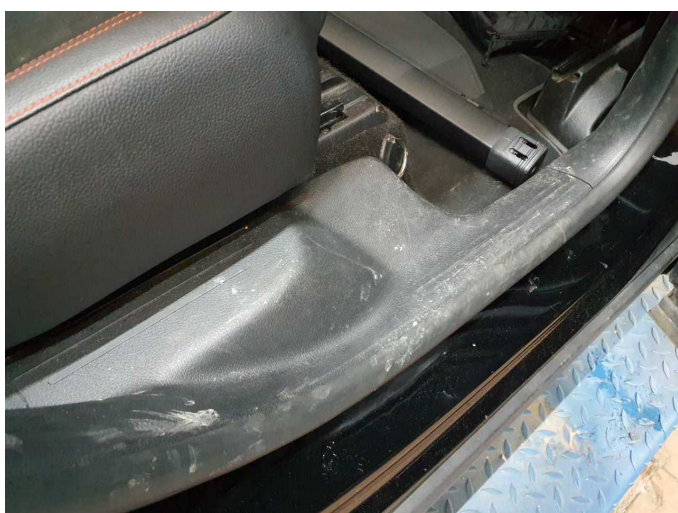
**Damage 4:** Interior: Interior - Soiled - Clean

| No. | Component group | Description |
|---|---|---|
| 4 | Interior | Interior - Soiled - Clean |

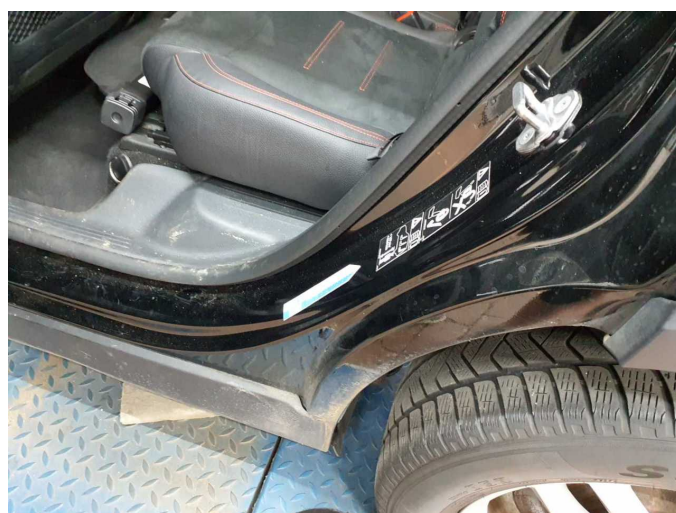
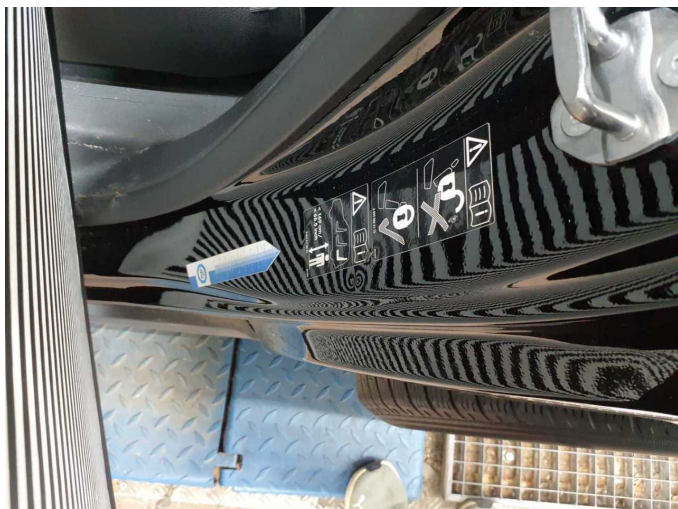
**Damage 5:** Side panel - rear left side: Sill - dent(s) - Smart repair

| No. | Component group | Description |
|---|---|---|
| 5 | Side panel - rear left side | Sill - dent(s) - Smart repair |

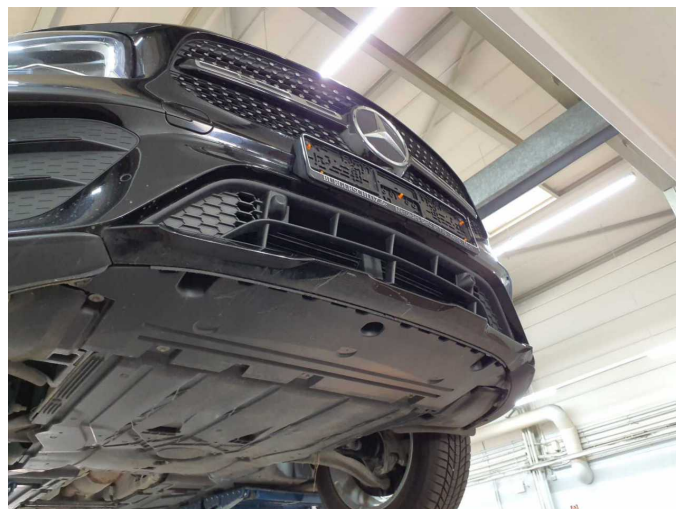
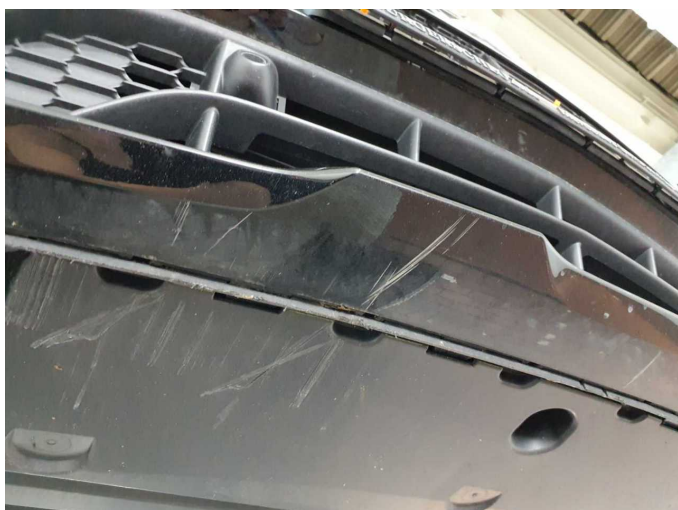
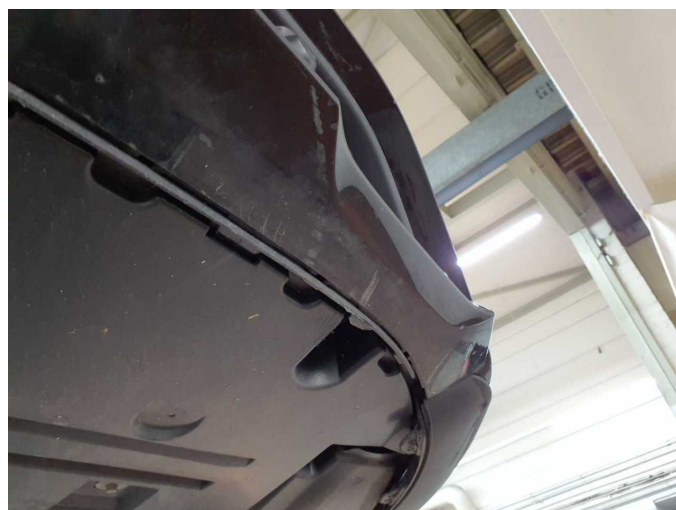
**Damage 6:** Front bumper: Spoiler - Scratch(es) - Paint

| No. | Component group | Description |
|---|---|---|
| 6 | Front bumper | Spoiler - Scratch(es) - Paint |

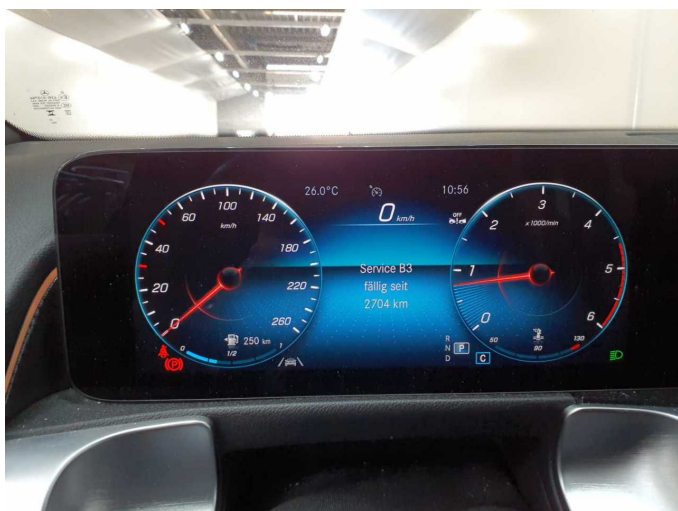
**Damage 7:** Misc.: Inspection / maintenance - Due - Perform

| No. | Component group | Description |
|---|---|---|
| 7 | Misc. | Inspection / maintenance - Due - Perform |

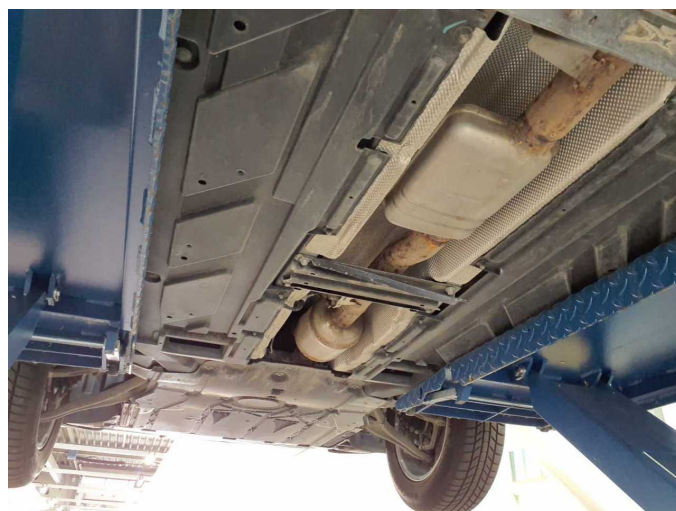
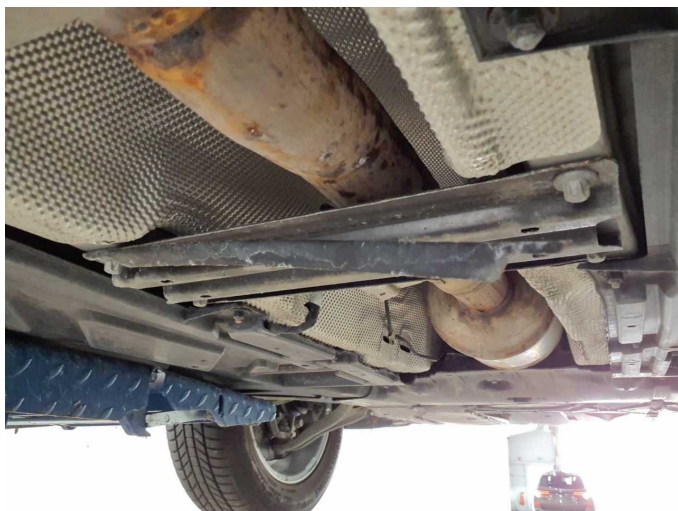
**Damage 8:** Body: Underbody - Broken / torn - Replace

| No. | Component group | Description |
|---|---|---|
| 8 | Body | Underbody - Broken / torn - Replace |

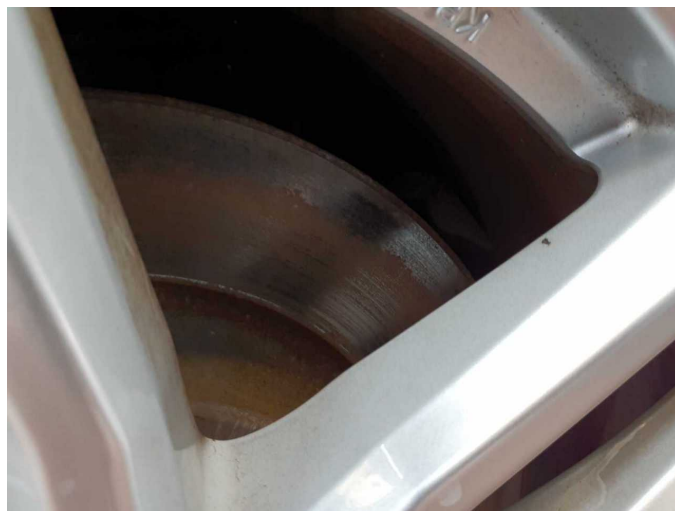
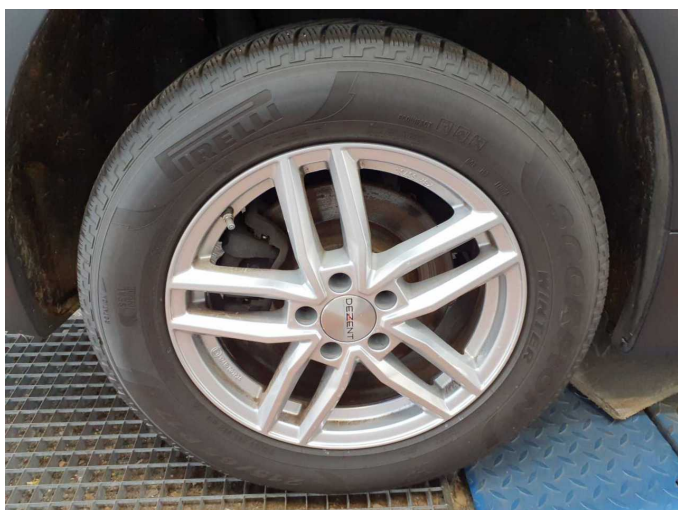
**Damage 9:** Braking system: Brake discs and pads - rear - Corrosion - Replace

| No. | Component group | Description |
|---|---|---|
| 9 | Braking system | Brake discs and pads - rear - Corrosion - Replace |

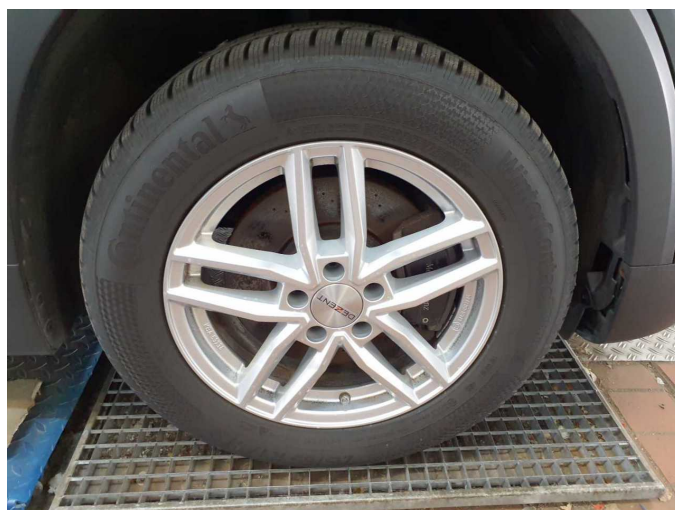
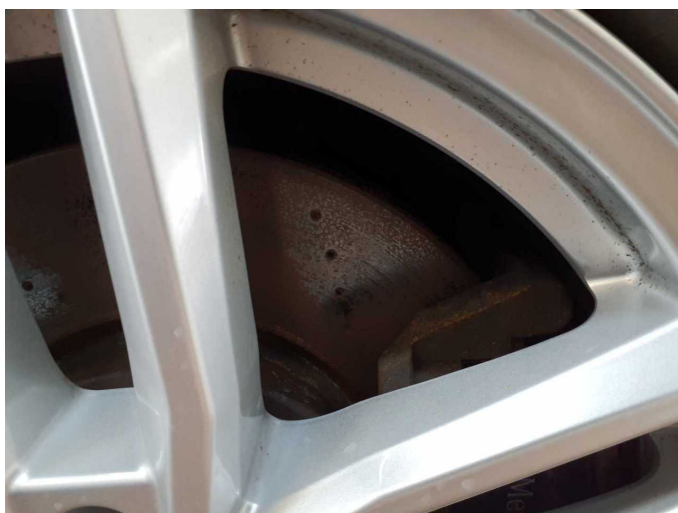
**Damage 10:** Braking system: Brake discs and brake pads - front - Corrosion - Replace

| No. | Component group | Description |
|---|---|---|
| 10 | Braking system | Brake discs and brake pads - front - Corrosion - Replace |

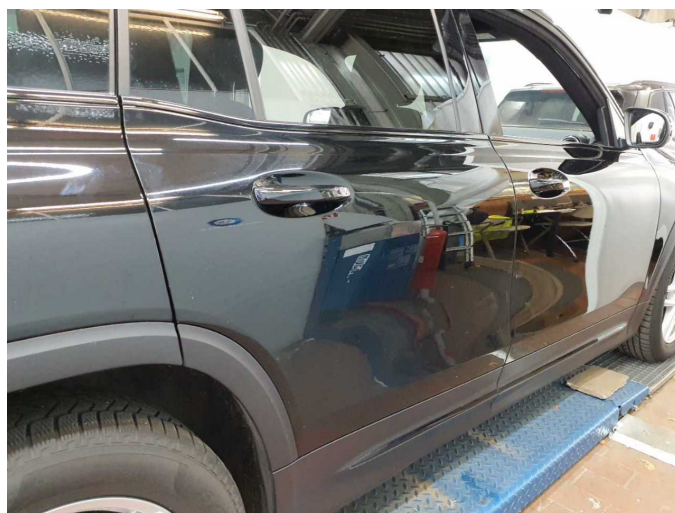
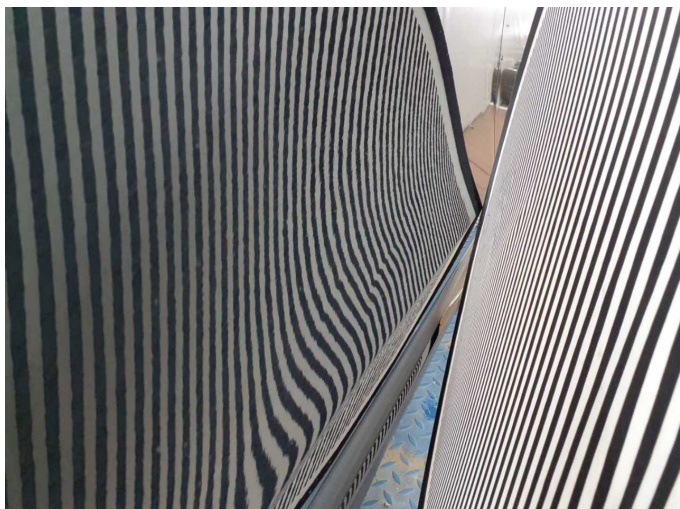
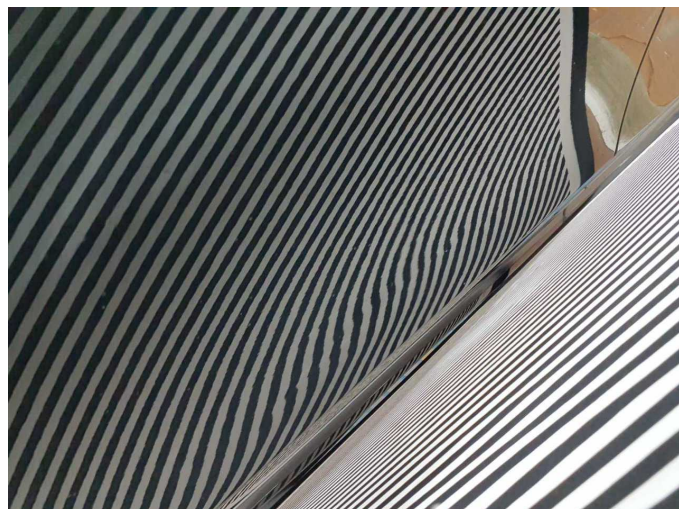
| No. | Repainting |
|---|---|
| 2 | Door - rear right side, Unprofessionally carried out, Invoice of repair done Non-existent |

| Door - rear right side | 250 µm | | |

**Damage 11:** Door - rear right side: Door (Orangenhaut) - Unprofessionally repaired - Paint

| No. | Component group | Description |
|---|---|---|
| 11 | Door - rear right side | Door (Orangenhaut) - Unprofessionally repaired - Paint |

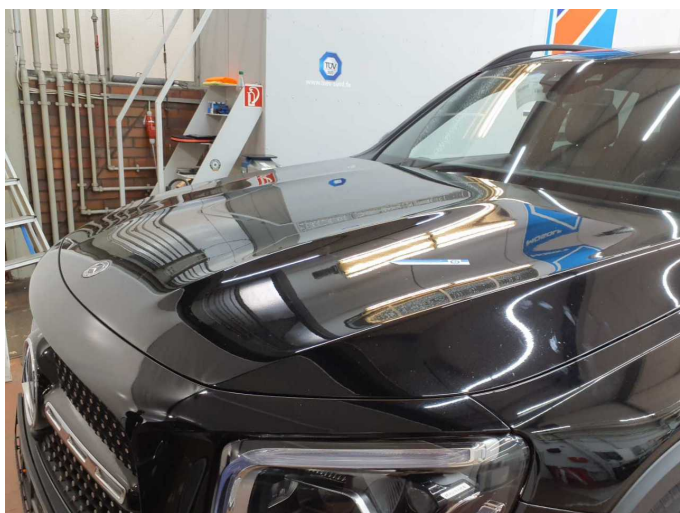
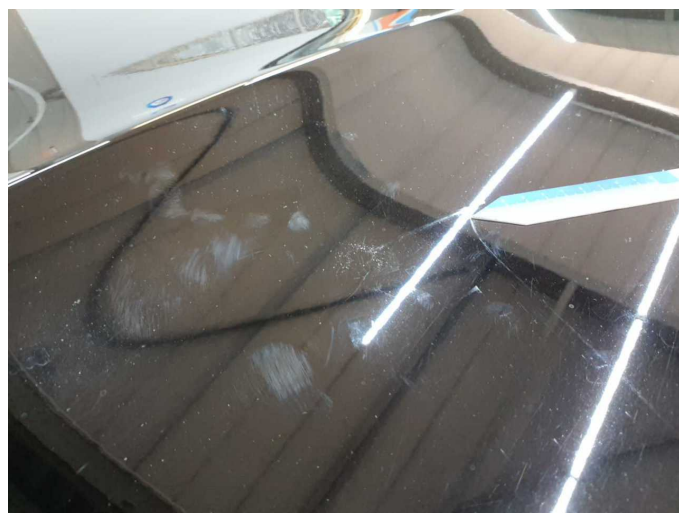
**Damage 12:** Bonnet: Bonnet (Verätzung) - Paint defect - Lacquer

| No. | Component group | Description |
|---|---|---|
| 12 | Bonnet | Bonnet (Verätzung) - Paint defect - Lacquer |

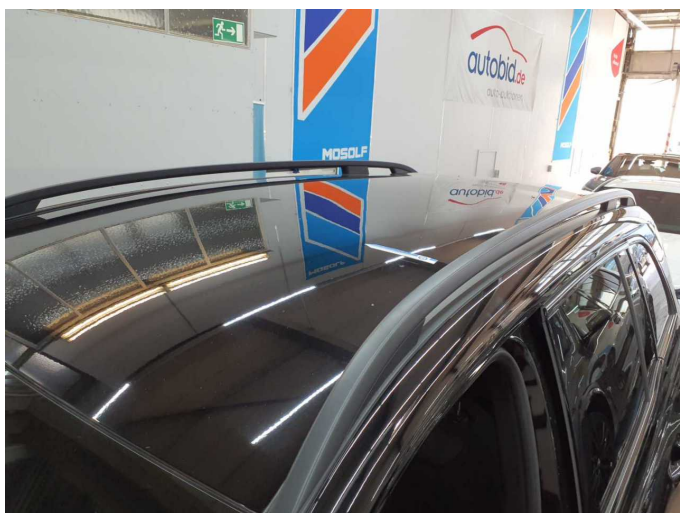
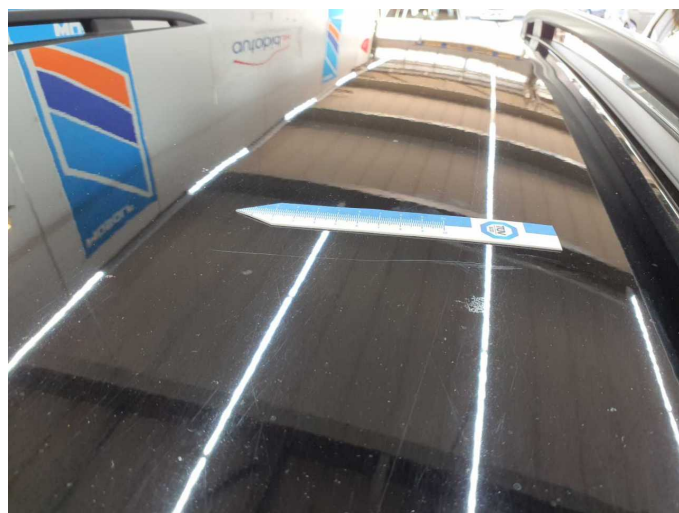
**Damage 13:** Roof: Roof - Scratch(es) - Paint

| No. | Component group | Description |
|---|---|---|
| 13 | Roof | Roof - Scratch(es) - Paint |

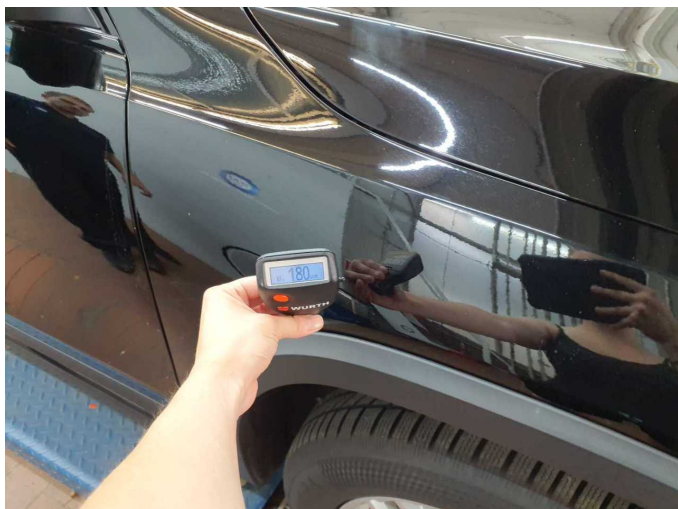
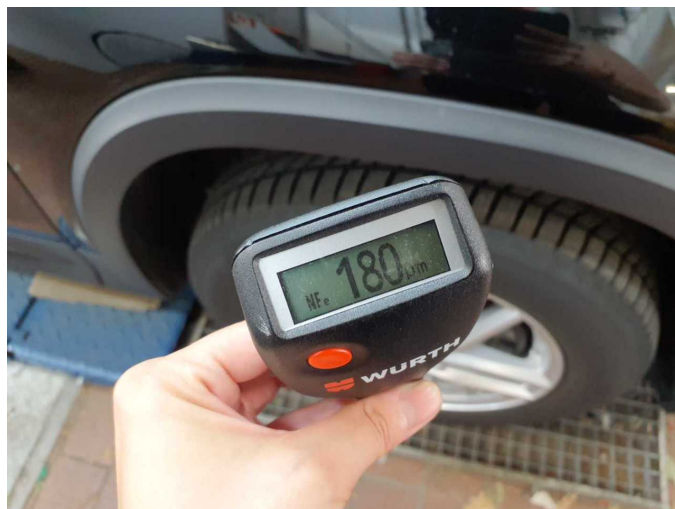
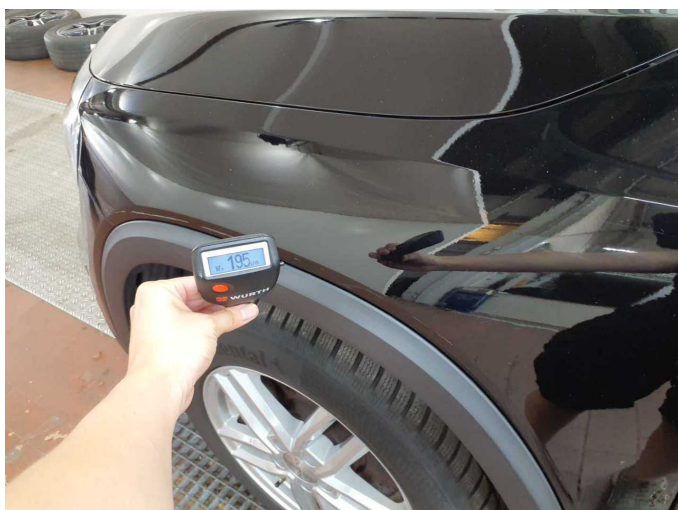
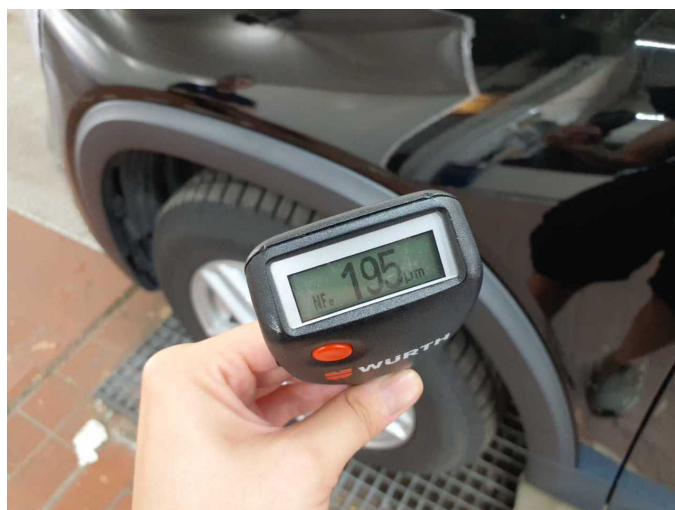
| No. | Repainting |
|---|---|
| 1 | Mudguard - left side, Mudguard - right side, Professionally carried out, Invoice of repair done Non-existent |

| Mudguard - left side | 195 µm | Mudguard - right side | 180 µm |

**Repainting 1:** Mudguard - left side, Mudguard - right side

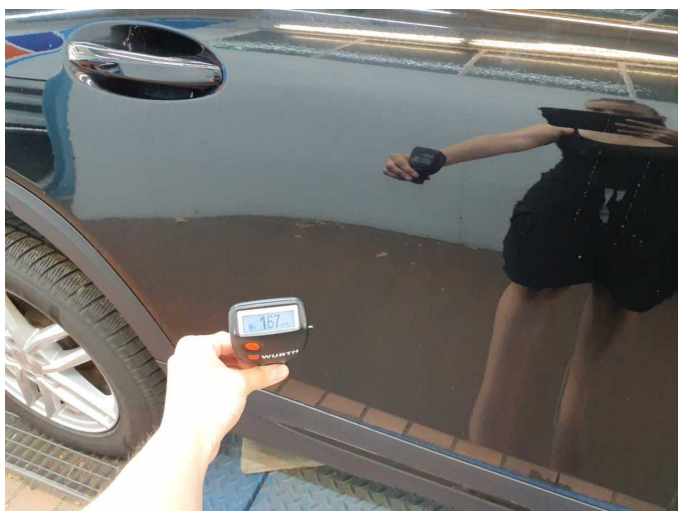
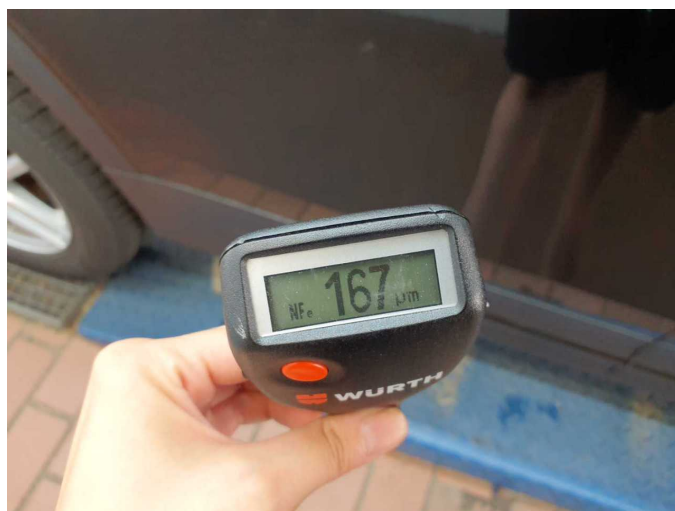
**Repainting 2:** Door - rear right side
