Expertise

Protocol number: 46070857  
Order No. / Reference: 26534445  
Inspection date: 22 Jun 2026

Manufacturer: Mercedes-Benz  
VIN: W1KAH0EB4PF106617

Model: C 220 d T 9G-TRONIC AMG Line

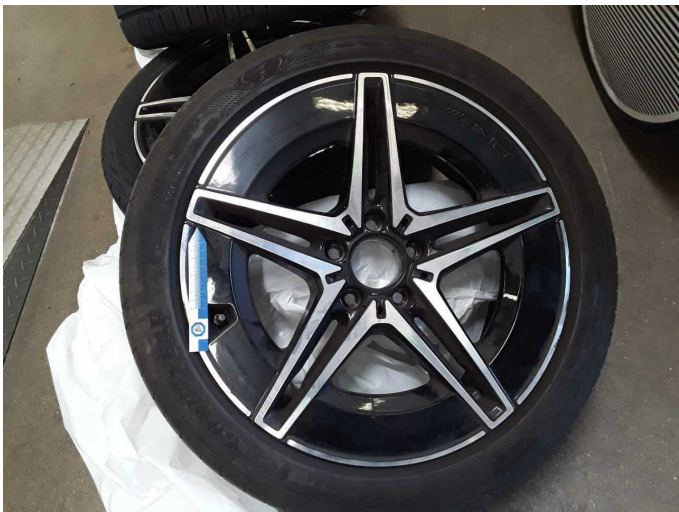
| No. | Component group | Description |
|---|---|---|
| 2 | 2nd wheel set | 1 alloy rim - Scratch(es) - Loss in value |

Damage 2: 2nd wheel set: 1 alloy rim - Scratch(es) - Loss in value

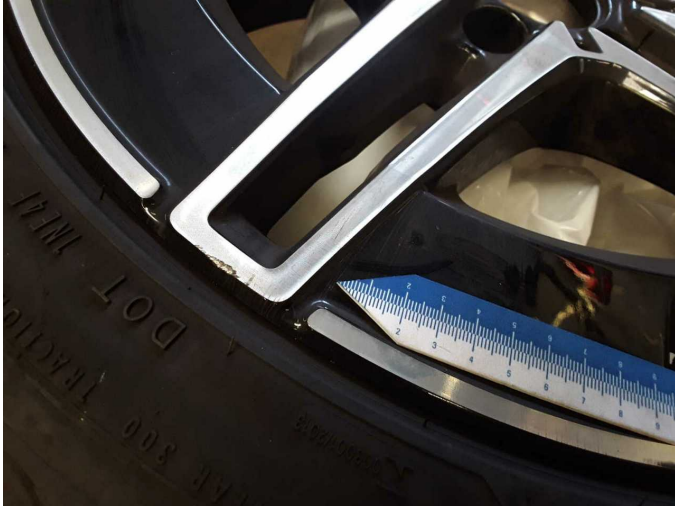
**Damage 2:** 2nd wheel set: 1 alloy rim - Scratch(es) - Loss in value

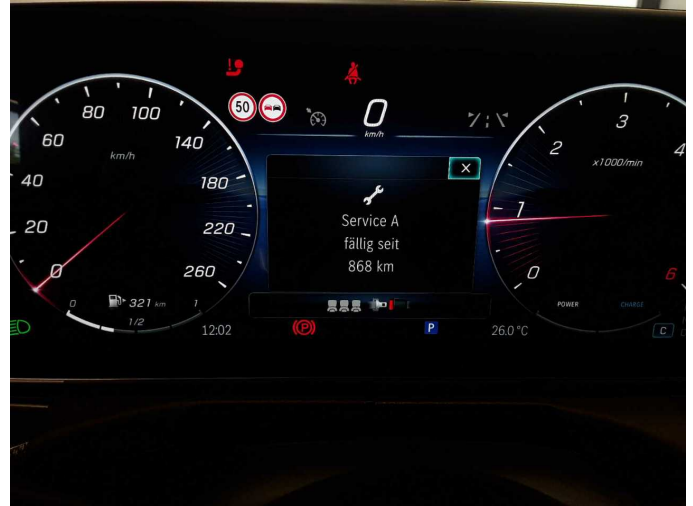
| No. | Component group | Description |
|---|---|---|
| 3 | Misc. | Inspection / maintenance - Due - Perform |

**Damage 3:** Misc.: Inspection / maintenance - Due - Perform

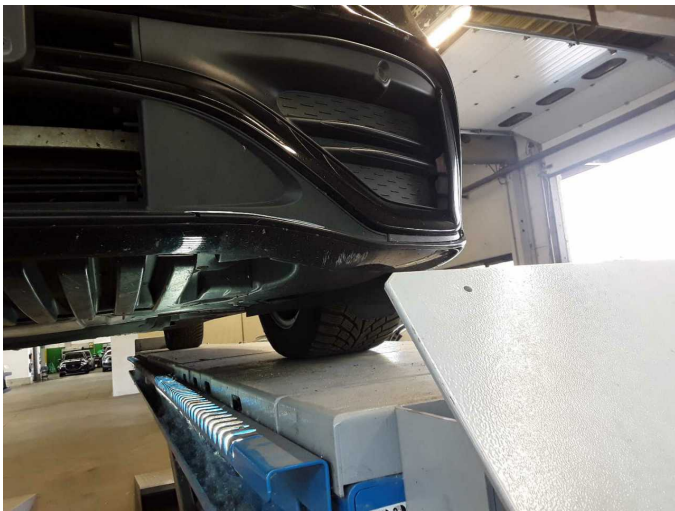
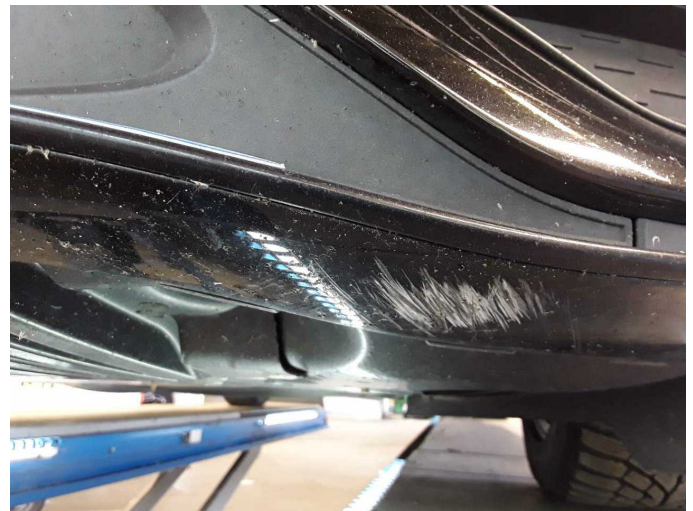
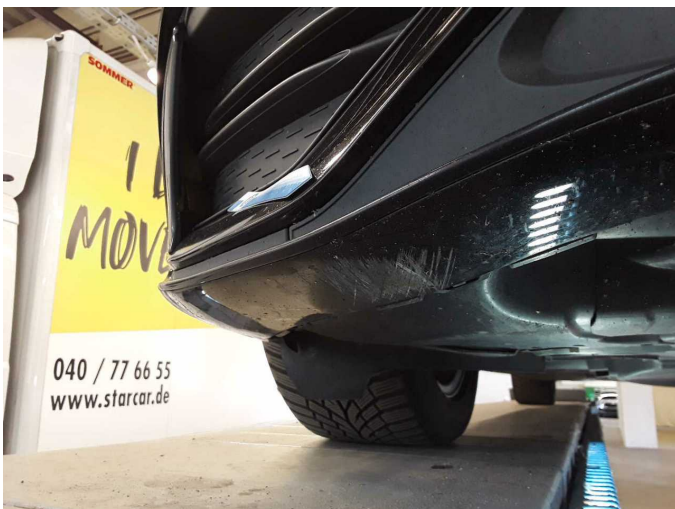
| No. | Component group | Description |
|---|---|---|
| 4 | Front bumper | Front bumper - Scratched - Paint |

**Damage 4:** Front bumper: Front bumper - Scratched - Paint

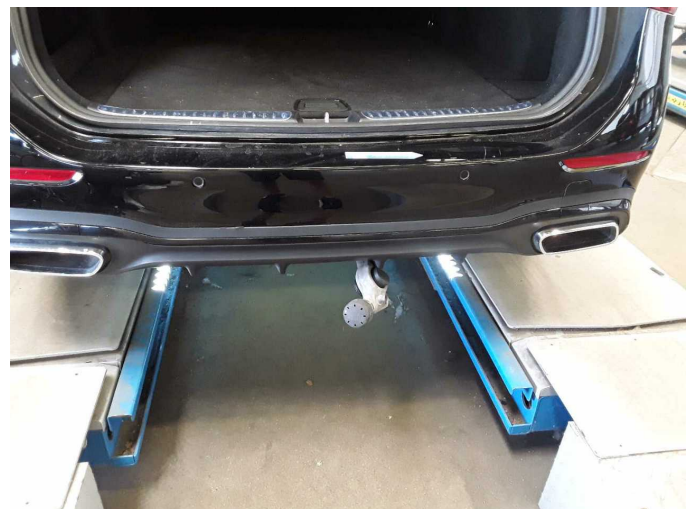
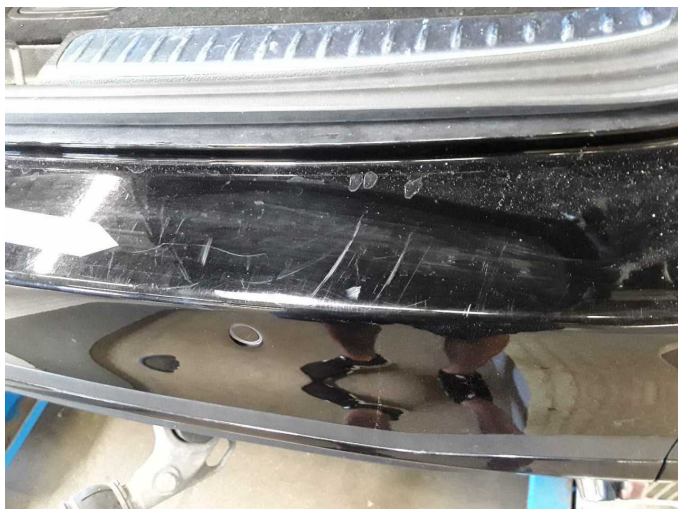
| No. | Component group | Description |
|---|---|---|
| 5 | Rear bumper | Rear bumper - Scratch(es) - Paint |

**Damage 5:** Rear bumper: Rear bumper - Scratch(es) - Paint

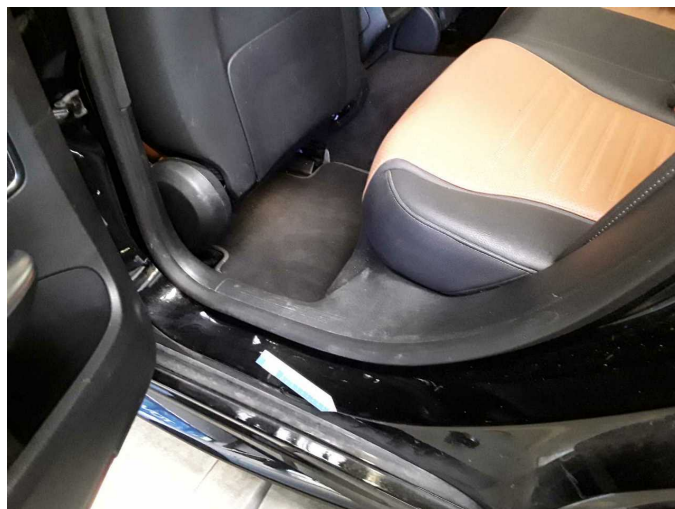
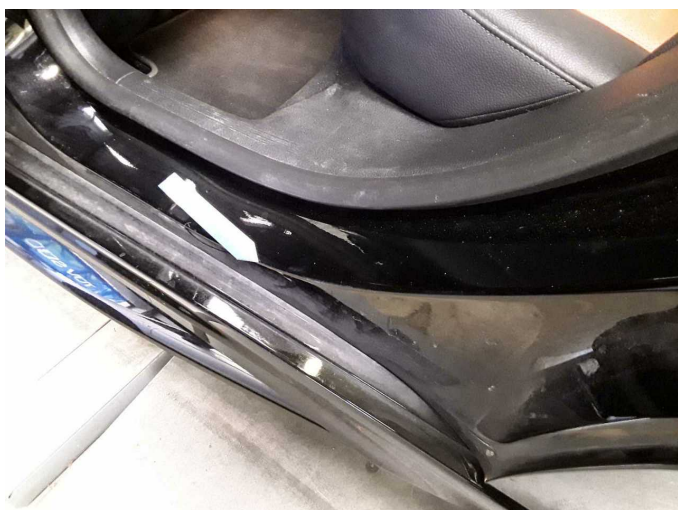
| No. | Component group | Description |
|---|---|---|
| 1 | Side panel - rear left side | Sill - Scratch(es) - No deduction |

**Wear and tear 1:** Side panel - rear left side: Sill - Scratch(es) - No deduction

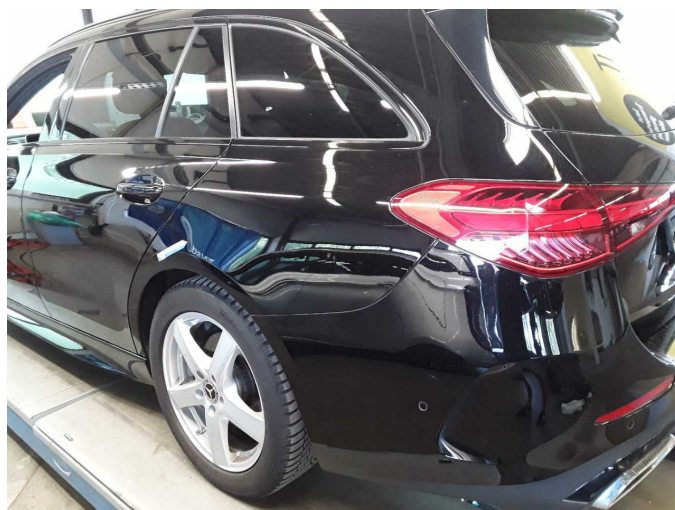
| No. | Component group | Description |
|---|---|---|
| 2 | Body | Body (Waschanlagekratzer) - Scratch(es) - No deduction |

**Wear and tear 2:** Body: Body (Waschanlagekratzer) - Scratch(es) - No deduction

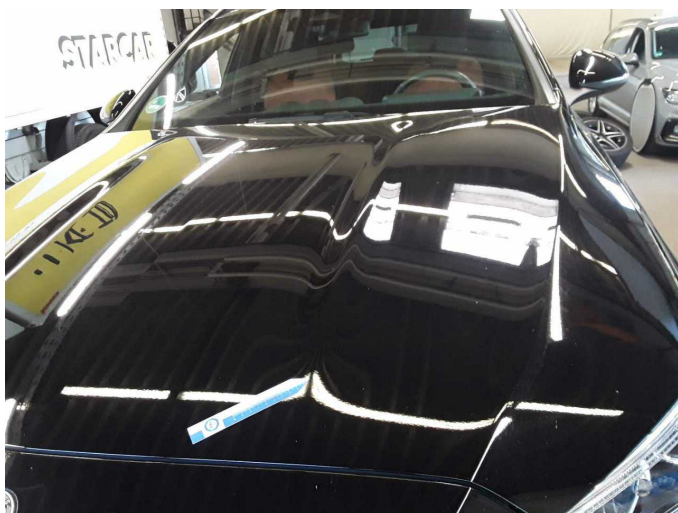
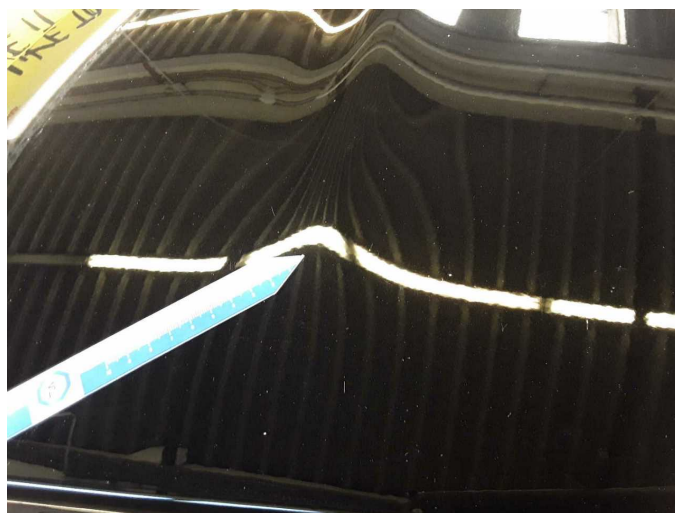
| No. | Component group | Description |
|---|---|---|
| 3 | Bonnet | Bonnet - Stone chips - No deduction |

**Wear and tear 3:** Bonnet: Bonnet - Stone chips - No deduction

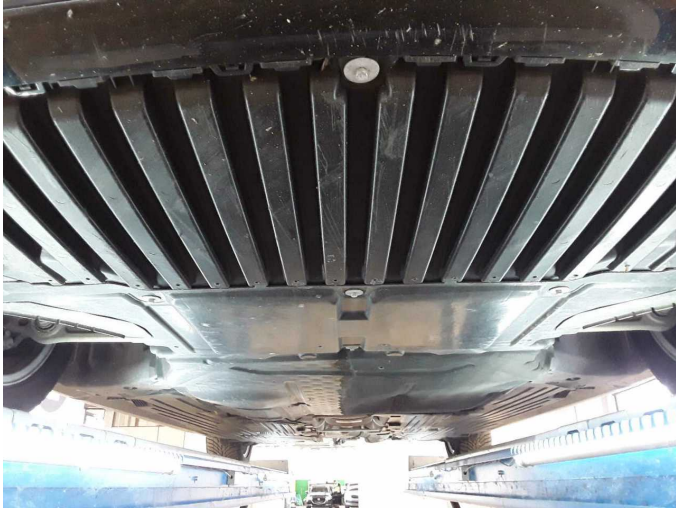
| No. | Component group | Description |
|---|---|---|
| 4 | Body | Underbody panelling - Scratched - No deduction |

**Wear and tear 4:** Body: Underbody panelling - Scratched - No deduction

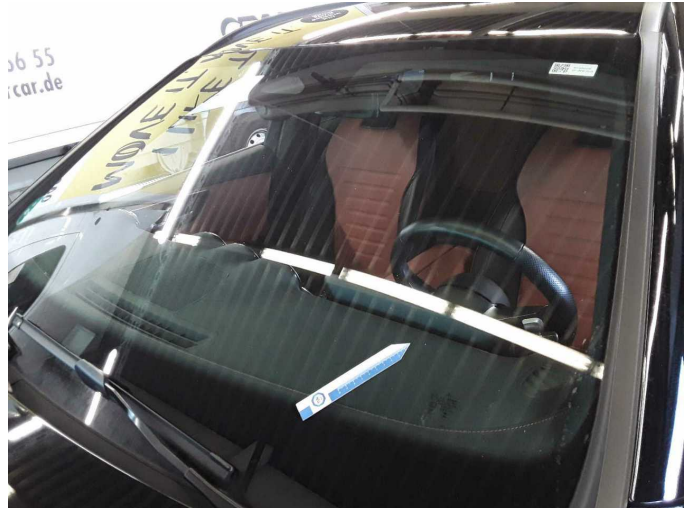
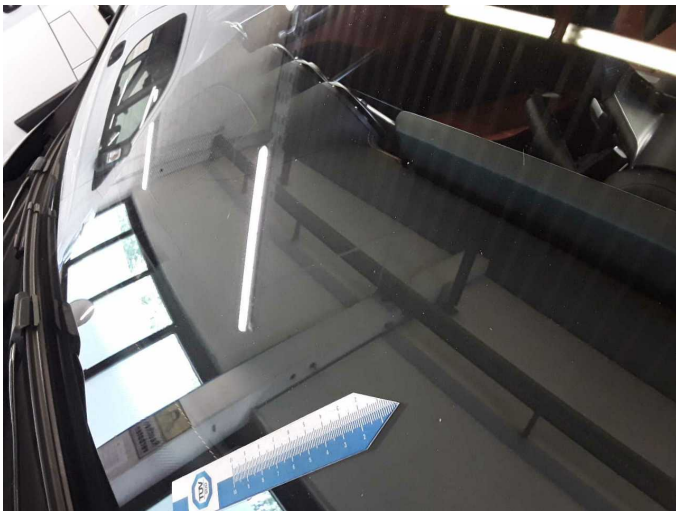
| No. | Component group | Description |
|---|---|---|
| 5 | Vehicle glazing | Windscreen - Stone chips - No deduction |

**Wear and tear 5:** Vehicle glazing: Windscreen - Stone chips - No deduction
