Expertise

Protocol number: 46462388  
Order No. / Reference: 26621543  
Inspection date: 10 Jul 2026

Manufacturer: Ford

Model: Focus Turnier 1.5 EcoBlue Start-Stopp-System Aut. ST-LINE  
VIGNALE

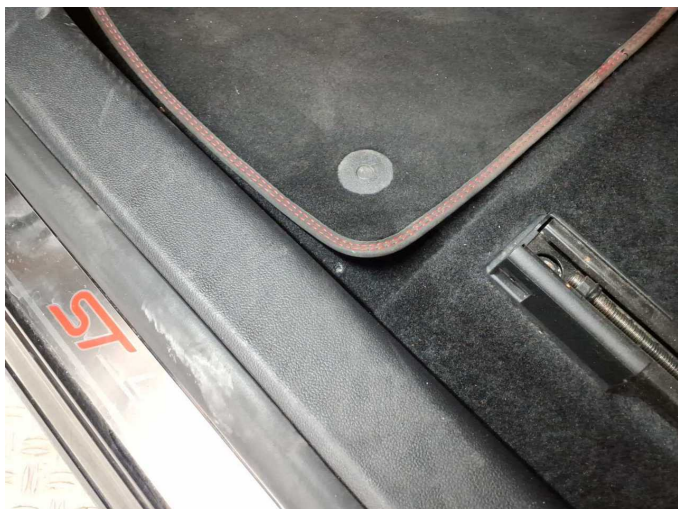
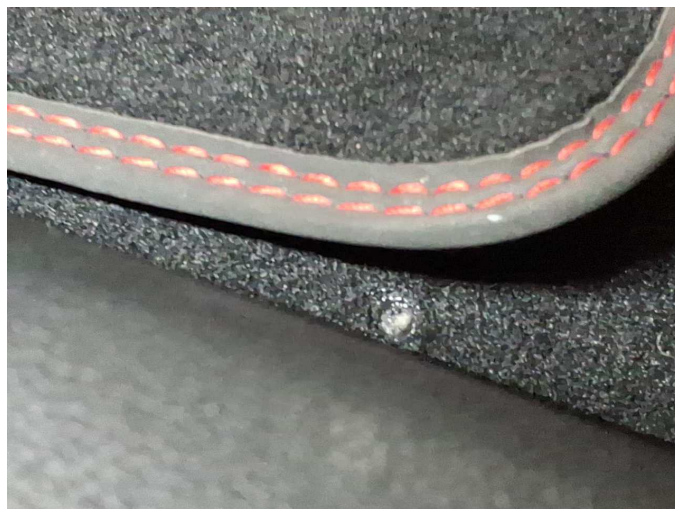
| No. | Component group | Description |
|---|---|---|
| 3 | Trim / covers | Carpet - Burn hole (cigarettes) - Smart repair |

**Damage 3:** Trim / covers: Carpet - Burn hole (cigarettes) - Smart repair

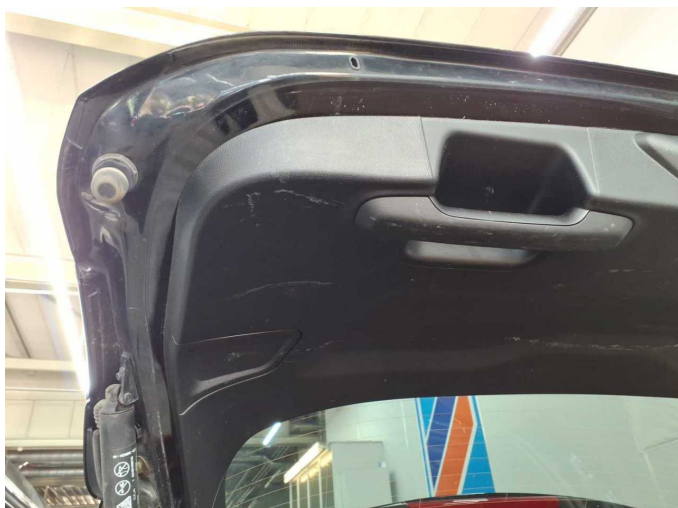
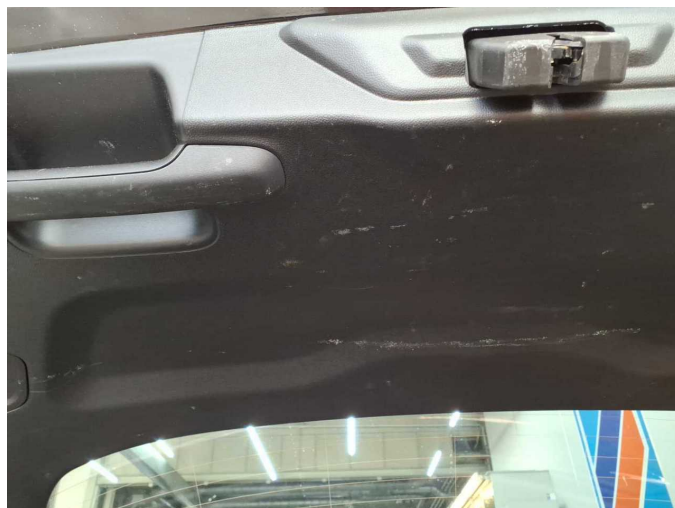
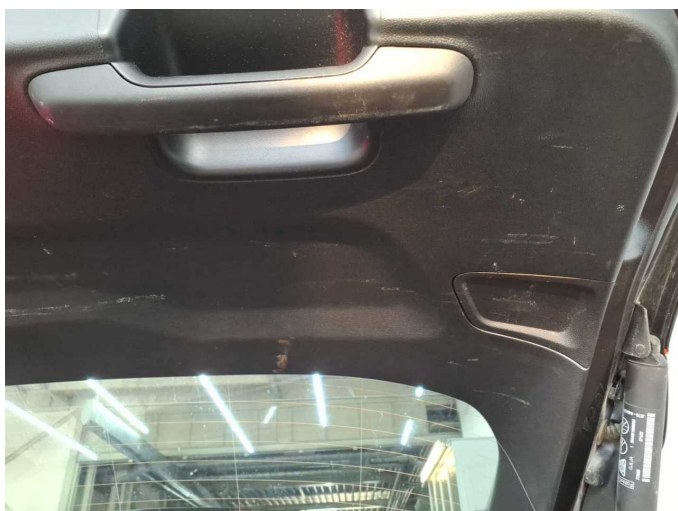
| No. | Component group | Description |
|---|---|---|
| 5 | Trim / covers | Boot lid - interior trim - Scratch(es) - Replace |

**Damage 5:** Trim / covers: Boot lid - interior trim - Scratch(es) - Replace

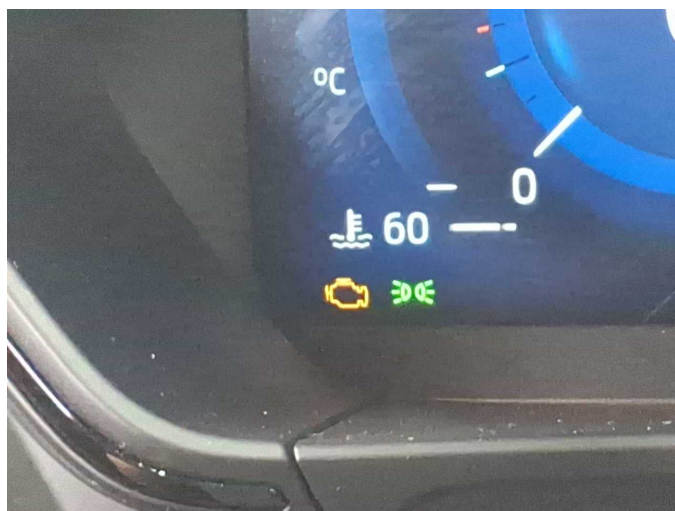
| Engine function test | An engine test run was performed, problem has been detected<br>This is due to the following reason.:<br>Motorkontrollleuchte leuchtet. |

| No. | Component group | Description |
|---|---|---|
| 6 | Instrument panel | Indicator light (Motorkontrollleuchte) - on - Perform diagnosis |

**Damage 6:** Instrument panel: Indicator light (Motorkontrolleuchte) - on - Perform diagnosis

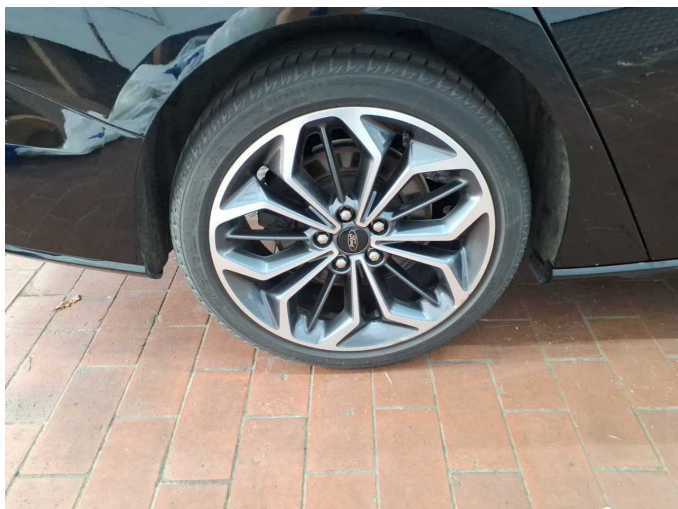
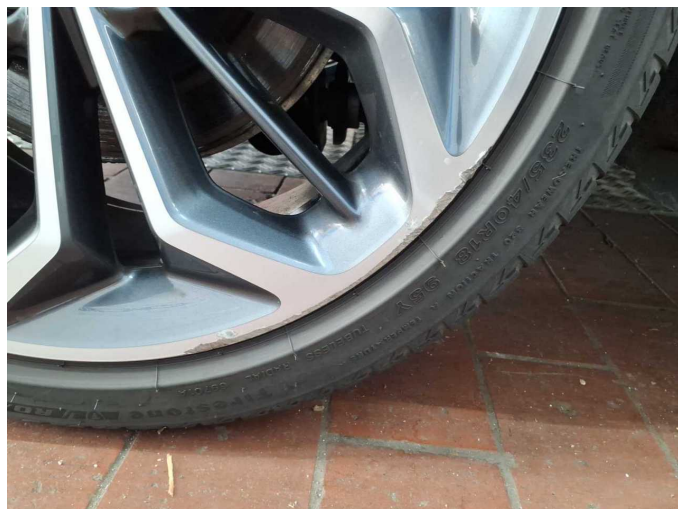
| No. | Component group | Description |
|---|---|---|
| 7 | Wheel / tyres | Alloy rim - rear right side (Materialabtrag) - Scratched - Replace |

**Damage 7:** Wheel / tyres: Alloy rim - rear right side (Materialabtrag) - Scratched - Replace

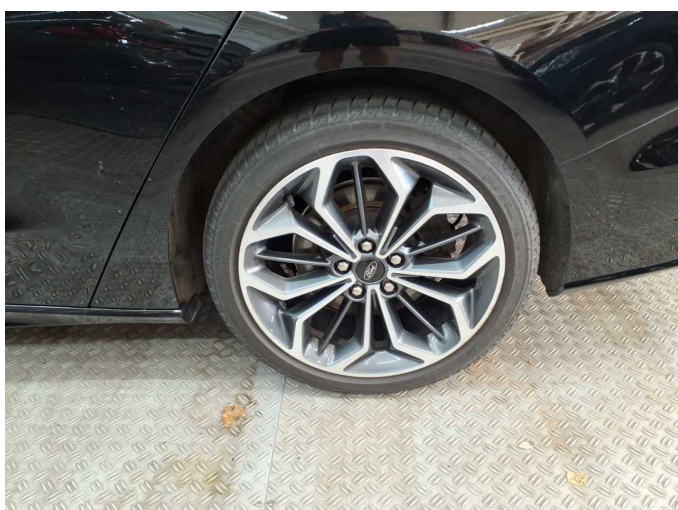
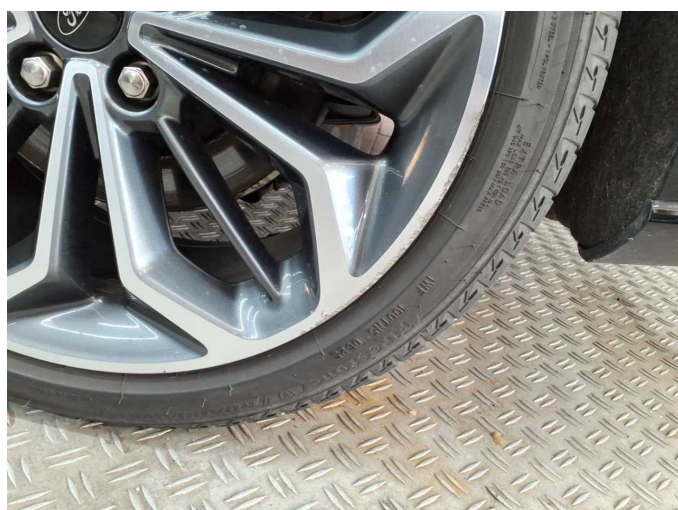
| No. | Component group | Description |
|---|---|---|
| 8 | Wheel / tyres | Alloy rim - rear left side (Materialabtrag) - Scratched - Replace |

**Damage 8:** Wheel / tyres: Alloy rim - rear left side (Materialabtrag) - Scratched - Replace

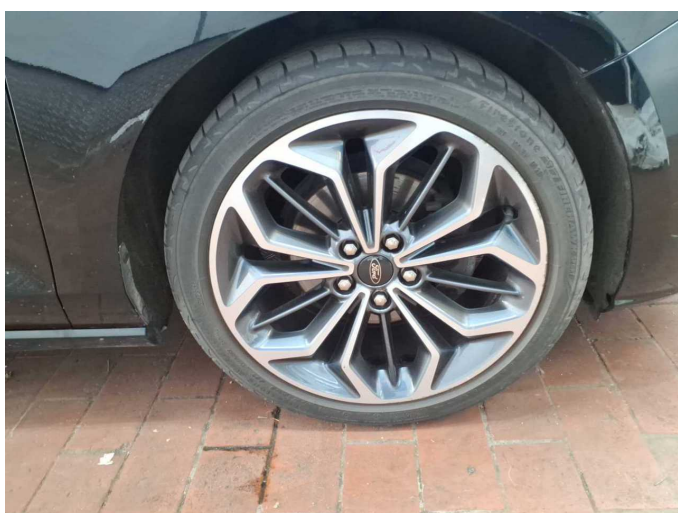
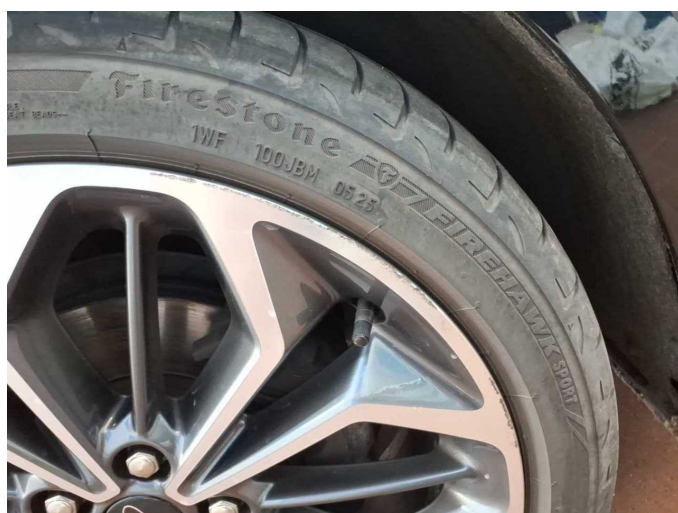
| No. | Component group | Description |
|---|---|---|
| 9 | Wheel / tyres | Alloy rim - front right side (Materialabtrag) - Scratched - Replace |

**Damage 9:** Wheel / tyres: Alloy rim - front right side (Materialabtrag) - Scratched - Replace

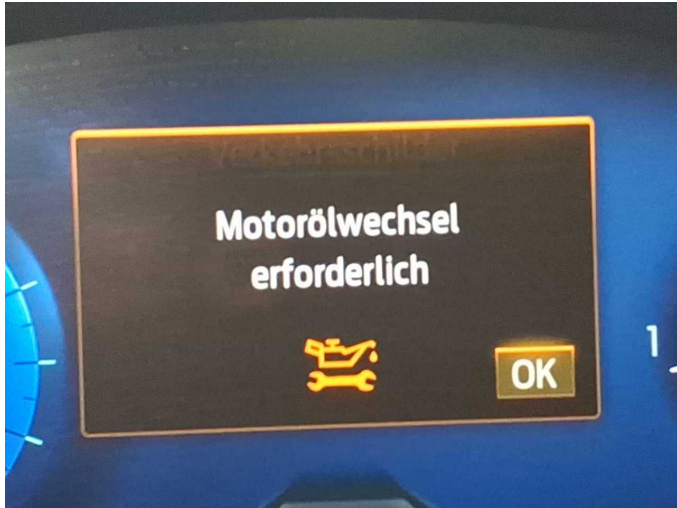
| No. | Component group | Description |
|---|---|---|
| 10 | Misc. | Inspection / maintenance - Due - Perform |

**Damage 10:** Misc.: Inspection / maintenance - Due - Perform

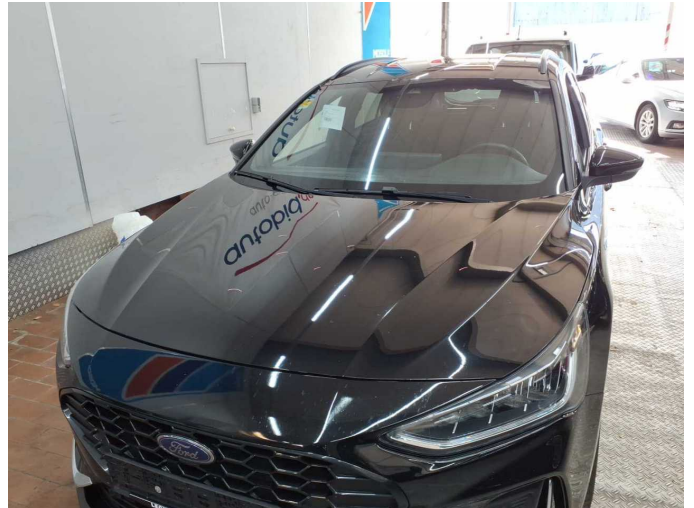
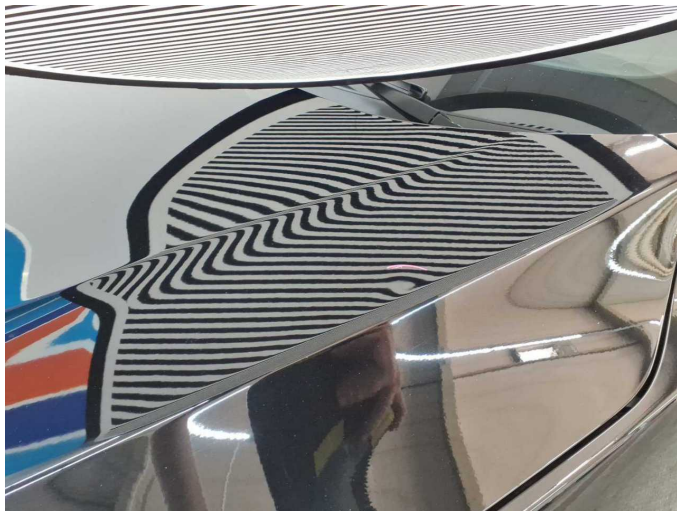
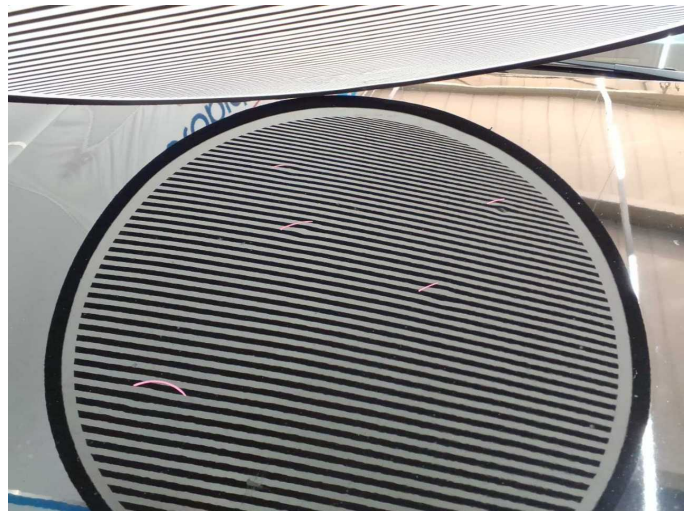
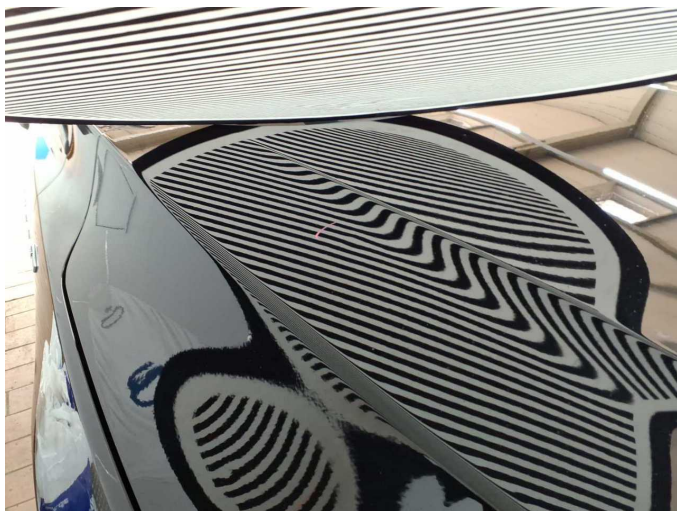
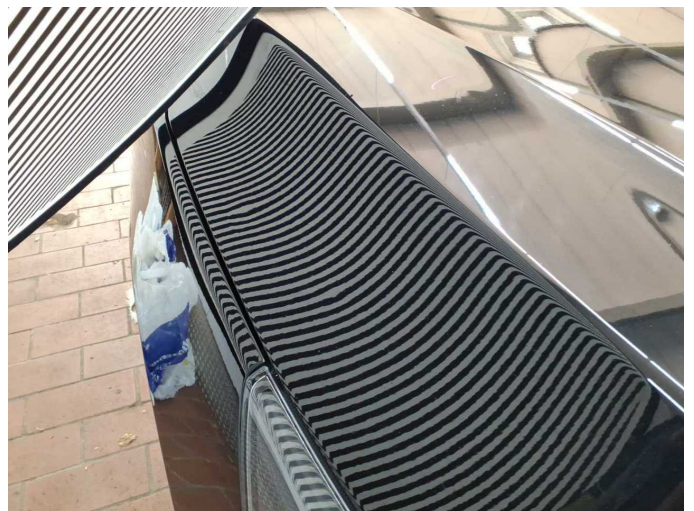
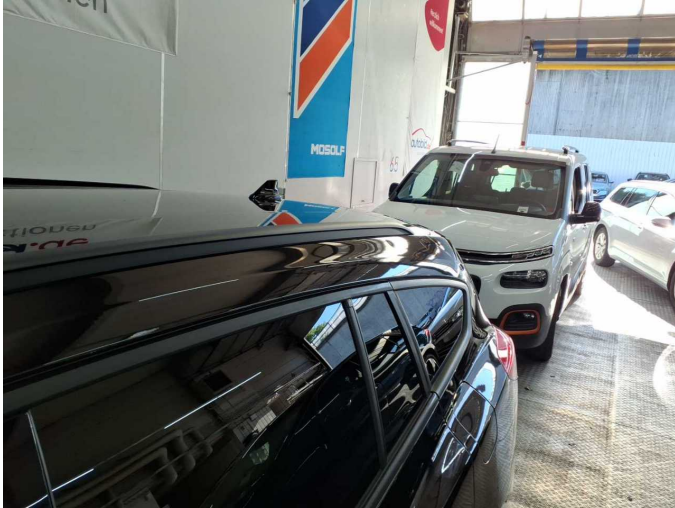
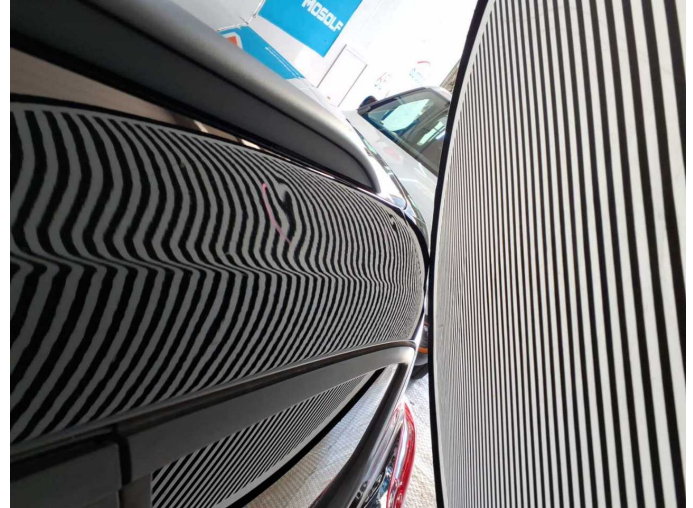
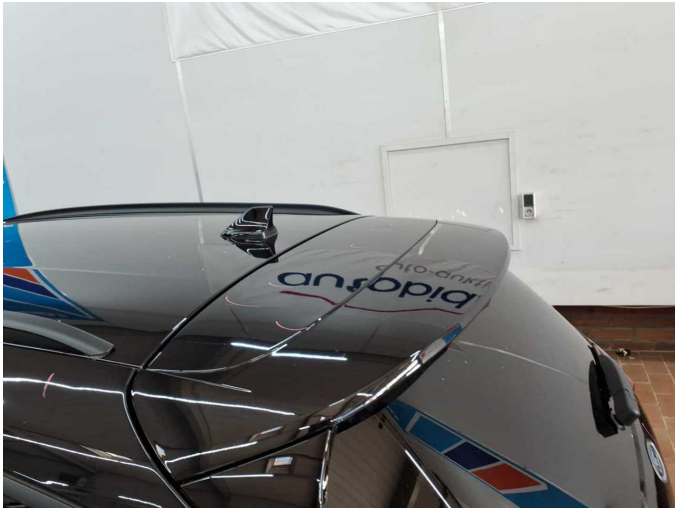
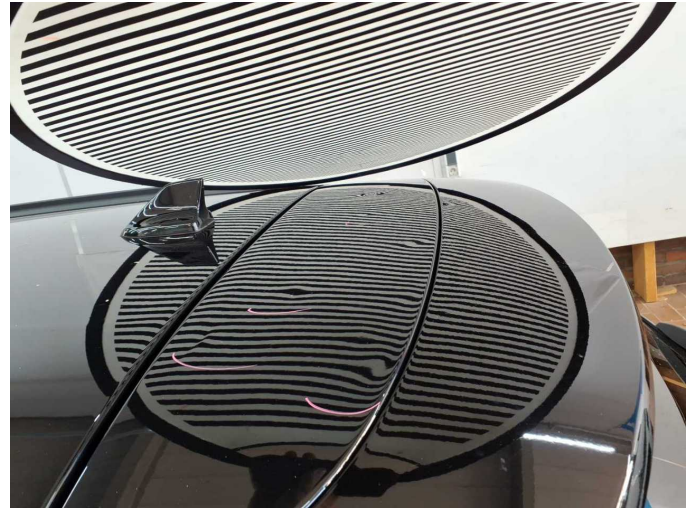
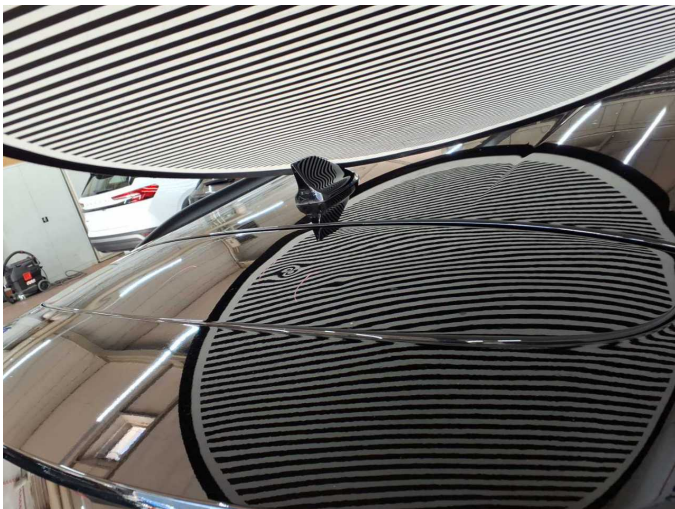
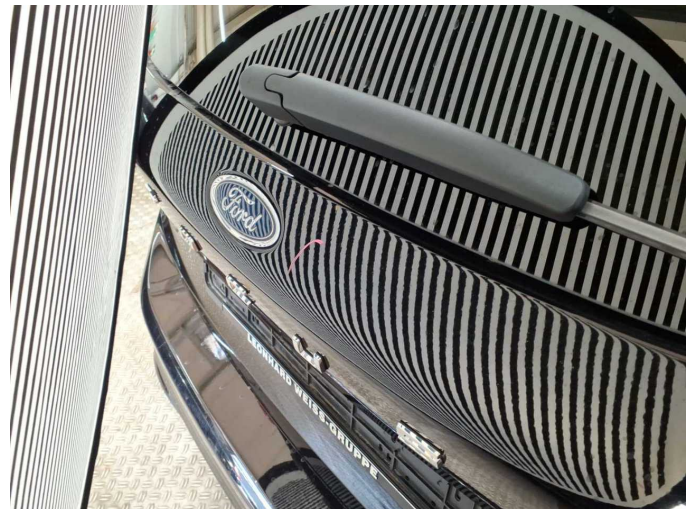
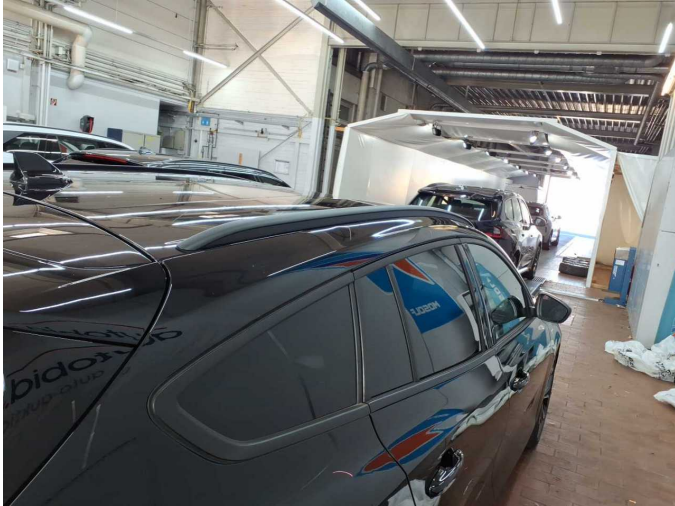
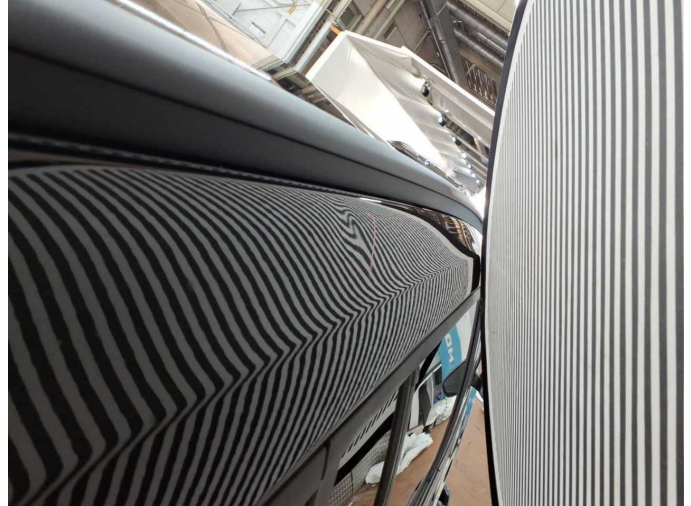
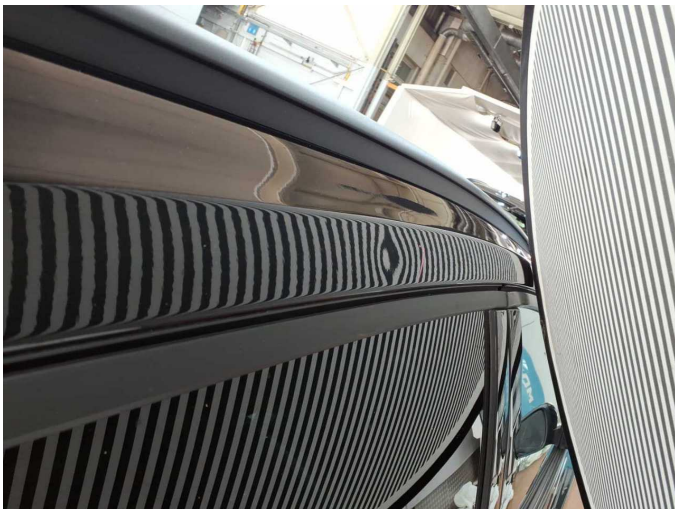
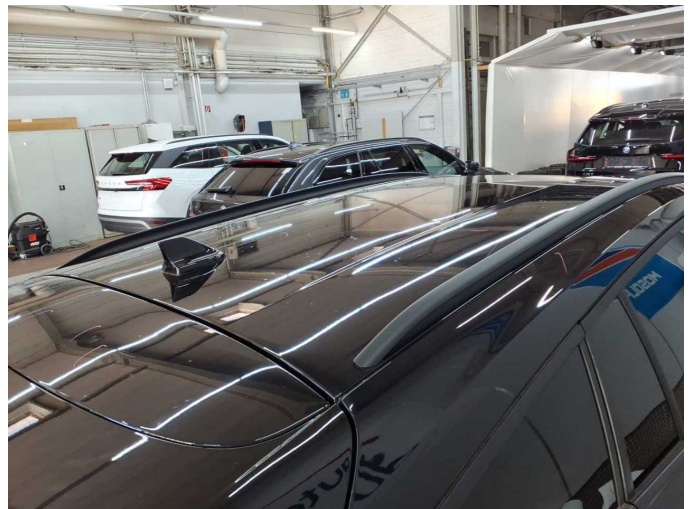
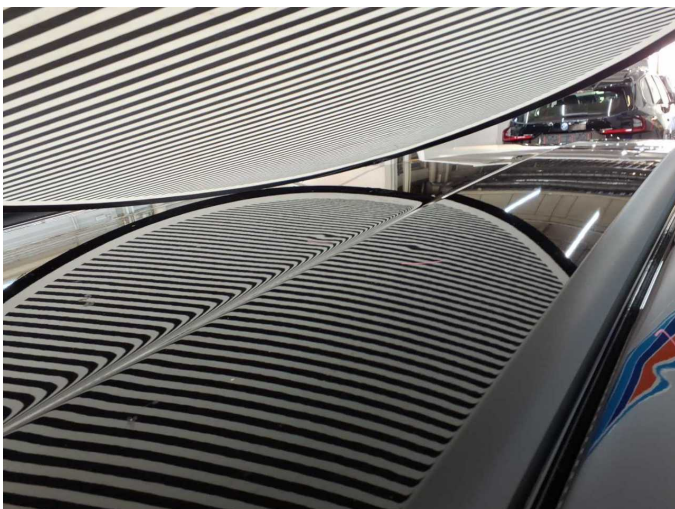
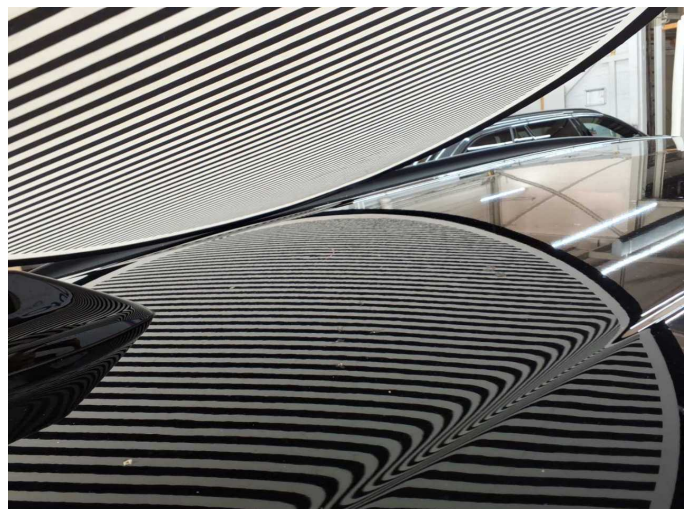
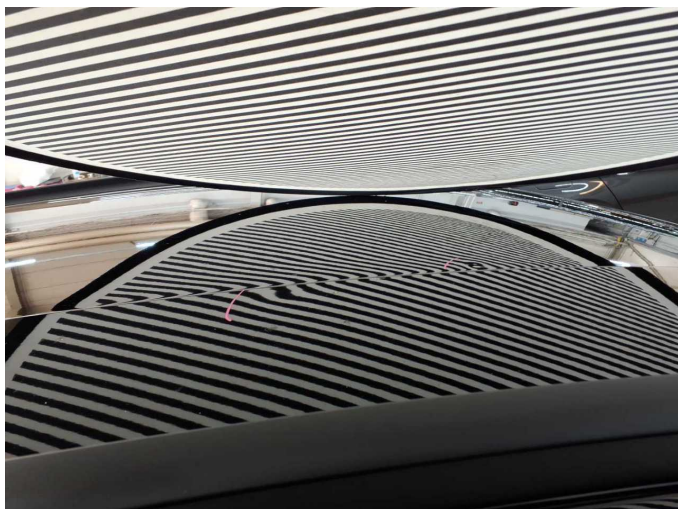
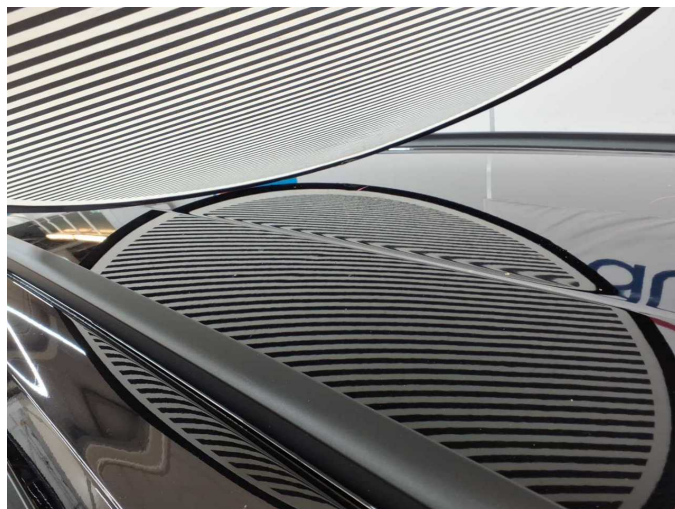
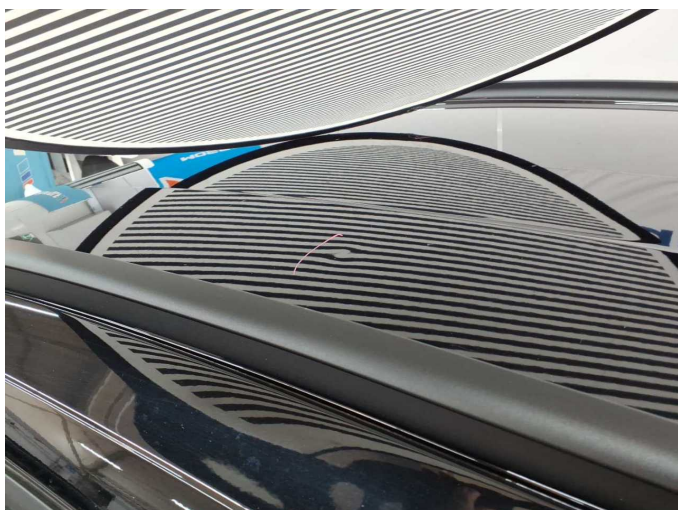
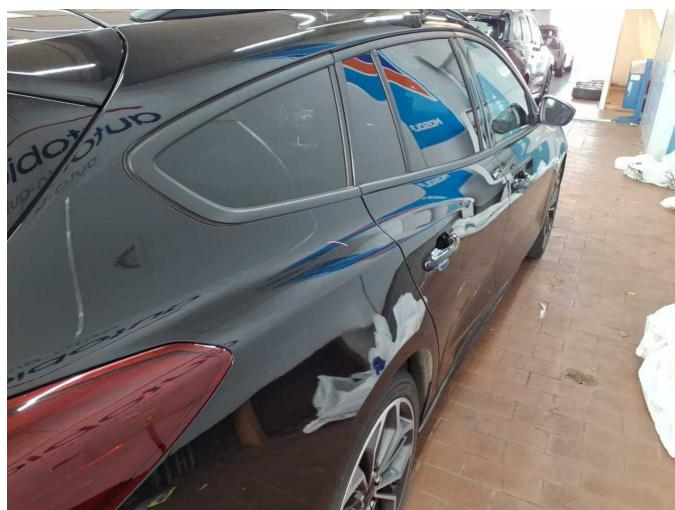
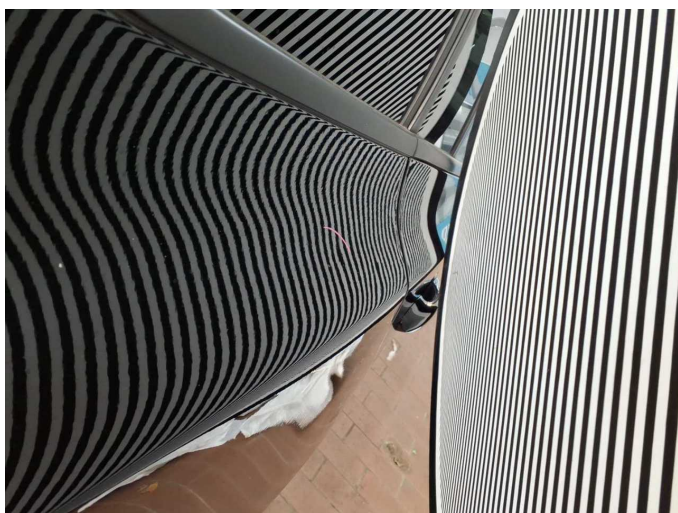
| No. | Component group | Description |
|---|---|---|
| 11 | Body | Body - Damage by hail - repair according to calculation |

**Damage 11:** Body: Body - Damage by hail - repair according to calculation
