Expertise

Protocol number: 46432684  
Order No. / Reference: 26631060  
Inspection date: 10 Jul 2026

Manufacturer: Skoda  
VIN: TMBLJ7NS4P8040803

Model: Kodiaq 2.0 TDI 4x4 DSG L&K

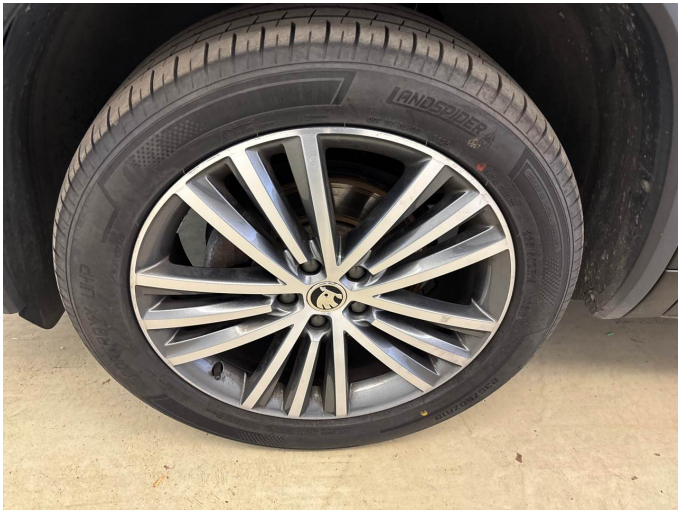
Figure 12: Mounted tyres

| # | Tyre size | Type of tyre | Manufacturer | Tread depth |
|---|---|---|---|---|
| 1) | 235/50 R19 103Y | Summer tyres on Light alloy | Sonstige | 4mm / 4mm |
| 2) | 235/50 R19 103Y | Summer tyres on Light alloy | Sonstige | 5mm / 5mm |

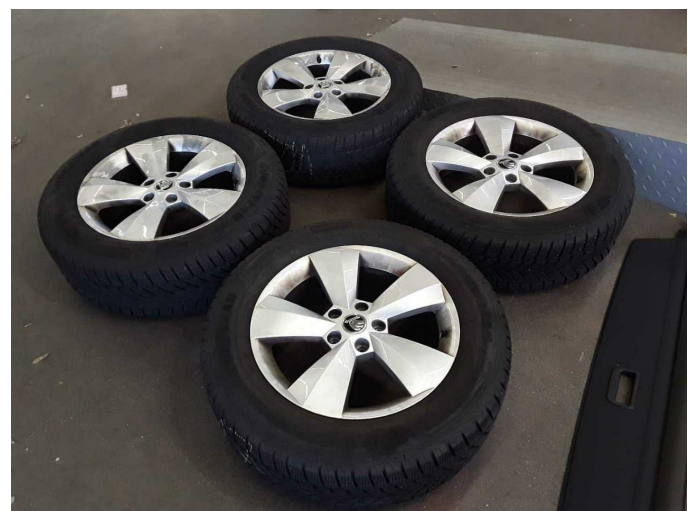
Figure 18: Additional tyres

| # | Tyre size | Type of tyre | Manufacturer | Tread depth |
|---|---|---|---|---|
| 1) | 215/65 R17 103V | Winter tyres on Light alloy | Goodyear | 5mm / 5mm |
| 2) | 215/65 R17 103V | Winter tyres on Light alloy | Goodyear | 5mm / 5mm |

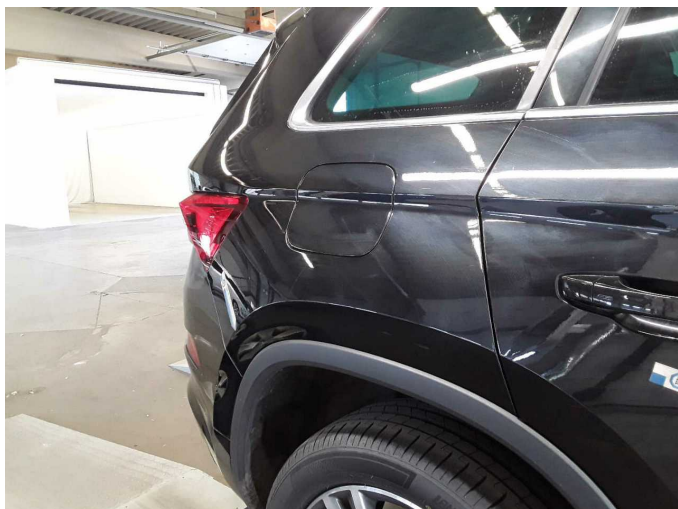
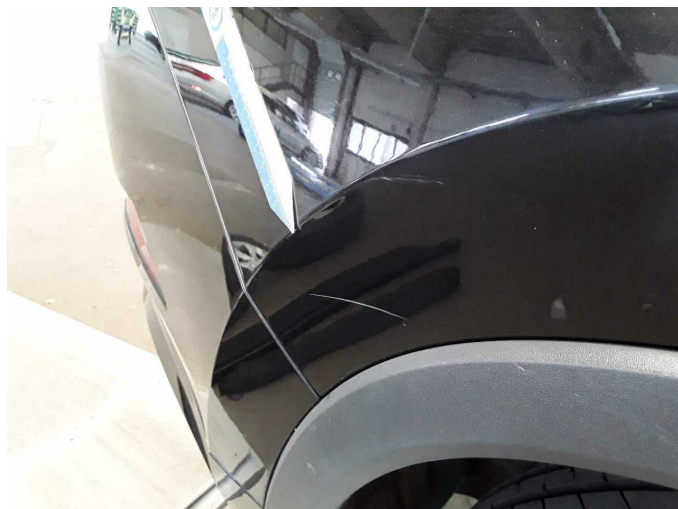
| No. | Component group | Description |
|---|---|---|
| 2 | Side panel - rear right side | Side panel - Scratch(es) - Paint |

**Damage 2:** Side panel - rear right side: Side panel - Scratch(es) - Paint

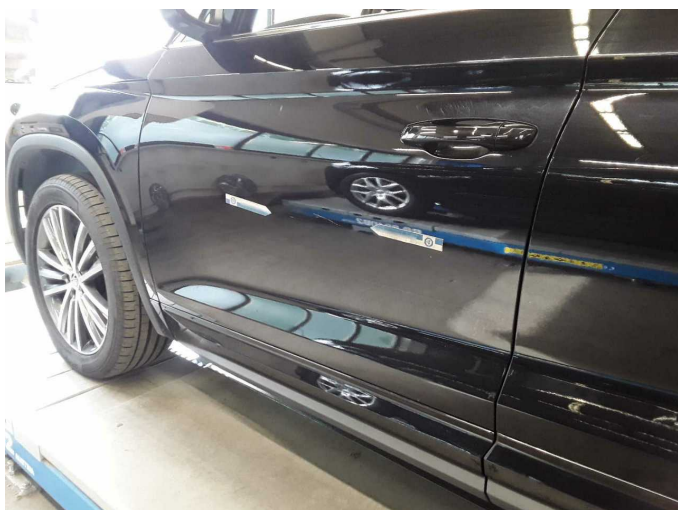
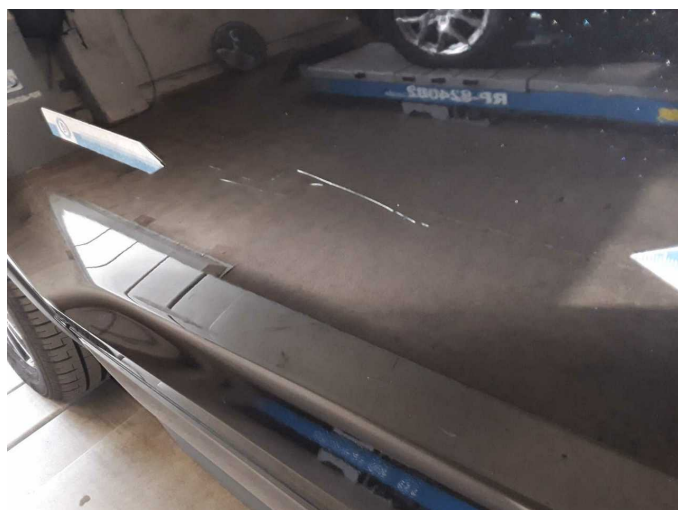
| No. | Component group | Description |
|---|---|---|
| 3 | Door - front left side | Door - Scratch(es) - Paint |

**Damage 3:** Door - front left side: Door - Scratch(es) - Paint

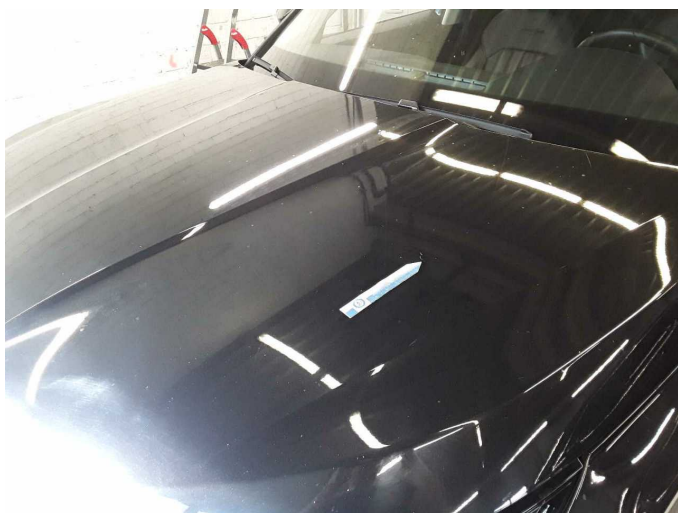
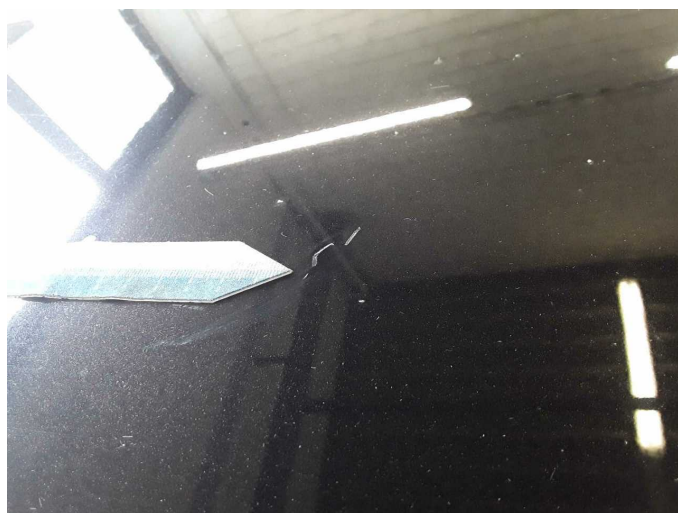
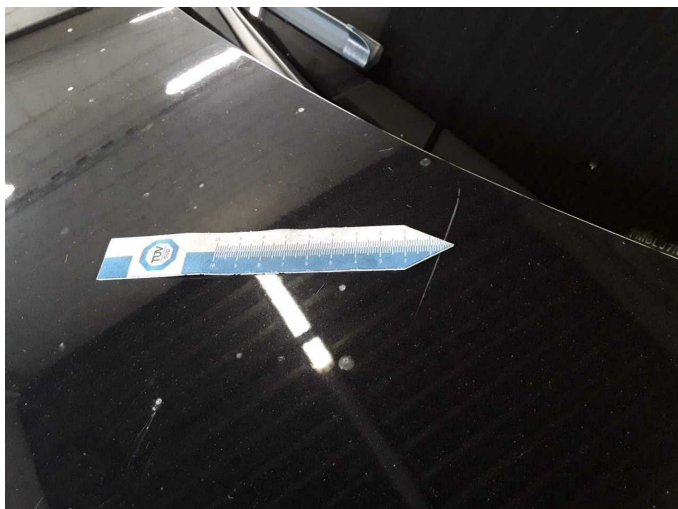
| No. | Component group | Description |
|---|---|---|
| 4 | Bonnet | Bonnet - Scratch(es) - Paint |

**Damage 4:** Bonnet: Bonnet - Scratch(es) - Paint

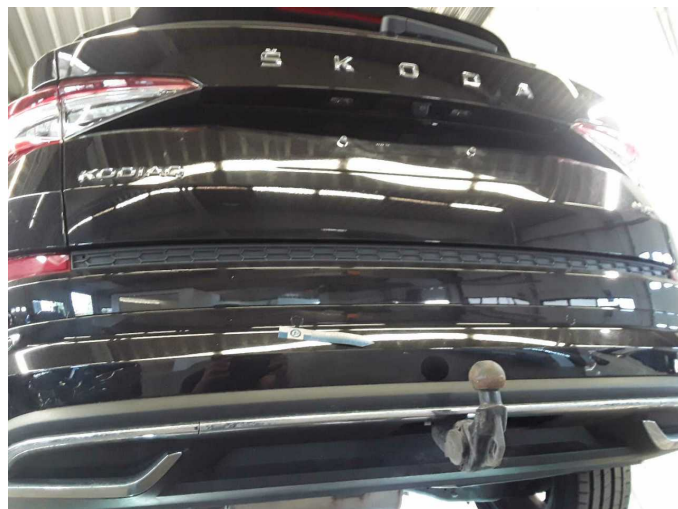
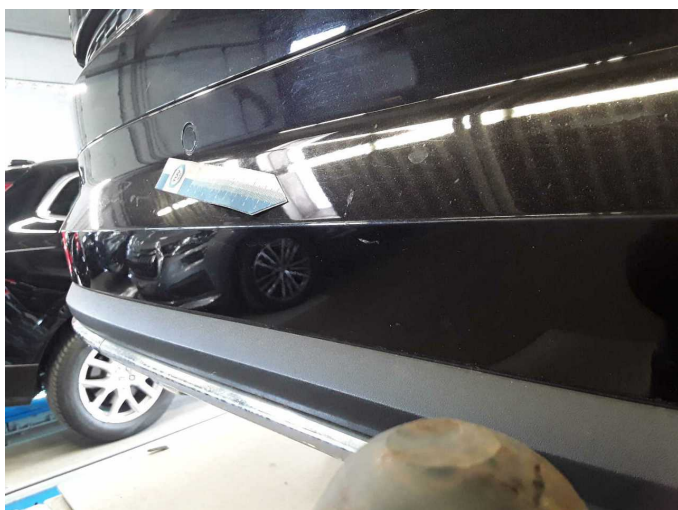
| No. | Component group | Description |
|---|---|---|
| 1 | Rear bumper | Rear bumper - Scratch(es) - No deduction |

**Wear and tear 1:** Rear bumper: Rear bumper - Scratch(es) - No deduction

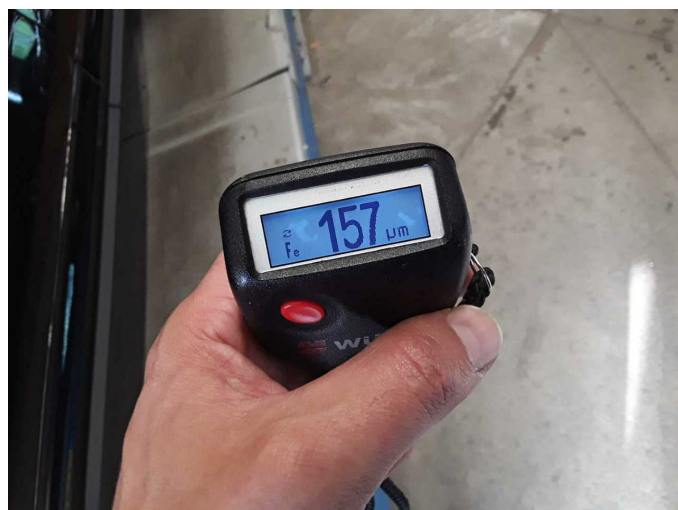
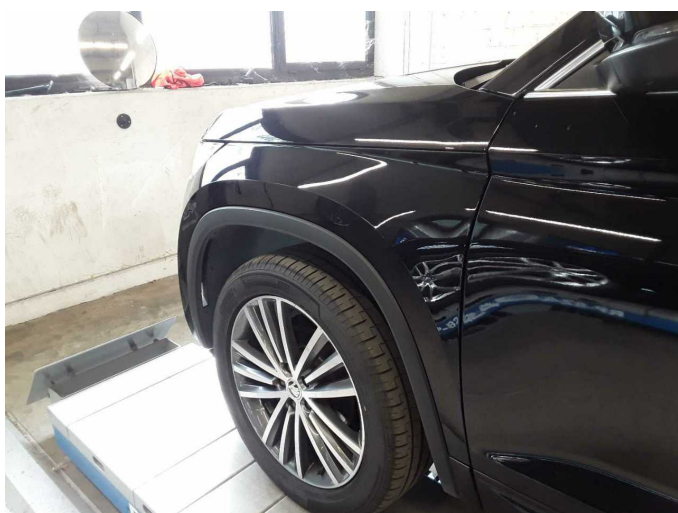
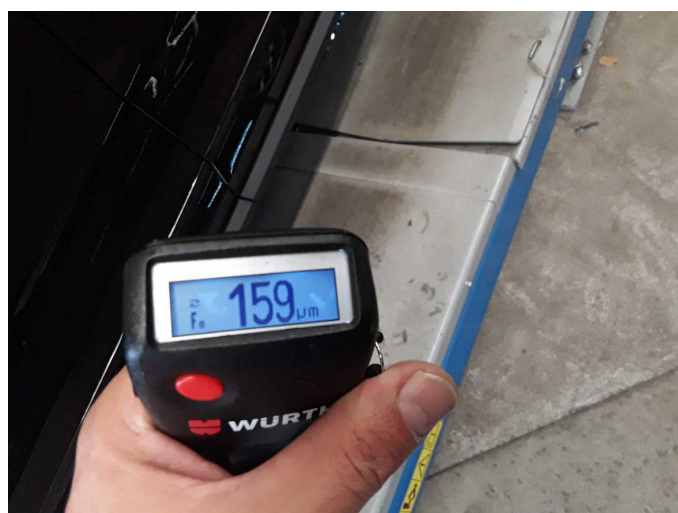
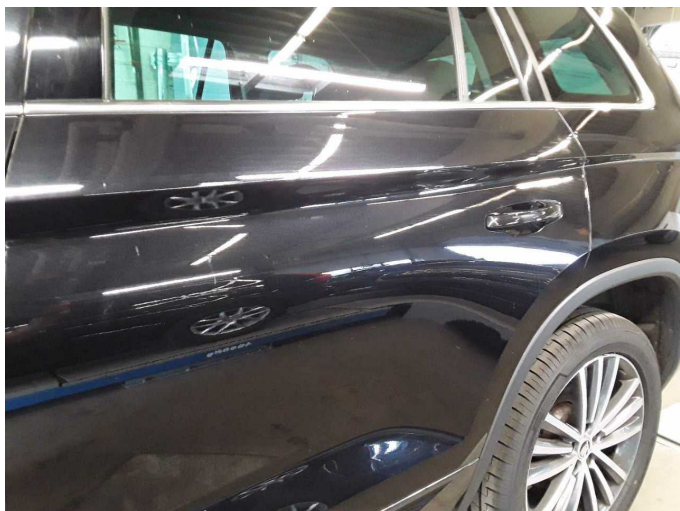
| No. | Repainting |
|---|---|
| 1 | Mudguard - left side, Door - rear left side, Professionally carried out, Invoice of repair done Non-existent |

| Mudguard - left side | 157 µm | Door - rear left side | 159 µm |

**Repainting 1:** Mudguard - left side, Door - rear left side
