Expertise

Protocol number: 45947973  
Order No. / Reference: 26385912  
Inspection date: 15 Jun 2026

Manufacturer: Volkswagen

Model: T-Roc 2.0 TDI SCR DSG Sport

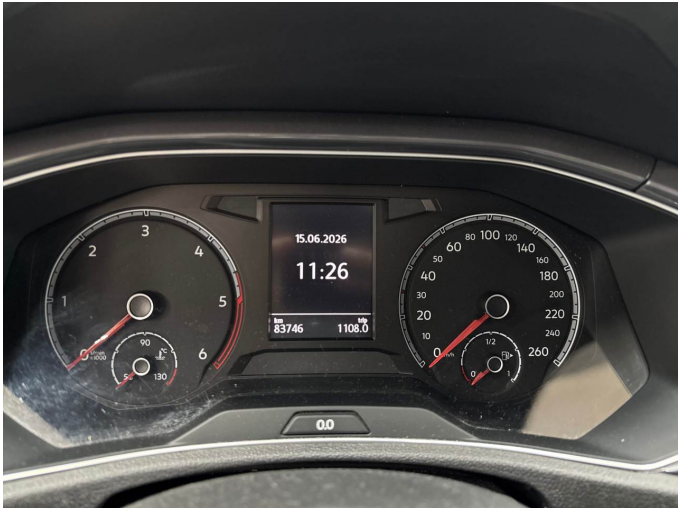
| Vehicle details | |
|---|---|
| Mileage (Read) | 83,746 km |

Figure 7: Instrument cluster

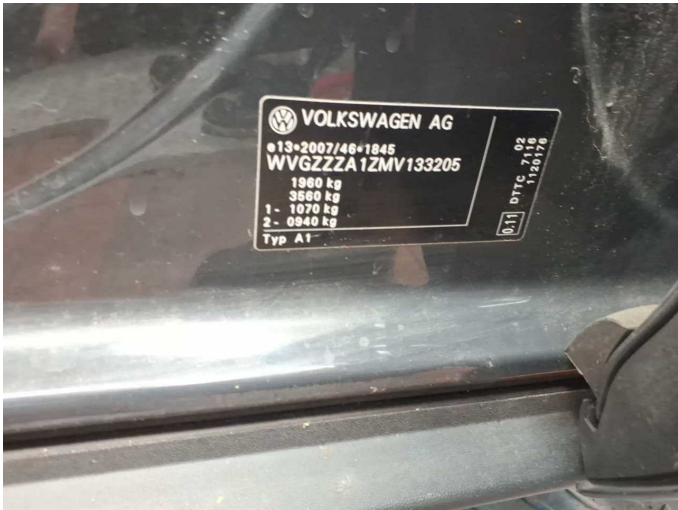
| VIN comparison | The vehicle identification number (VIN) was read from the vehicle and its conformity with the submitted documents was confirmed by the undersigned during the inspection. |

Figure 11: VIN

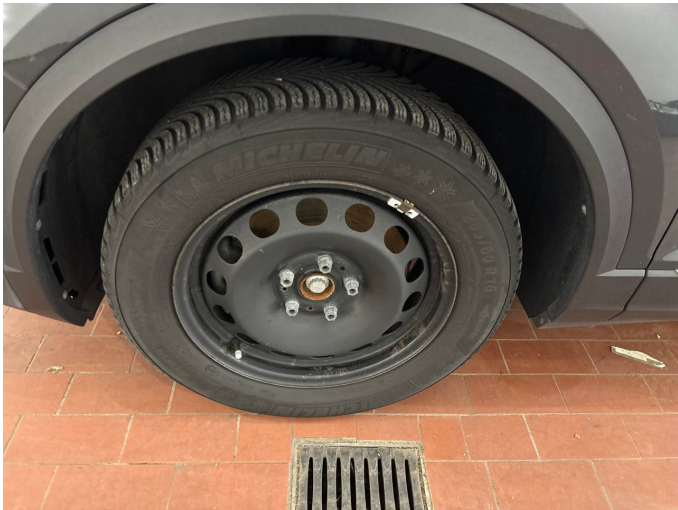
| # | Tyre size | Type of tyre | Manufacturer | Tread depth |
|---|---|---|---|---|
| 1) | 205/60 R16 92H | Winter tyres on Steel | Michelin | 5mm / 5mm |
| 2) | 205/60 R16 92H | Winter tyres on Steel | Michelin | 5mm / 5mm |

Figure 12: Mounted tyres

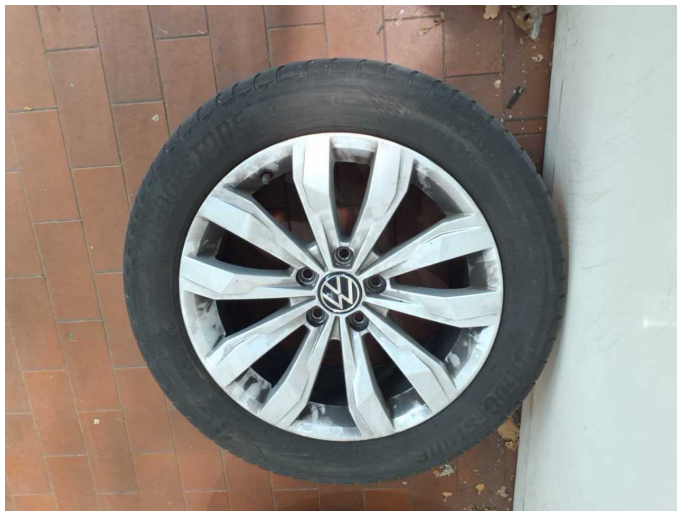
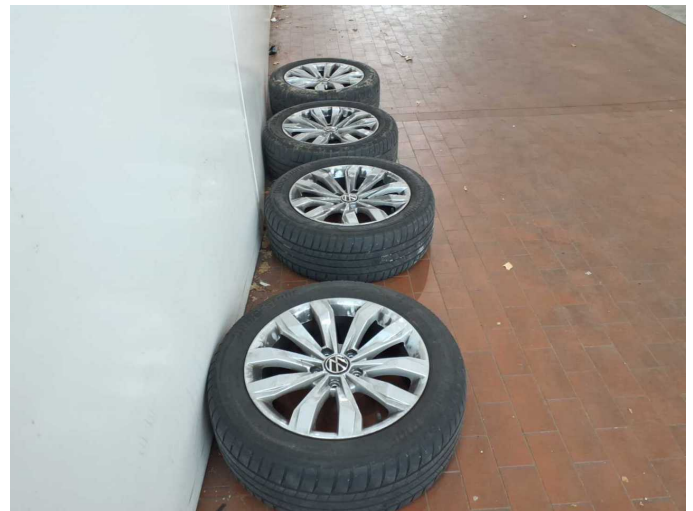
| # | Tyre size | Type of tyre | Manufacturer | Tread depth |
|---|---|---|---|---|
| 1) | 215/55 R17 94V | Summer tyres on Light alloy | Bridgestone | 3mm / 3mm |
| 2) | 215/55 R17 94V | Summer tyres on Light alloy | Bridgestone | 3mm / 3mm |

Figure 15: Additional tyres

Figure 16: Additional tyres

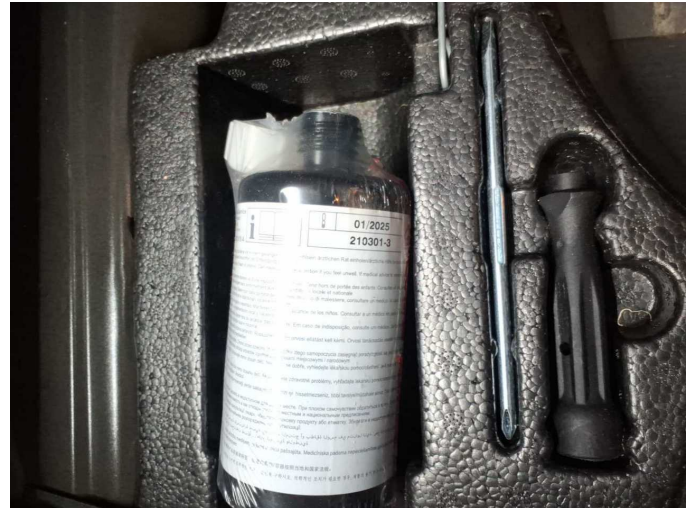
| No. | Component group | Description |
|---|---|---|
| 1 | Equipment | Tirefit filler - Expired - Replace |

**Damage 1:** Equipment: Tirefit filler - Expired - Replace

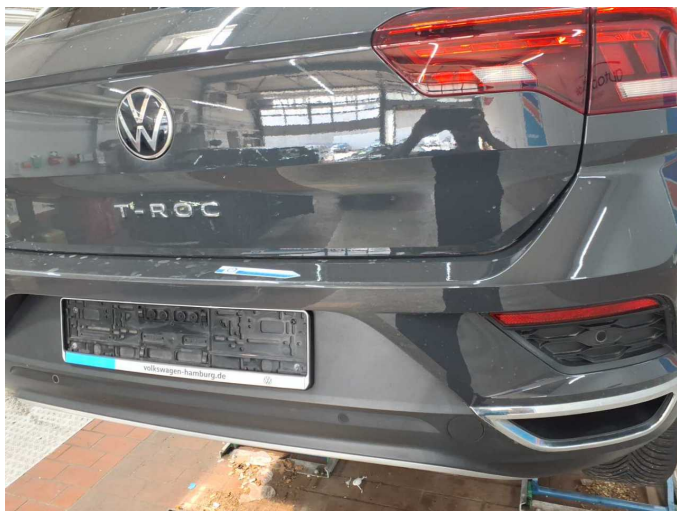
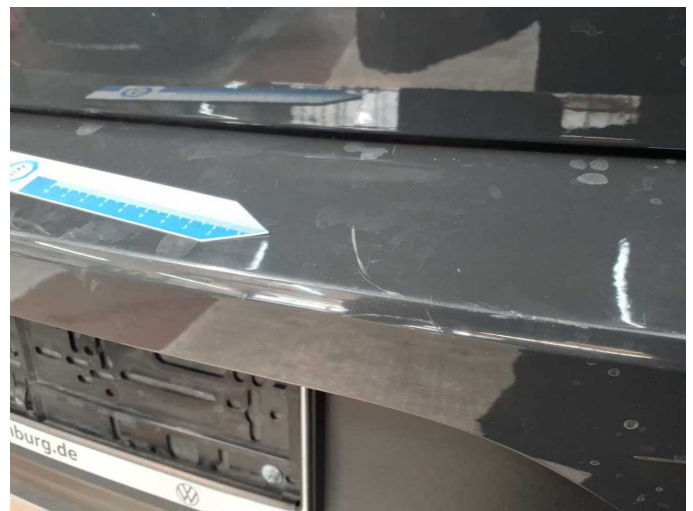
| No. | Component group | Description |
|---|---|---|
| 2 | Rear bumper | Rear bumper - Scratch(es) - Smart repair |

**Damage 2:** Rear bumper: Rear bumper - Scratch(es) - Smart repair

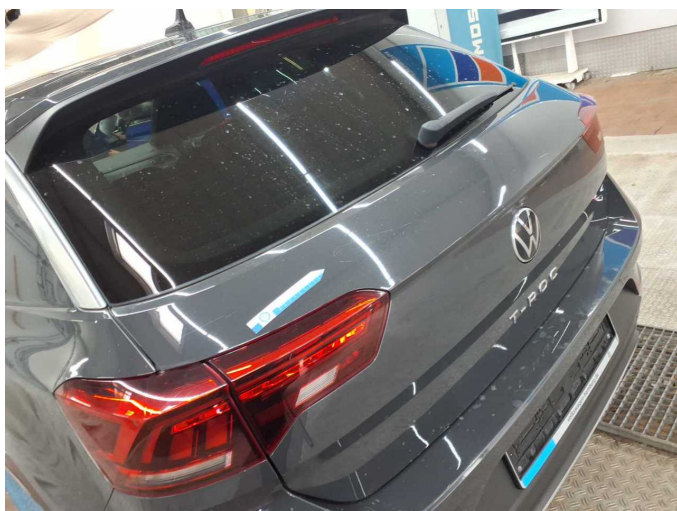
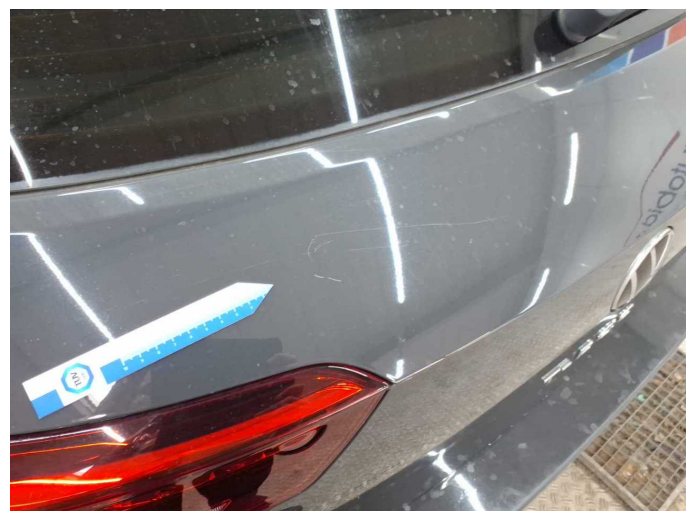
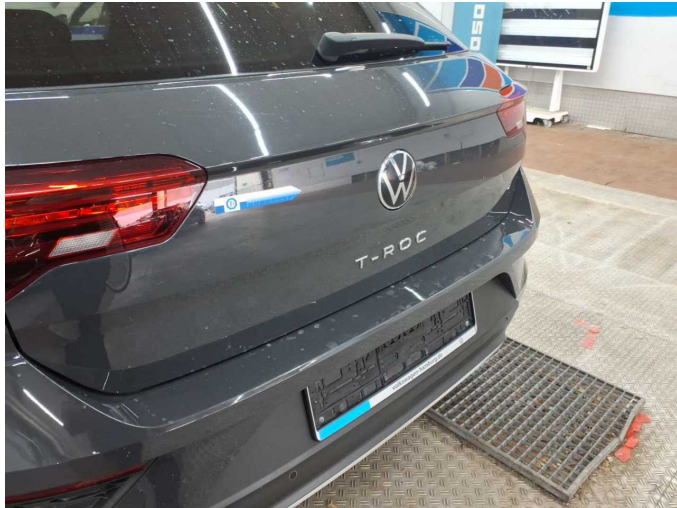
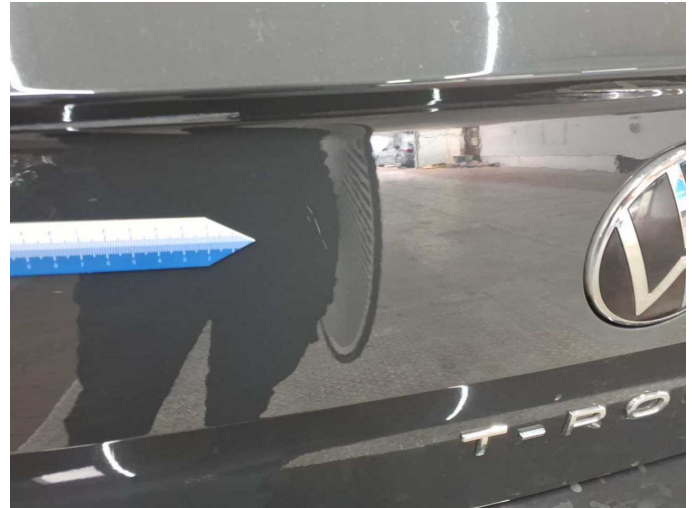
| No. | Component group | Description |
|---|---|---|
| 3 | Boot lid / rear door | Boot lid - Scratch(es) - Paint |

**Damage 3:** Boot lid / rear door: Boot lid - Scratch(es) - Paint
