Expertise

Protocol number: 46521558  
Order No. / Reference: 26638994  
Inspection date: 15 Jul 2026

Manufacturer: Volvo

Model: XC60 T8 AWD Plug-in Hybrid Polestar Engineered

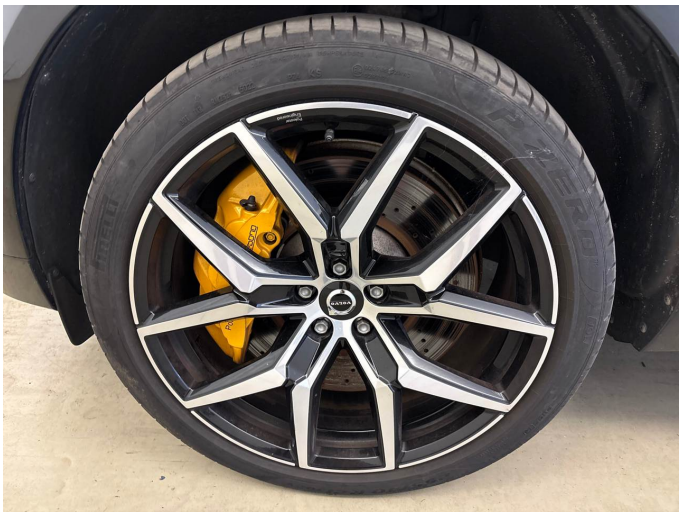
Figure 12: Mounted tyres

| # | Tyre size | Type of tyre | Manufacturer | Tread depth |
|---|---|---|---|---|
| 1) | 255/40 R21 102V | Summer tyres on Light alloy | Pirelli | 4mm / 4mm |
| 2) | 255/40 R21 102V | Summer tyres on Light alloy | Pirelli | 3mm / 3mm |

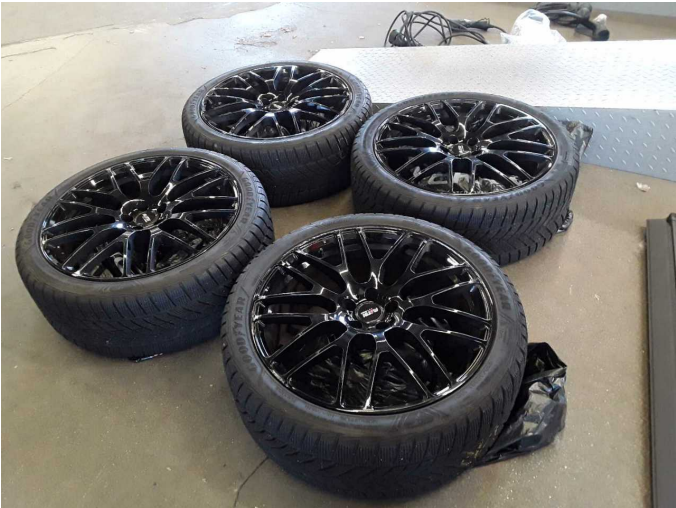
Figure 15: Additional tyres

| # | Tyre size | Type of tyre | Manufacturer | Tread depth |
|---|---|---|---|---|
| 1) | 255/40 R21 102V | Winter tyres on Light alloy | Goodyear | 5mm / 5mm |
| 2) | 255/40 R21 102V | Winter tyres on Light alloy | Goodyear | 5mm / 5mm |

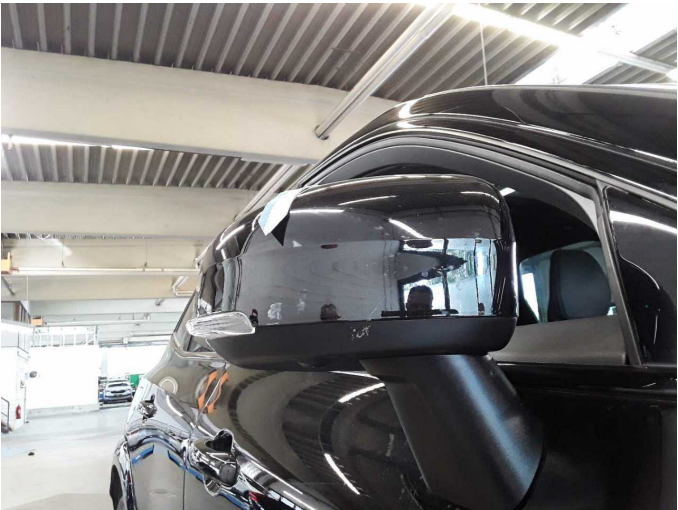
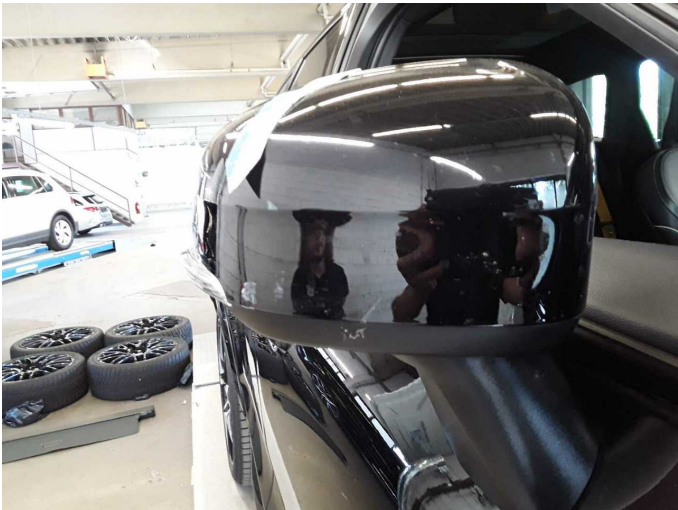
| No. | Component group | Description |
|---|---|---|
| 1 | Wing mirror - right side | Cap - Scratch(es) - Smart repair |

Damage 1: Wing mirror - right side: Cap - Scratch(es) - Smart repair

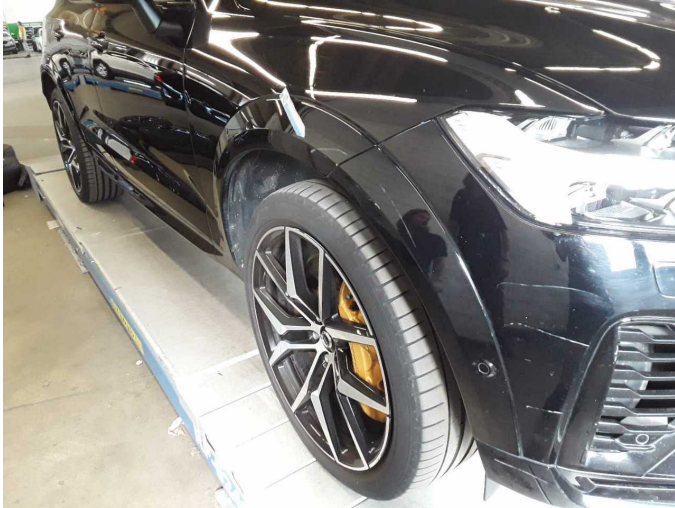
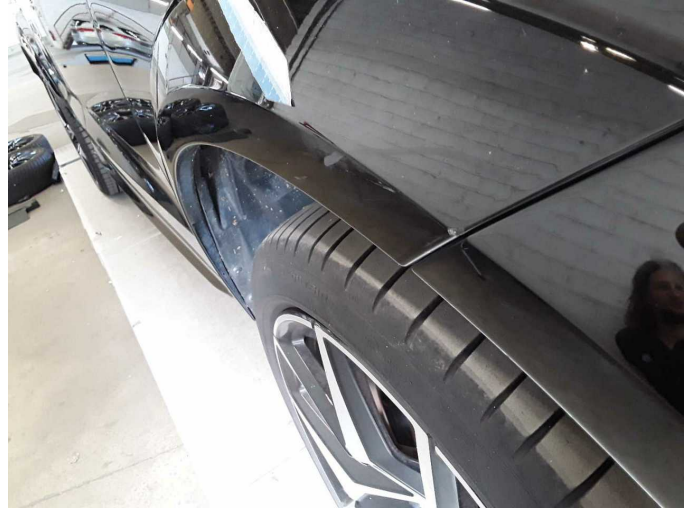
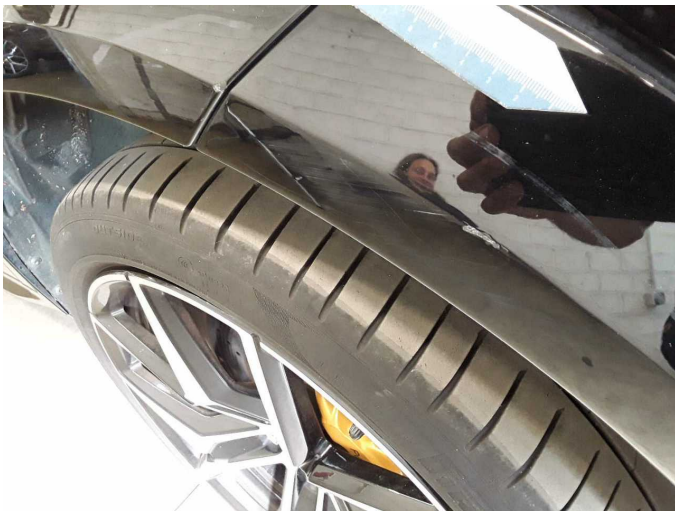
| No. | Component group | Description |
|---|---|---|
| 2 | Mudguard - right side | Wheel arch - Scratch(es) - Smart repair |

**Damage 2:** Mudguard - right side: Wheel arch - Scratch(es) - Smart repair

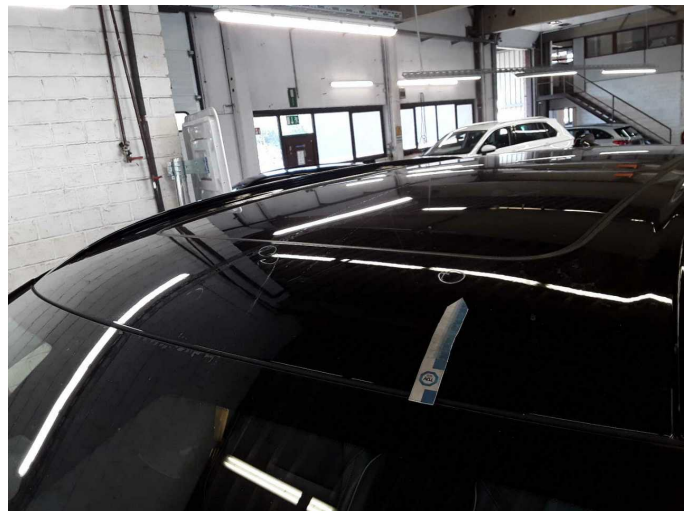
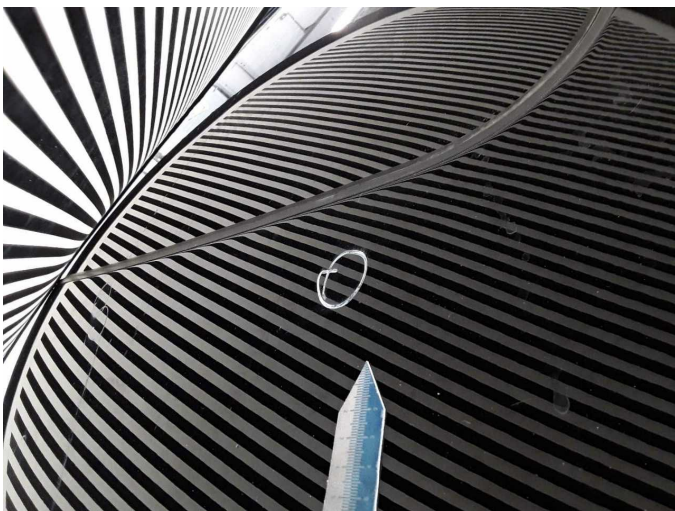
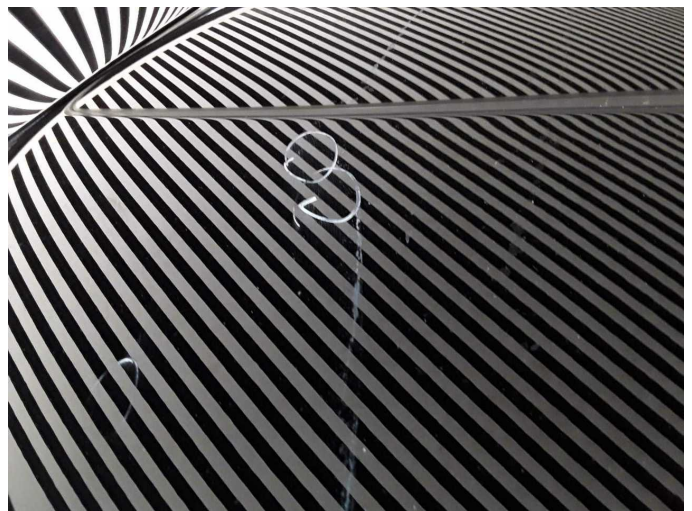
| No. | Component group | Description |
|---|---|---|
| 3 | Roof | Roof - dent(s) - Smooth repair work |

**Damage 3:** Roof: Roof - dent(s) - Smooth repair work

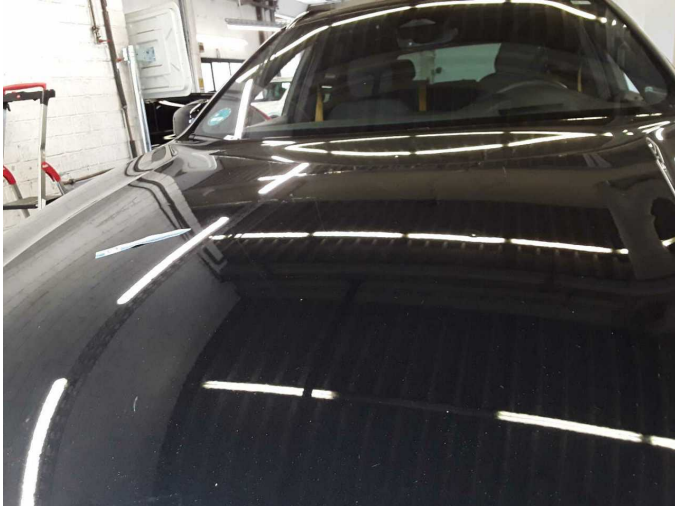
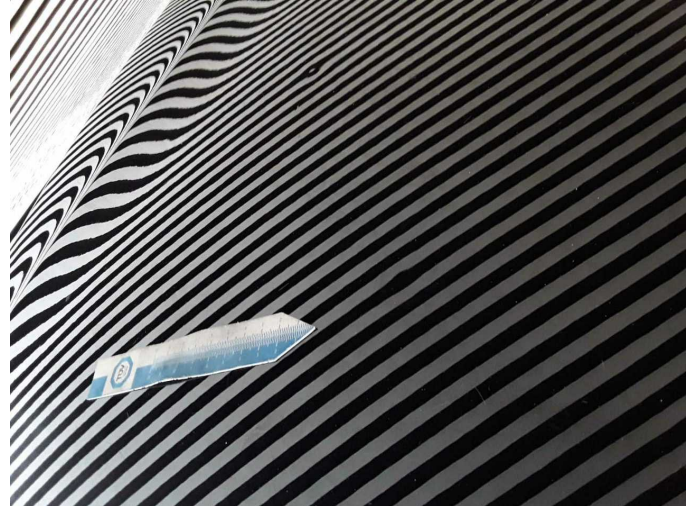
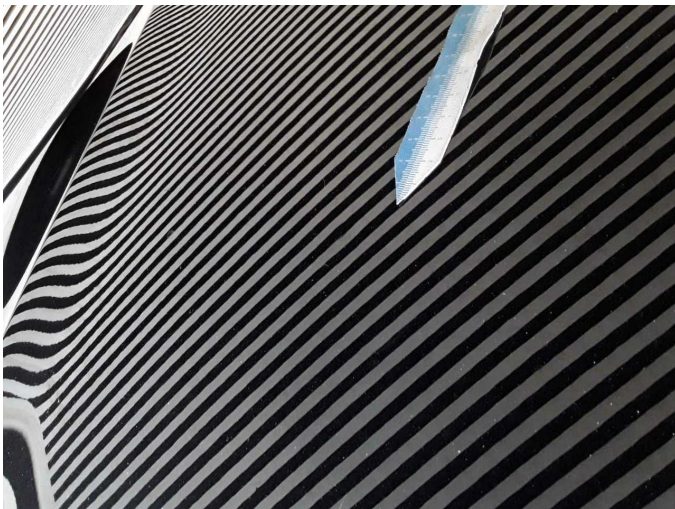
| No. | Component group | Description |
|---|---|---|
| 5 | Bonnet | Bonnet (5 Dellen) - dent(s) - Smooth repair work |

**Damage 5:** Bonnet: Bonnet (5 Dellen) - dent(s) - Smooth repair work

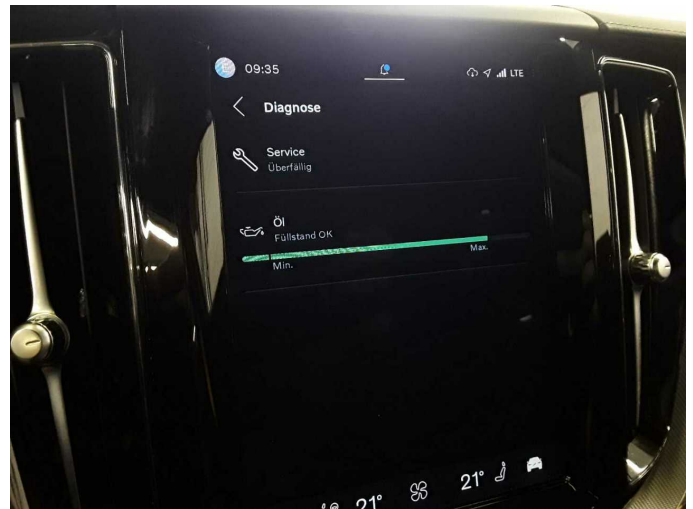
| No. | Component group | Description |
|---|---|---|
| 6 | Misc. | Inspection / maintenance - Due - Perform |

**Damage 6:** Misc.: Inspection / maintenance - Due - Perform

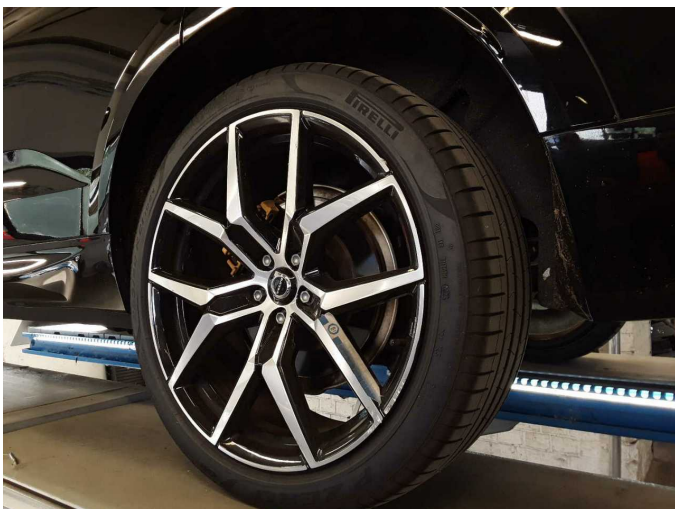
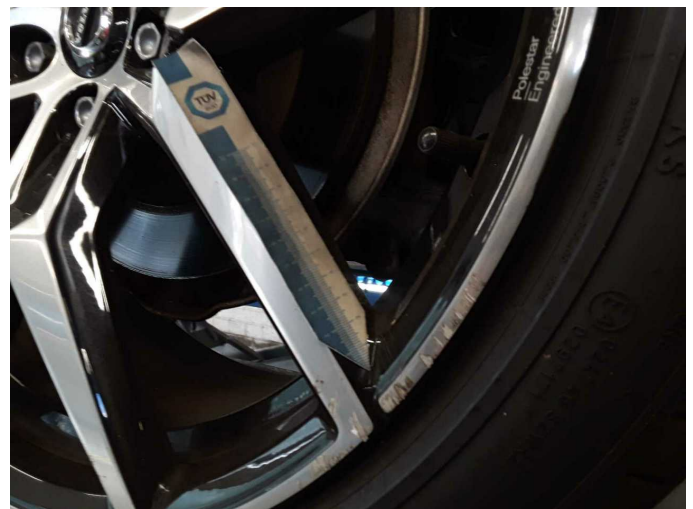
| No. | Component group | Description |
|---|---|---|
| 7 | Wheel / tyres | Alloy rim - rear left side - Scratched - Loss in value |

**Damage 7:** Wheel / tyres: Alloy rim - rear left side - Scratched - Loss in value

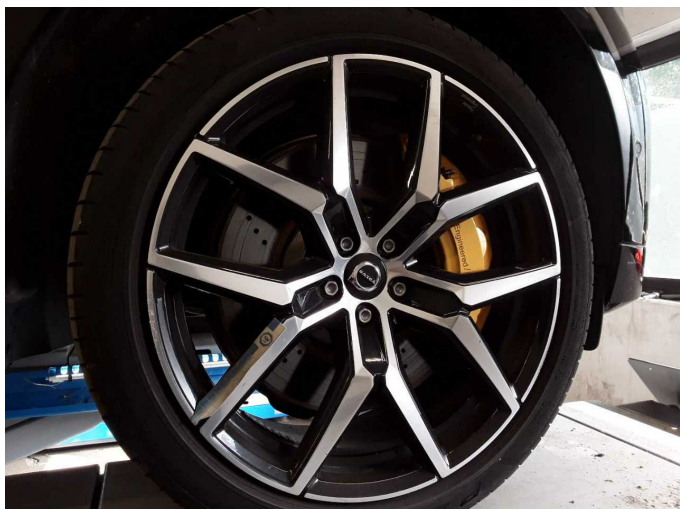
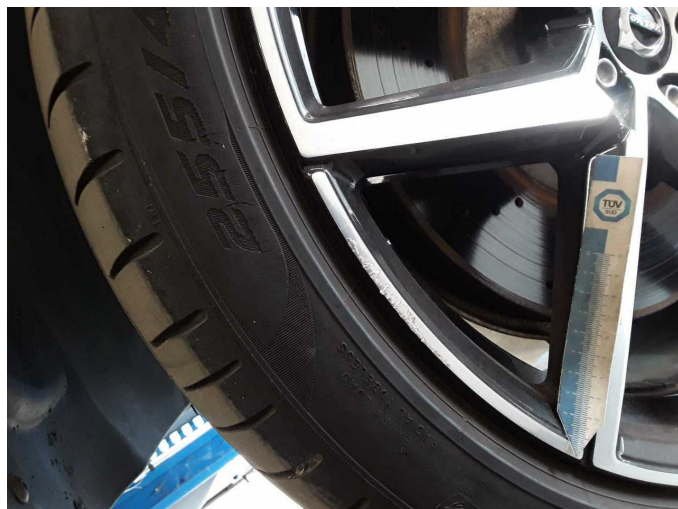
| No. | Component group | Description |
|---|---|---|
| 8 | Wheel / tyres | Alloy rim - front right side - Scratch(es) - Loss in value |

**Damage 8:** Wheel / tyres: Alloy rim - front right side - Scratch(es) - Loss in value

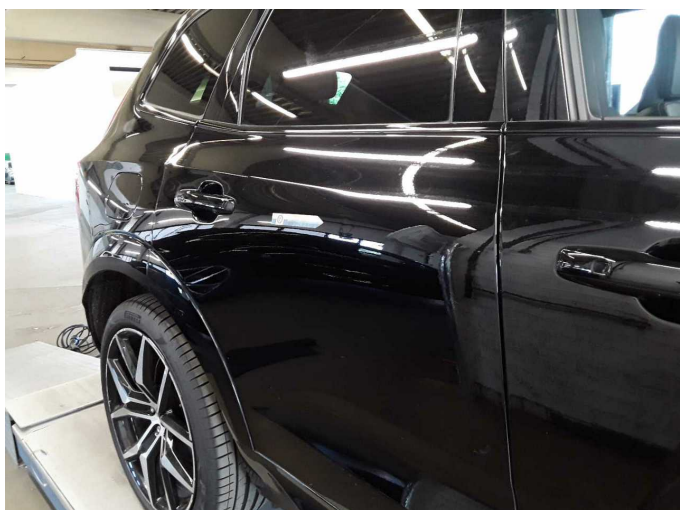
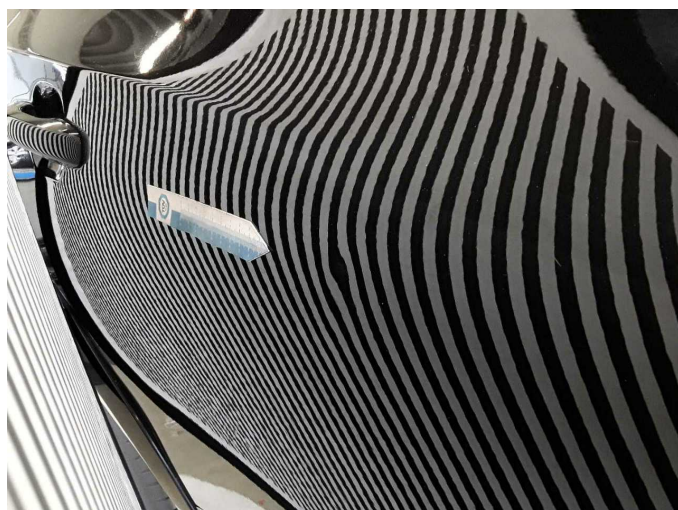
| No. | Component group | Description |
|---|---|---|
| 9 | Door - rear right side | Door - Deformed - Repair and paint |

**Damage 9:** Door - rear right side: Door - Deformed - Repair and paint

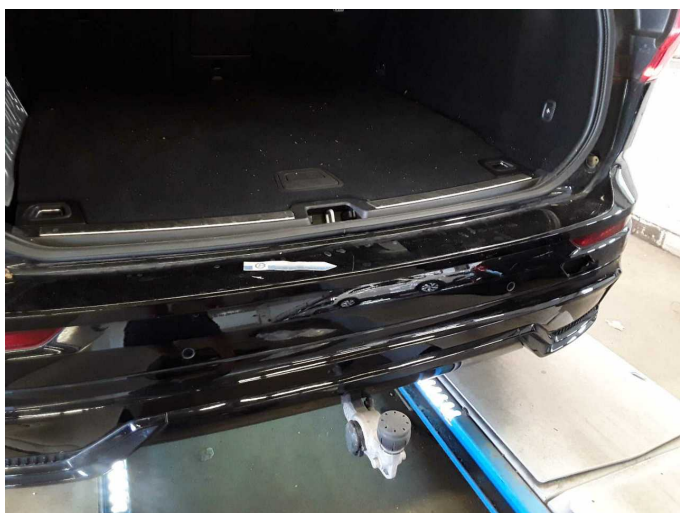
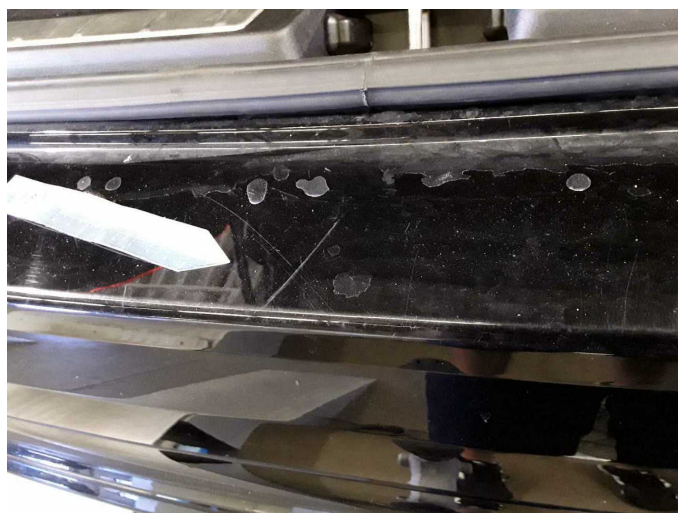
| No. | Component group | Description |
|---|---|---|
| 10 | Rear bumper | Rear bumper - Scratch(es) - Paint |

**Damage 10:** Rear bumper: Rear bumper - Scratch(es) - Paint

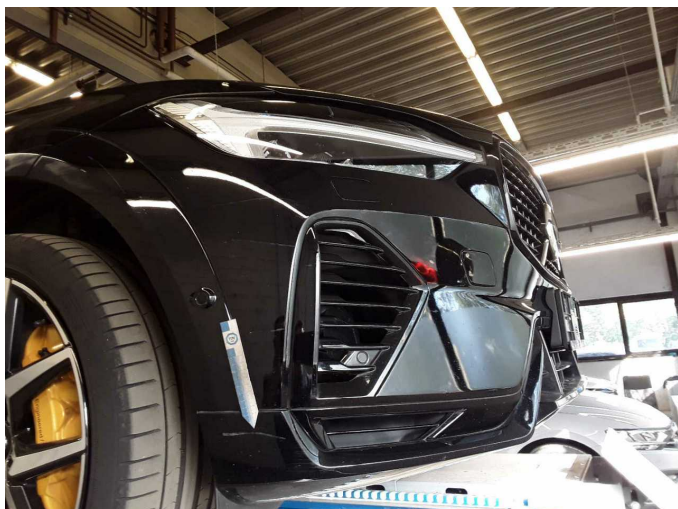
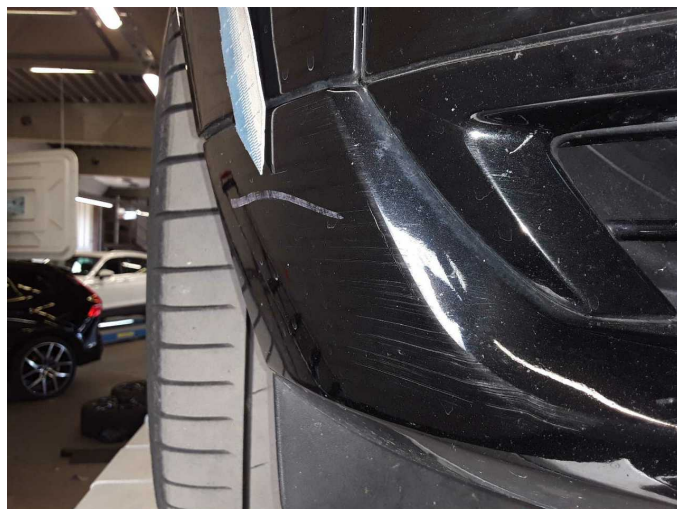
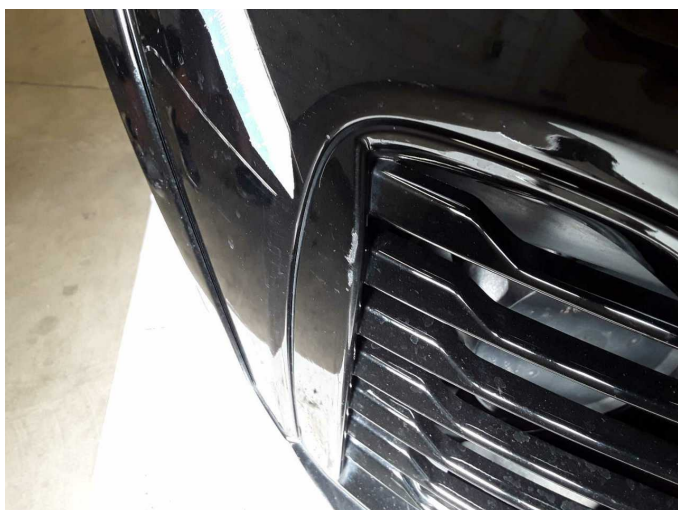
| No. | Component group | Description |
|---|---|---|
| 11 | Front bumper | Front bumper - Scratch(es) - Paint |

**Damage 11:** Front bumper: Front bumper - Scratch(es) - Paint

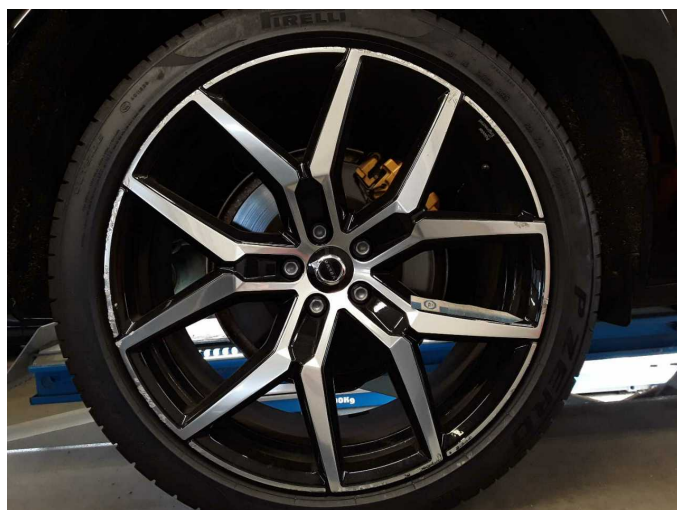
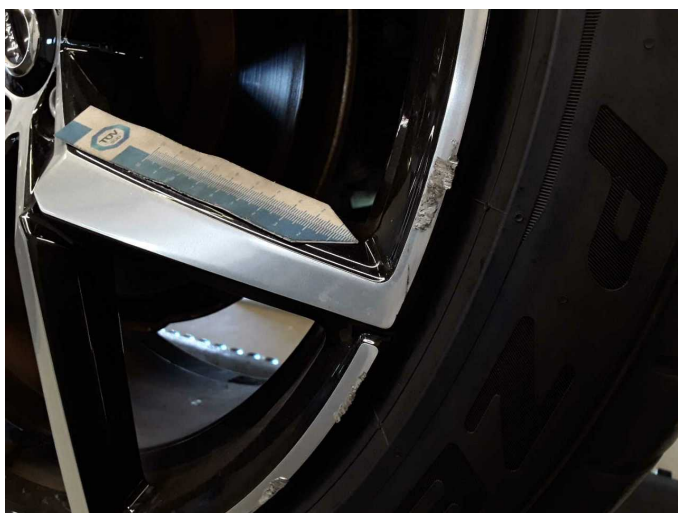
| No. | Component group | Description |
|---|---|---|
| 12 | Wheel / tyres | Alloy rim - rear right side (Materialabtrag) - Scratched - repair according to calculation |

**Damage 12:** Wheel / tyres: Alloy rim - rear right side (Materialabtrag) - Scratched - repair according to calculation
