Expertise

Protocol number: 46315362  
Order No. / Reference: 26349025  
Inspection date: 3 Jul 2026

| Manufacturer: Opel | Model: Astra Sports Tourer 1.5 D Automatik Business Edition |

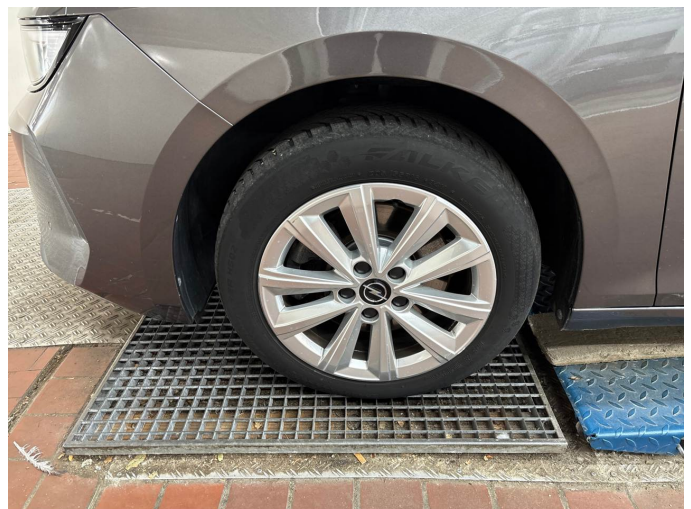
Figure 12: Mounted tyres

| # | Tyre size | Type of tyre | Manufacturer | Tread depth |
|---|---|---|---|---|
| 1) | 205/55 R16 94V | Winter tyres on Light alloy | Falken | 0mm / 0mm |
| 2) | 205/55 R16 94V | Winter tyres on Light alloy | Falken | 5mm / 5mm |

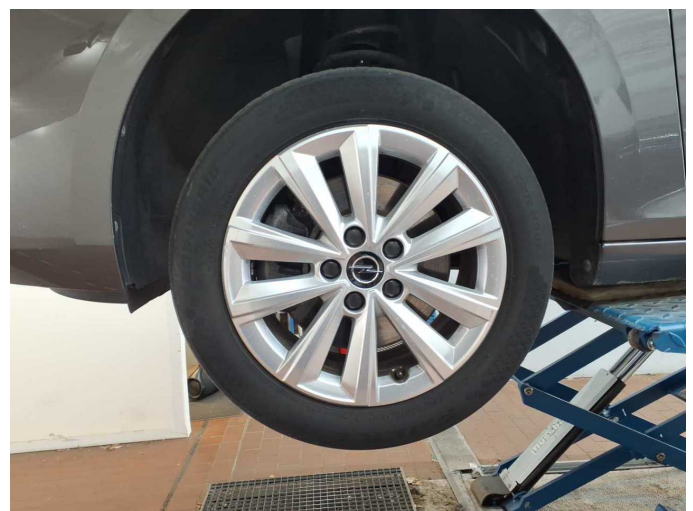
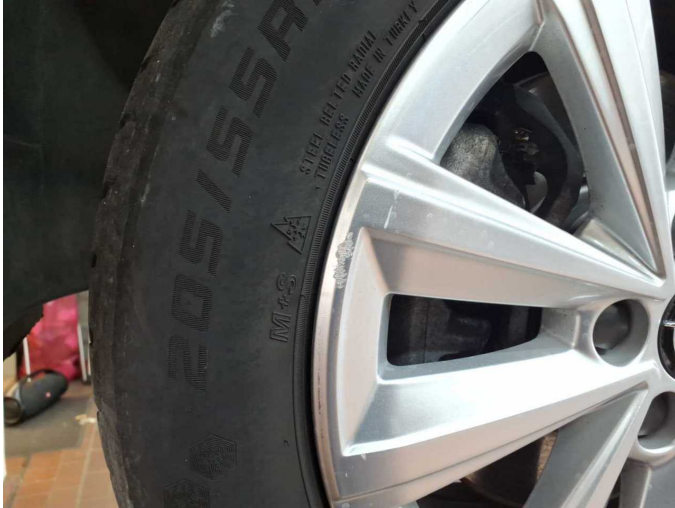
| No. | Component group | Description |
|---|---|---|
| 1 | Wheel / tyres | Alloy rim - front left side - Scratch(es) - Loss in value |

**Damage 1:** Wheel / tyres: Alloy rim - front left side - Scratch(es) - Loss in value

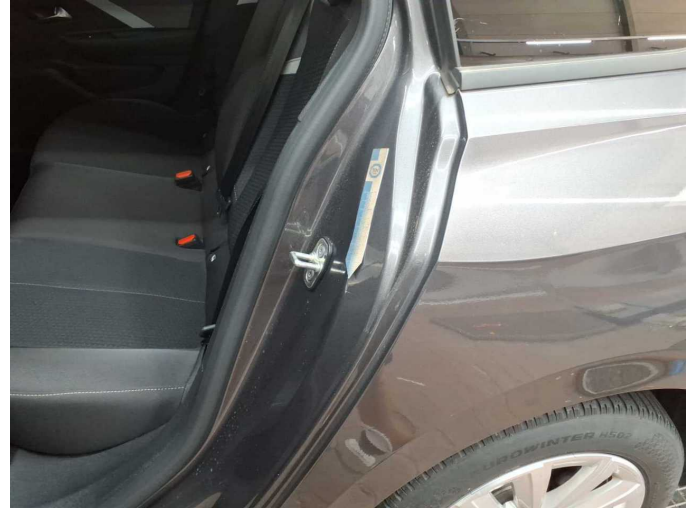
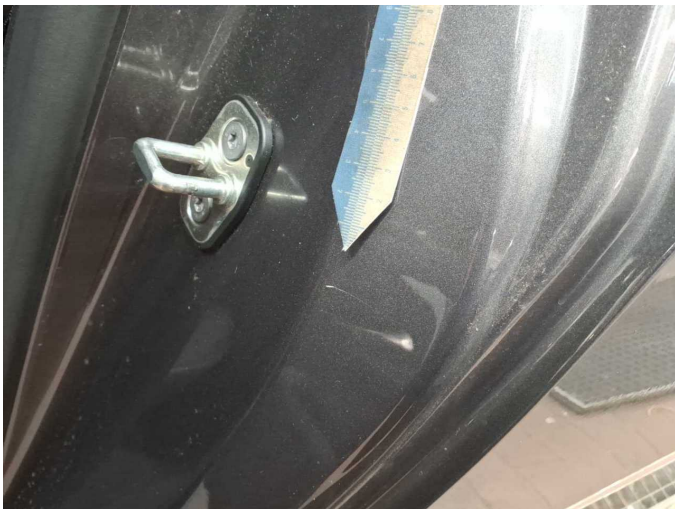
| No. | Component group | Description |
|---|---|---|
| 2 | Side panel - rear left side | Sill - Scratch(es) - Smart repair |

**Damage 2:** Side panel - rear left side: Sill - Scratch(es) - Smart repair

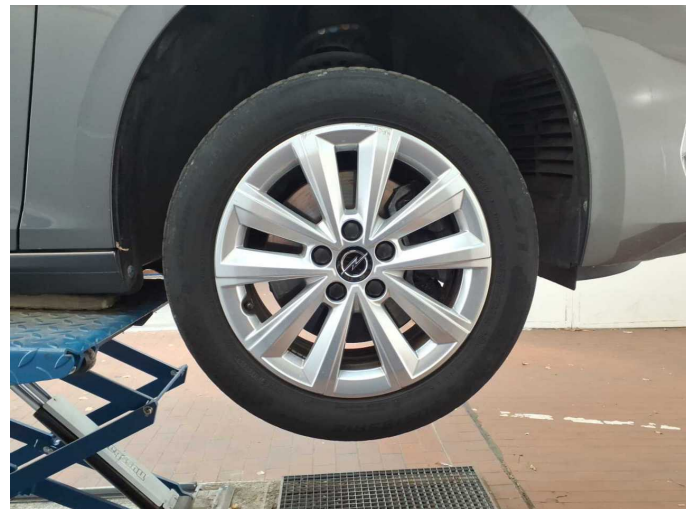
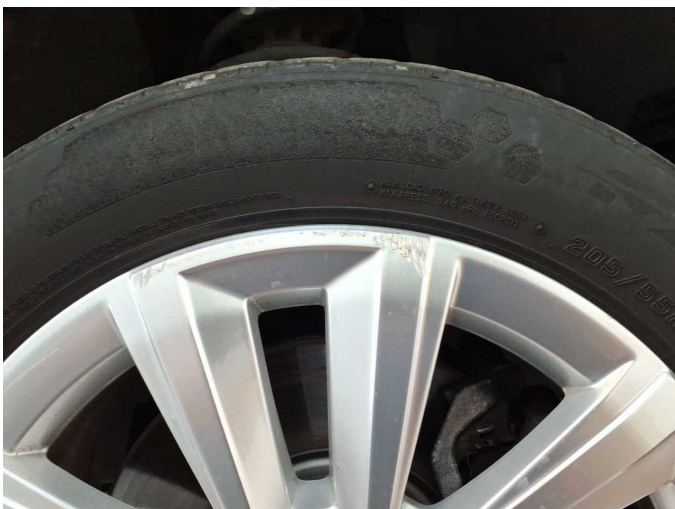
| No. | Component group | Description |
|---|---|---|
| 3 | Wheel / tyres | Alloy rim - front right side - Scratch(es) - Loss in value |

**Damage 3:** Wheel / tyres: Alloy rim - front right side - Scratch(es) - Loss in value

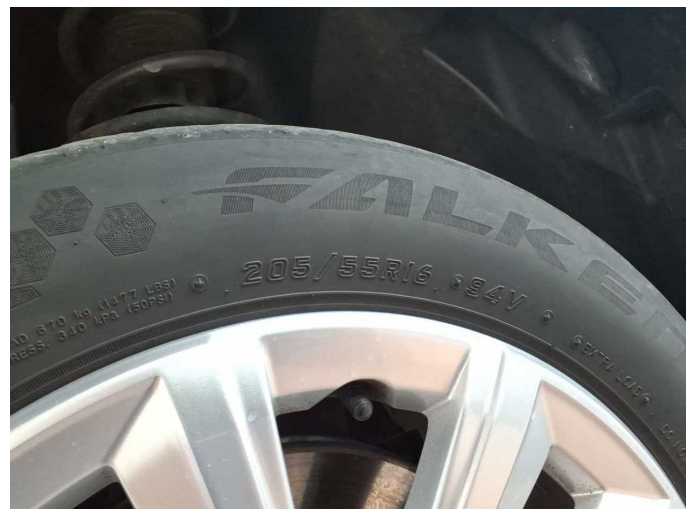
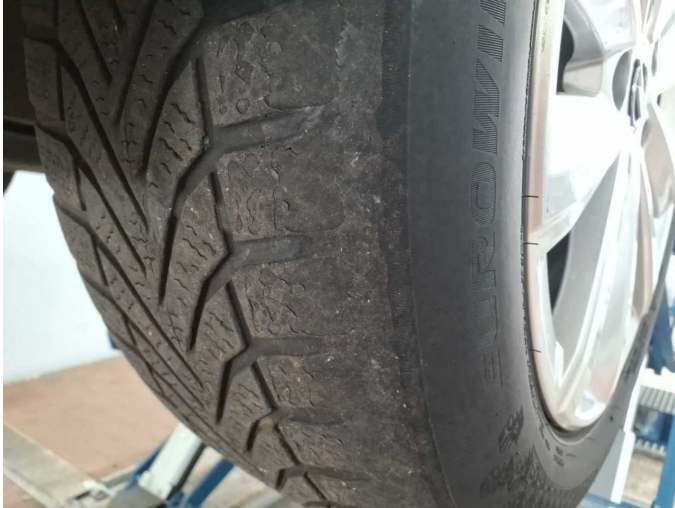
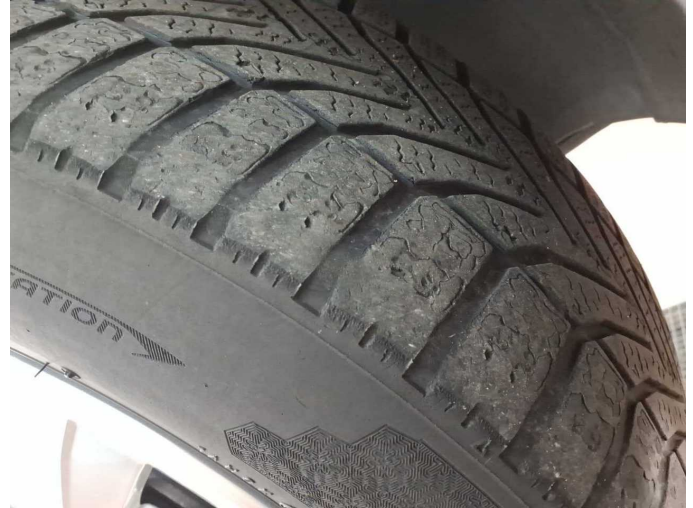
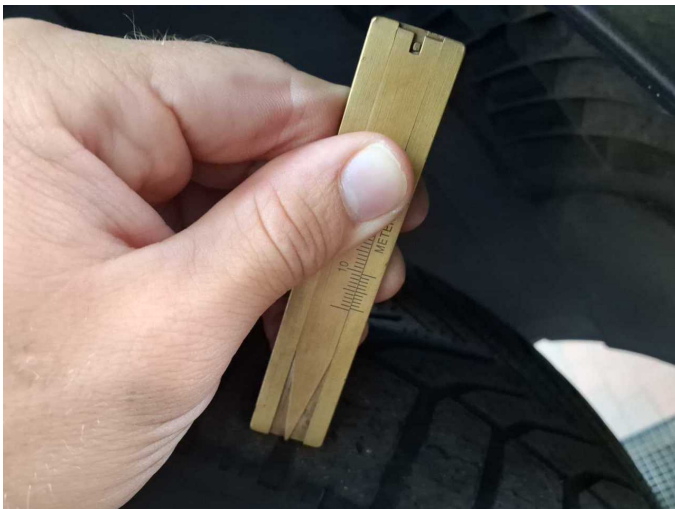
| No. | Component group | Description |
|---|---|---|
| 4 | Wheel / tyres | Tyre - front - Worn - Replace |

**Damage 4:** Wheel / tyres: Tyre - front - Worn - Replace

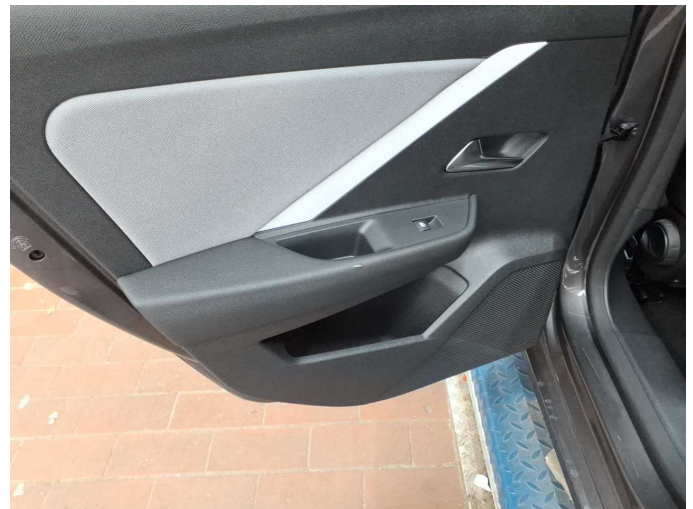
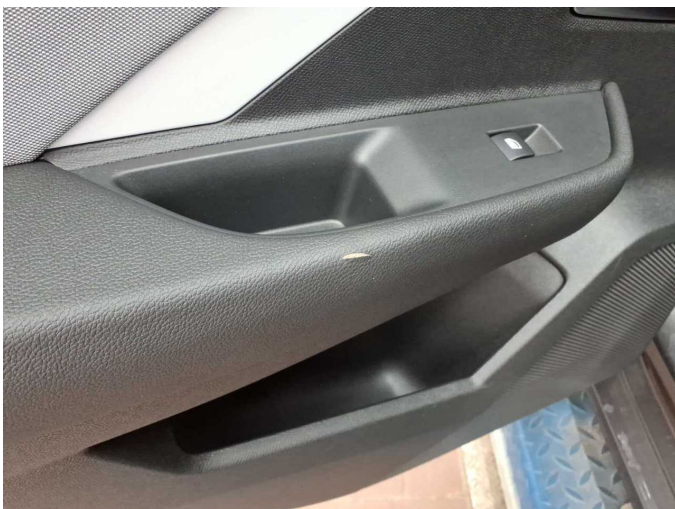
| No. | Component group | Description |
|---|---|---|
| 5 | Trim / covers | Door trim - rear left side - Broken / torn - Replace |

**Damage 5:** Trim / covers: Door trim - rear left side - Broken / torn - Replace

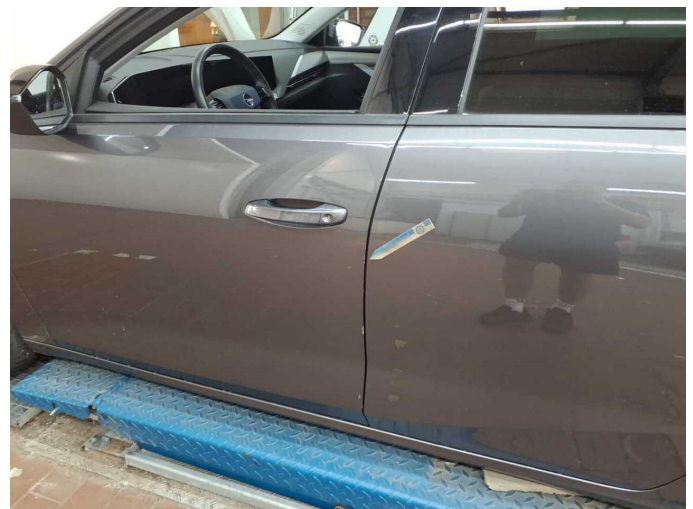
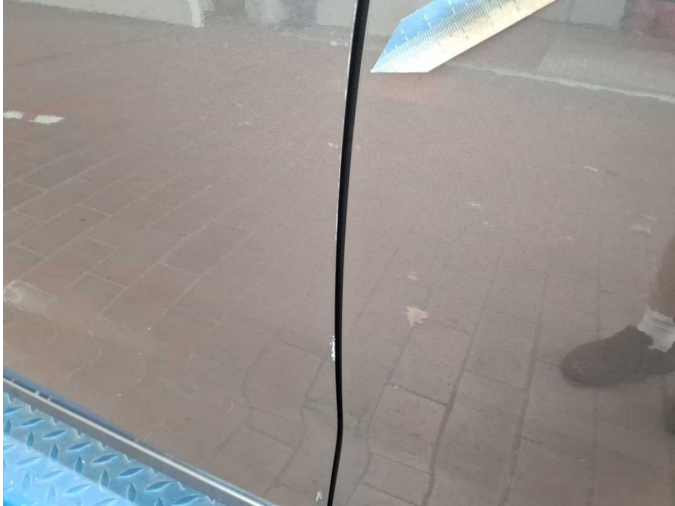
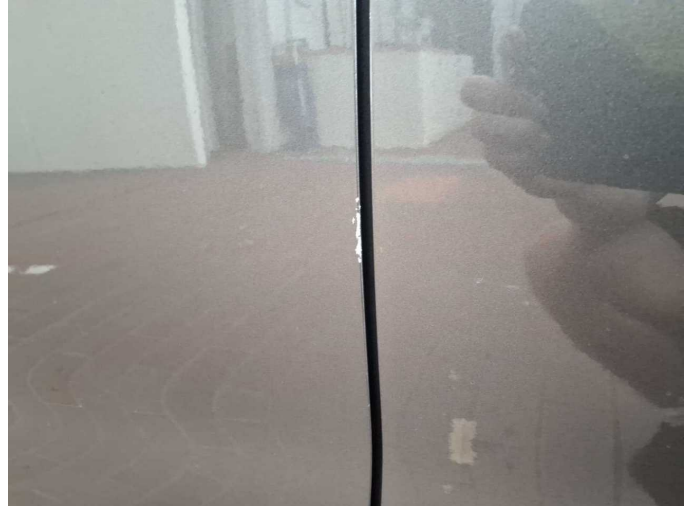
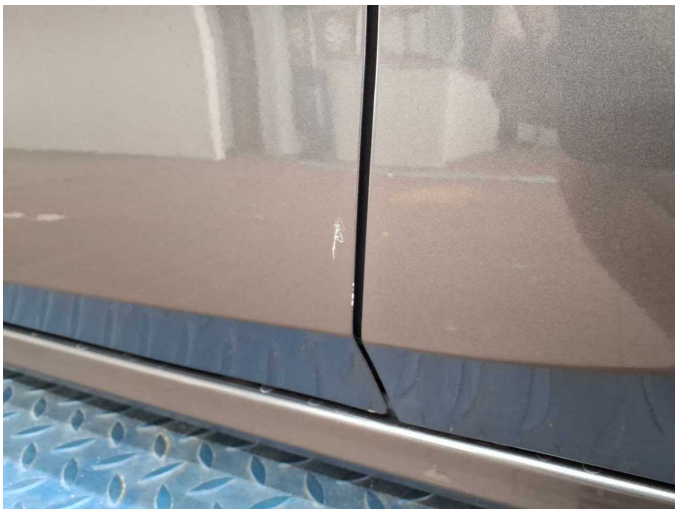
| No. | Component group | Description |
|---|---|---|
| 6 | Door - front left side | Door edge - Scratch(es) - Paint |

**Damage 6:** Door - front left side: Door edge - Scratch(es) - Paint

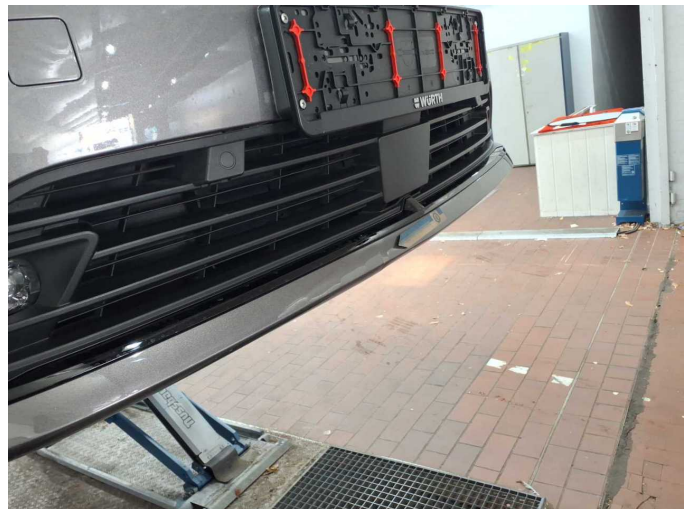
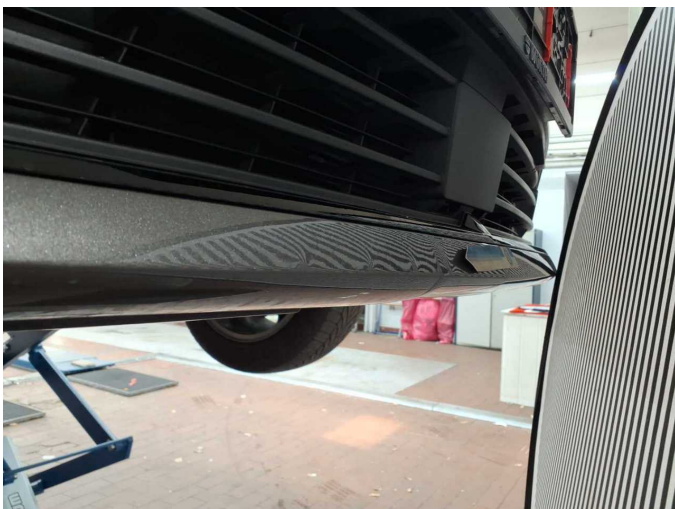
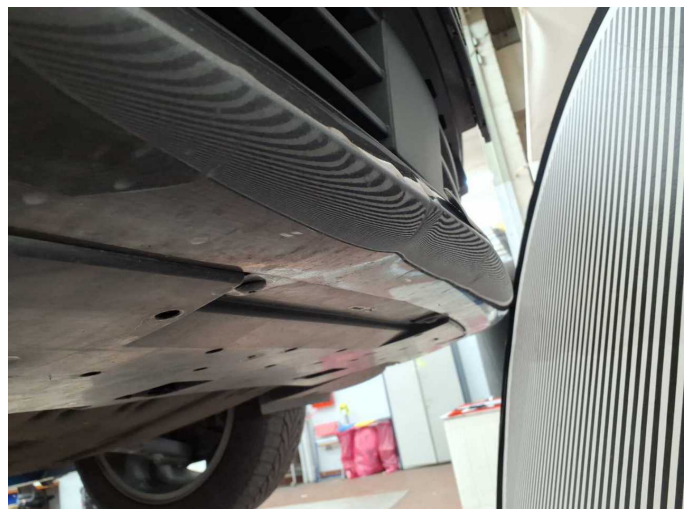
| No. | Component group | Description |
|---|---|---|
| 7 | Front bumper | Front bumper - Deformed - Replace |

**Damage 7:** Front bumper: Front bumper - Deformed - Replace
