Expertise

Protocol number: 46545378  
Order No. / Reference: 26570192  
Inspection date: 14 Jul 2026

Manufacturer: Audi

Model: A6 40 TDI quattro S tronic sport

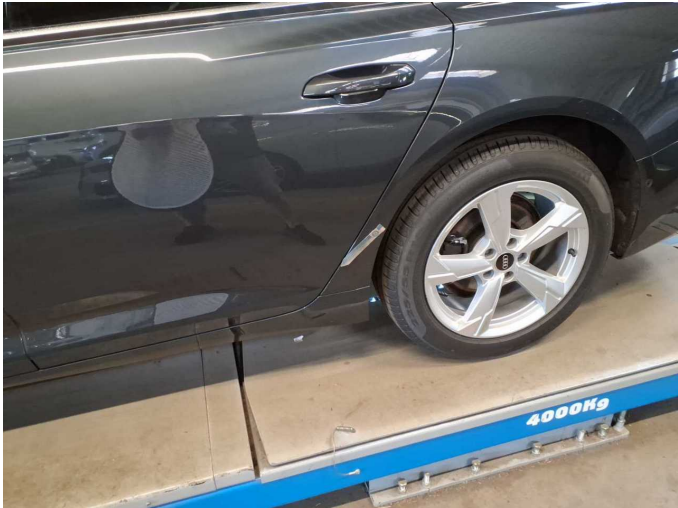
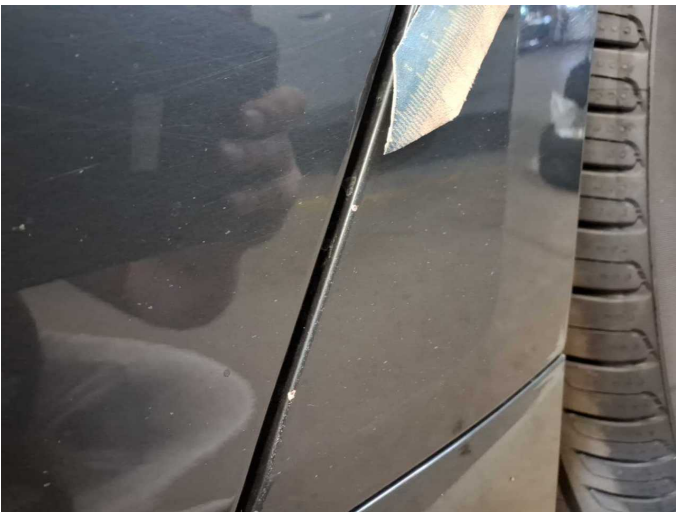
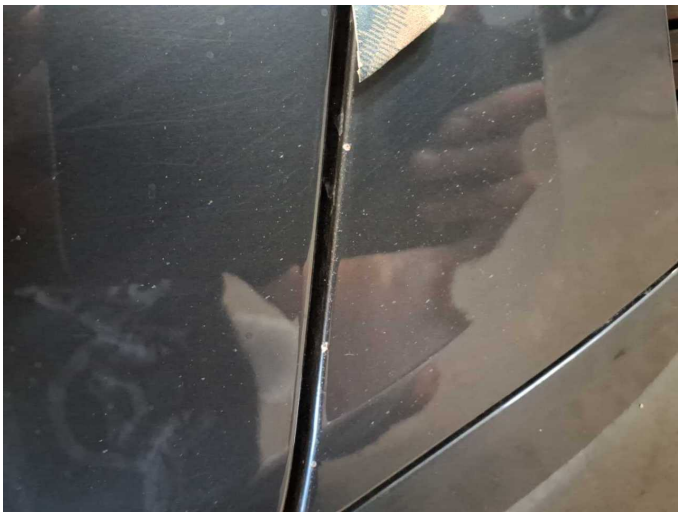
| No. | Component group | Description |
|---|---|---|
| 2 | Side panel - rear left side | Side panel - Scratch(es) - Smart repair |

Damage 2: Side panel - rear left side: Side panel - Scratch(es) - Smart repair

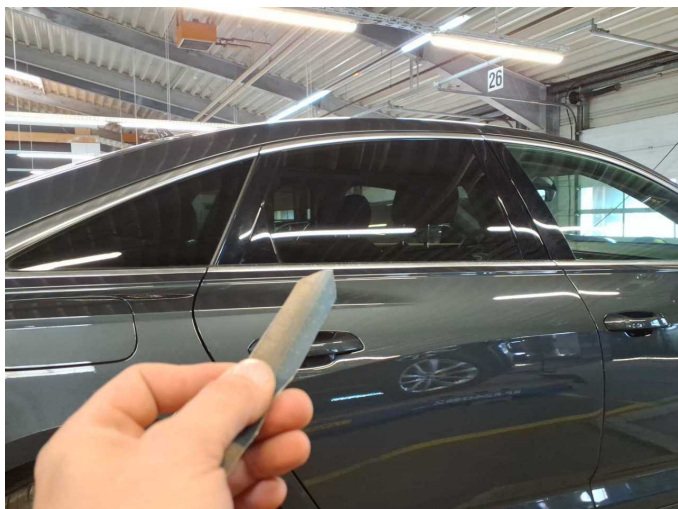
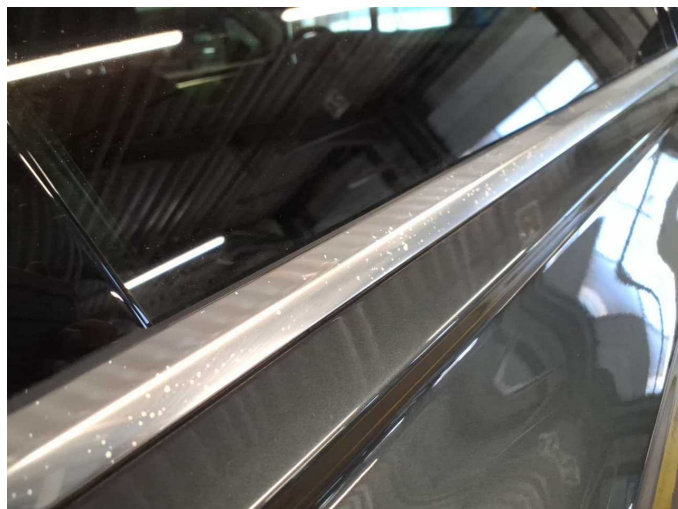
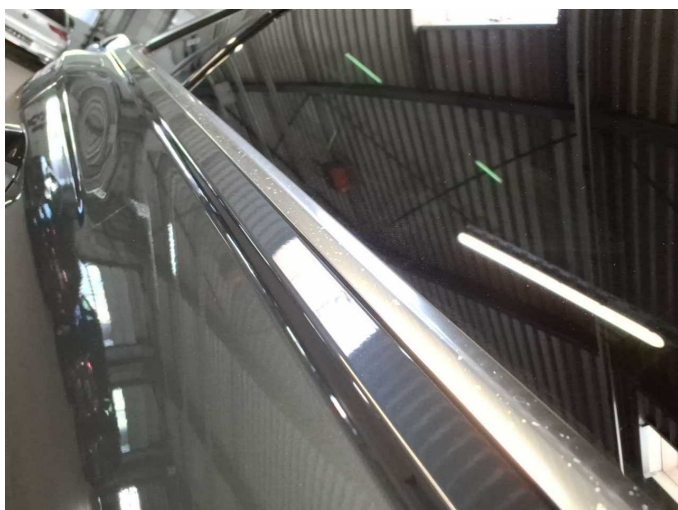
| No. | Component group | Description |
|---|---|---|
| 3 | Door - rear right side | Strip - outer (Anätzungen) - Paint defect - Replace |

**Damage 3:** Door - rear right side: Strip - outer (Anätzungen) - Paint defect - Replace

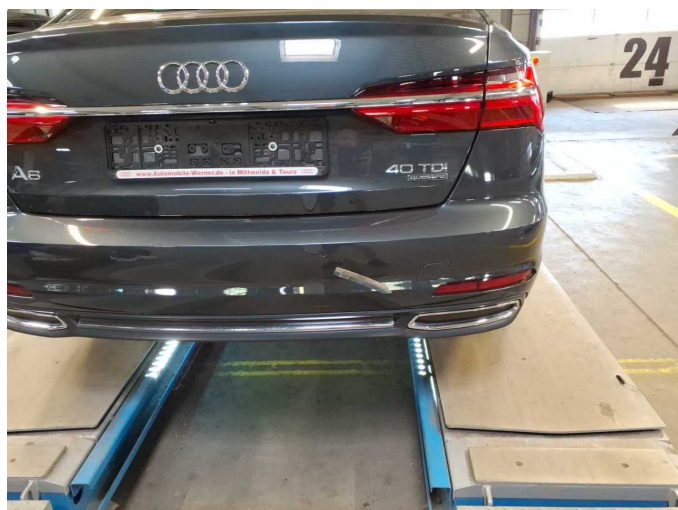
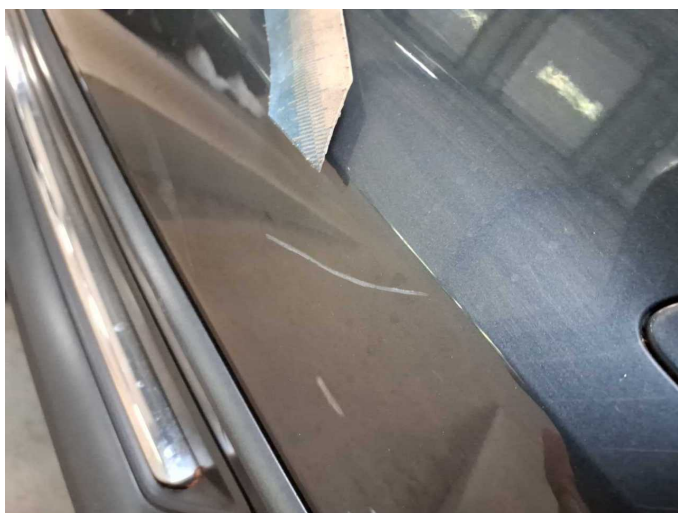
| No. | Component group | Description |
|---|---|---|
| 4 | Rear bumper | Rear bumper - Scratch(es) - Smart repair |

**Damage 4:** Rear bumper: Rear bumper - Scratch(es) - Smart repair

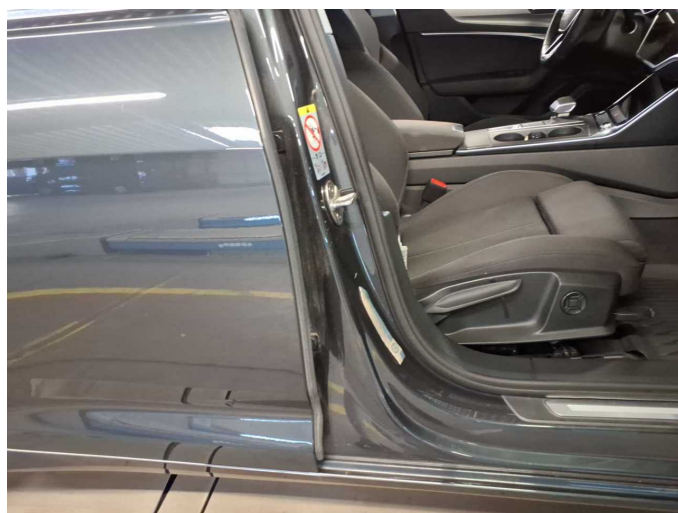
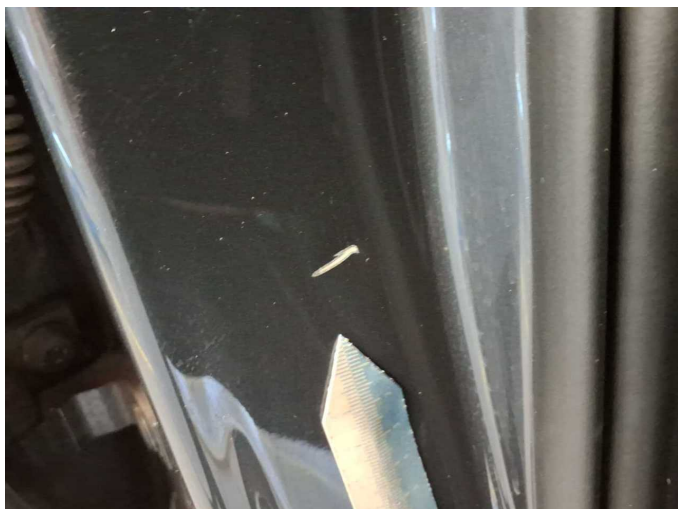
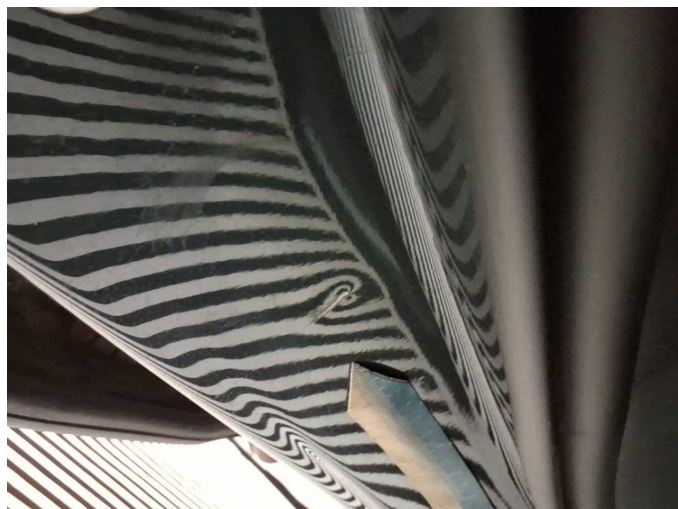
| No. | Component group | Description |
|---|---|---|
| 5 | Body | B-pillar - right side - Dent / paintcoat damage - Smart repair |

**Damage 5:** Body: B-pillar - right side - Dent / paintcoat damage - Smart repair

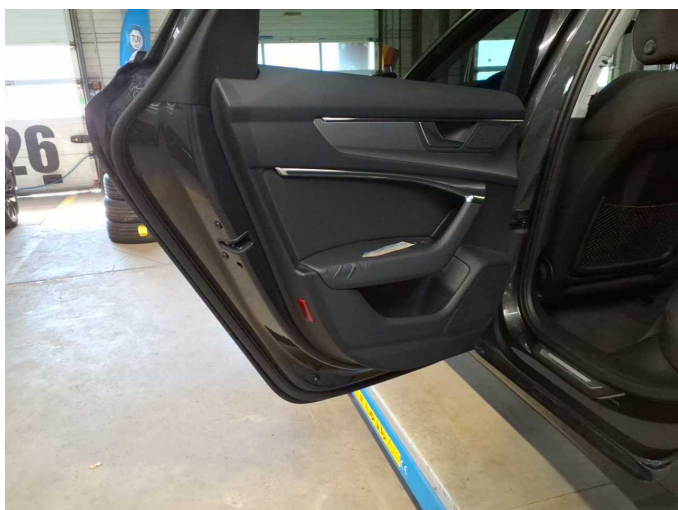
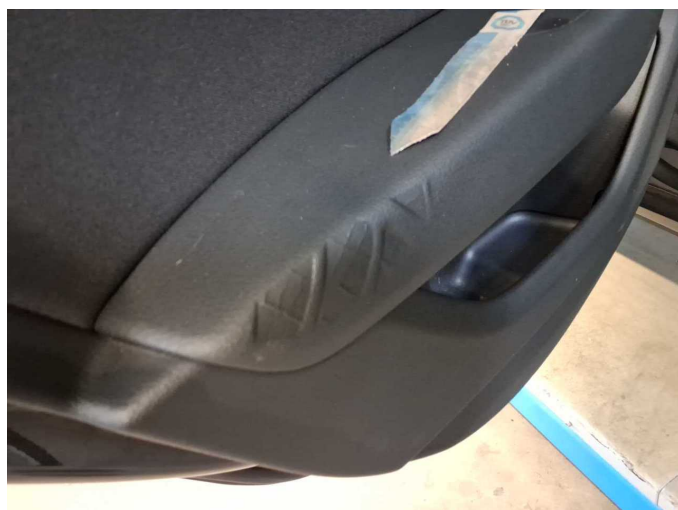
| No. | Component group | Description |
|---|---|---|
| 6 | Door - rear left side | Door handle - inside - Deformed - Smart repair |

**Damage 6:** Door - rear left side: Door handle - inside - Deformed - Smart repair

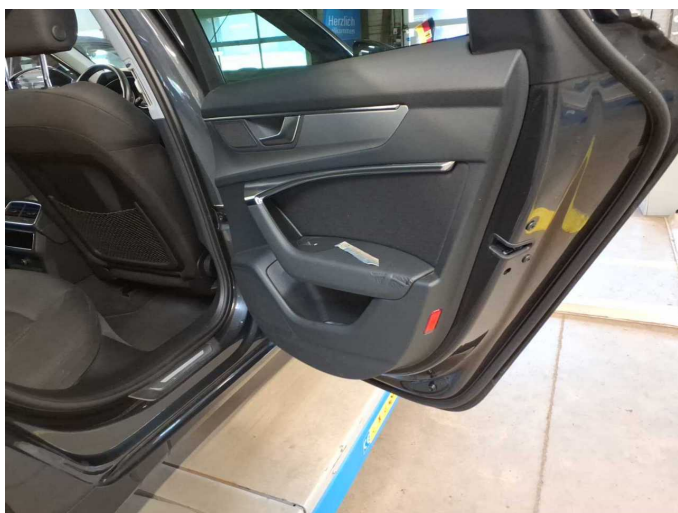
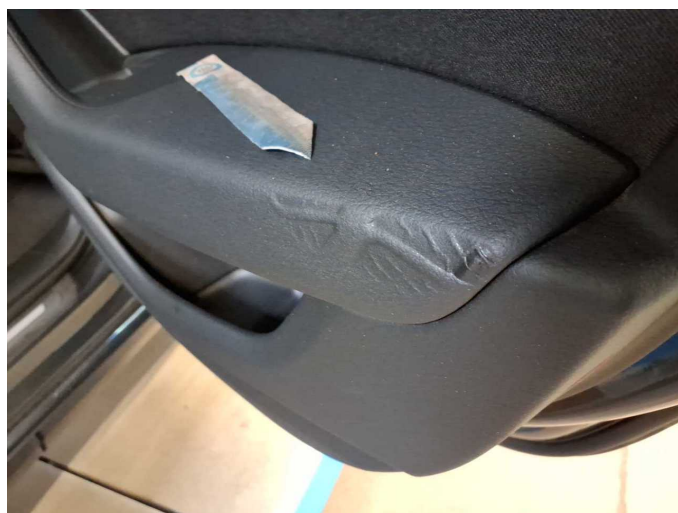
| No. | Component group | Description |
|---|---|---|
| 7 | Door - rear right side | Door handle - inside - Deformed - Smart repair |

**Damage 7:** Door - rear right side: Door handle - inside - Deformed - Smart repair

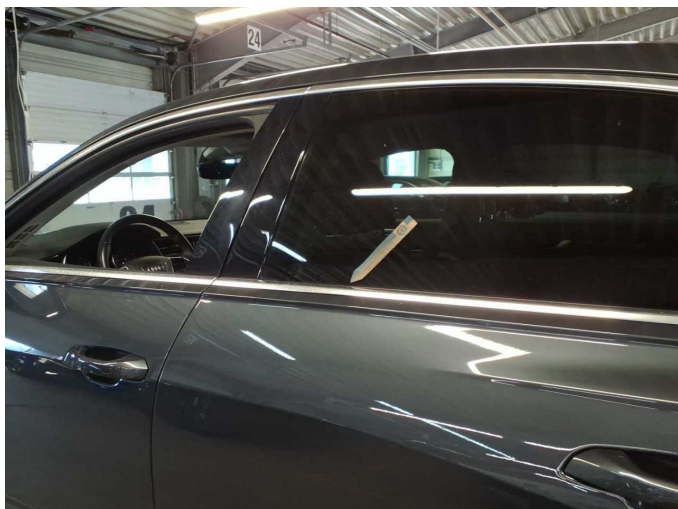
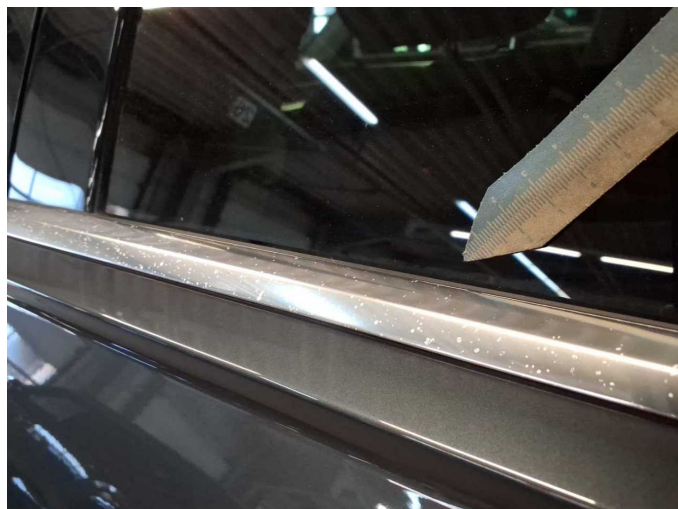
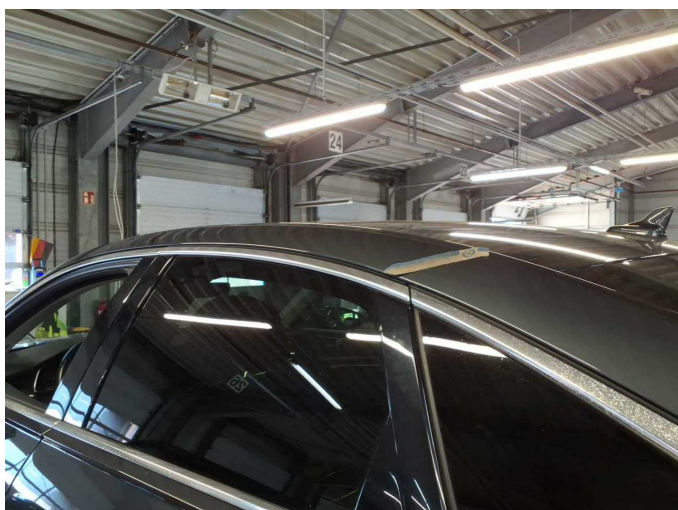
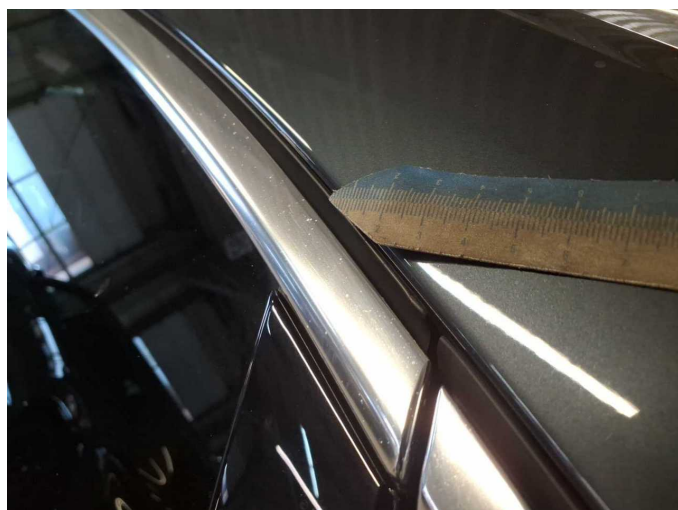
| No. | Component group | Description |
|---|---|---|
| 8 | Door - rear left side | Strip - outer (oben und unten, Anätzungen) - Paint defect - Replace |

**Damage 8:** Door - rear left side: Strip - outer (oben und unten, Anätzungen) - Paint defect - Replace

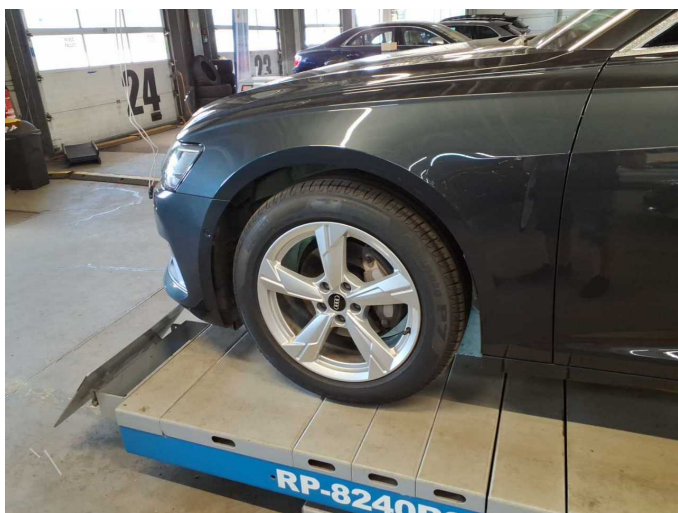
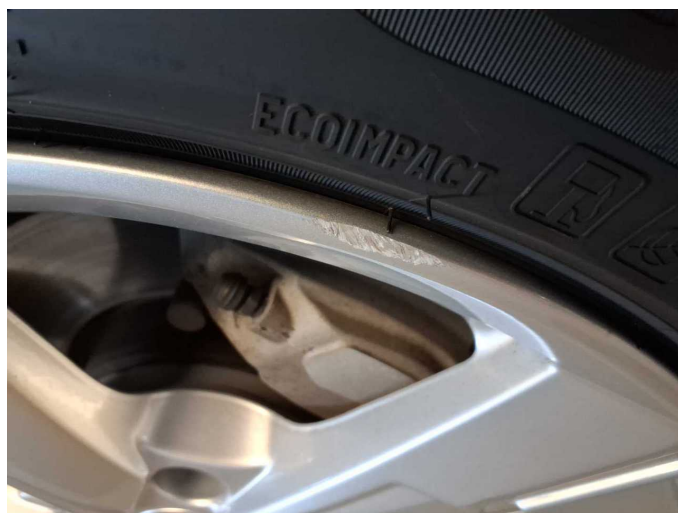
| No. | Component group | Description |
|---|---|---|
| 9 | Wheel / tyres | Alloy rim - front left side - Scratch(es) - Loss in value |

**Damage 9:** Wheel / tyres: Alloy rim - front left side - Scratch(es) - Loss in value

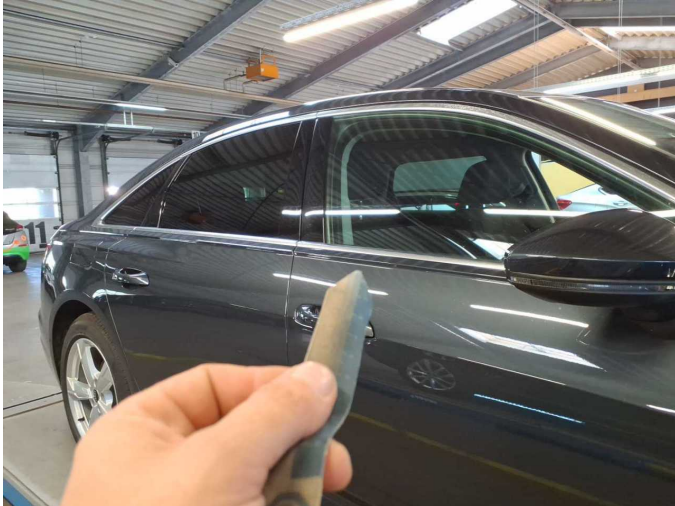
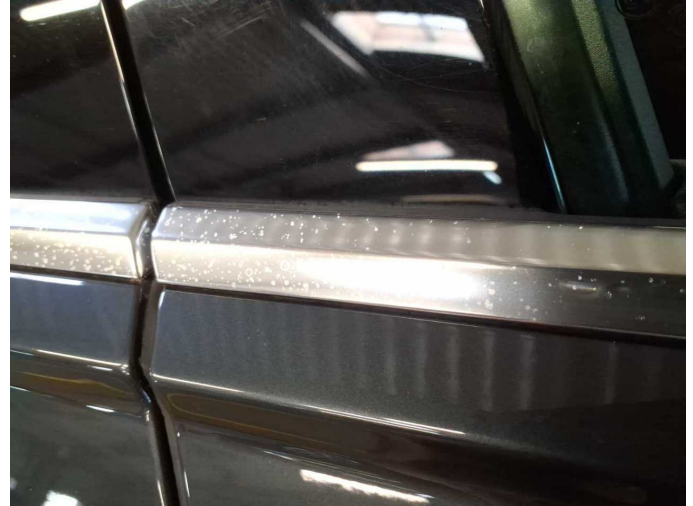
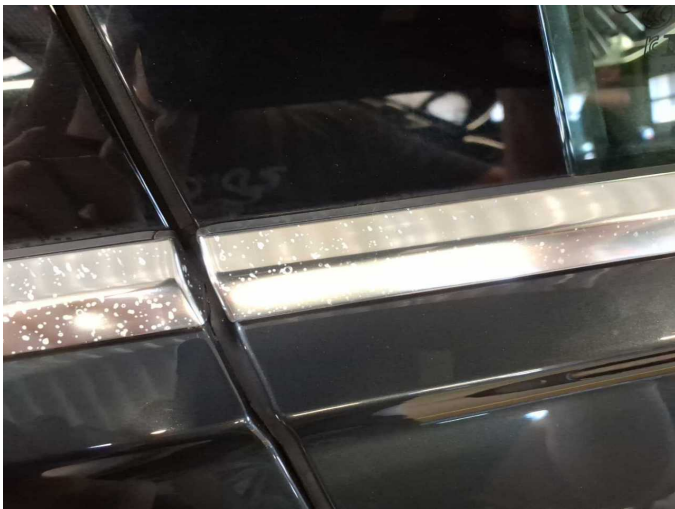
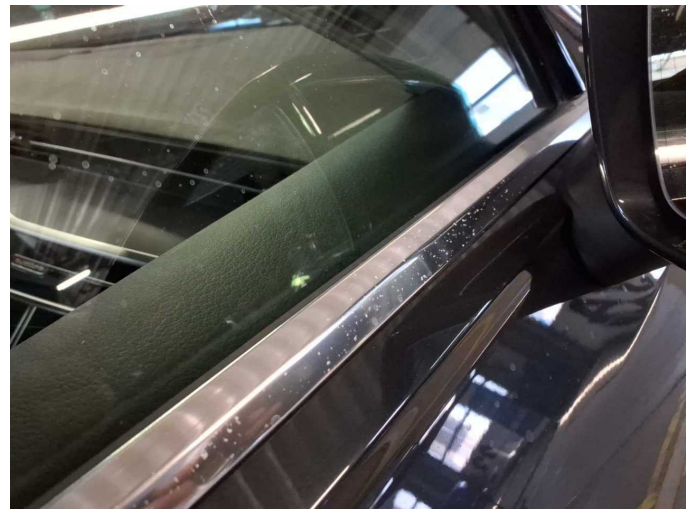
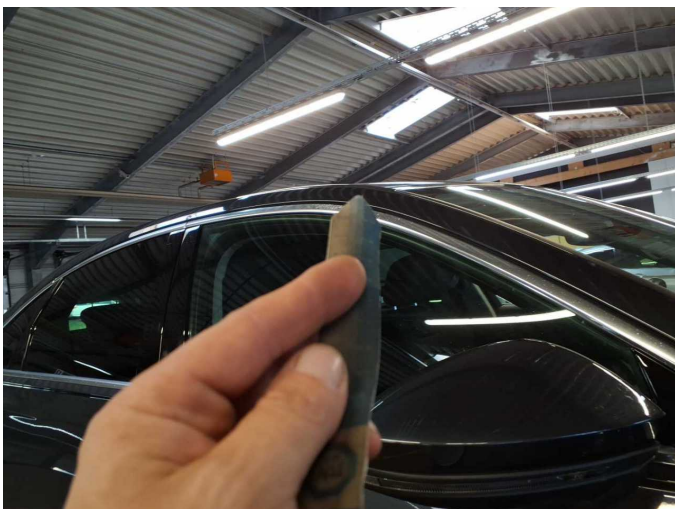
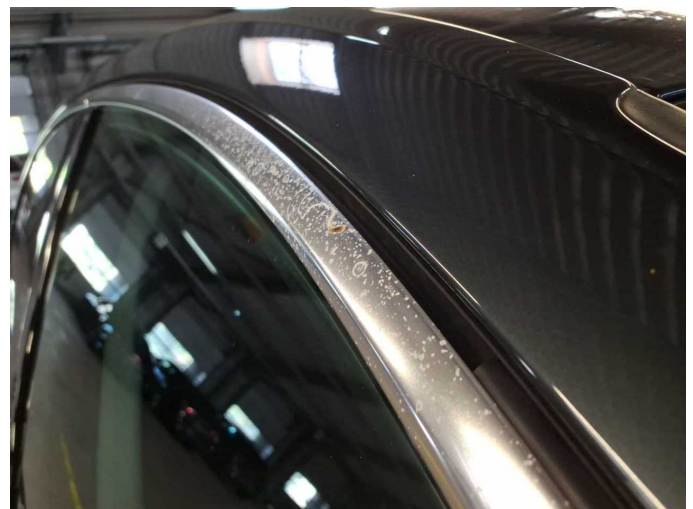
| No. | Component group | Description |
|---|---|---|
| 10 | Door - front right side | Strip - outer (oben und unten, Anätzungen) - Paint defect - Replace |

**Damage 10:** Door - front right side: Strip - outer (oben und unten, Anätzungen) - Paint defect - Replace

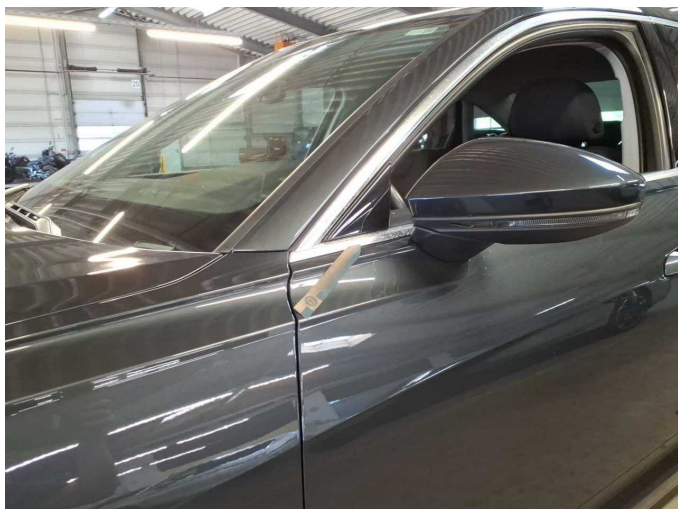
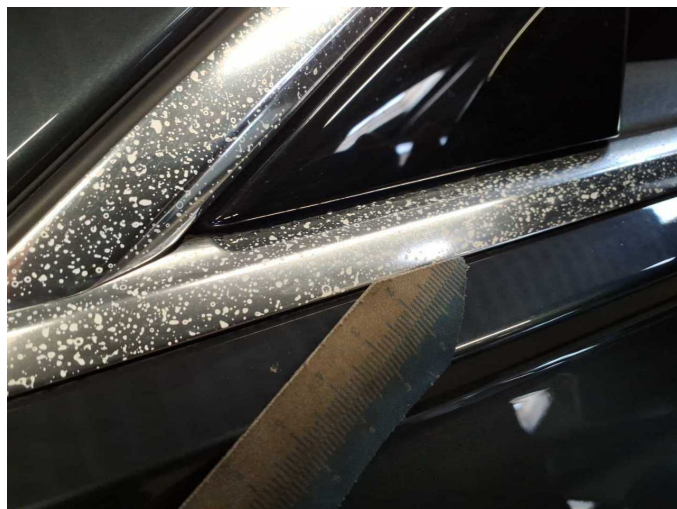
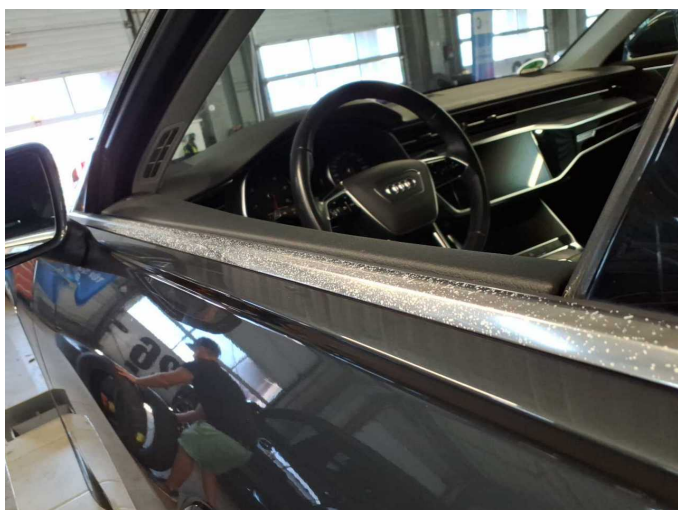
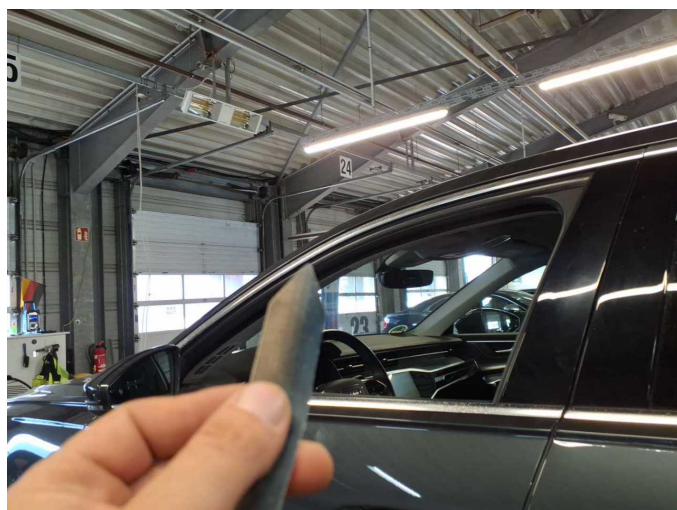
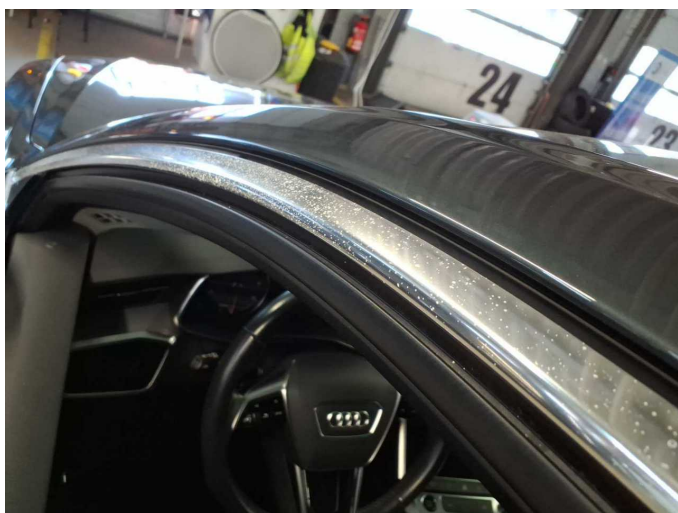
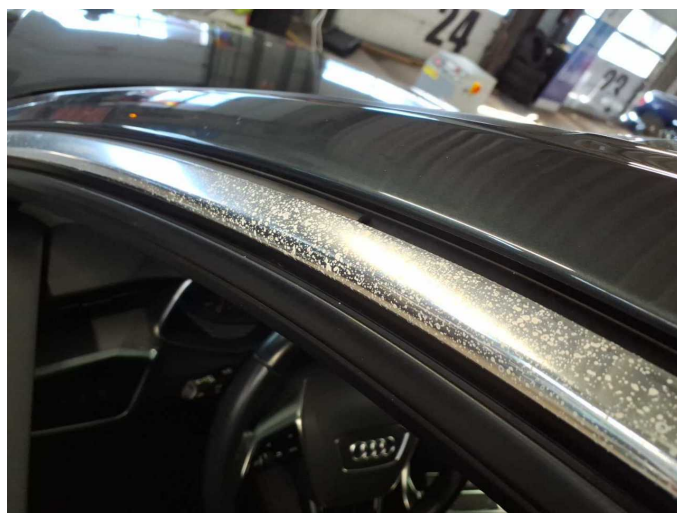
| No. | Component group | Description |
|---|---|---|
| 11 | Door - front left side | Strip - outer (oben und unten, Anätzungen) - Paint defect - Replace |

**Damage 11:** Door - front left side: Strip - outer (oben und unten, Anätzungen) - Paint defect - Replace

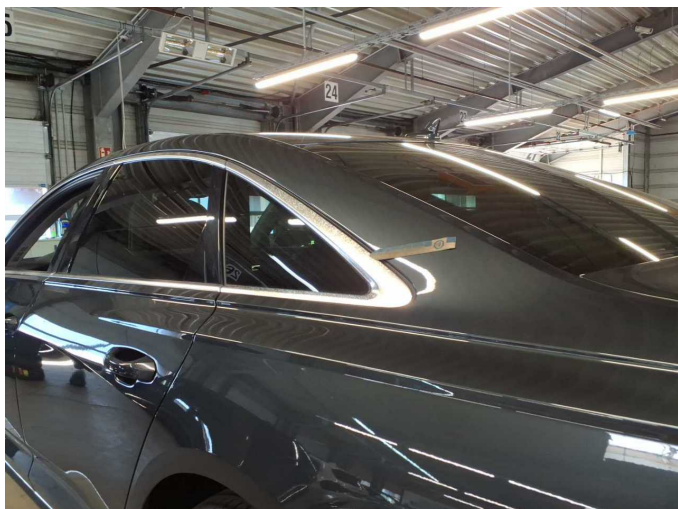
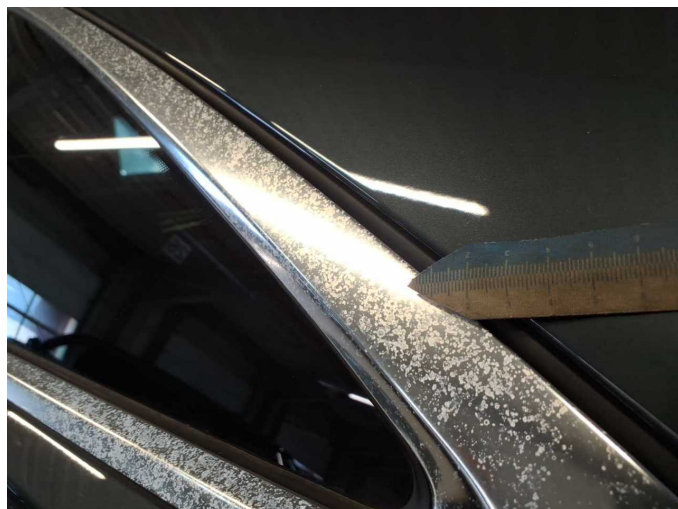
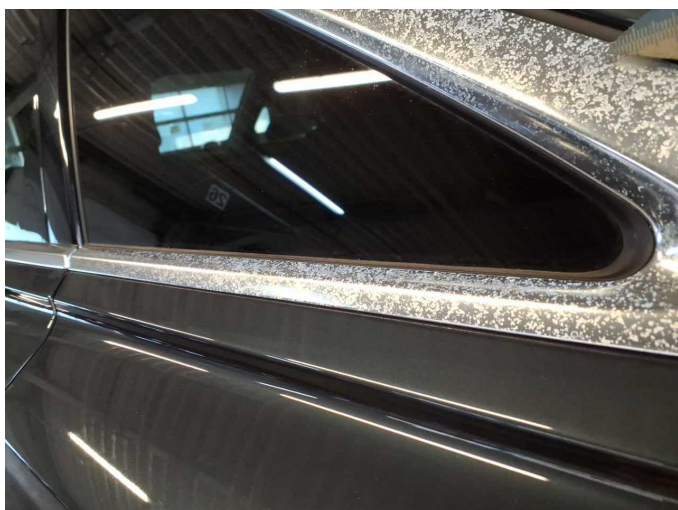
| No. | Component group | Description |
|---|---|---|
| 12 | Trim / covers | Brightware / decorative strip (Dreieckfenster, Anätzungen) - Paint defect - Replace |

**Damage 12:** Trim / covers: Brightware / decorative strip (Dreieckfenster, Anätzungen) - Paint defect - Replace

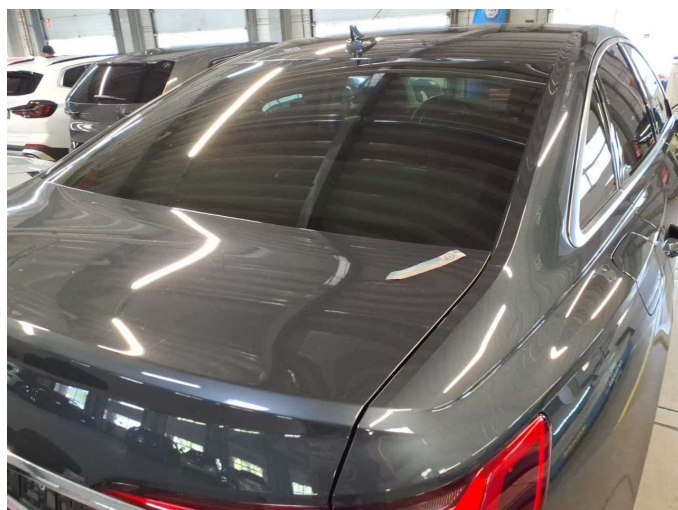
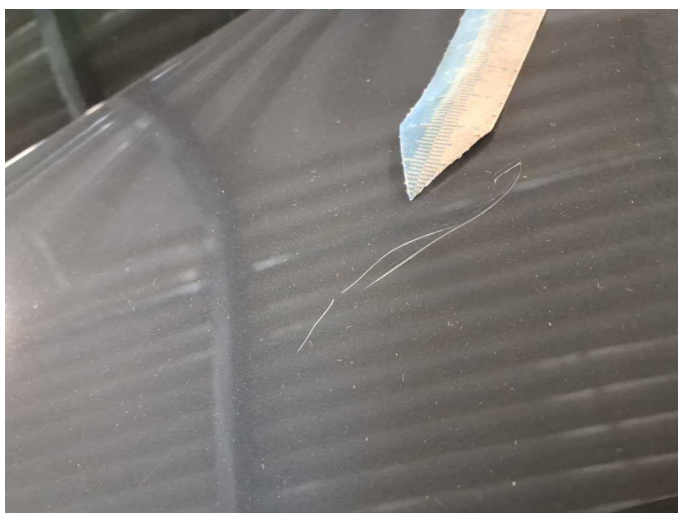
| No. | Component group | Description |
|---|---|---|
| 13 | Boot lid / rear door | Boot lid - Scratch(es) - Paint |

**Damage 13:** Boot lid / rear door: Boot lid - Scratch(es) - Paint

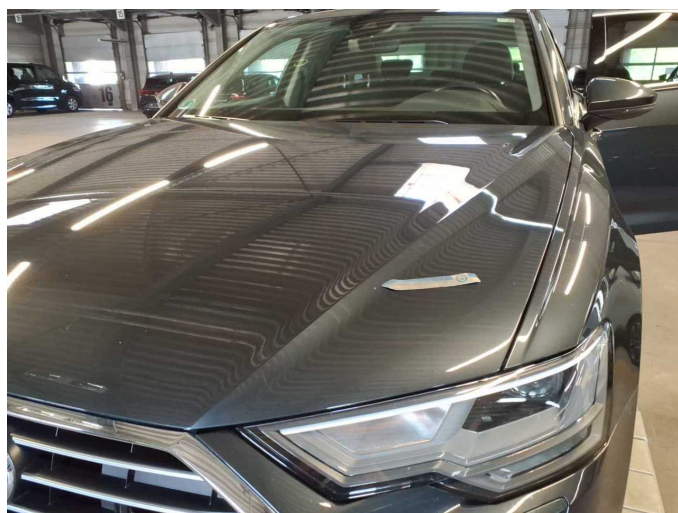
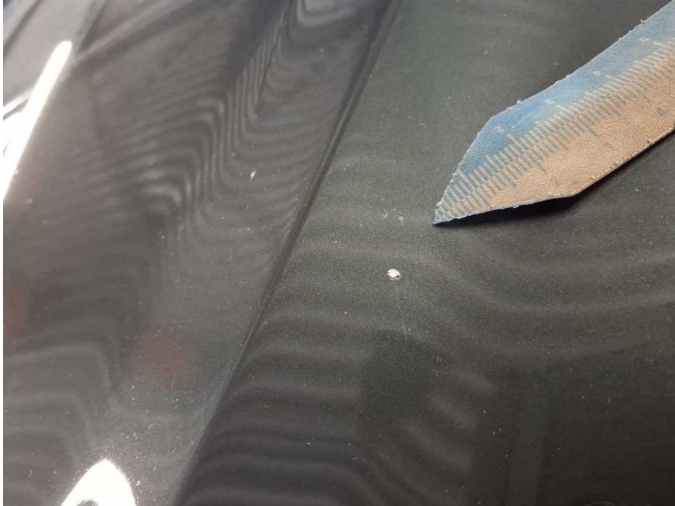
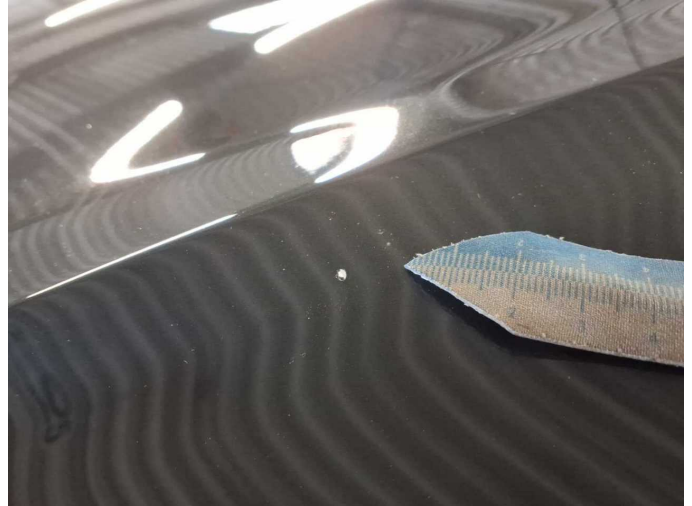
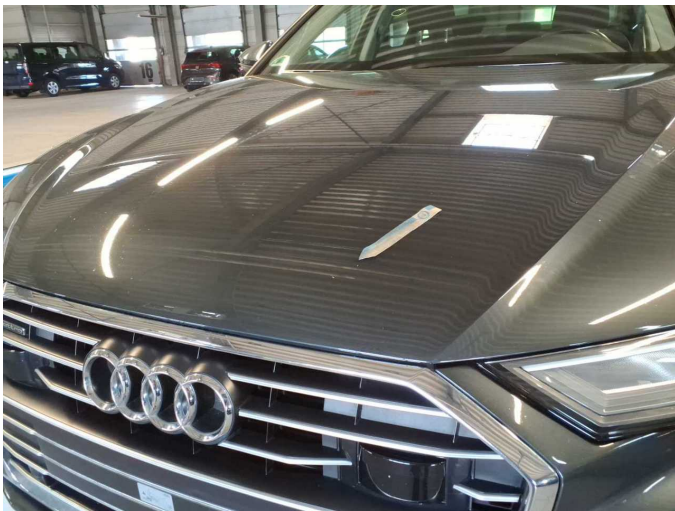
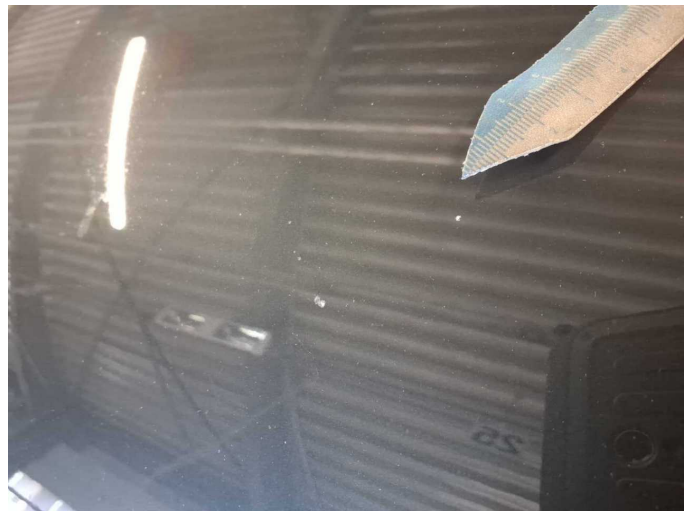
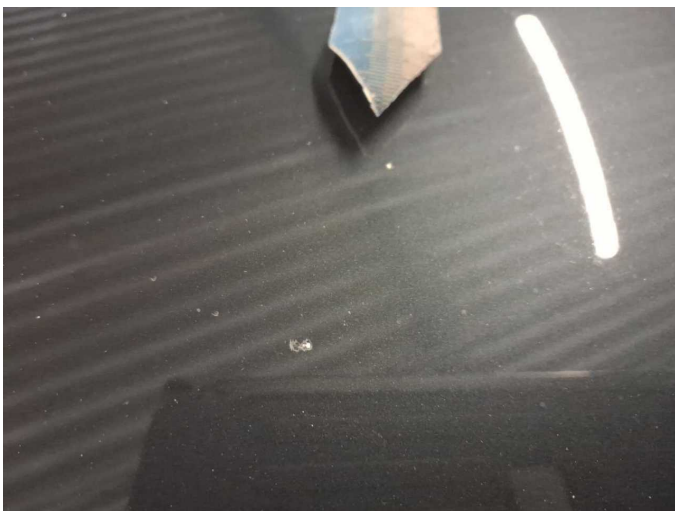
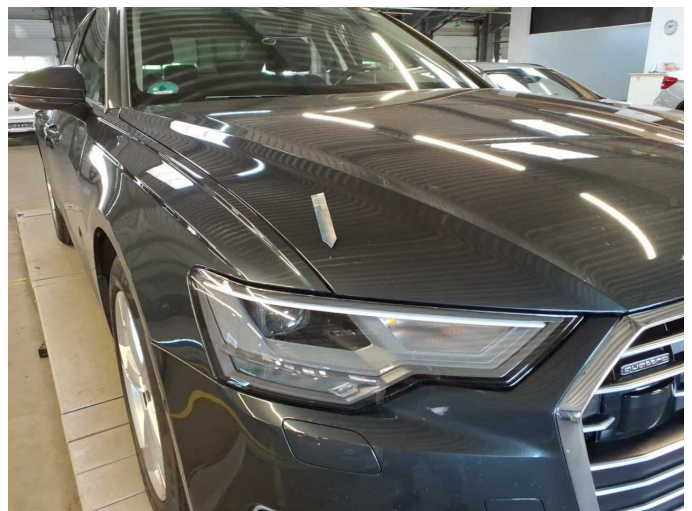
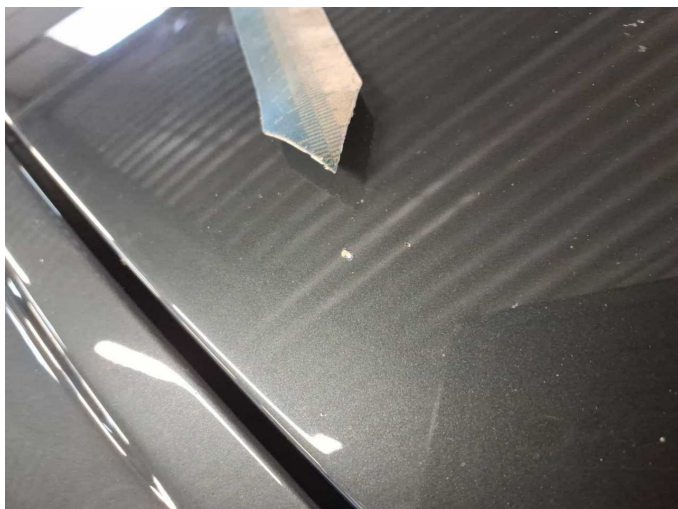
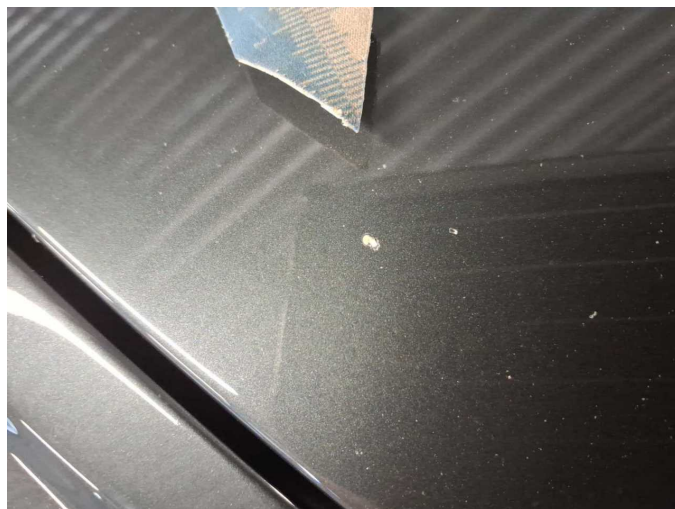
| No. | Component group | Description |
|---|---|---|
| 14 | Bonnet | Bonnet - Stone chips - Paint |

**Damage 14:** Bonnet: Bonnet - Stone chips - Paint

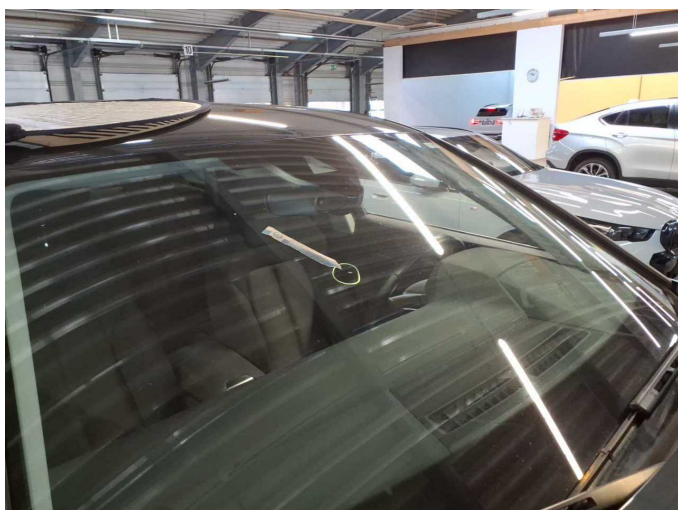
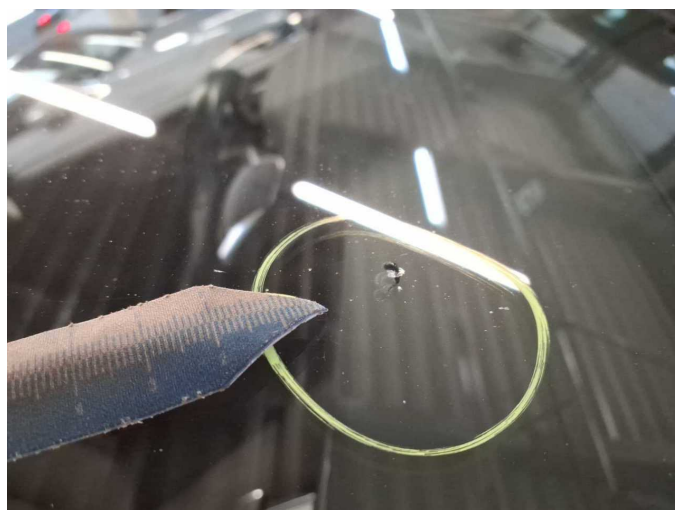
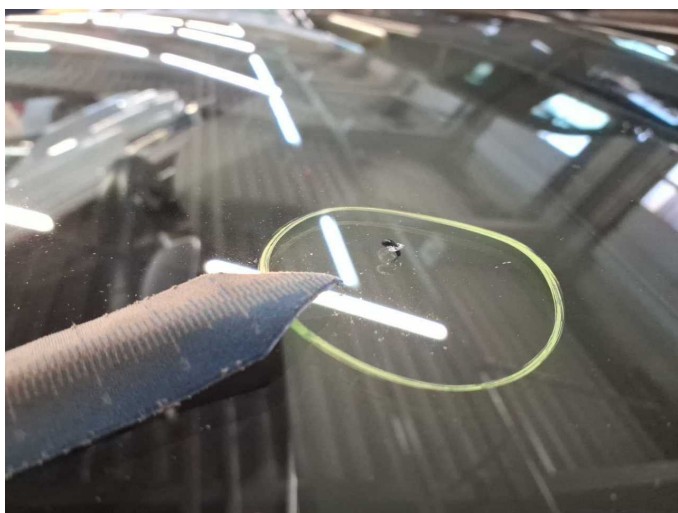
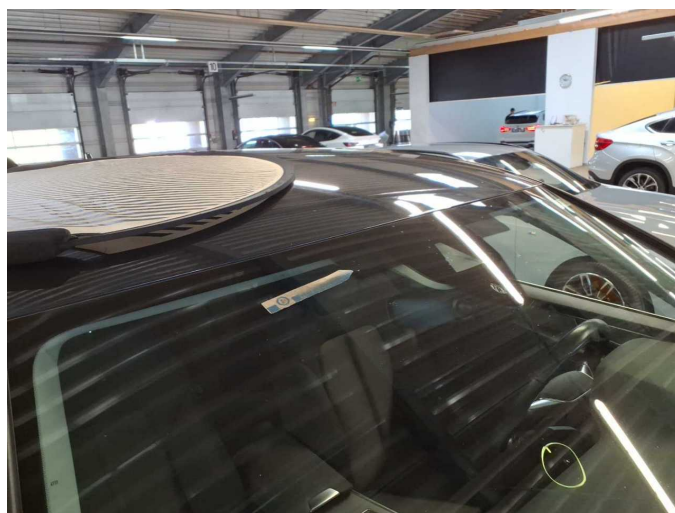
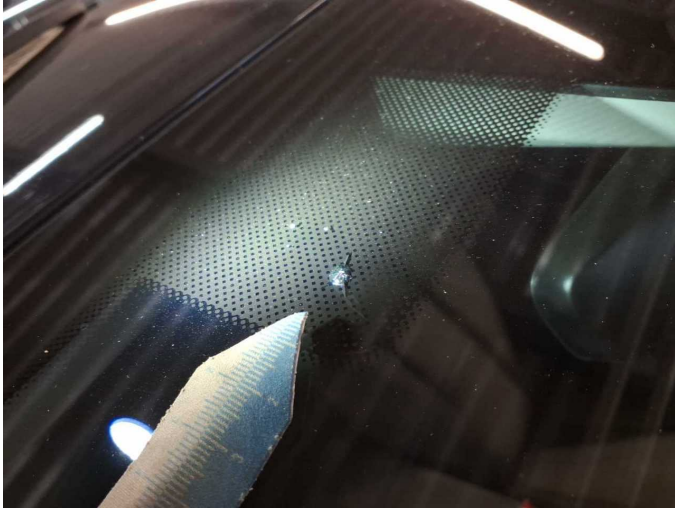
| No. | Component group | Description |
|---|---|---|
| 15 | Vehicle glazing | Windscreen (Rissbildung) - Stone chips - Replace |

**Damage 15:** Vehicle glazing: Windscreen (Rissbildung) - Stone chips - Replace
