Expertise

Protocol number: 46870538  
Order No. / Reference: 26716467  
Inspection date: 4 Aug 2026

Manufacturer: Volkswagen  
VIN: WVGZZAWZMU035297

Model: Polo 1.0 TSI DSG OPF Highline

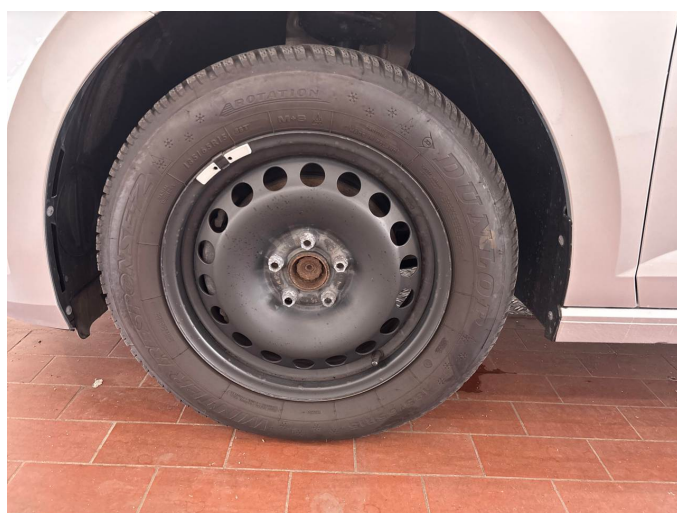
| Tyres | | | | |
|---|---|---|---|---|
| 1) | 185/65 R15 88T | Winter tyres on Steel | Dunlop | 6mm / 6mm |
| 2) | 185/65 R15 88T | Winter tyres on Steel | Dunlop | 6mm / 6mm |

Figure 12: Mounted tyres

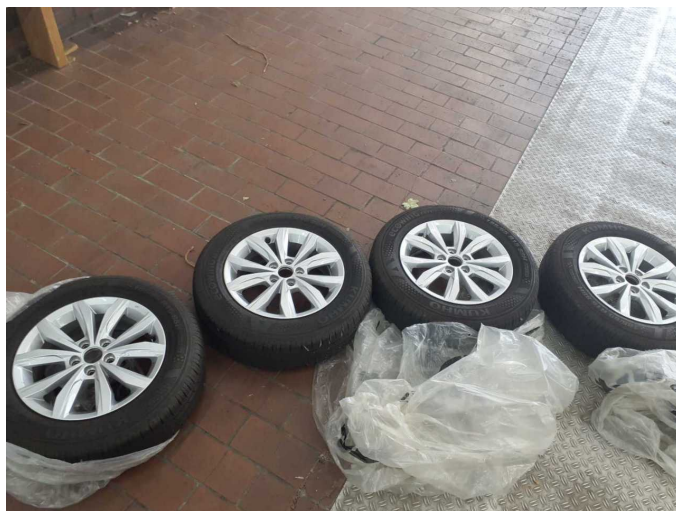
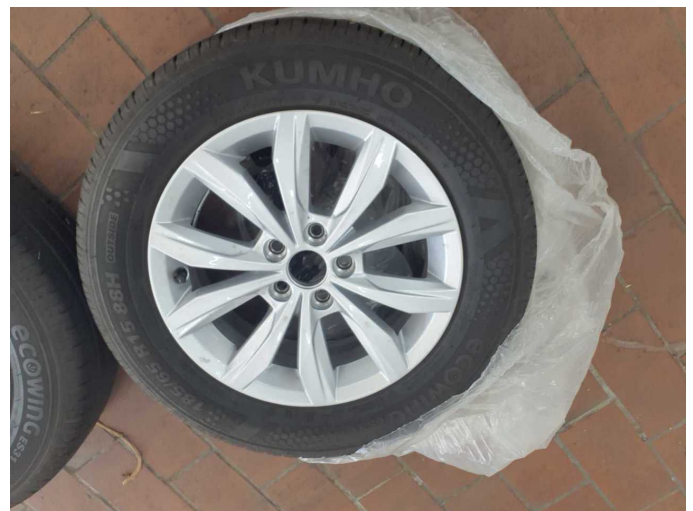
| Tyres | | | | |
|---|---|---|---|---|
| 1) | 185/65 R15 88H | Summer tyres on Light alloy | Kumho | 6mm / 6mm |
| 2) | 185/65 R15 88H | Summer tyres on Light alloy | Kumho | 6mm / 6mm |

Figure 15: Additional tyres

Figure 16: Additional tyres

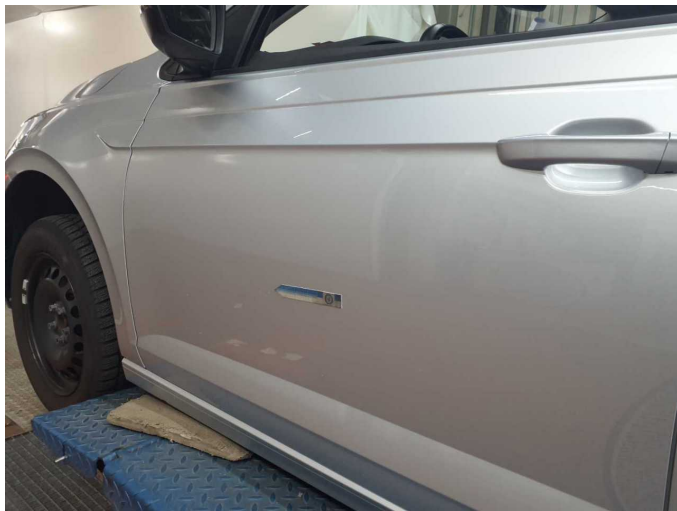
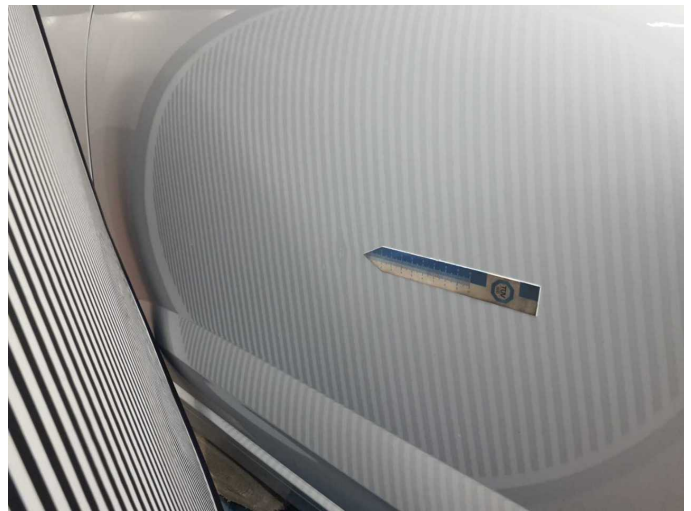
Damage 2: Door - front left side: Door - dent(s) - Smart repair

| No. | Component group | Description |
|---|---|---|
| 2 | Door - front left side | Door - dent(s) - Smart repair |

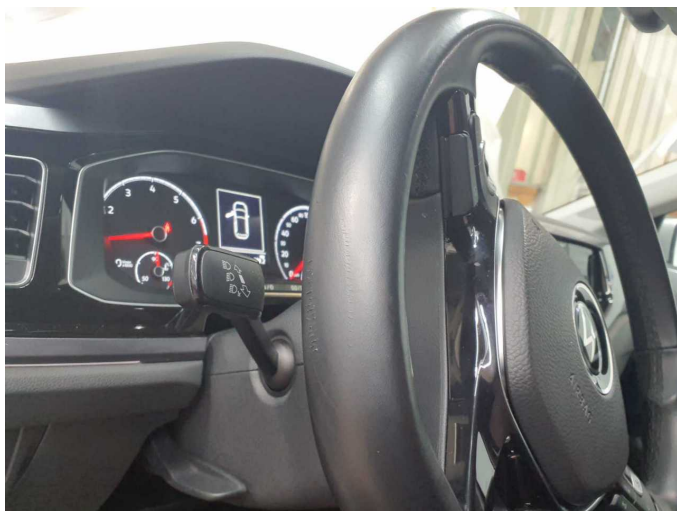
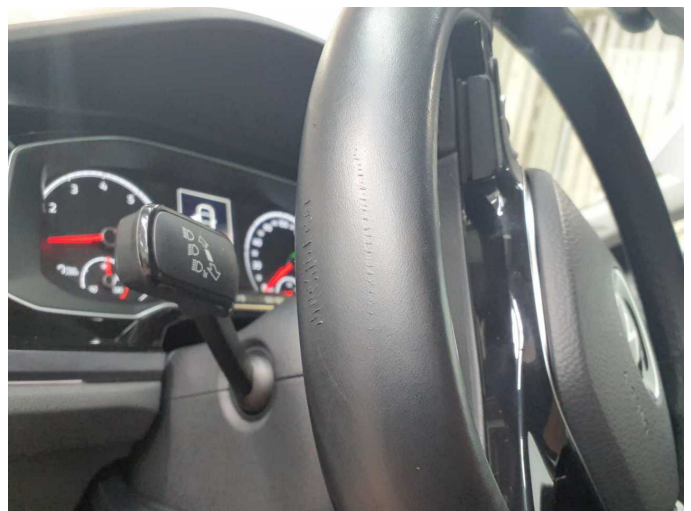
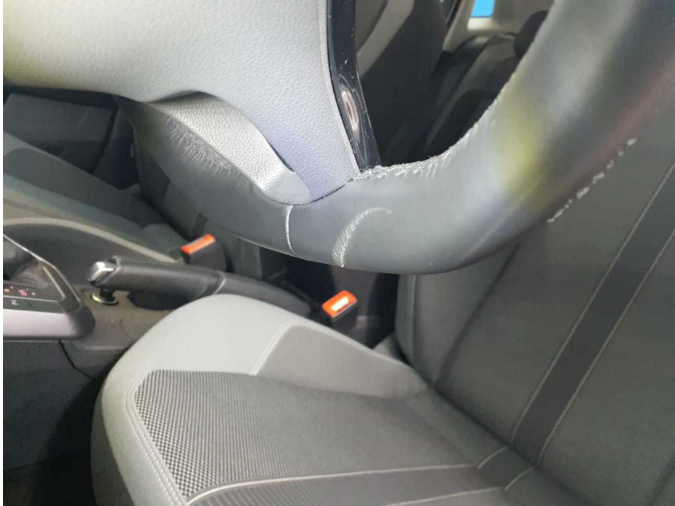
Damage 3: Steering system: Steering wheel - Scratch(es) - Smart repair

**Damage 3:** Steering system: Steering wheel - Scratch(es) - Smart repair

| No. | Component group | Description |
|---|---|---|
| 3 | Steering system | Steering wheel - Scratch(es) - Smart repair |

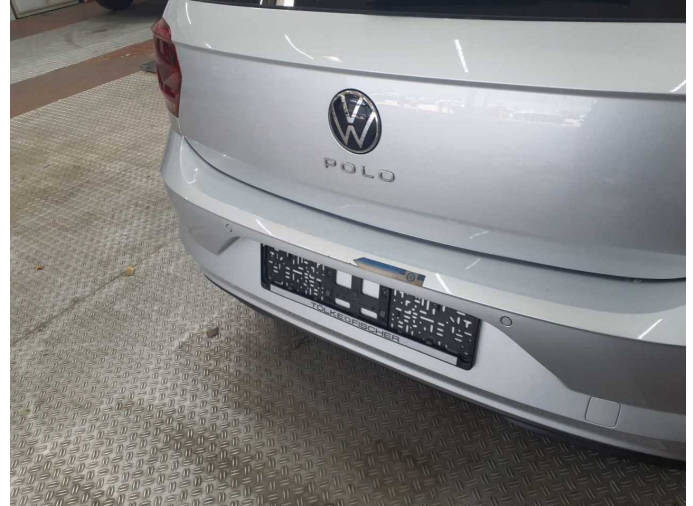
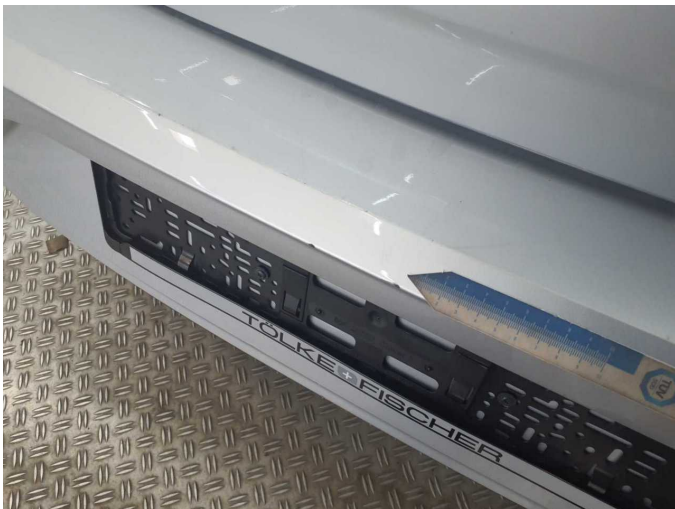
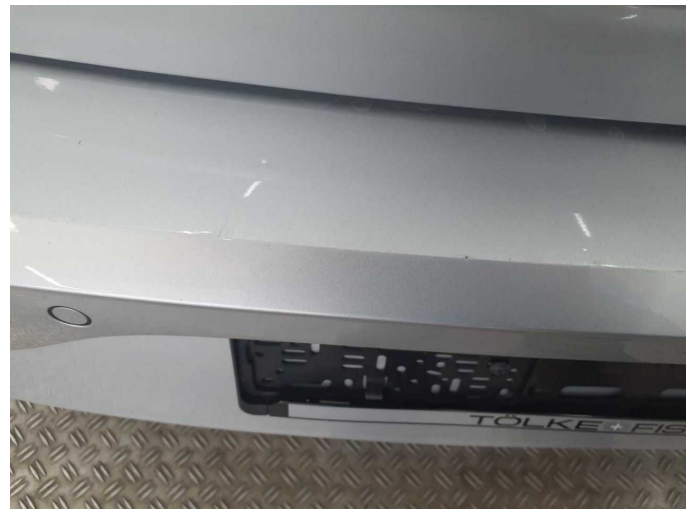
**Damage 4:** Rear bumper: Rear bumper - Scratch(es) - Smart repair

| No. | Component group | Description |
|---|---|---|
| 4 | Rear bumper | Rear bumper - Scratch(es) - Smart repair |

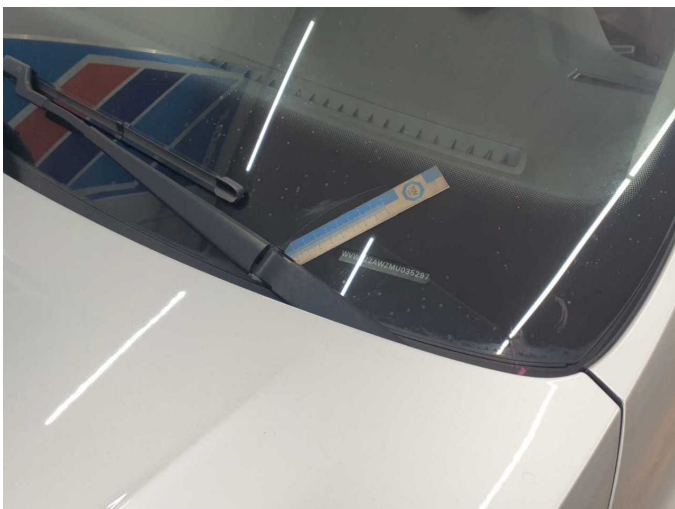
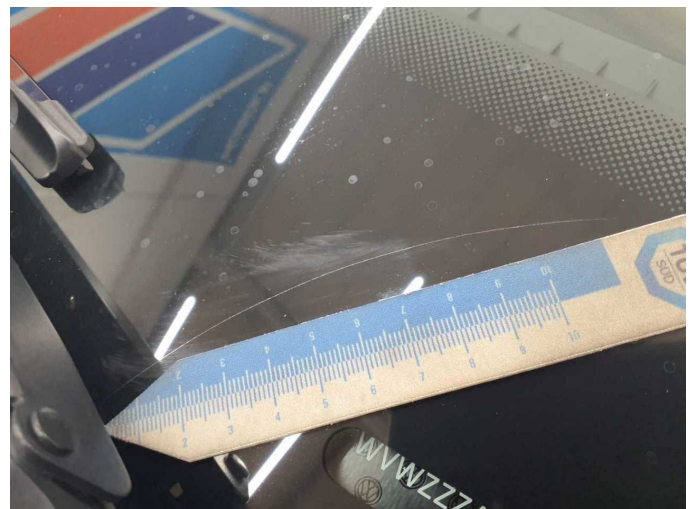
**Damage 5:** Vehicle glazing: Windscreen - Scratch(es) - Replace

| No. | Component group | Description |
|---|---|---|
| 5 | Vehicle glazing | Windscreen - Scratch(es) - Replace |

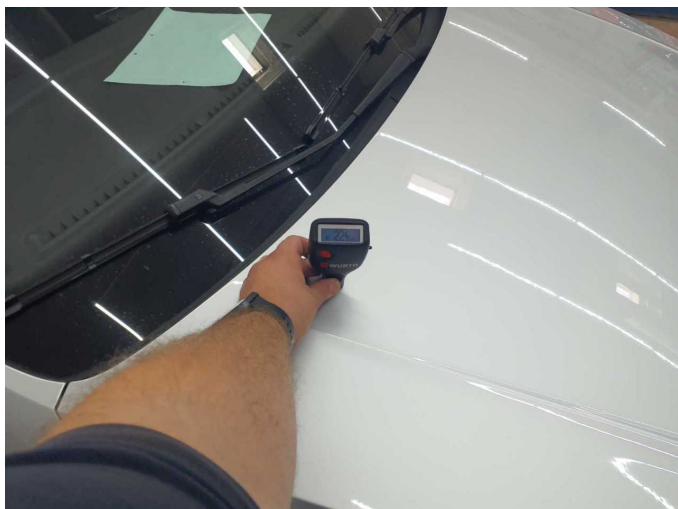
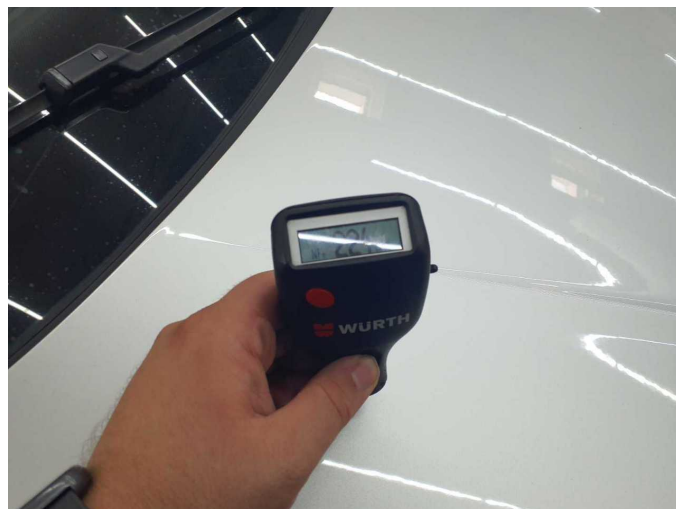
**Repainting 1: Bonnet**

| No. | Repainting |
|---|---|
| 1 | Bonnet, Professionally carried out |

| Bonnet | 224 µm |
