Expertise

Protocol number: 46384529  
Order No. / Reference: 26529863  
Inspection date: 7 Jul 2026

Model: Passat Variant 2.0 TDI SCR DSG Business

VIN: WVGZZZ3CZPE077913

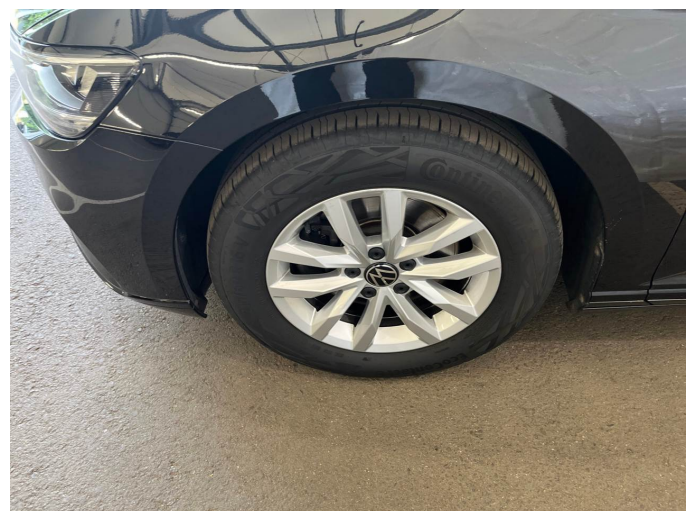
Figure 12: Mounted tyres

| Tyres | | | | |
|---|---|---|---|---|
| 1) | 215/60 R16 95V | Summer tyres on Light alloy | Continental | 5mm / 5mm |
| 2) | 215/60 R16 95V | Summer tyres on Light alloy | Falken | 6mm / 6mm |

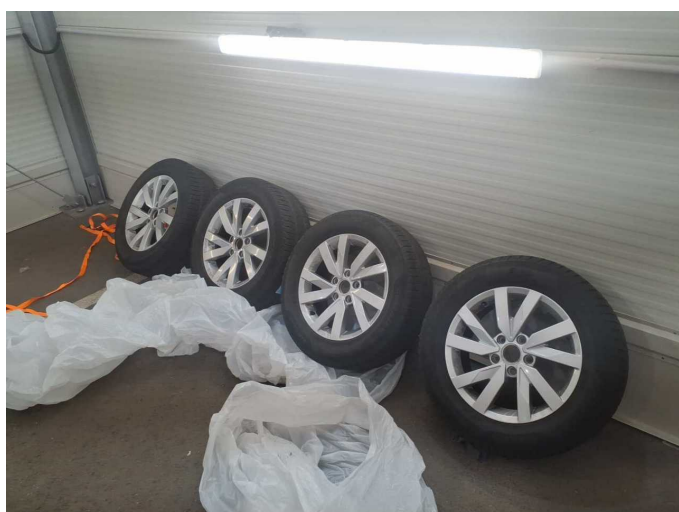
Figure 15: Additional tyres

| Tyres | | | | |
|---|---|---|---|---|
| 1) | 215/60 R16 95H | Winter tires (with run-flat tires) on Light alloy | Pirelli | 3mm / 3mm |
| 2) | 215/60 R16 95H | Winter tires (with run-flat tires) on Light alloy | Pirelli | 6mm / 6mm |

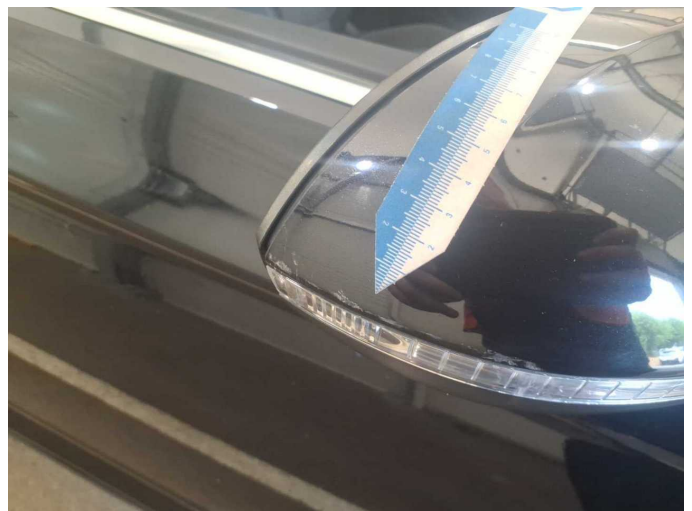
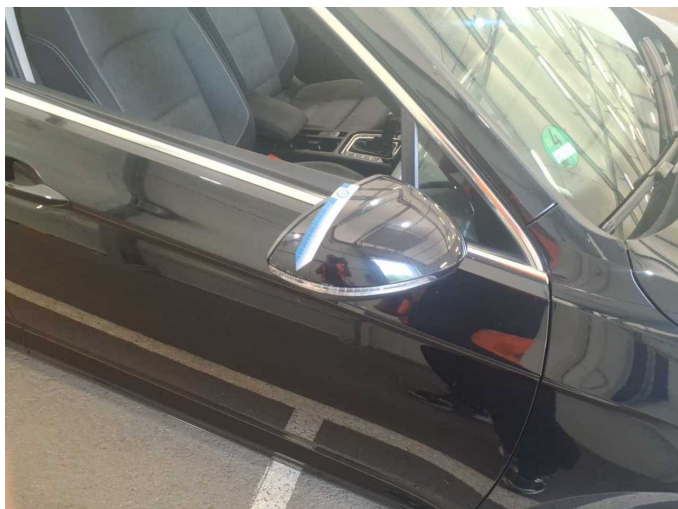
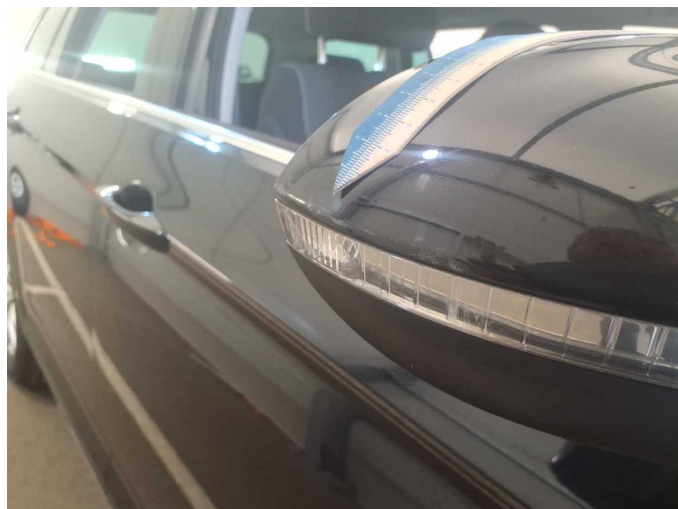
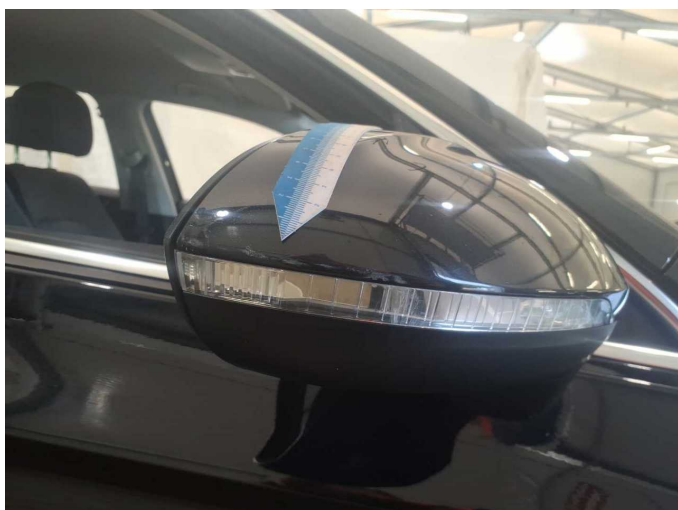
| No. | Component group | Description |
|---|---|---|
| 1 | Wing mirror - right side | Cap - Scratch(es) - Smart repair |

Damage 1: Wing mirror - right side: Cap - Scratch(es) - Smart repair

**Damage 1:** Wing mirror - right side: Cap - Scratch(es) - Smart repair

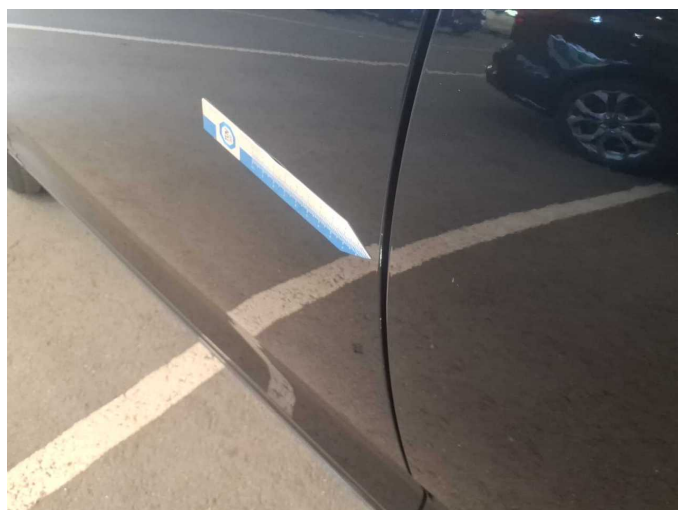
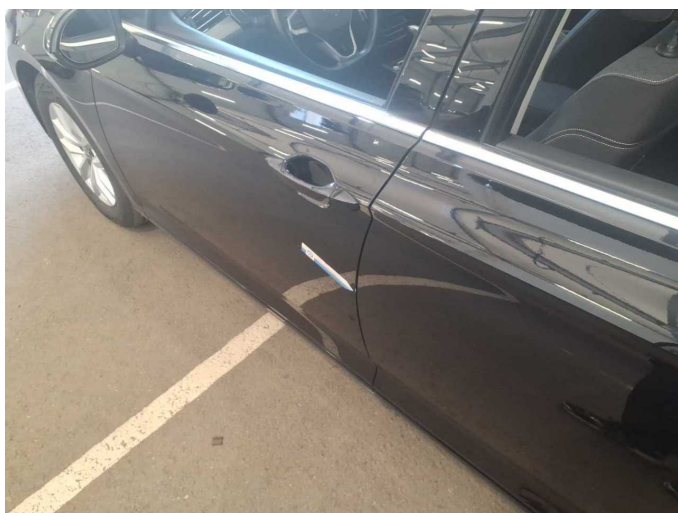
| No. | Component group | Description |
|---|---|---|
| 2 | Door - front left side | Door edge - Scratch(es) - Smart repair |

**Damage 2:** Door - front left side: Door edge - Scratch(es) - Smart repair

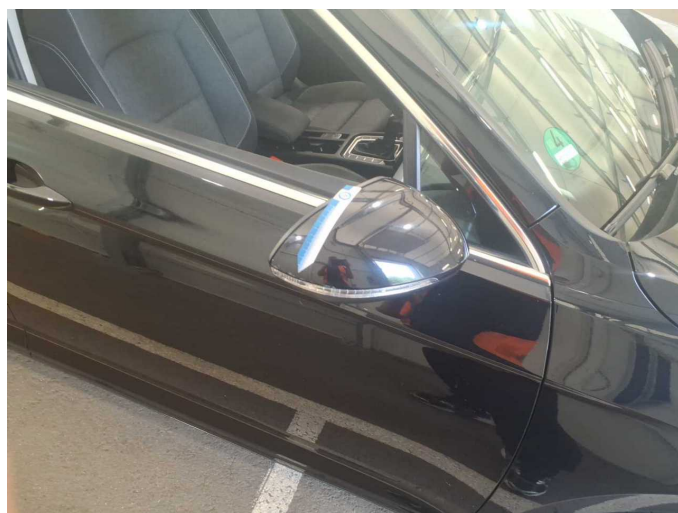
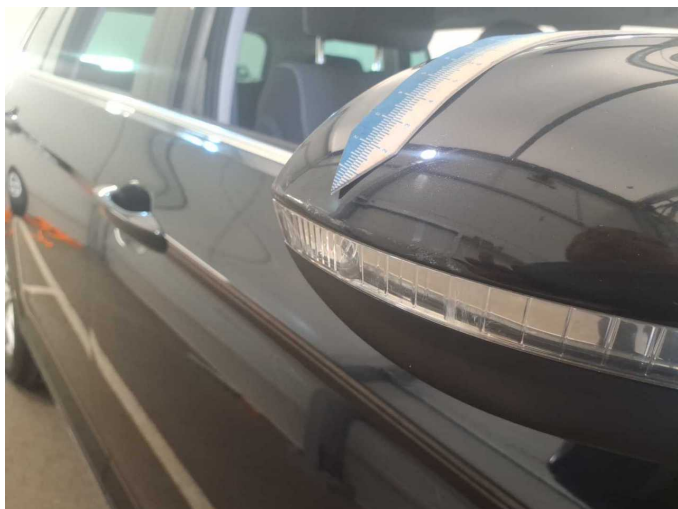
| No. | Component group | Description |
|---|---|---|
| 3 | Indicator - front | Indicator - front (Blinker Spiegel Rechts) - Scratched - Replace |

**Damage 3:** Indicator - front: Indicator - front (Blinker Spiegel Rechts) - Scratched - Replace

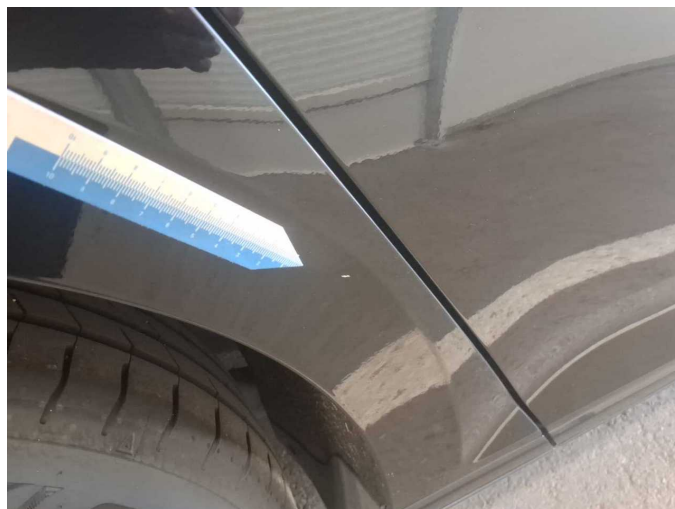
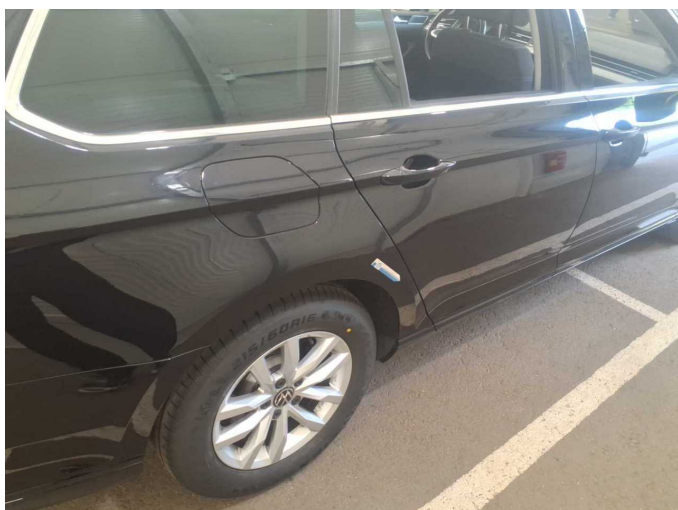
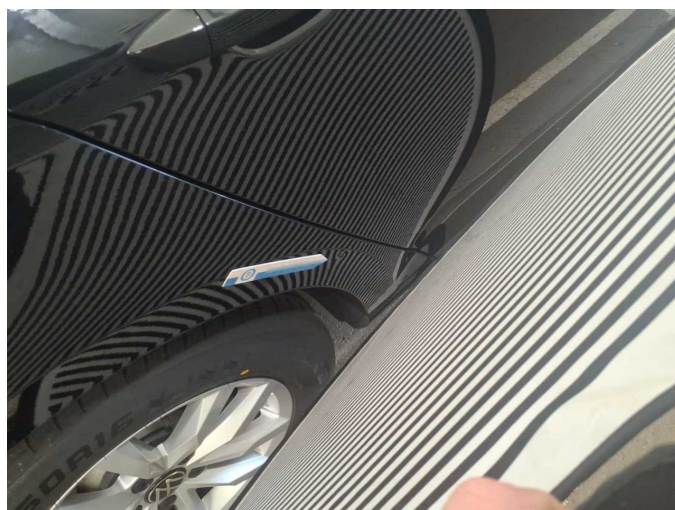
| No. | Component group | Description |
|---|---|---|
| 4 | Side panel - rear right side | Side panel - Dent / paintcoat damage - Smart repair |

**Damage 4:** Side panel - rear right side: Side panel - Dent / paintcoat damage - Smart repair

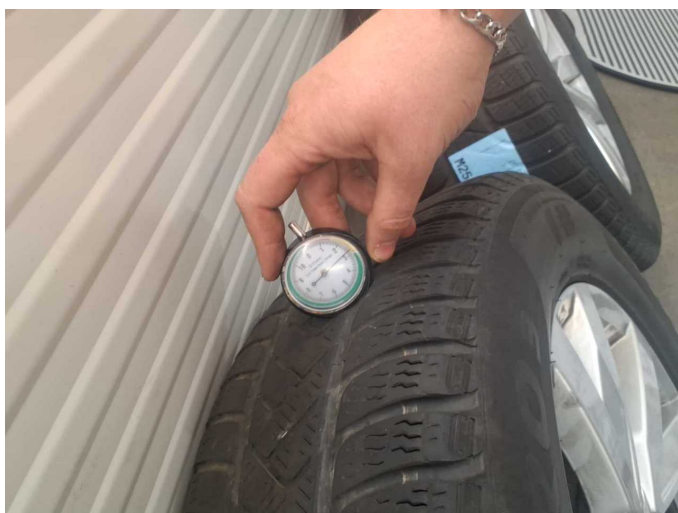
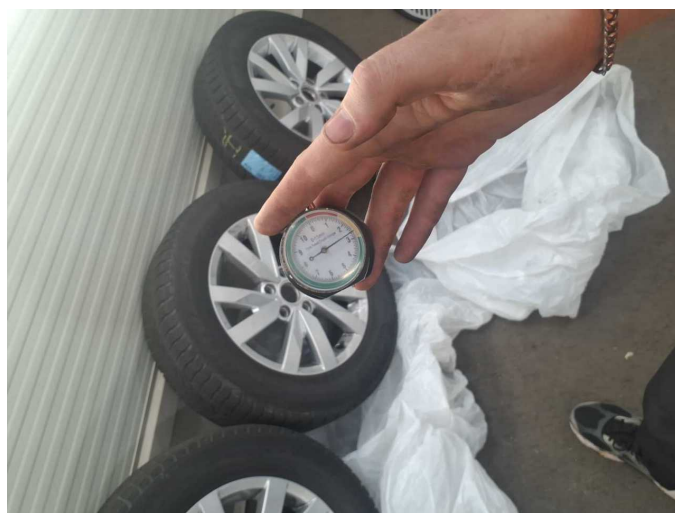
| No. | Component group | Description |
|---|---|---|
| 5 | 2nd wheel set | 1 tyre - Does not meet the leasing specifications - Replace |

**Damage 5:** 2nd wheel set: 1 tyre - Does not meet the leasing specifications - Replace

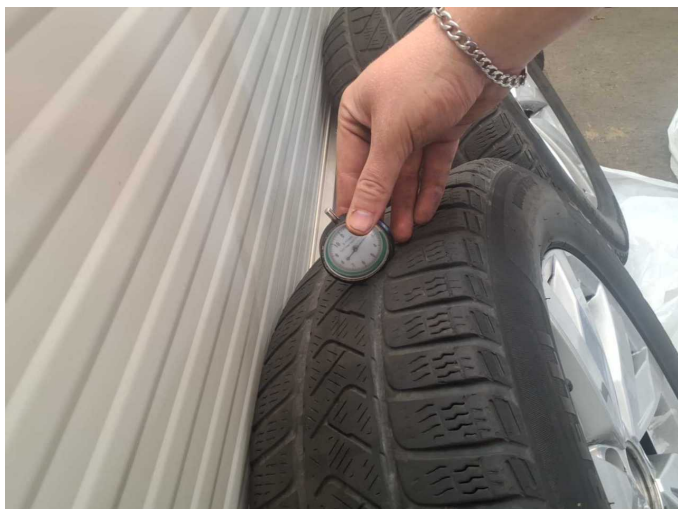
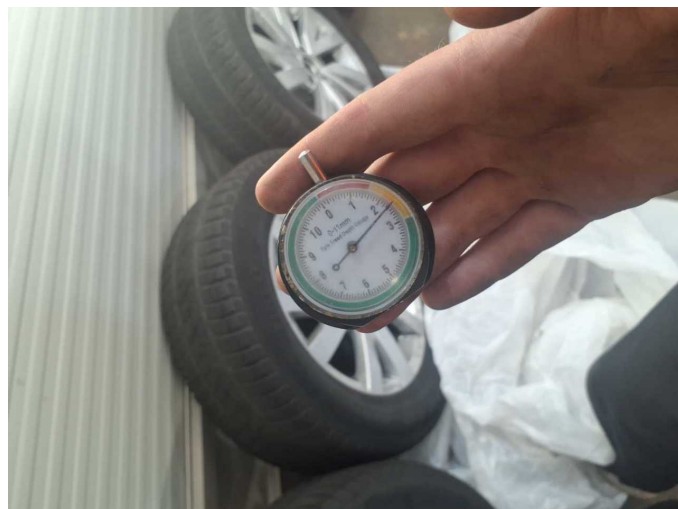
| No. | Component group | Description |
|---|---|---|
| 6 | 2nd wheel set | 1 tyre - Does not meet the leasing specifications - Replace |

**Damage 6:** 2nd wheel set: 1 tyre - Does not meet the leasing specifications - Replace

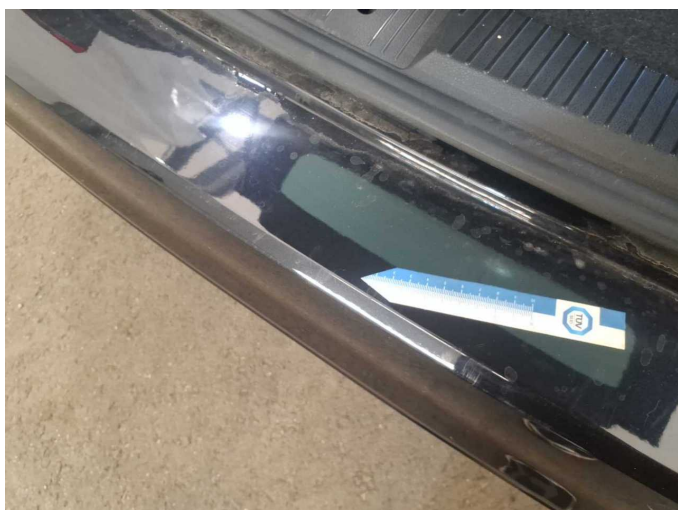
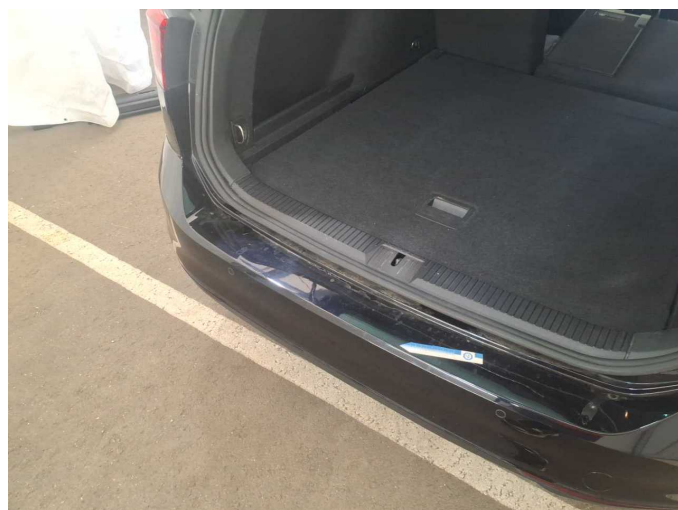
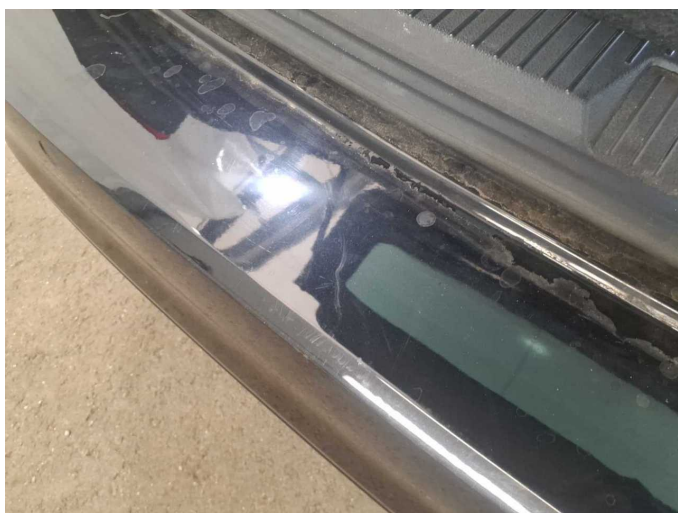
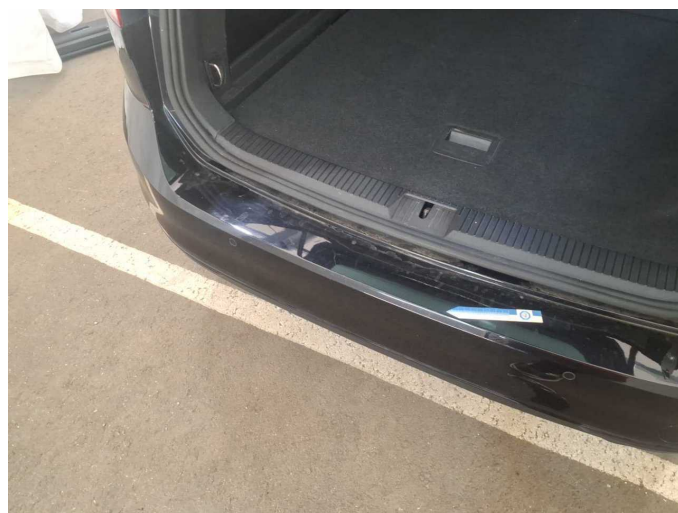
| No. | Component group | Description |
|---|---|---|
| 7 | Rear bumper | Rear bumper - Scratch(es) - Paint |

**Damage 7:** Rear bumper: Rear bumper - Scratch(es) - Paint

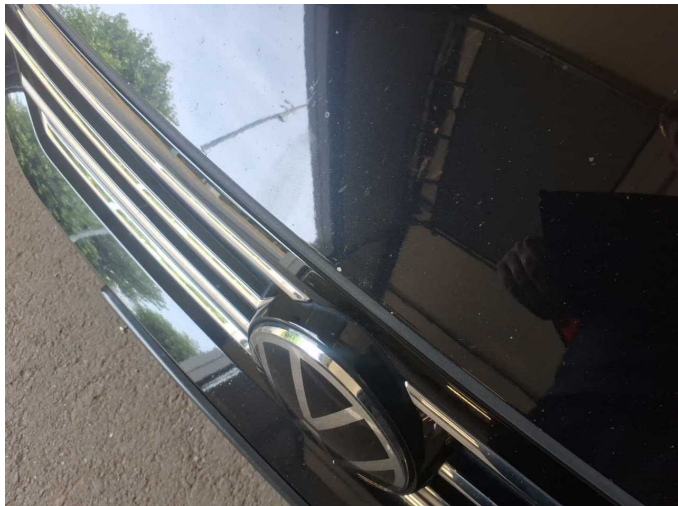
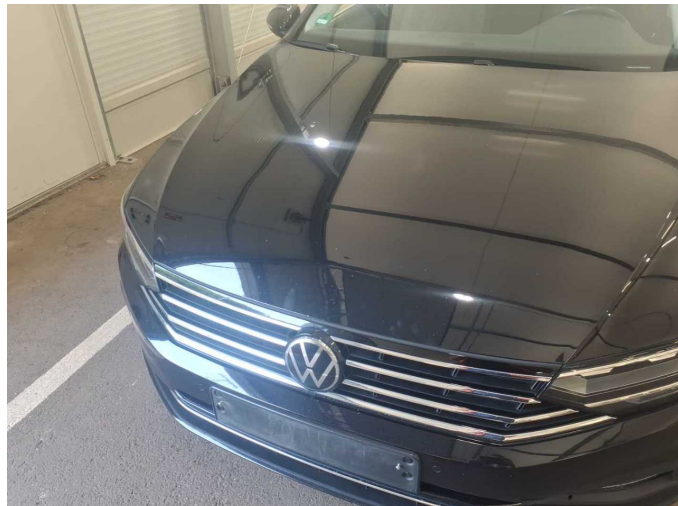
| No. | Component group | Description |
|---|---|---|
| 1 | Bonnet | Bonnet - Stone chips - No deduction |

**Wear and tear 1:** Bonnet: Bonnet - Stone chips - No deduction

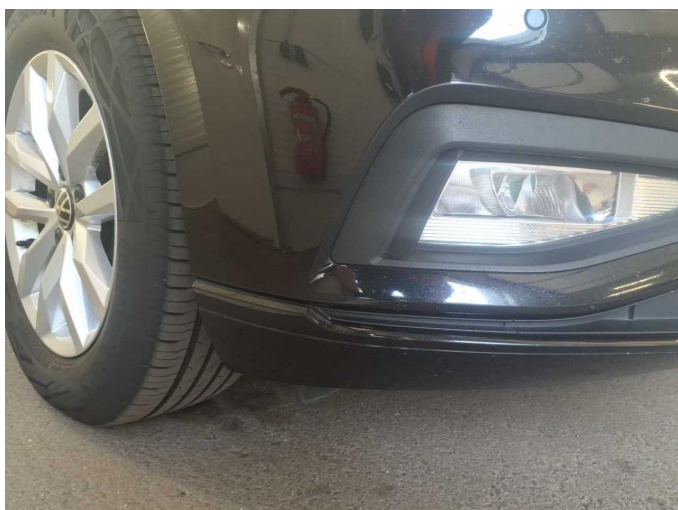
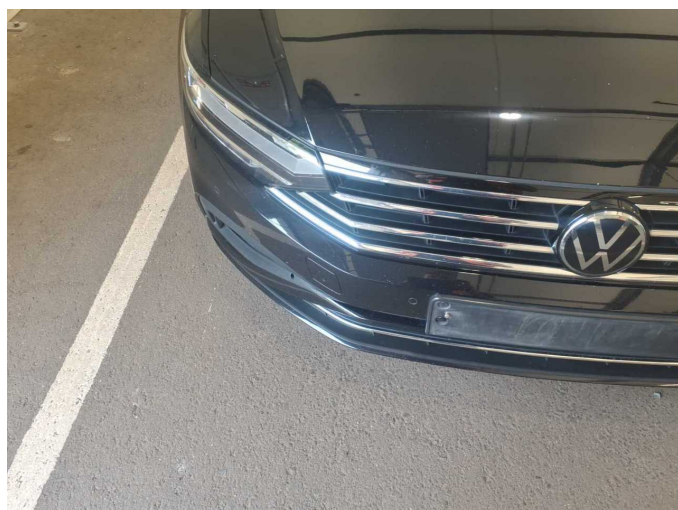
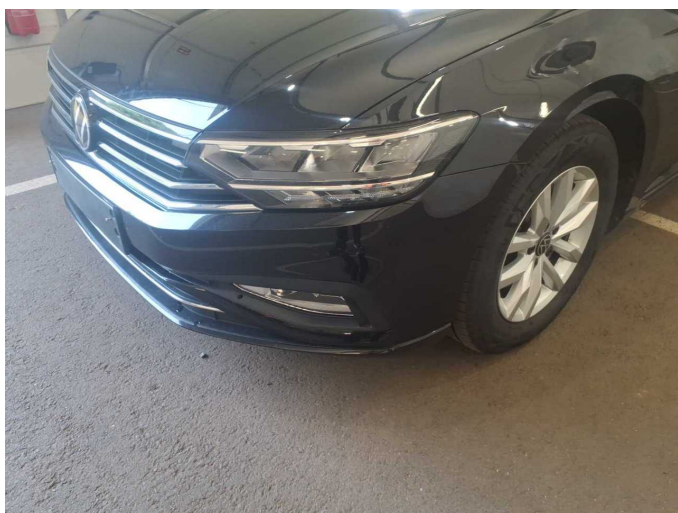
| No. | Component group | Description |
|---|---|---|
| 2 | Front bumper | Front bumper - Stone chips - No deduction |

**Wear and tear 2:** Front bumper: Front bumper - Stone chips - No deduction
