Expertise

Protocol number: 46054010  
Order No. / Reference: 26488869  
Inspection date: 19 Jun 2026

Manufacturer: Ford  
VIN: WF0FXXWPMHPC28856

Model: Kuga 2.5 Duratec PHEV TITANIUM X

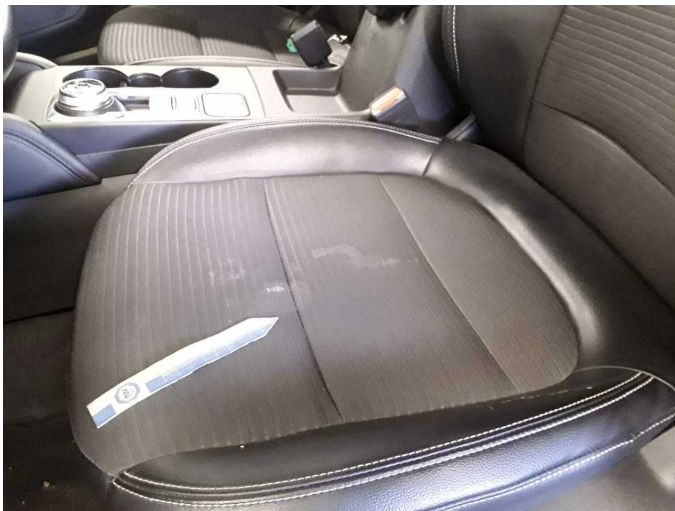
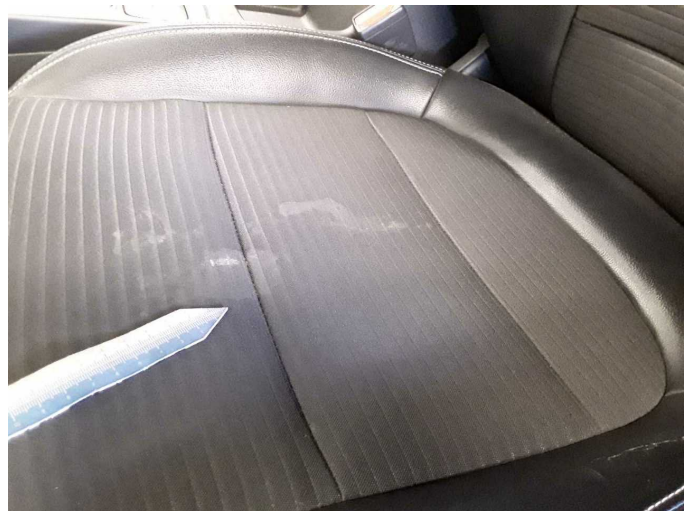
| No. | Component group | Description |
|---|---|---|
| 1 | Seat - front | Seat cover - left side - Soiled - Clean |

**Damage 1:** Seat - front: Seat cover - left side - Soiled - Clean

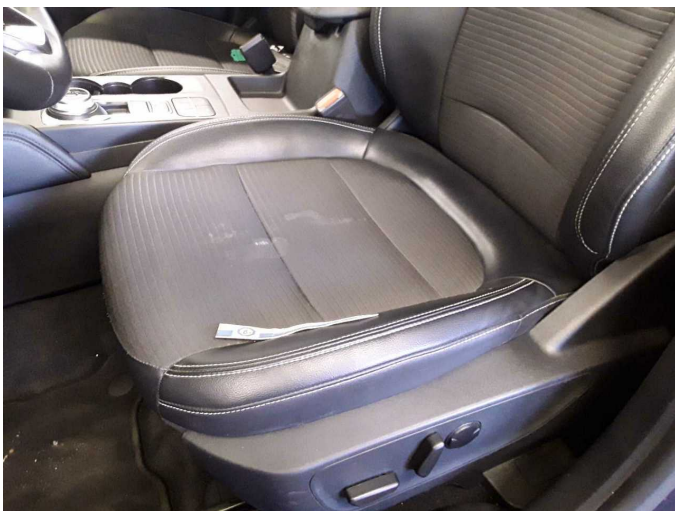
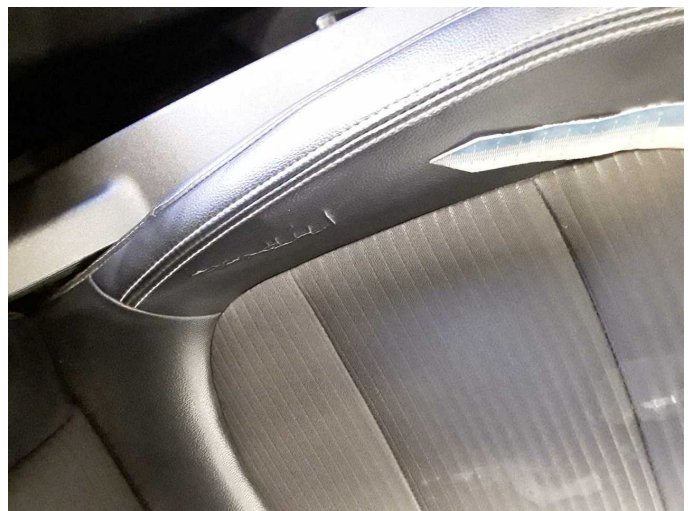
| No. | Component group | Description |
|---|---|---|
| 3 | Seat - front | Seat cover - left side - Porous / cracked - Smart repair |

**Damage 3:** Seat - front: Seat cover - left side - Porous / cracked - Smart repair

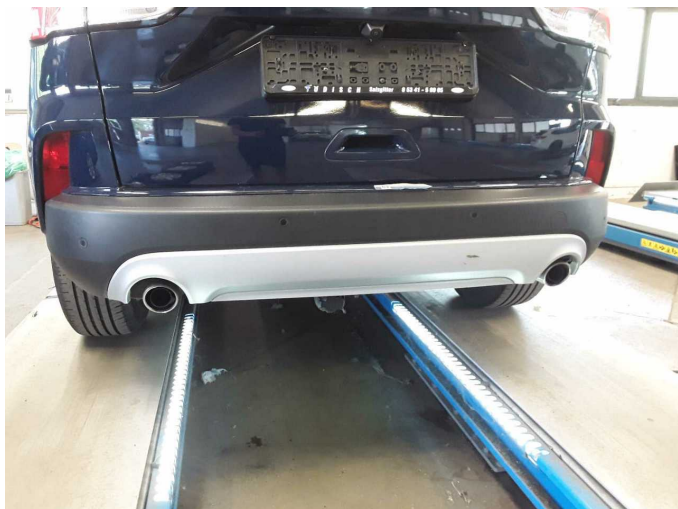
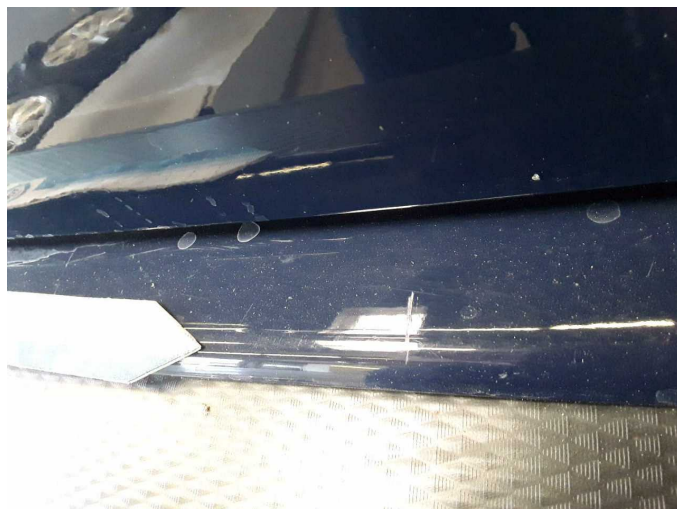
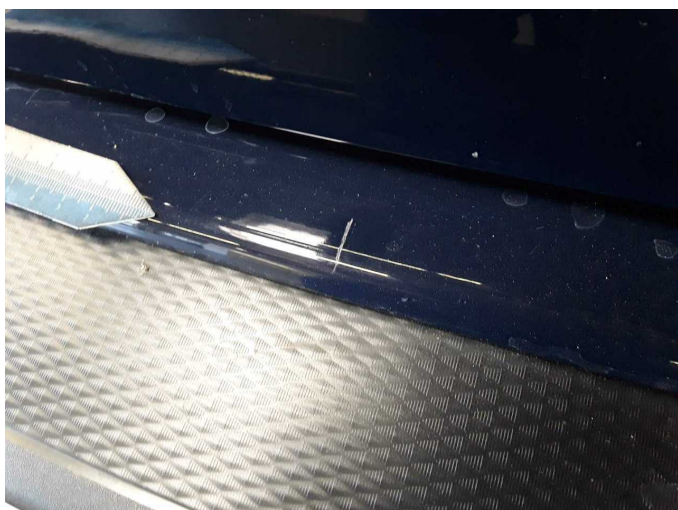
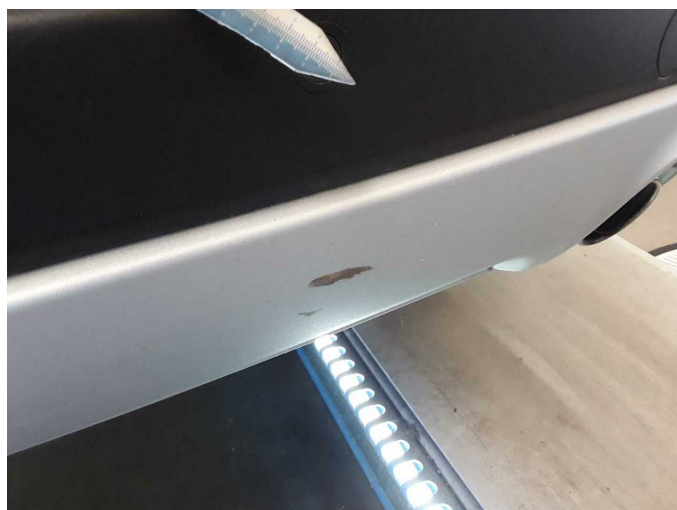
| No. | Component group | Description |
|---|---|---|
| 4 | Rear bumper | Rear bumper (inkl. Spoiler) - Scratch(es) - Paint |

**Damage 4:** Rear bumper: Rear bumper (inkl. Spoiler) - Scratch(es) - Paint

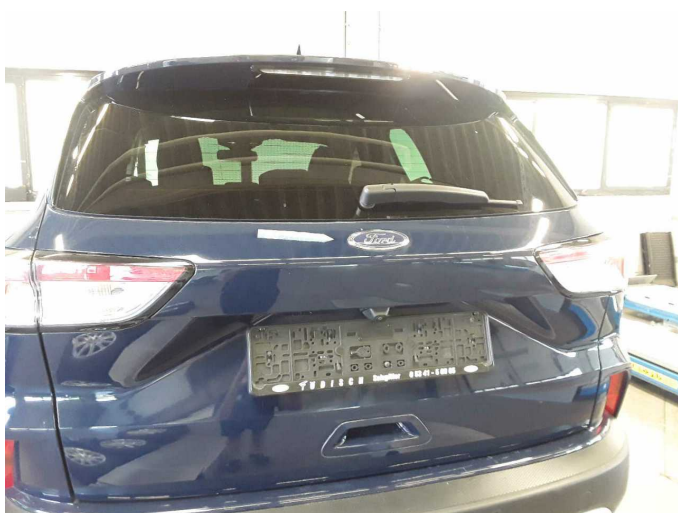
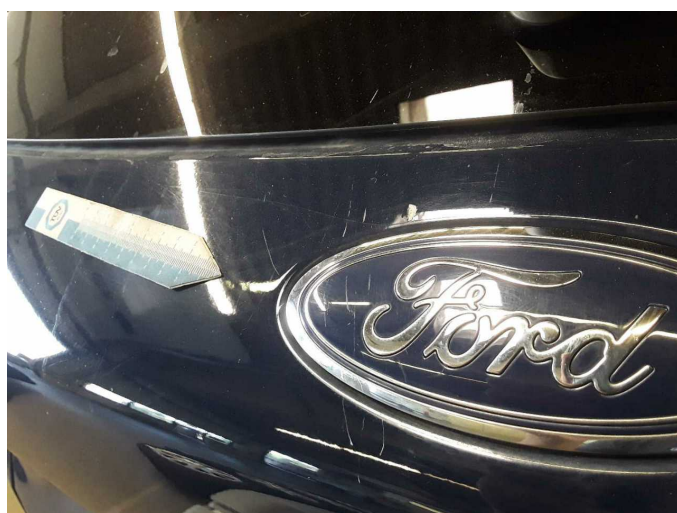
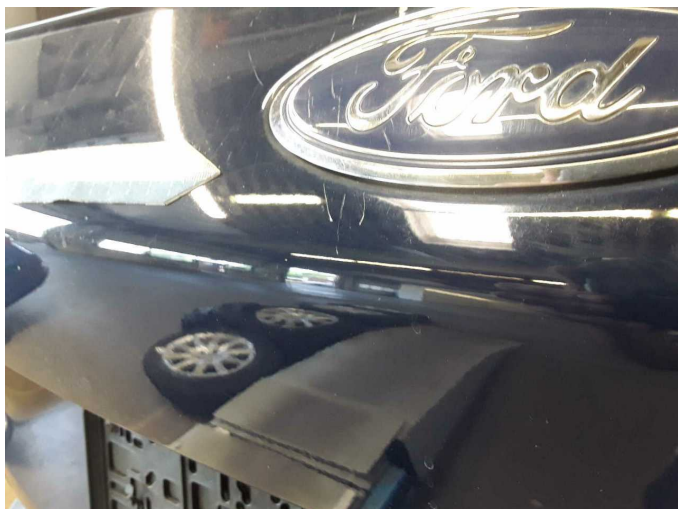
| No. | Component group | Description |
|---|---|---|
| 5 | Boot lid / rear door | Boot lid - Scratch(es) - Paint |

**Damage 5:** Boot lid / rear door: Boot lid - Scratch(es) - Paint

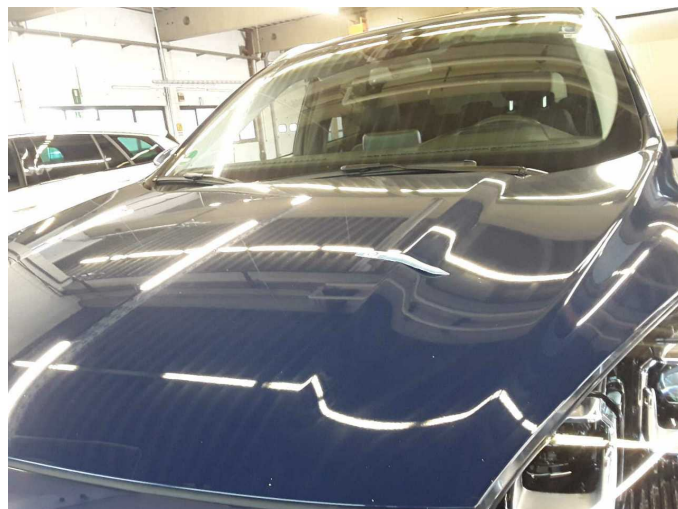
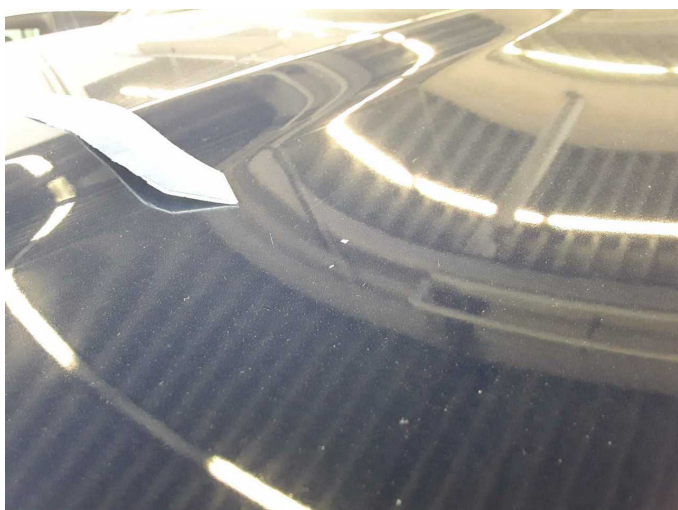
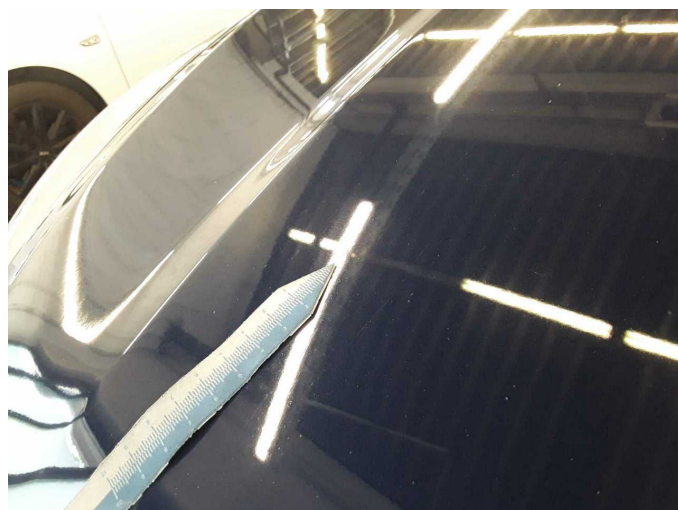
| No. | Component group | Description |
|---|---|---|
| 2 | Bonnet | Bonnet - Stone chips - No deduction |

**Wear and tear 2:** Bonnet: Bonnet - Stone chips - No deduction

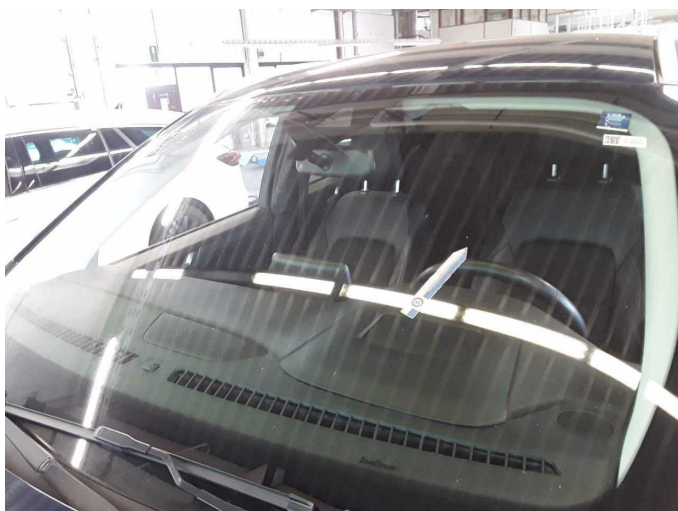
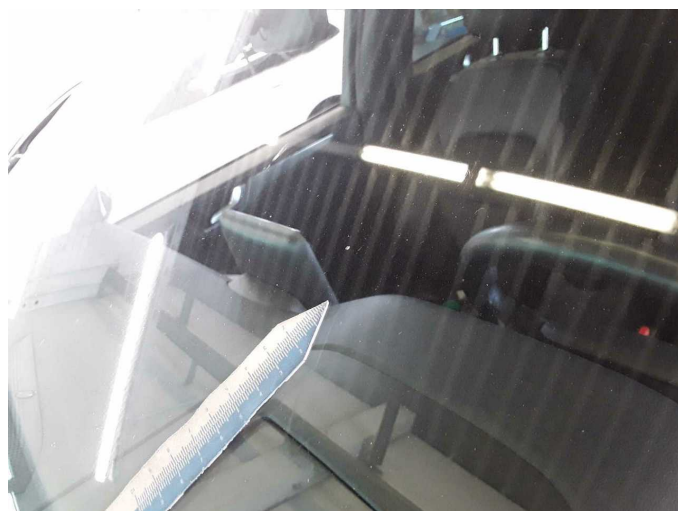
| No. | Component group | Description |
|---|---|---|
| 3 | Vehicle glazing | Windscreen - Stone chips - No deduction |

**Wear and tear 3:** Vehicle glazing: Windscreen - Stone chips - No deduction

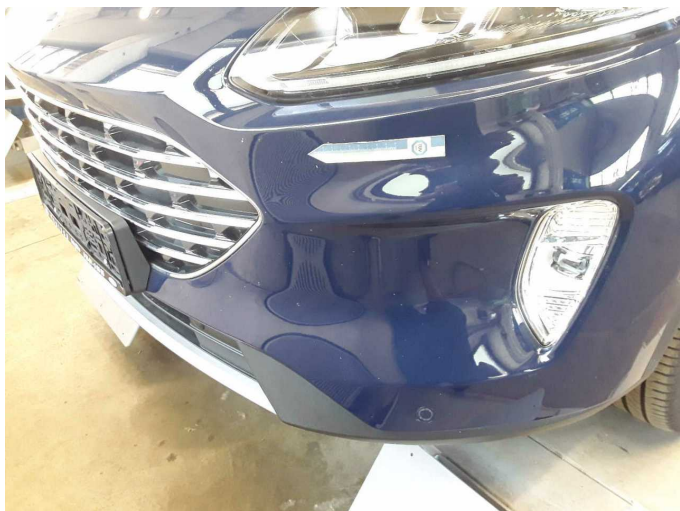
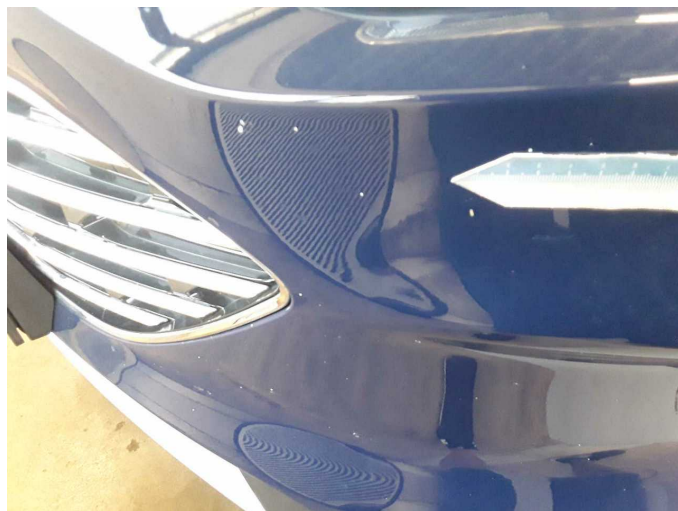
| No. | Component group | Description |
|---|---|---|
| 5 | Front bumper | Front bumper - Stone chips - No deduction |

**Wear and tear 5:** Front bumper: Front bumper - Stone chips - No deduction

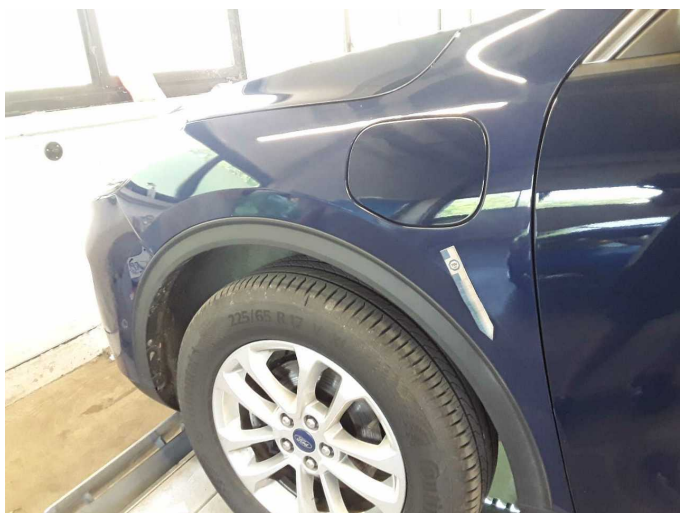
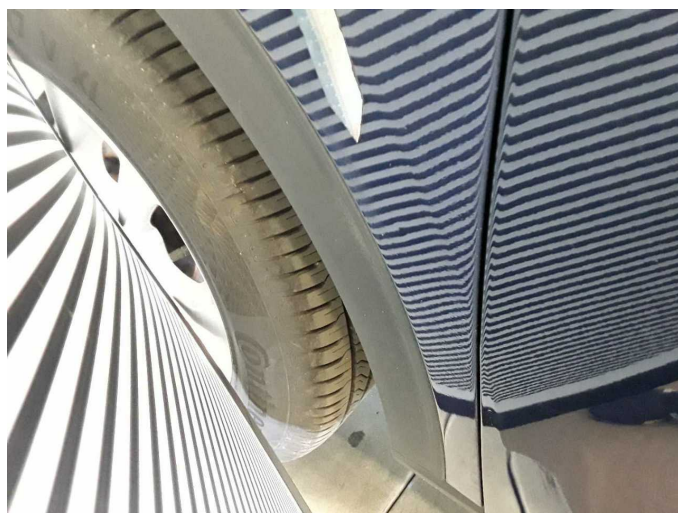
| No. | Component group | Description |
|---|---|---|
| 6 | Mudguard - left side | Mudguard - left side - dent(s) - Smooth repair work |

**Wear and tear 6:** Mudguard - left side: Mudguard - left side - dent(s) - Smooth repair work
