Expertise

Protocol number: 46140296
Order No. / Reference: 26335686
Inspection date: 18 Jun 2026

Model: Tiguan Allspace 2.0 TDI SCR DSG Life

VIN: WVGZZZ5N0PM043404

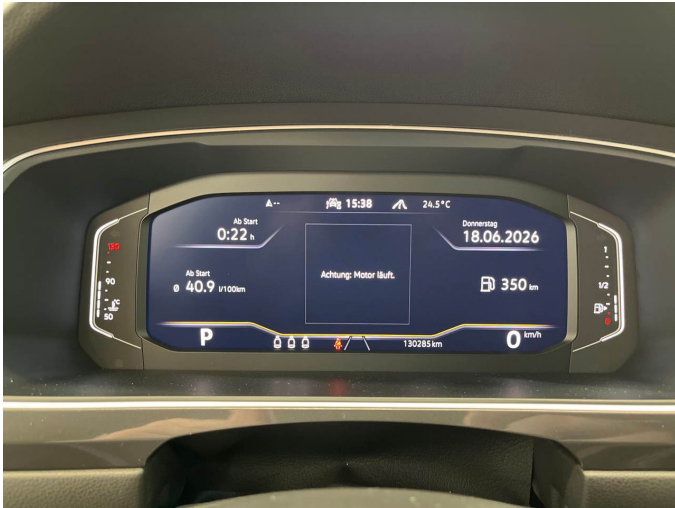
Figure 7: Instrument cluster

Vehicle Identification number	WVGZZZ5N0PM043404
Mileage (Read)	130,285 km
First registration	6 Apr 2023
Number of holders	1
Next periodical technical inspection (Report on hand)	03/2028

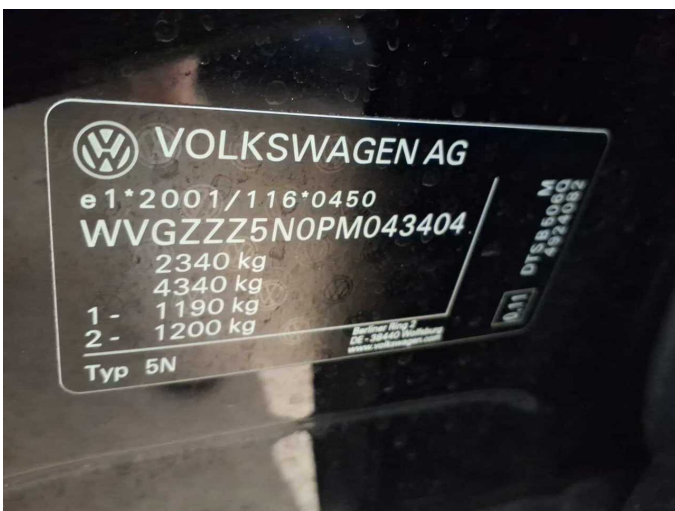
Figure 11: VIN

Documents submitted	At the time of the inspection, the vehicle registration certificate Part 2 (title) was available, but the vehicle registration certificate Part 1 (document) was not. (Copy)
VIN comparison	The vehicle identification number (VIN) was read from the vehicle and its conformity with the submitted documents was confirmed by the undersigned during the inspection.
Inspection	The inspection conditions were sufficient for the assessment of the vehicle. No lifting equipment or pit was available for inspecting the vehicle. Therefore, inspection of the vehicle's underside was only possible to a limited extent.
Test drive	No test drive/shunting maneuver was carried out during the inspection of the vehicle.
Engine function test	An engine test run was performed.

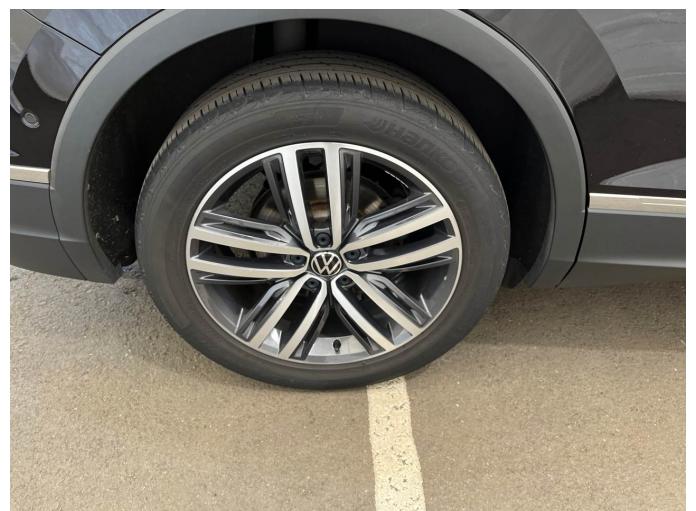
Figure 12: Mounted tyres

Mounted tyres				
#	Tyre size	Type of tyre	Manufacturer	Tread depth
1)	235/50 R19 99V	Summer tyres on Light alloy	Hankook	5mm / 5mm
2)	235/50 R19 99V	Summer tyres on Light alloy	Hankook	5mm / 5mm
Additional tyres				
#	Tyre size	Type of tyre	Manufacturer	Tread depth
1)	215/65 R17 99H	Winter tires (with run-flat tires) on Light alloy	Pirelli	5mm / 5mm
2)	215/65 R17 99H	Winter tires (with run-flat tires) on Light alloy	Pirelli	5mm / 5mm

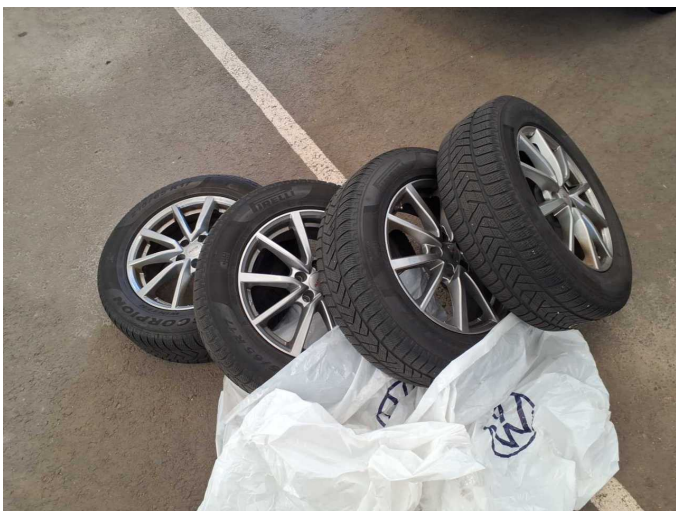
Figure 17: Additional tyres

- Der angegebene Winterradsatz ist kein Bestandteil des Auslieferungsumfangs.

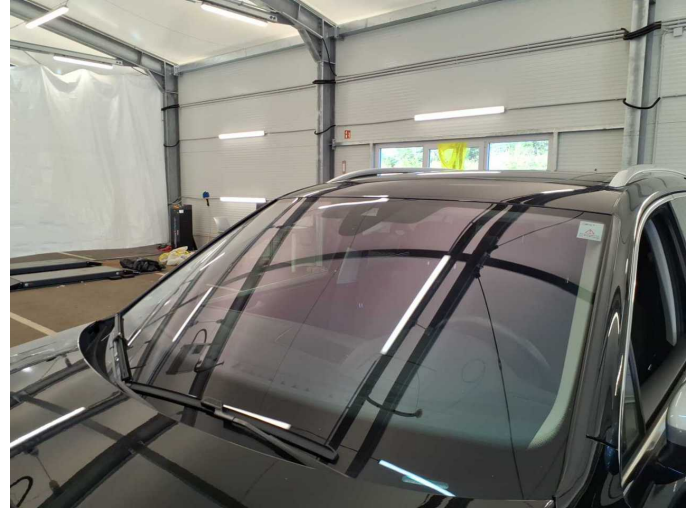
No.	Component group	Description
1	Vehicle glazing	Windscreen (Mit Rissbildung im Fahrersichtfeld) - Stone chips - Replace

Damage 1: Vehicle glazing: Windscreen (Mit Rissbildung im Fahrersichtfeld) - Stone chips - Replace

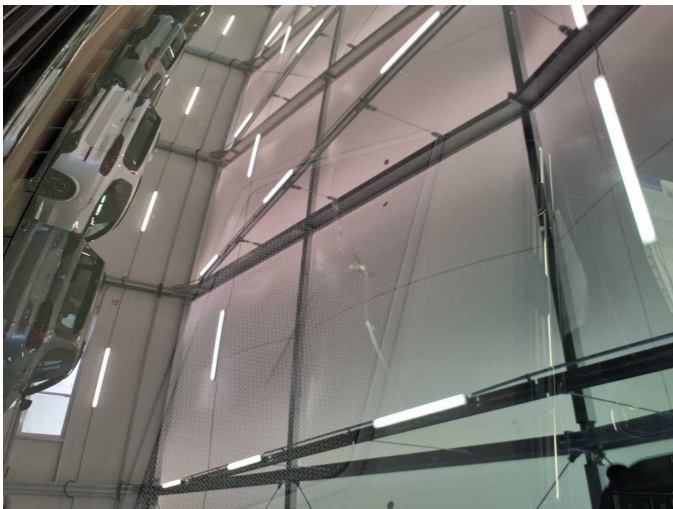
Damage 1: Vehicle glazing: Windscreen (Mit Rissbildung im Fahrersichtfeld) - Stone chips - Replace

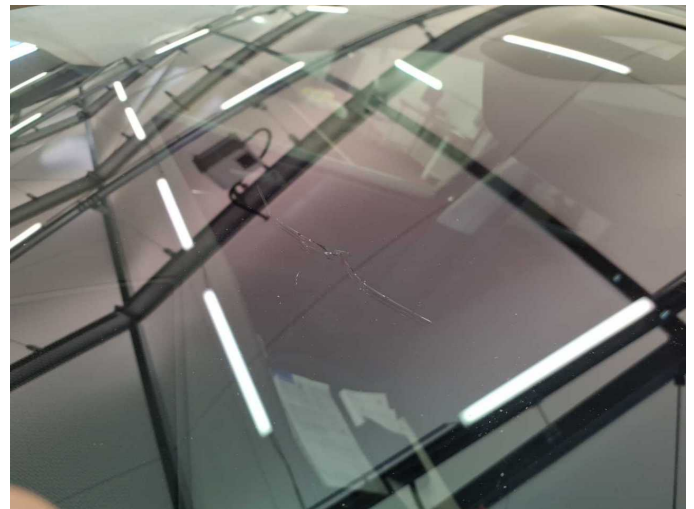
Damage 1: Vehicle glazing: Windscreen (Mit Rissbildung im Fahrersichtfeld) - Stone chips - Replace
