Expertise

Protocol number: 46336293  
Order No. / Reference: 26600628  
Inspection date: 6 Jul 2026

Manufacturer: Ford  
VIN: WF0JXXWPCJNY75883

Model: S-Max 2.0 EcoBlue Aut. VIGNALE

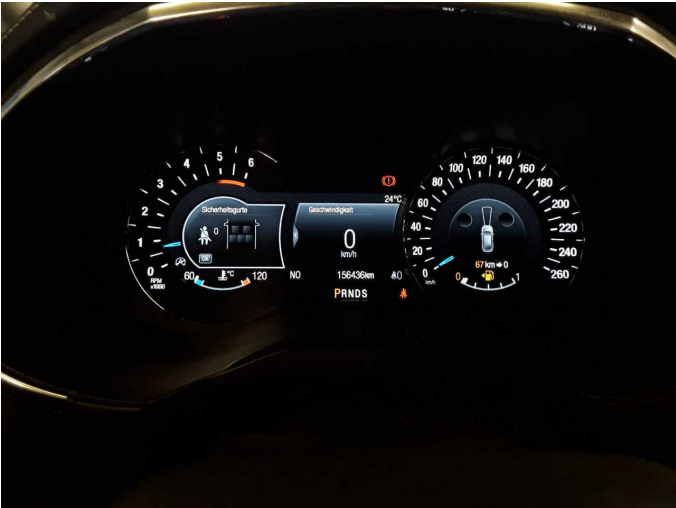
| Vehicle details | |
|---|---|
| Mileage (Read) | 156,436 km |

Figure 7: Instrument cluster

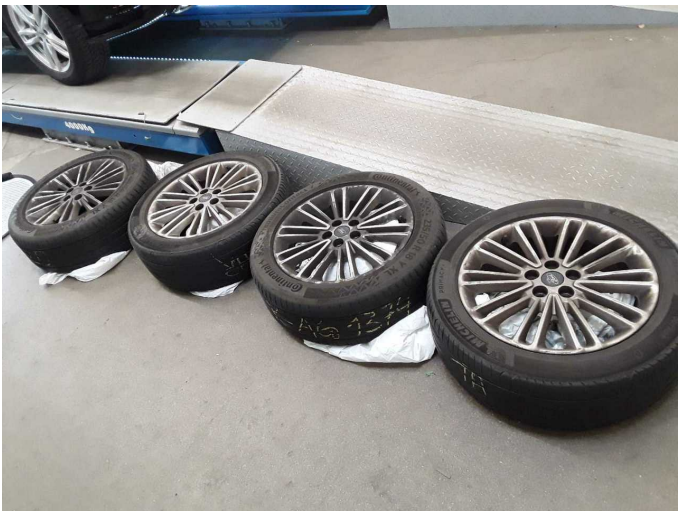
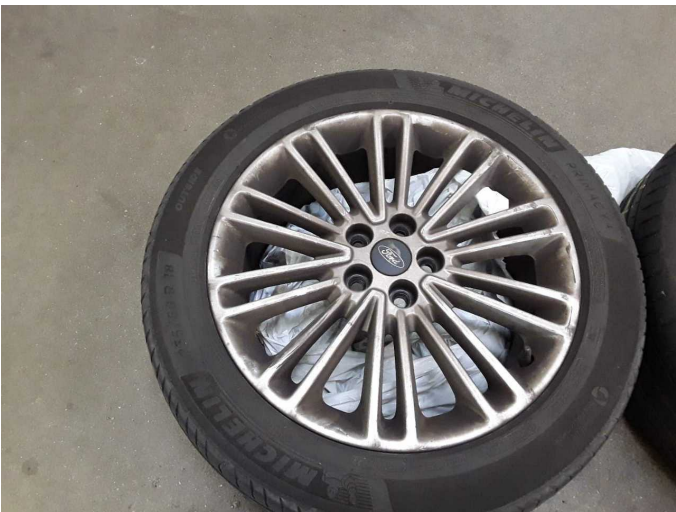
| # | Tyre size | Type of tyre | Manufacturer | Tread depth |
|---|---|---|---|---|
| 1) | 235/50 R18 101Y | Summer tyres on Light alloy | Continental | 3mm / 3mm |
| 2) | 235/50 R18 101Y | Summer tyres on Light alloy | Michelin | 3mm / 3mm |

Figure 16: Additional tyres

Figure 17: Additional tyres

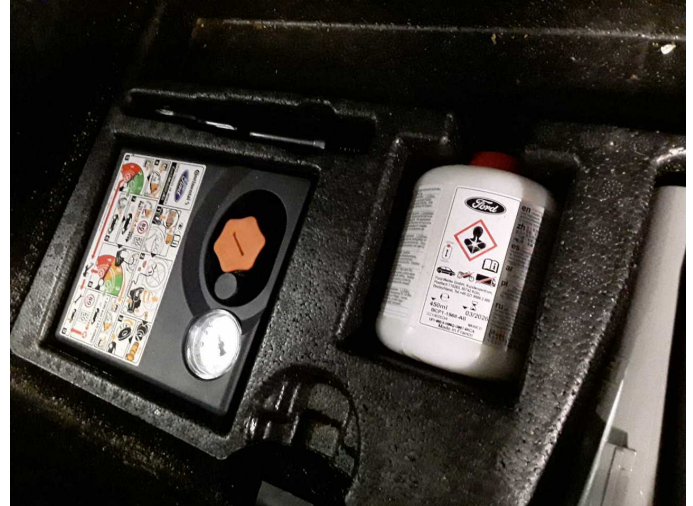
| No. | Component group | Description |
|---|---|---|
| 1 | Equipment | Tirefit filler - Expired - Replace |

**Damage 1:** Equipment: Tirefit filler - Expired - Replace

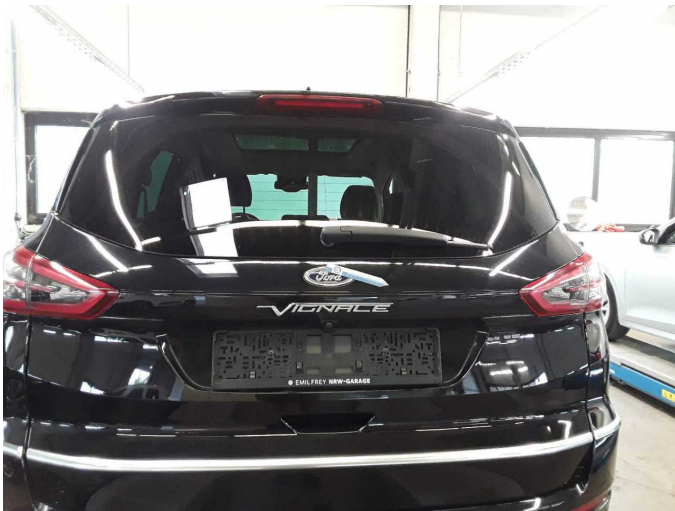
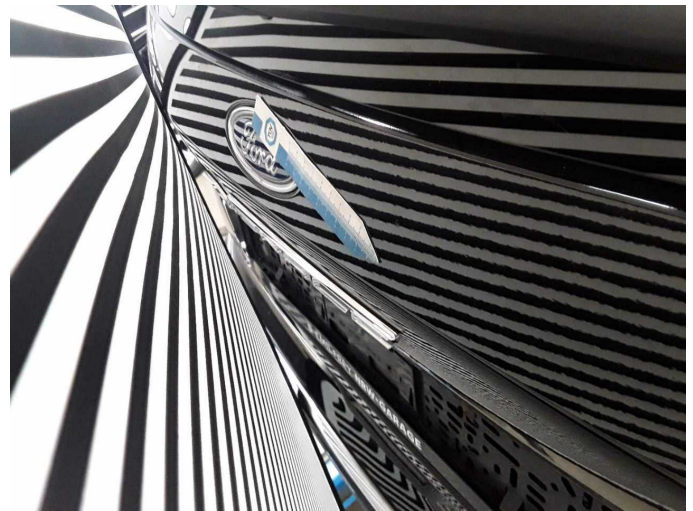
| No. | Component group | Description |
|---|---|---|
| 2 | Boot lid / rear door | Boot lid - dent(s) - Smooth repair work |

**Damage 2:** Boot lid / rear door: Boot lid - dent(s) - Smooth repair work

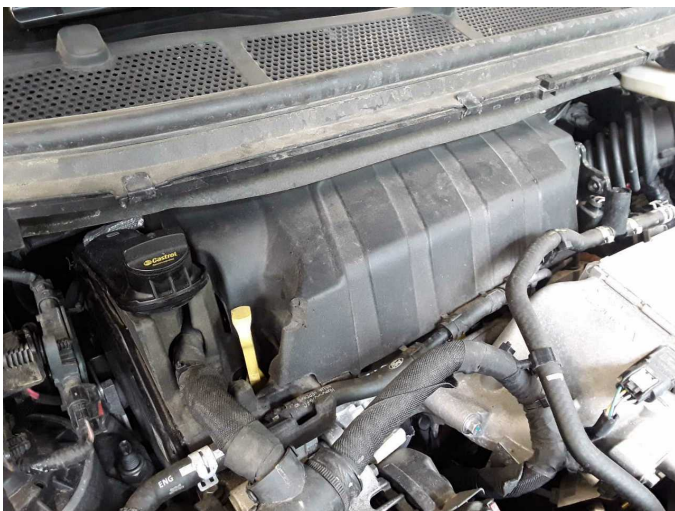
| No. | Component group | Description |
|---|---|---|
| 3 | Engine | Engine cover - Deformed - Replace |

**Damage 3:** Engine: Engine cover - Deformed - Replace

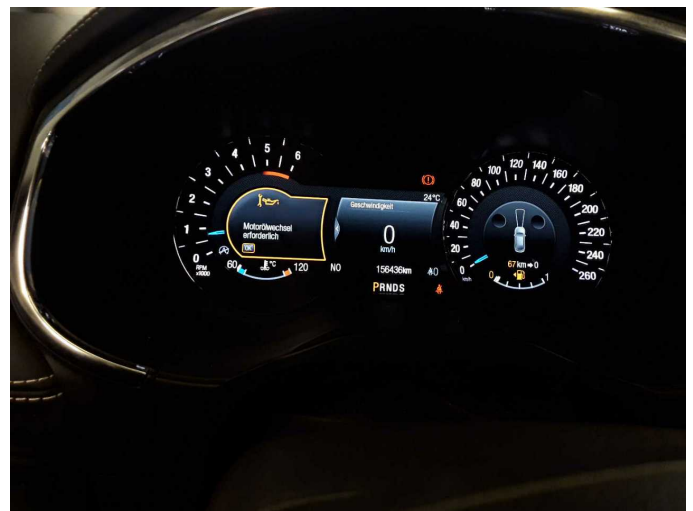
| No. | Component group | Description |
|---|---|---|
| 4 | Misc. | Inspection / maintenance - Due - Perform |

**Damage 4:** Misc.: Inspection / maintenance - Due - Perform

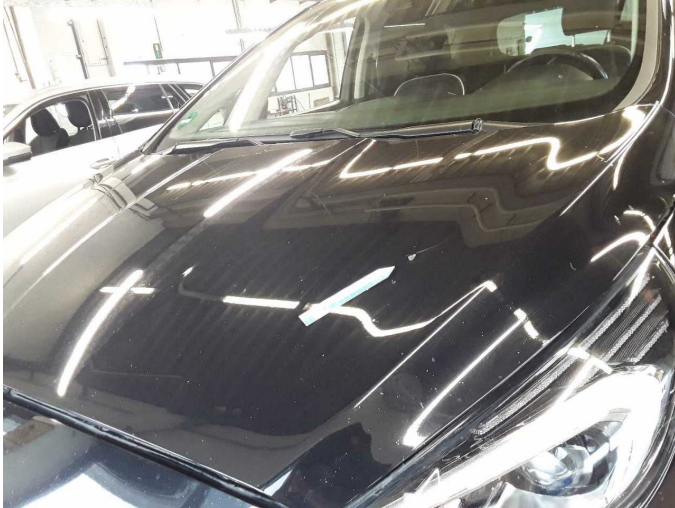
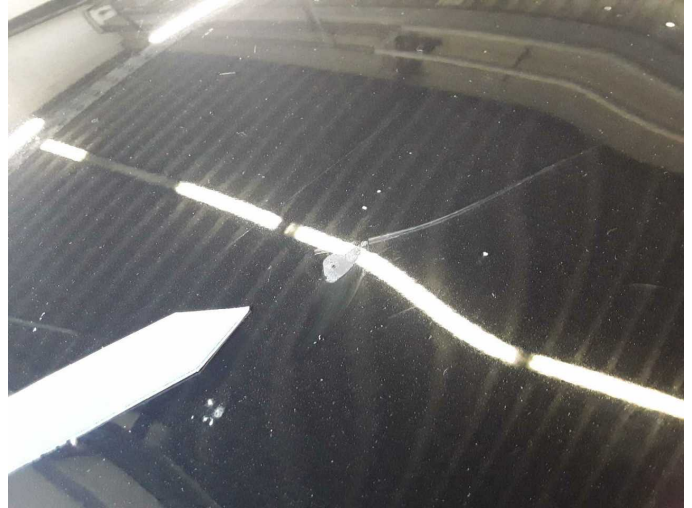
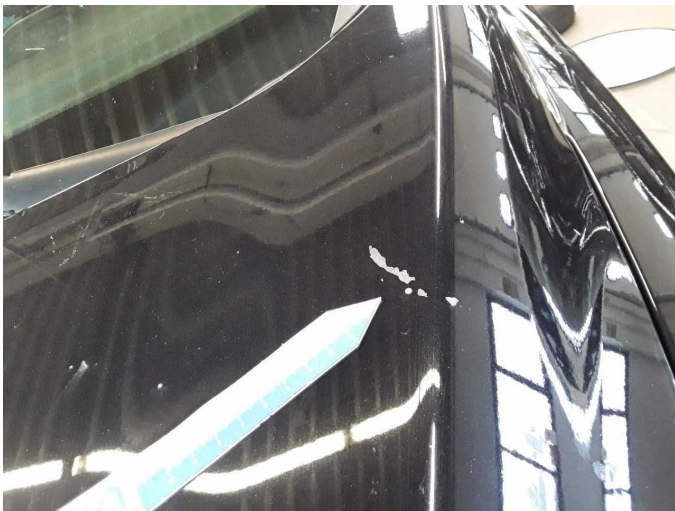
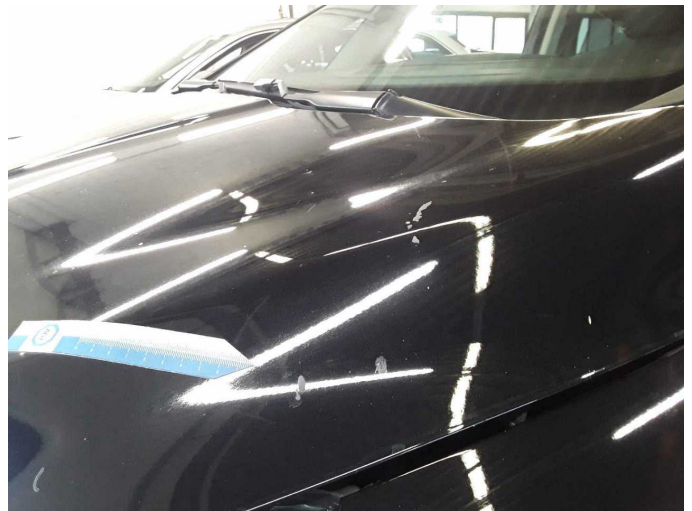
| No. | Component group | Description |
|---|---|---|
| 5 | Bonnet | Bonnet (Harz) - Paint defect - Paint |

**Damage 5:** Bonnet: Bonnet (Harz) - Paint defect - Paint

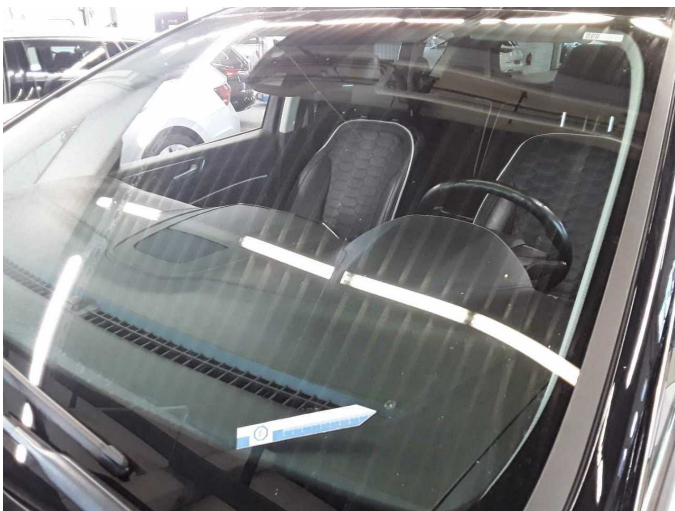
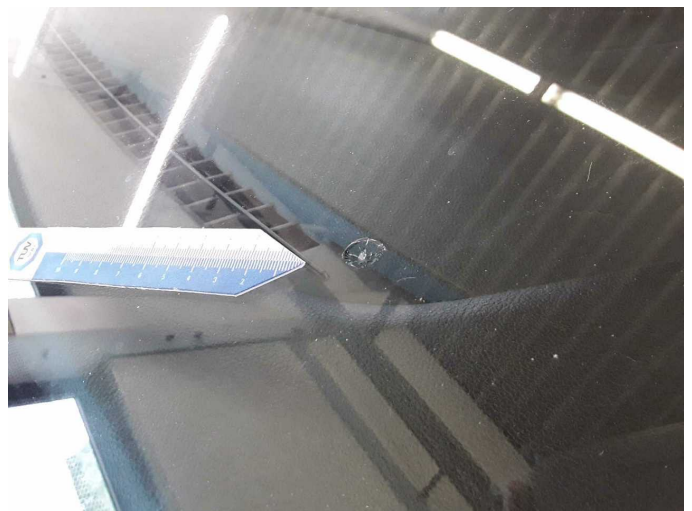
| No. | Component group | Description |
|---|---|---|
| 6 | Vehicle glazing | Windscreen (Rissbildung) - Stone chips - Replace |

**Damage 6:** Vehicle glazing: Windscreen (Rissbildung) - Stone chips - Replace

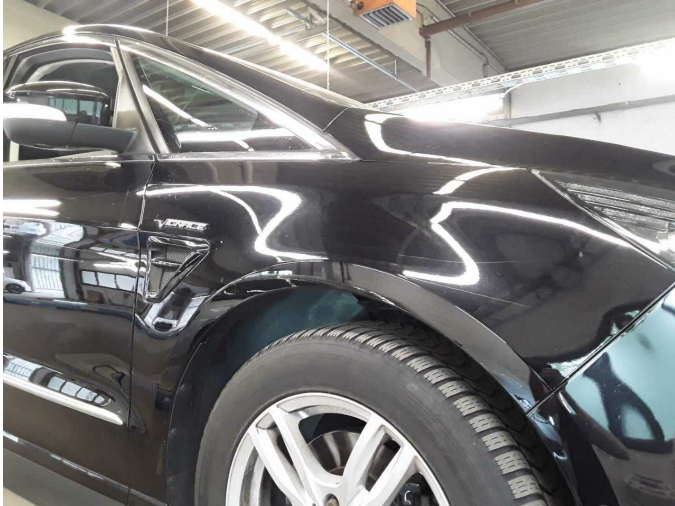
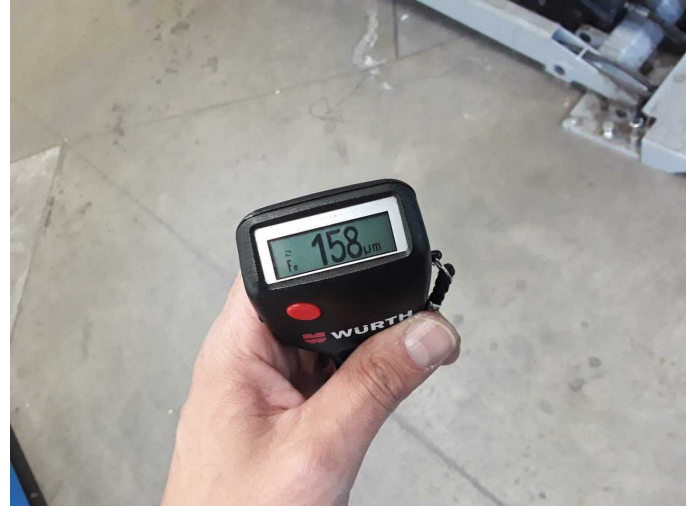
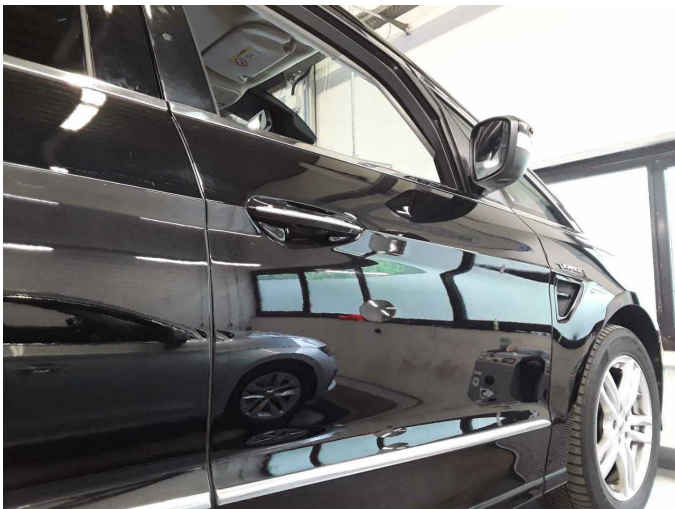
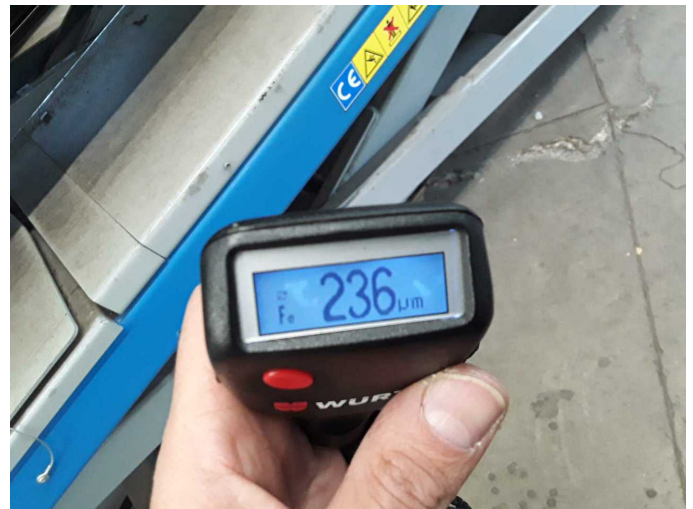
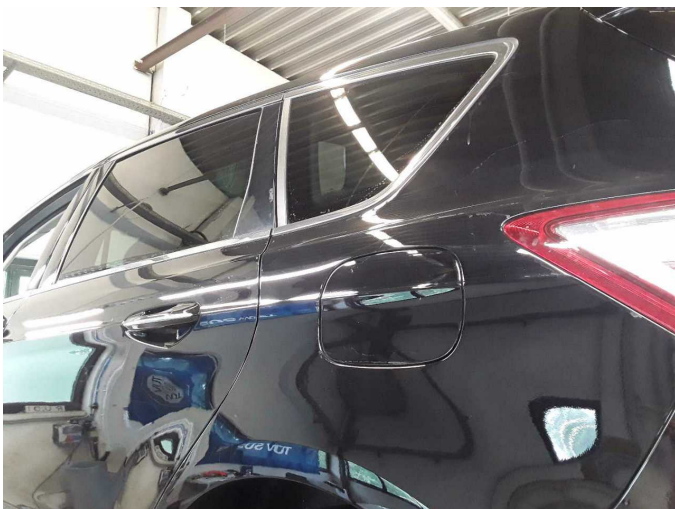
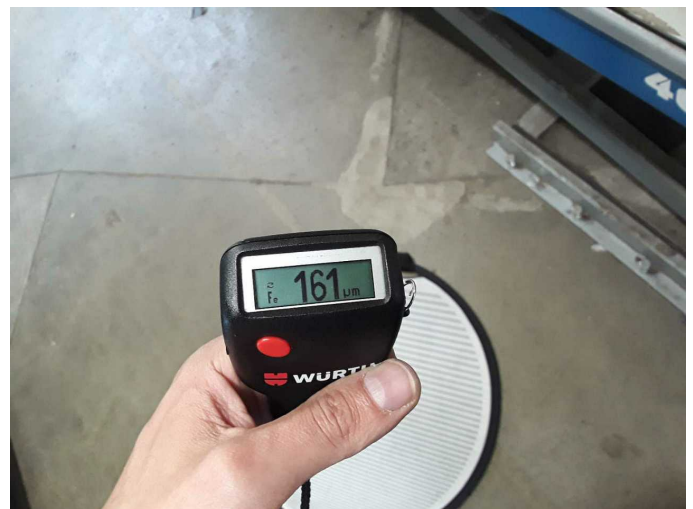
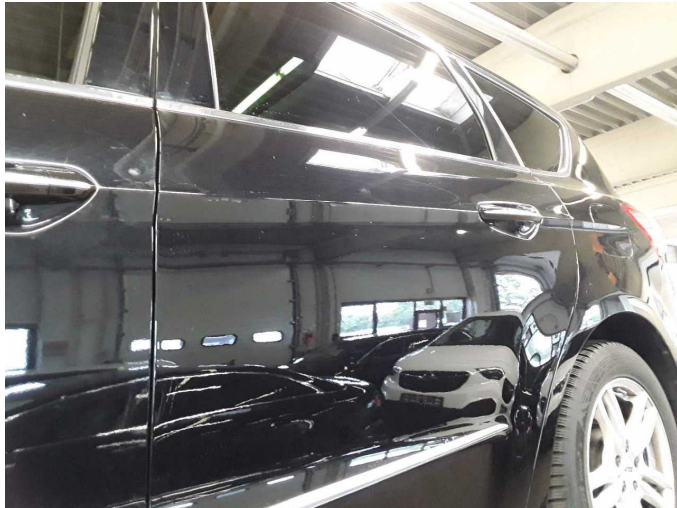
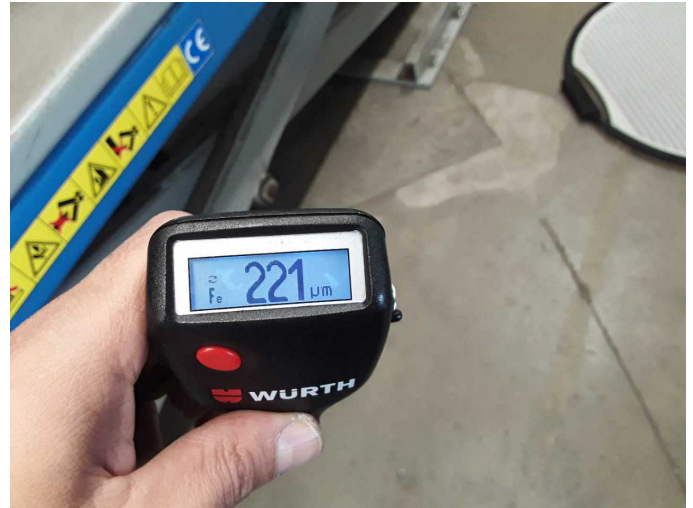
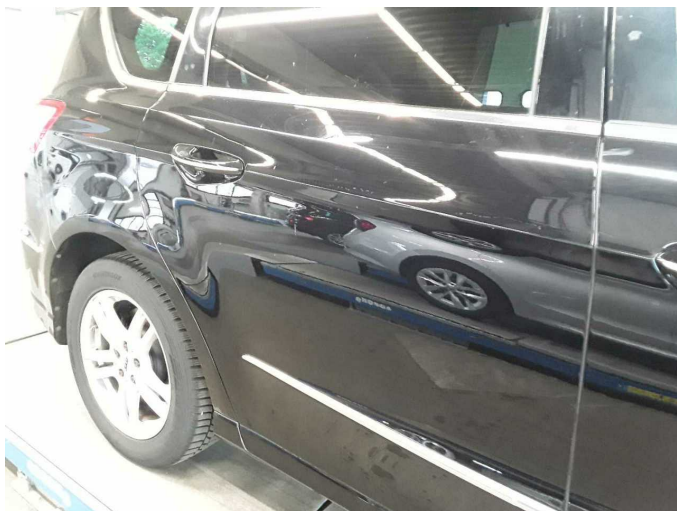
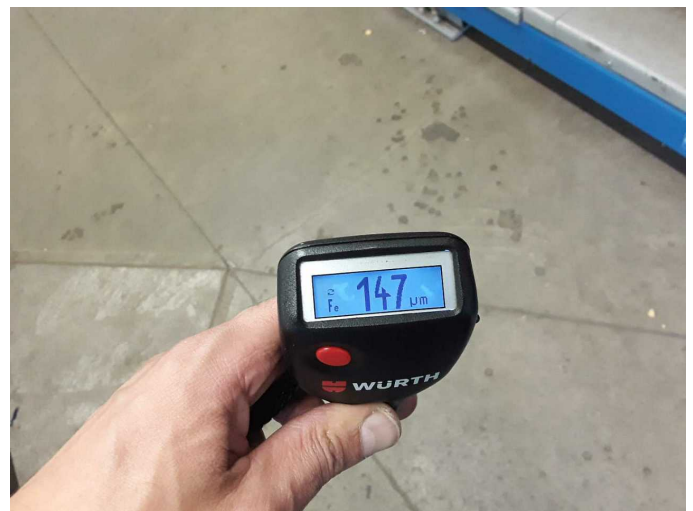
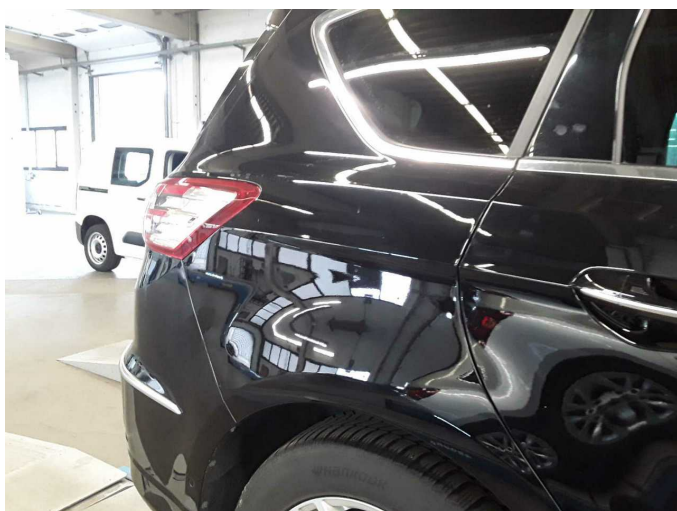
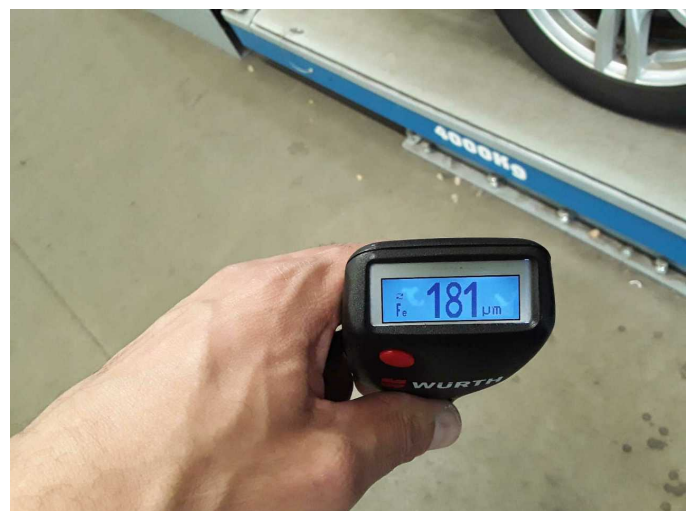
| No. | Repainting |
|---|---|
| 1 | Mudguard - right side, Side panel - rear left side, Side panel - rear right side, Door - rear right side, Door - front right side, Professionally carried out, Invoice of repair done Non-existent |

**Repainting 1:** Mudguard - right side, Side panel - rear left side, Side panel - rear right side, Door - rear right side, Door - front right side
