Expertise

Protocol number: 46902173  
Order No. / Reference: 26827307  
Inspection date: 3 Aug 2026

Model: Insignia Grand Sport 2.0 Diesel Automatik Business

VIN: W0VZT6EP1N1031515

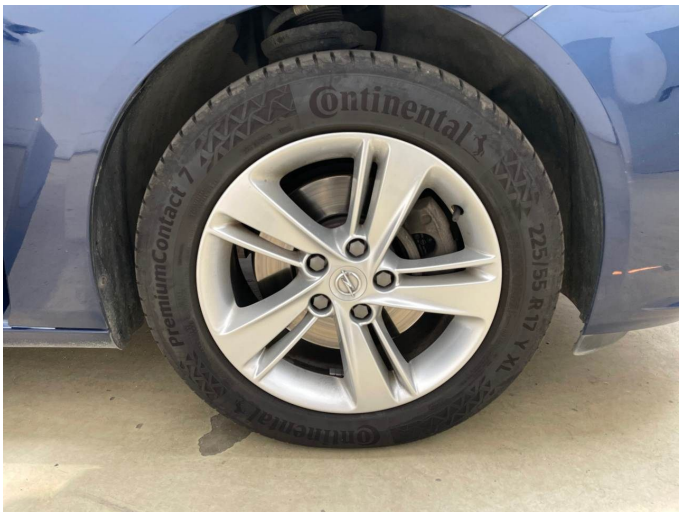
| # | Tyre size | Type of tyre | Manufacturer | Tread depth |
|---|---|---|---|---|
| 1) | 225/55 R17 101Y | Summer tyres on Light alloy | Continental | 5mm / 5mm |
| 2) | 225/55 R17 101Y | Summer tyres on Light alloy | Continental | 4mm / 4mm |

Figure 12: Mounted tyres

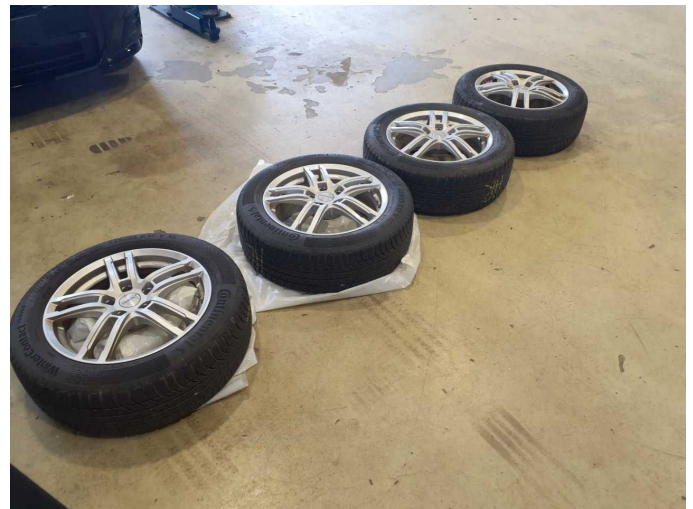
| # | Tyre size | Type of tyre | Manufacturer | Tread depth |
|---|---|---|---|---|
| 1) | 225/55 R17 101V | Winter tyres on Light alloy | Continental | 5mm / 5mm |
| 2) | 225/55 R17 101V | Winter tyres on Light alloy | Continental | 5mm / 5mm |

Figure 16: Additional tyres

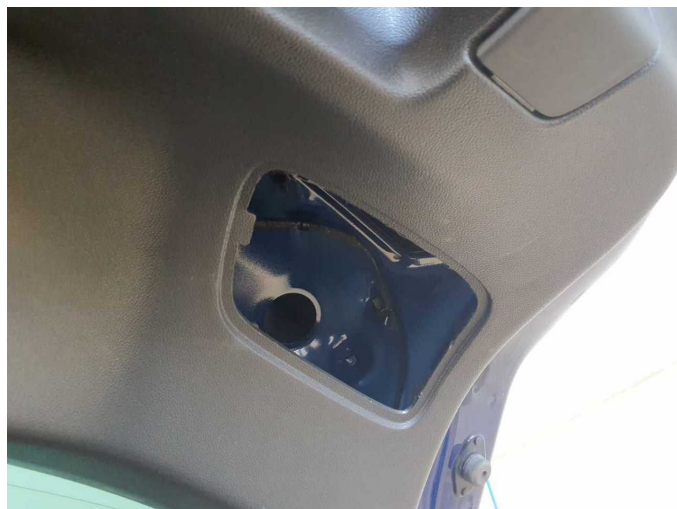
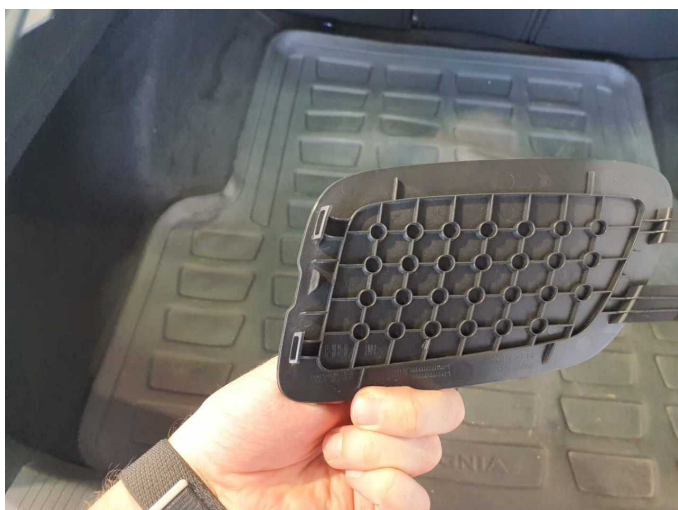
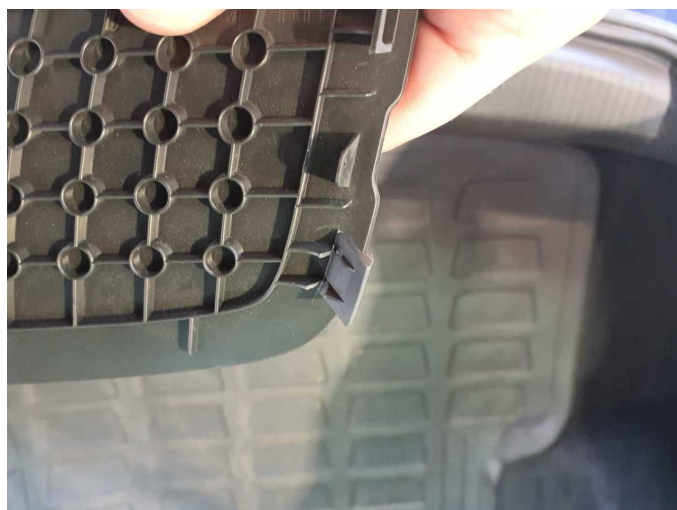
| No. | Component group | Description |
|---|---|---|
| 1 | Trim / covers | Trim / covers - Broken / torn - Replace |

**Damage 1:** Trim / covers: Trim / covers - Broken / torn - Replace

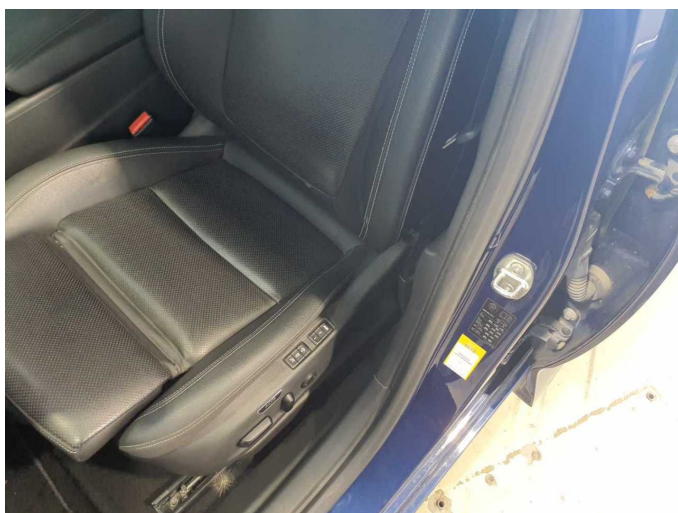
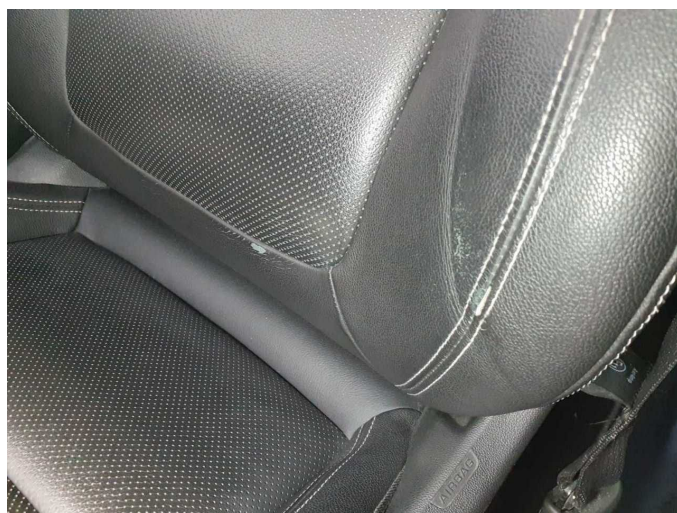
| No. | Component group | Description |
|---|---|---|
| 2 | Seat - front | Seat cover - left side - Scratch(es) - Smart repair |

**Damage 2:** Seat - front: Seat cover - left side - Scratch(es) - Smart repair

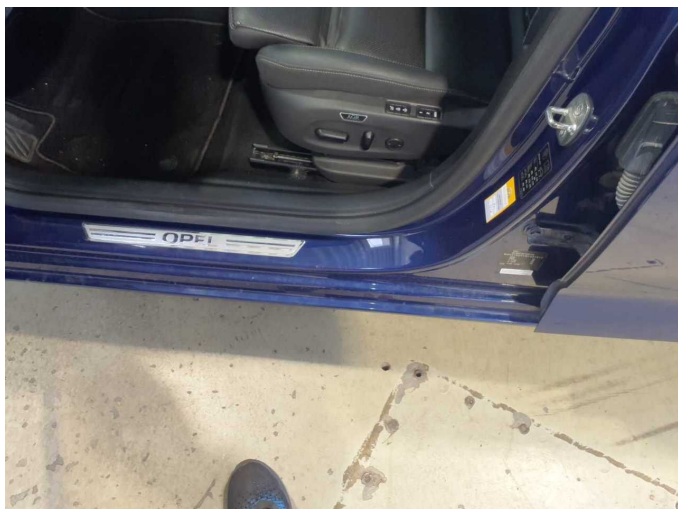
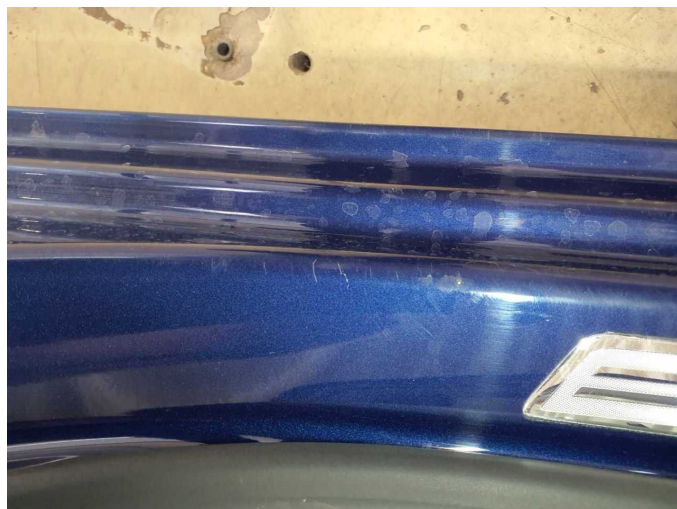
| No. | Component group | Description |
|---|---|---|
| 3 | Sill - left side | Sill - Scratch(es) - Smart repair |

**Damage 3:** Sill - left side: Sill - Scratch(es) - Smart repair

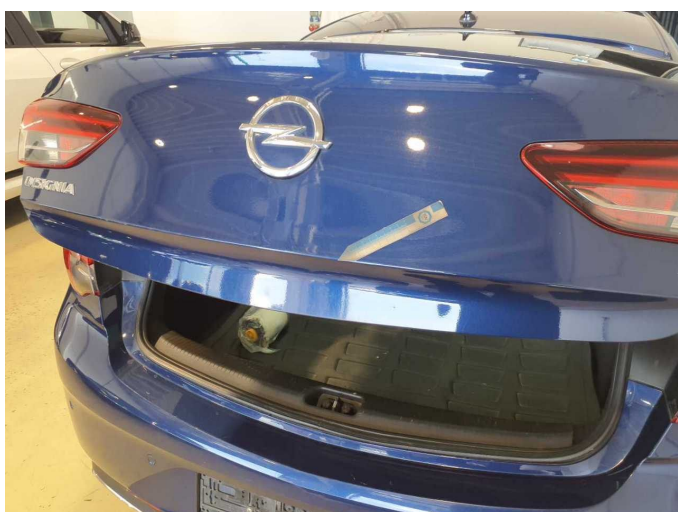
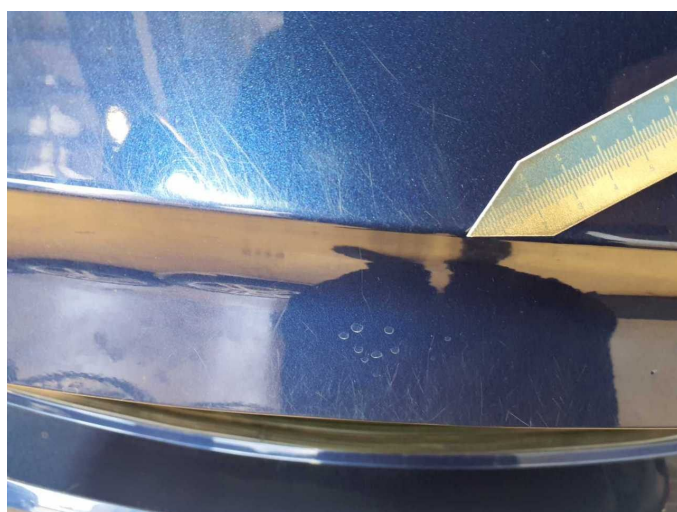
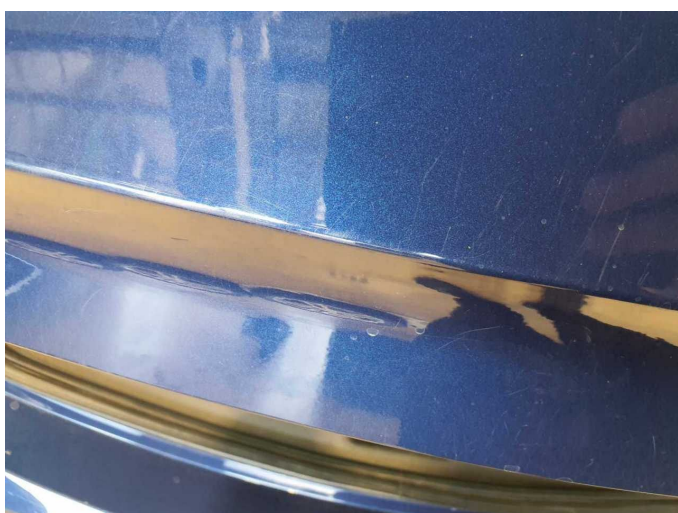
| No. | Component group | Description |
|---|---|---|
| 4 | Boot lid / rear door | Boot lid - Scratch(es) - Smart repair |

**Damage 4:** Boot lid / rear door: Boot lid - Scratch(es) - Smart repair

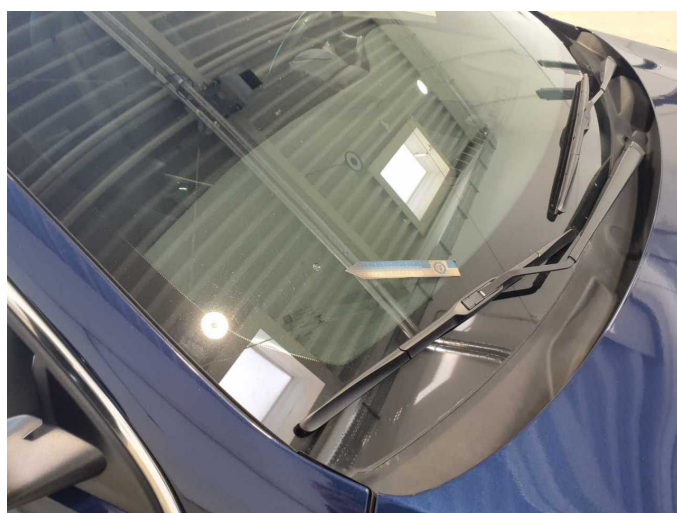
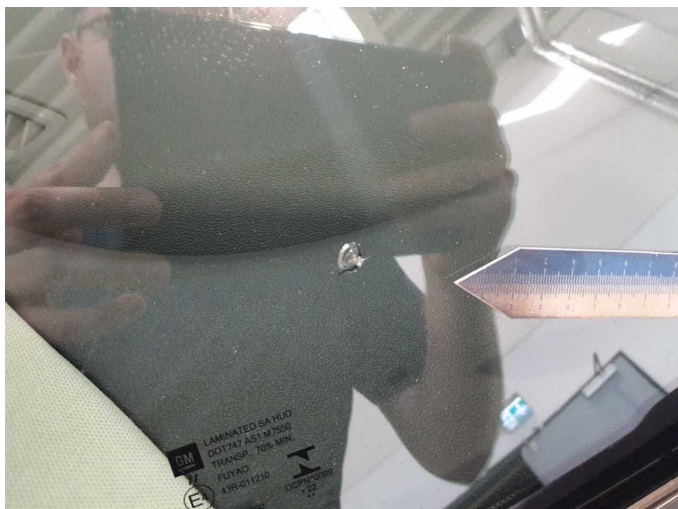
| No. | Component group | Description |
|---|---|---|
| 5 | Vehicle glazing | Windscreen - Stone chips - Smart repair |

**Damage 5:** Vehicle glazing: Windscreen - Stone chips - Smart repair

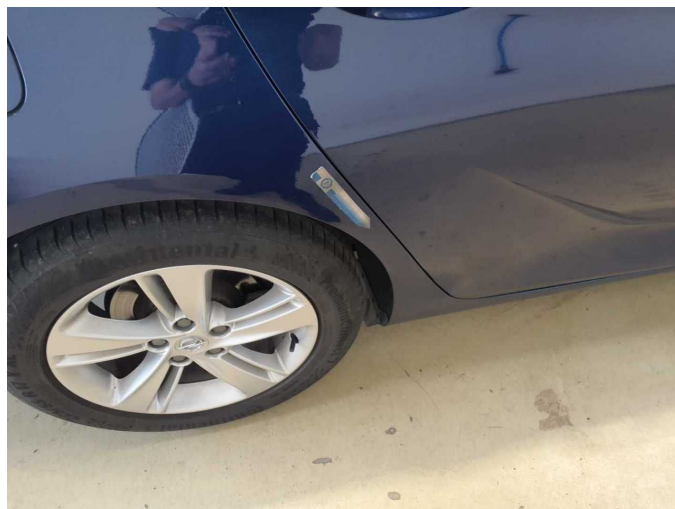
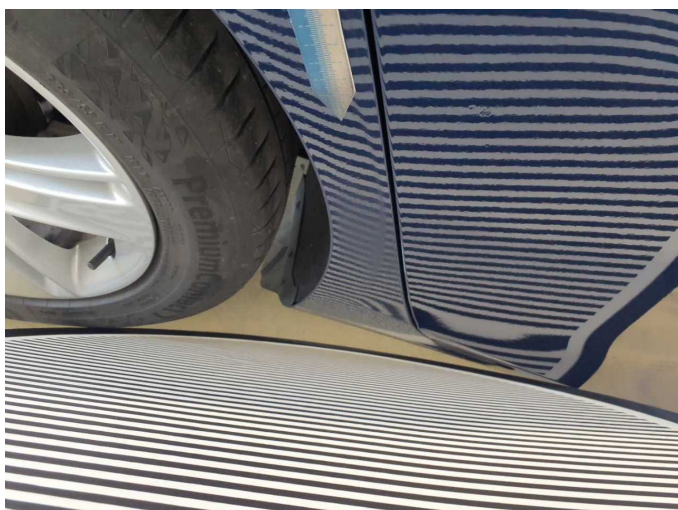
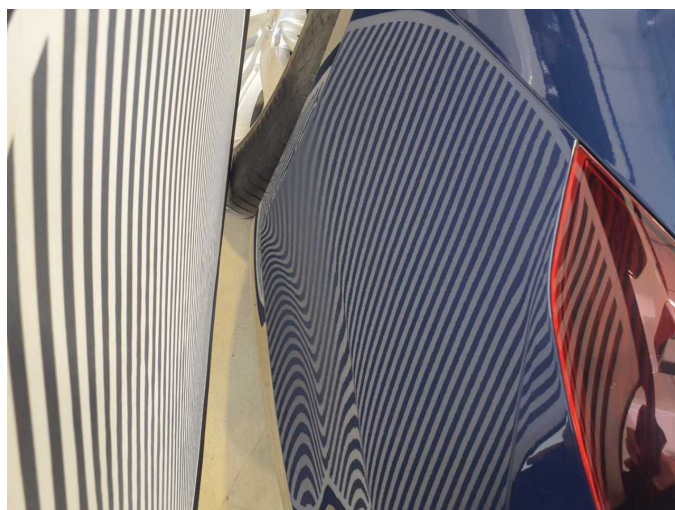
| No. | Component group | Description |
|---|---|---|
| 6 | Body | Body (Matt) - Paint defect - Smart repair |

**Damage 6:** Body: Body (Matt) - Paint defect - Smart repair

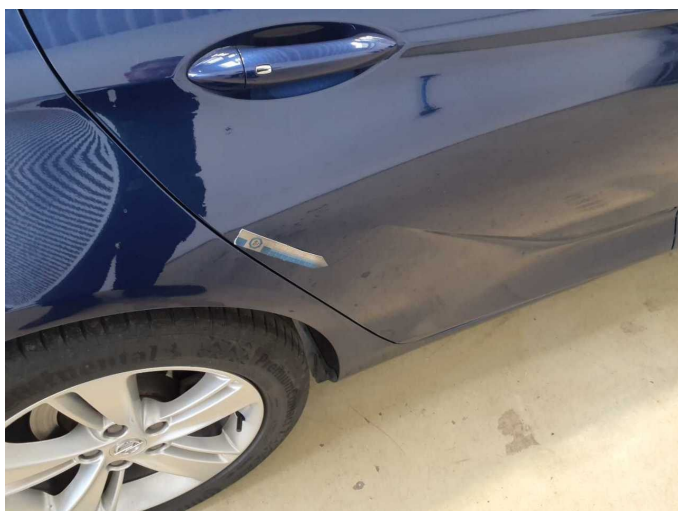
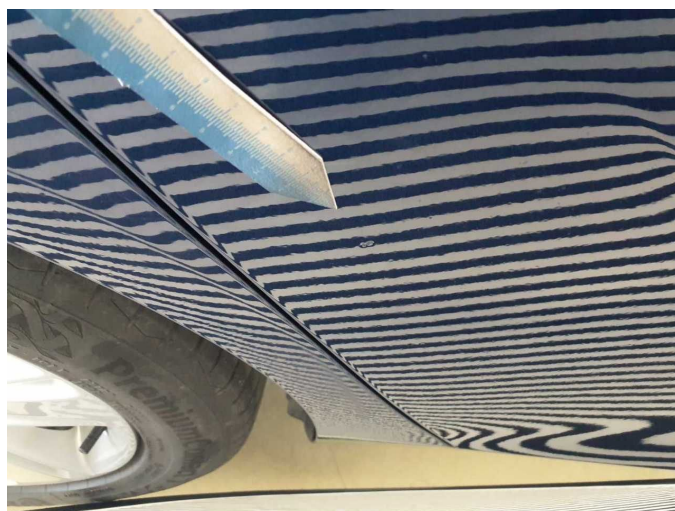
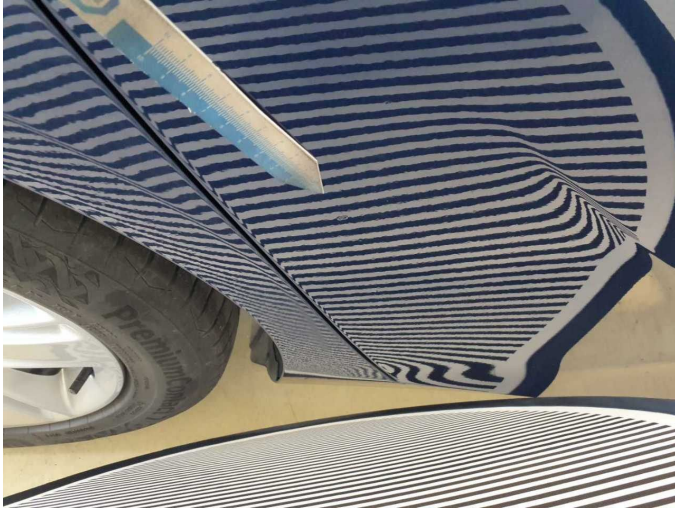
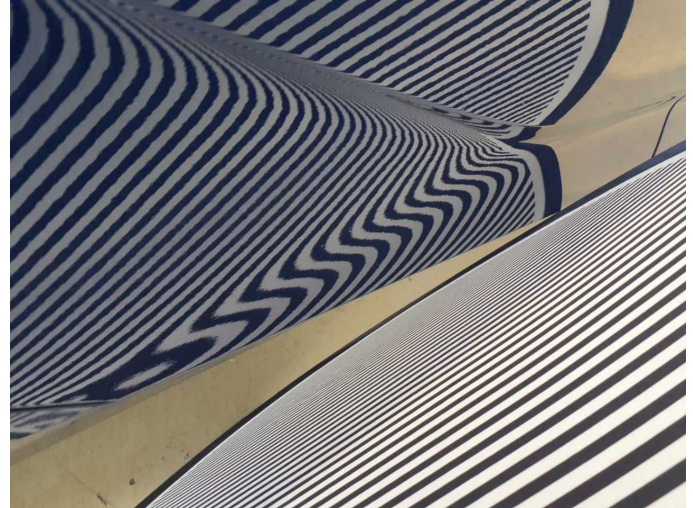
| No. | Component group | Description |
|---|---|---|
| 7 | Door - rear right side | Door (Einschlüsse-Mehrkosten möglich) - Unprofessionally repaired - Conditioning |

**Damage 7:** Door - rear right side: Door (Einschlüsse-Mehrkosten möglich) - Unprofessionally repaired - Conditioning

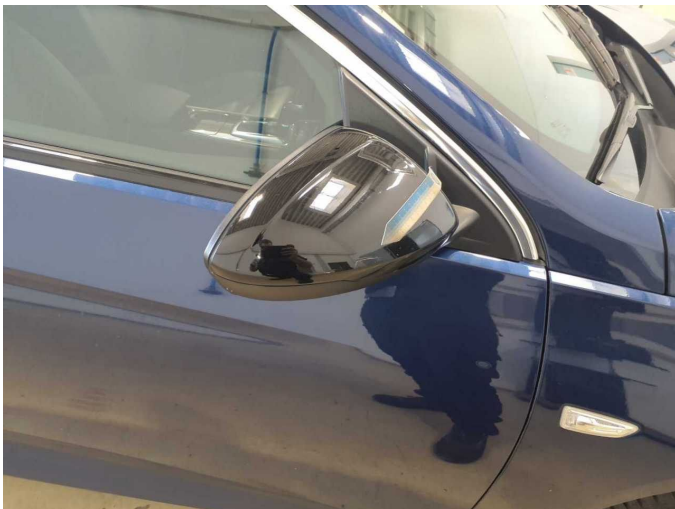
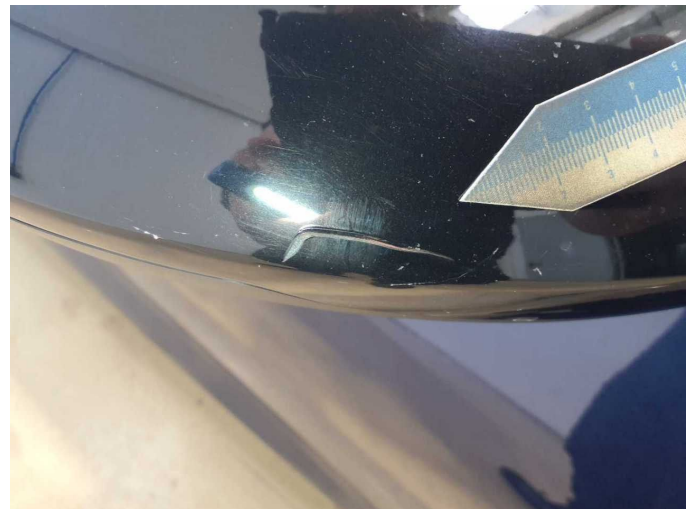
| No. | Component group | Description |
|---|---|---|
| 8 | Wing mirror - right side | Cap (tiefer) - Scratch(es) - Replace |

**Damage 8:** Wing mirror - right side: Cap (tiefer) - Scratch(es) - Replace

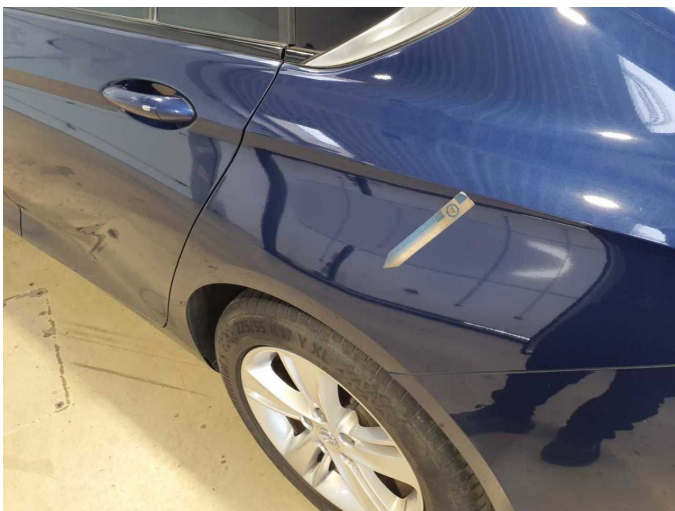
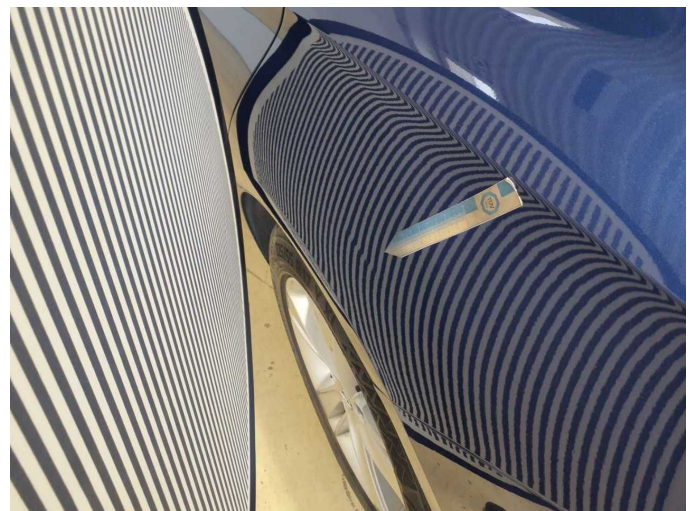
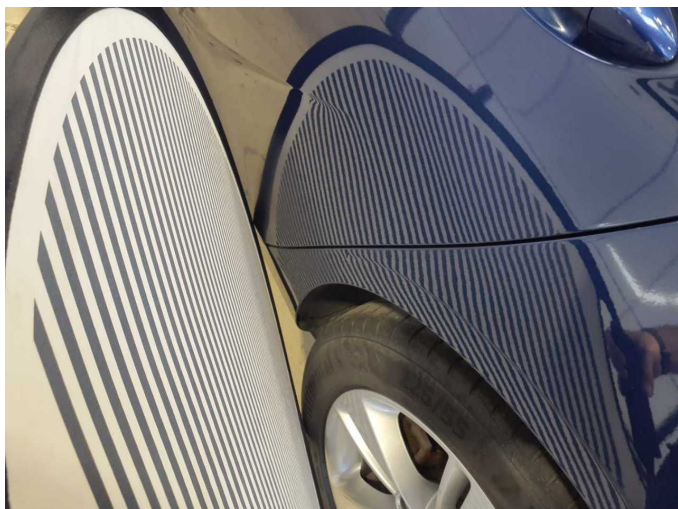
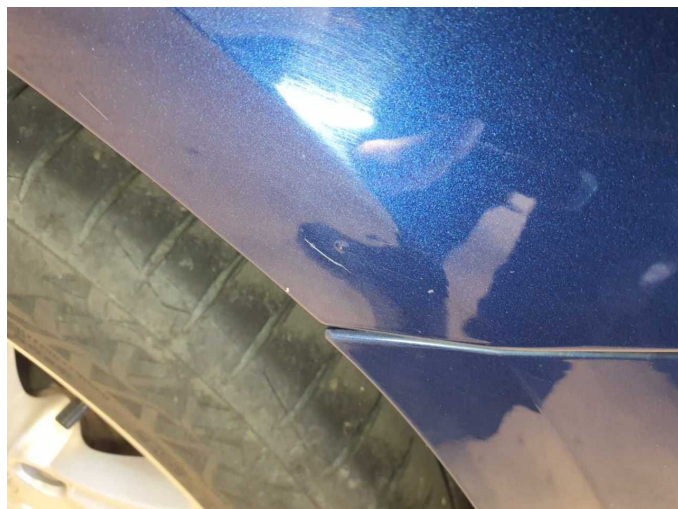
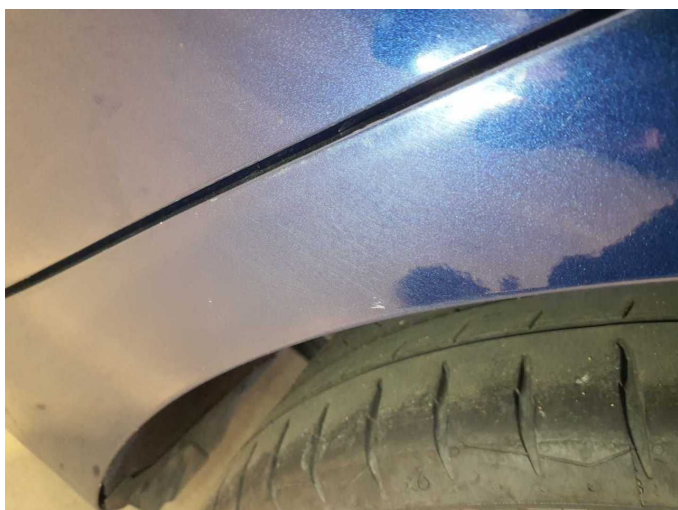
| No. | Component group | Description |
|---|---|---|
| 9 | Side panel - rear left side | Side panel - Dent / paintcoat damage - Repair and paint |

**Damage 9:** Side panel - rear left side: Side panel - Dent / paintcoat damage - Repair and paint

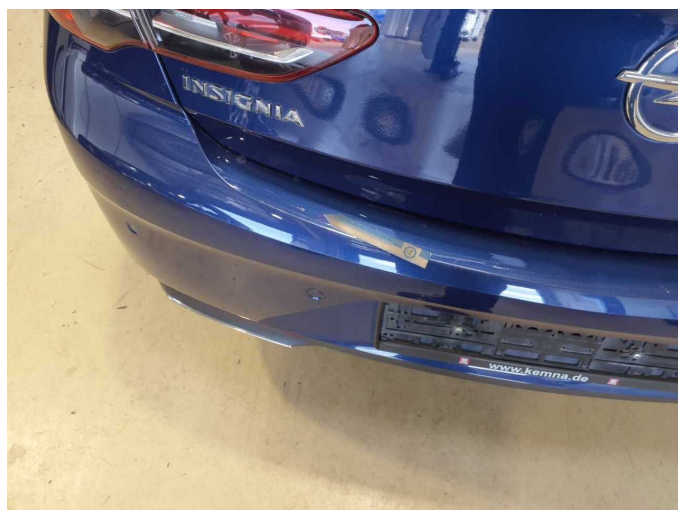
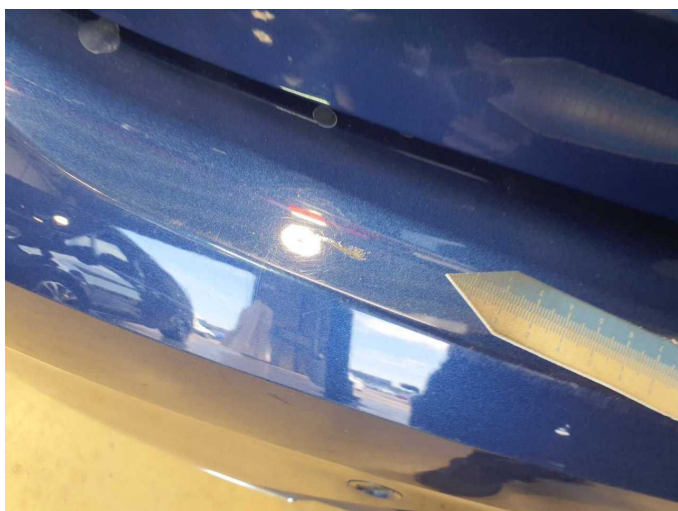
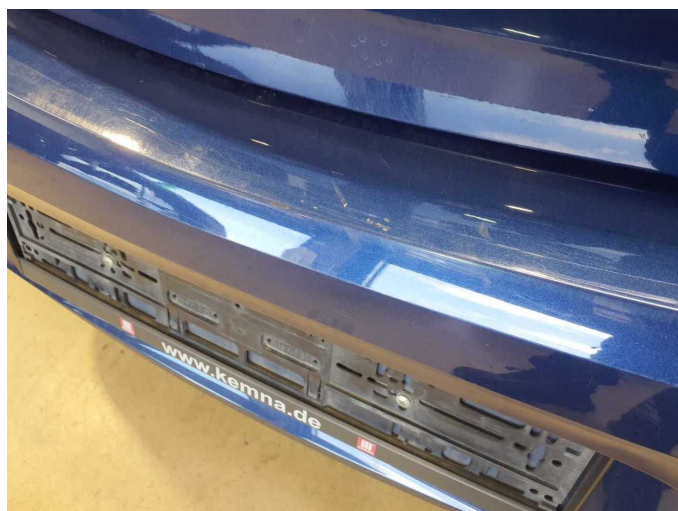
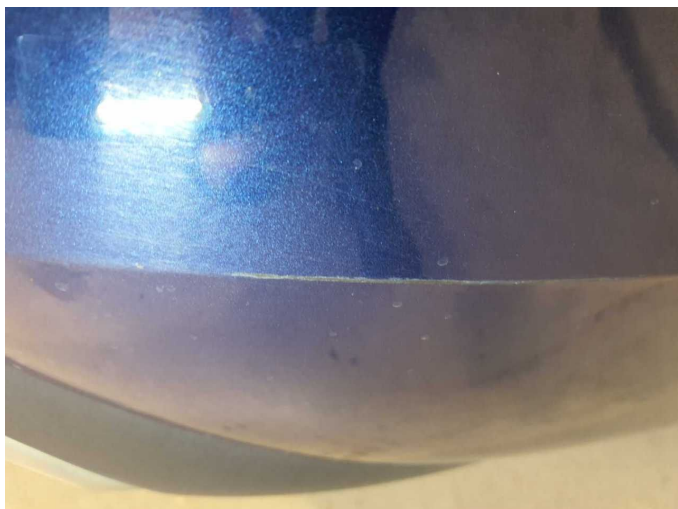
| No. | Component group | Description |
|---|---|---|
| 10 | Rear bumper | Rear bumper - Scratch(es) - Paint |

**Damage 10:** Rear bumper: Rear bumper - Scratch(es) - Paint

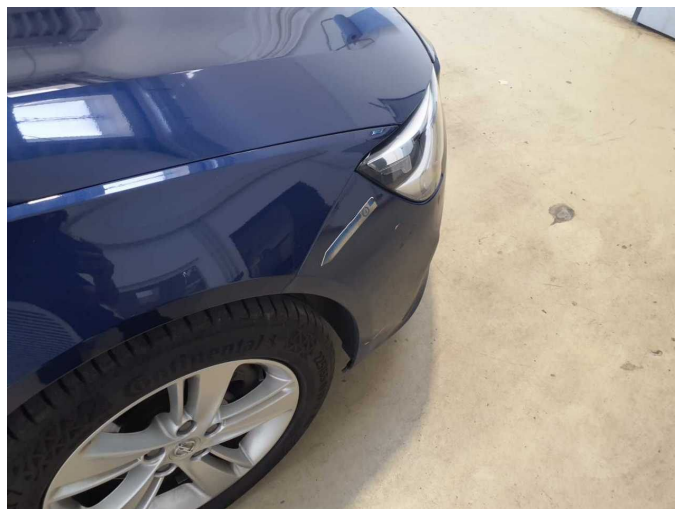
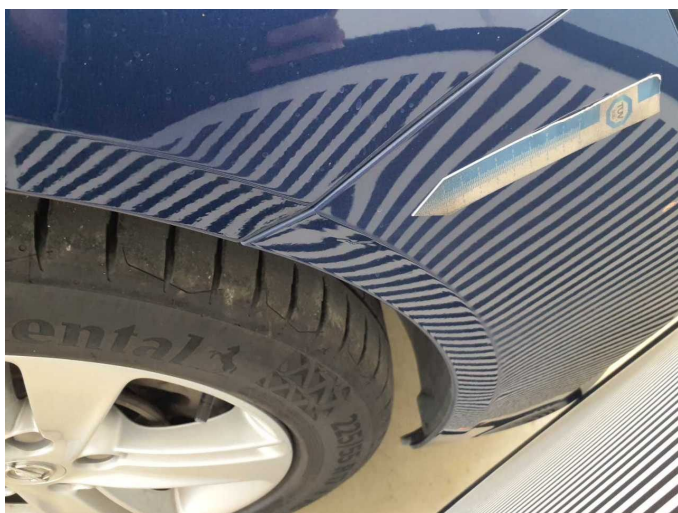
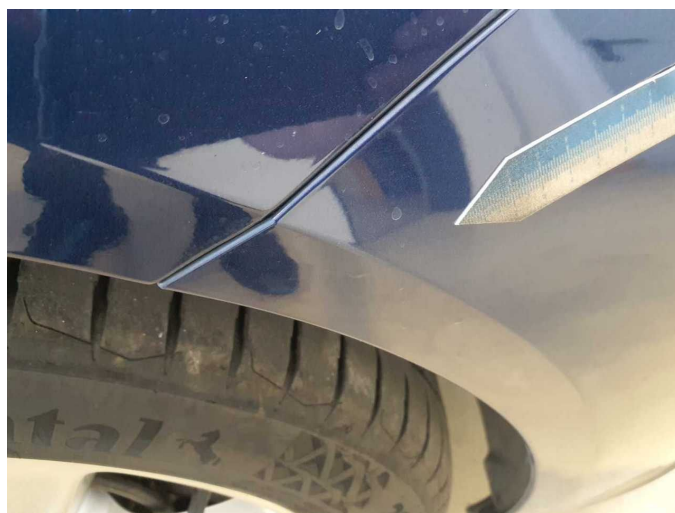
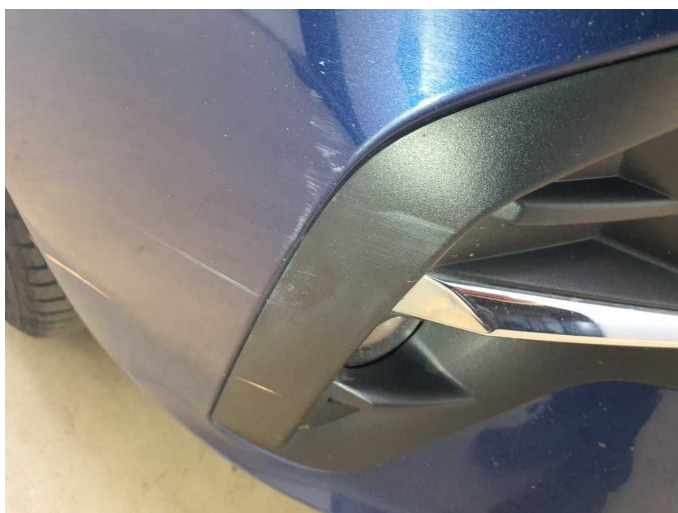
| No. | Component group | Description |
|---|---|---|
| 11 | Front bumper | Front bumper (+ Blende) - Scratched - Repair and paint |

**Damage 11:** Front bumper: Front bumper (+ Blende) - Scratched - Repair and paint

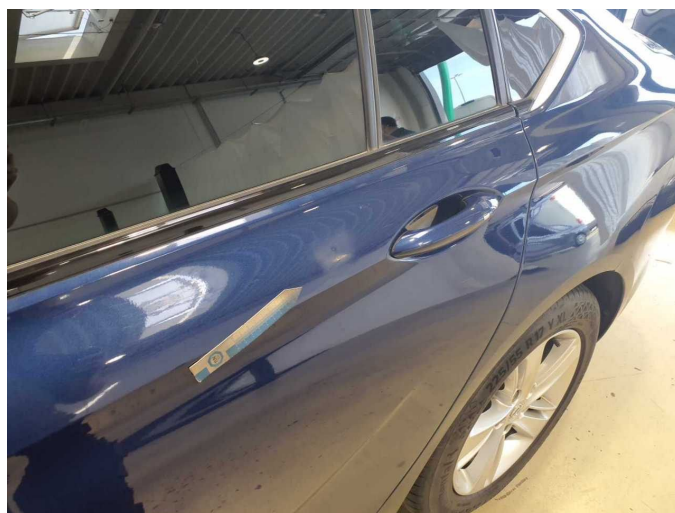
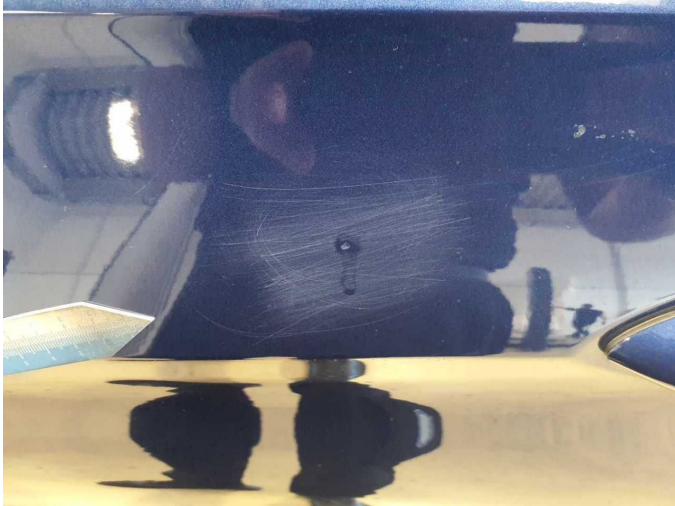
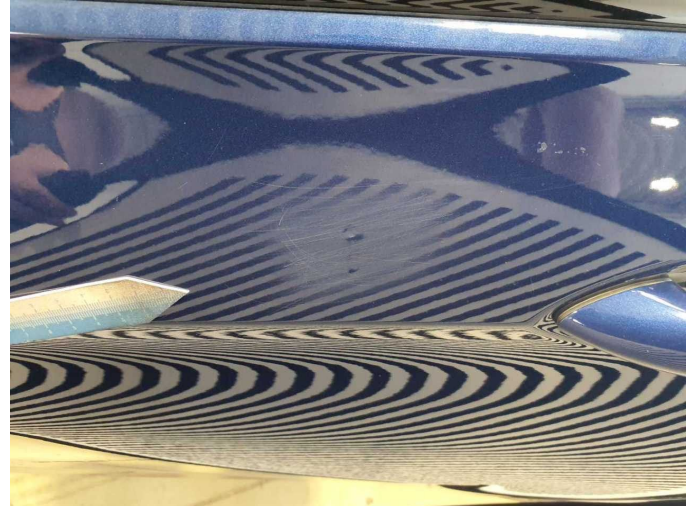
| No. | Component group | Description |
|---|---|---|
| 12 | Door - rear left side | Door (Anätzung) - Scratched - Paint |

**Damage 12:** Door - rear left side: Door (Anätzung) - Scratched - Paint

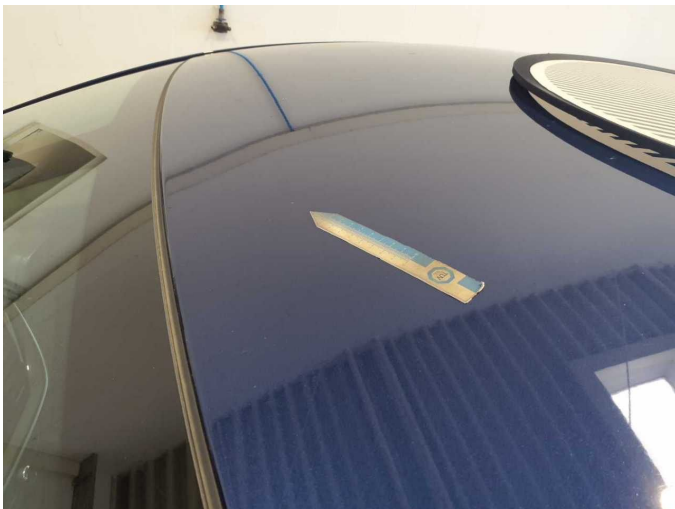
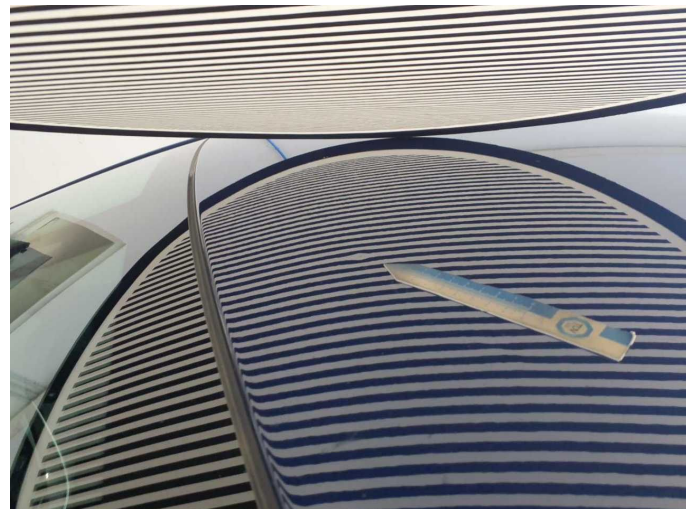
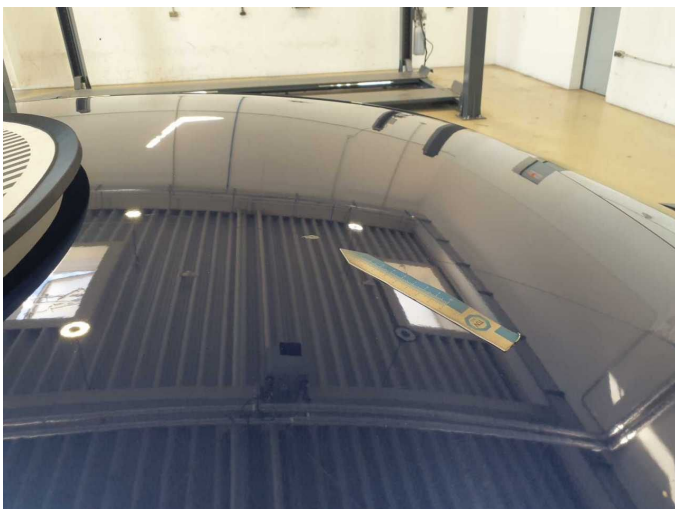
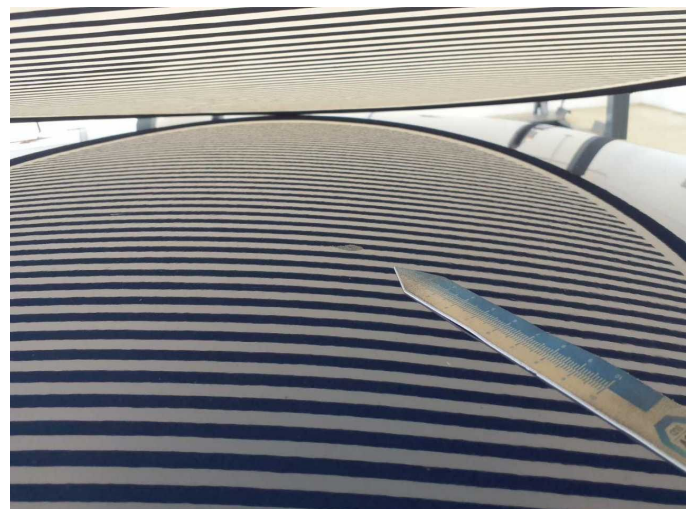
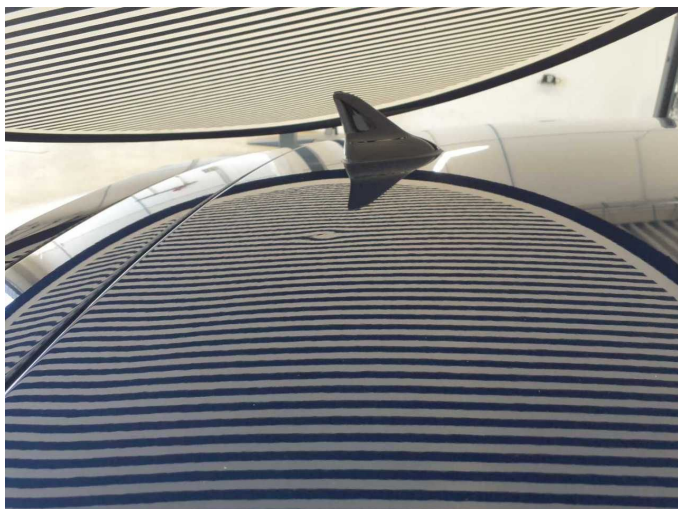
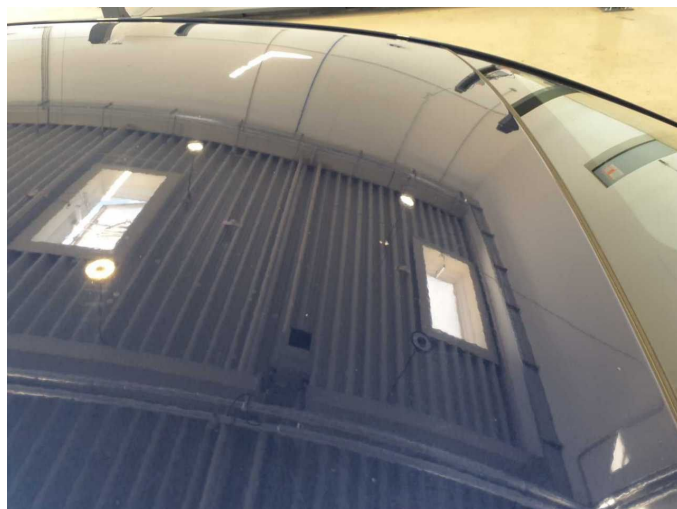
| No. | Component group | Description |
|---|---|---|
| 13 | Roof | Roof (+Anätzung) - Dent / paintcoat damage - Repair and paint |

**Damage 13:** Roof: Roof (+Anätzung) - Dent / paintcoat damage - Repair and paint

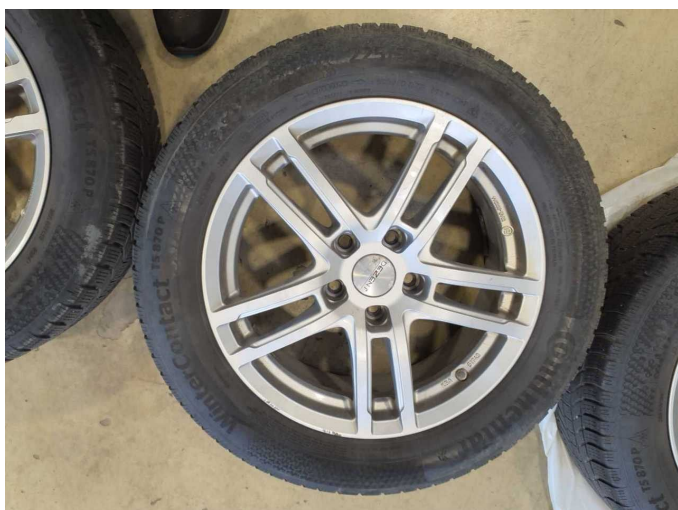
| No. | Component group | Description |
|---|---|---|
| 1 | 2nd wheel set | 1 alloy rim - Scratch(es) - No deduction |

**Wear and tear 1:** 2nd wheel set: 1 alloy rim - Scratch(es) - No deduction

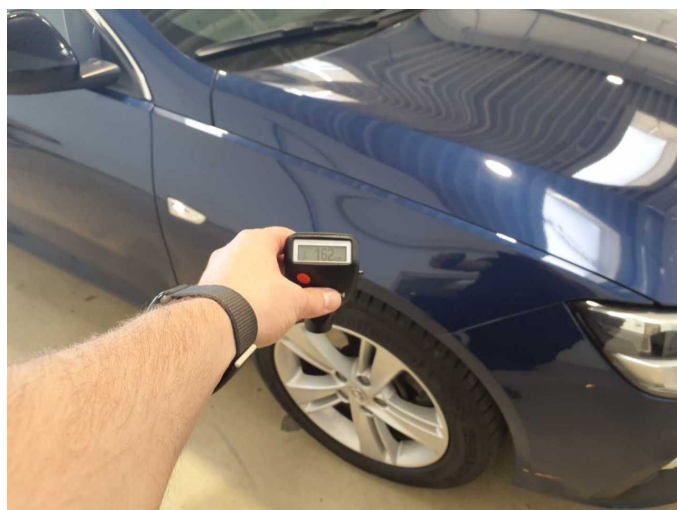
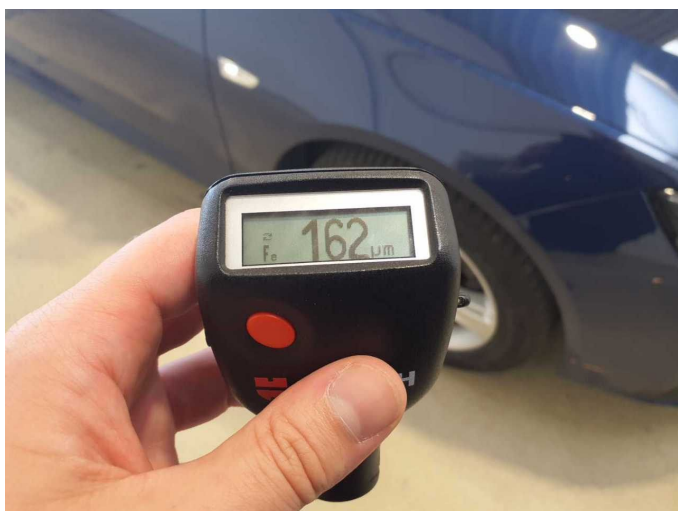
- 1 Mudguard - right side, Professionally carried out, Invoice of repair done Non-existent
- 2 Door - rear right side, Unprofessionally carried out, Invoice of repair done Non-existent

| Mudguard - right side | 162 µm | Door - rear right side | 163 µm |

**Repainting 1:** Mudguard - right side

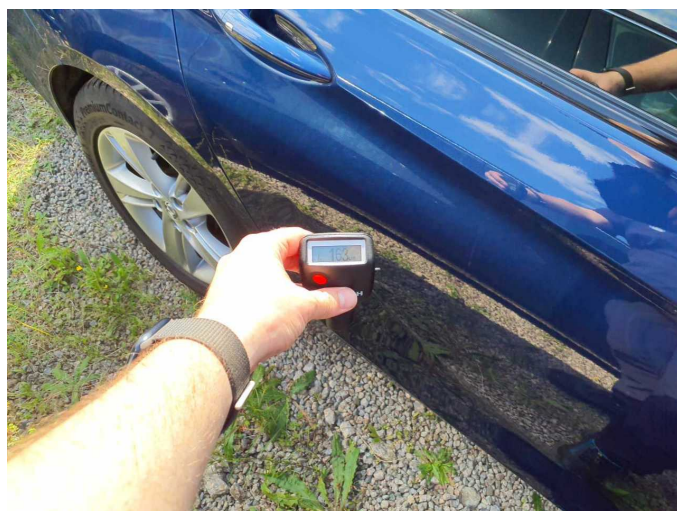
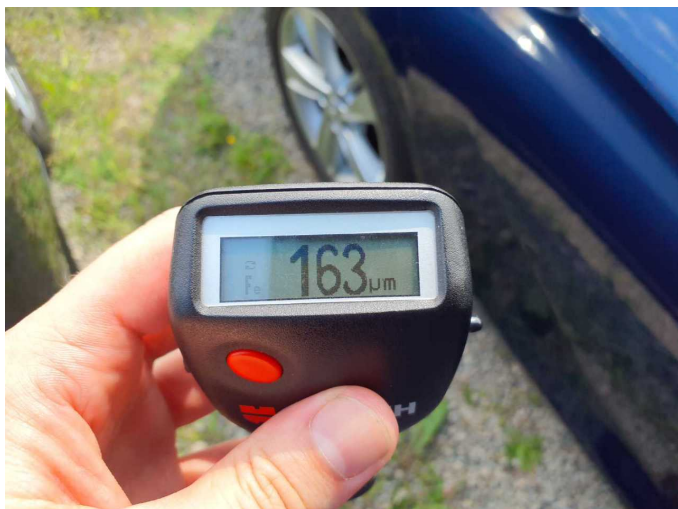
**Repainting 2:** Door - rear right side
