Expertise

Protocol number: 46689886  
Order No. / Reference: 26685131  
Inspection date: 22 Jul 2026

Manufacturer: Volkswagen

Model: Multivan 2,0 TDI SCR Kurz Edition

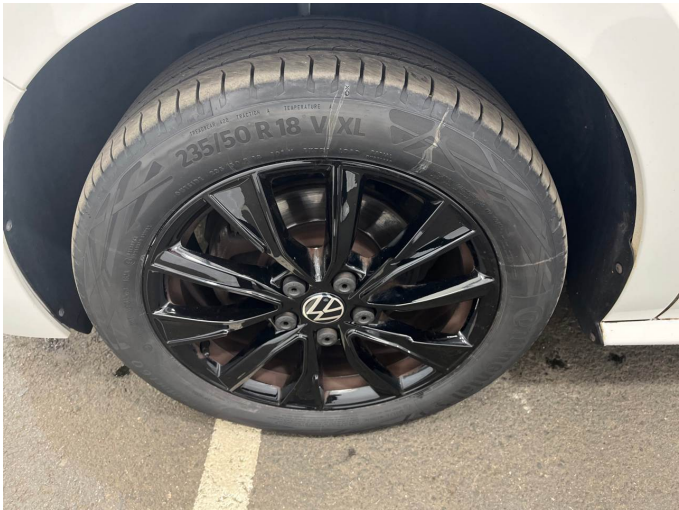
Figure 12: Mounted tyres

| # | Tyre size | Type of tyre | Manufacturer | Tread depth |
|---|---|---|---|---|
| 1) | 235/50 R18 101V | Summer tyres on Light alloy | Continental | 5mm / 5mm |
| 2) | 235/50 R18 101H | Summer tyres on Light alloy | Hankook | 6mm / 6mm |

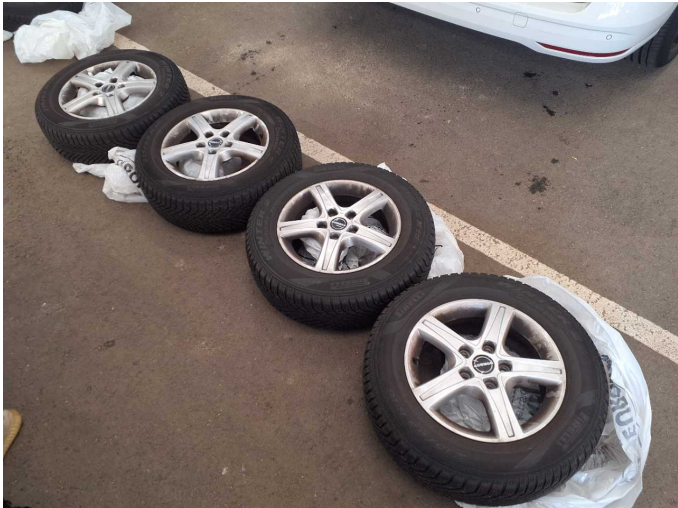
Figure 16: Additional tyres

| # | Tyre size | Type of tyre | Manufacturer | Tread depth |
|---|---|---|---|---|
| 1) | 215/65 R16 102H | Winter tyres on Light alloy | Pirelli | 6mm / 6mm |
| 2) | 215/65 R16 102H | Winter tyres on Light alloy | Pirelli | 6mm / 6mm |

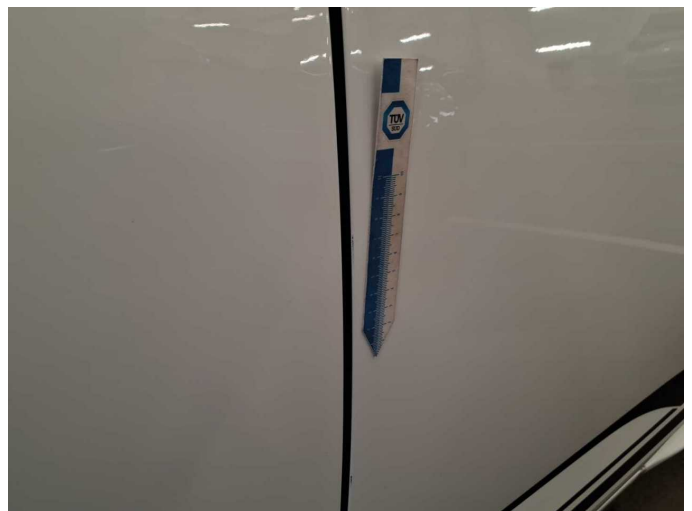
| No. | Component group | Description |
|---|---|---|
| 1 | Door - front right side | Door edge - Scratch(es) - Smart repair |

**Damage 1:** Door - front right side: Door edge - Scratch(es) - Smart repair

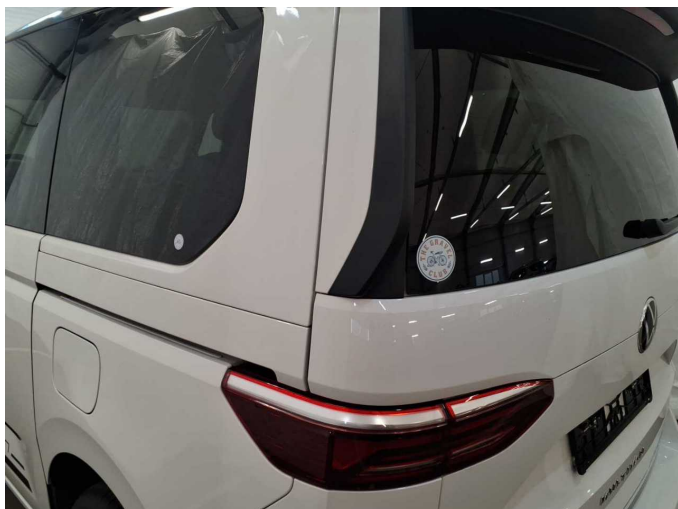
| No. | Component group | Description |
|---|---|---|
| 2 | Body | Body - Glued / labelled - De-glue / neutralise |

**Damage 2:** Body: Body - Glued / labelled - De-glue / neutralise

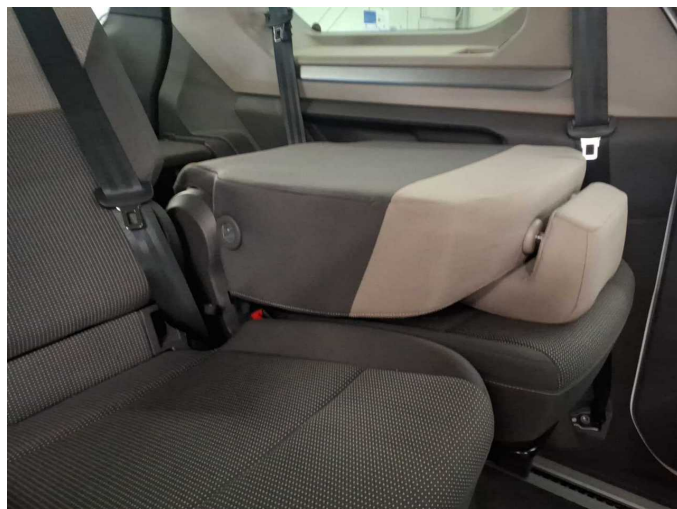
| No. | Component group | Description |
|---|---|---|
| 3 | Seat - rear | Back seat (Sitzverstellung hinten Links klemmt) - Functional / admissibility - Perform diagnosis |

**Damage 3:** Seat - rear: Back seat (Sitzverstellung hinten Links klemmt) - Functional / admissibility - Perform diagnosis

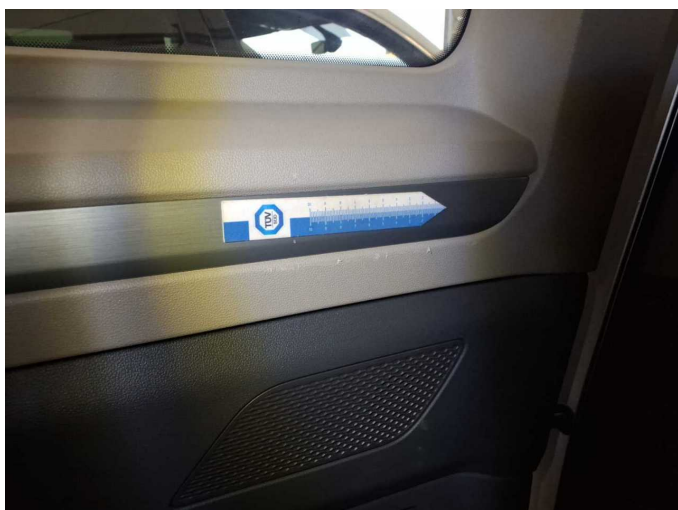
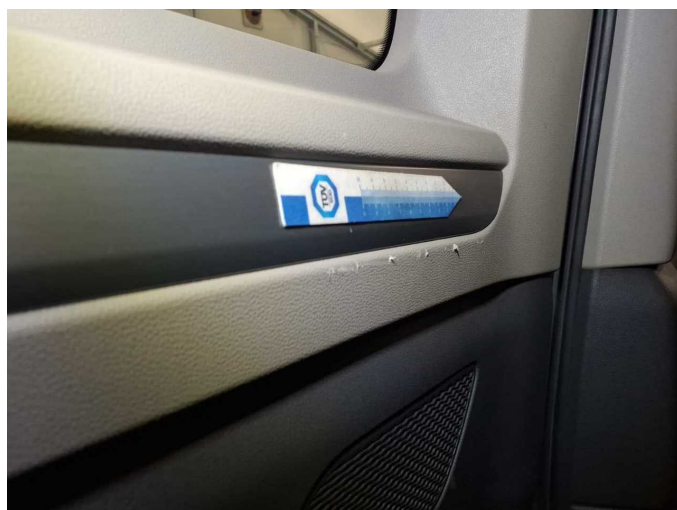
| No. | Component group | Description |
|---|---|---|
| 4 | Trim / covers | Door trim - rear left side - Scratch(es) - Loss in value |

**Damage 4:** Trim / covers: Door trim - rear left side - Scratch(es) - Loss in value

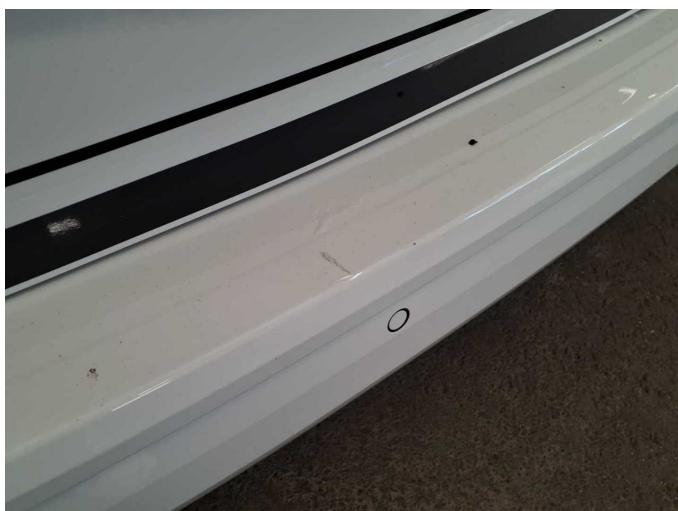
| No. | Component group | Description |
|---|---|---|
| 1 | Rear bumper | Rear bumper - Scratch(es) - No deduction |

**Wear and tear 1:** Rear bumper: Rear bumper - Scratch(es) - No deduction

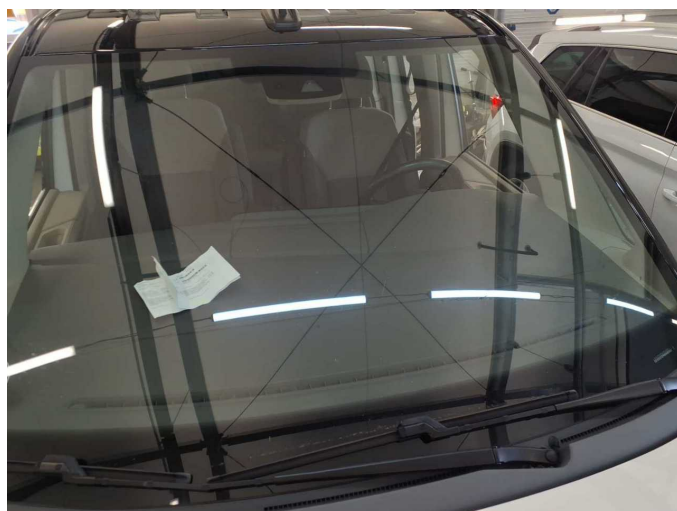
| No. | Component group | Description |
|---|---|---|
| 2 | Vehicle glazing | Windscreen - Stone chips - No deduction |

**Wear and tear 2:** Vehicle glazing: Windscreen - Stone chips - No deduction

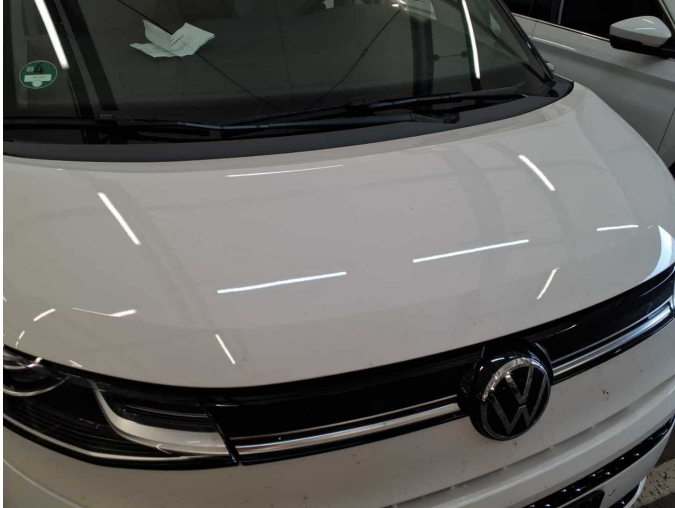
| No. | Component group | Description |
|---|---|---|
| 3 | Bonnet | Bonnet - Stone chips - No deduction |

**Wear and tear 3:** Bonnet: Bonnet - Stone chips - No deduction

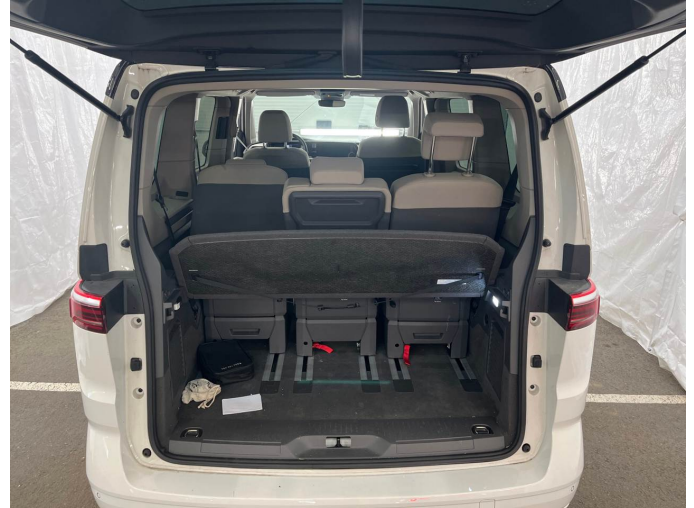
Interior - Luggage net

**Missing part 1:** Interior: Luggage net - Missing - Replace
