Expertise

Protocol number: 46896234  
Order No. / Reference: 26498107  
Inspection date: 3 Aug 2026

Manufacturer: Audi  
VIN: WAUZZZGY8RA103670

Model: A3 30 TDI Limousine S tronic

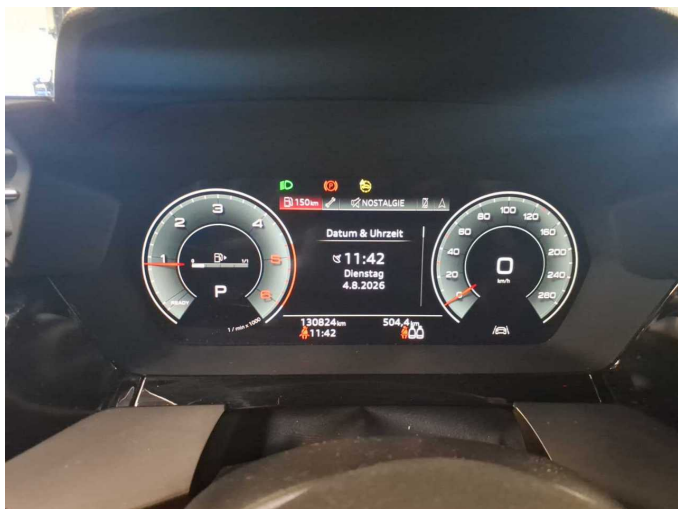
| Vehicle details | |
|---|---|
| Mileage (Read) | 130,824 km |

Figure 7: Instrument cluster

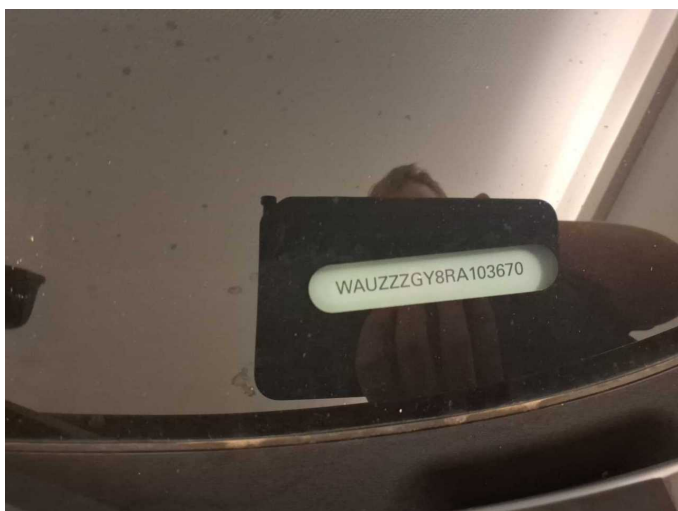
Figure 11: VIN

| VIN comparison | The vehicle identification number (VIN) was read from the vehicle and its conformity with the submitted documents was confirmed by the undersigned during the inspection. |

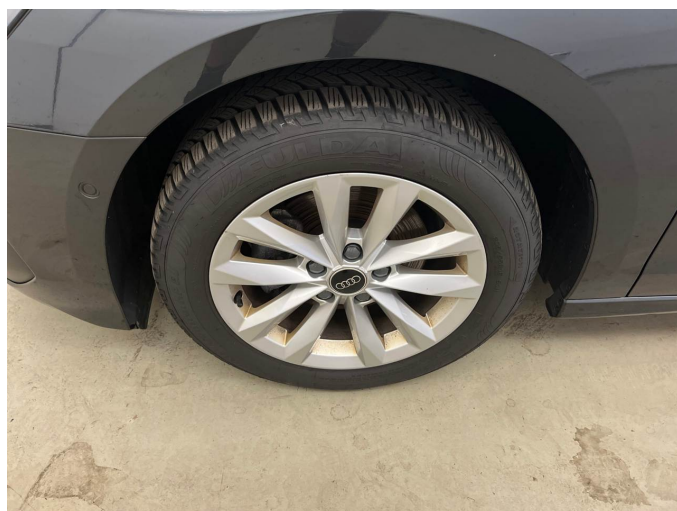
Figure 12: Mounted tyres

| # | Tyre size | Type of tyre | Manufacturer | Tread depth |
|---|---|---|---|---|
| 1) | 205/55 R16 91H | Winter tyres on Light alloy | Fulda | 6mm / 6mm |
| 2) | 205/55 R16 91H | Winter tyres on Light alloy | Fulda | 7mm / 7mm |

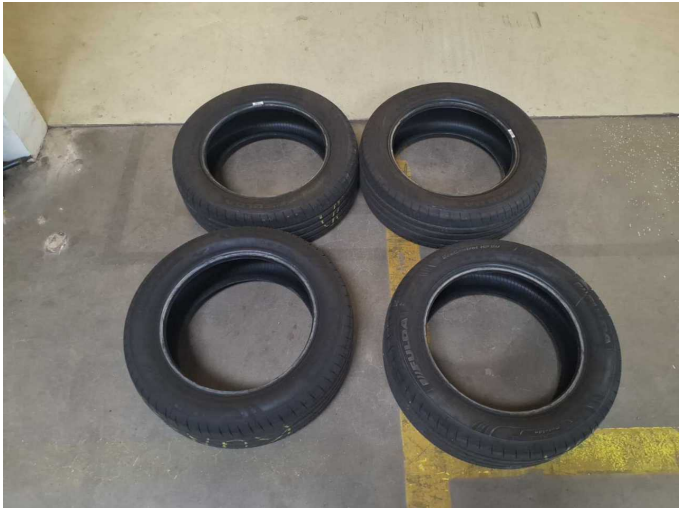
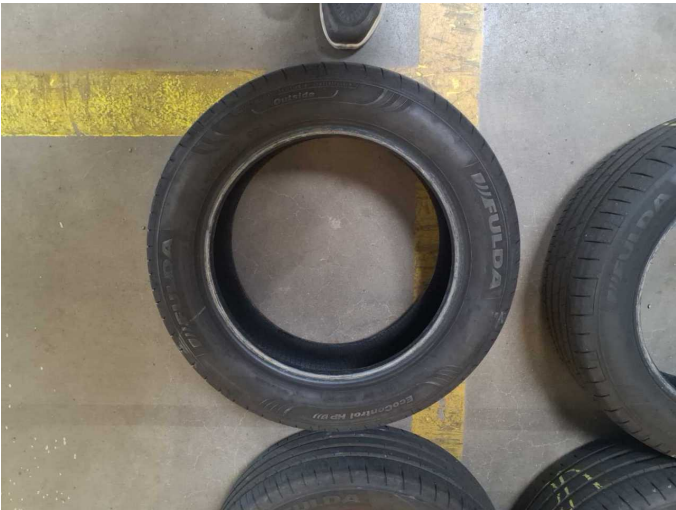
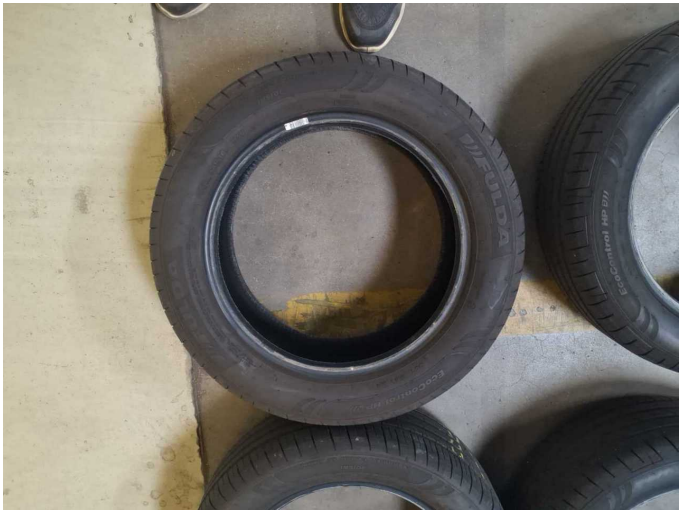
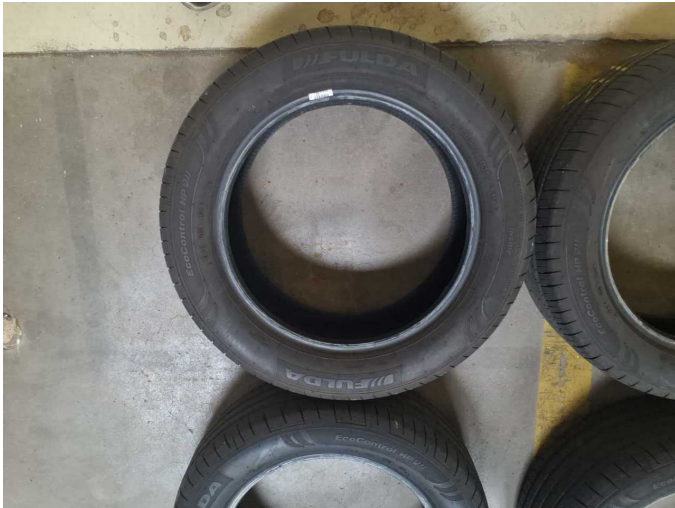
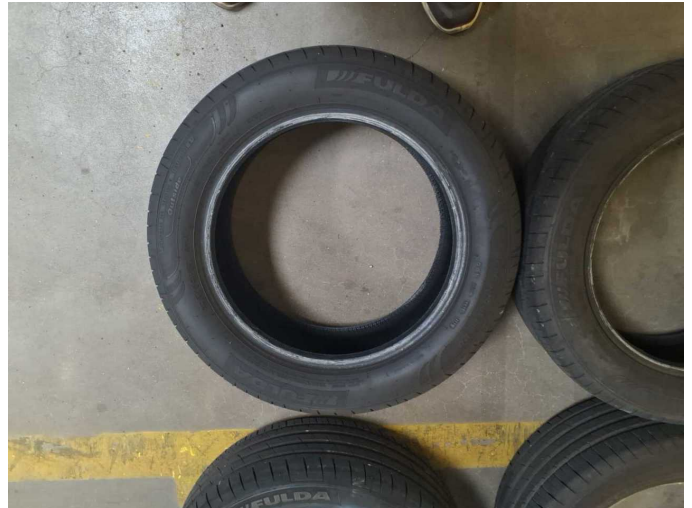
| # | Tyre size | Type of tyre | Manufacturer | Tread depth |
|---|---|---|---|---|
| 1) | 205/55 R16 91V | Summer tyres (Without wheel rim) | Fulda | 7mm / 7mm |
| 2) | 205/55 R16 91V | Summer tyres (Without wheel rim) | Fulda | 7mm / 7mm |

Figure 16: Additional tyres

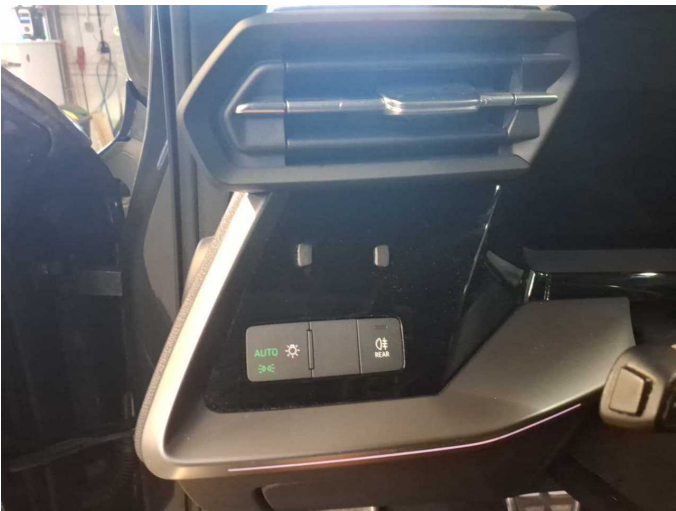
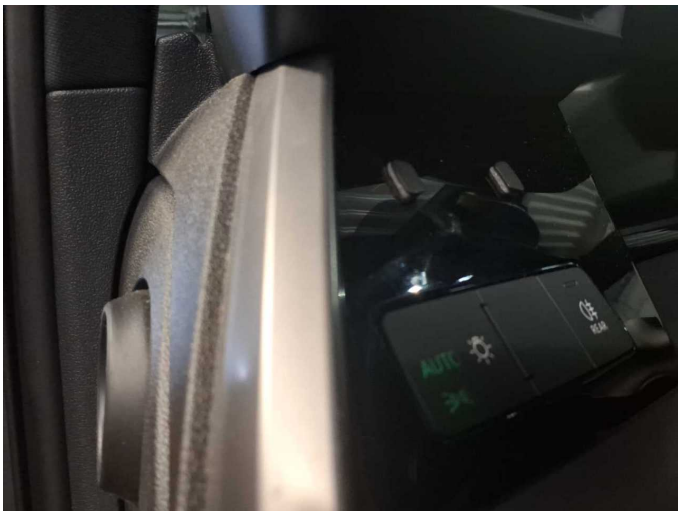
| No. | Component group | Description |
|---|---|---|
| 1 | Interior | Interior (Zierleiste) - Glued / labelled - De-glue / neutralise |

Damage 1: Interior: Interior (Zierleiste) - Glued / labelled - De-glue / neutralise

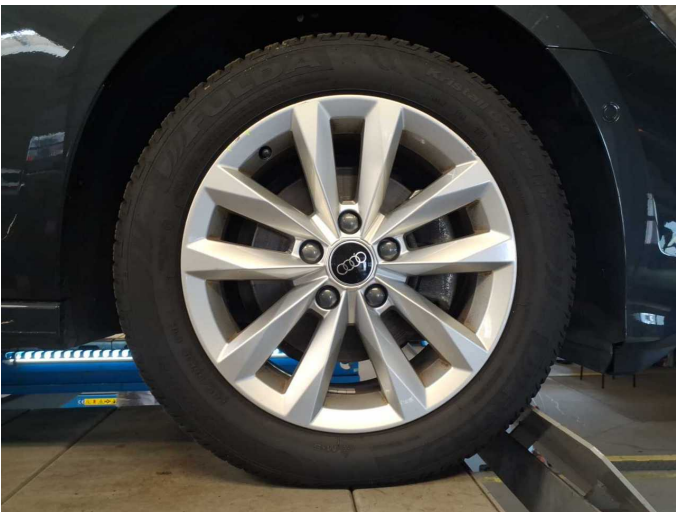
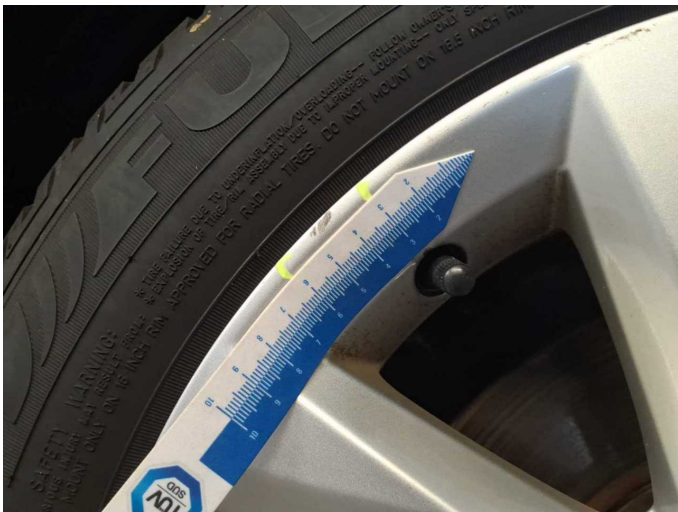
| No. | Component group | Description |
|---|---|---|
| 2 | Wheel / tyres | Alloy rim - front right side - Scratch(es) - Smart repair |

Damage 2: Wheel / tyres: Alloy rim - front right side - Scratch(es) - Smart repair

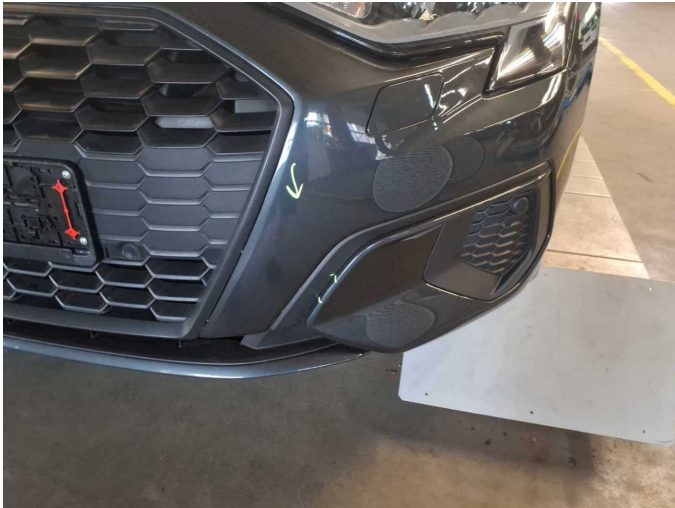
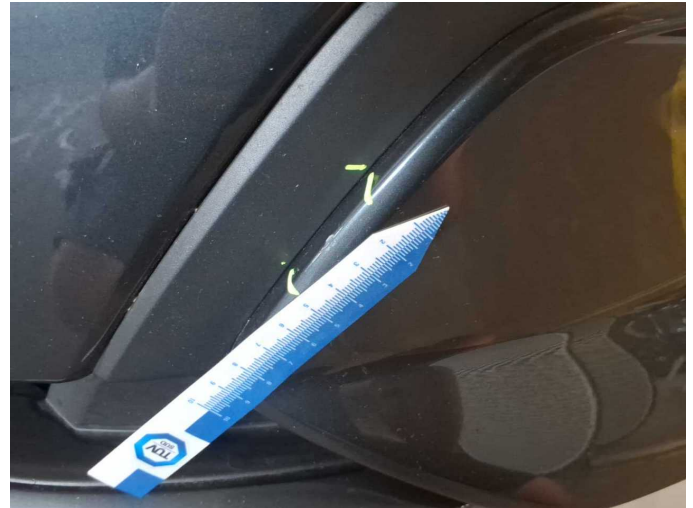
| No. | Component group | Description |
|---|---|---|
| 3 | Front bumper | Cover bumper - front - Stone chips - Smart repair |

**Damage 3:** Front bumper: Cover bumper - front - Stone chips - Smart repair

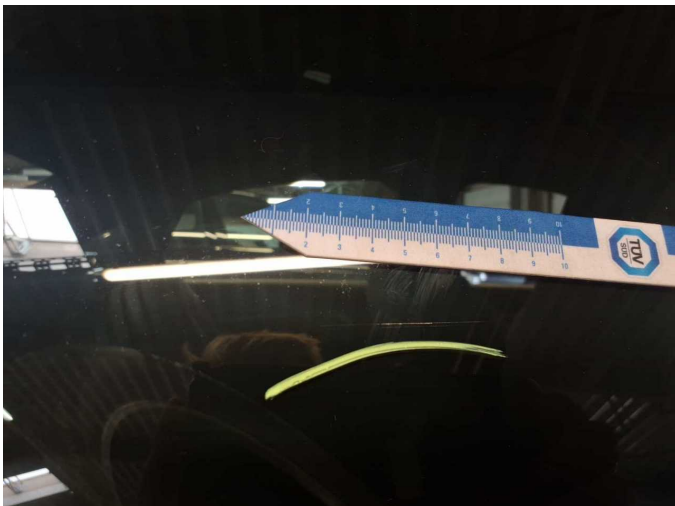
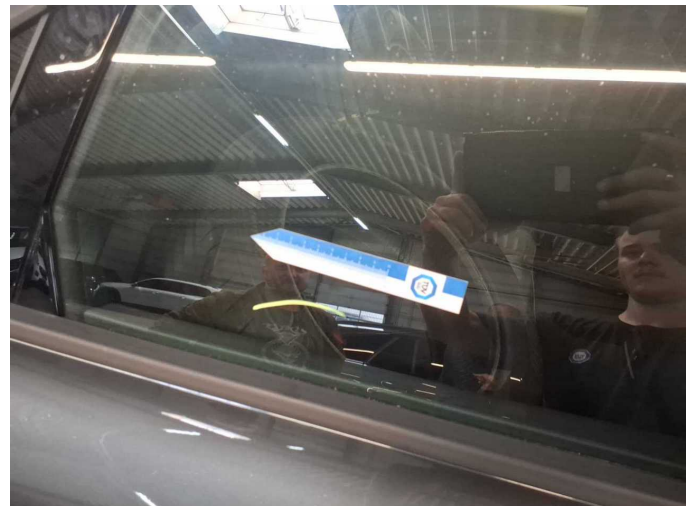
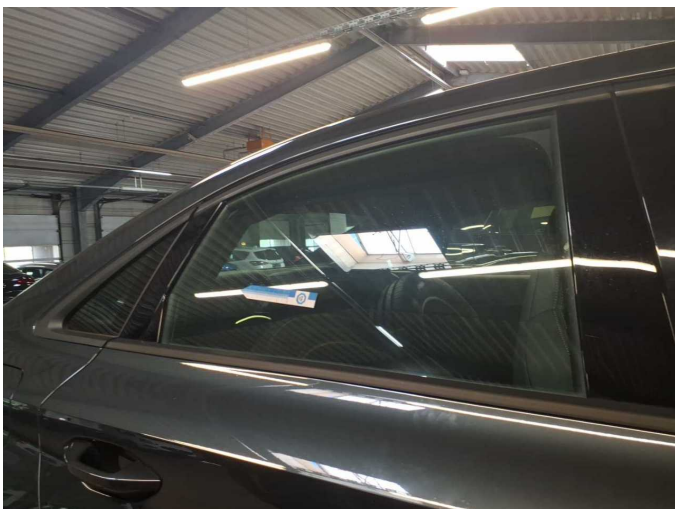
| No. | Component group | Description |
|---|---|---|
| 4 | Vehicle glazing | Side window - rear right side - Scratch(es) - Loss in value |

**Damage 4:** Vehicle glazing: Side window - rear right side - Scratch(es) - Loss in value

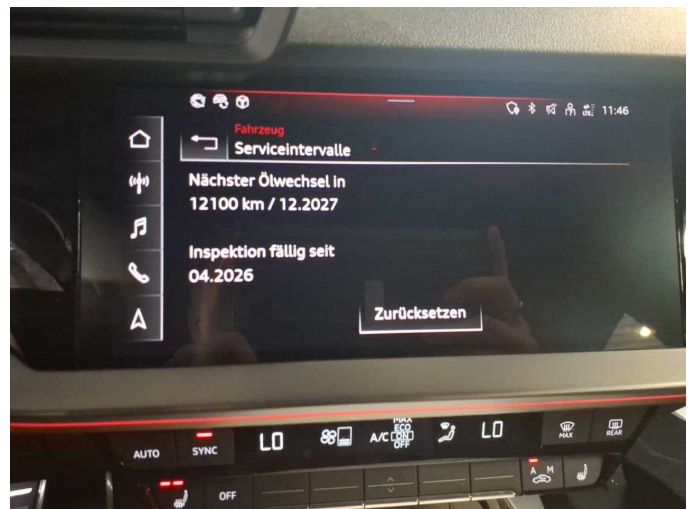
| No. | Component group | Description |
|---|---|---|
| 5 | Misc. | Inspection / maintenance - Due - Perform |

**Damage 5:** Misc.: Inspection / maintenance - Due - Perform

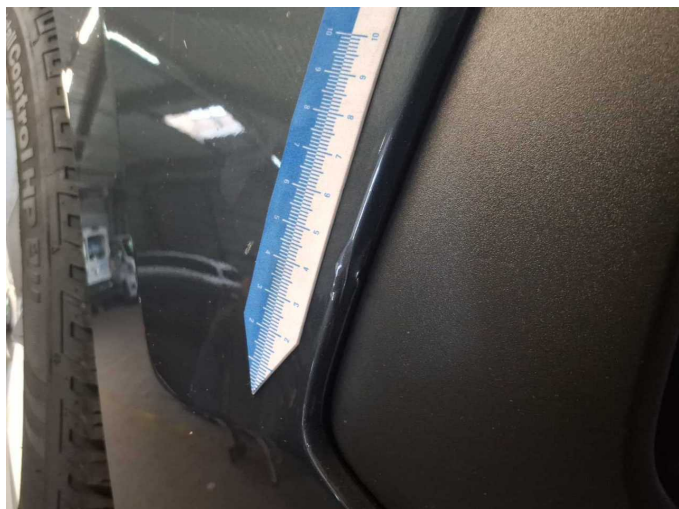
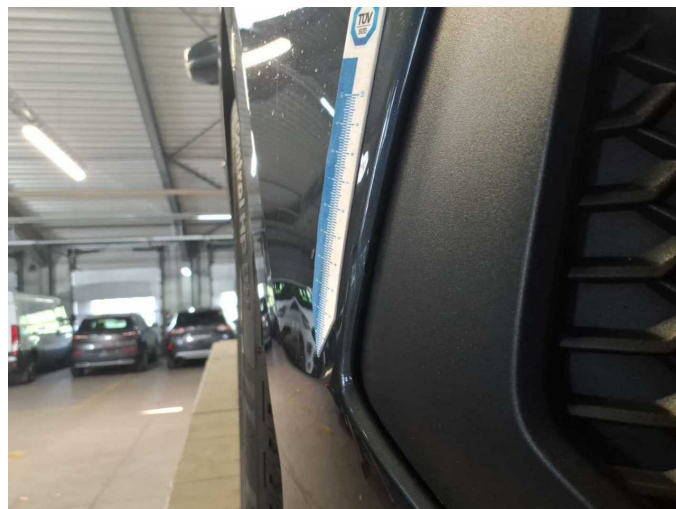
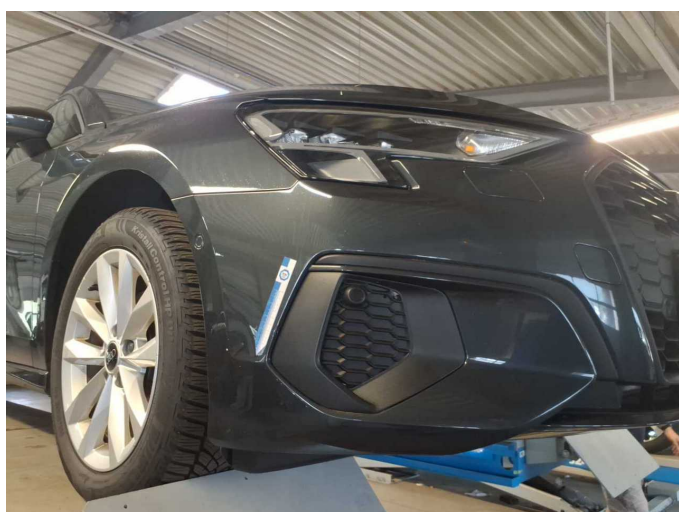
| No. | Component group | Description |
|---|---|---|
| 6 | Front bumper | Front bumper - Paint defect - Paint |

**Damage 6:** Front bumper: Front bumper - Paint defect - Paint

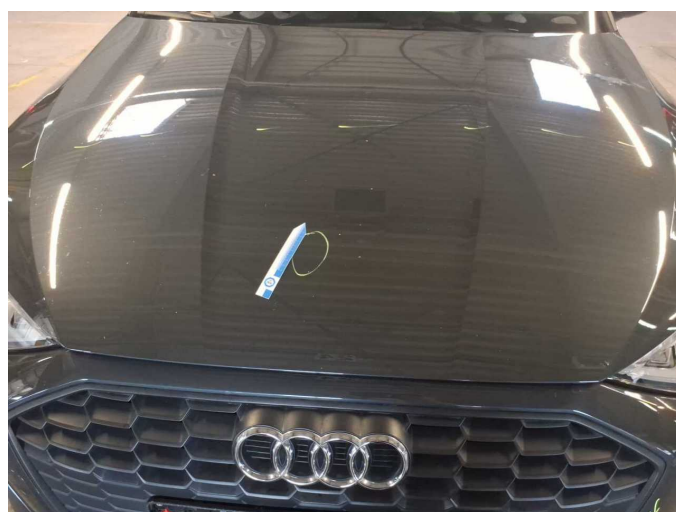
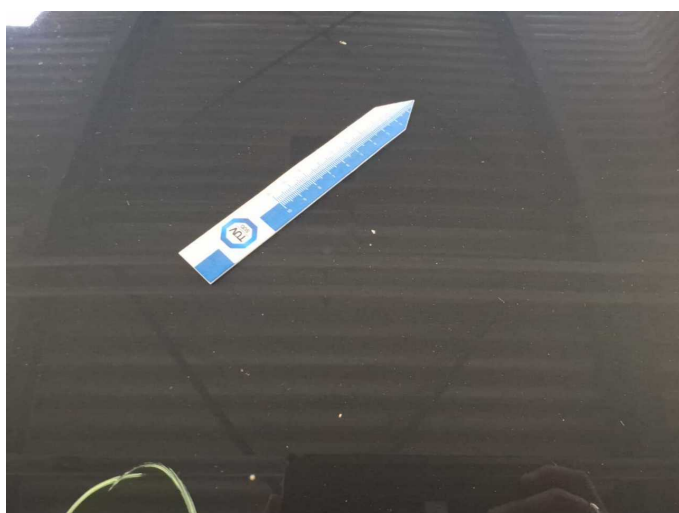
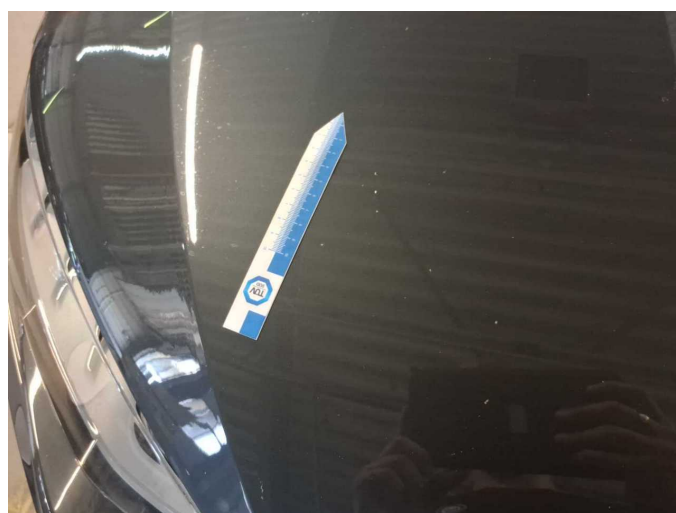
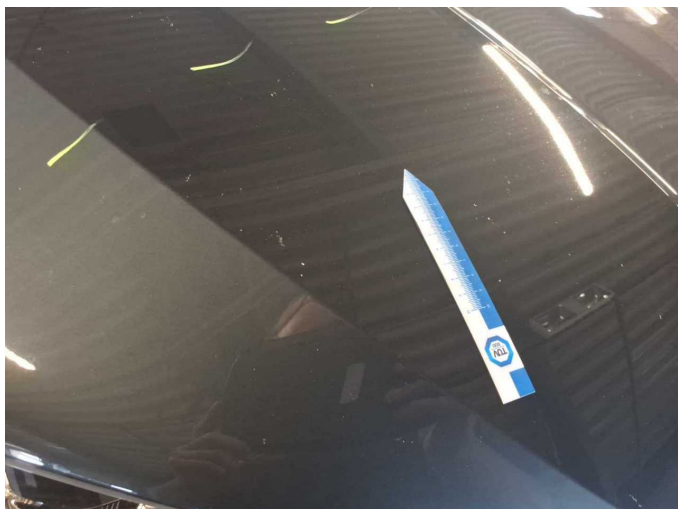
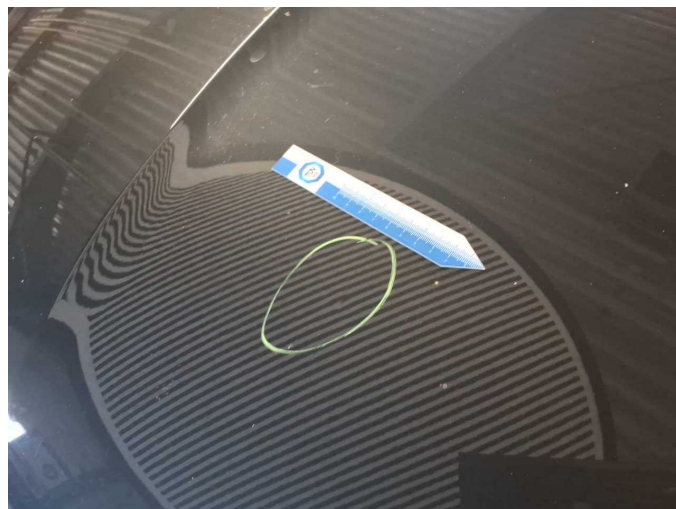
| No. | Component group | Description |
|---|---|---|
| 7 | Bonnet | Bonnet (Sandstrahleffekt) - Dent / paintcoat damage - Repair and paint |

**Damage 7:** Bonnet: Bonnet (Sandstrahleffekt) - Dent / paintcoat damage  
- Repair and paint

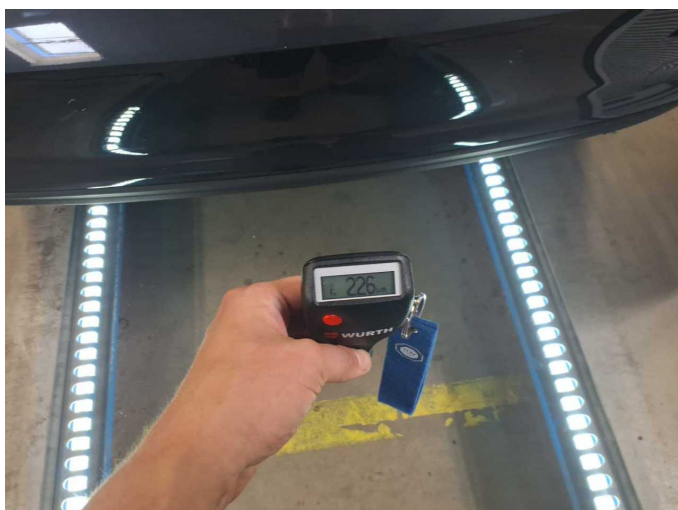
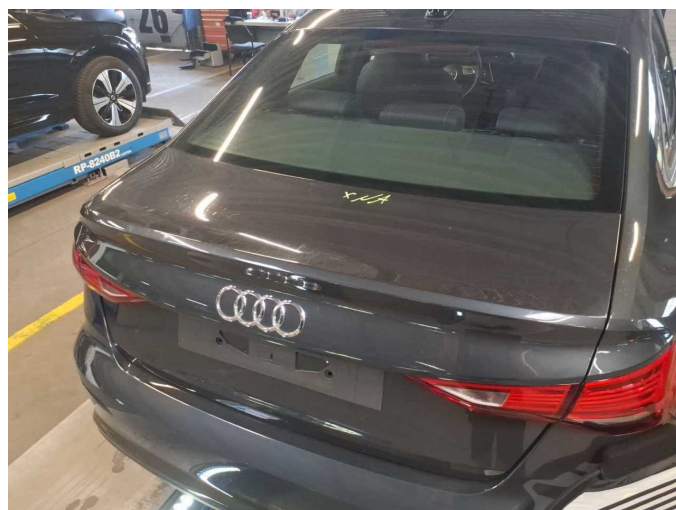
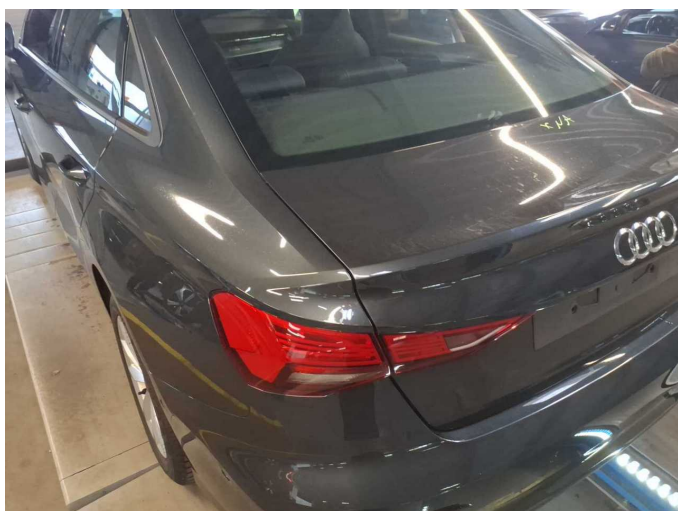
| No. | Repainting |
|---|---|
| 1 | Boot lid / rear door, Professionally carried out, Invoice of repair done Non-existent |

**Repainting 1:** Boot lid / rear door

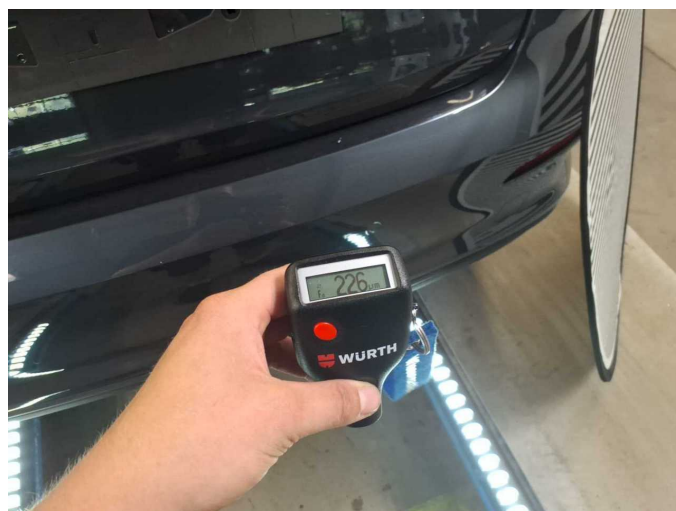
| Boot lid / rear door | 226 µm |

**Boot lid / rear door:** 226 µm
