Expertise

Protocol number: 46508674  
Order No. / Reference: 26545037  
Inspection date: 7 Jul 2026

Manufacturer: Ford

Model: Focus Turnier 1.5 EcoBlue Start-Stopp-System Aut.  
COOL&CONNECT

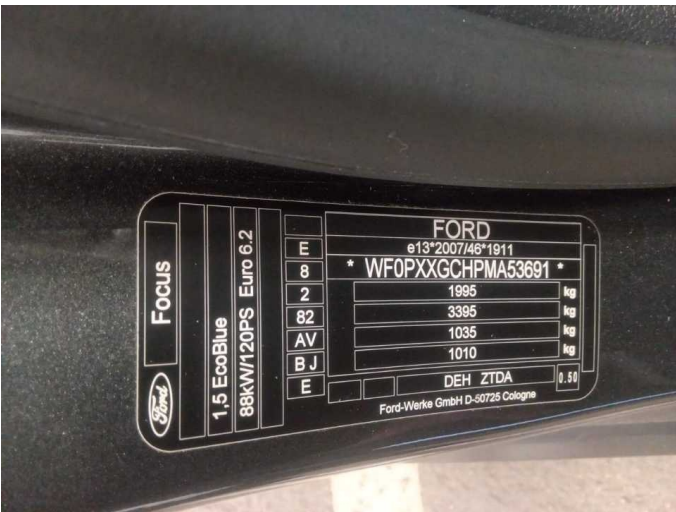
Figure 11: VIN

| VIN comparison | The vehicle identification number (VIN) was read from the vehicle and its conformity with the submitted documents was confirmed by the undersigned during the inspection. |

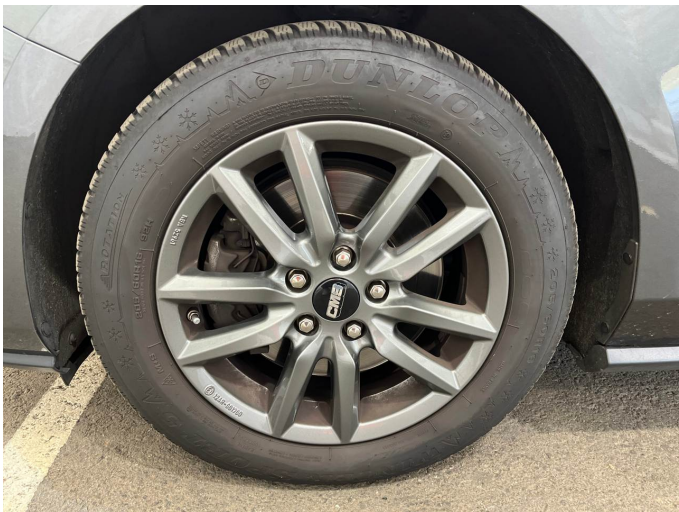
Figure 12: Mounted tyres

| Tyres | | | | |
|---|---|---|---|---|
| 1) | 205/60 R16 92H | Winter tyres on Light alloy | Dunlop | 5mm / 5mm |
| 2) | 205/60 R16 92H | Winter tyres on Light alloy | Dunlop | 7mm / 7mm |

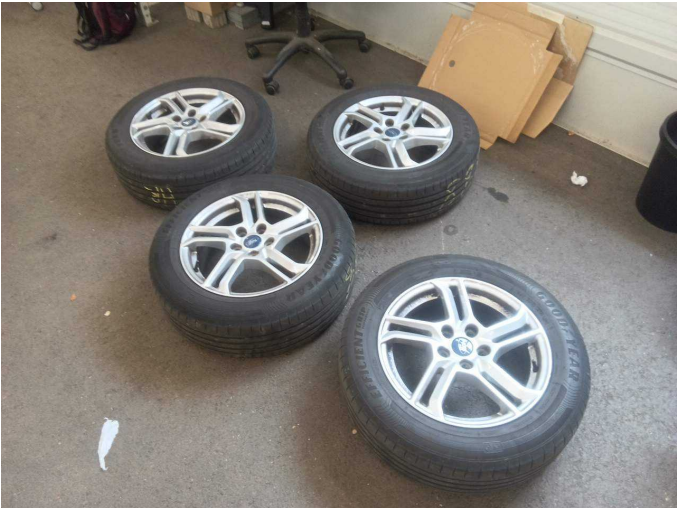
Figure 21: Additional tyres

| Tyres | | | | |
|---|---|---|---|---|
| 1) | 205/60 R16 92V | Summer tyres on Light alloy | Goodyear | 4mm / 4mm |
| 2) | 205/60 R16 92V | Summer tyres on Light alloy | Goodyear | 5mm / 5mm |

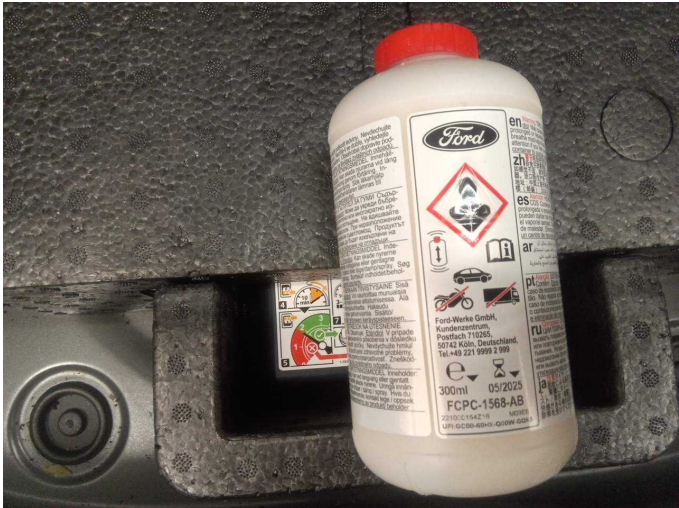
| No. | Component group | Description |
|---|---|---|
| 1 | Equipment | Tirefit filler - Expired - Replace |

Damage 1: Equipment: Tirefit filler - Expired - Replace

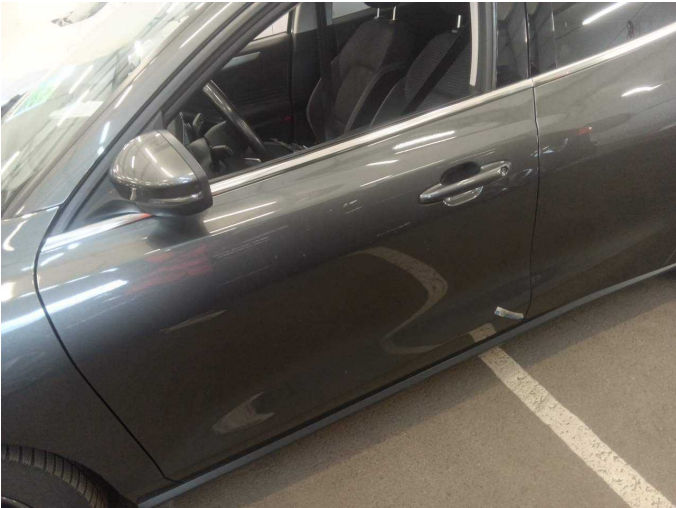
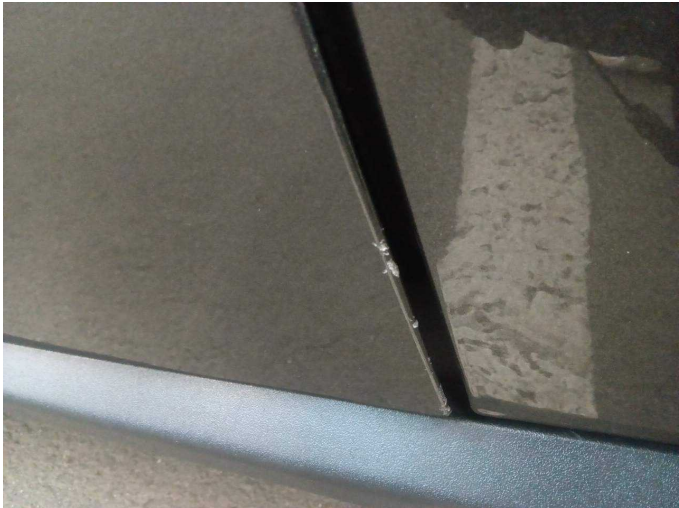
| No. | Component group | Description |
|---|---|---|
| 2 | Door - front left side | Door edge - Scratched - Smart repair |

Damage 2: Door - front left side: Door edge - Scratched - Smart repair

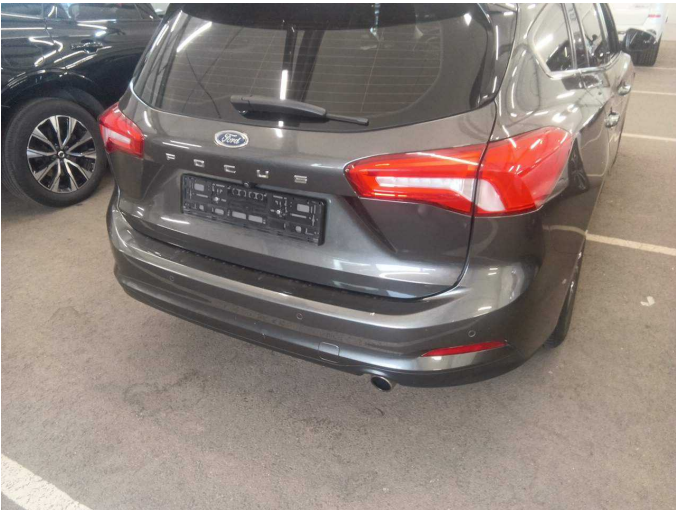
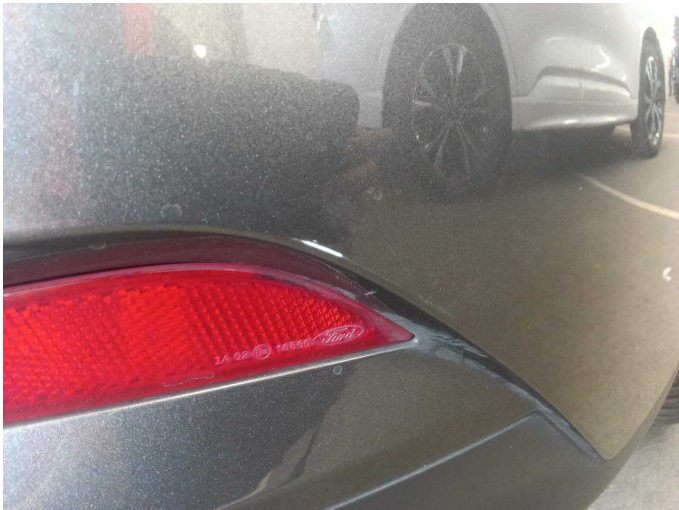
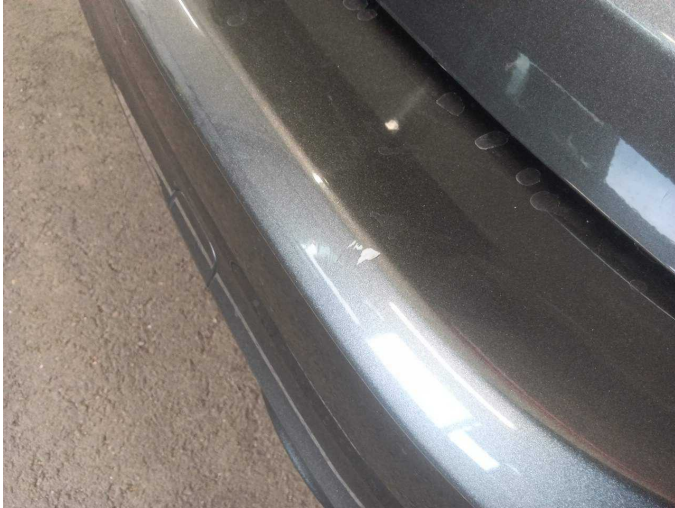
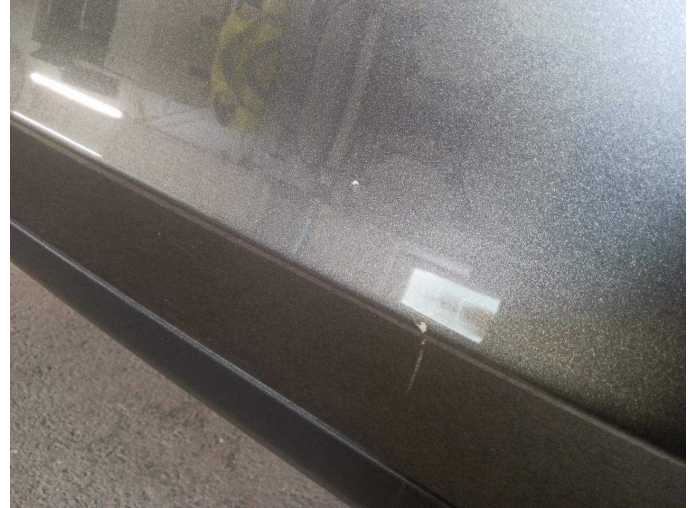
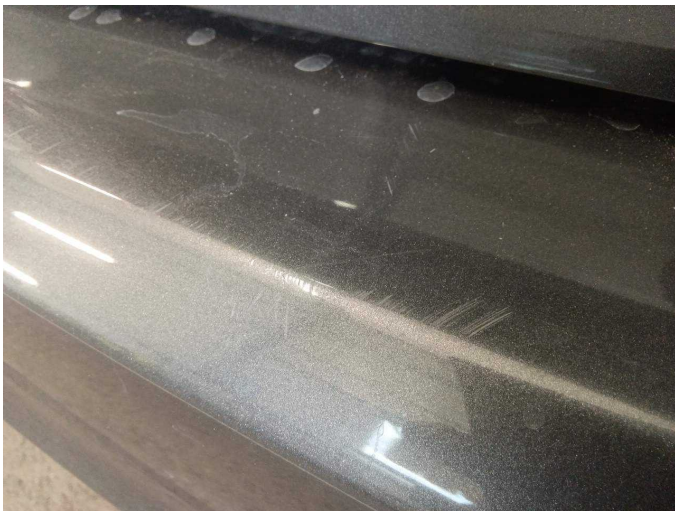
| No. | Component group | Description |
|---|---|---|
| 3 | Rear bumper | Rear bumper - Scratch(es) - Paint |

Damage 3: Rear bumper: Rear bumper - Scratch(es) - Paint

**Damage 3:** Rear bumper: Rear bumper - Scratch(es) - Paint
