Expertise

Protocol number: 46480104  
Order No. / Reference: 26617504  
Inspection date: 10 Jul 2026

Manufacturer: Ford

Model: Mustang Mach-E

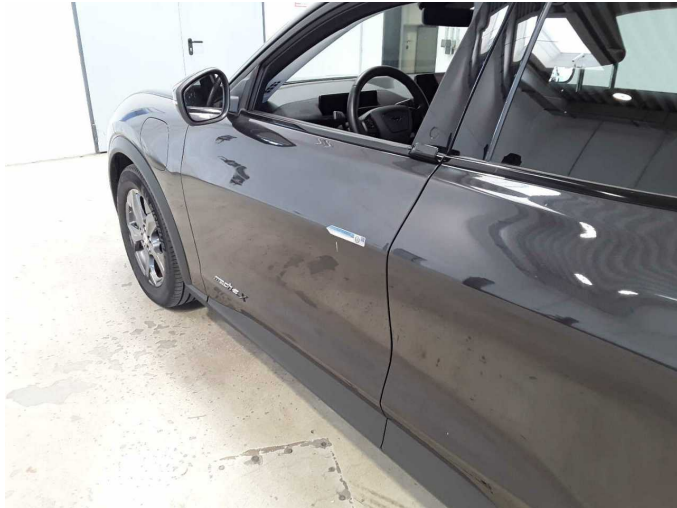
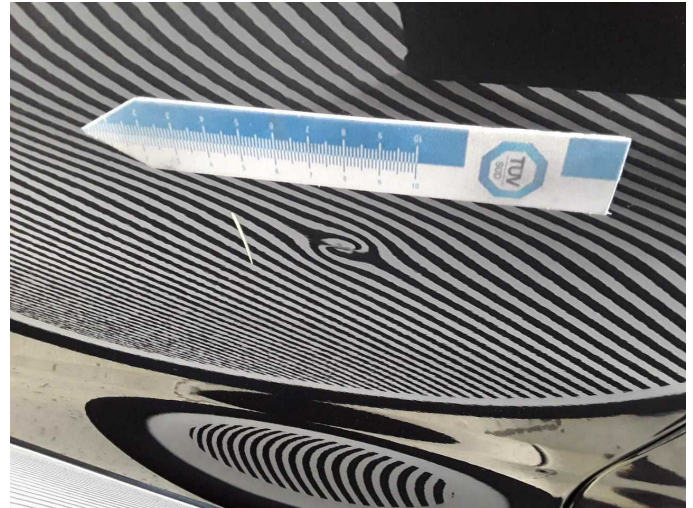
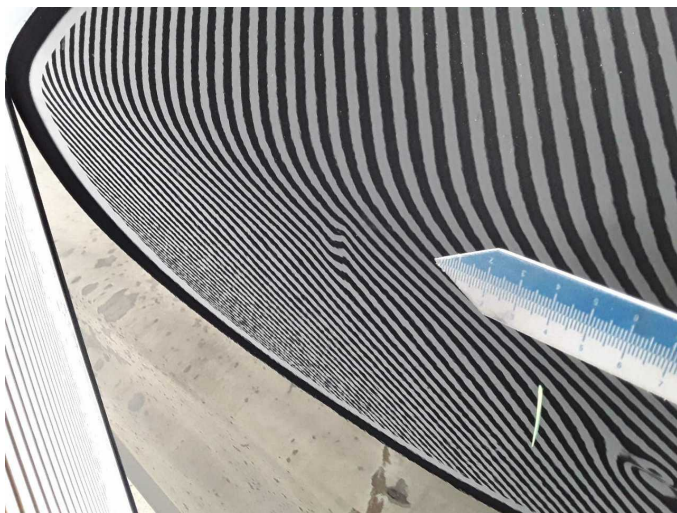
| No. | Component group | Description |
|---|---|---|
| 3 | Door - front left side | Door - dent(s) - Smart repair |

**Damage 3:** Door - front left side: Door - dent(s) - Smart repair

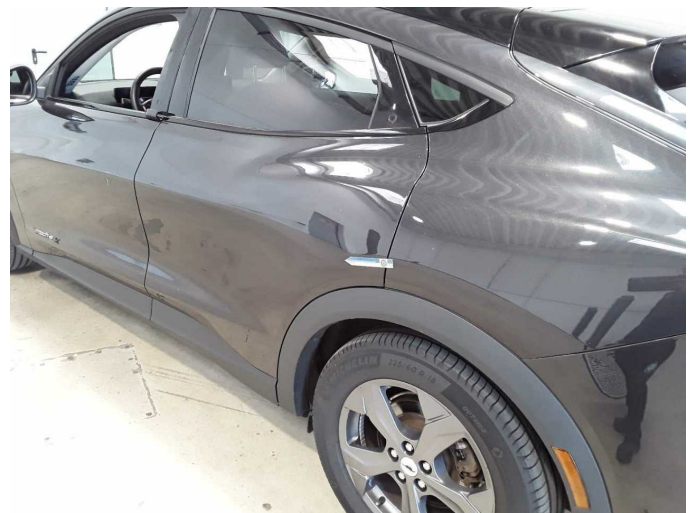
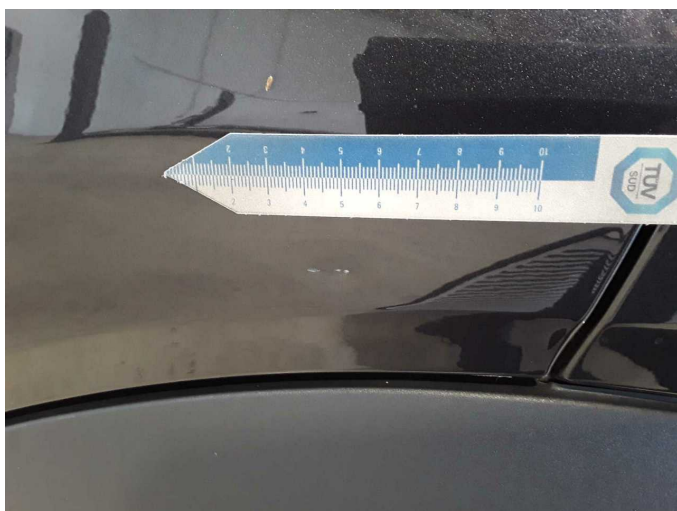
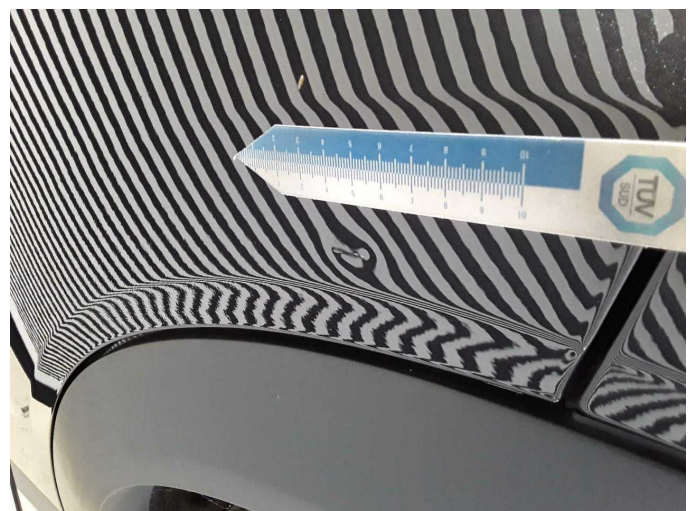
| No. | Component group | Description |
|---|---|---|
| 4 | Door - rear left side | Door - Dent / paintcoat damage - Smart repair |

**Damage 4:** Door - rear left side: Door - Dent / paintcoat damage - Smart repair

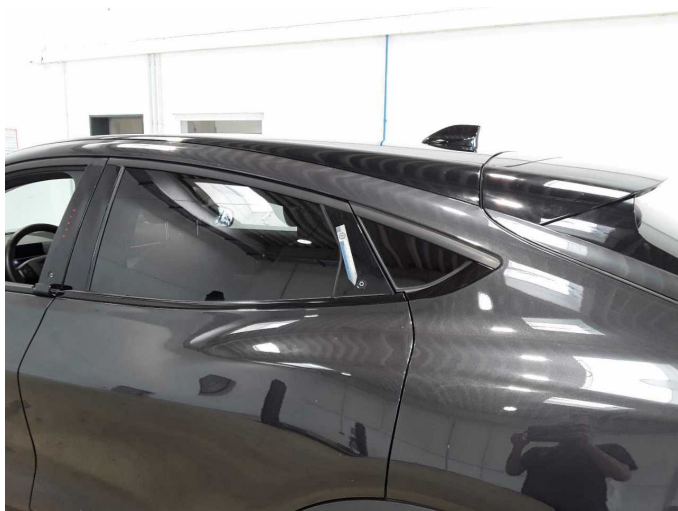
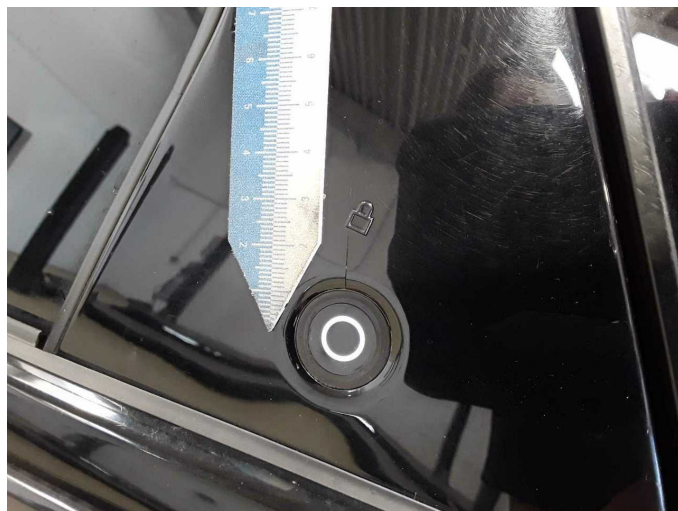
| No. | Component group | Description |
|---|---|---|
| 5 | Door - rear left side | Door handle - outside - Broken / torn - Replace |

**Damage 5:** Door - rear left side: Door handle - outside - Broken / torn - Replace

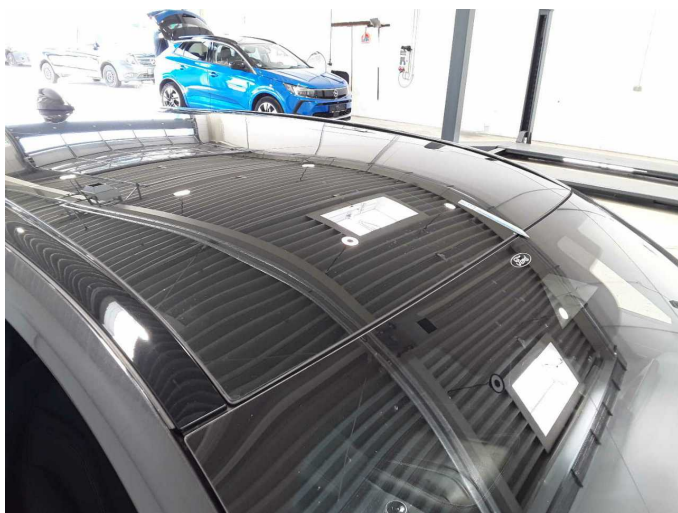
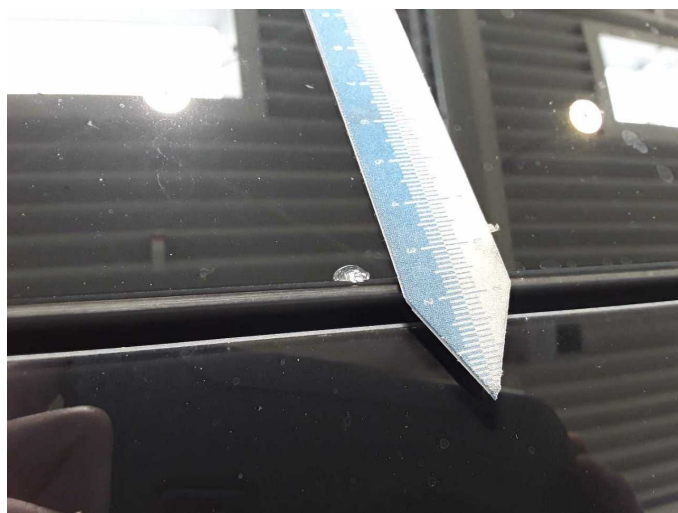
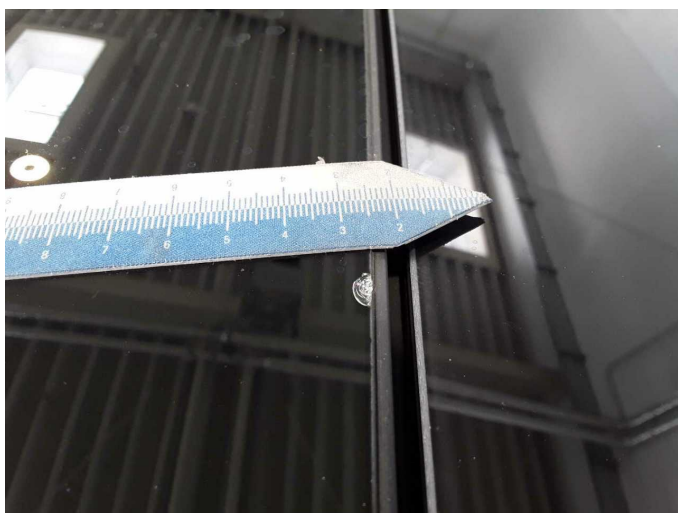
| No. | Component group | Description |
|---|---|---|
| 6 | Roof | Sun roof / glass - Stone chips - repair according to calculation |

**Damage 6:** Roof: Sun roof / glass - Stone chips - repair according to calculation
