## Expertise

Protocol number: 45969738  
Order No. / Reference: 26511083  
Inspection date: 16 Jun 2026

Manufacturer: Peugeot

Model: 5008 BlueHDi 130 EAT8 Allure Pack

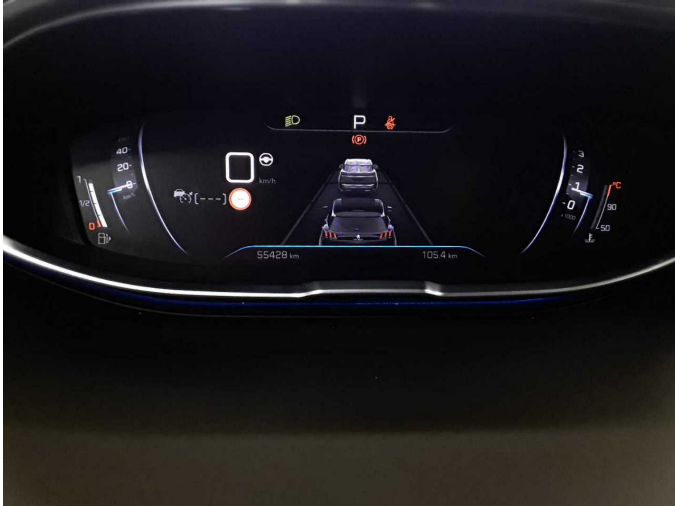
Figure 7: Instrument cluster

**Mileage (Read)** 55,428 km

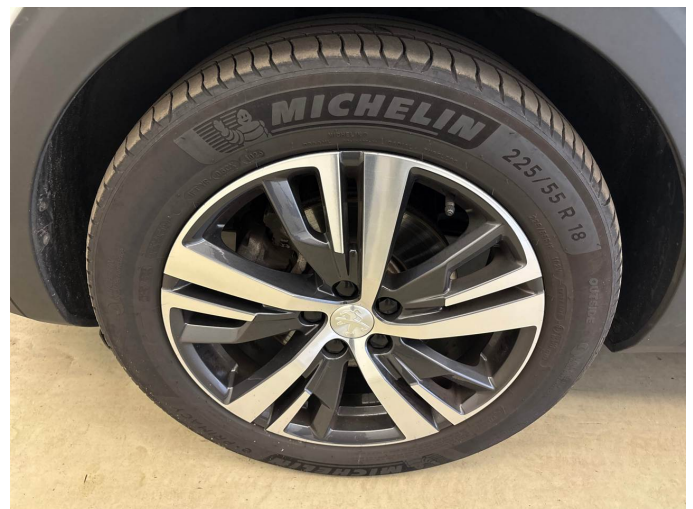
Figure 12: Mounted tyres

Mounted tyres				
#	Tyre size	Type of tyre	Manufacturer	Tread depth
1)	225/55 R18 102V	Summer tyres on Light alloy	Michelin	5mm / 5mm
2)	225/55 R18 102V	Summer tyres on Light alloy	Michelin	5mm / 5mm
Replacement				
Typ	Tyre size	Type of tyre	Manufacturer	Tread depth
	Tirefit	Expiration date 12/2029

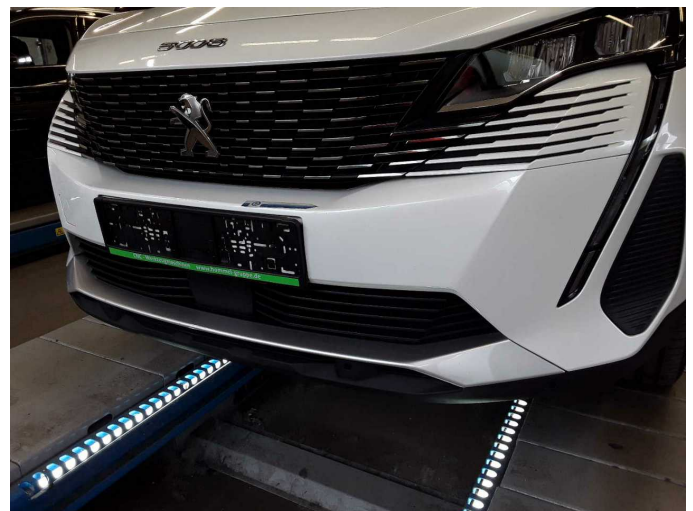
No.	Component group	Description
1	Front bumper	Front bumper - Stone chips - No deduction
2	Bonnet	Bonnet - Stone chips - No deduction
3	Vehicle glazing	Windscreen - Stone chips - No deduction

Wear and tear 1: Front bumper: Front bumper - Stone chips - No deduction

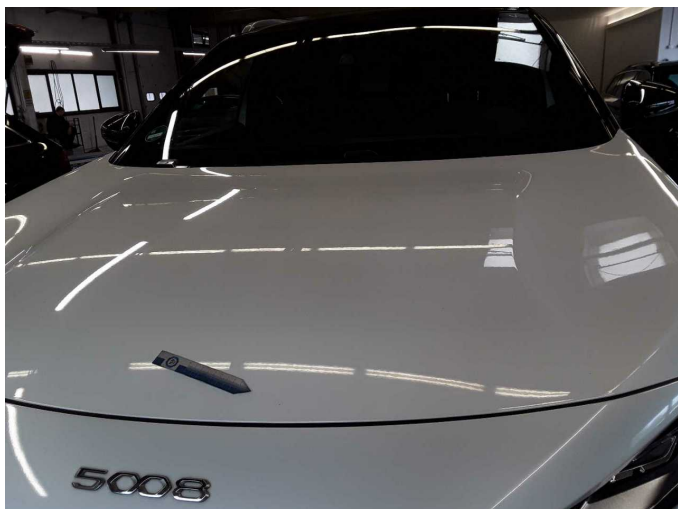
**Wear and tear 2:** Bonnet: Bonnet - Stone chips - No deduction

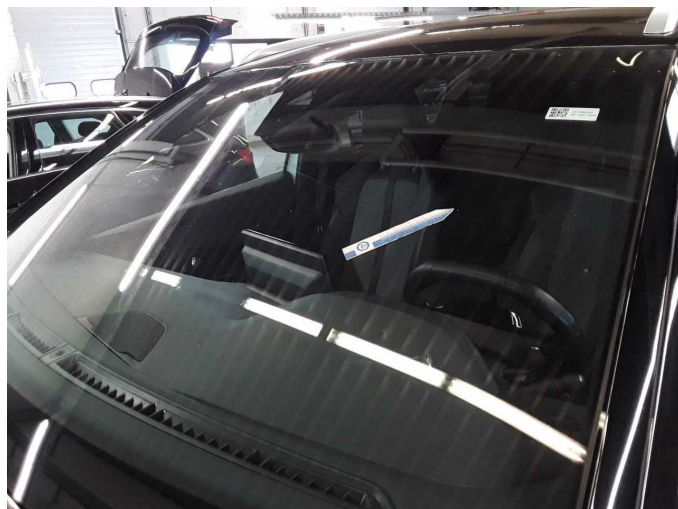
**Wear and tear 3:** Vehicle glazing: Windscreen - Stone chips - No deduction
