Expertise

Protocol number: 46594699  
Order No. / Reference: 26746881  
Inspection date: 20 Jul 2026

Model: XC60 T8 AWD Recharge Core

VIN: LYVUZH5V1PB315297

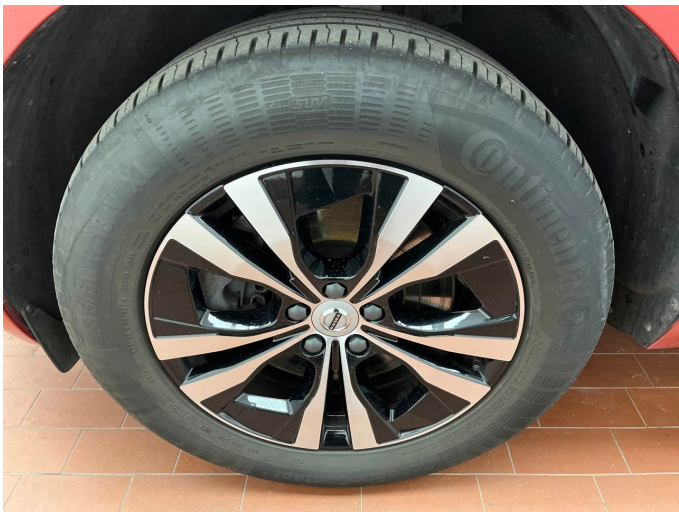
Figure 12: Mounted tyres

| # | Tyre size | Type of tyre | Manufacturer | Tread depth |
|---|---|---|---|---|
| 1) | 235/60 R18 107V | Summer tyres on Light alloy | Continental | 5mm / 5mm |
| 2) | 235/60 R18 107V | Summer tyres on Light alloy | Continental | 5mm / 5mm |

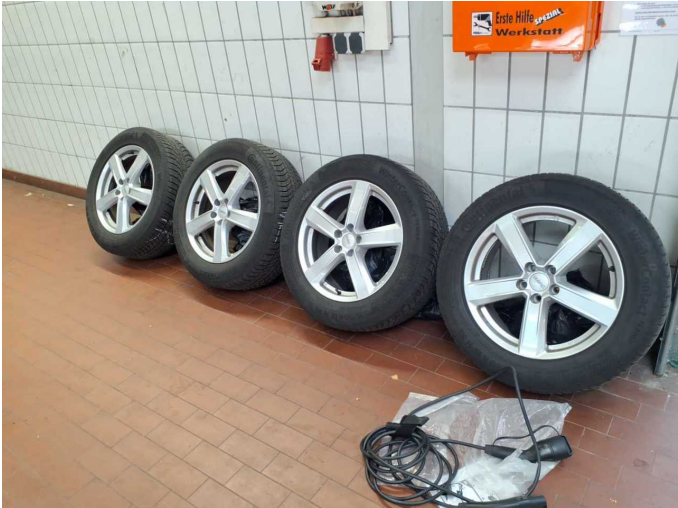
Figure 16: Additional tyres

| # | Tyre size | Type of tyre | Manufacturer | Tread depth |
|---|---|---|---|---|
| 1) | 235/60 R18 107H | Winter tyres on Light alloy | Continental | 4mm / 4mm |
| 2) | 235/60 R18 107H | Winter tyres on Light alloy | Continental | 6mm / 6mm |

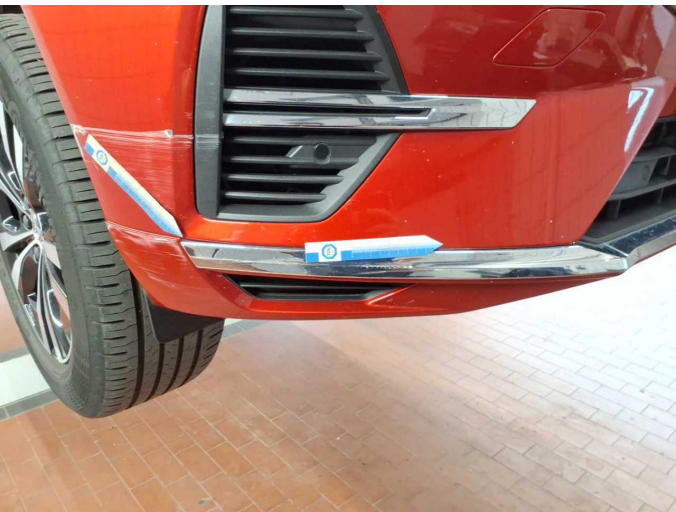
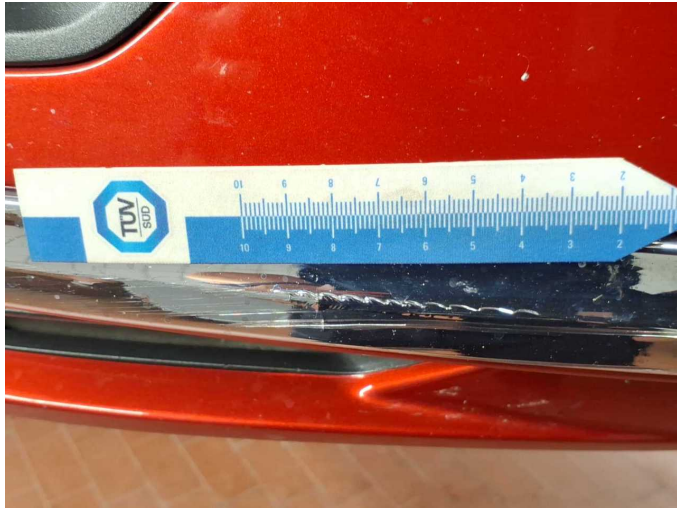
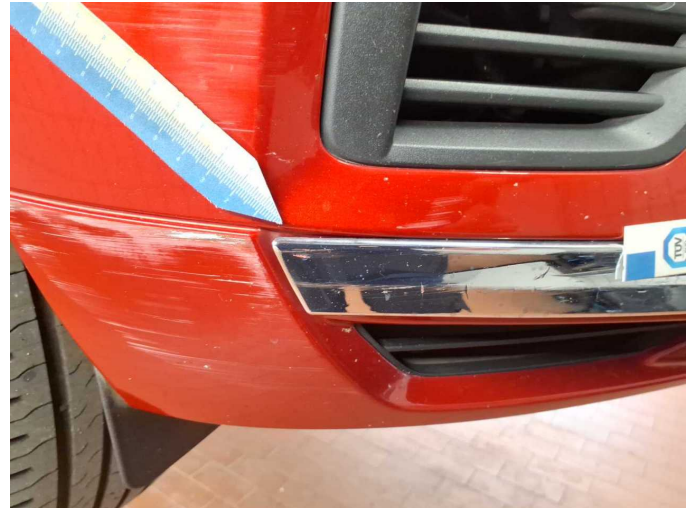
| No. | Component group | Description |
|---|---|---|
| 1 | Front bumper | Cover bumper - front (Rschts Chrom) - Scratched - Replace |

Damage 1: Front bumper: Cover bumper - front (Rschts Chrom) - Scratched - Replace

**Damage 1:** Front bumper: Cover bumper - front (Rschts Chrom) - Scratched - Replace

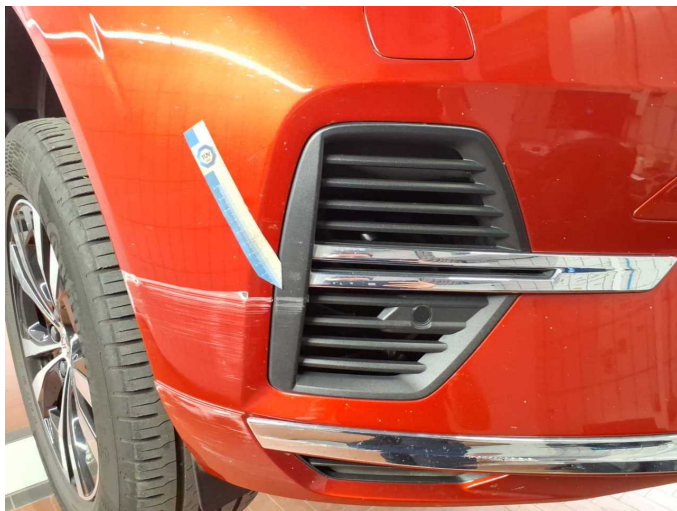
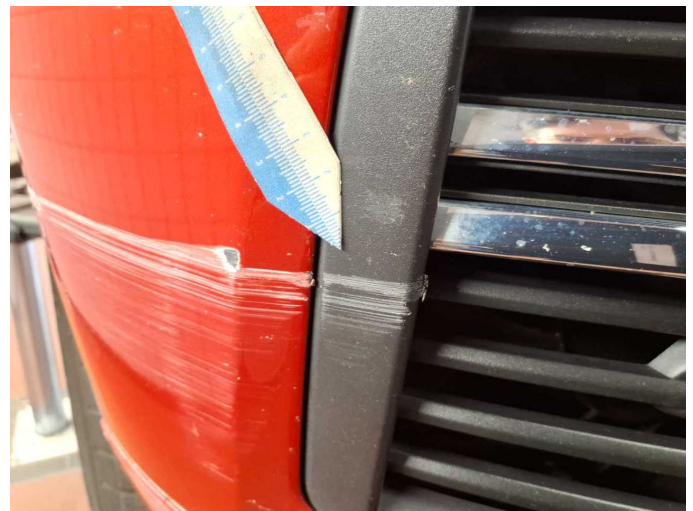
| No. | Component group | Description |
|---|---|---|
| 2 | Front bumper | Cover bumper - front (Rechts Plastik) - Scratched - Replace |

**Damage 2:** Front bumper: Cover bumper - front (Rechts Plastik) - Scratched - Replace

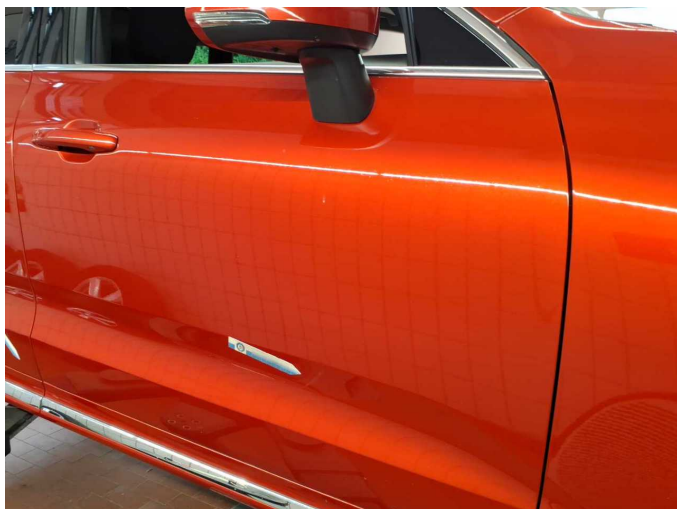
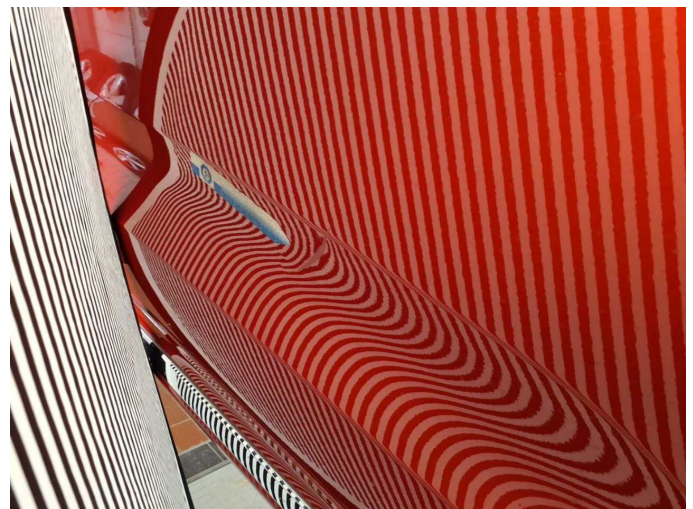
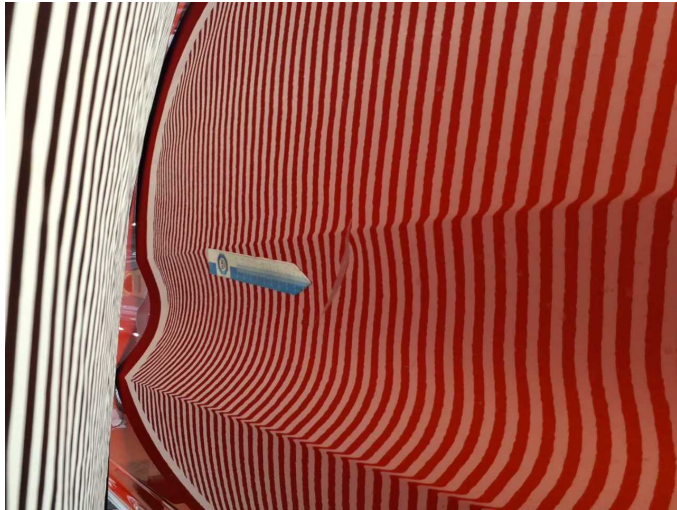
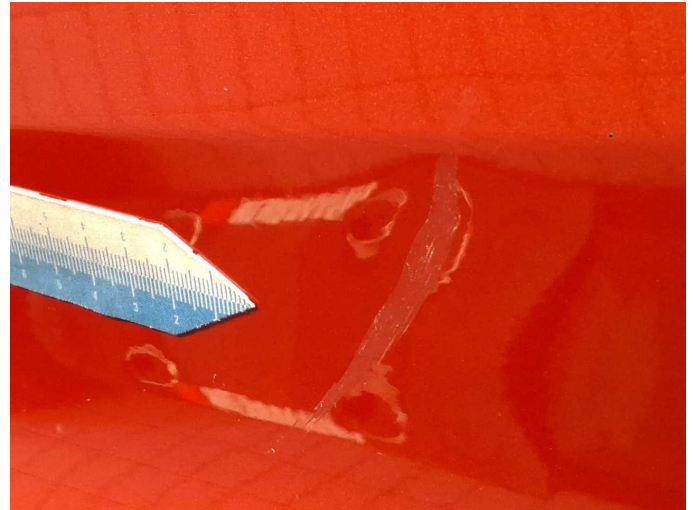
| No. | Component group | Description |
|---|---|---|
| 3 | Door - front right side | Door - dent(s) - Smooth repair work |

**Damage 3:** Door - front right side: Door - dent(s) - Smooth repair work

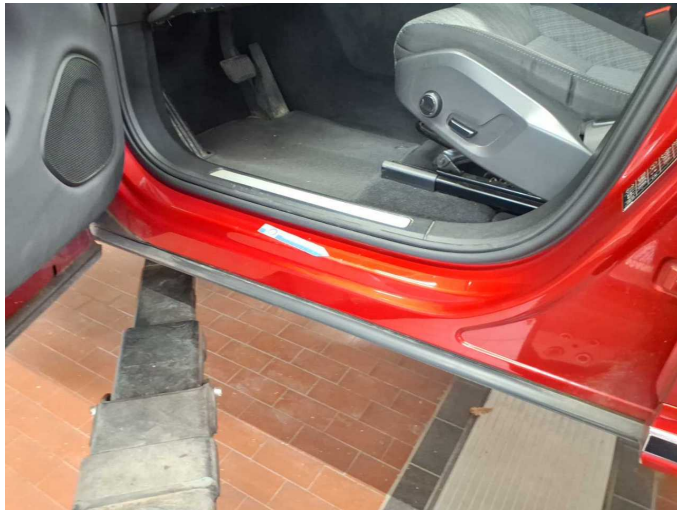
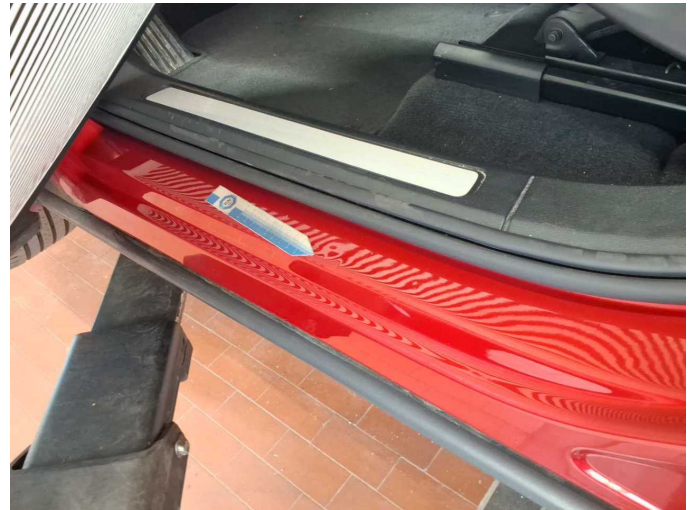
| No. | Component group | Description |
|---|---|---|
| 4 | Sill - left side | Sill - dent(s) - Smooth repair work |

**Damage 4:** Sill - left side: Sill - dent(s) - Smooth repair work

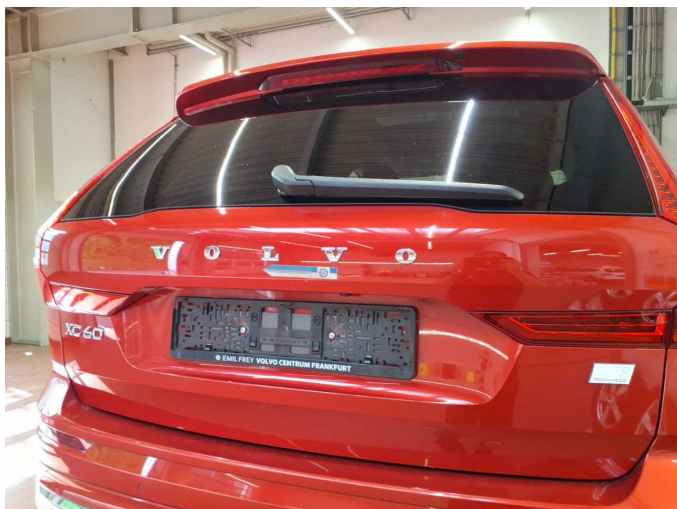
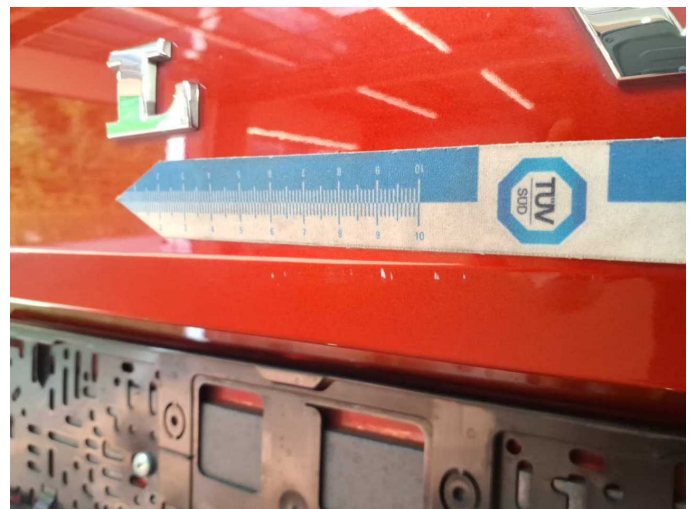
| No. | Component group | Description |
|---|---|---|
| 5 | Boot lid / rear door | Boot lid - Scratch(es) - Smart repair |

**Damage 5:** Boot lid / rear door: Boot lid - Scratch(es) - Smart repair

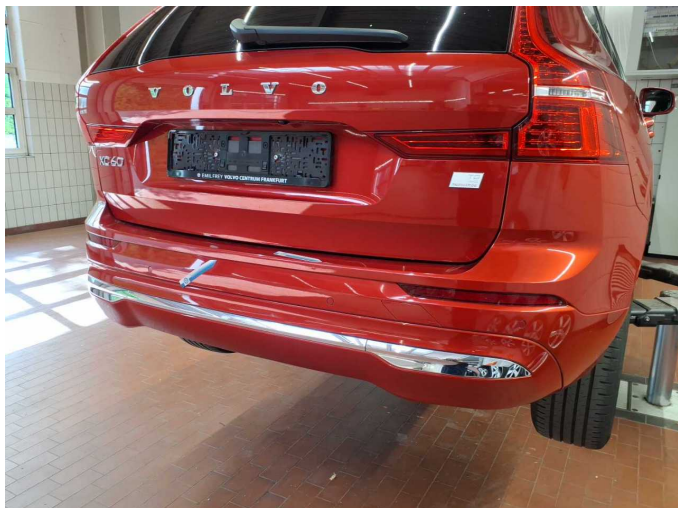
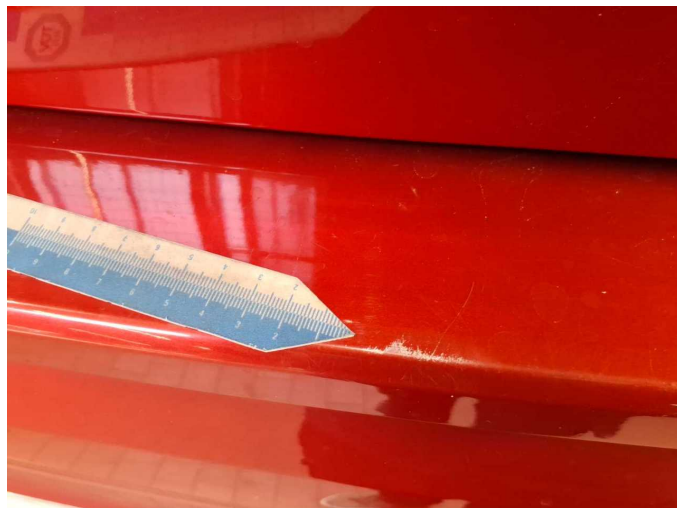
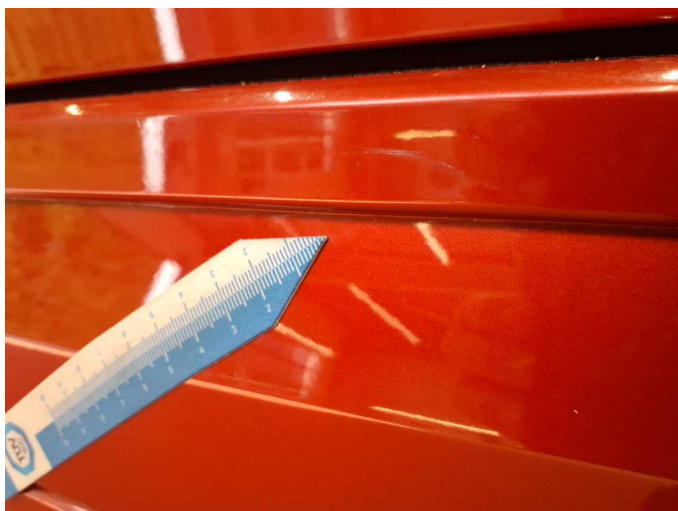
| No. | Component group | Description |
|---|---|---|
| 6 | Rear bumper | Rear bumper - Scratch(es) - Paint |

**Damage 6:** Rear bumper: Rear bumper - Scratch(es) - Paint

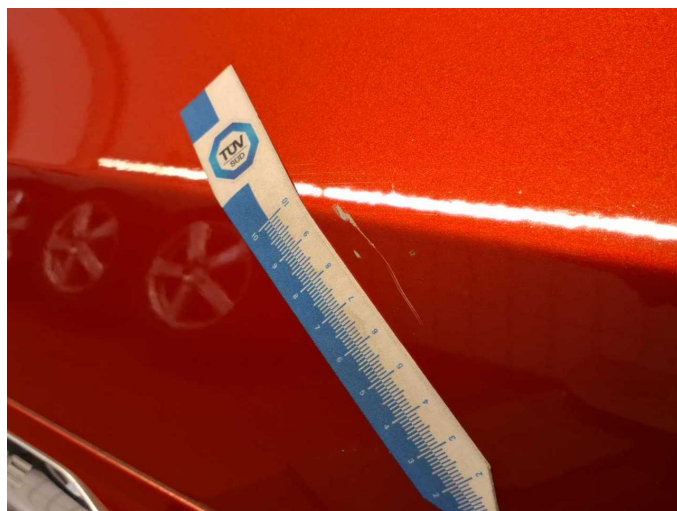
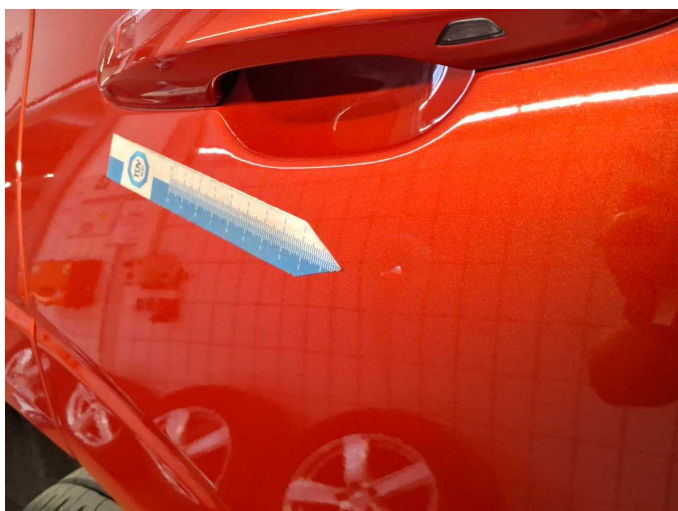
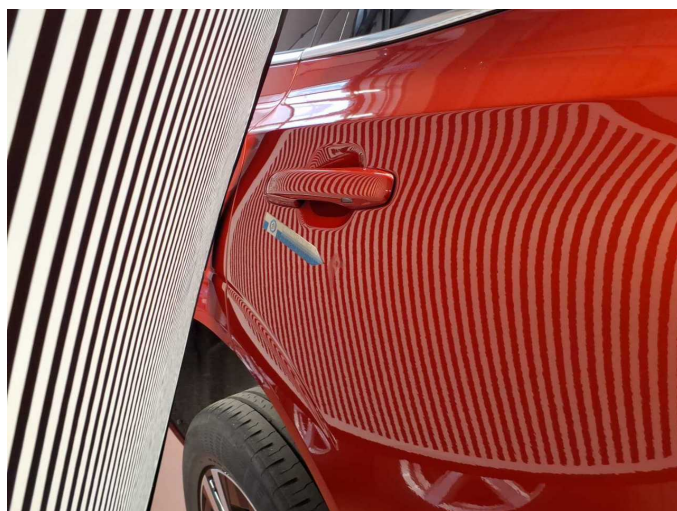
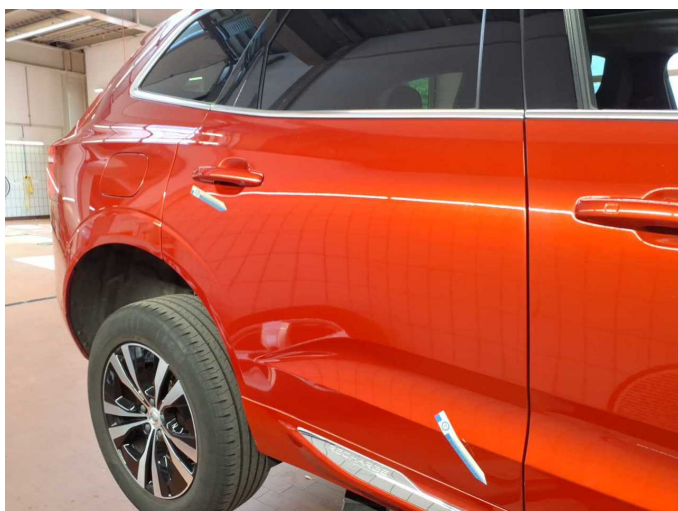
| No. | Component group | Description |
|---|---|---|
| 7 | Door - rear right side | Door - Dent / paintcoat damage - Repair and paint |

**Damage 7:** Door - rear right side: Door - Dent / paintcoat damage - Repair and paint

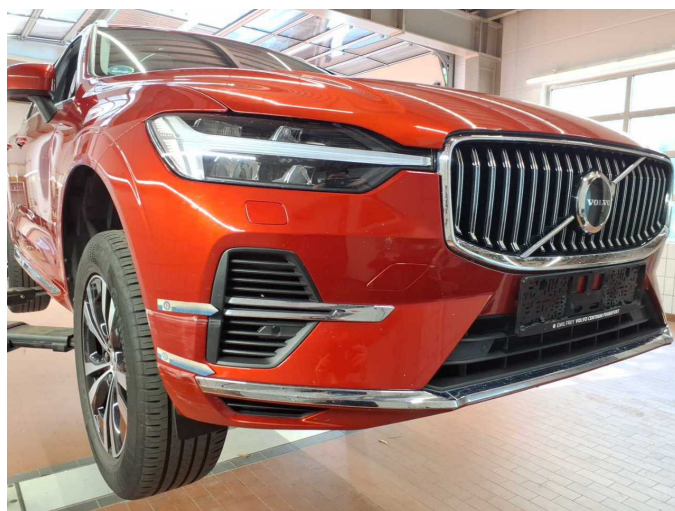
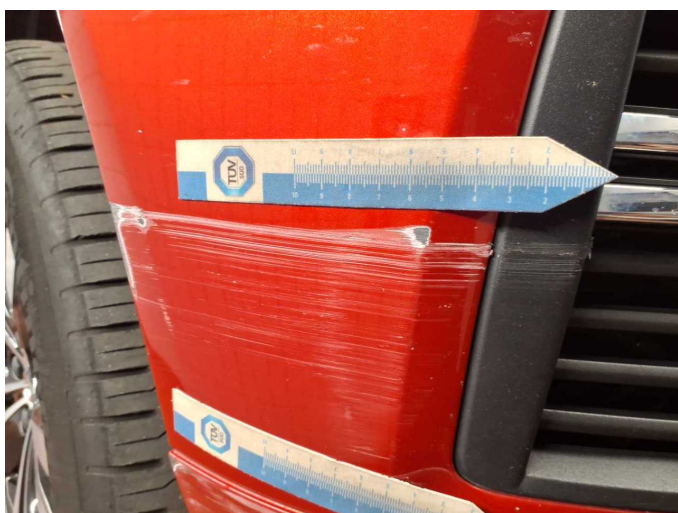
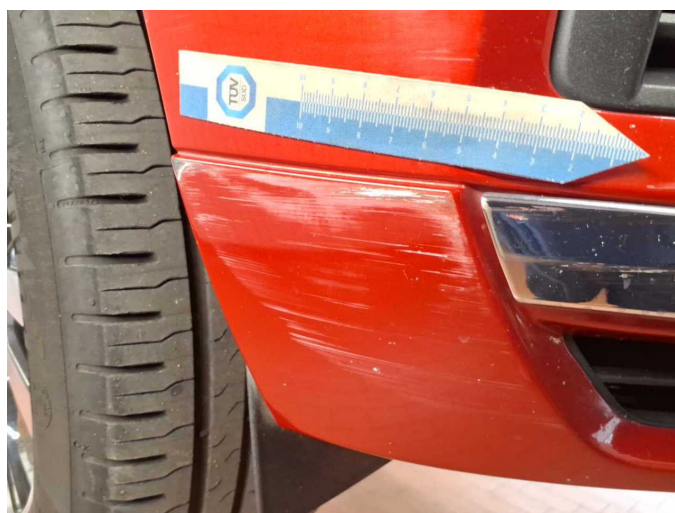
| No. | Component group | Description |
|---|---|---|
| 8 | Front bumper | Front bumper - Scratched - Paint |

**Damage 8:** Front bumper: Front bumper - Scratched - Paint

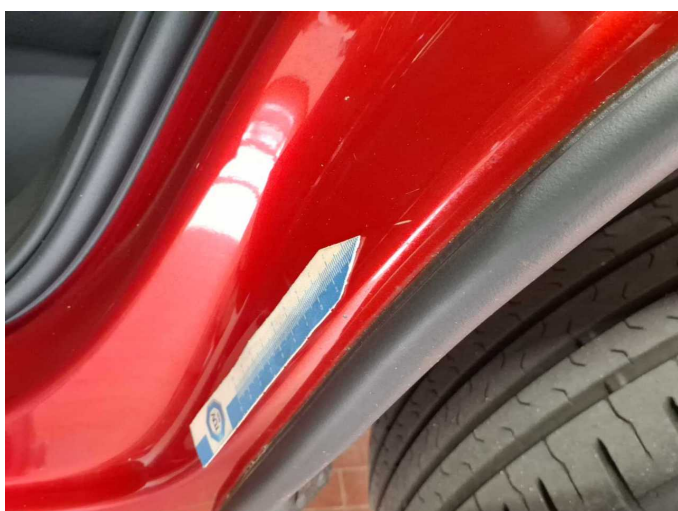
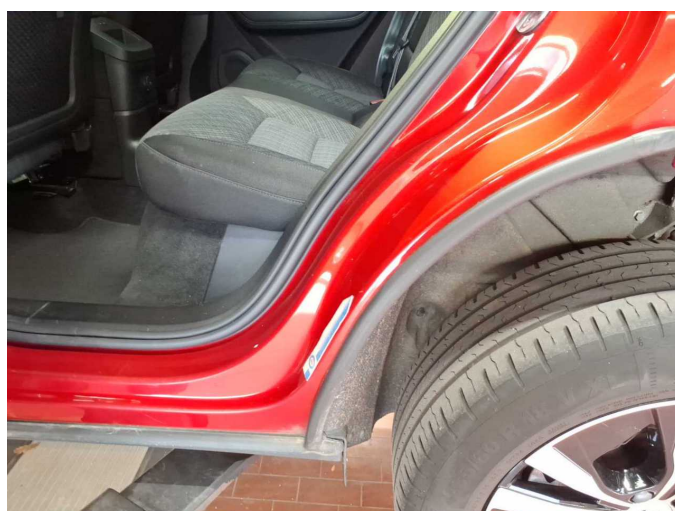
| No. | Component group | Description |
|---|---|---|
| 1 | Side panel - rear left side | Sill - Scratch(es) - No deduction |

**Wear and tear 1:** Side panel - rear left side: Sill - Scratch(es) - No deduction

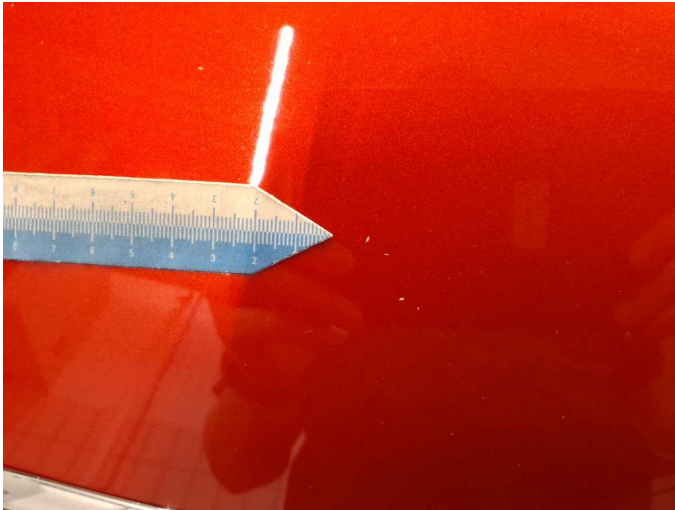
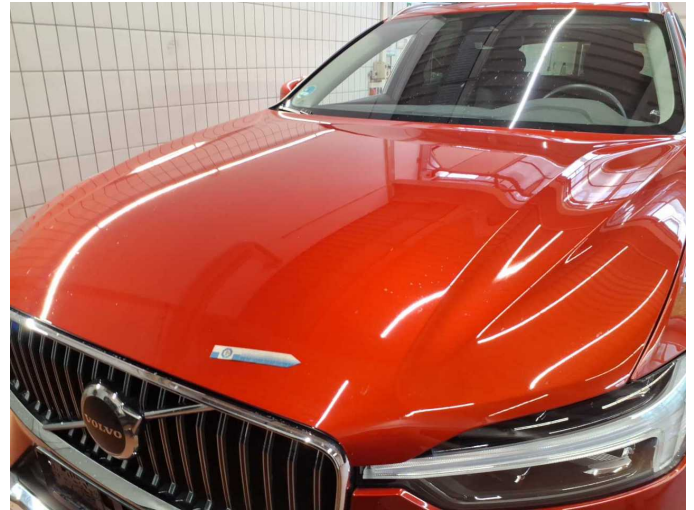
| No. | Component group | Description |
|---|---|---|
| 3 | Bonnet | Bonnet - Stone chips - No deduction |

**Wear and tear 3:** Bonnet: Bonnet - Stone chips - No deduction
