Expertise

Protocol number: 46633642  
Order No. / Reference: 26660923  
Inspection date: 21 Jul 2026

Manufacturer: Volvo

Model: V60 B4 D Geartronic Inscription

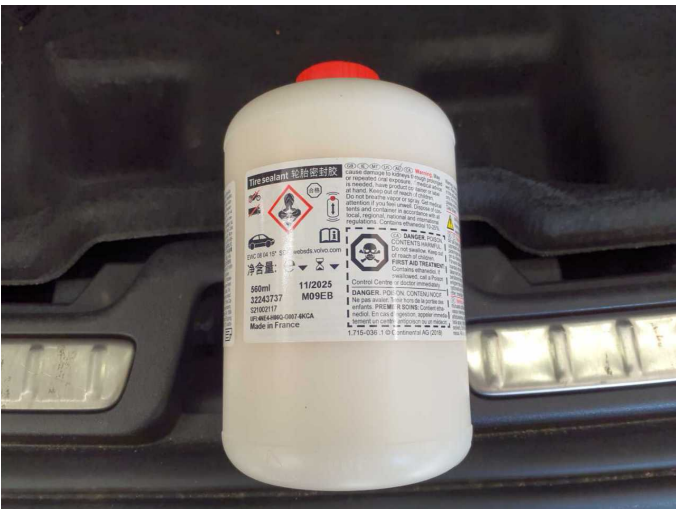
Damage 1: Equipment: Tirefit filler - Expired - Replace

| No. | Component group | Description |
|---|---|---|
| 1 | Equipment | Tirefit filler - Expired - Replace |

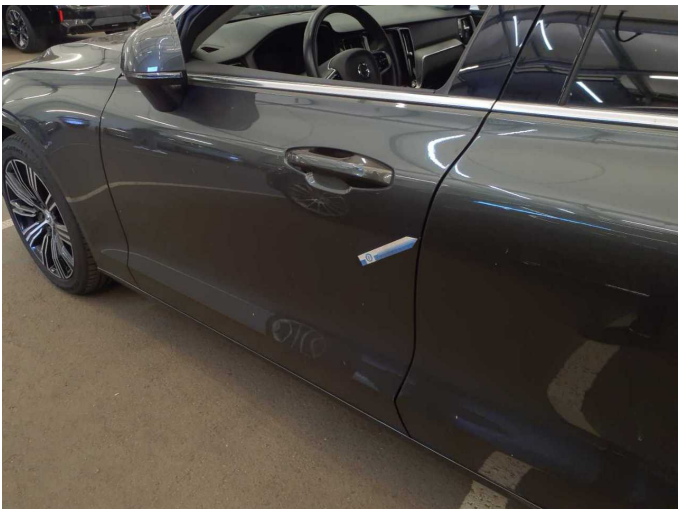
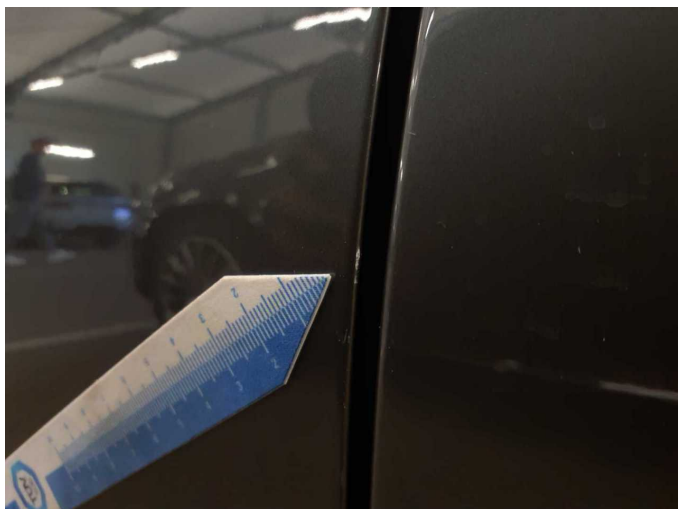
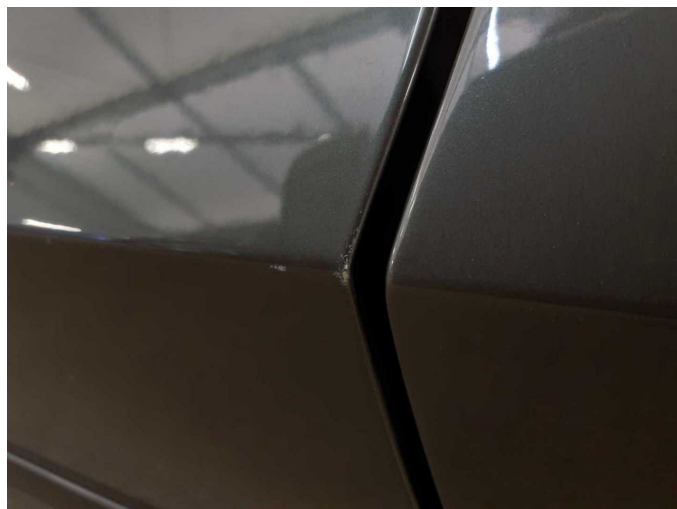
Damage 2: Door - front left side: Door edge - Scratch(es) - Smart repair

**Damage 2:** Door - front left side: Door edge - Scratch(es) - Smart repair

| No. | Component group | Description |
|---|---|---|
| 2 | Door - front left side | Door edge - Scratch(es) - Smart repair |

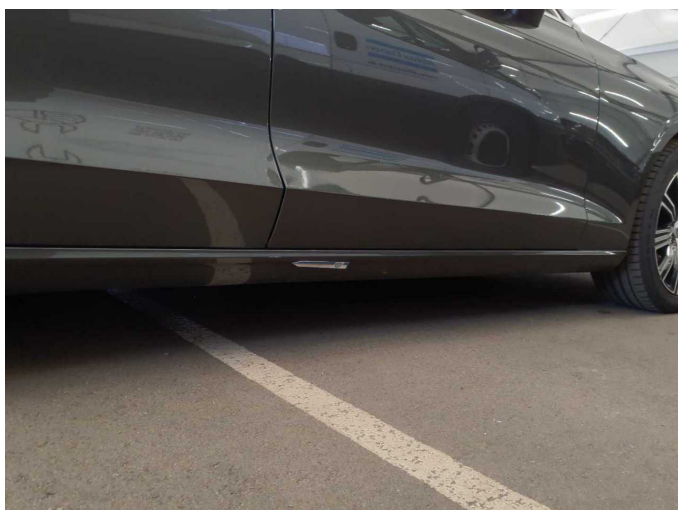
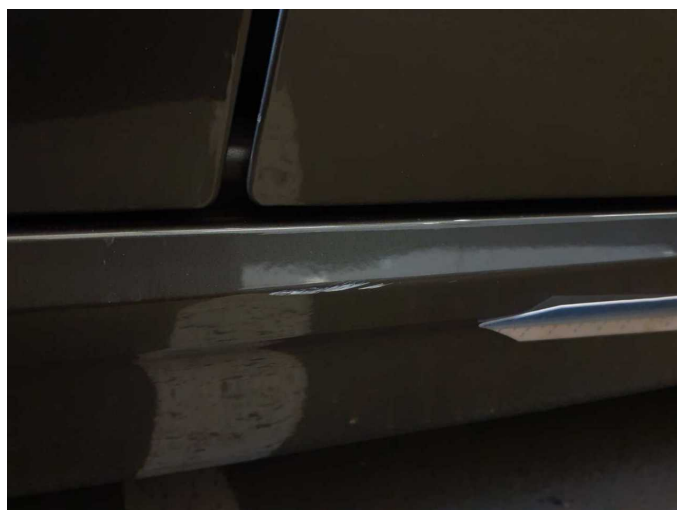
**Damage 3:** Sill - right side: Trim - Scratch(es) - Smart repair

| No. | Component group | Description |
|---|---|---|
| 3 | Sill - right side | Trim - Scratch(es) - Smart repair |

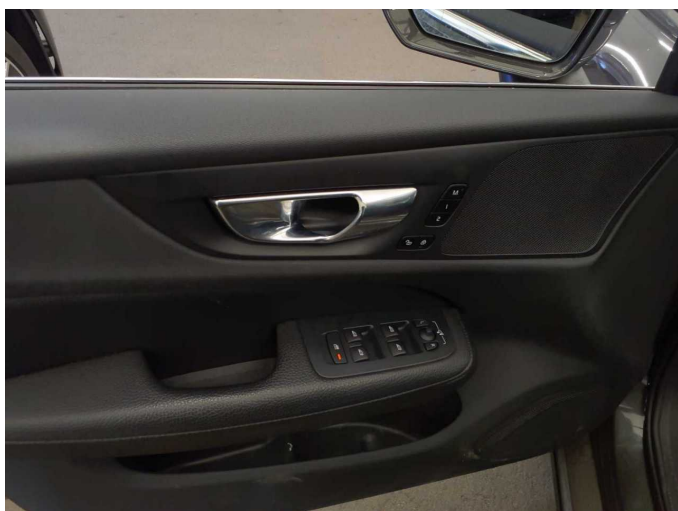
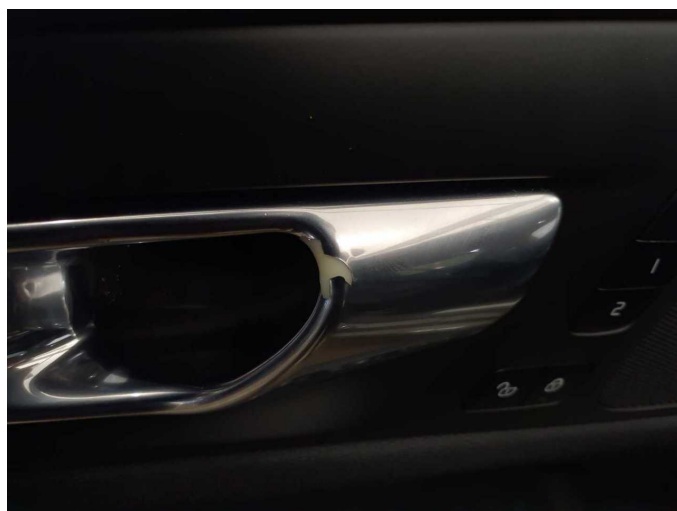
**Damage 4:** Door - front left side: Door handle - inside (Beschichtung) - Paint defect - Replace

| No. | Component group | Description |
|---|---|---|
| 4 | Door - front left side | Door handle - inside (Beschichtung) - Paint defect - Replace |

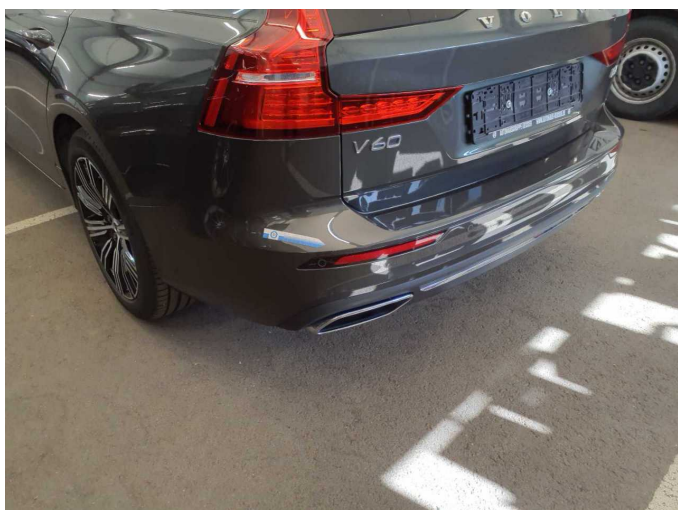
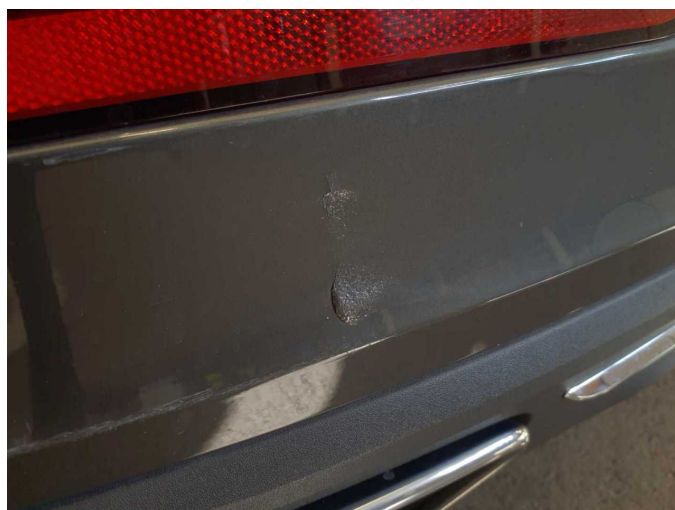
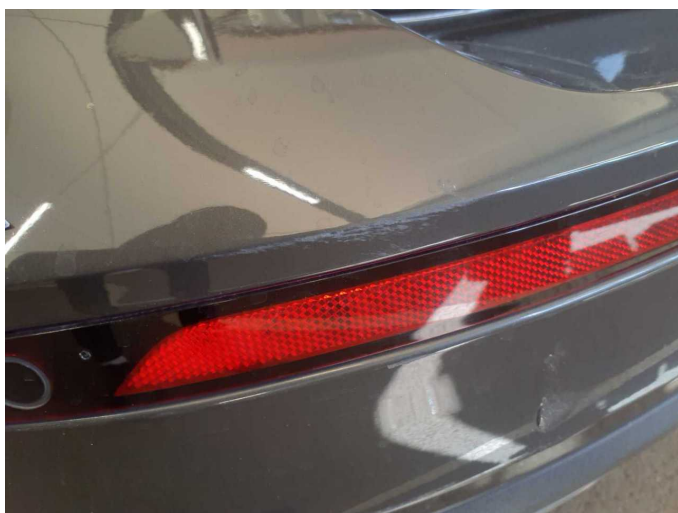
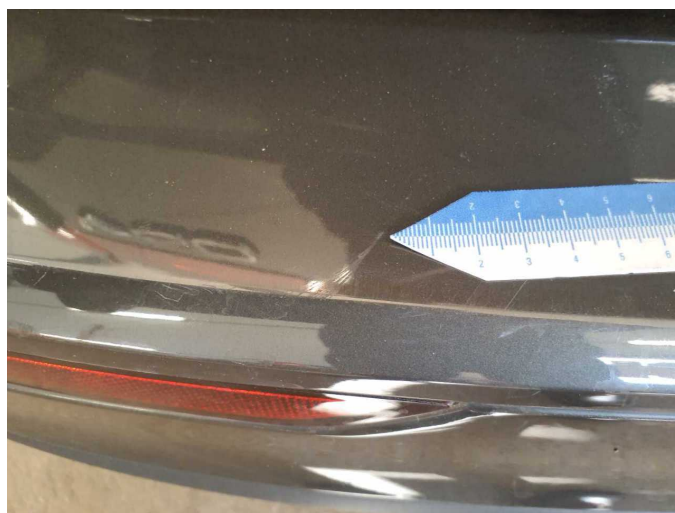
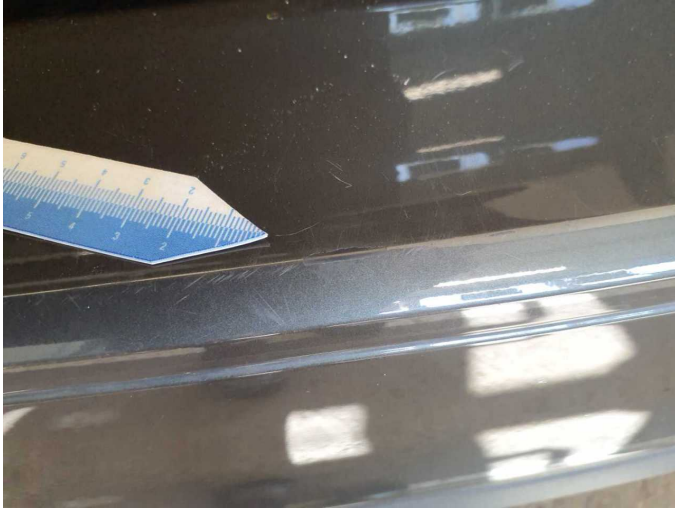
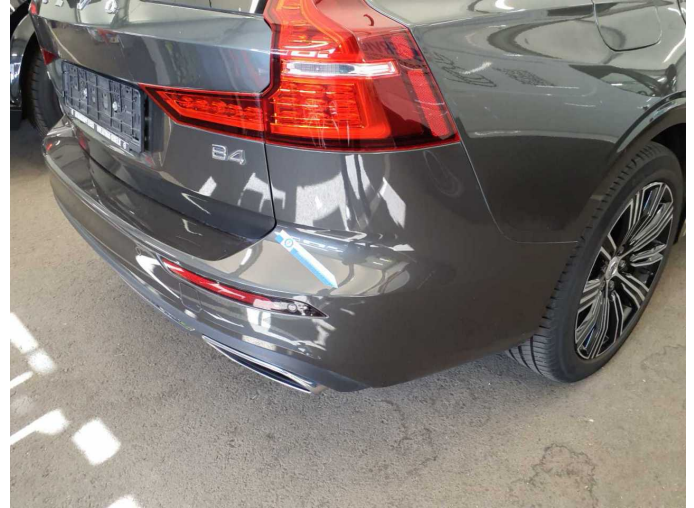
**Damage 6:** Rear bumper: Rear bumper - Scratch(es) - Paint

| No. | Component group | Description |
|---|---|---|
| 6 | Rear bumper | Rear bumper - Scratch(es) - Paint |

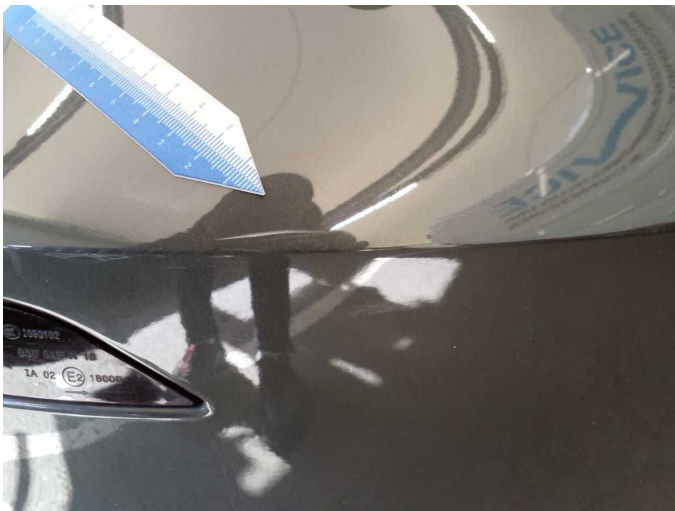
**Damage 6:** Rear bumper: Rear bumper - Scratch(es) - Paint
