Expertise

Protocol number: 46544731  
Order No. / Reference: 26670971  
Inspection date: 16 Jul 2026

Manufacturer: Mercedes-Benz

Model: GLC-Coupe 300 de 4Matic 9G-TRONIC

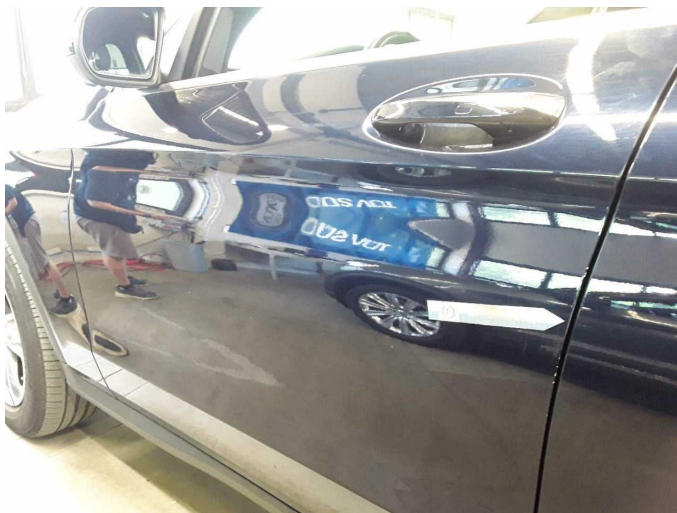
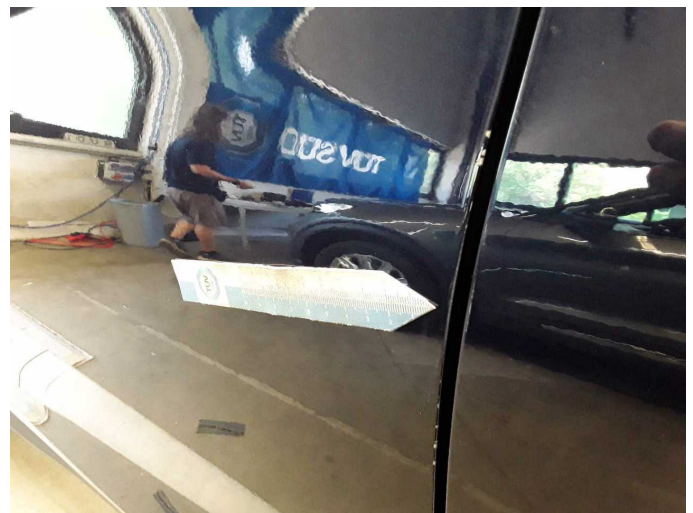
Damage 1: Door - front left side: Door - Scratch(es) - Smart repair

| No. | Component group | Description |
|---|---|---|
| 1 | Door - front left side | Door - Scratch(es) - Smart repair |

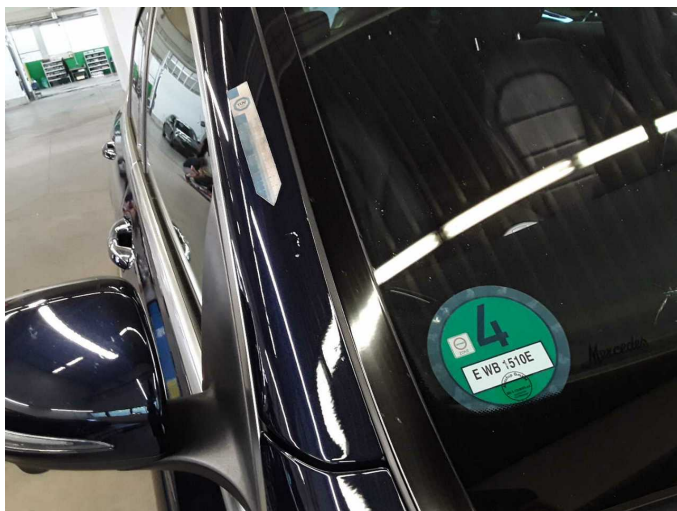
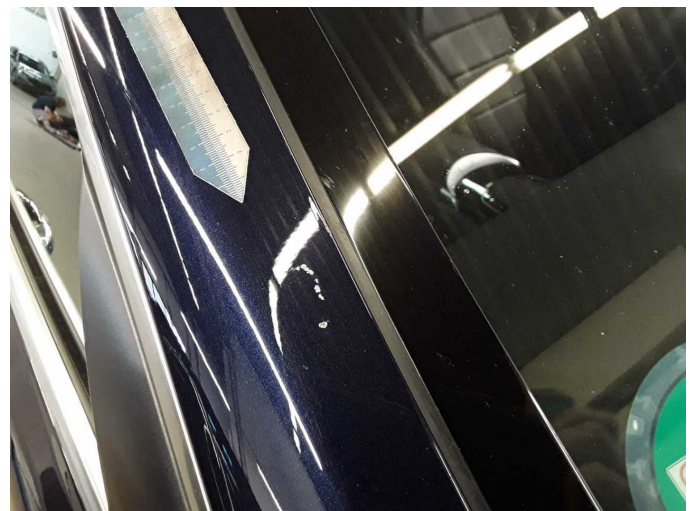
Damage 2: Roof: Roof rail - right side - Stone chips - Paint

| No. | Component group | Description |
|---|---|---|
| 2 | Roof | Roof rail - right side - Stone chips - Paint |

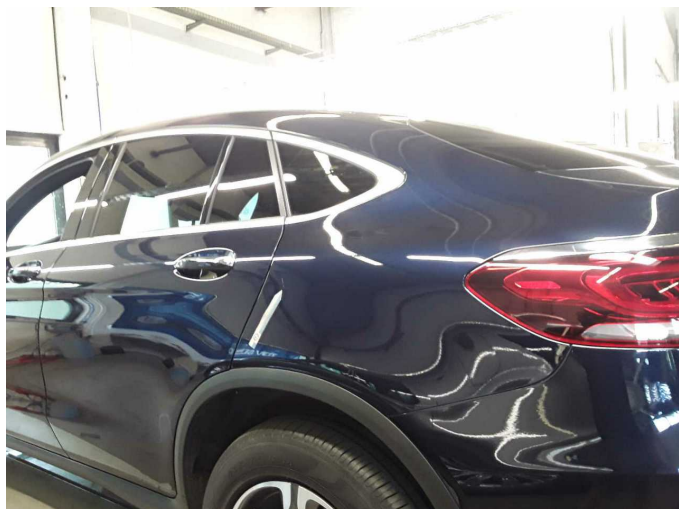
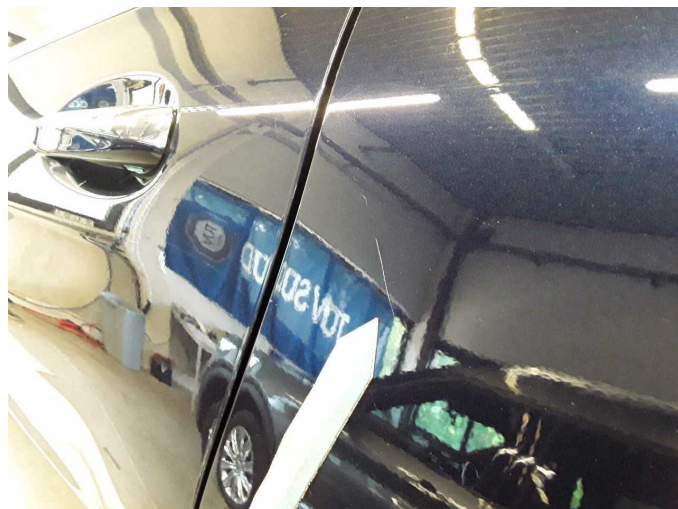
**Damage 3:** Side panel - rear left side: Side panel - Scratch(es) - Paint

| No. | Component group | Description |
|---|---|---|
| 3 | Side panel - rear left side | Side panel - Scratch(es) - Paint |

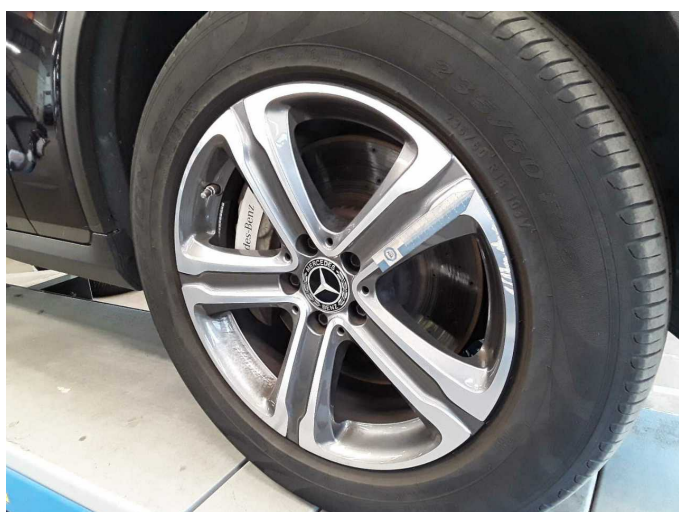
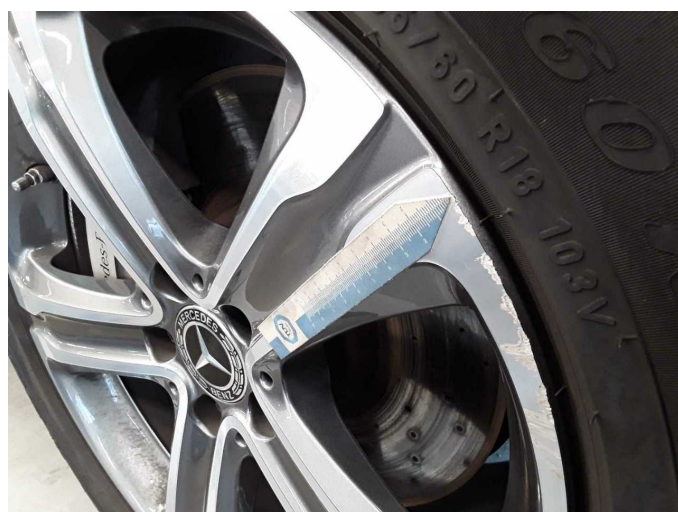
**Damage 4:** Wheel / tyres: Alloy rim - front right side - Scratched - Replace

| No. | Component group | Description |
|---|---|---|
| 4 | Wheel / tyres | Alloy rim - front right side - Scratched - Replace |

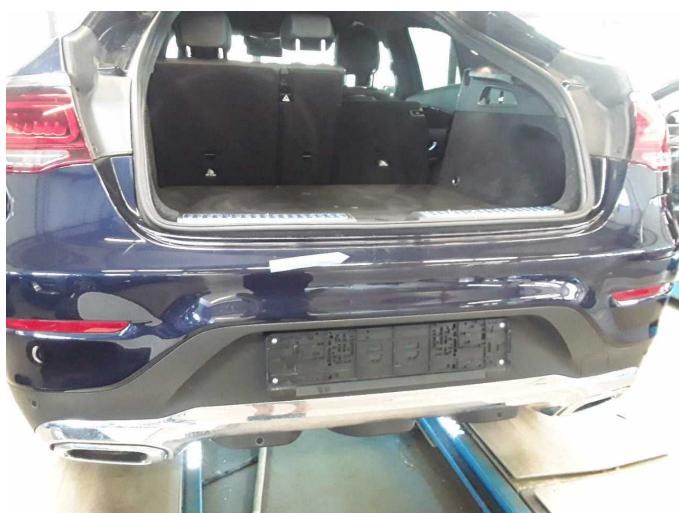
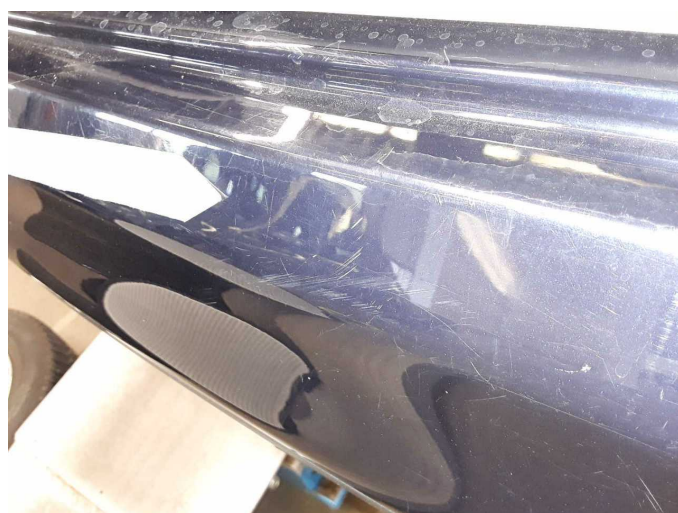
**Damage 5:** Rear bumper: Rear bumper - Scratch(es) - Paint

| No. | Component group | Description |
|---|---|---|
| 5 | Rear bumper | Rear bumper - Scratch(es) - Paint |

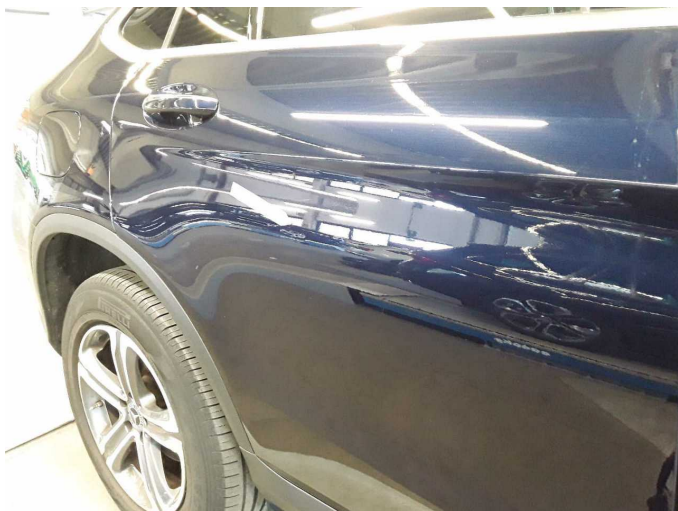
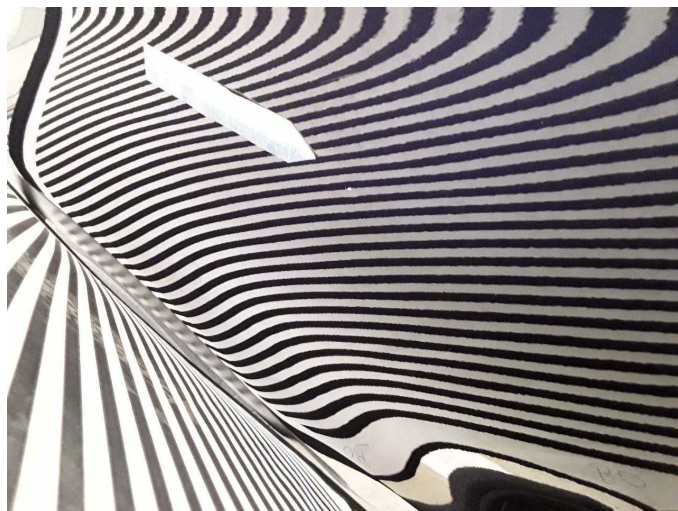
**Damage 6:** Door - rear right side: Door - Dent / paintcoat damage - Repair and paint

| No. | Component group | Description |
|---|---|---|
| 6 | Door - rear right side | Door - Dent / paintcoat damage - Repair and paint |

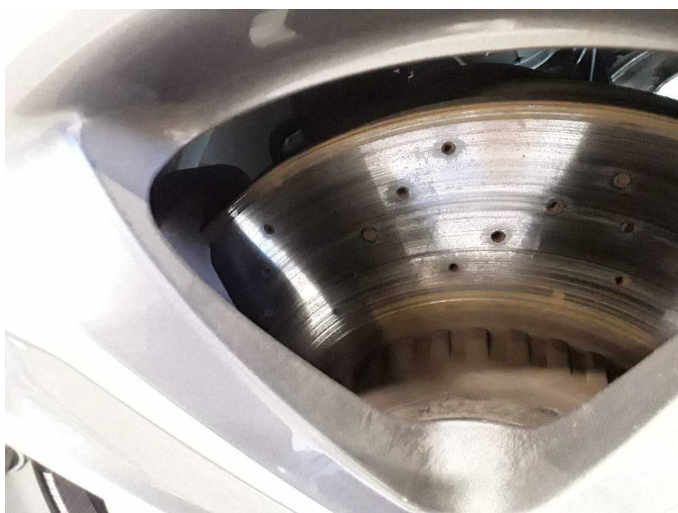
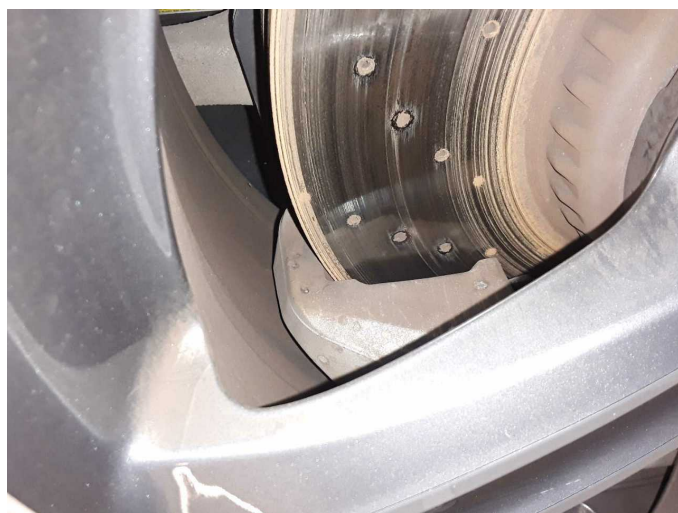
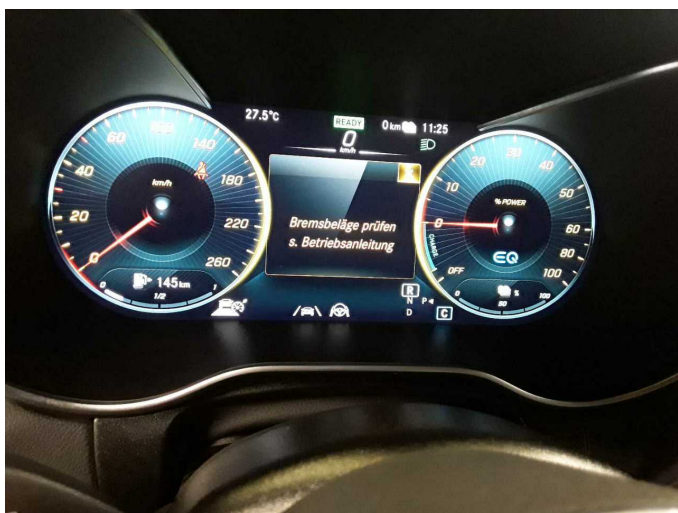
**Damage 7:** Braking system: Brake discs and brake pads - front - Worn - Replace

| No. | Component group | Description |
|---|---|---|
| 7 | Braking system | Brake discs and brake pads - front - Worn - Replace |

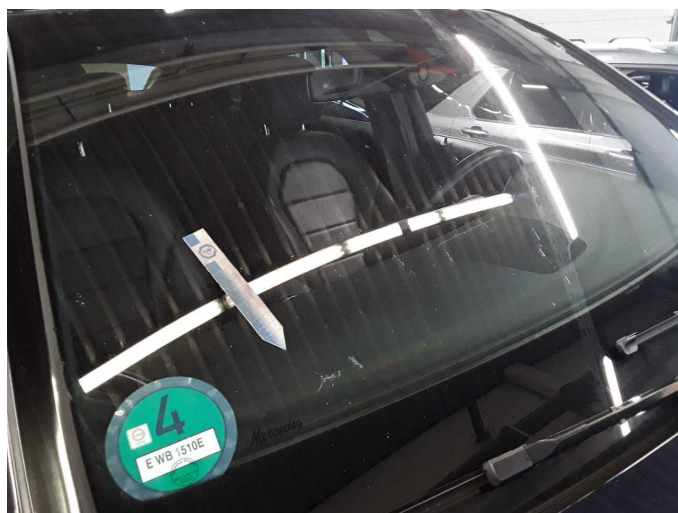
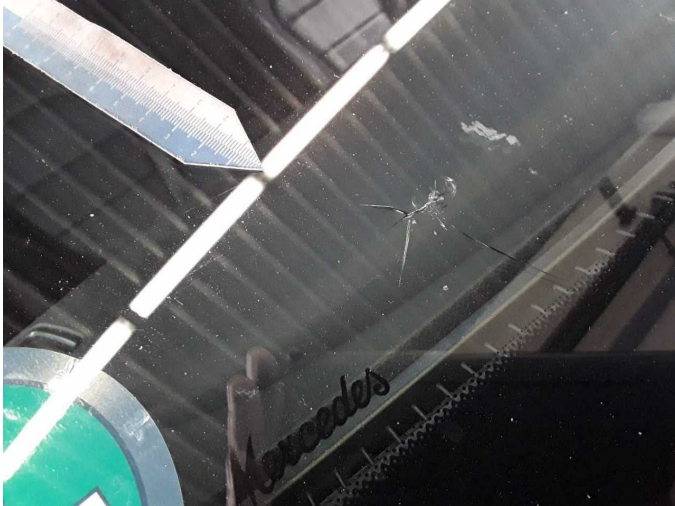
**Damage 8:** Vehicle glazing: Windscreen (Rissbildung) - Stone chips - Replace

| No. | Component group | Description |
|---|---|---|
| 8 | Vehicle glazing | Windscreen (Rissbildung) - Stone chips - Replace |

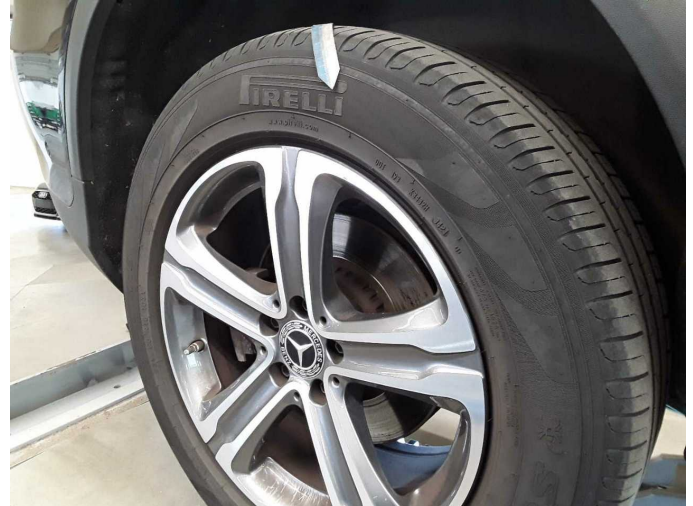
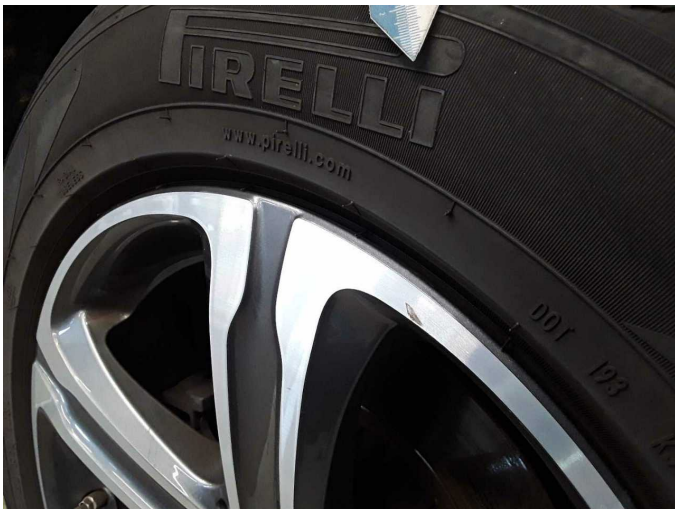
**Wear and tear 1:** Wheel / tyres: Alloy rim - rear right side - Scratch(es) - No deduction

| No. | Component group | Description |
|---|---|---|
| 1 | Wheel / tyres | Alloy rim - rear right side - Scratch(es) - No deduction |
