## Expertise

Protocol number: 45048162  
Order No. / Reference: 26219180  
Inspection date: 20 Apr 2026

Manufacturer: Volvo

Model: XC60 B4 B Core

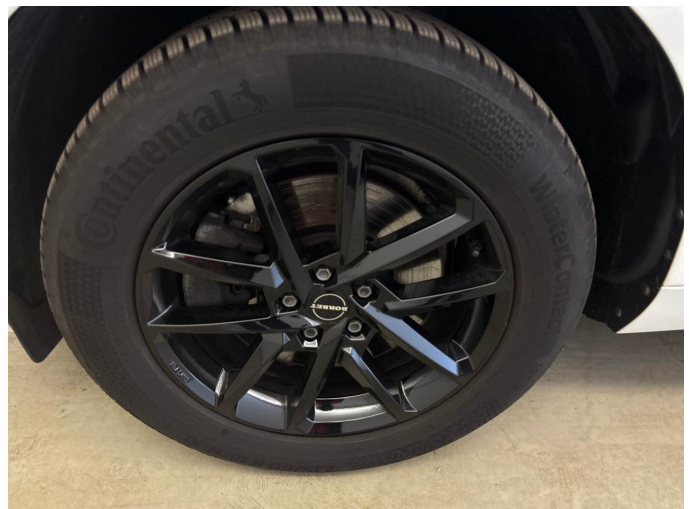
Figure 12: Mounted tyres

#	Tyre size	Type of tyre	Manufacturer	Tread depth
1)	235/60 R18 107H	Winter tyres on Light alloy	Continental	7mm / 7mm
2)	235/60 R18 107H	Winter tyres on Light alloy	Continental	7mm / 7mm

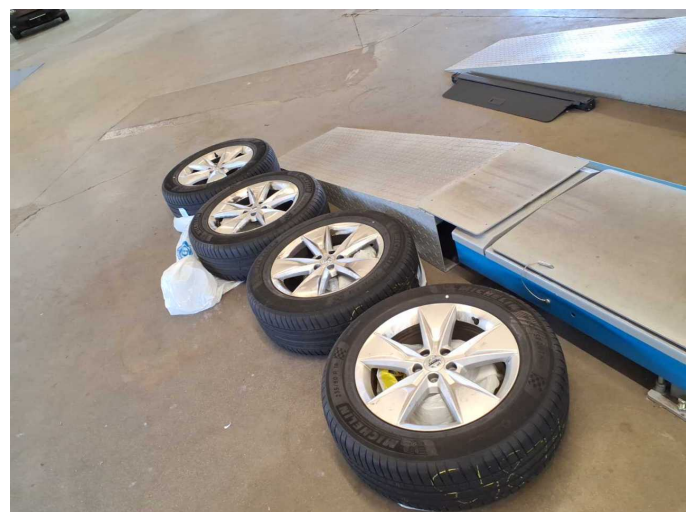
Figure 18: Additional tyres

#	Tyre size	Type of tyre	Manufacturer	Tread depth
1)	235/60 R18 107V	Summer tyres on Light alloy	Michelin	5mm / 5mm
2)	235/60 R18 107V	Summer tyres on Light alloy	Michelin	5mm / 5mm

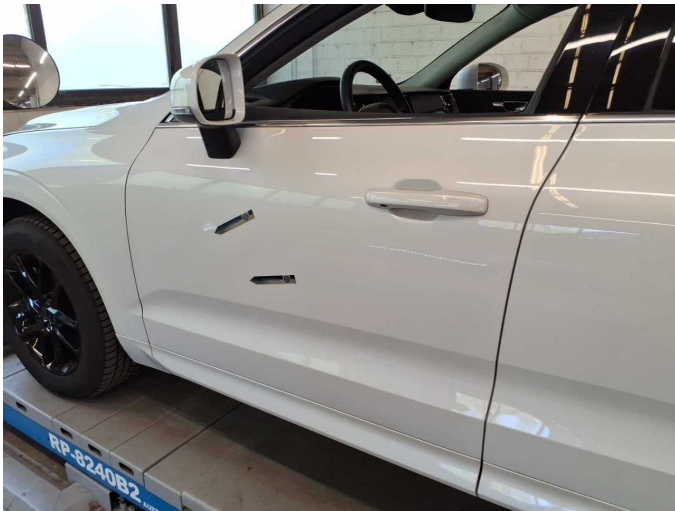
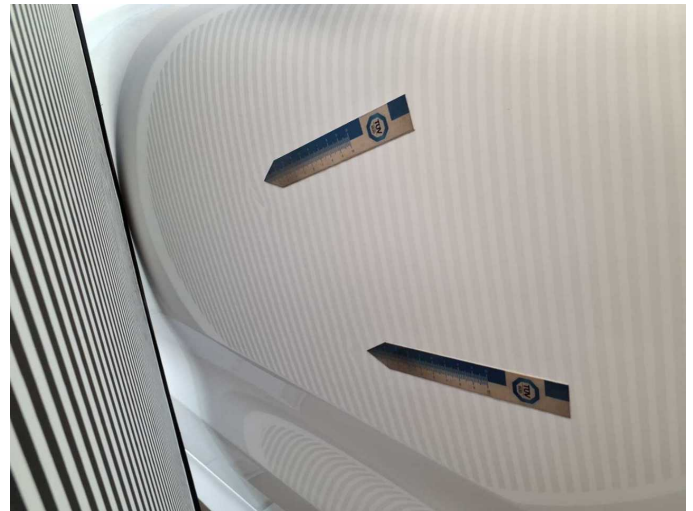
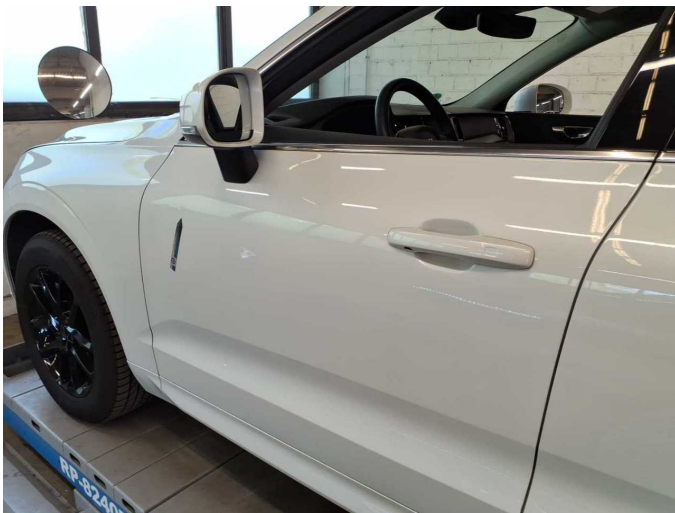
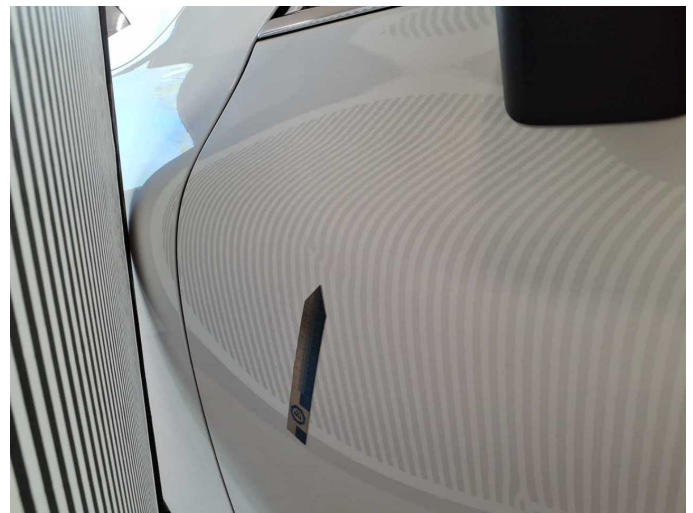
**Damage 1:** Door - front left side: Door (3 stk) - dent(s) - Smart repair

No.	Component group	Description
1	Door - front left side	Door (3 stk) - dent(s) - Smart repair
2	Bonnet	Insulation lining - Missing - Replace

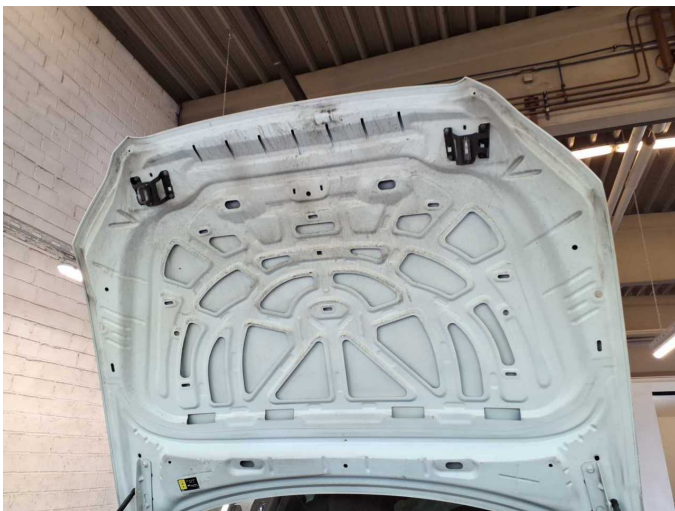
**Damage 2:** Bonnet: Insulation lining - Missing - Replace

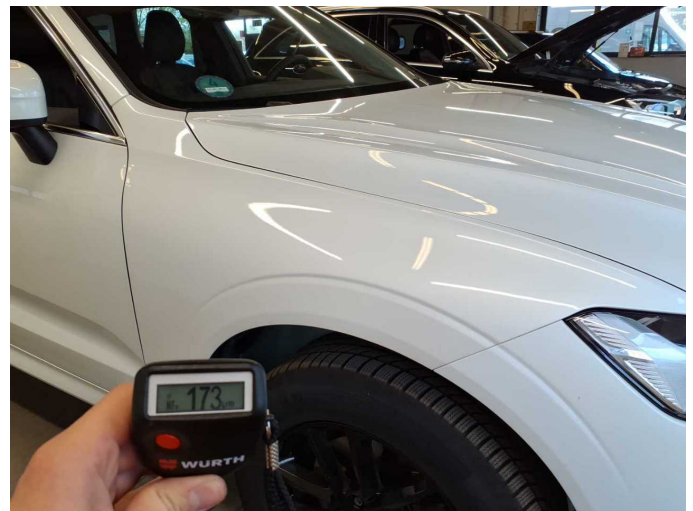
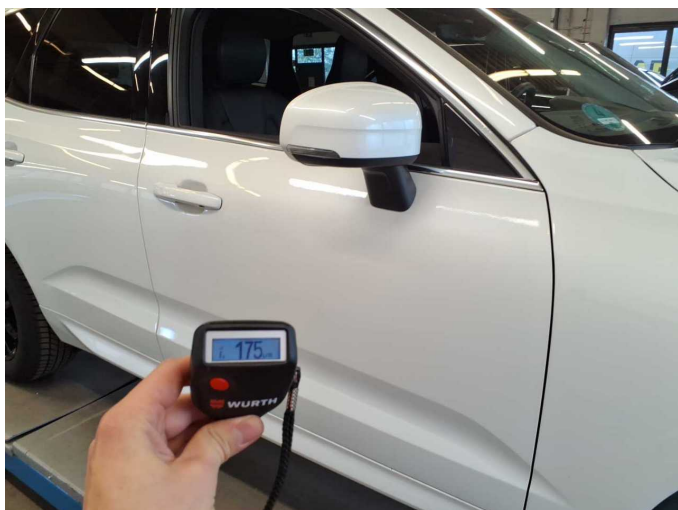
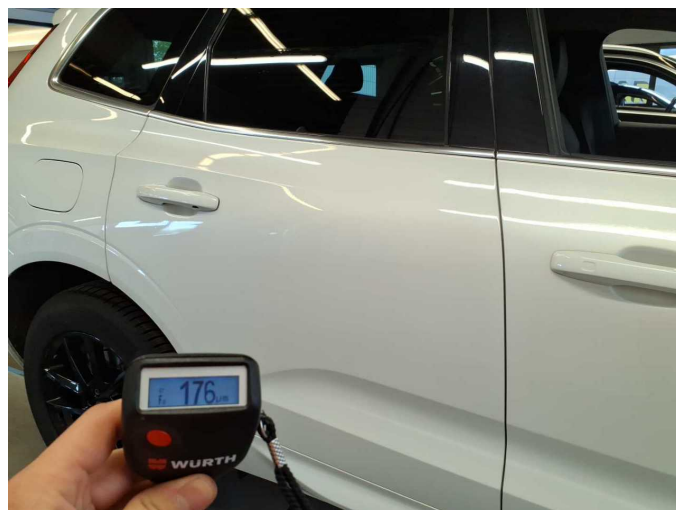
No.	Repainting
1	Mudguard - right side, Door - rear right side, Door - front right side, Professionally carried out, Invoice of repair done Non-existent

Mudguard - right side	173 µm	Door - rear right side	176 µm
Door - front right side	175 µm

**Repainting 1:** Mudguard - right side, Door - rear right side, Door - front right side
