Expertise

Protocol number: 46103770  
Order No. / Reference: 26528452  
Inspection date: 17 Jun 2026

| Manufacturer: Ford | Model: Focus 1.5 EcoBlue Start-Stopp-System Aut. TITANIUM X |

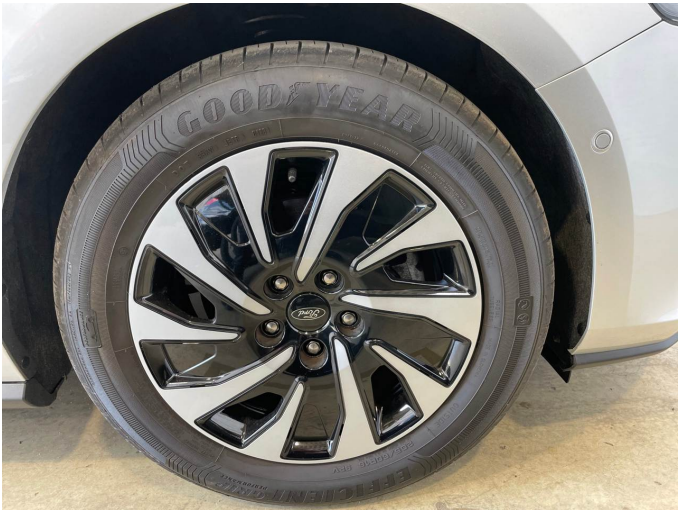
Figure 12: Mounted tyres

| Tyres | | | | |
|---|---|---|---|---|
| 1) | 205/60 R16 92V | Summer tyres on Steel rim with wheel cover | Goodyear | 6mm / 6mm |
| 2) | 205/60 R16 92V | Summer tyres on Steel rim with wheel cover | Goodyear | 6mm / 6mm |

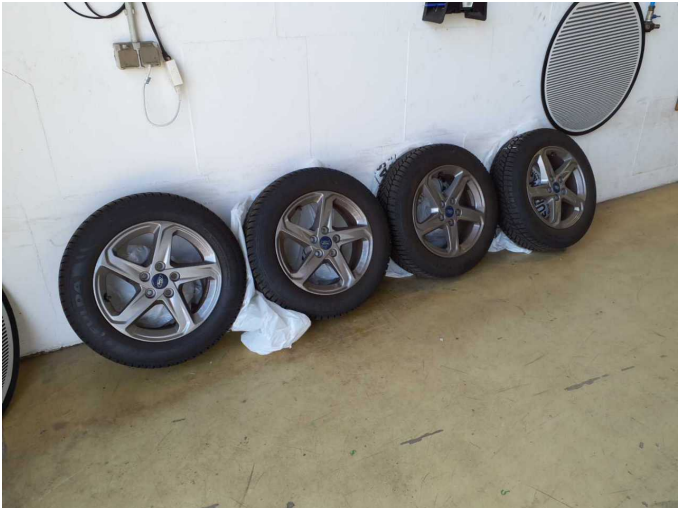
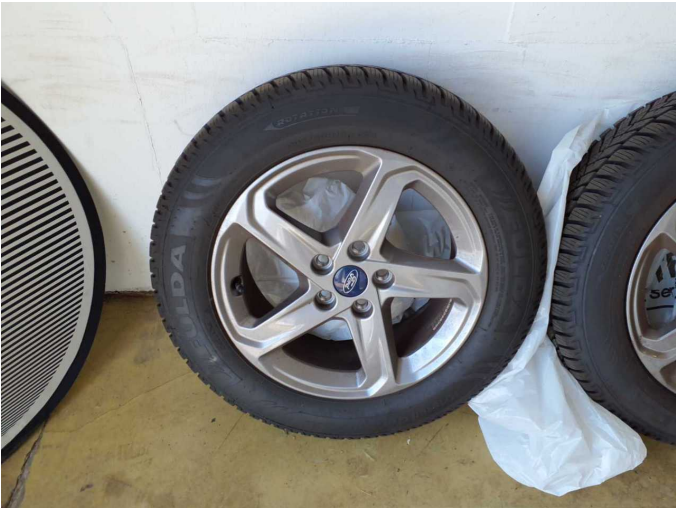
Figure 14: Additional tyres

| Tyres | | | | |
|---|---|---|---|---|
| 1) | 205/60 R16 92H | Winter tyres on Light alloy | Fulda | 8mm / 8mm |
| 2) | 205/60 R16 92H | Winter tyres on Light alloy | Fulda | 8mm / 8mm |

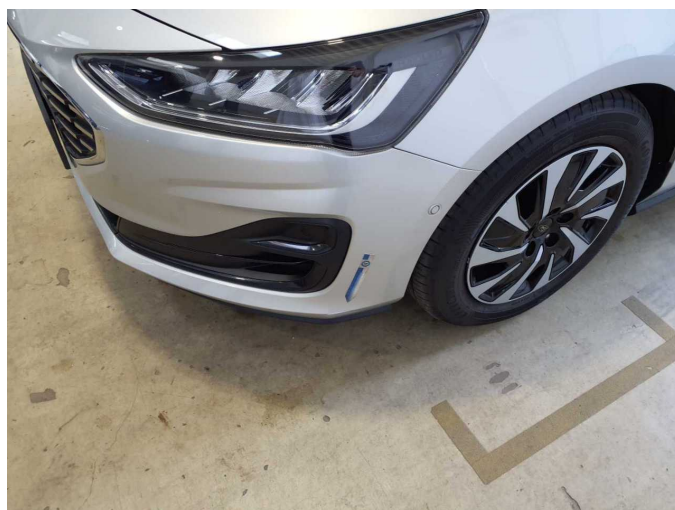
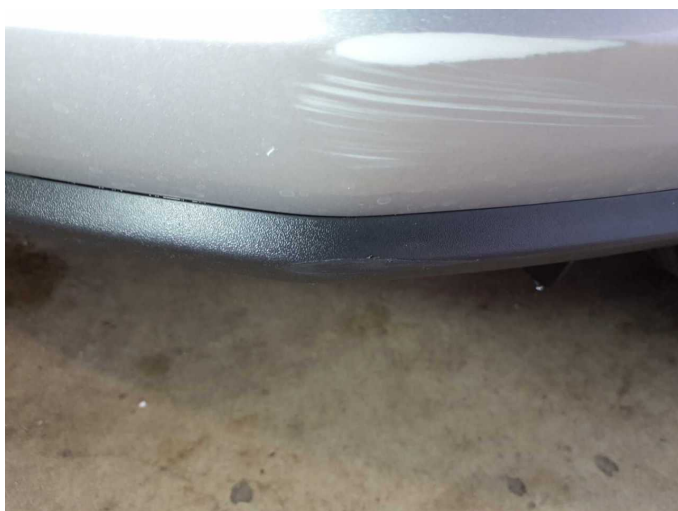
**Damage 1:** Front bumper: Spoiler - Scratch(es) - Replace

| No. | Component group | Description |
|---|---|---|
| 1 | Front bumper | Spoiler - Scratch(es) - Replace |

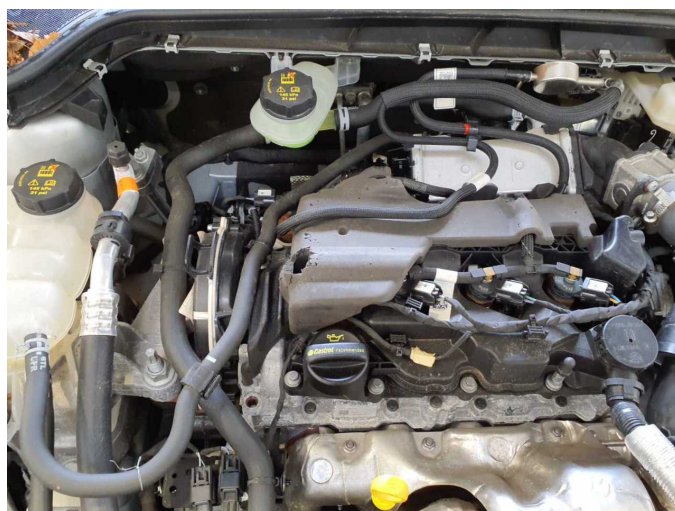
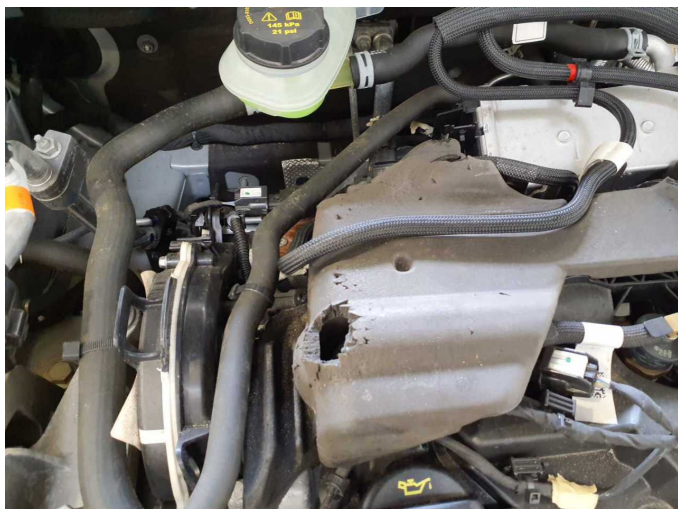
**Damage 2:** Misc.: Misc. (Isolierung Motorabdeckung) - Damage caused by marten / rodent - Replace

| No. | Component group | Description |
|---|---|---|
| 2 | Misc. | Misc. (Isolierung Motorabdeckung) - Damage caused by marten / rodent - Replace |

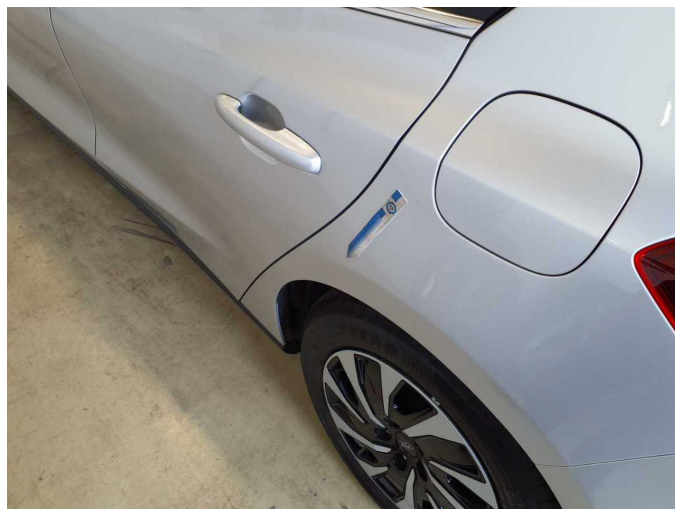
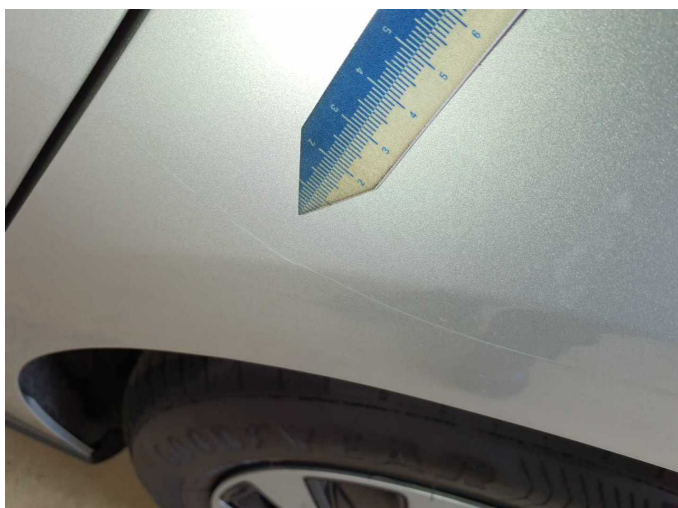
**Damage 3:** Side panel - rear left side: Side panel - Scratch(es) - Smart repair

| No. | Component group | Description |
|---|---|---|
| 3 | Side panel - rear left side | Side panel - Scratch(es) - Smart repair |

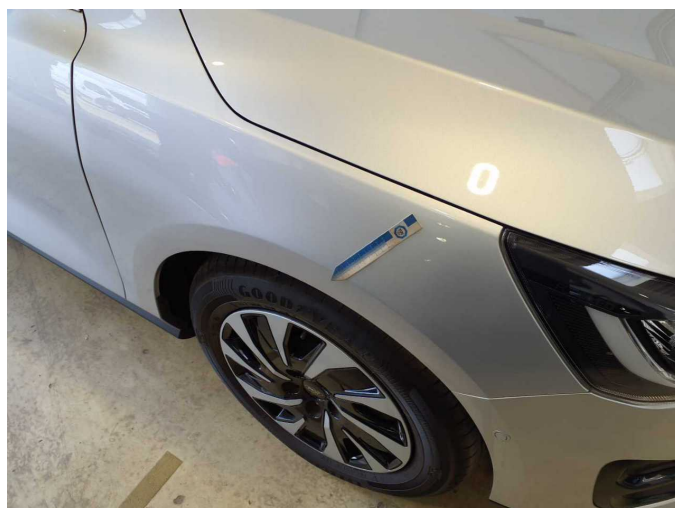
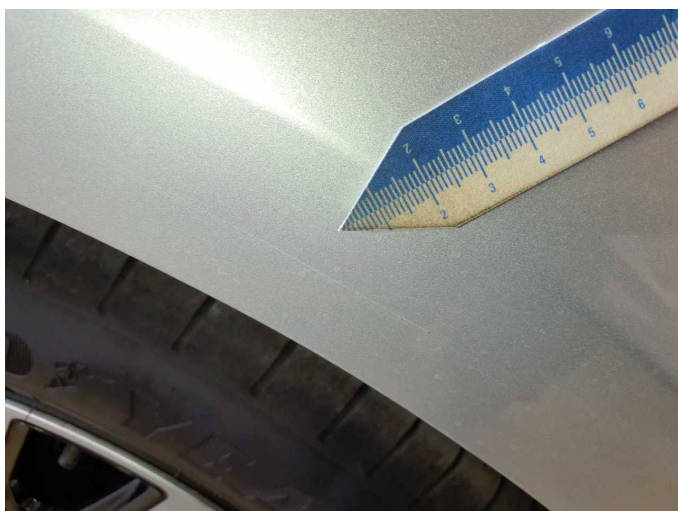
**Damage 4:** Mudguard - right side: Mudguard - right side - Scratch(es) - Smart repair

| No. | Component group | Description |
|---|---|---|
| 4 | Mudguard - right side | Mudguard - right side - Scratch(es) - Smart repair |

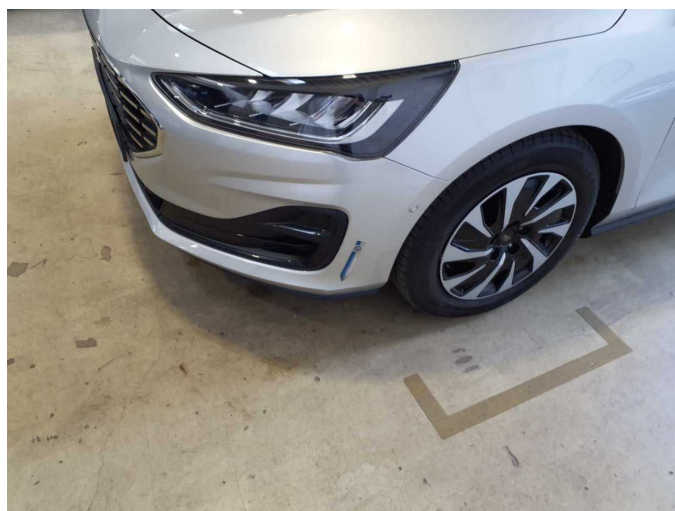
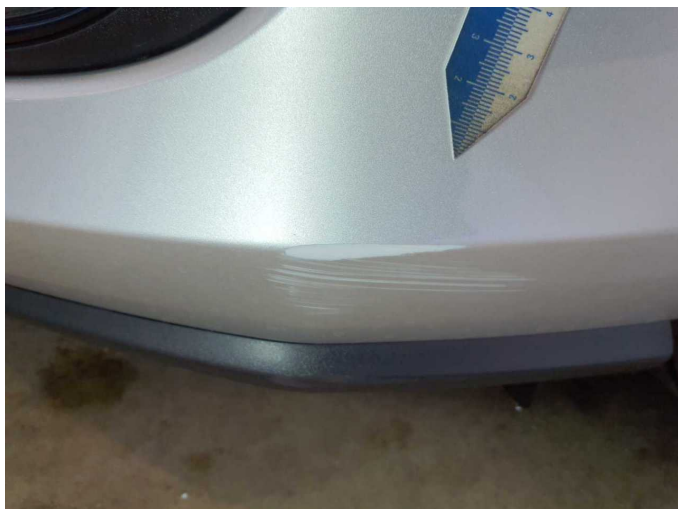
**Damage 6:** Front bumper: Front bumper - Scratch(es) - Paint

| No. | Component group | Description |
|---|---|---|
| 6 | Front bumper | Front bumper - Scratch(es) - Paint |

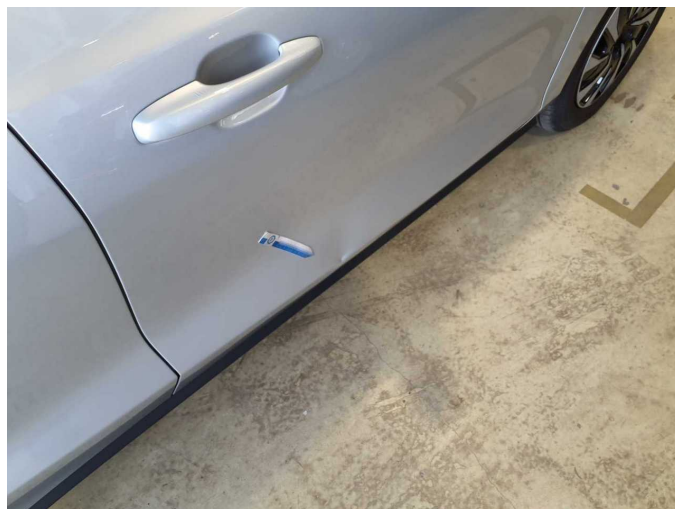
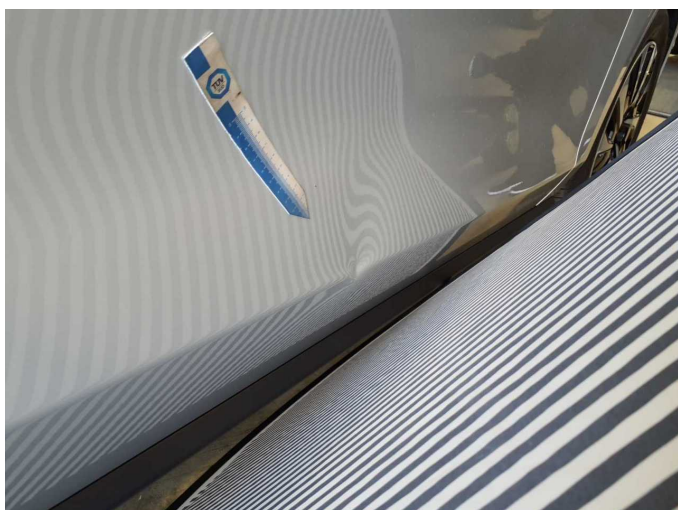
**Damage 7:** Door - front right side: Door - dent(s) - Repair and paint

| No. | Component group | Description |
|---|---|---|
| 7 | Door - front right side | Door - dent(s) - Repair and paint |

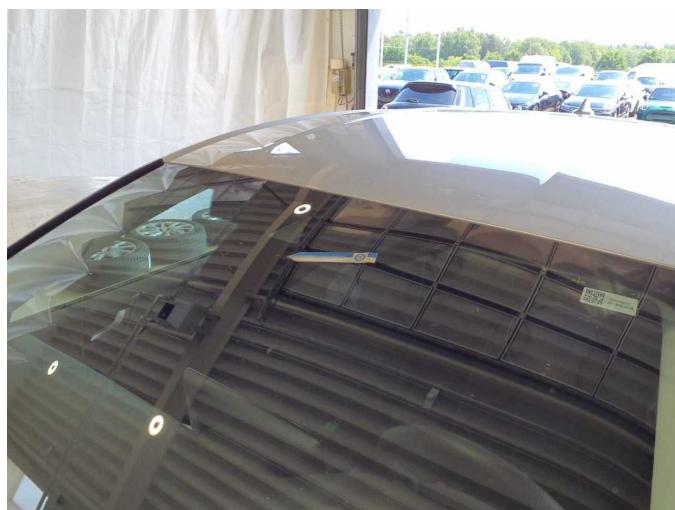
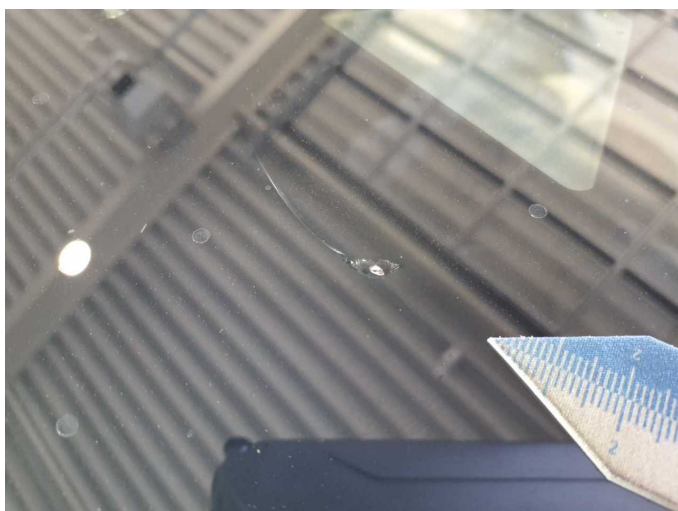
**Damage 8:** Vehicle glazing: Windscreen - Stone chips - Replace

| No. | Component group | Description |
|---|---|---|
| 8 | Vehicle glazing | Windscreen - Stone chips - Replace |

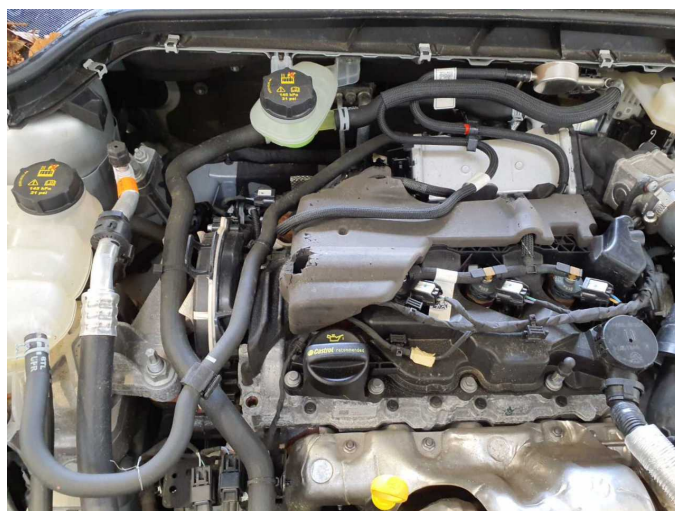
**Missing part 3:** Engine: Engine cover - Missing - Replace

Trim / covers - Floor mats (Gummimatten)  
Equipment - Fire extinguisher  
Engine - Engine cover
