Expertise

Manufacturer: Volkswagen

Model: Tiguan 2.0 TDI SCR 4MOTION DSG Elegance

VIN: WVGZZZ5N4PW085630

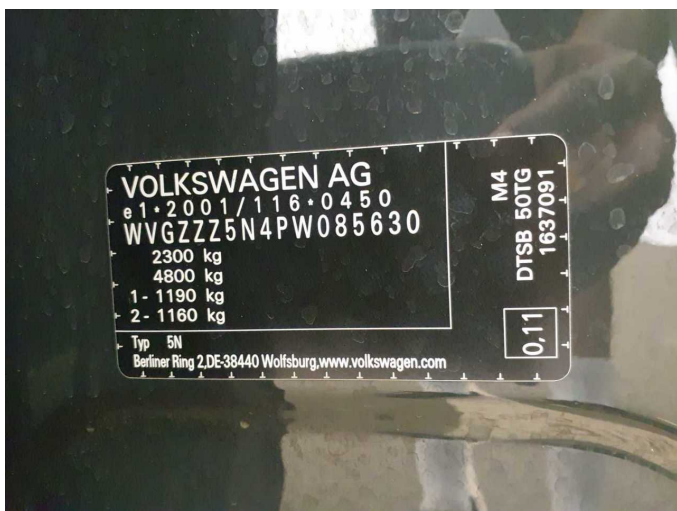
Figure 11: VIN

| VIN comparison | The vehicle identification number (VIN) was read from the vehicle and its conformity with the submitted documents was confirmed by the undersigned during the inspection. |

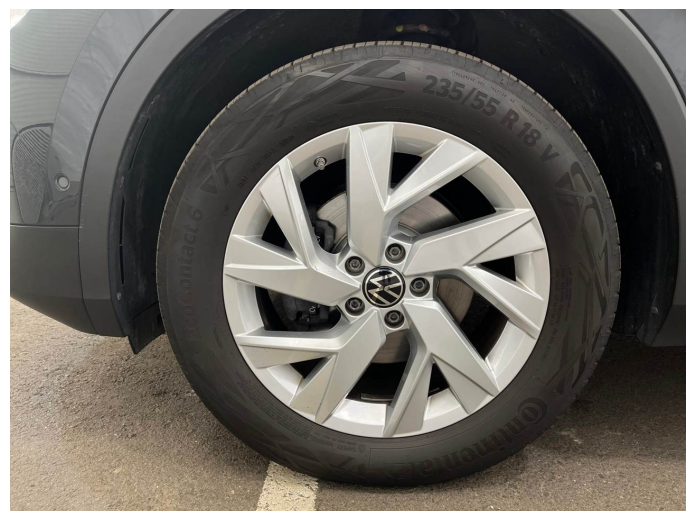
Figure 12: Mounted tyres

| Tyres | | | | |
|---|---|---|---|---|
| 1) | 235/55 R18 100V | Summer tyres on Light alloy | Continental | 5mm / 5mm |
| 2) | 235/55 R18 100V | Summer tyres on Light alloy | Continental | 5mm / 5mm |

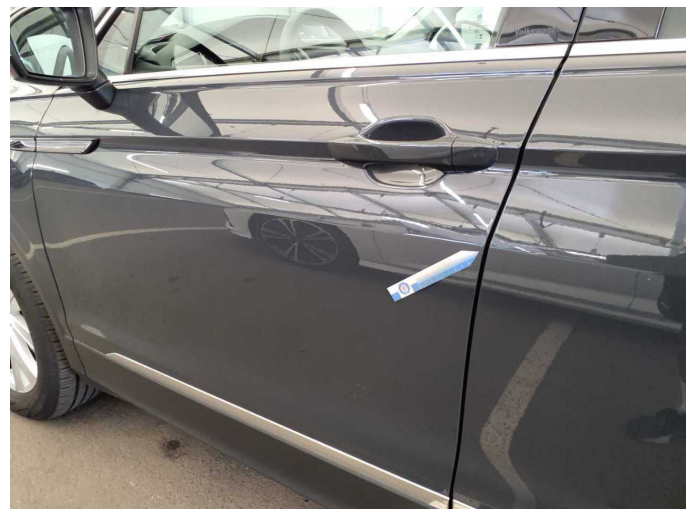
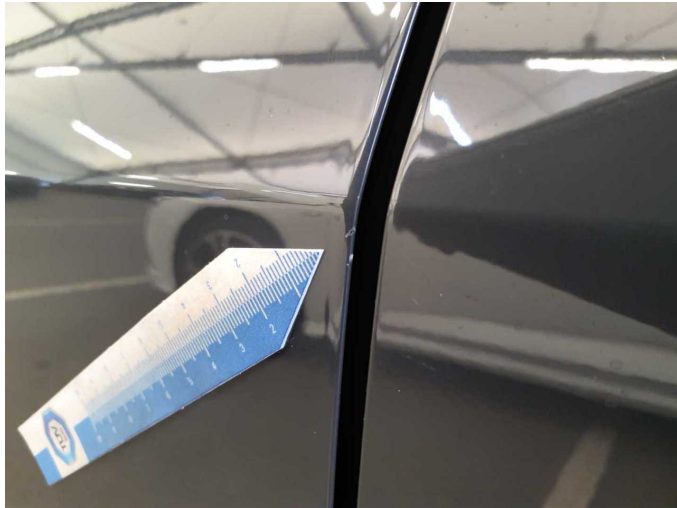
| No. | Component group | Description |
|---|---|---|
| 1 | Door - front left side | Door edge - Scratch(es) - Smart repair |

Damage 1: Door - front left side: Door edge - Scratch(es) - Smart repair

**Damage 1:** Door - front left side: Door edge - Scratch(es) - Smart repair

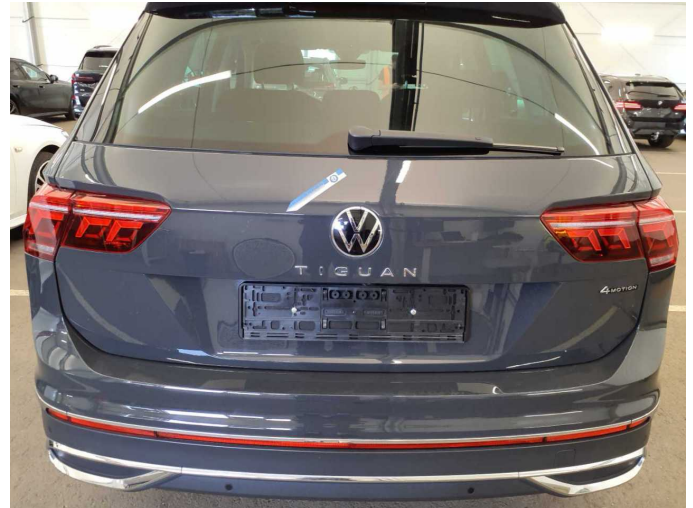
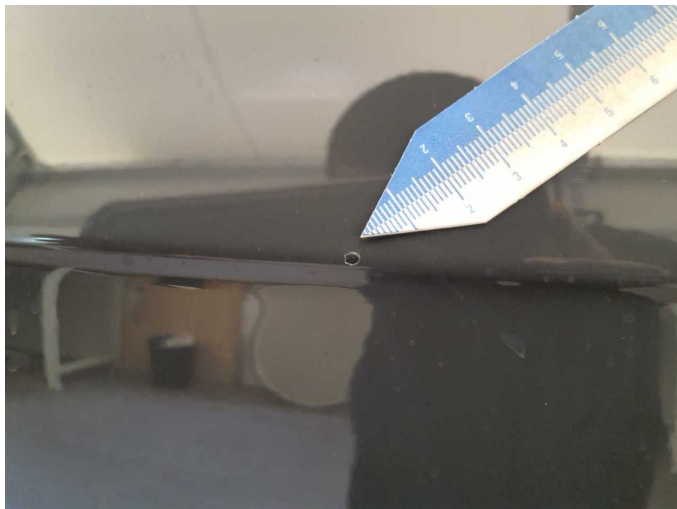
| No. | Component group | Description |
|---|---|---|
| 2 | Boot lid / rear door | Boot lid - Scratch(es) - Loss in value |

**Damage 2:** Boot lid / rear door: Boot lid - Scratch(es) - Loss in value
