Expertise

Protocol number: 46448872  
Order No. / Reference: 25933750  
Inspection date: 7 Jul 2026

Manufacturer: Mercedes-Benz  
VIN: W1VVLFEZ2T4559305

Model: Vito 116 CDI Tourer Lang Aut. PRO

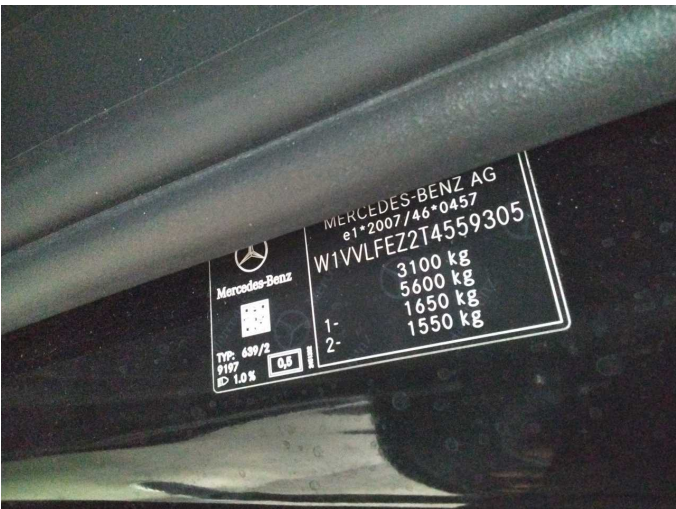
Figure 12: Mounted tyres

| VIN comparison | The vehicle identification number (VIN) was read from the vehicle and its conformity with the submitted documents was confirmed by the undersigned during the inspection. |

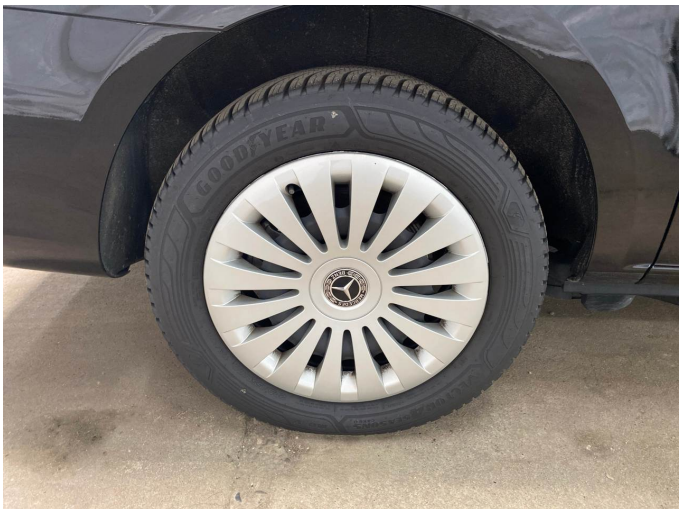
| # | Tyre size | Type of tyre | Manufacturer | Tread depth |
|---|---|---|---|---|
| 1) | 225/55 R17 107H | All-season tyres on Steel rim with wheel cover | Goodyear | 8mm / 8mm |
| 2) | 225/55 R17 107H | All-season tyres on Steel rim with wheel cover | Goodyear | 8mm / 8mm |

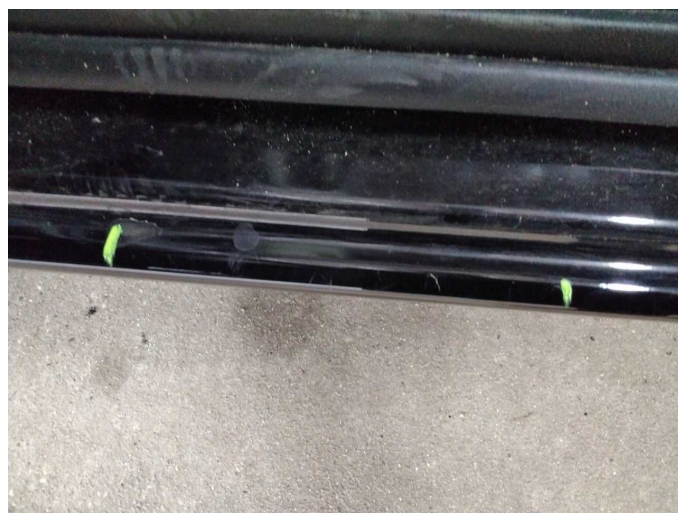
| No. | Component group | Description |
|---|---|---|
| 1 | Sill - left side | Sill - Scratch(es) - Smart repair |

**Damage 1:** Sill - left side: Sill - Scratch(es) - Smart repair

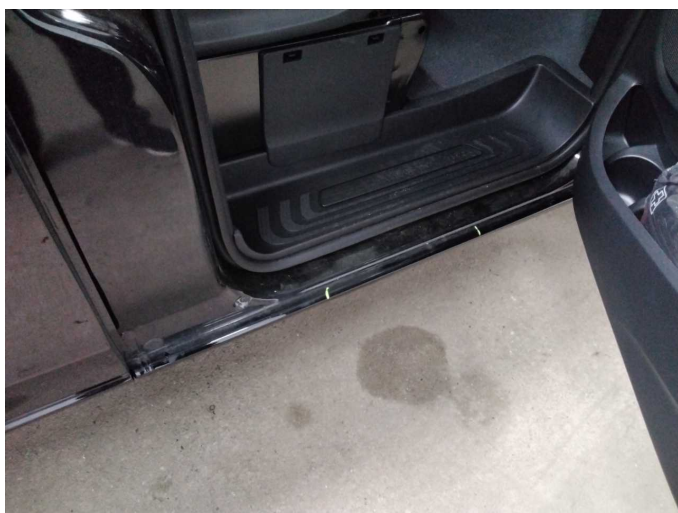
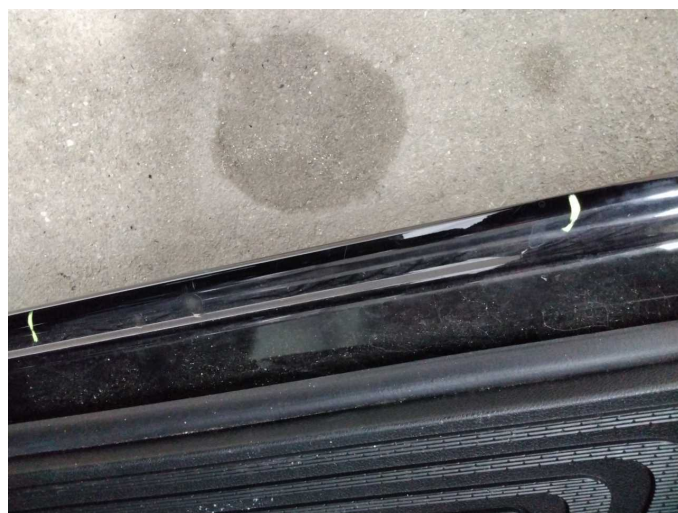
| No. | Component group | Description |
|---|---|---|
| 2 | Sill - right side | Sill - Scratch(es) - Smart repair |

**Damage 2:** Sill - right side: Sill - Scratch(es) - Smart repair

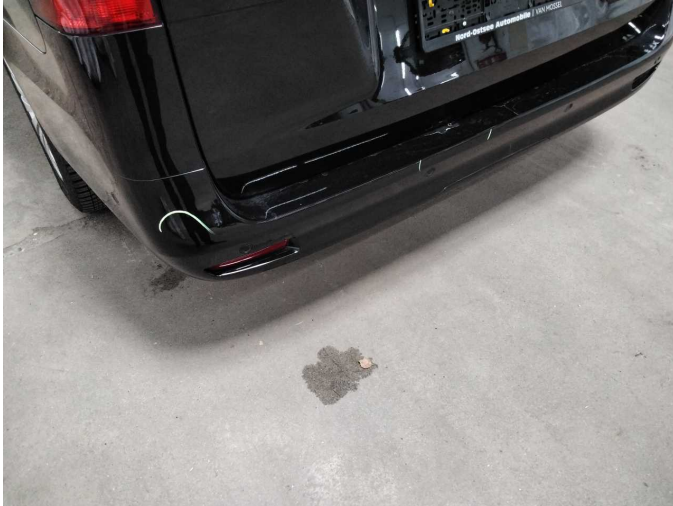
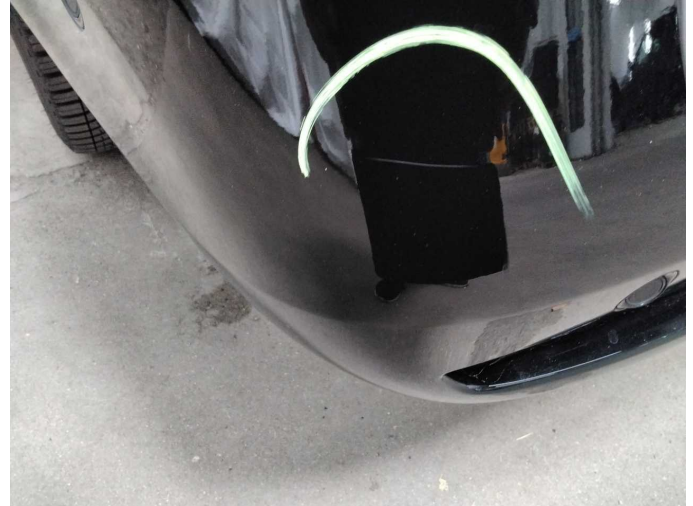
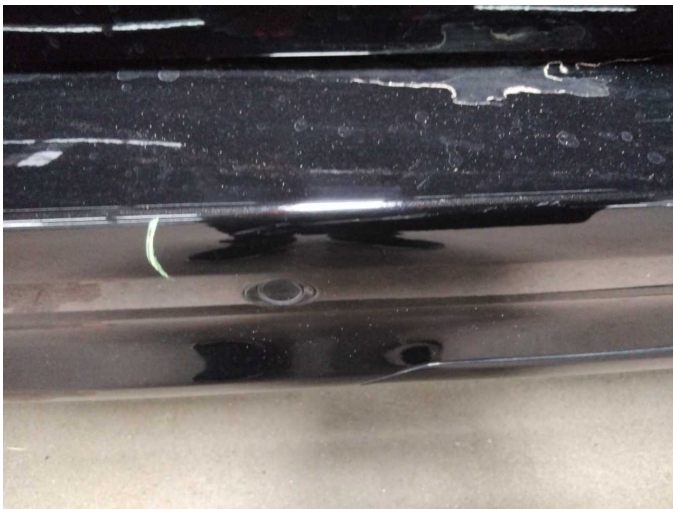
| No. | Component group | Description |
|---|---|---|
| 3 | Rear bumper | Rear bumper - Scratch(es) - Paint |

**Damage 3:** Rear bumper: Rear bumper - Scratch(es) - Paint
