Expertise

Protocol number: 46293212  
Order No. / Reference: 26588322  
Inspection date: 30 Jun 2026

Manufacturer: Ford

Model: Transit Custom 300 L1H1 LKW VA Trail

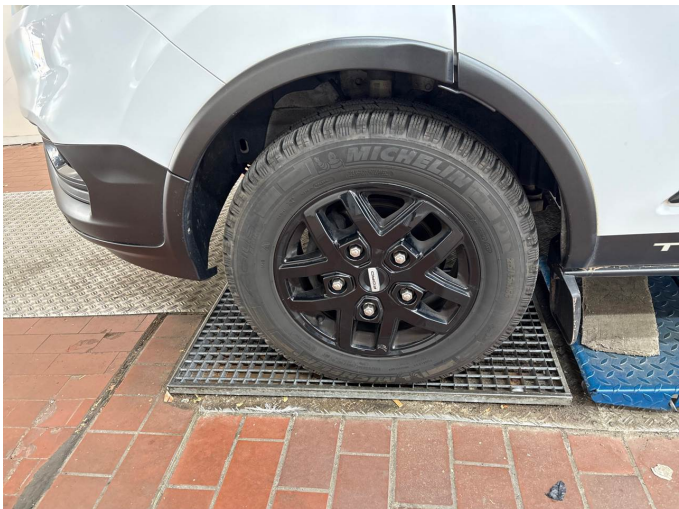
Figure 12: Mounted tyres

| # | Tyre size | Type of tyre | Manufacturer | Tread depth |
|---|---|---|---|---|
| 1) | 215/50 R16 109R | Winter tyres on Light alloy | Michelin | 6mm / 6mm |
| 2) | 215/50 R16 109R | Winter tyres on Light alloy | Michelin | 9mm / 9mm |

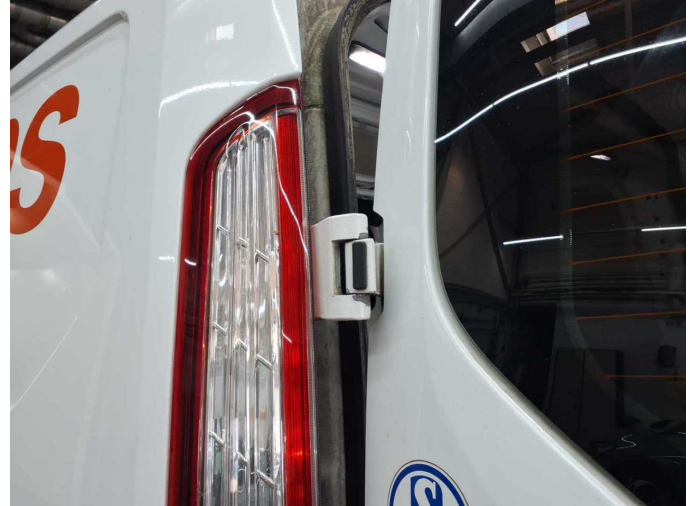
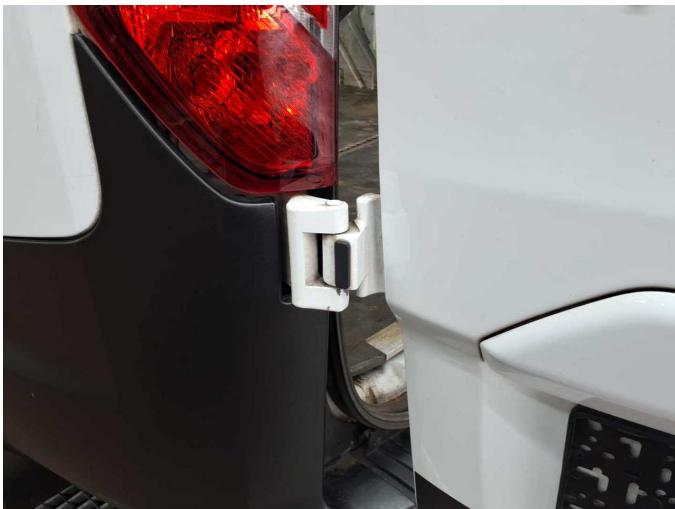
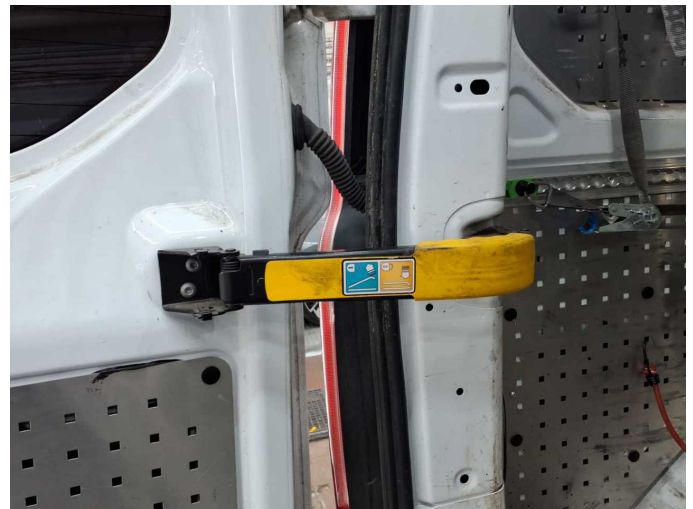
**Damage 1:** Boot lid / rear door: Rear door - left side (Öffnet sehr schwergängig) - Perform diagnosis

| No. | Component group | Description |
|---|---|---|
| 1 | Boot lid / rear door | Rear door - left side (Öffnet sehr schwergängig) - Perform diagnosis |

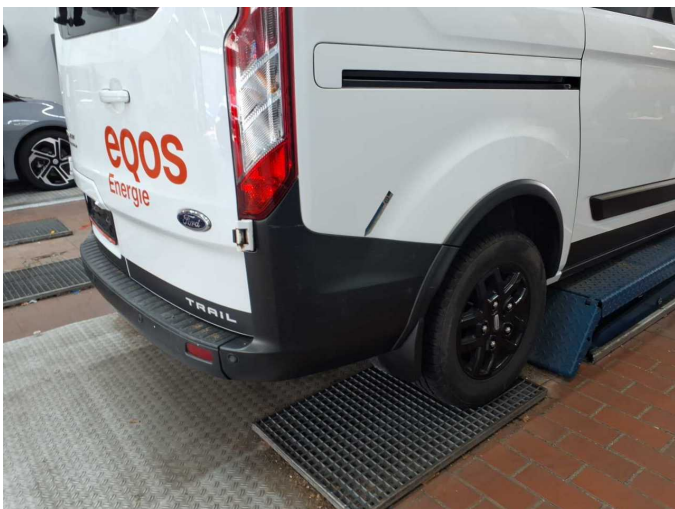
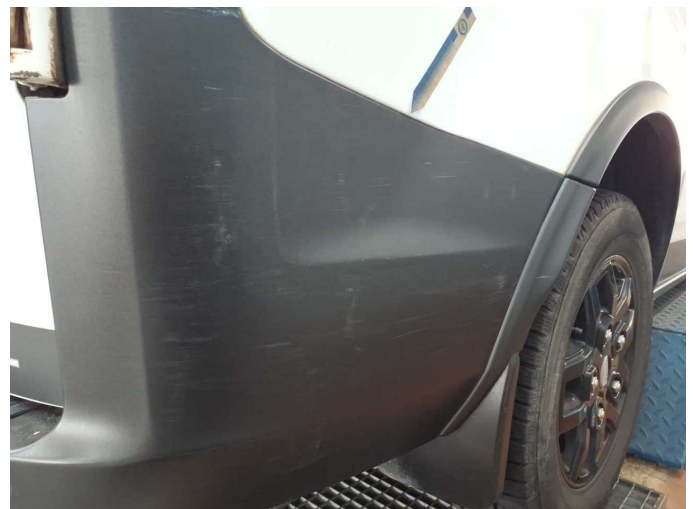
**Damage 2:** Rear bumper: Rear bumper - Scratch(es) - Loss in value

| No. | Component group | Description |
|---|---|---|
| 2 | Rear bumper | Rear bumper - Scratch(es) - Loss in value |

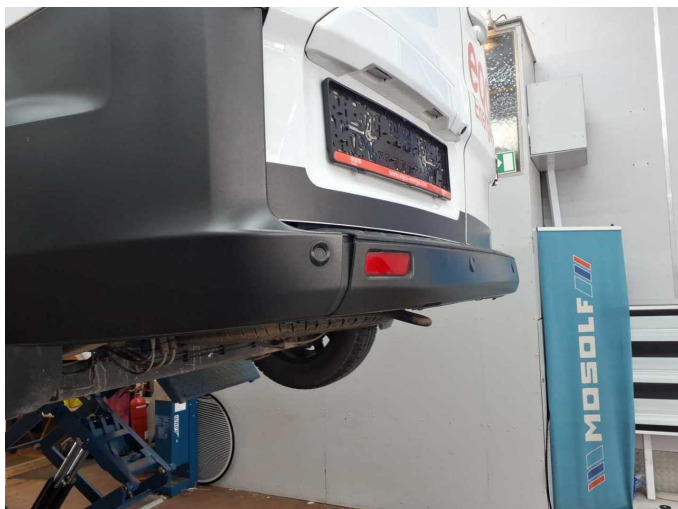
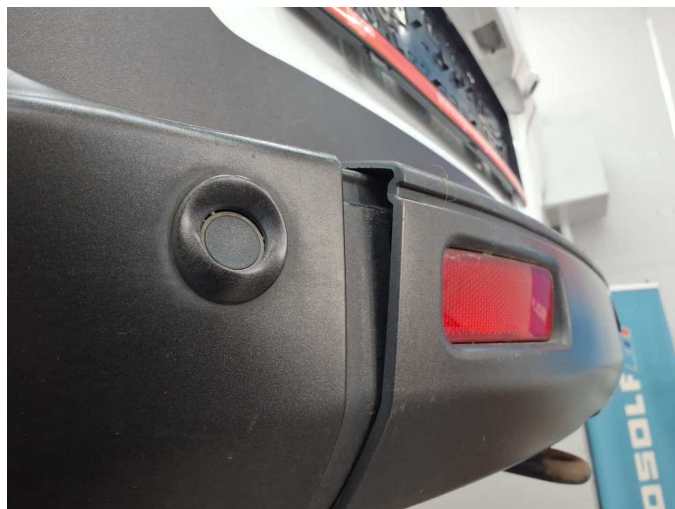
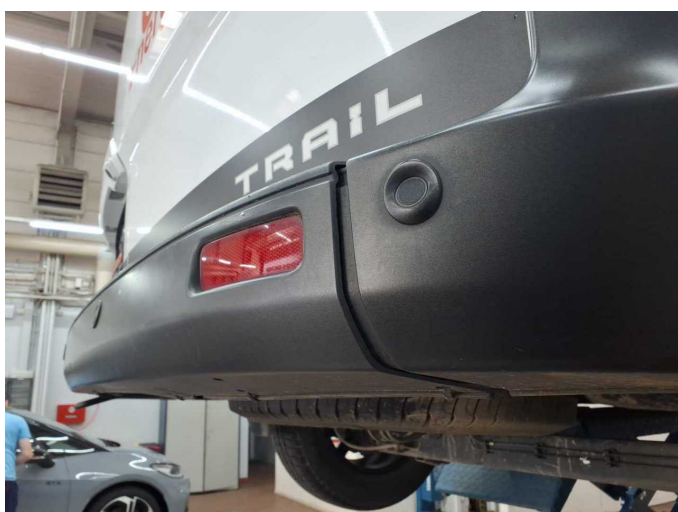
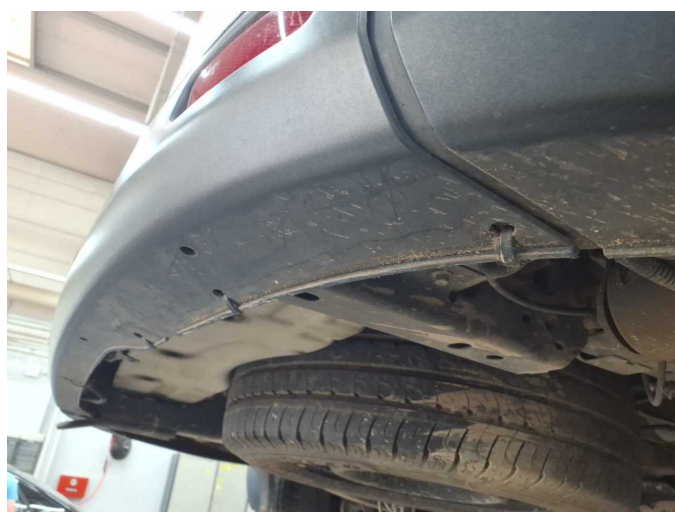
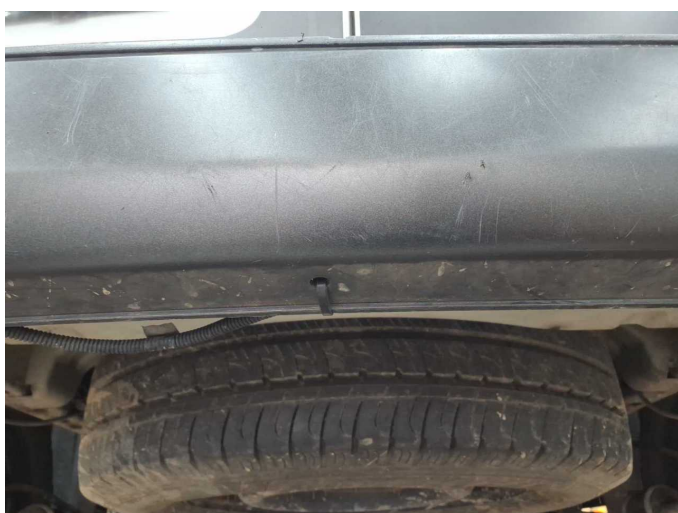
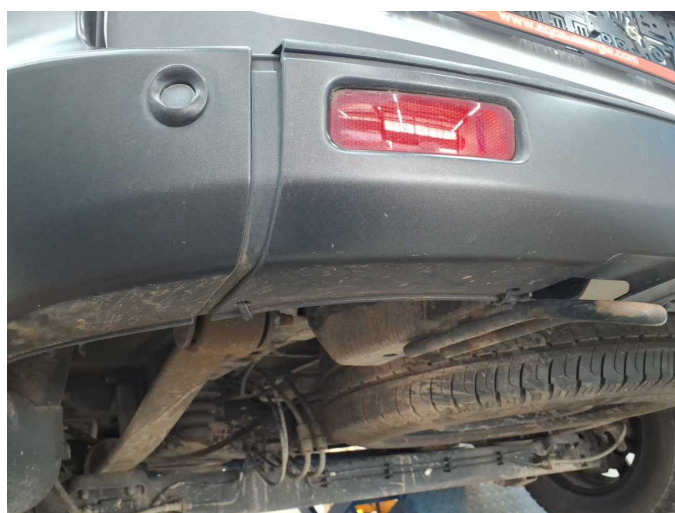
**Damage 3:** Rear bumper: Rear bumper - Loose - Repair

| No. | Component group | Description |
|---|---|---|
| 3 | Rear bumper | Rear bumper - Loose - Repair |

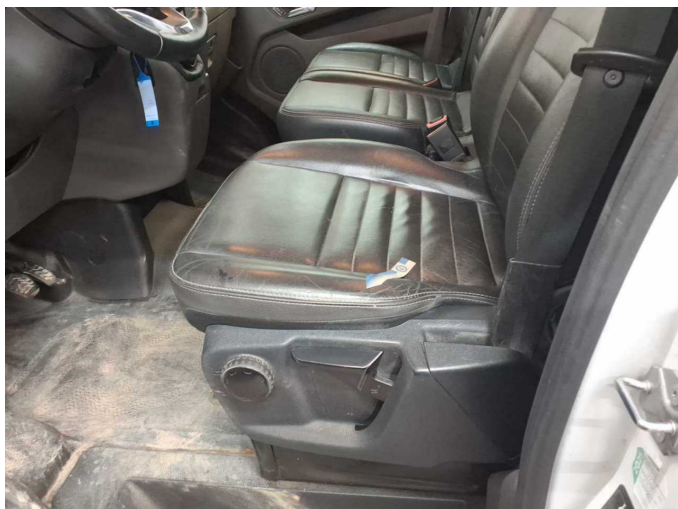
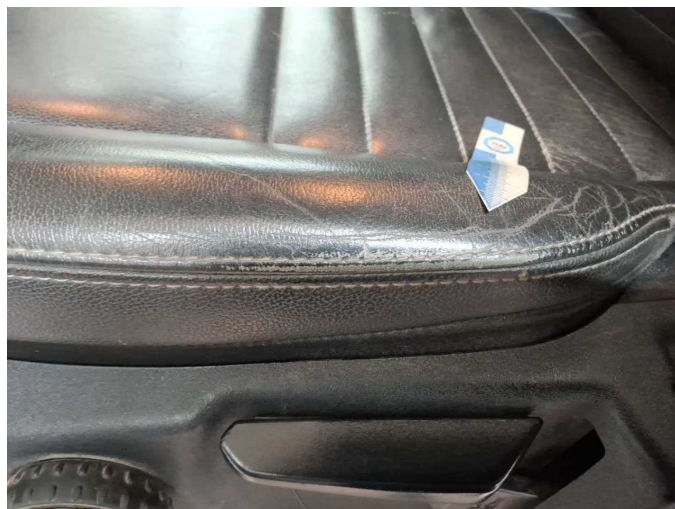
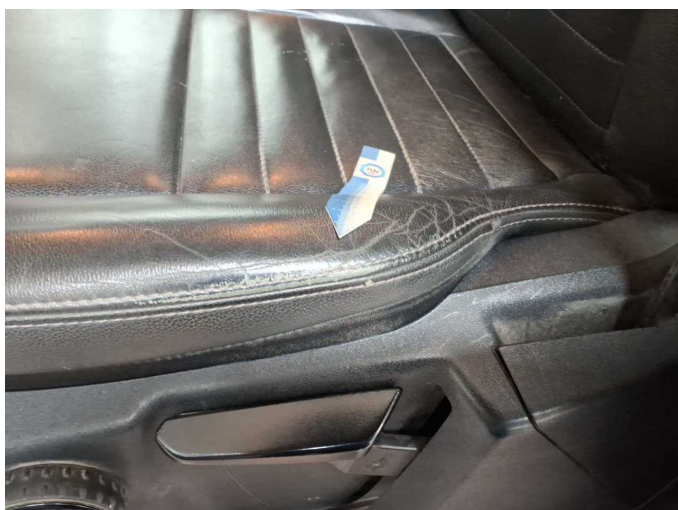
**Damage 4:** Seat - front: Seat cover - left side - Abrasion - Loss in value

| No. | Component group | Description |
|---|---|---|
| 4 | Seat - front | Seat cover - left side - Abrasion - Loss in value |

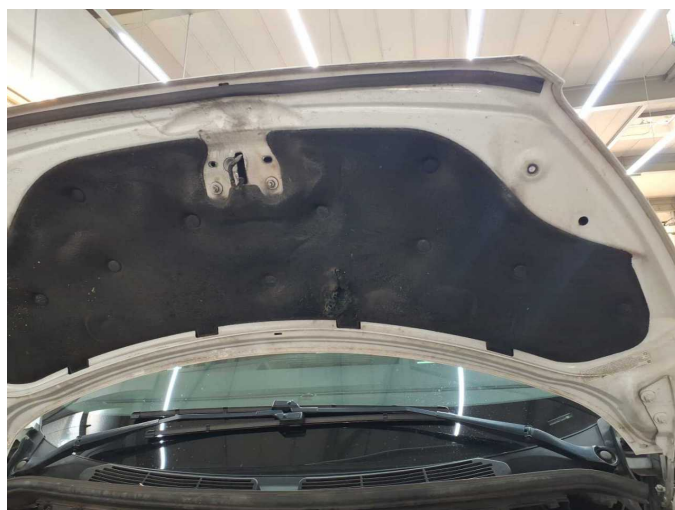
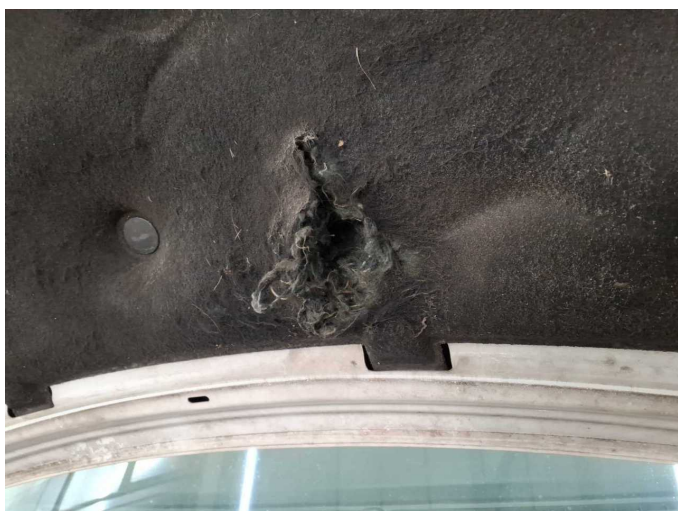
**Damage 5:** Bonnet: Insulation lining - Damage caused by marten / rodent - Replace

| No. | Component group | Description |
|---|---|---|
| 5 | Bonnet | Insulation lining - Damage caused by marten / rodent - Replace |

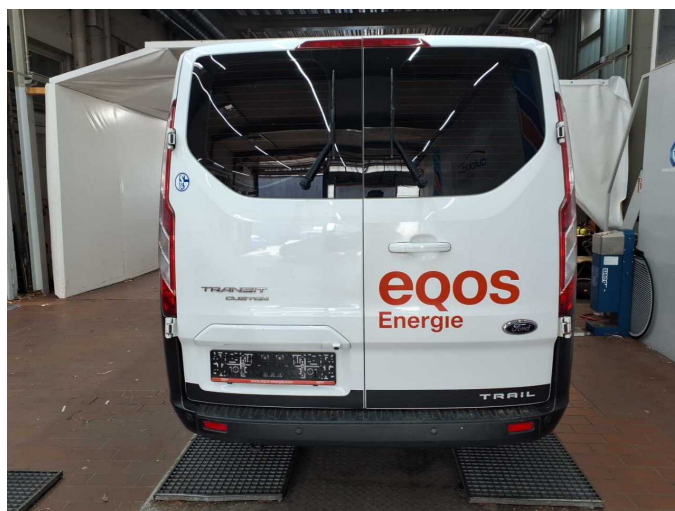
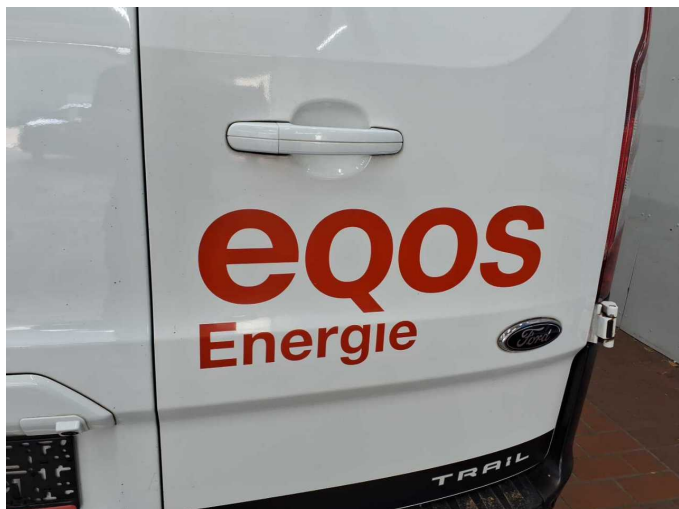
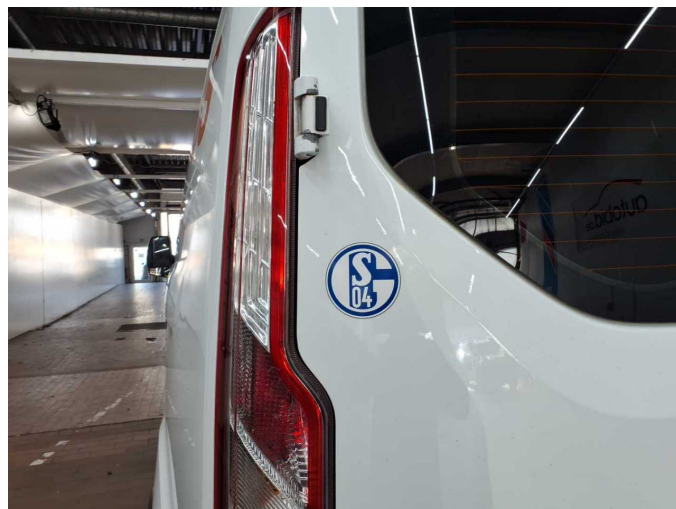
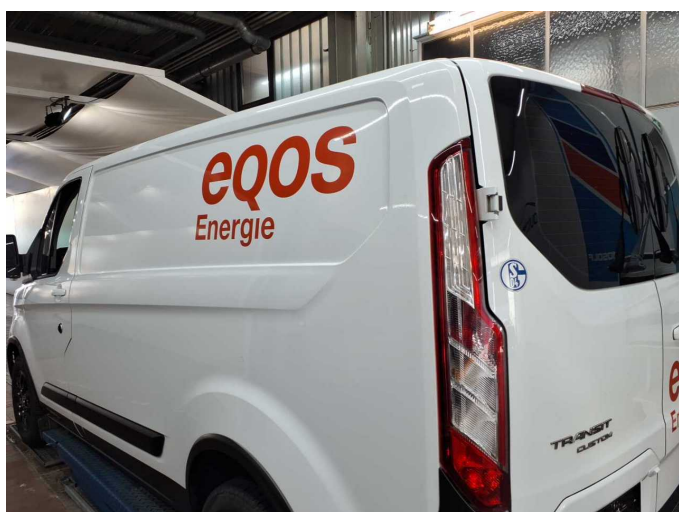
**Damage 6:** Body: Body - Glued / labelled - De-glue / neutralise

| No. | Component group | Description |
|---|---|---|
| 6 | Body | Body - Glued / labelled - De-glue / neutralise |

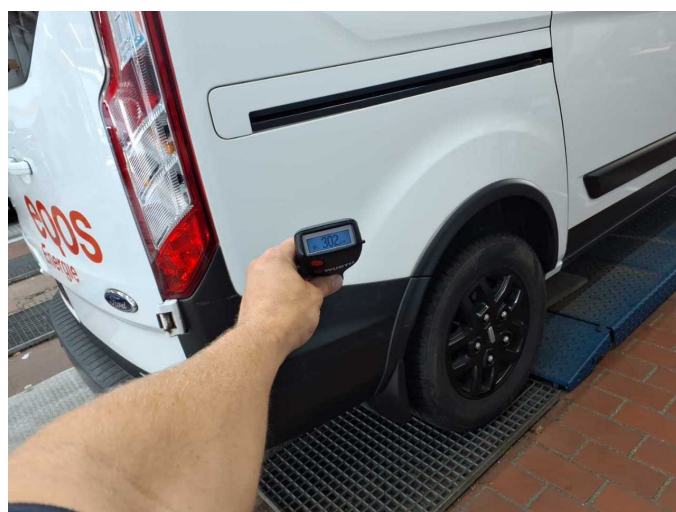
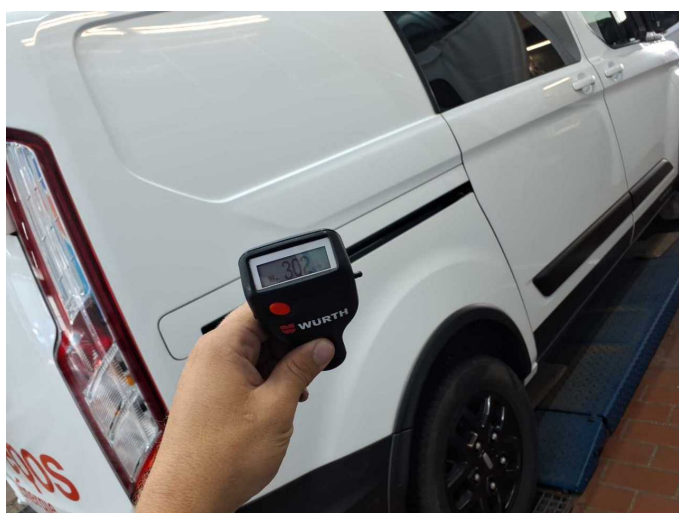
| No. | Repainting |
|---|---|
| 1 | Side panel - rear right side, Professionally carried out, Invoice of repair done Non-existent |

| Side panel - rear right side | 302 µm |

**Repainting 1:** Side panel - rear right side
