Protocol number: 45576652
Order No. / Reference: 26353779
Inspection date: 20 May 2026

Manufacturer: MAN

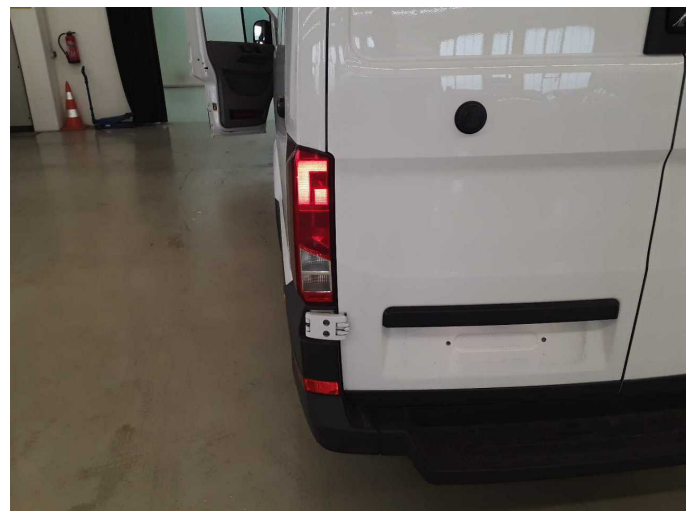
Damage 1: Tail light: Tail lamp - left side (Leuchtmittel Rücklicht) - Non-operational - Replace

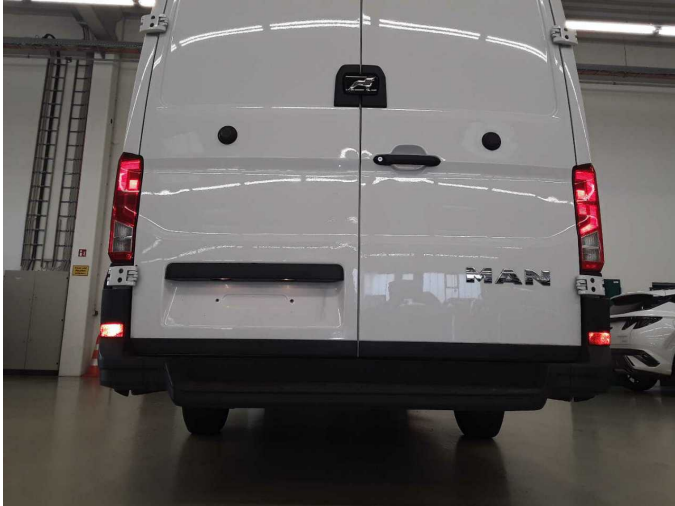
Damage 1: Tail light: Tail lamp - left side (Leuchtmittel Rücklicht) - Non-operational - Replace

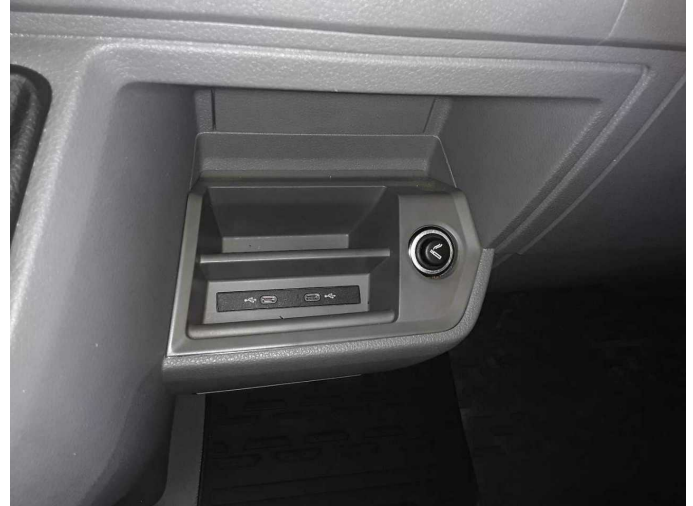
Missing part 1: Interior: Ashtray - front - Missing - Replace

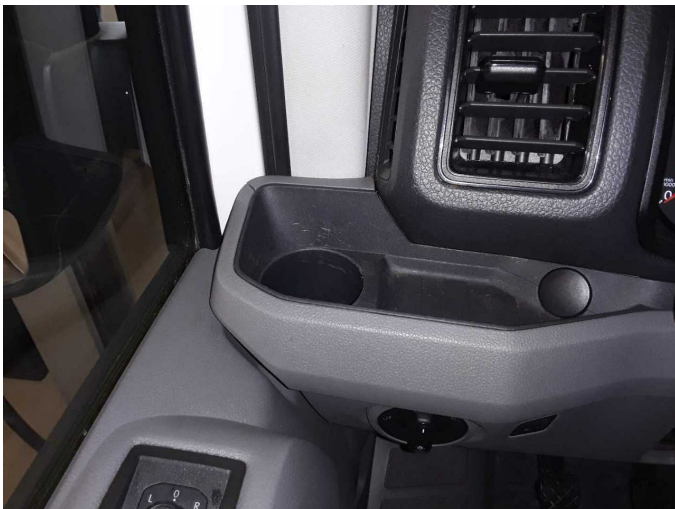
Missing part 1: Interior: Ashtray - front - Missing - Replace
