Expertise

Protocol number: 45506908
Order No. / Reference: 26287142
Inspection date: 19 May 2026

Manufacturer: Skoda

Model: Kodiaq 1.5 TSI mHEV DSG Selection

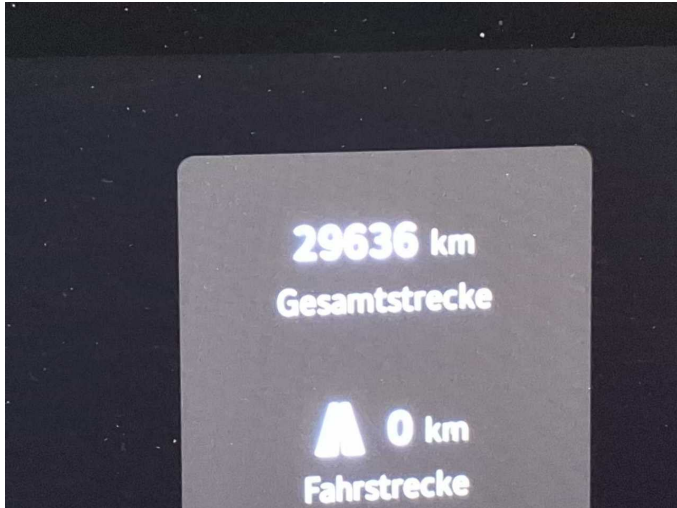
Figure 7: Instrument cluster

Mileage (Read) 29,636 km

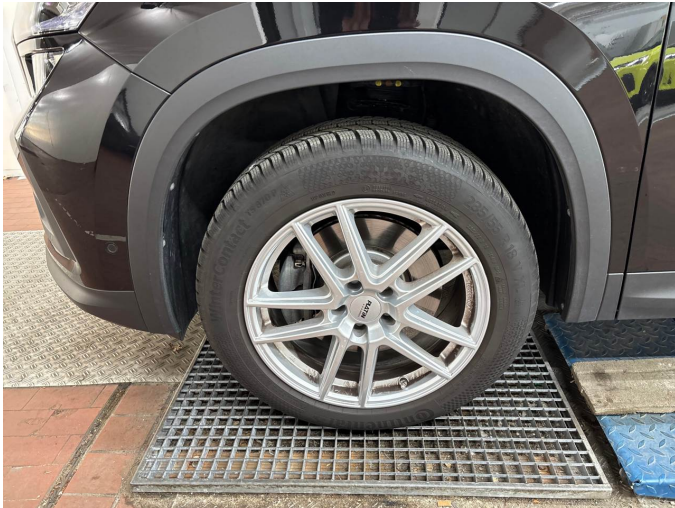
Figure 13: Mounted tyres

Mounted tyres				
#	Tyre size	Type of tyre	Manufacturer	Tread depth
1)	235/55 R18 104V	Winter tyres on Light alloy	Continental	6mm / 6mm
2)	235/55 R18 104V	Winter tyres on Light alloy	Continental	7mm / 7mm
Additional tyres				
#	Tyre size	Type of tyre	Manufacturer	Tread depth
1)	235/55 R18 100V	Summer tyres on Light alloy	Kumho	4mm / 4mm
2)	235/55 R18 100V	Summer tyres on Light alloy	Kumho	5mm / 5mm
Replacement				
Typ	Tyre size	Type of tyre	Manufacturer	Tread depth
N	145/85 R18 103T	Summer tyres on Steel	Sonstige	3 mm

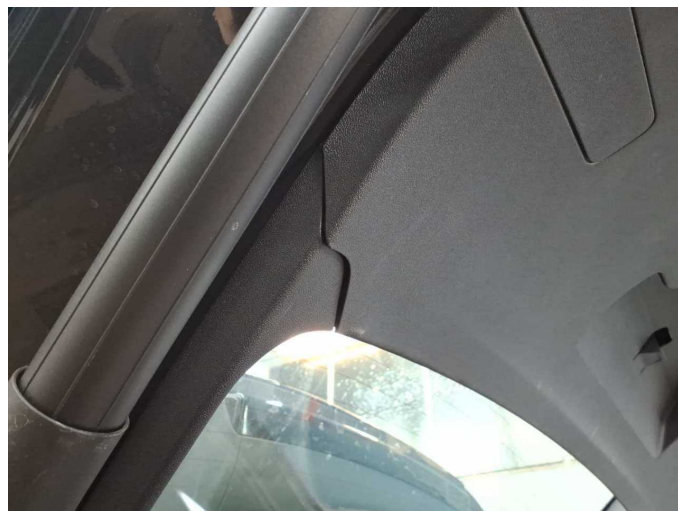
Damage 1: Trim / covers: Boot lid - interior trim - Loose - Repair

No.	Component group	Description
1	Trim / covers	Boot lid - interior trim - Loose - Repair
