Expertise

Protocol number: 46177366  
Order No. / Reference: 26571266  
Inspection date: 26 Jun 2026

Manufacturer: Volkswagen

Model: Passat Variant 2.0 TDI SCR DSG Business

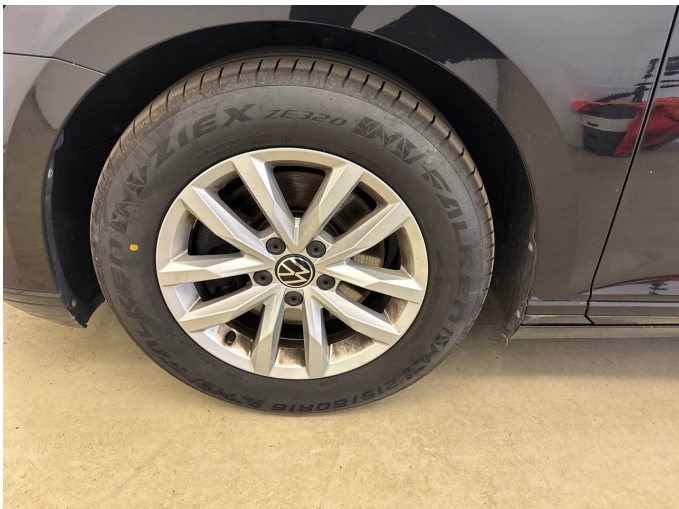
Figure 12: Mounted tyres

| # | Tyre size | Type of tyre | Manufacturer | Tread depth |
|---|---|---|---|---|
| 1) | 215/60 R16 95V | Summer tyres on Light alloy | Falken | 4mm / 4mm |
| 2) | 215/60 R16 95V | Summer tyres on Light alloy | Falken | 4mm / 4mm |

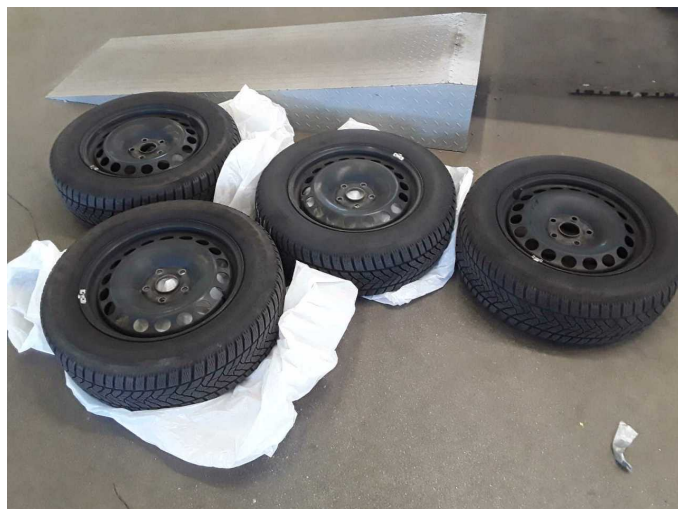
Figure 14: Additional tyres

| # | Tyre size | Type of tyre | Manufacturer | Tread depth |
|---|---|---|---|---|
| 1) | 215/60 R16 95H | Winter tyres on Steel | Dunlop | 6mm / 6mm |
| 2) | 215/60 R16 95H | Winter tyres on Steel | Dunlop | 5mm / 5mm |

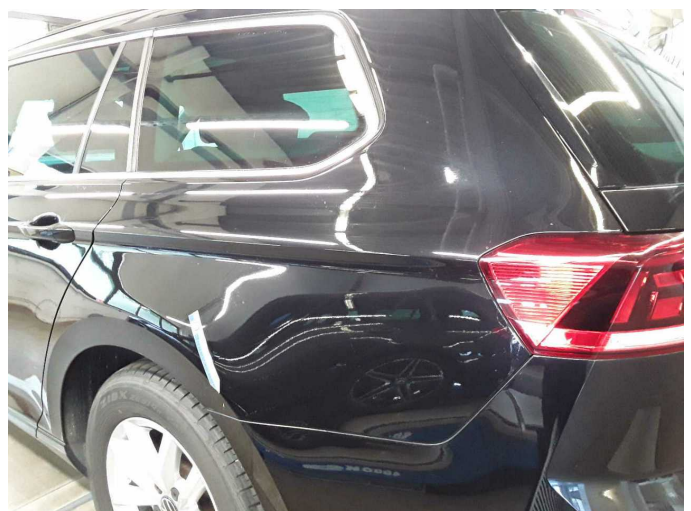
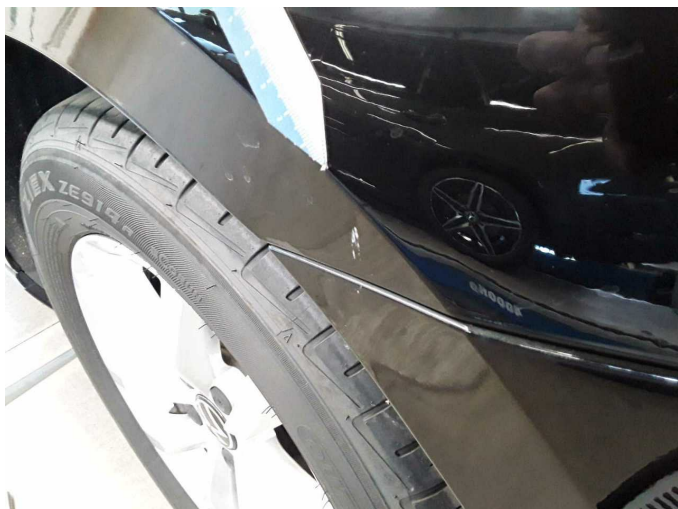
| No. | Component group | Description |
|---|---|---|
| 1 | Side panel - rear left side | Side panel - Scratch(es) - Smart repair |

**Damage 1:** Side panel - rear left side: Side panel - Scratch(es) - Smart repair

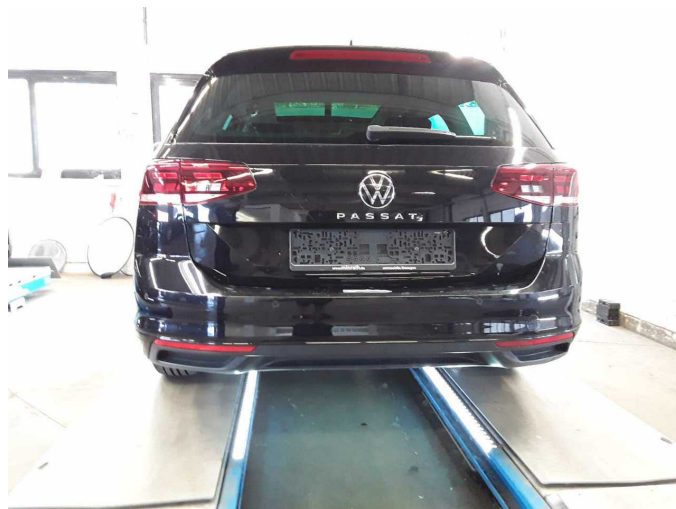
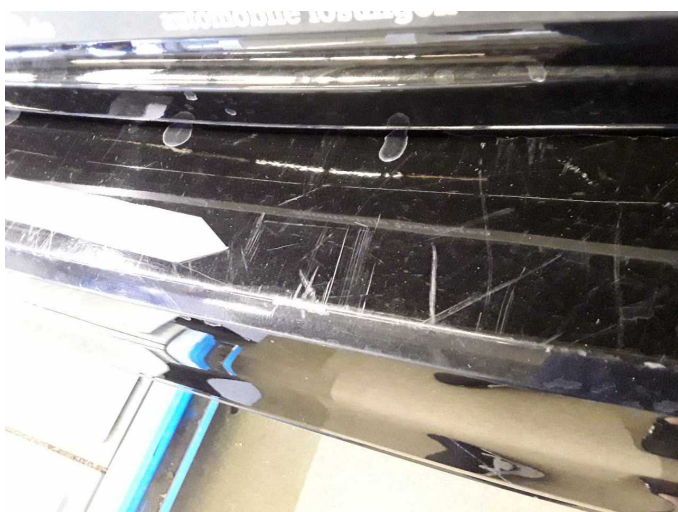
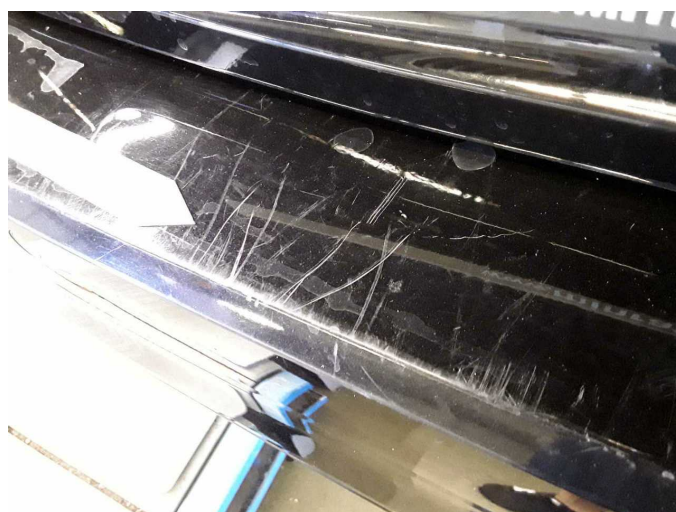
| No. | Component group | Description |
|---|---|---|
| 2 | Rear bumper | Rear bumper - Scratch(es) - Paint |

**Damage 2:** Rear bumper: Rear bumper - Scratch(es) - Paint

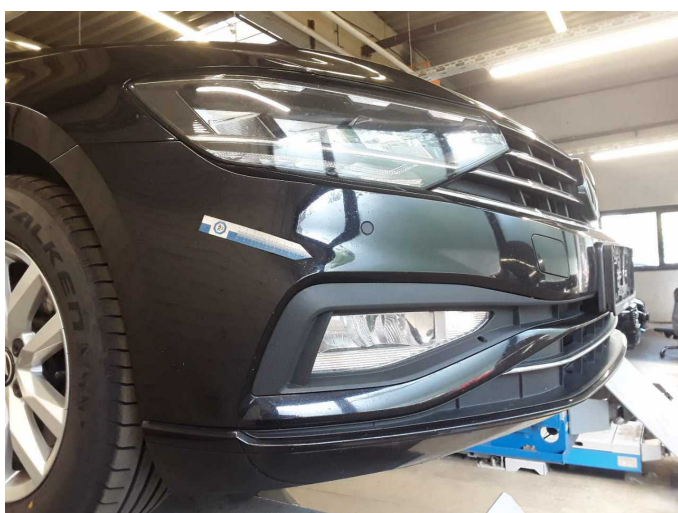
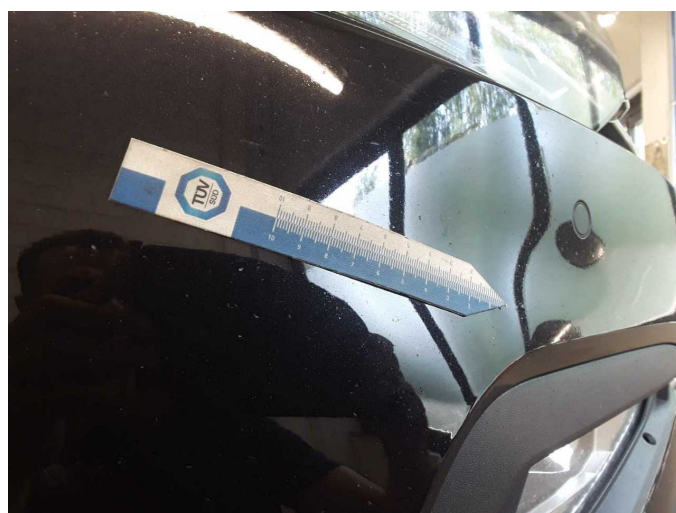
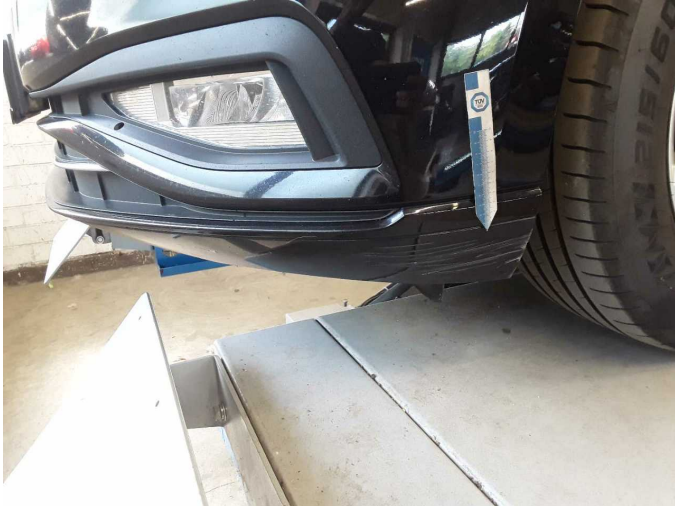
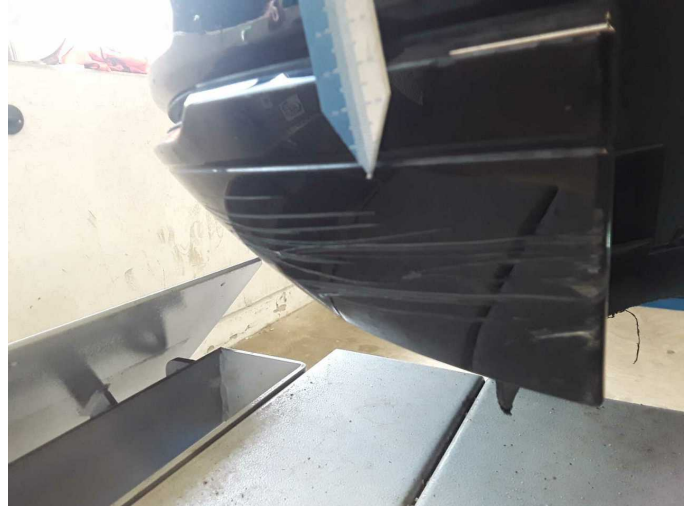
| No. | Component group | Description |
|---|---|---|
| 3 | Front bumper | Front bumper - Scratched - Paint |

**Damage 3:** Front bumper: Front bumper - Scratched - Paint

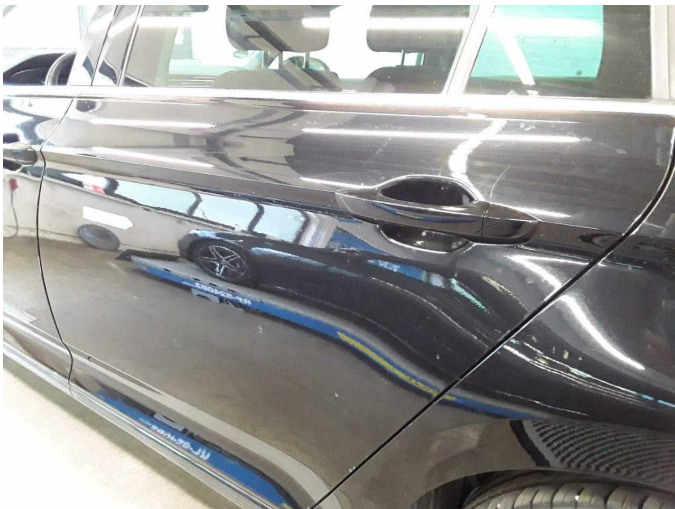
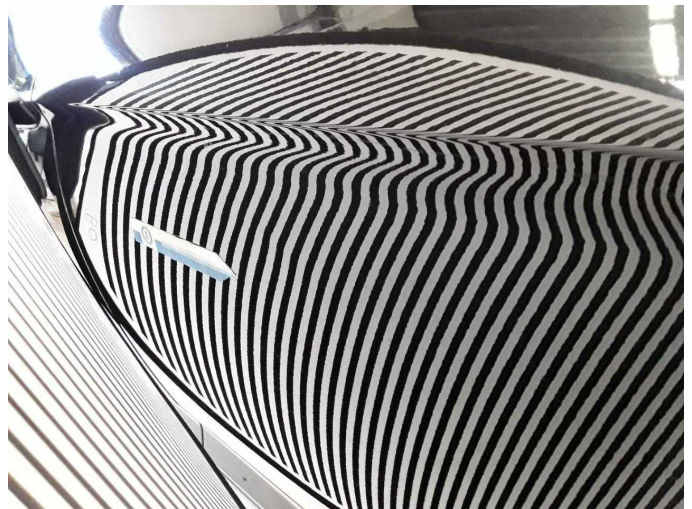
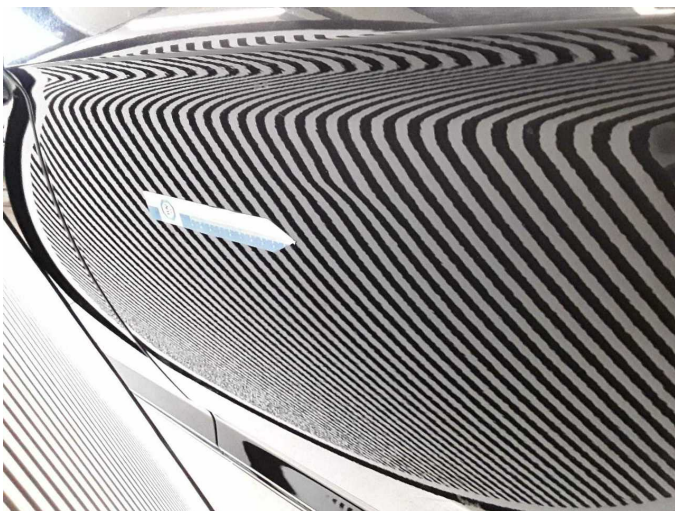
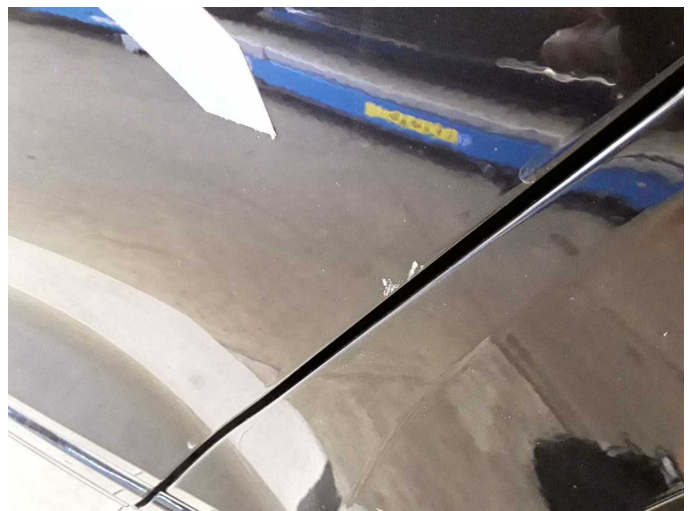
| No. | Component group | Description |
|---|---|---|
| 4 | Door - rear left side | Door - Dent / paintcoat damage - Repair and paint |

**Damage 4:** Door - rear left side: Door - Dent / paintcoat damage - Repair and paint

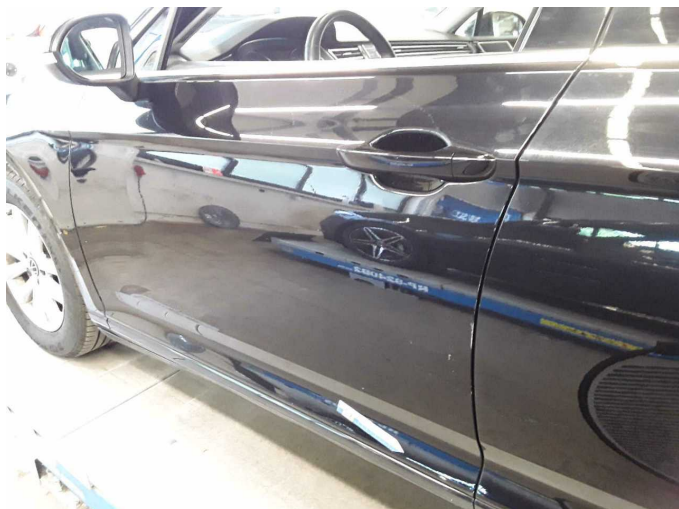
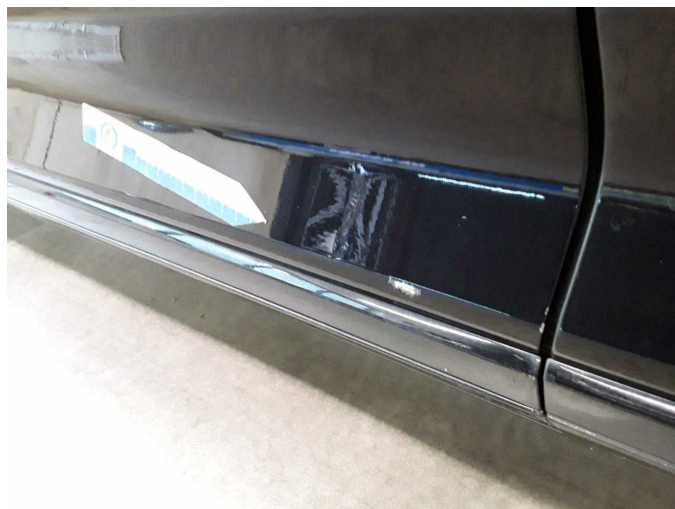
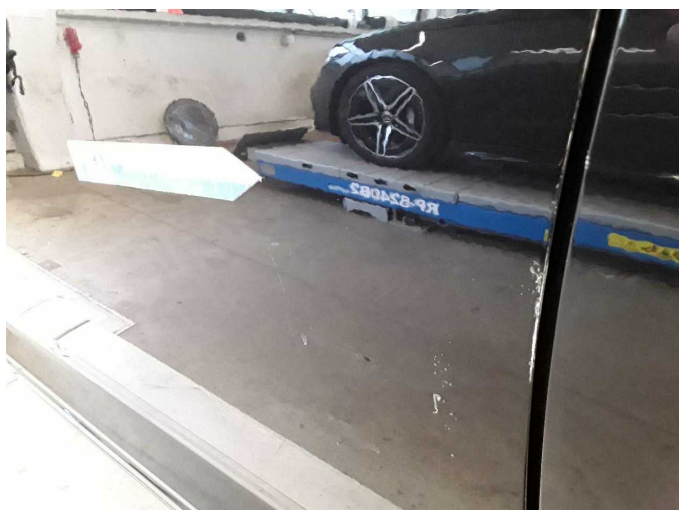
| No. | Component group | Description |
|---|---|---|
| 5 | Door - front left side | Door - Scratch(es) - Paint |

**Damage 5:** Door - front left side: Door - Scratch(es) - Paint

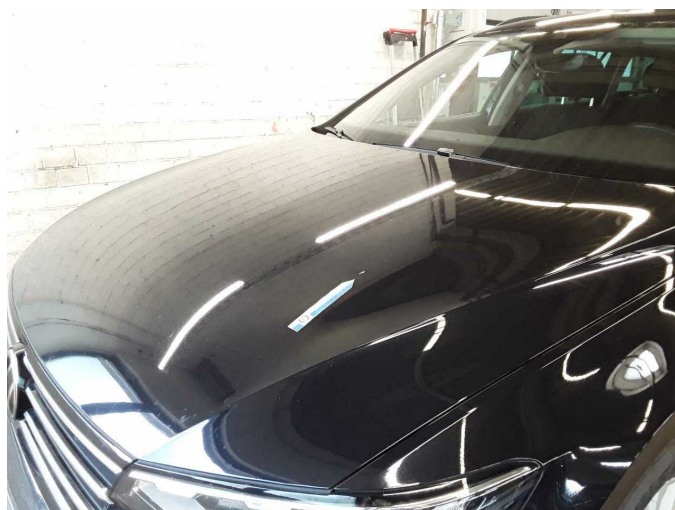
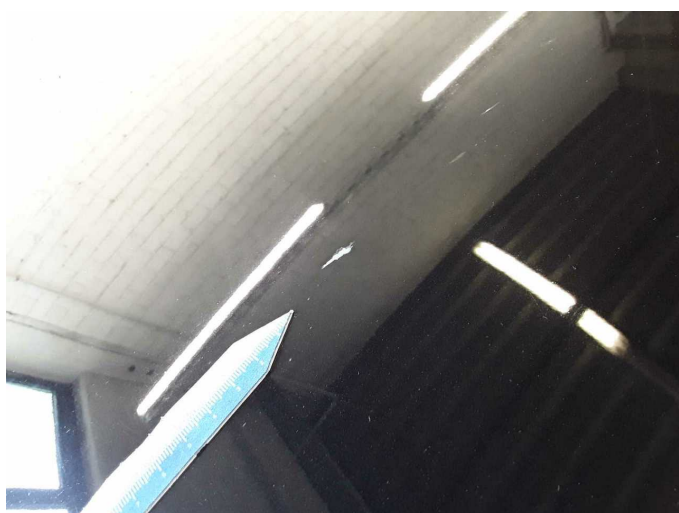
| No. | Component group | Description |
|---|---|---|
| 6 | Bonnet | Bonnet - Scratch(es) - Paint |

**Damage 6:** Bonnet: Bonnet - Scratch(es) - Paint

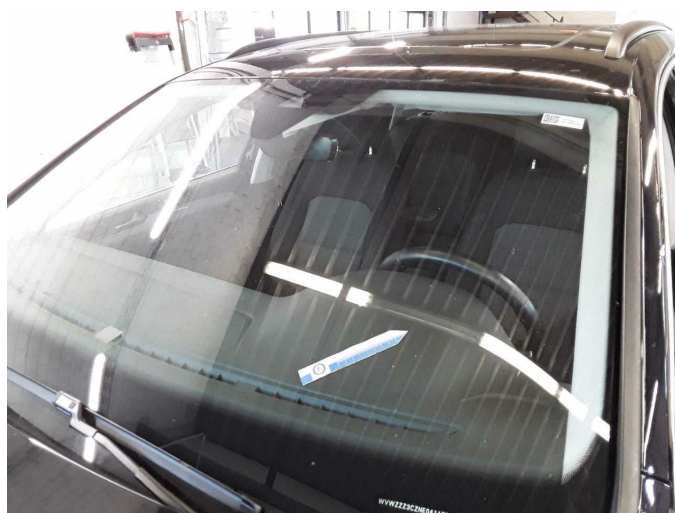
| No. | Component group | Description |
|---|---|---|
| 1 | Vehicle glazing | Windscreen - Stone chips - No deduction |

**Wear and tear 1:** Vehicle glazing: Windscreen - Stone chips - No deduction
