Expertise

Protocol number: 45612137  
Order No. / Reference: 26367396-1  
Inspection date: 18 May 2026

Manufacturer: Skoda  
VIN: TMBJJ8NX1PY098313

Model: Octavia Combi 2.0 TDI Style

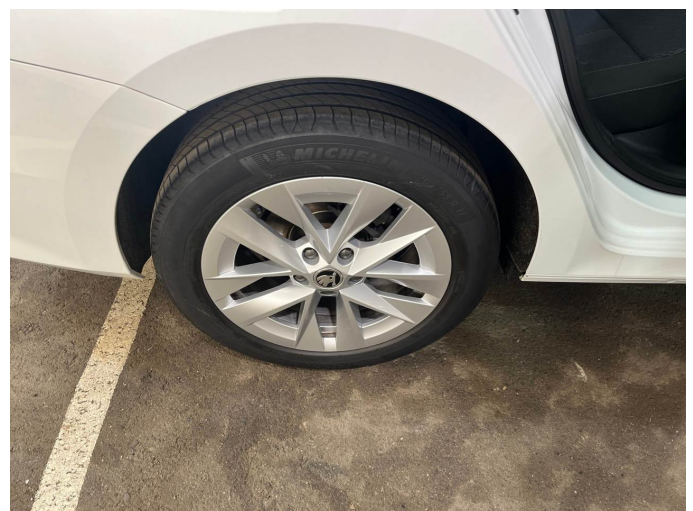
Figure 12: Mounted tyres

| # | Tyre size | Type of tyre | Manufacturer | Tread depth |
|---|---|---|---|---|
| 1) | 205/55 R17 91V | Summer tyres on Light alloy | Michelin | 5mm / 5mm |
| 2) | 205/55 R17 91V | Summer tyres on Light alloy | Michelin | 6mm / 6mm |

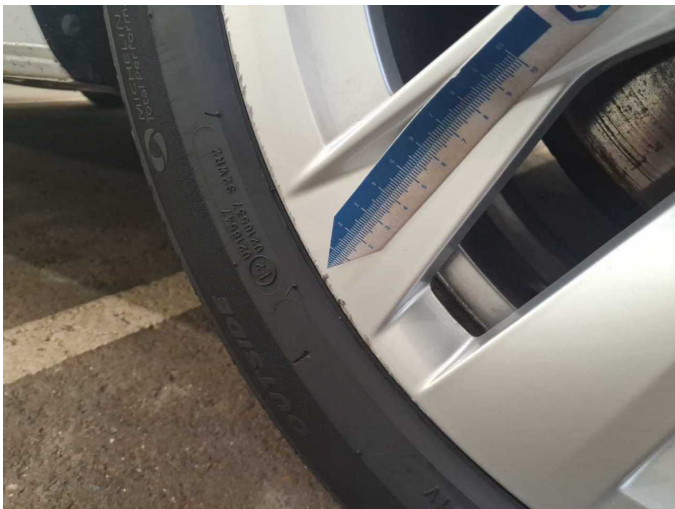
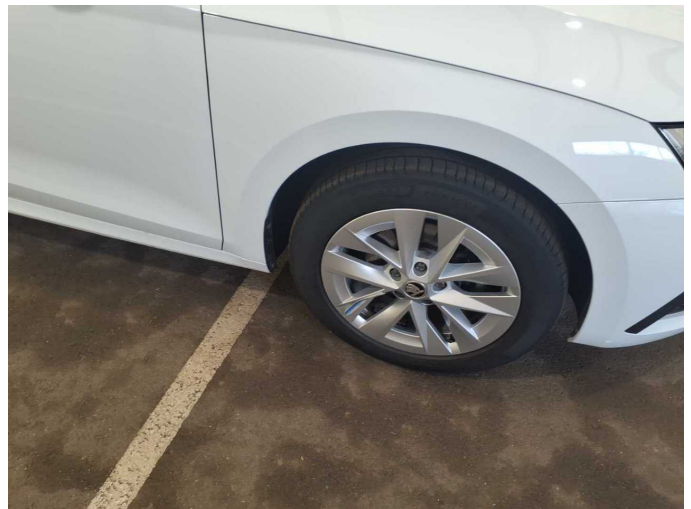
**Damage 1:** Wheel / tyres: Alloy rim - front right side - Scratched - Loss in value

| No. | Component group | Description |
|---|---|---|
| 1 | Wheel / tyres | Alloy rim - front right side - Scratched - Loss in value |

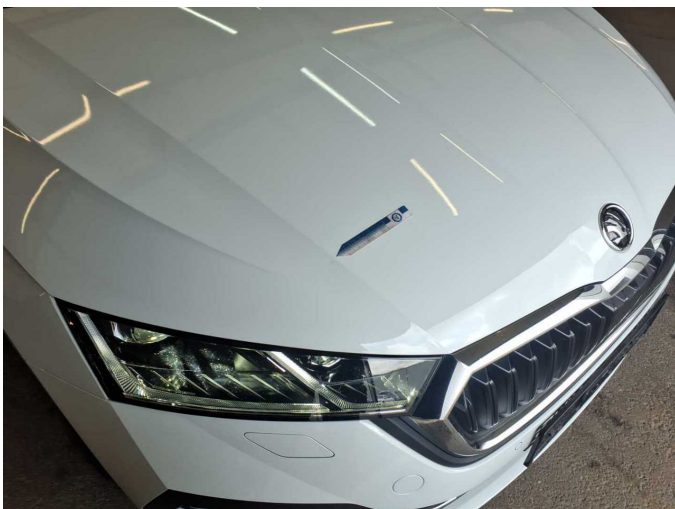
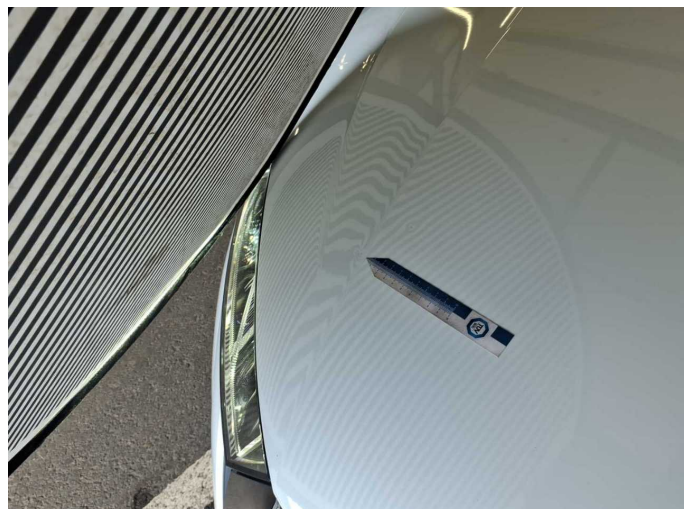
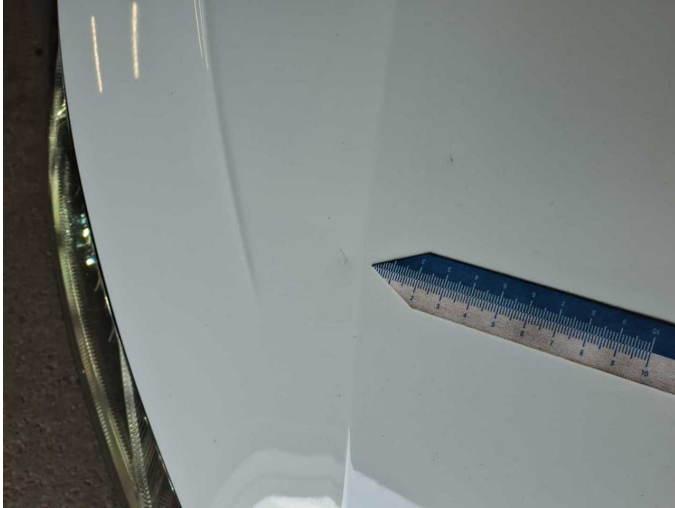
**Damage 2:** Bonnet: Bonnet - Dent / paintcoat damage - Paint

| No. | Component group | Description |
|---|---|---|
| 2 | Bonnet | Bonnet - Dent / paintcoat damage - Paint |

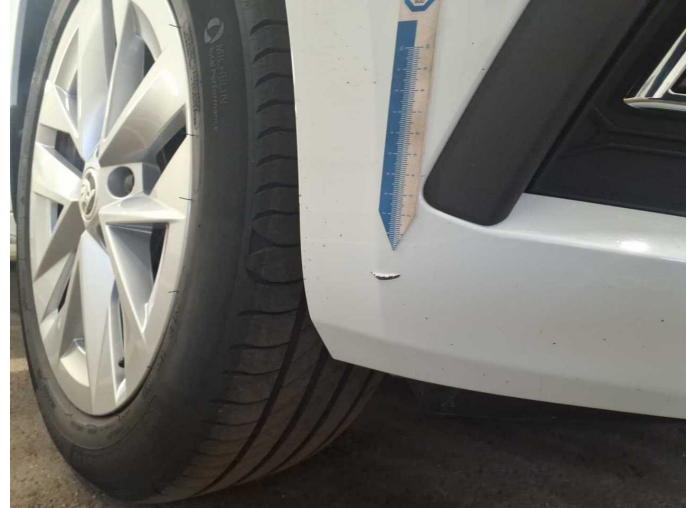
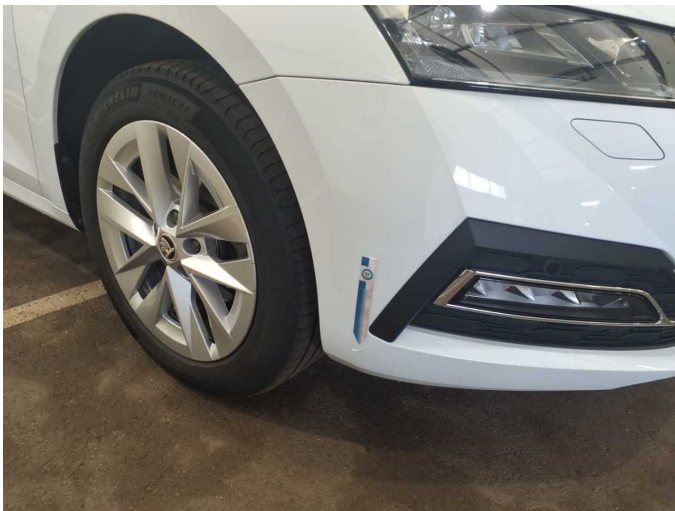
**Damage 3:** Front bumper: Front bumper - Scratch(es) - Paint

| No. | Component group | Description |
|---|---|---|
| 3 | Front bumper | Front bumper - Scratch(es) - Paint |
