Expertise

Protocol number: 46845995  
Order No. / Reference: 26772613  
Inspection date: 3 Aug 2026

| Manufacturer: Polestar | Model: 2 Dual Motor 78kWh |

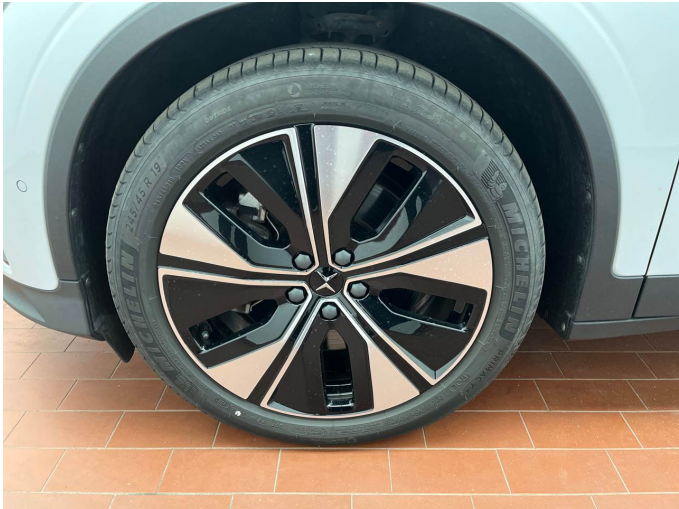
Figure 12: Mounted tyres

| Mounted tyres | | | | |
|---|---|---|---|---|
| 1) | 245/45 R19 102V | Summer tyres on Light alloy | Michelin | 6mm / 6mm |
| 2) | 245/45 R19 102V | Summer tyres on Light alloy | Michelin | 6mm / 6mm |

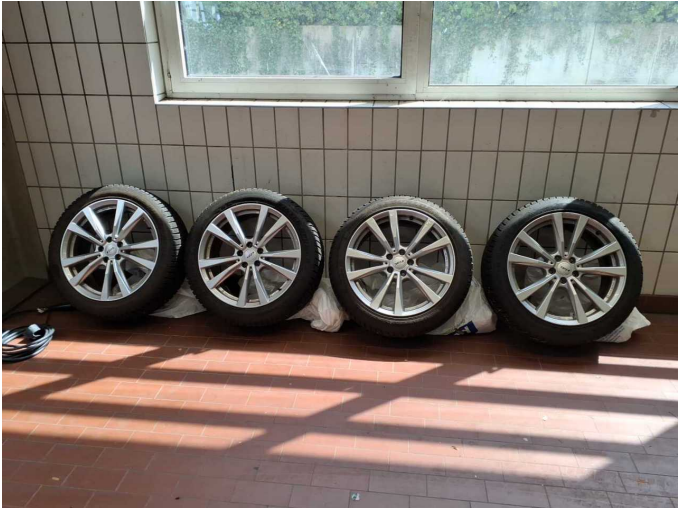
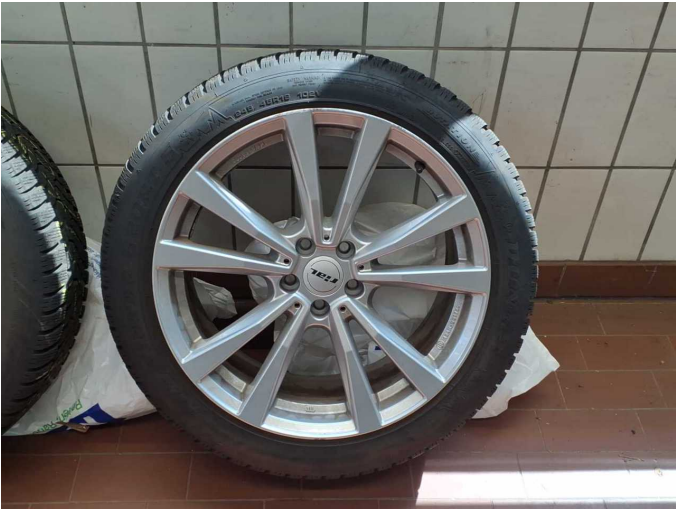
Figure 16: Additional tyres

| Mounted tyres | | | | |
|---|---|---|---|---|
| 1) | 245/45 R19 102V | Winter tyres on Light alloy | Dunlop | 8mm / 8mm |
| 2) | 245/45 R19 102V | Winter tyres on Light alloy | Dunlop | 8mm / 8mm |

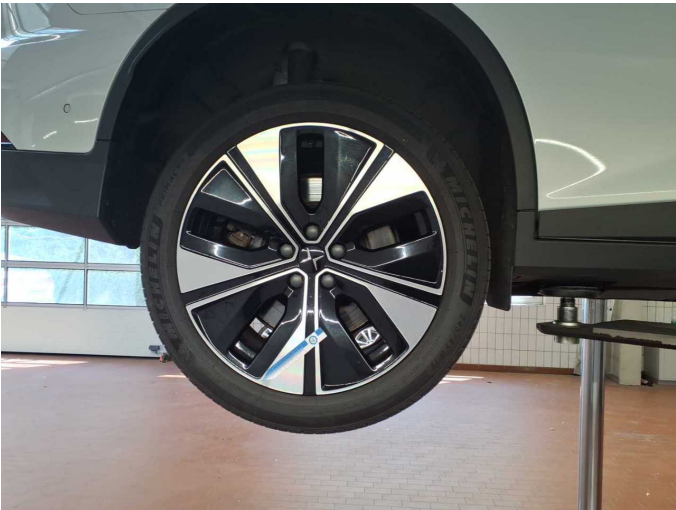
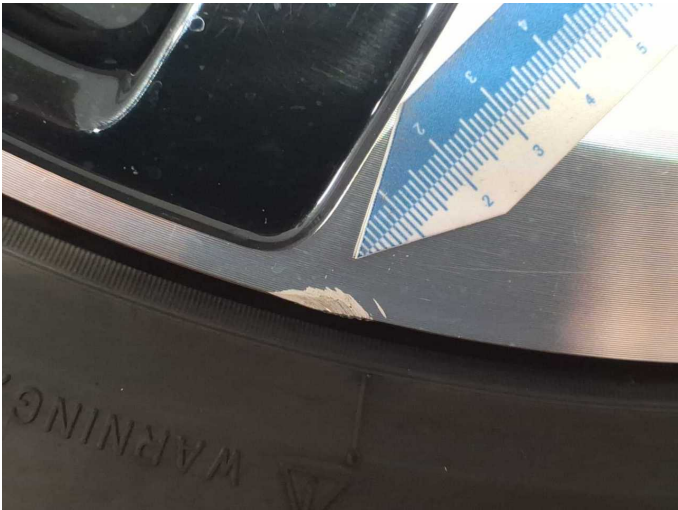
| No. | Component group | Description |
|---|---|---|
| 1 | Wheel / tyres | Alloy rim - rear right side - Scratched - Loss in value |

Damage 1: Wheel / tyres: Alloy rim - rear right side - Scratched - Loss in value

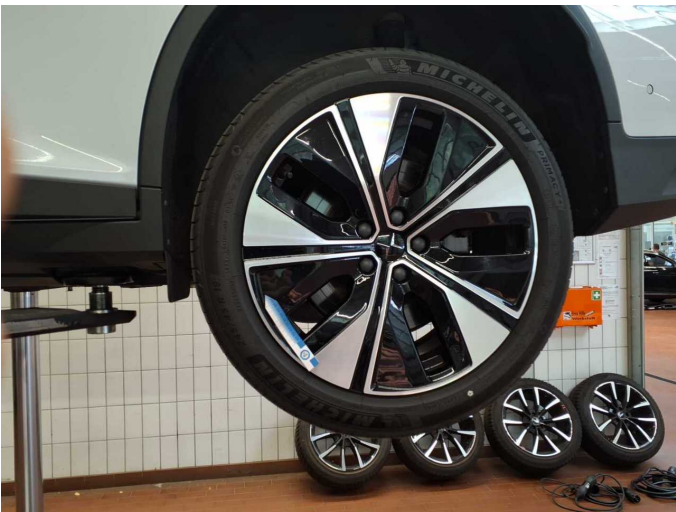
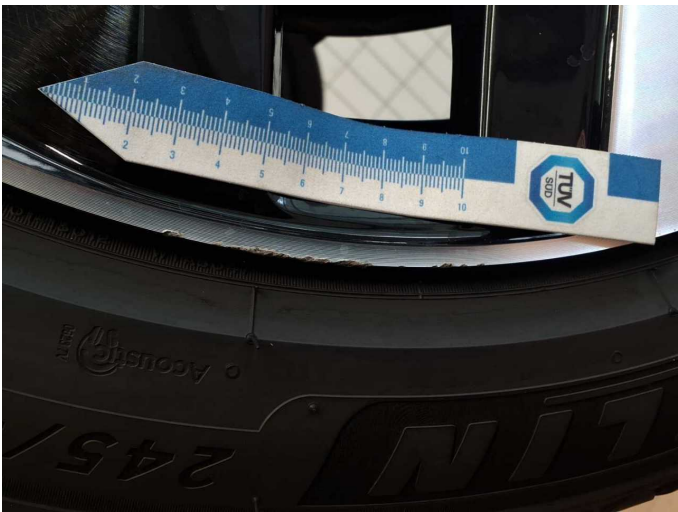
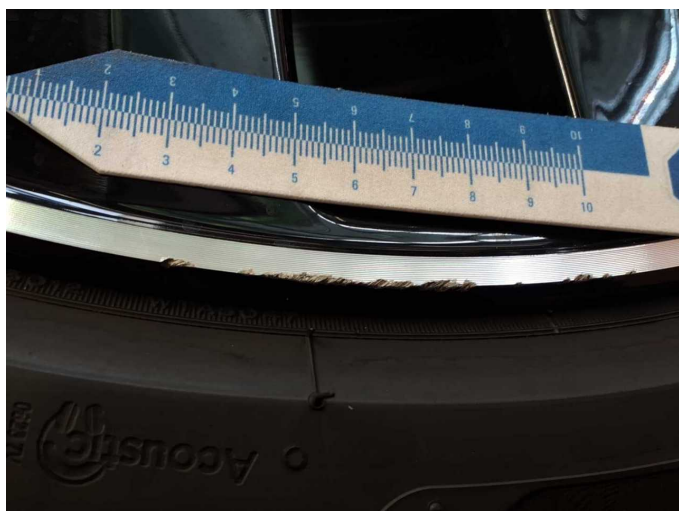
| No. | Component group | Description |
|---|---|---|
| 2 | Wheel / tyres | Alloy rim - rear left side - Scratched - Loss in value |

Damage 2: Wheel / tyres: Alloy rim - rear left side - Scratched - Loss in value

**Damage 2:** Wheel / tyres: Alloy rim - rear left side - Scratched - Loss in value

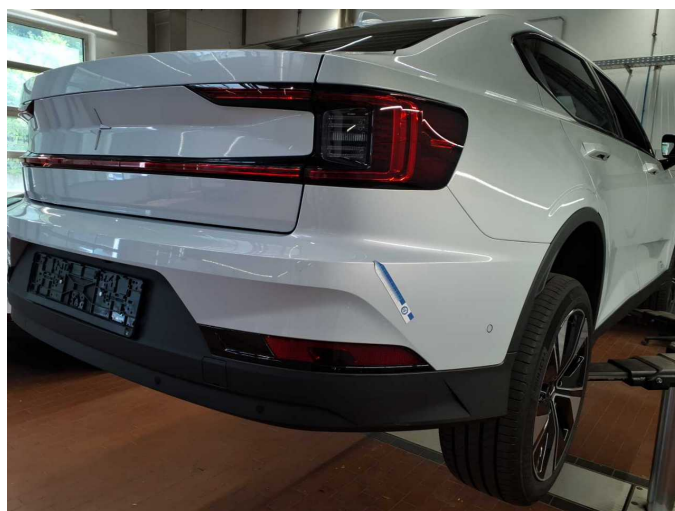
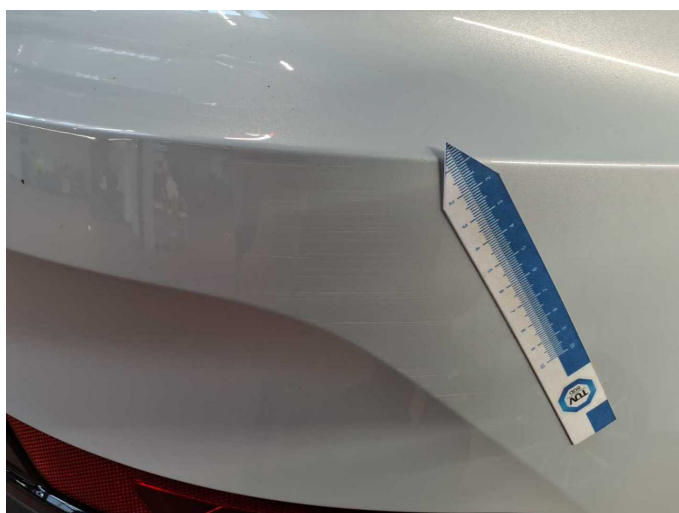
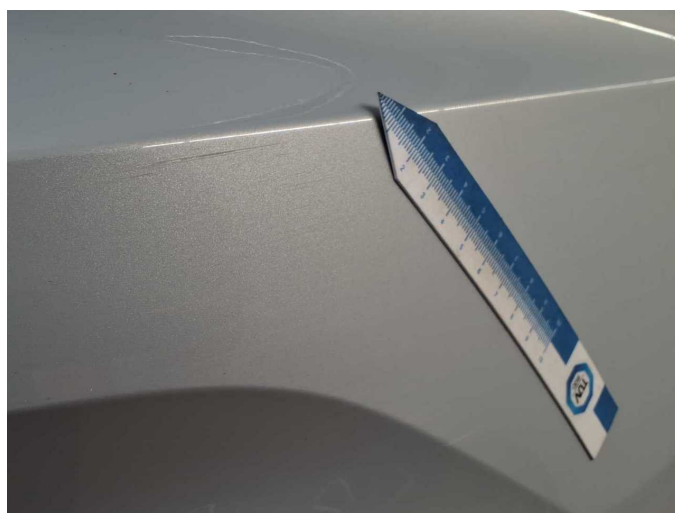
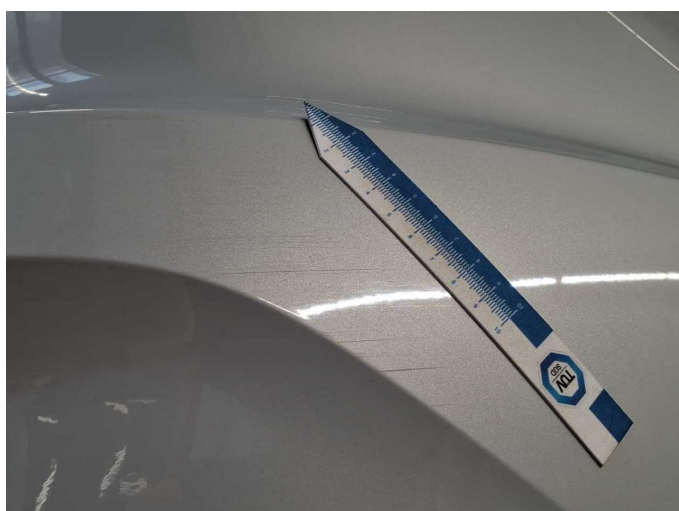
| No. | Component group | Description |
|---|---|---|
| 3 | Rear bumper | Rear bumper - Scratch(es) - Paint |

**Damage 3:** Rear bumper: Rear bumper - Scratch(es) - Paint

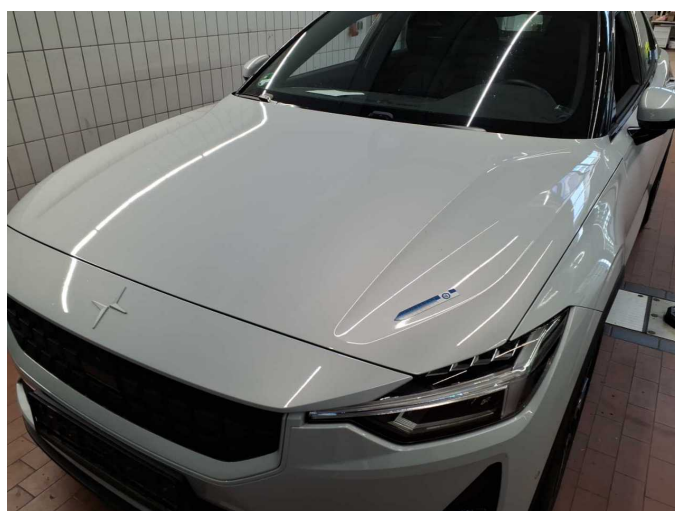
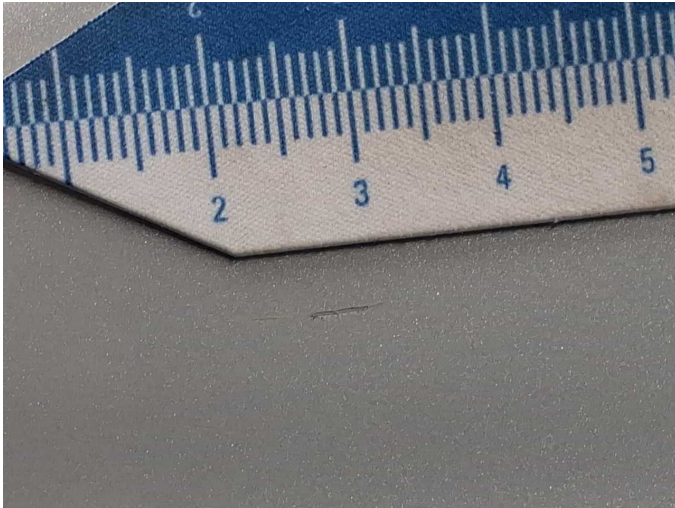
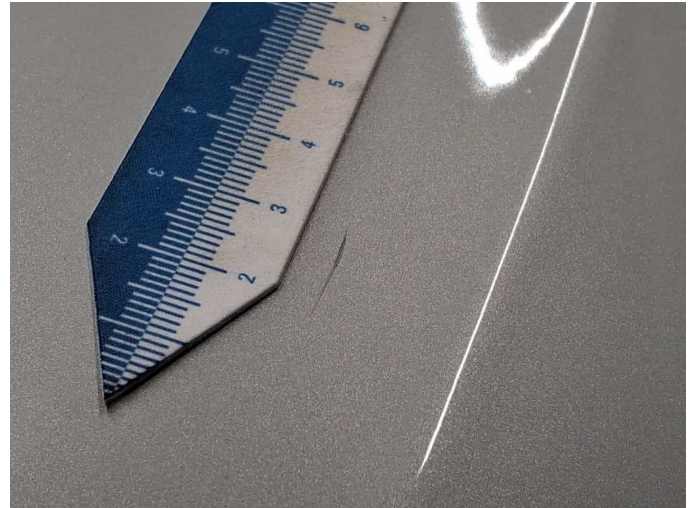
| No. | Component group | Description |
|---|---|---|
| 4 | Bonnet | Bonnet - Scratch(es) - Paint |

**Damage 4:** Bonnet: Bonnet - Scratch(es) - Paint
