Expertise

Protocol number: 46365754  
Order No. / Reference: 26577813  
Inspection date: 30 Jun 2026

Manufacturer: Ford

Model: Mondeo Turnier 2.0 EcoBlue Aut. Titanium

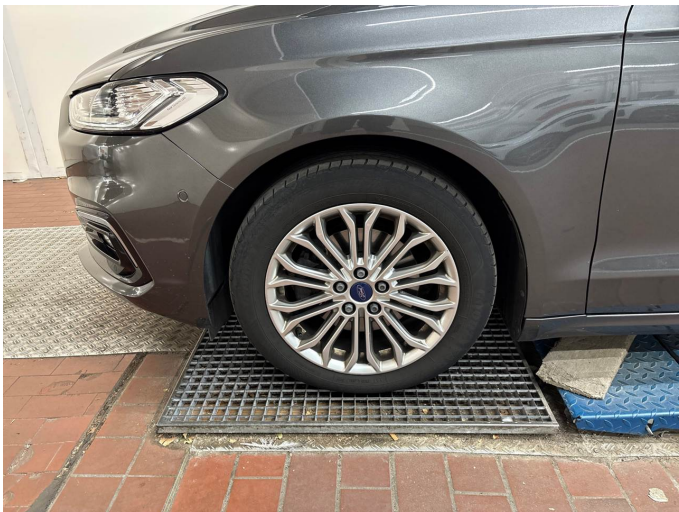
| Tyres | | | | |
|---|---|---|---|---|
| 1) | 215/55 R17 94W | Summer tyres on Light alloy | Goodyear | 6mm / 6mm |

Figure 12: Mounted tyres

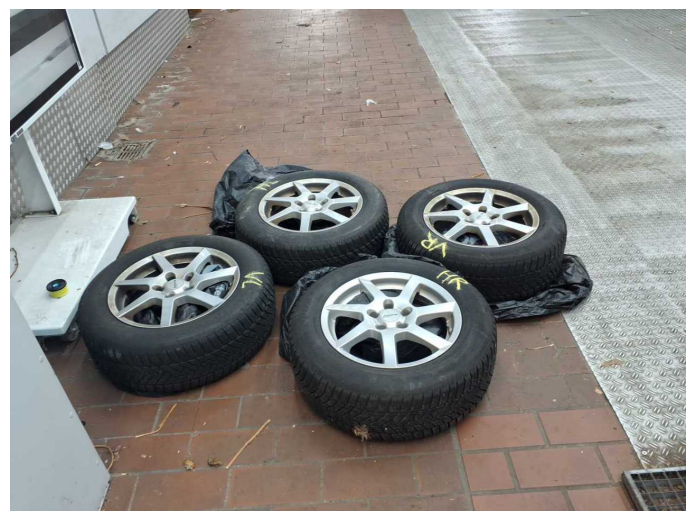
| Tyres | | | | |
|---|---|---|---|---|
| 1) | 215/60 R16 99H | Winter tyres on Light alloy | Dunlop | 8mm / 8mm |

Figure 18: Additional tyres

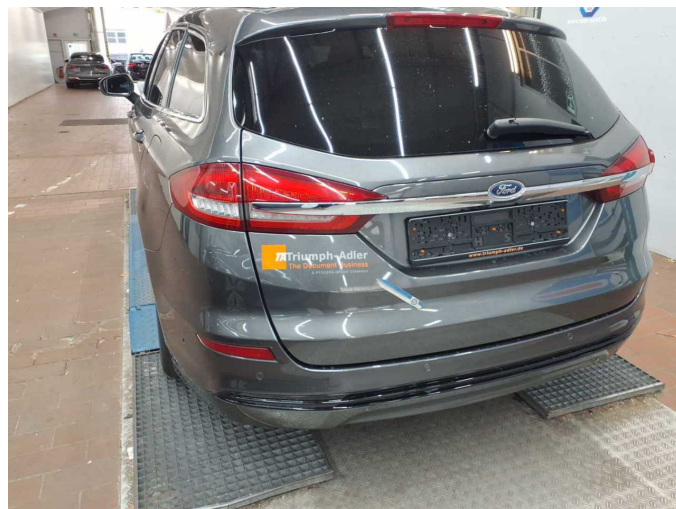
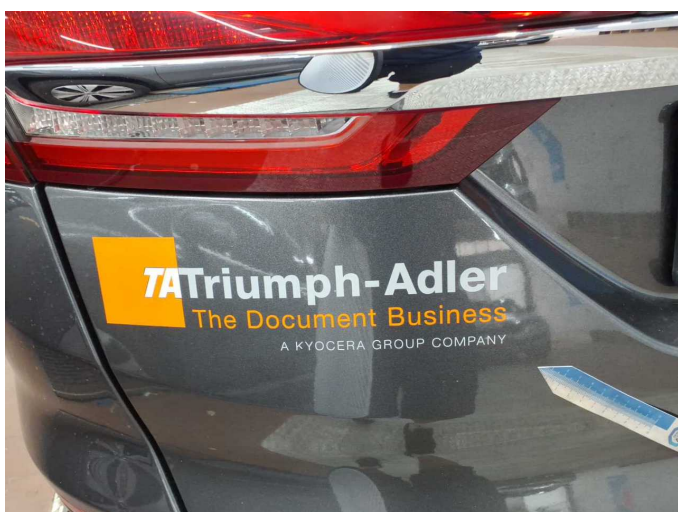
**Damage 1:** Boot lid / rear door: Boot lid - Glued / labelled - De-glue / neutralise

| No. | Component group | Description |
|---|---|---|
| 1 | Boot lid / rear door | Boot lid - Glued / labelled - De-glue / neutralise |

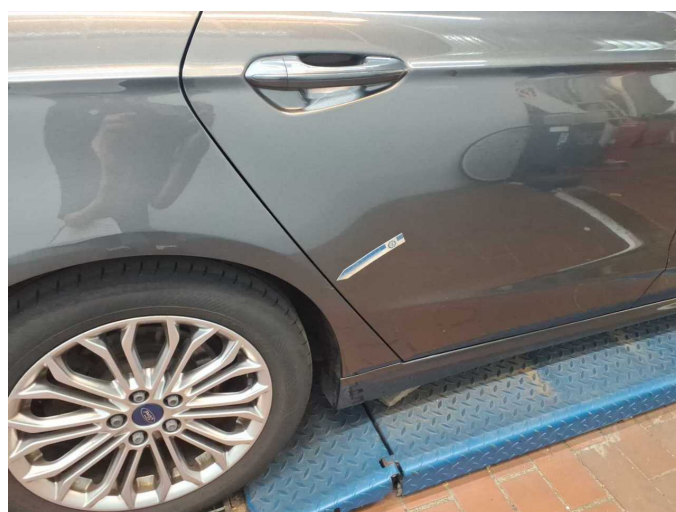
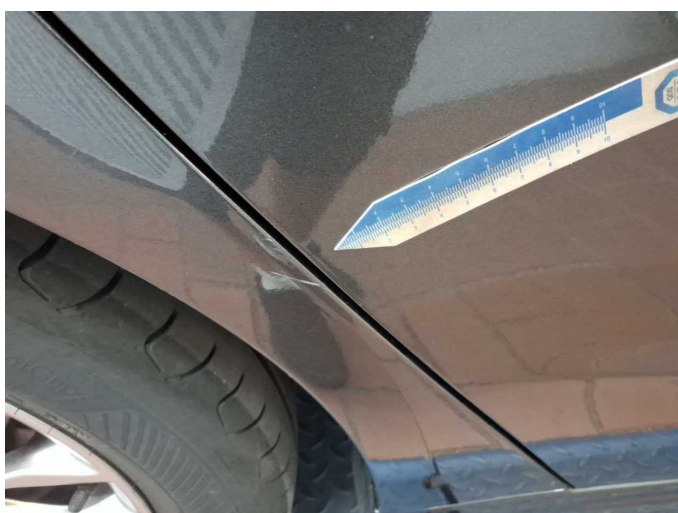
**Damage 2:** Side panel - rear right side: Elbow - Scratch(es) - Smart repair

| No. | Component group | Description |
|---|---|---|
| 2 | Side panel - rear right side | Elbow - Scratch(es) - Smart repair |

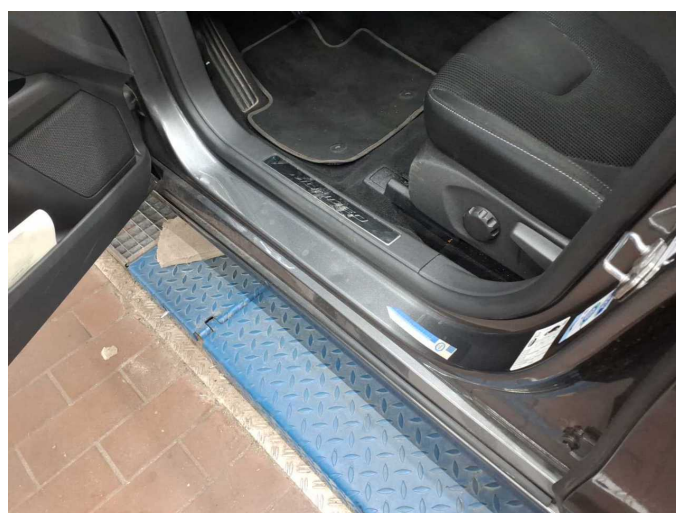
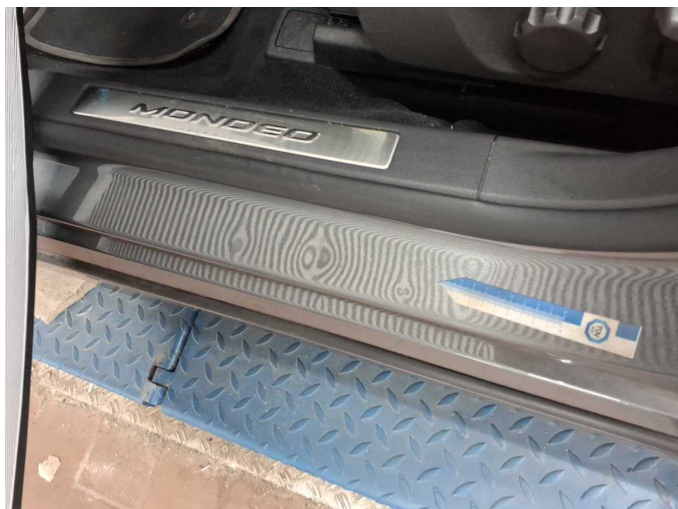
**Damage 3:** Sill - left side: Sill - dent(s) - Smart repair

| No. | Component group | Description |
|---|---|---|
| 3 | Sill - left side | Sill - dent(s) - Smart repair |

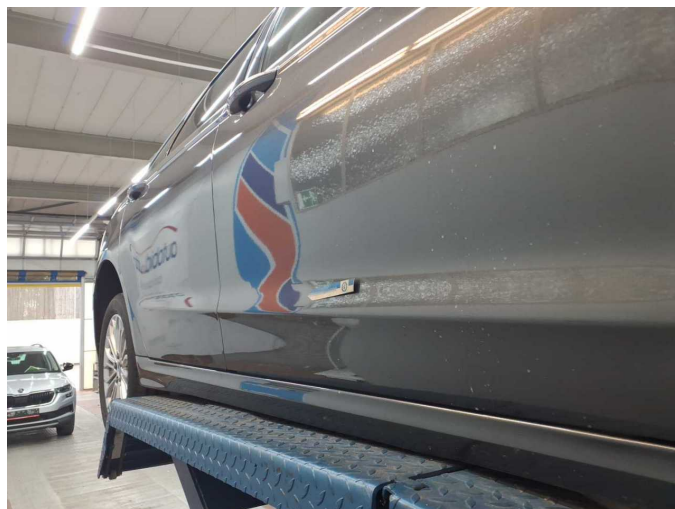
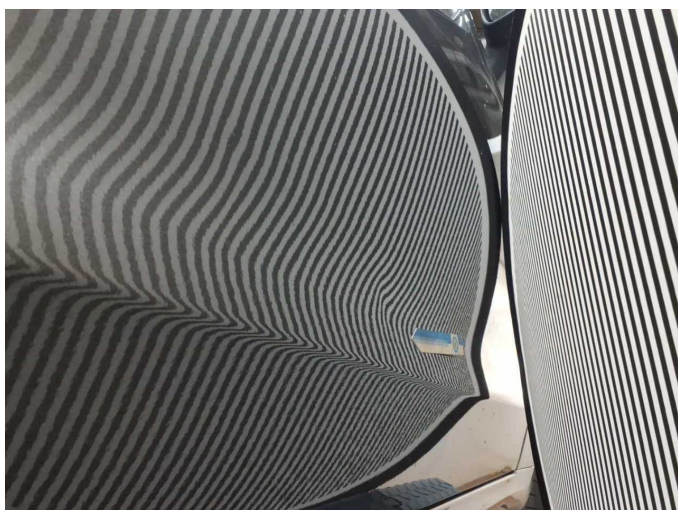
**Damage 4:** Door - front right side: Door - dent(s) - Repair and paint

| No. | Component group | Description |
|---|---|---|
| 4 | Door - front right side | Door - dent(s) - Repair and paint |

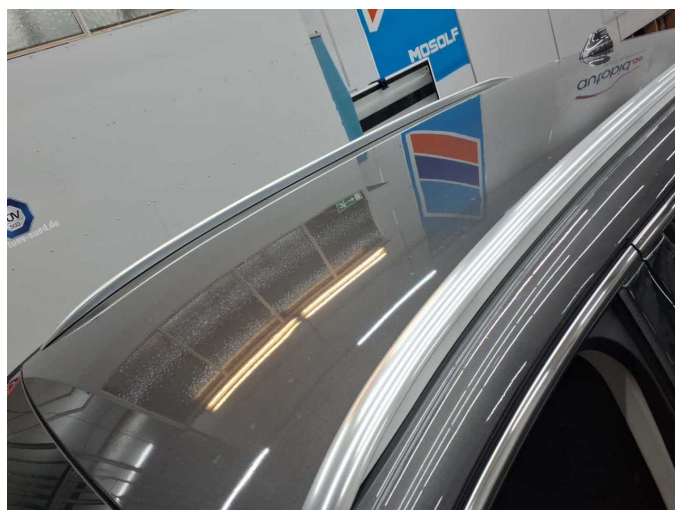
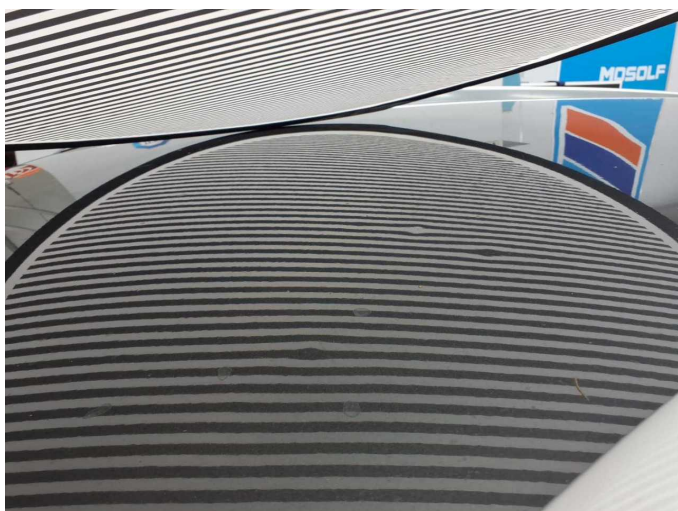
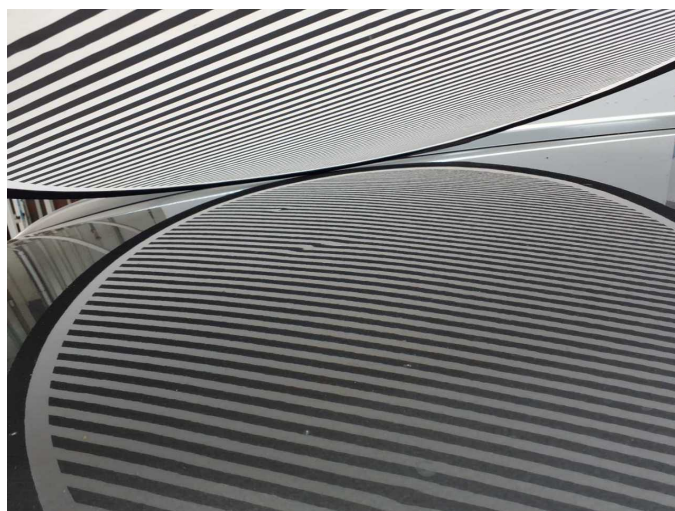
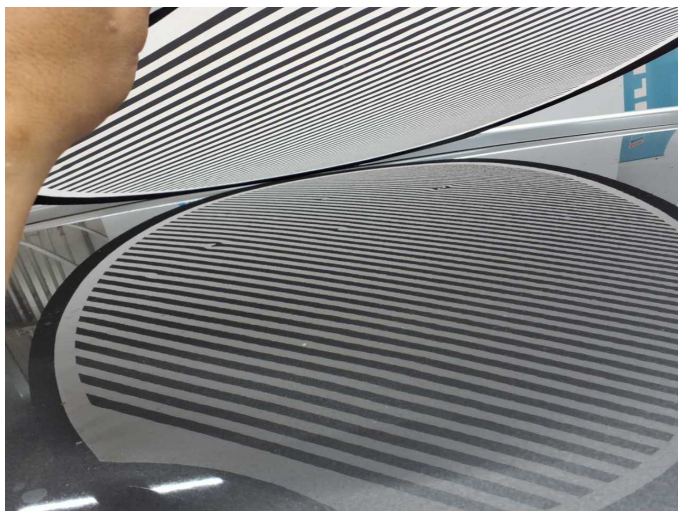
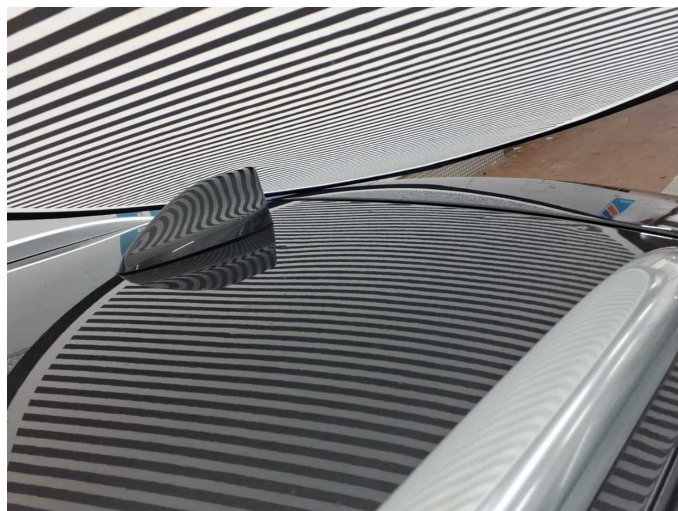
**Damage 5:** Roof: Roof - dent(s) - Smooth repair work

| No. | Component group | Description |
|---|---|---|
| 5 | Roof | Roof - dent(s) - Smooth repair work |

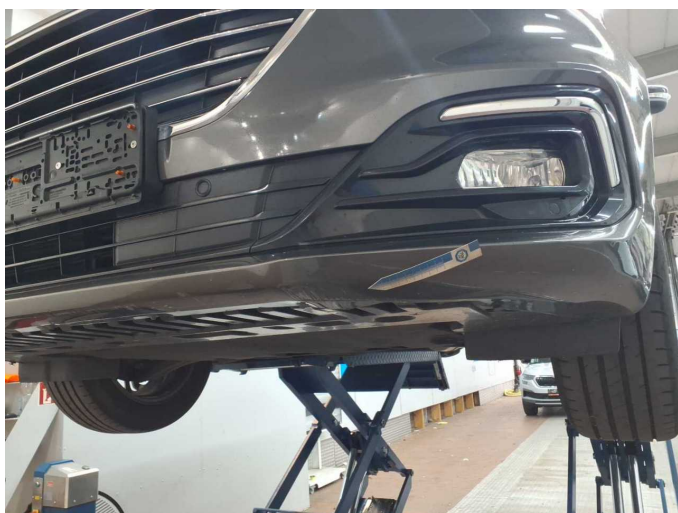
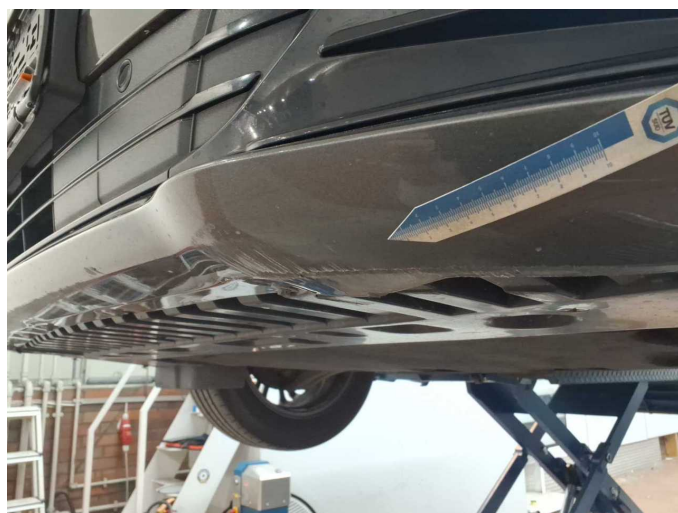
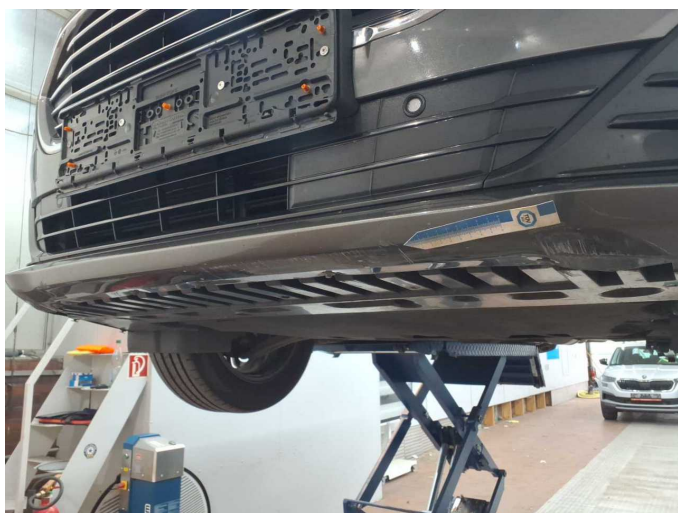
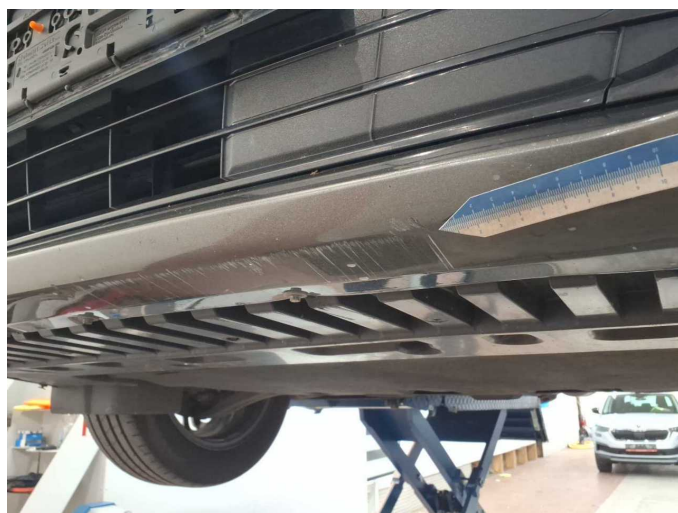
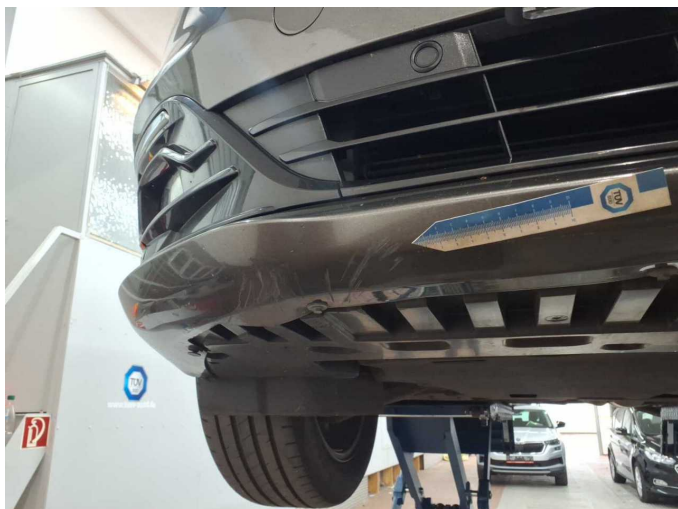
**Damage 6:** Front bumper: Front bumper - Scratch(es) - Paint

| No. | Component group | Description |
|---|---|---|
| 6 | Front bumper | Front bumper - Scratch(es) - Paint |

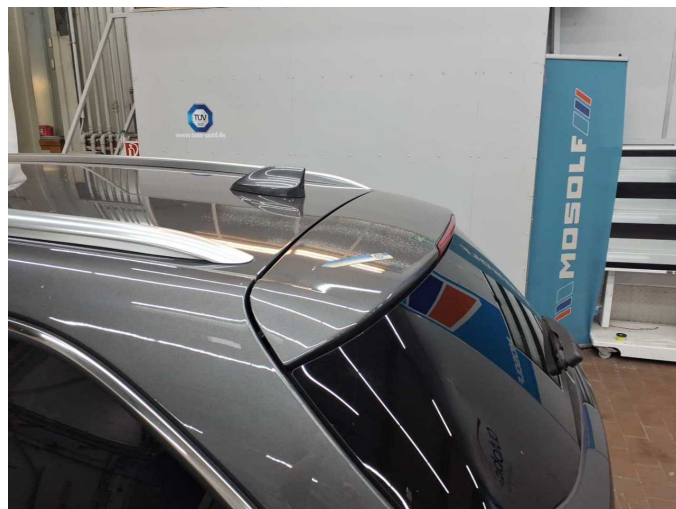
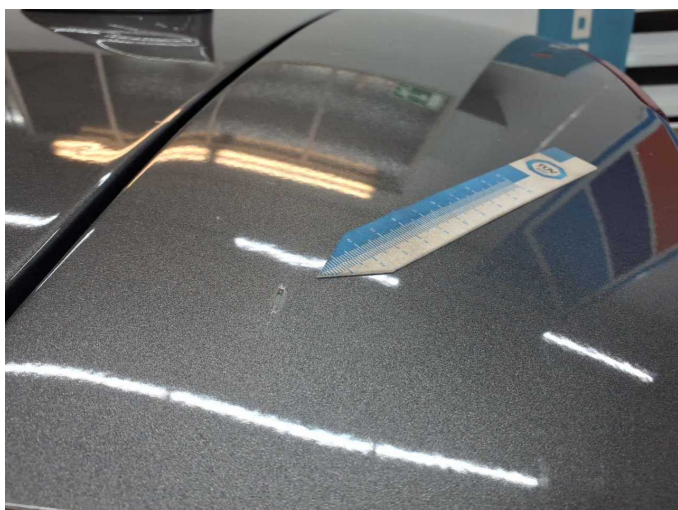
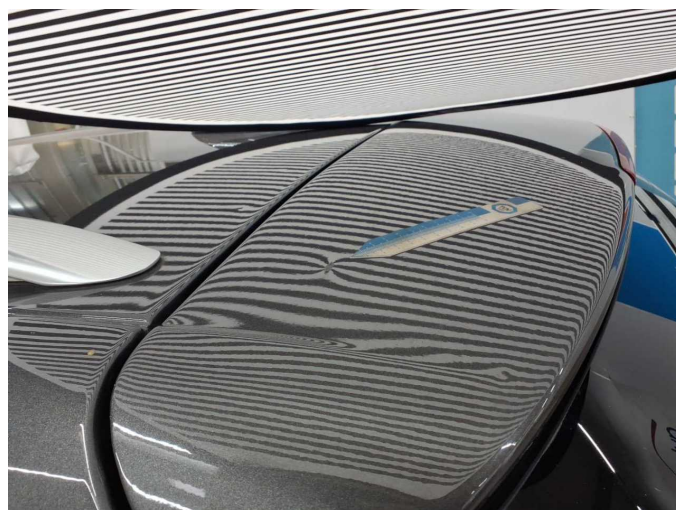
**Damage 7:** Boot lid / rear door: Rear spoiler - Dent / paintcoat damage - Replace

| No. | Component group | Description |
|---|---|---|
| 7 | Boot lid / rear door | Rear spoiler - Dent / paintcoat damage - Replace |

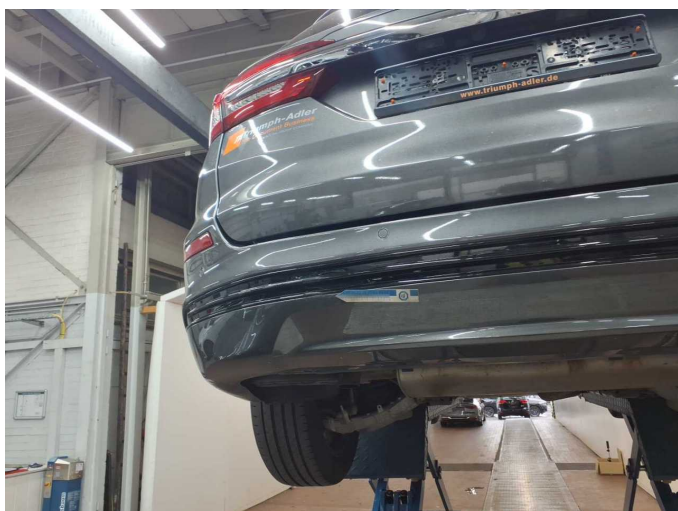
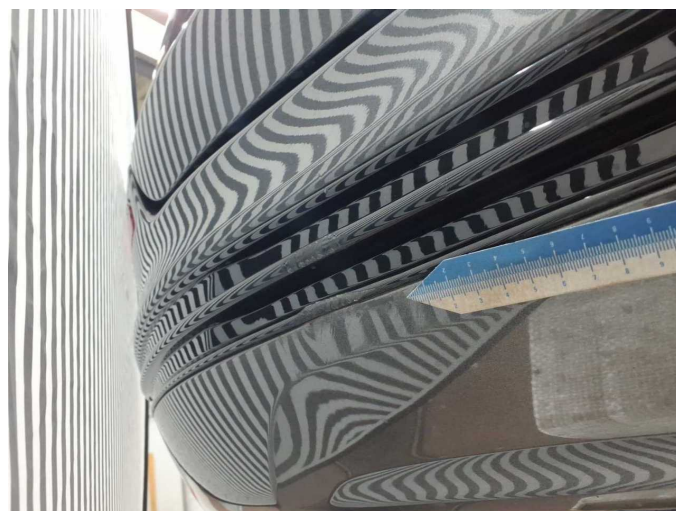
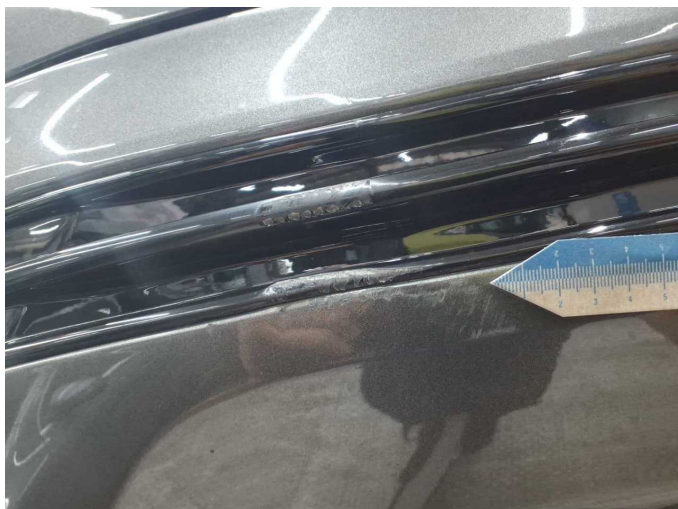
**Damage 8:** Rear bumper: Spoiler (Mit Zierleiste) - Dent / paintcoat damage - Replace

| No. | Component group | Description |
|---|---|---|
| 8 | Rear bumper | Spoiler (Mit Zierleiste) - Dent / paintcoat damage - Replace |

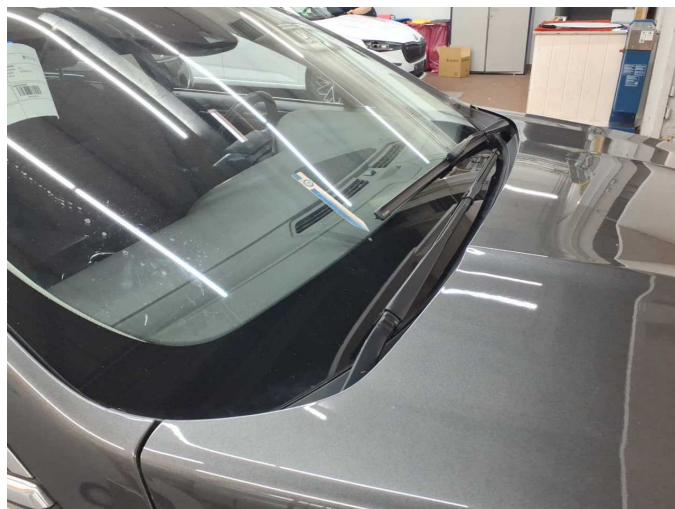
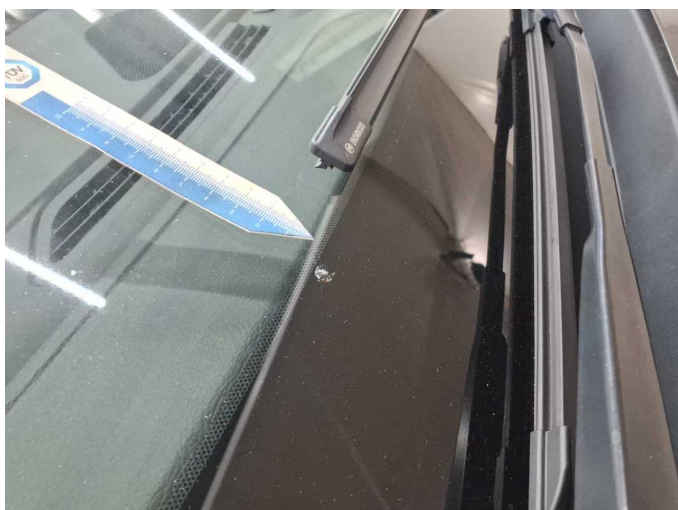
**Damage 9:** Vehicle glazing: Windscreen - Stone chips - Replace

| No. | Component group | Description |
|---|---|---|
| 9 | Vehicle glazing | Windscreen - Stone chips - Replace |

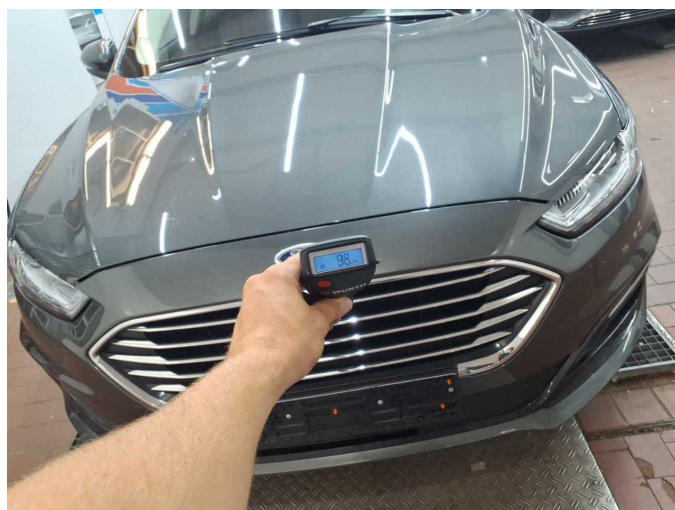
**Previous damage 1:** Front

| No. | Previous damage | Extent of damage (Net) |
|---|---|---|
| 1 | Front, Provided by user / customer, from 27 Oct 2025 | 1.071,10 € |

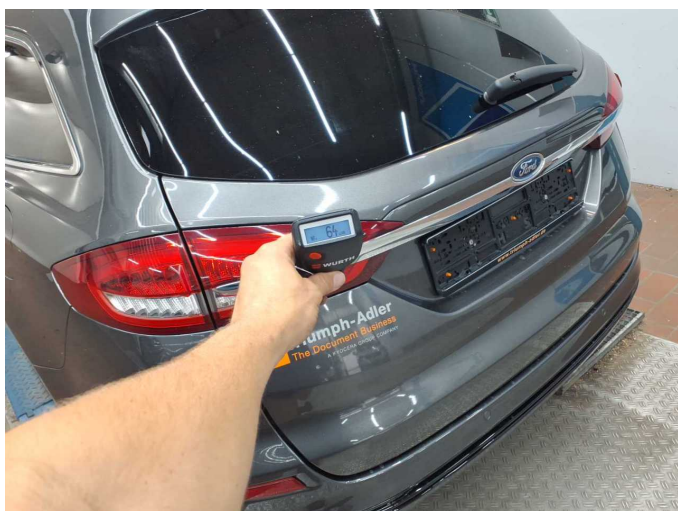
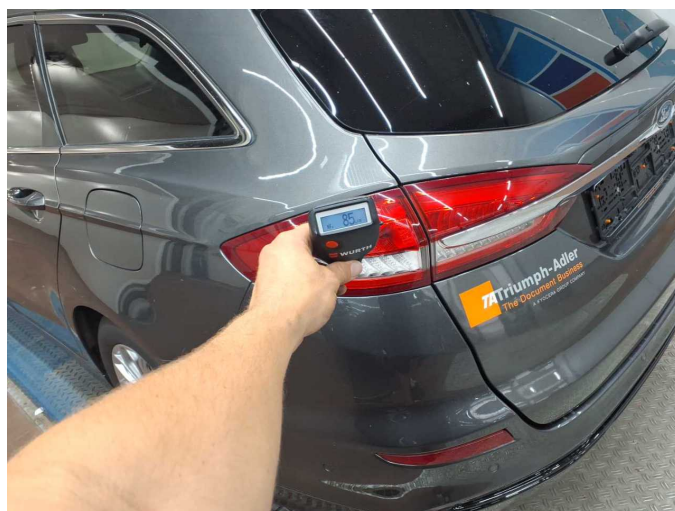
**Previous damage 2:** Rear, Side - left

| No. | Previous damage | Extent of damage (Net) |
|---|---|---|
| 2 | Rear, Side - left, Provided by user / customer, from 17 Nov 2025 | 2.684,02 € |
