Expertise

Protocol number: 46481431  
Order No. / Reference: 26526684-1  
Inspection date: 30 Jun 2026

Manufacturer: Mercedes-Benz

Model: GLC 300 d 4Matic 9G-TRONIC

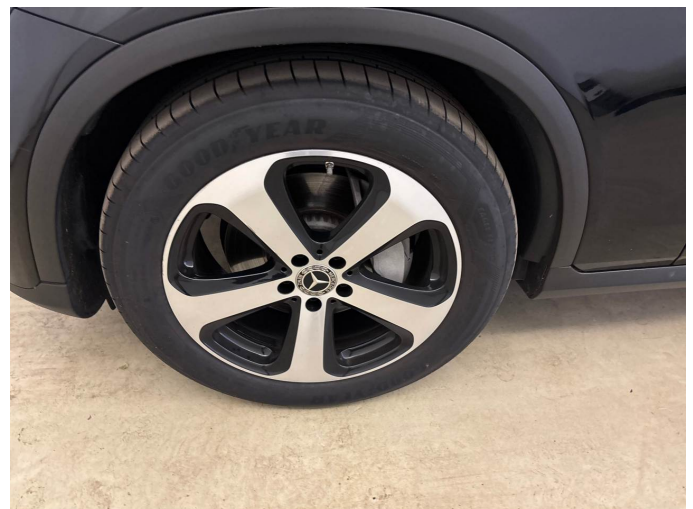
**Figure 12: Mounted tyres**

| # | Tyre size | Type of tyre | Manufacturer | Tread depth |
|---|---|---|---|---|
| 1) | 235/55 R19 105W | Summer tyres on Light alloy | Goodyear | 5mm / 5mm |
| 2) | 235/55 R19 105W | Summer tyres on Light alloy | Goodyear | 5mm / 5mm |

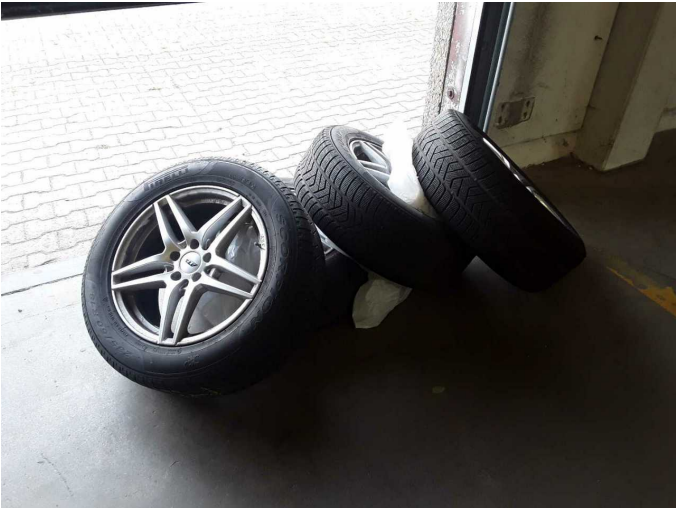
Figure 15: Additional tyres

| # | Tyre size | Type of tyre | Manufacturer | Tread depth |
|---|---|---|---|---|
| 1) | 235/60 R18 107H | Winter tyres on Light alloy | Pirelli | 5mm / 5mm |
| 2) | 235/60 R18 107H | Winter tyres on Light alloy | Pirelli | 5mm / 5mm |

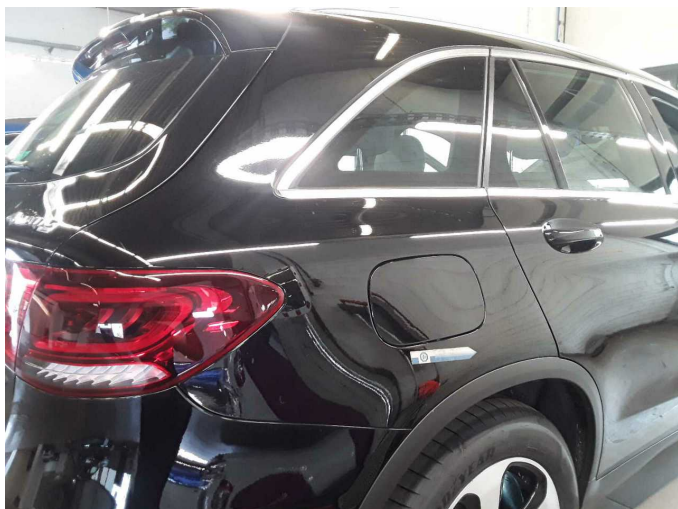
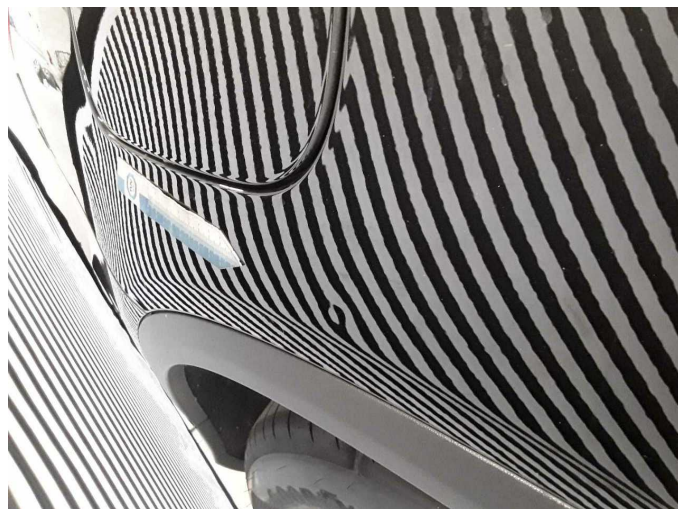
| No. | Component group | Description |
|---|---|---|
| 1 | Side panel - rear right side | Side panel - dent(s) - Smooth repair work |

**Damage 1:** Side panel - rear right side: Side panel - dent(s) - Smooth repair work

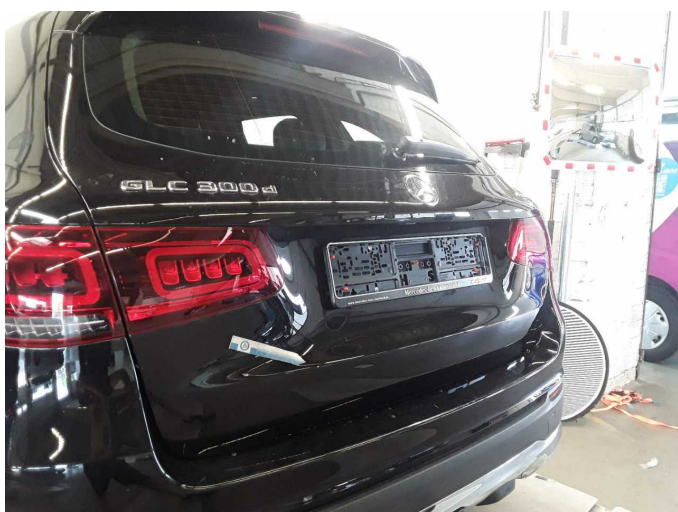
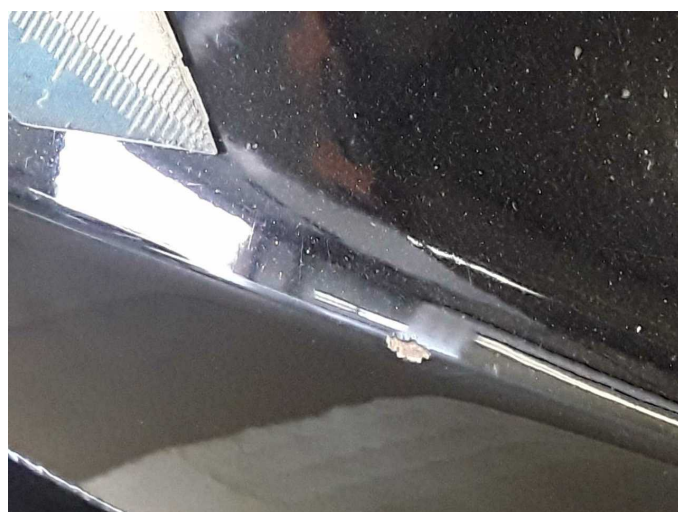
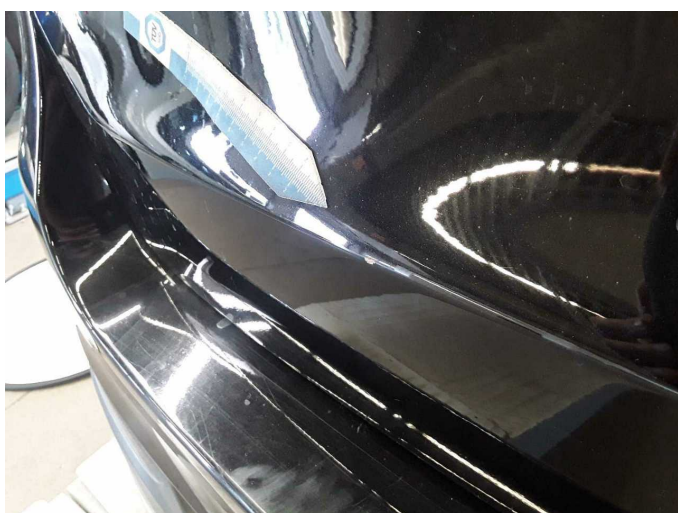
| No. | Component group | Description |
|---|---|---|
| 3 | Boot lid / rear door | Boot lid - Corrosion - Smart repair |

**Damage 3:** Boot lid / rear door: Boot lid - Corrosion - Smart repair

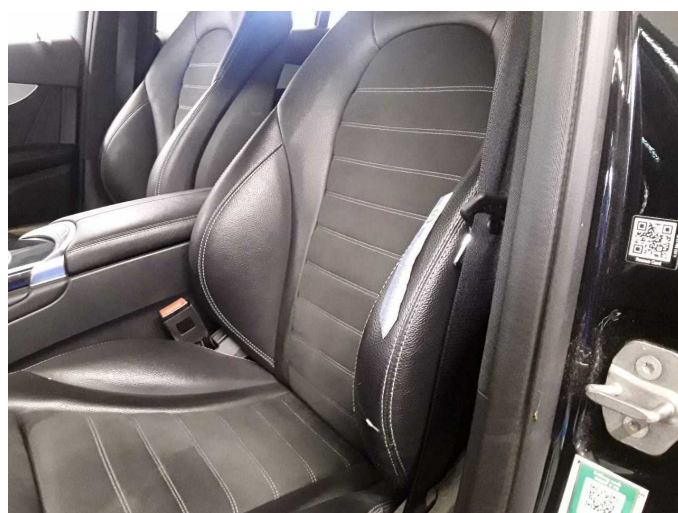
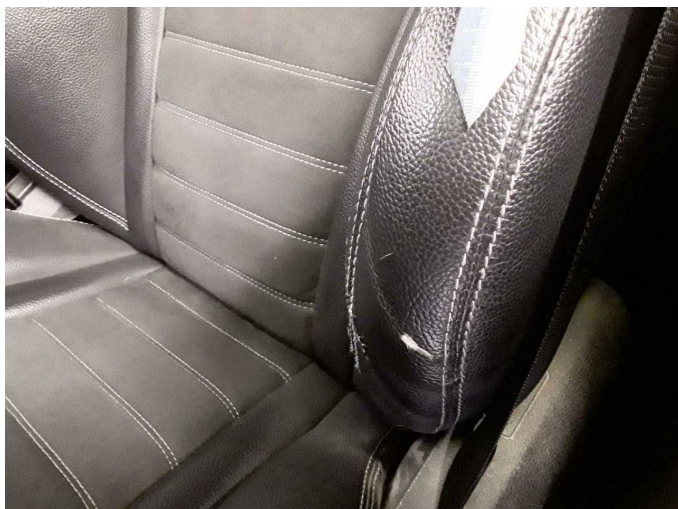
| No. | Component group | Description |
|---|---|---|
| 4 | Seat - front | Backrest cover - left side - Damaged - Replace |

**Damage 4:** Seat - front: Backrest cover - left side - Damaged - Replace

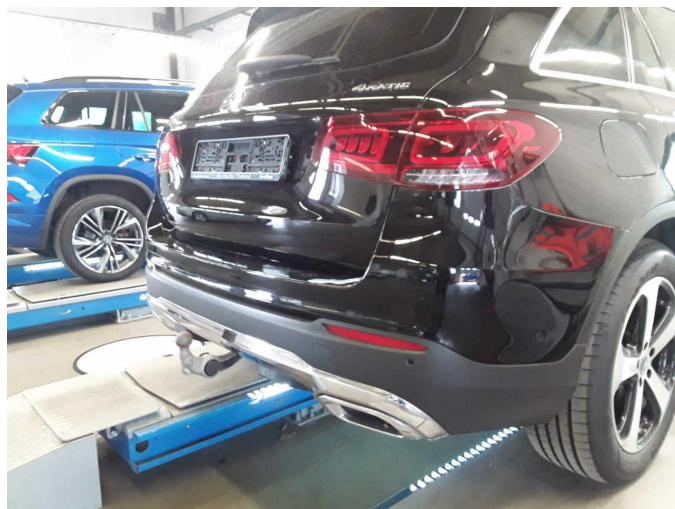
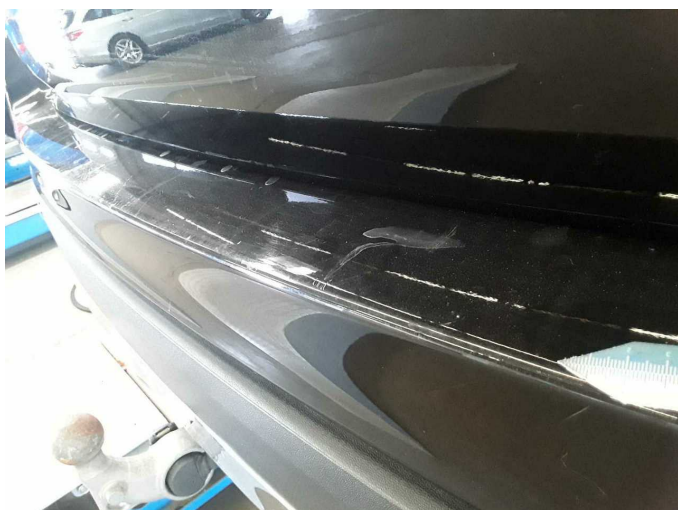
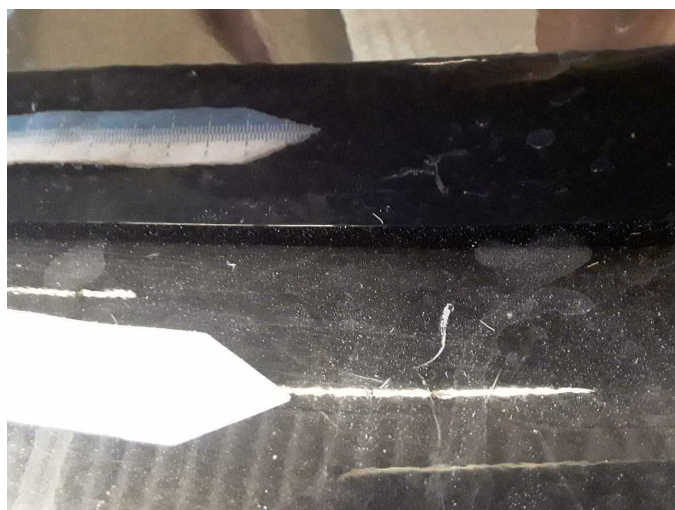
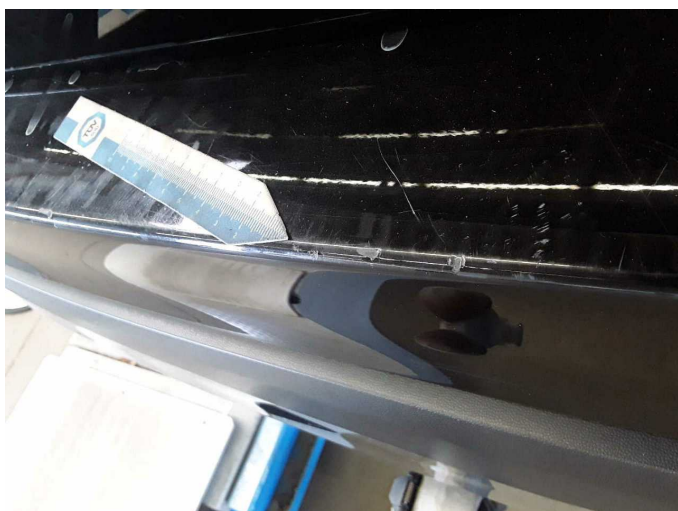
| No. | Component group | Description |
|---|---|---|
| 5 | Rear bumper | Rear bumper - Scratch(es) - Paint |

**Damage 5:** Rear bumper: Rear bumper - Scratch(es) - Paint

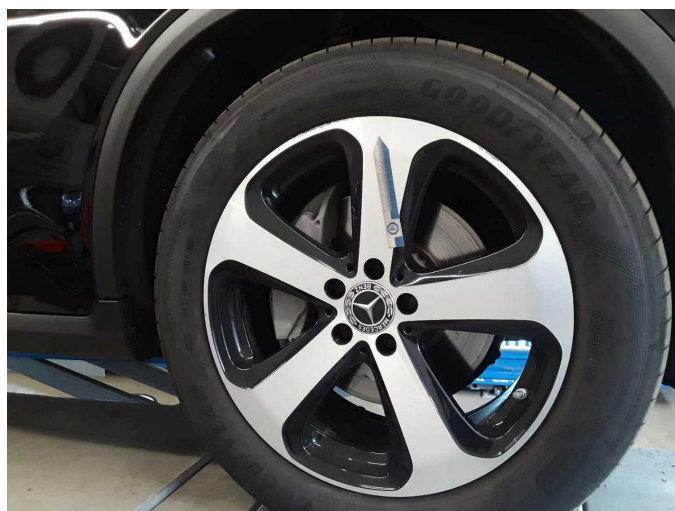
| No. | Component group | Description |
|---|---|---|
| 6 | Wheel / tyres | Alloy rim - front right side (Materialabtrag) - Scratched - Replace |

**Damage 6:** Wheel / tyres: Alloy rim - front right side (Materialabtrag) - Scratched - Replace

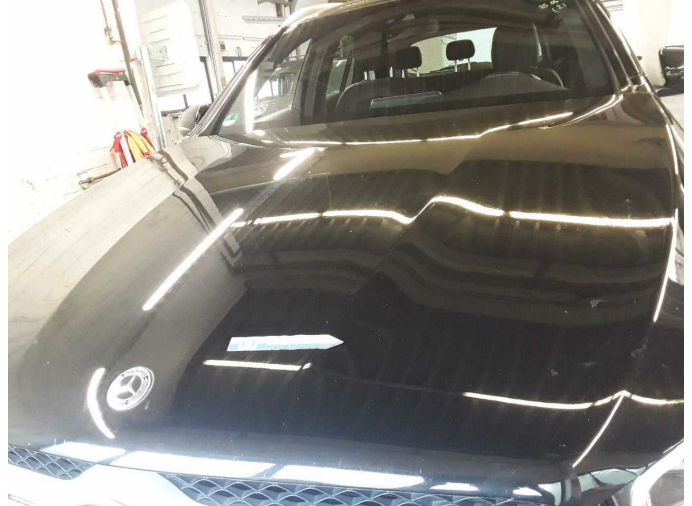
| No. | Component group | Description |
|---|---|---|
| 1 | Bonnet | Bonnet - Stone chips - No deduction |

**Wear and tear 1:** Bonnet: Bonnet - Stone chips - No deduction

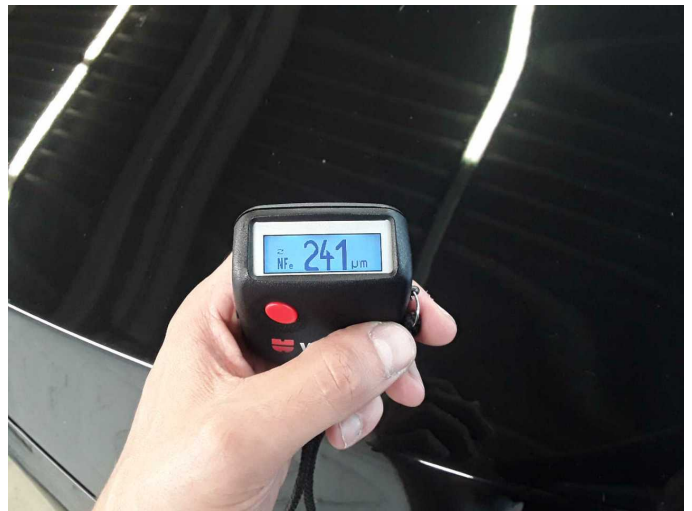
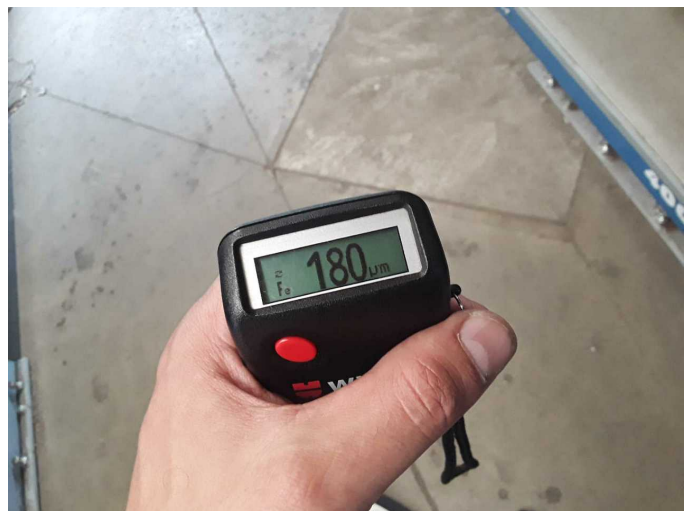
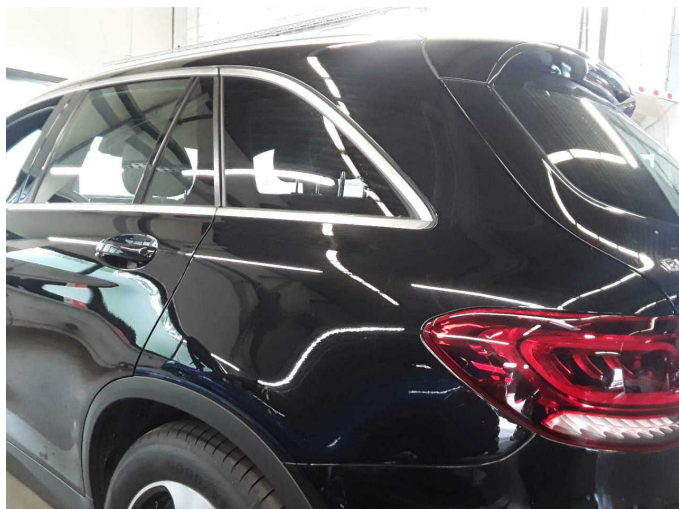
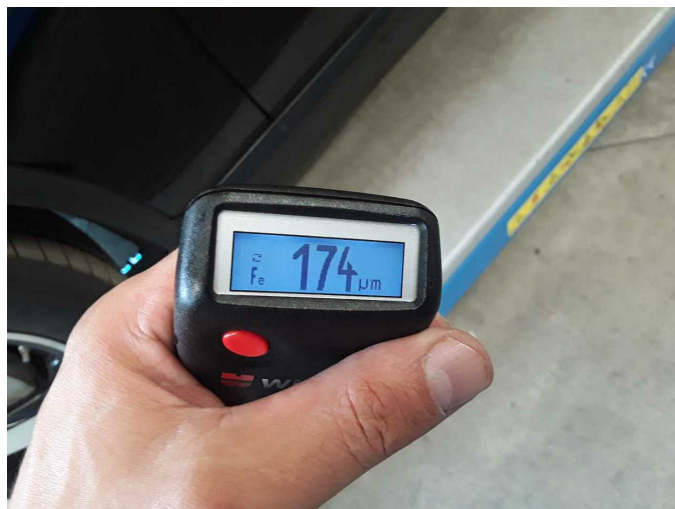
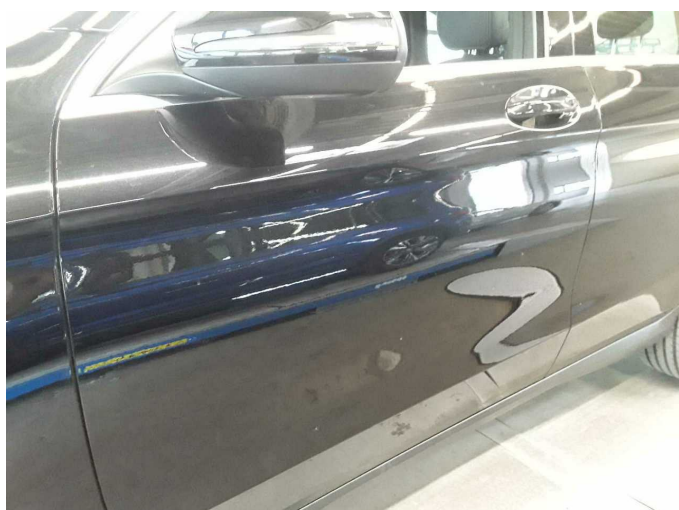
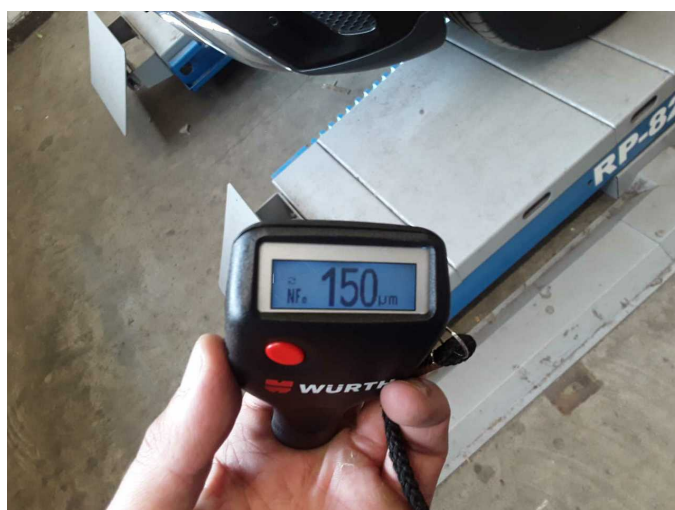
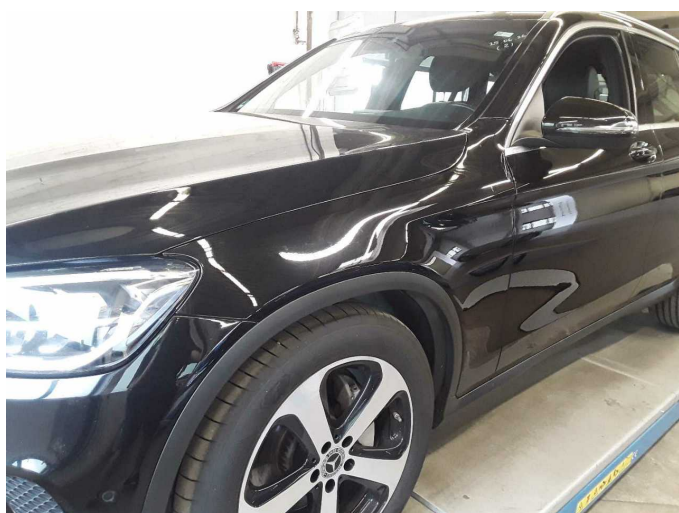
| No. | Repainting |
|---|---|
| 1 | Mudguard - left side, Bonnet, Side panel - rear left side, Door - front left side, Professionally carried out |

**Repainting 1:** Mudguard - left side, Bonnet, Side panel - rear left side, Door - front left side
