Expertise

Protocol number: 46455532  
Order No. / Reference: 26383516  
Inspection date: 10 Jul 2026

Model: GLE 350 de 4Matic 9G-TRONIC Advanced

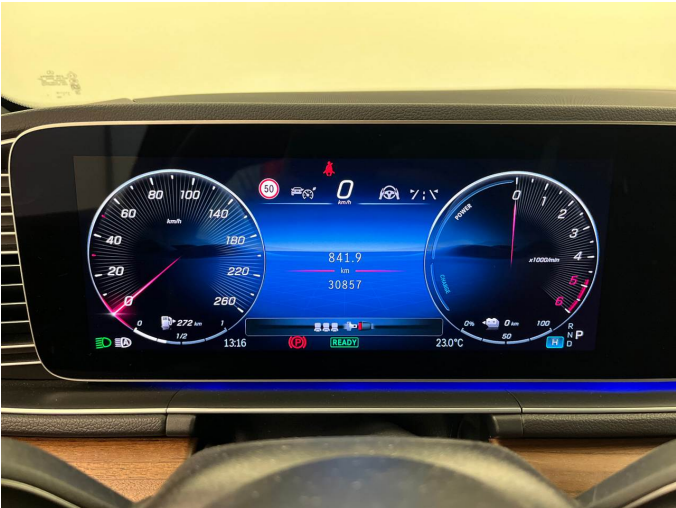
| Vehicle details | |
|---|---|
| Mileage (Read) | 30,857 km |

Figure 7: Instrument cluster

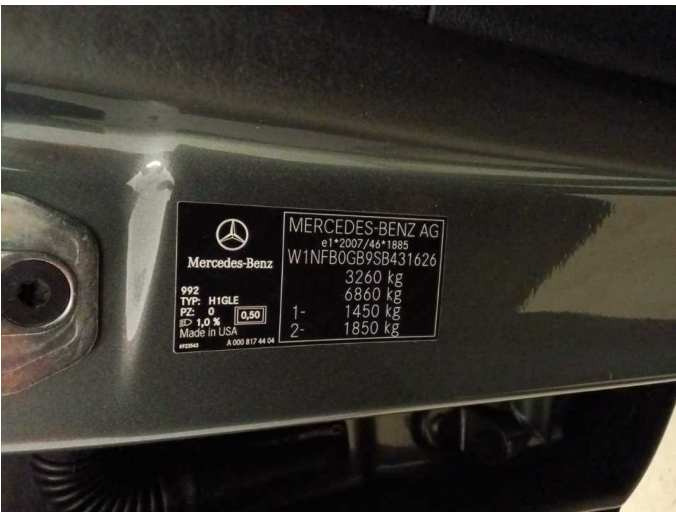
Figure 11: VIN

| VIN comparison | The vehicle identification number (VIN) was read from the vehicle and its conformity with the submitted documents was confirmed by the undersigned during the inspection. |

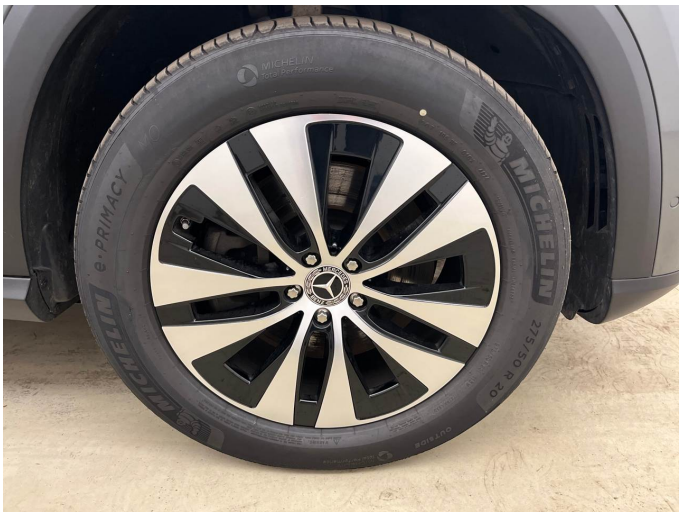
| # | Tyre size | Type of tyre | Manufacturer | Tread depth |
|---|---|---|---|---|
| 1) | 275/50 R20 113W | Summer tyres on Light alloy | Michelin | 5mm / 5mm |
| 2) | 275/50 R20 113W | Summer tyres on Light alloy | Michelin | 5mm / 5mm |

Figure 12: Mounted tyres

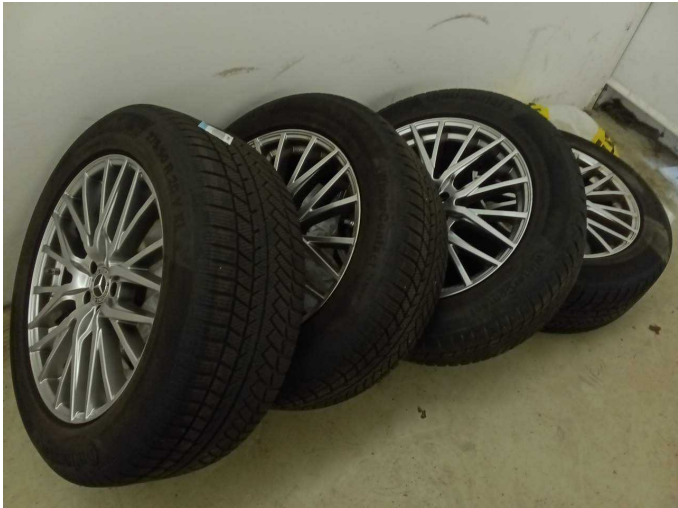
| # | Tyre size | Type of tyre | Manufacturer | Tread depth |
|---|---|---|---|---|
| 1) | 275/50 R20 113V | Winter tyres on Light alloy | Continental | 7mm / 7mm |
| 2) | 275/50 R20 113V | Winter tyres on Light alloy | Continental | 5mm / 5mm |

Figure 14: Additional tyres

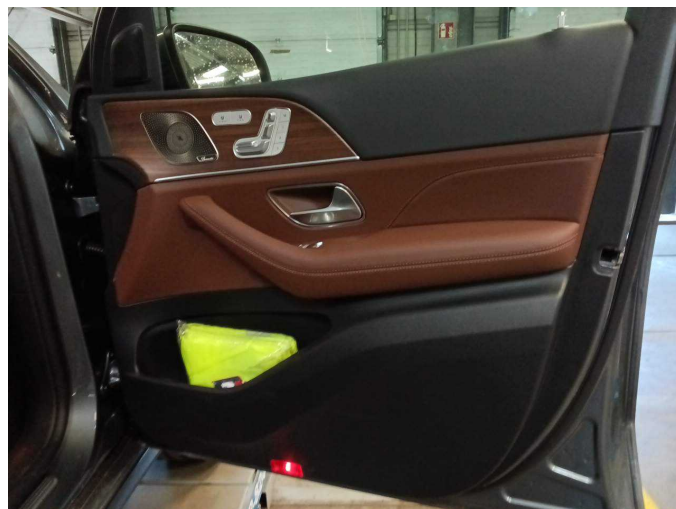
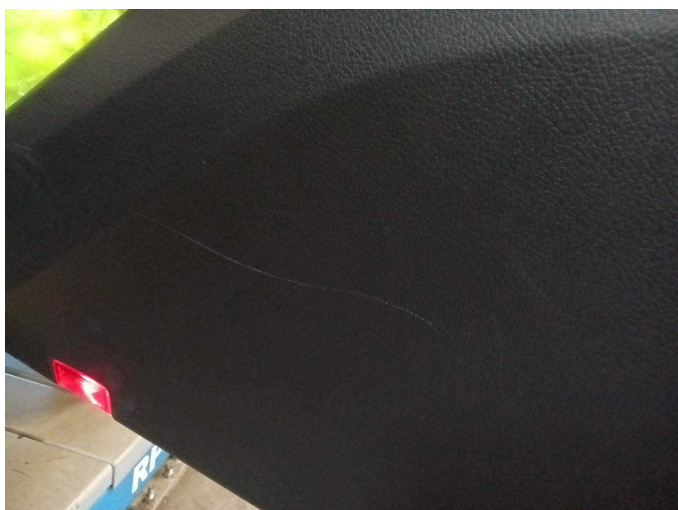
**Damage 1:** Trim / covers: Door trim - front right side - Scratch(es) - Smart repair

| No. | Component group | Description |
|---|---|---|
| 1 | Trim / covers | Door trim - front right side - Scratch(es) - Smart repair |

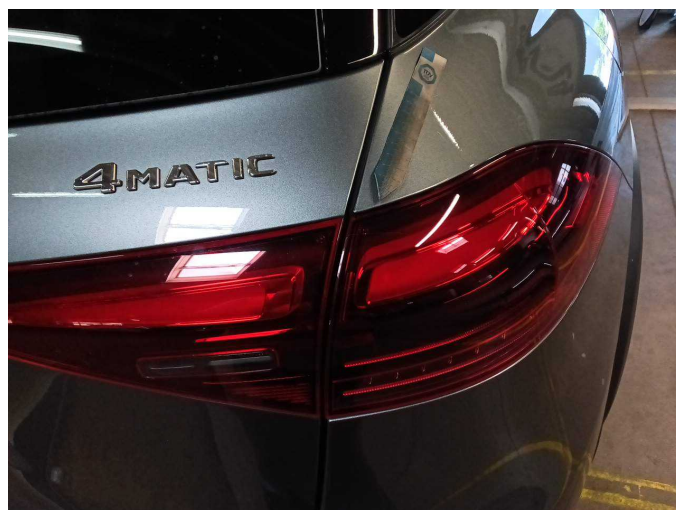
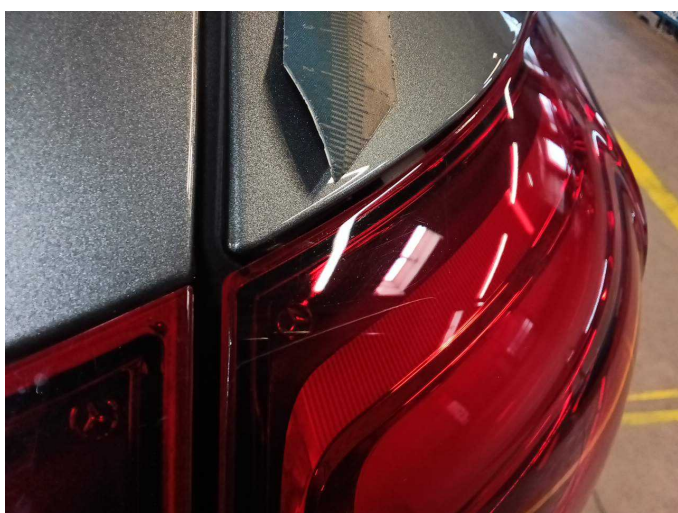
**Damage 2:** Tail light: Tail lamp - right side - Scratch(es) - Replace

| No. | Component group | Description |
|---|---|---|
| 2 | Tail light | Tail lamp - right side - Scratch(es) - Replace |

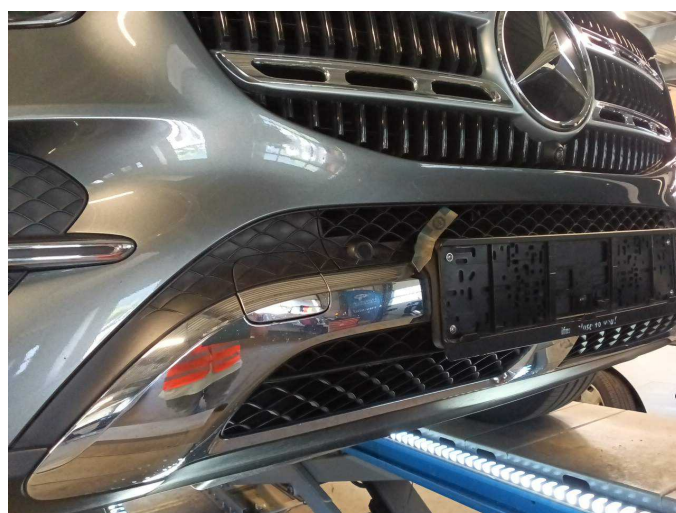
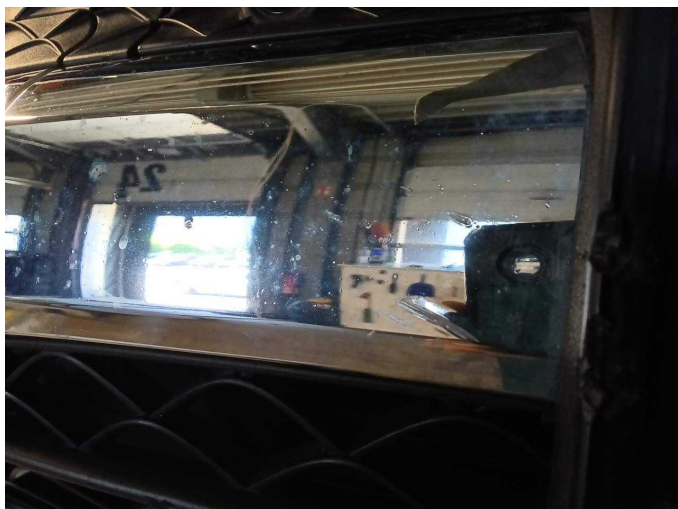
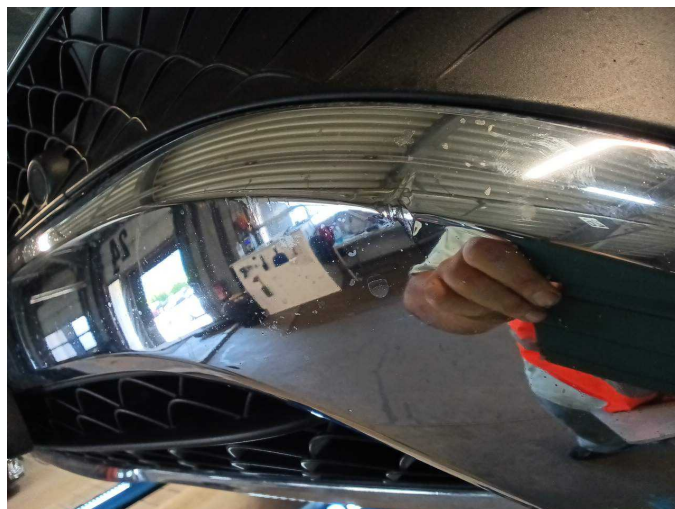
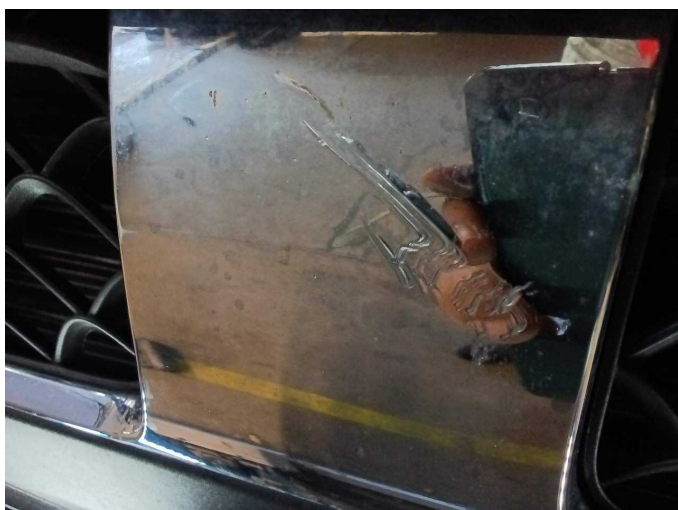
**Damage 3:** Front bumper: Spoiler - Scratch(es) - Replace

| No. | Component group | Description |
|---|---|---|
| 3 | Front bumper | Spoiler - Scratch(es) - Replace |

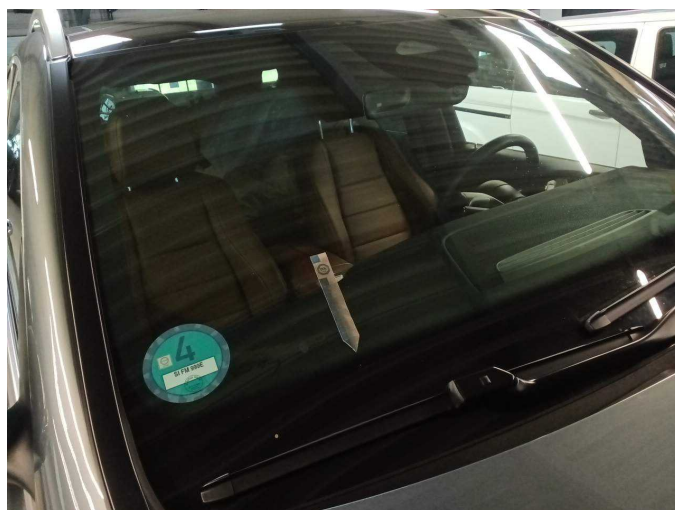
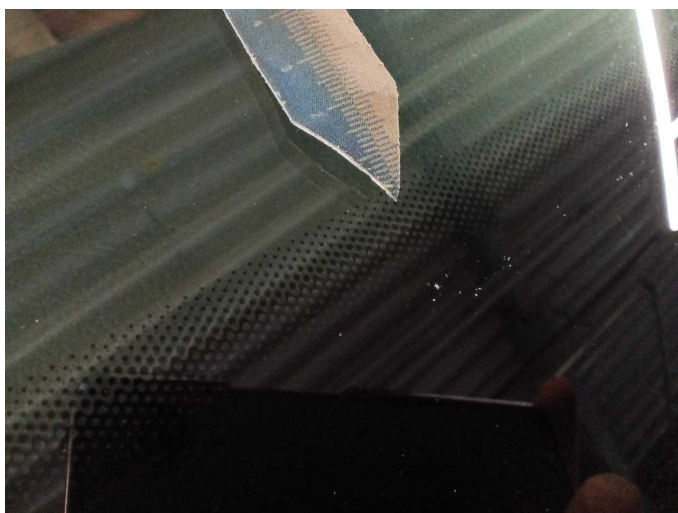
| No. | Component group | Description |
|---|---|---|
| 1 | Vehicle glazing | Windscreen - Stone chips - No deduction |

**Wear and tear 1:** Vehicle glazing: Windscreen - Stone chips - No deduction

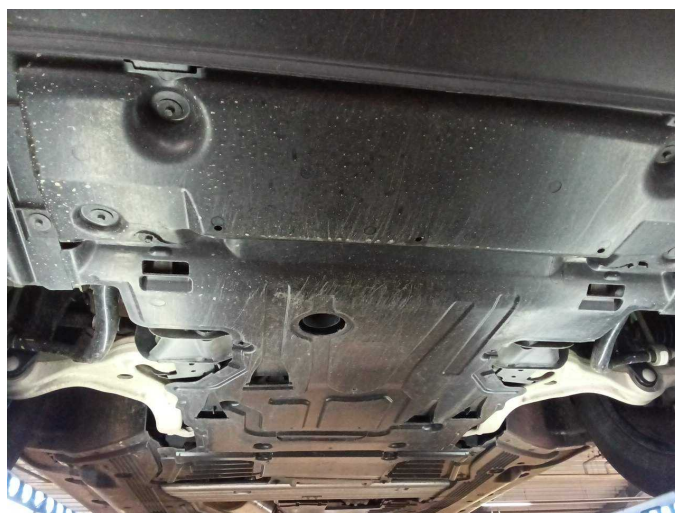
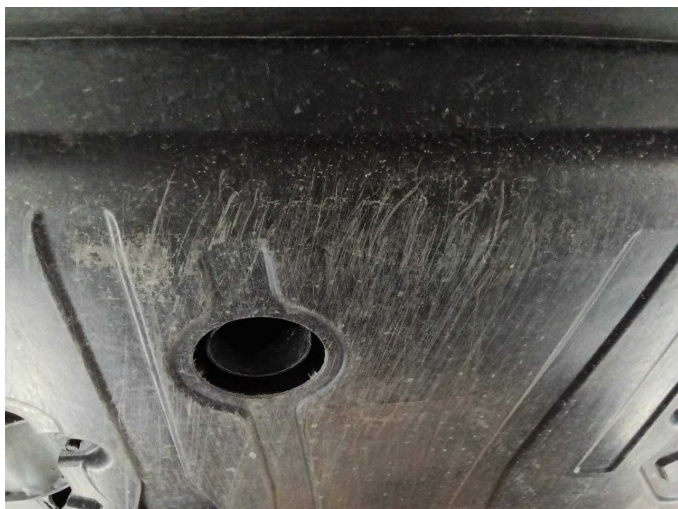
| No. | Component group | Description |
|---|---|---|
| 2 | Engine | Engine cowling - lower - Scratched - No deduction |

**Wear and tear 2:** Engine: Engine cowl - lower - Scratched - No deduction

**Wear and tear 2:** Engine: Engine cowling - lower - Scratched - No deduction
