Expertise

Protocol number: 46532198  
Order No. / Reference: 26755726  
Inspection date: 14 Jul 2026

Manufacturer: Skoda  
VIN: TMBLN9NS5N8018113

Model: Kodiaq 2.0 TDI 4x4 DSG Sportline

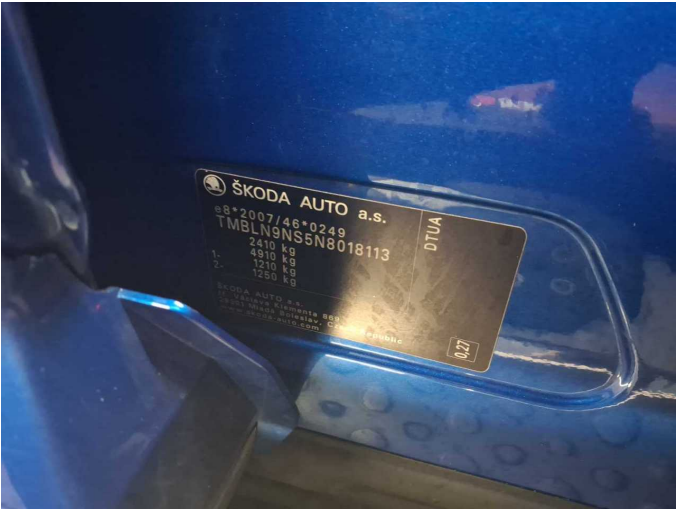
| VIN comparison | The vehicle identification number (VIN) was read from the vehicle and its conformity with the submitted documents was confirmed by the undersigned during the inspection. |

Figure 11: VIN

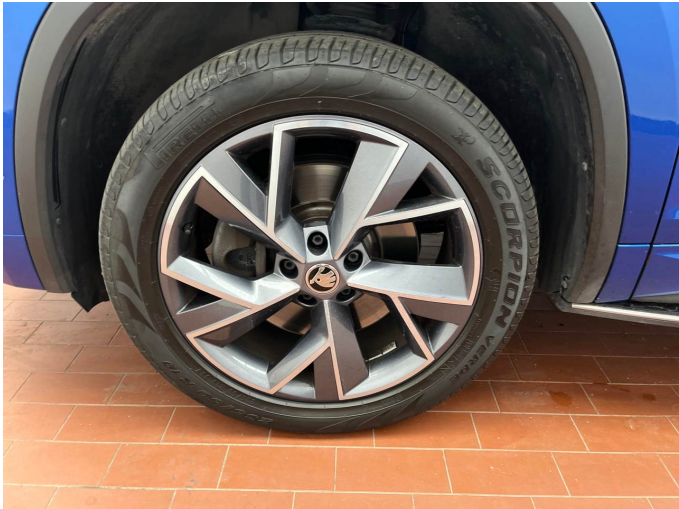
| # | Tyre size | Type of tyre | Manufacturer | Tread depth |
|---|---|---|---|---|
| 1) | 235/50 R19 99V | Summer tyres (with run-flat tyres) on Light alloy | Pirelli | 5mm / 5mm |
| 2) | 235/50 R19 99V | Summer tyres (with run-flat tyres) on Light alloy | Pirelli | 7mm / 7mm |

Figure 12: Mounted tyres

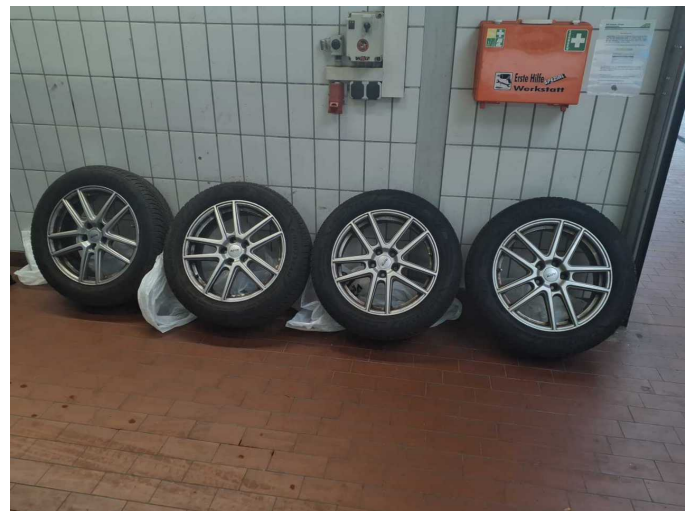
| # | Tyre size | Type of tyre | Manufacturer | Tread depth |
|---|---|---|---|---|
| 1) | 235/55 R18 104V | Winter tyres on Light alloy | Goodyear | 7mm / 7mm |
| 2) | 235/55 R18 104V | Winter tyres on Light alloy | Goodyear | 8mm / 8mm |

Figure 16: Additional tyres

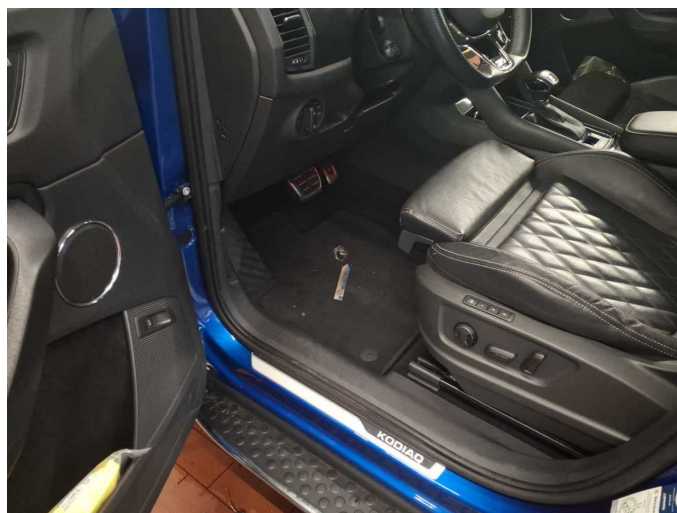
**Damage 1:** Trim / covers: Floor mats - Holes - Replace

| No. | Component group | Description |
|---|---|---|
| 1 | Trim / covers | Floor mats - Holes - Replace |

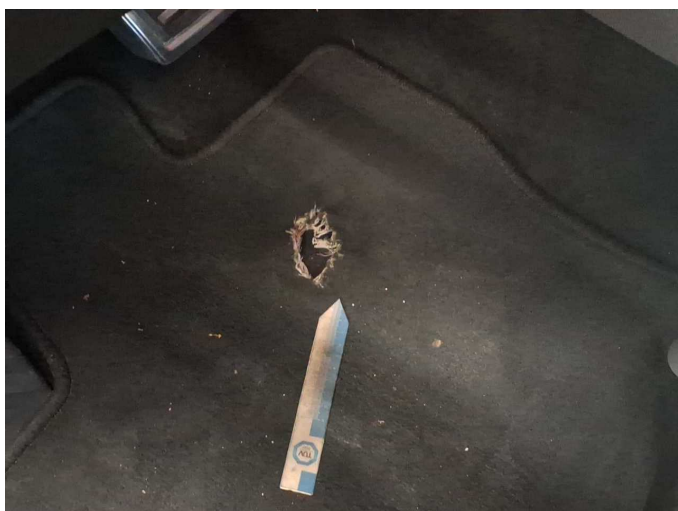
**Damage 1:** Trim / covers: Floor mats - Holes - Replace

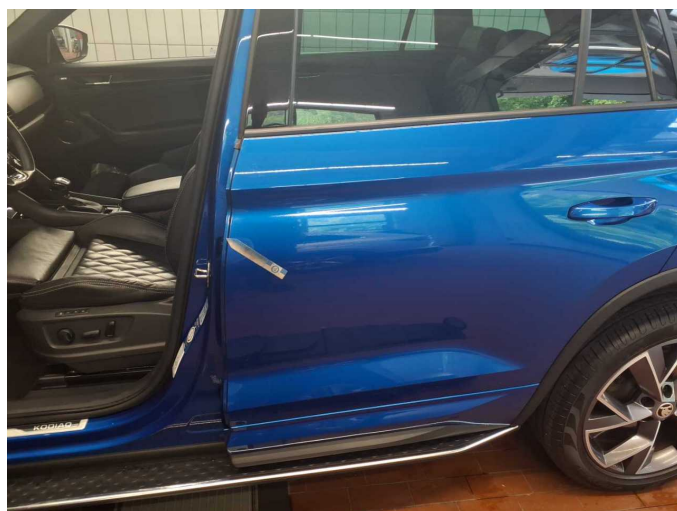
**Damage 2:** Door - rear left side: Door - Scratch(es) - Smart repair

| No. | Component group | Description |
|---|---|---|
| 2 | Door - rear left side | Door - Scratch(es) - Smart repair |

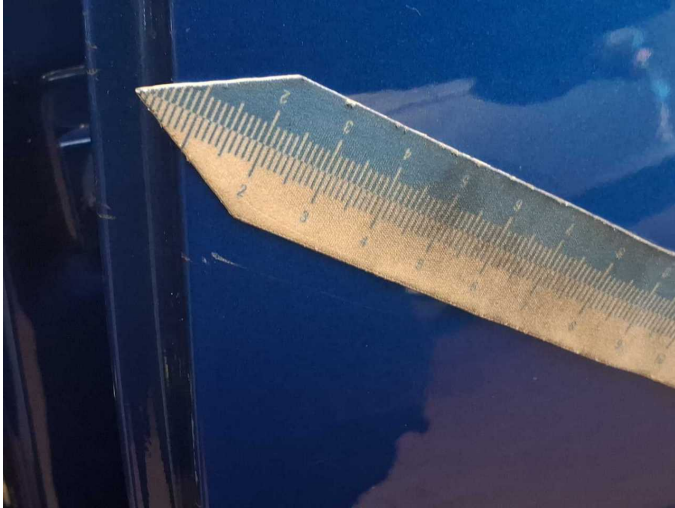
**Damage 2:** Door - rear left side: Door - Scratch(es) - Smart repair

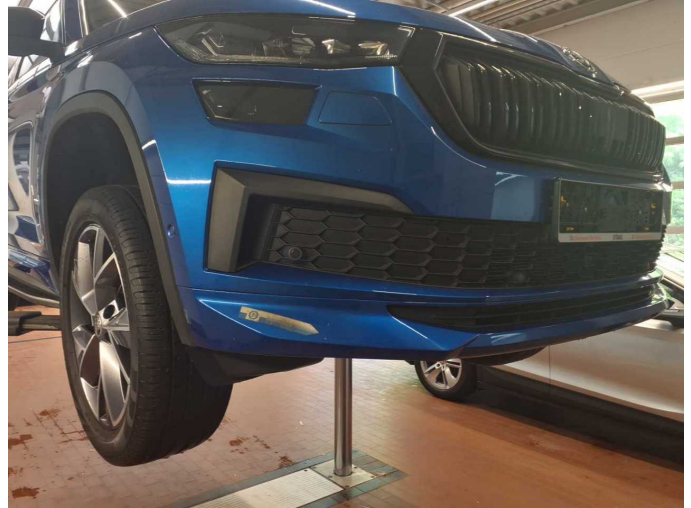
**Wear and tear 1:** Front bumper: Spoiler - Stone chips - No deduction

| No. | Component group | Description |
|---|---|---|
| 1 | Front bumper | Spoiler - Stone chips - No deduction |

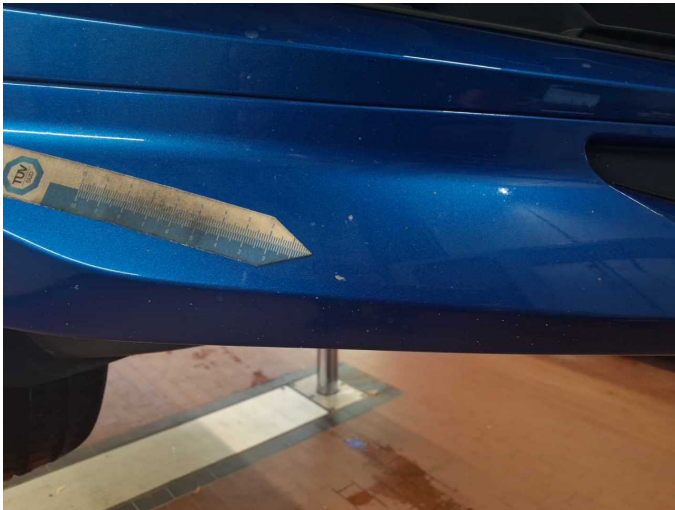
**Wear and tear 1:** Front bumper: Spoiler - Stone chips - No deduction

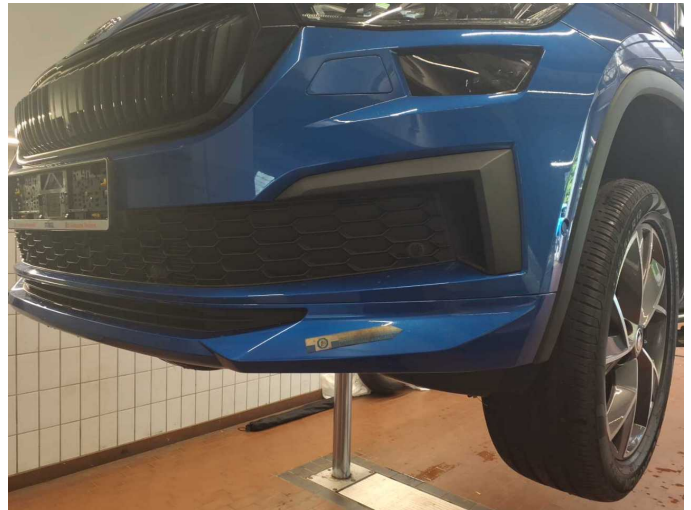
**Wear and tear 1:** Front bumper: Spoiler - Stone chips - No deduction

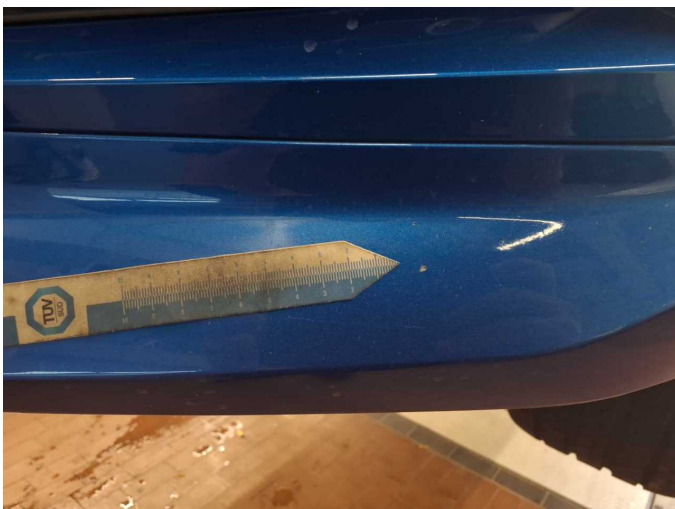
**Wear and tear 1:** Front bumper: Spoiler - Stone chips - No deduction

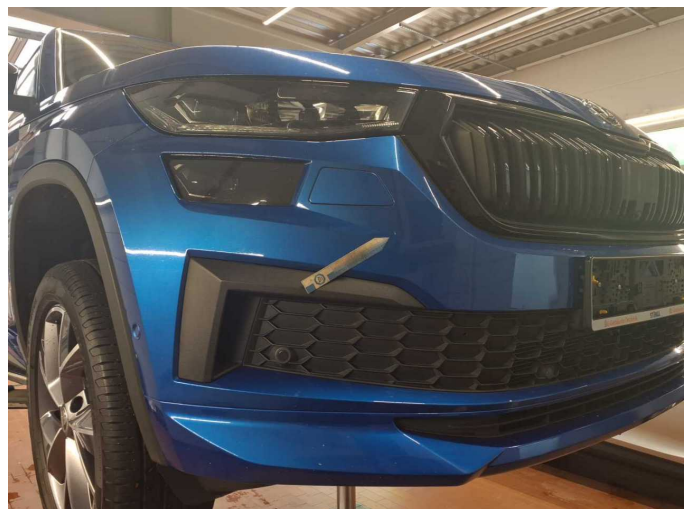
**Wear and tear 2:** Front bumper: Front bumper - Stone chips - No deduction

| No. | Component group | Description |
|---|---|---|
| 2 | Front bumper | Front bumper - Stone chips - No deduction |

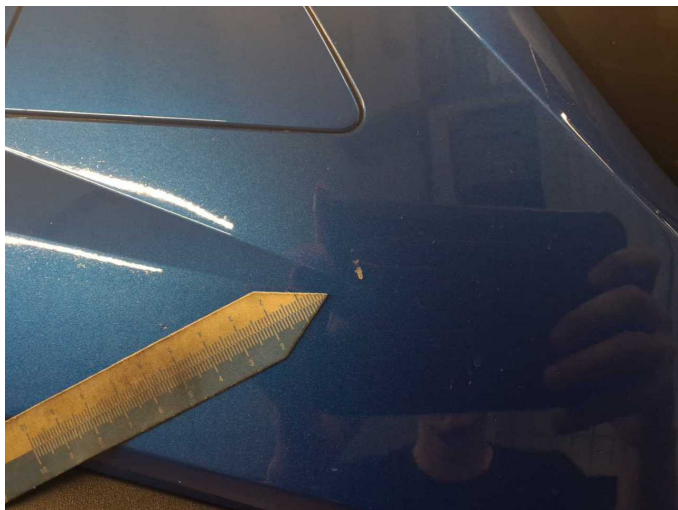
**Wear and tear 2:** Front bumper: Front bumper - Stone chips - No deduction
