Expertise

Protocol number: 46000776  
Order No. / Reference: 26308131  
Inspection date: 17 Jun 2026

Manufacturer: Opel

Model: Astra Sports Tourer 1.2 Turbo Automatik GS

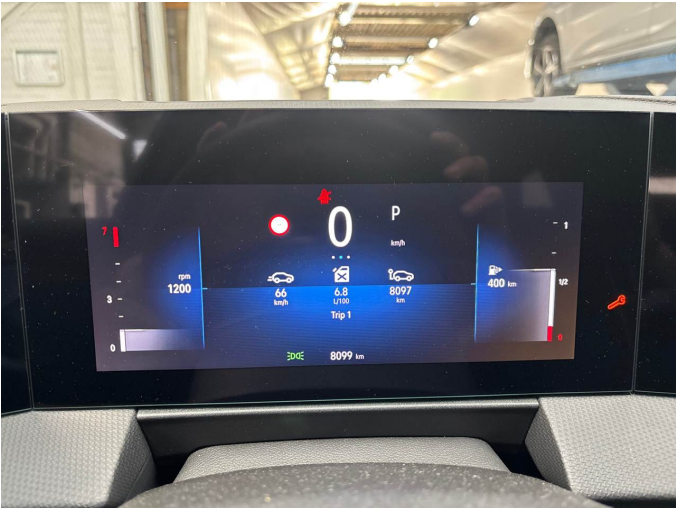
| Mileage (Read) | 8,099 km |

Figure 7: Instrument cluster

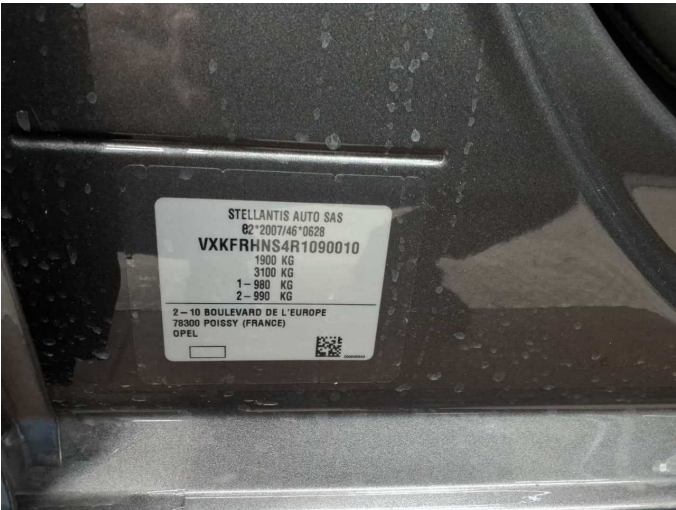
| VIN comparison | The vehicle identification number (VIN) was read from the vehicle and its conformity with the submitted documents was confirmed by the undersigned during the inspection. |

Figure 11: VIN

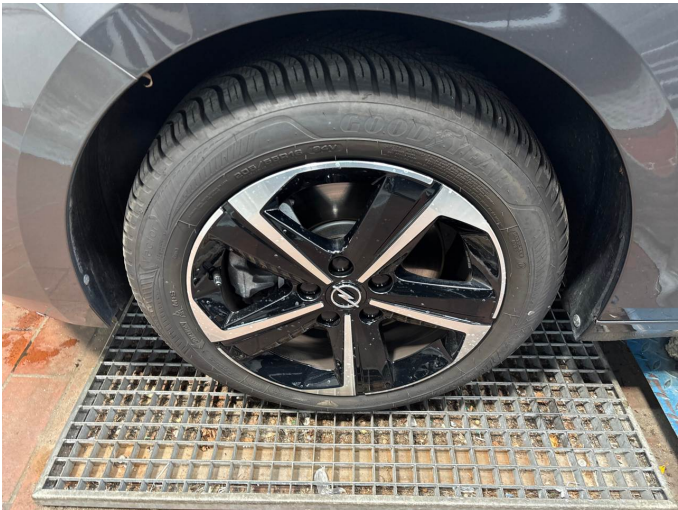
| # | Tyre size | Type of tyre | Manufacturer | Tread depth |
|---|---|---|---|---|
| 1) | 205/55 R16 94V | All-season tyres on Light alloy | Goodyear | 6mm / 6mm |
| 2) | 205/55 R16 94V | All-season tyres on Light alloy | Goodyear | 6mm / 6mm |

Figure 12: Mounted tyres

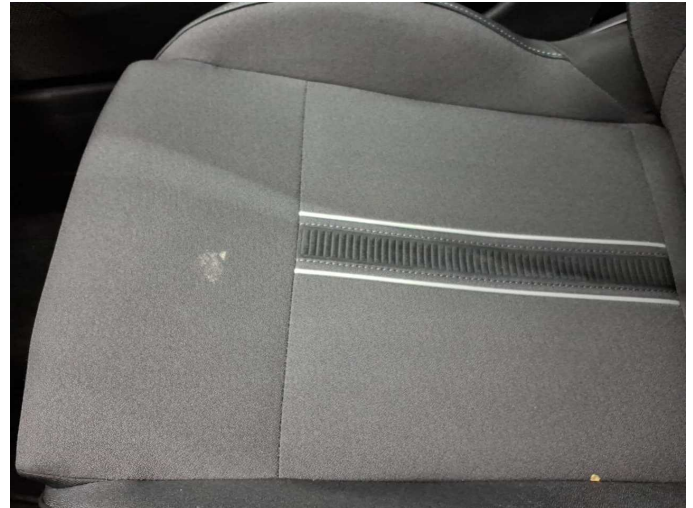
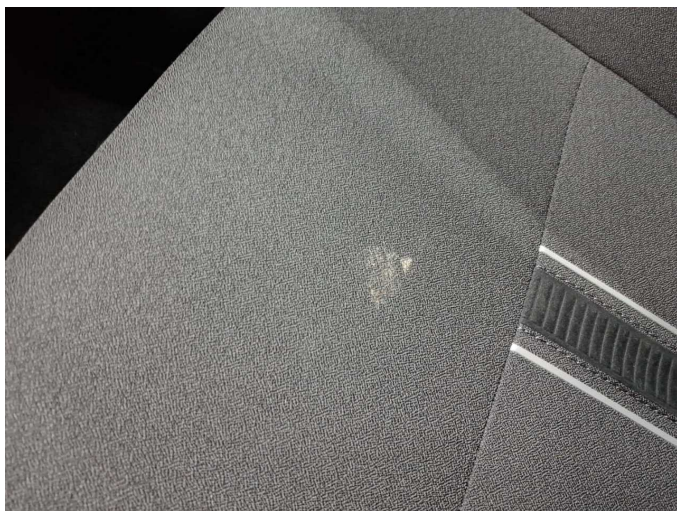
| No. | Component group | Description |
|---|---|---|
| 1 | Seat - front | Seat - right side (Fleck) - Soiled - Clean |

**Damage 1:** Seat - front: Seat - right side (Fleck) - Soiled - Clean

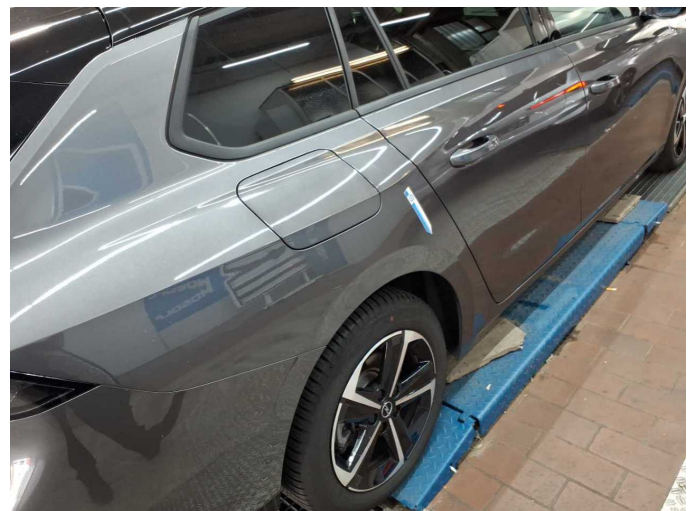
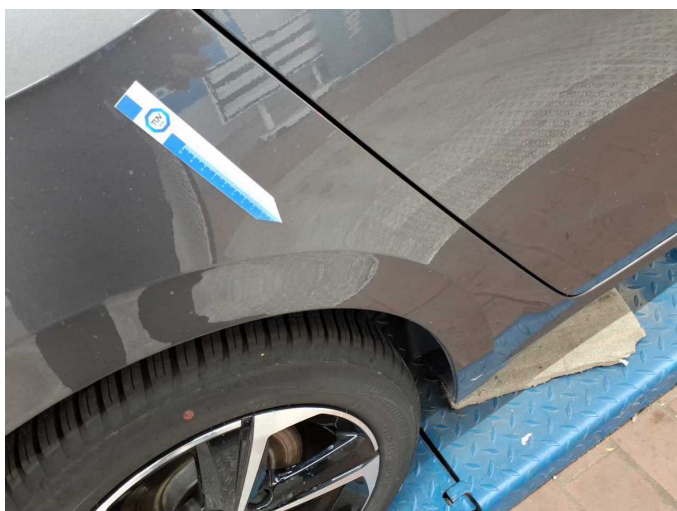
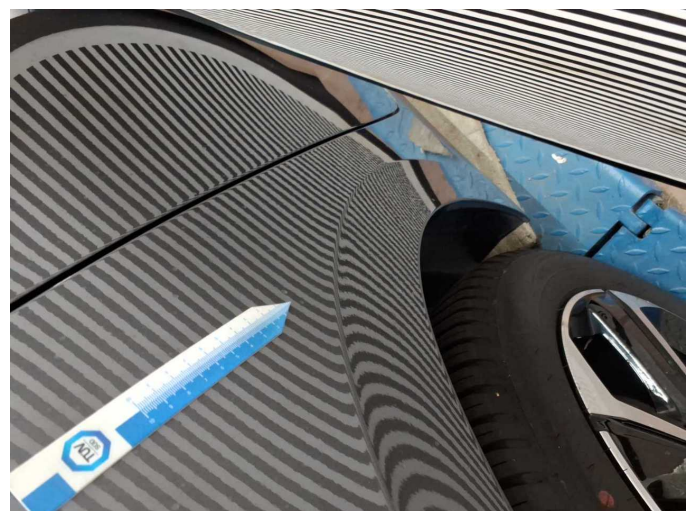
| No. | Component group | Description |
|---|---|---|
| 2 | Side panel - rear right side | Side panel - dent(s) - Smooth repair work |

**Damage 2:** Side panel - rear right side: Side panel - dent(s) - Smooth repair work

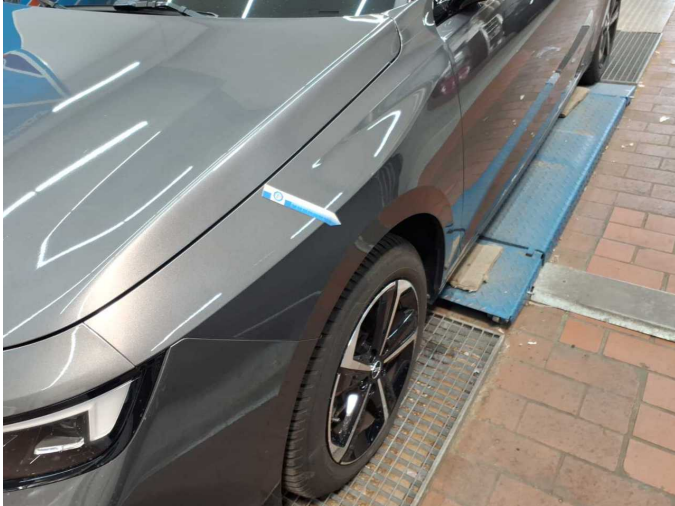
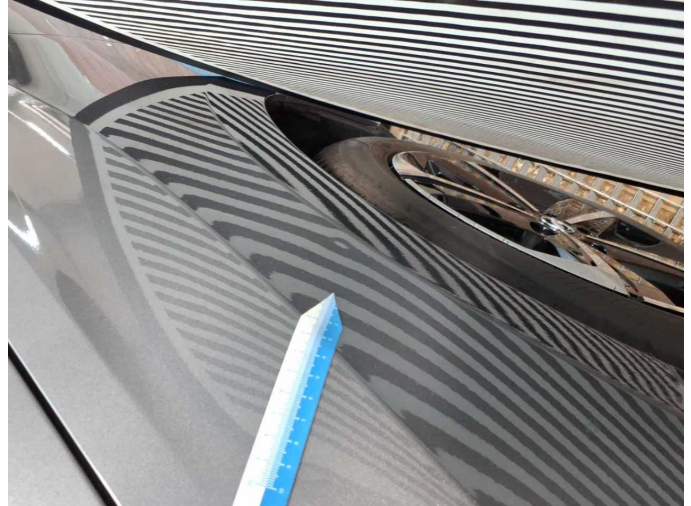
| No. | Component group | Description |
|---|---|---|
| 3 | Mudguard - left side | Mudguard - left side - dent(s) - Smooth repair work |

**Damage 3:** Mudguard - left side: Mudguard - left side - dent(s) - Smooth repair work

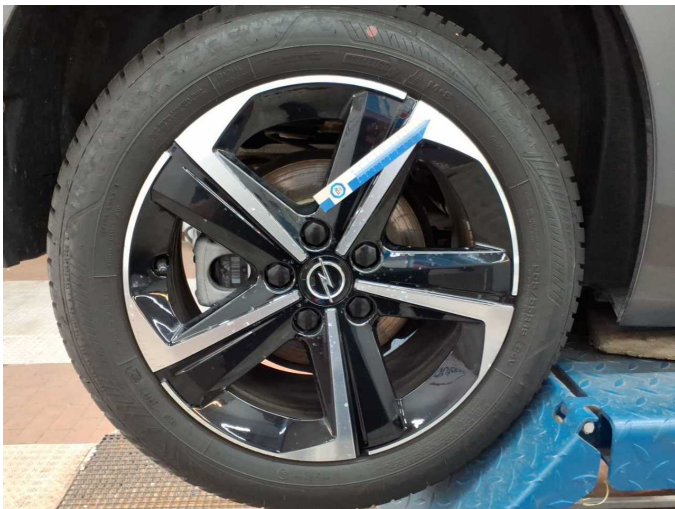
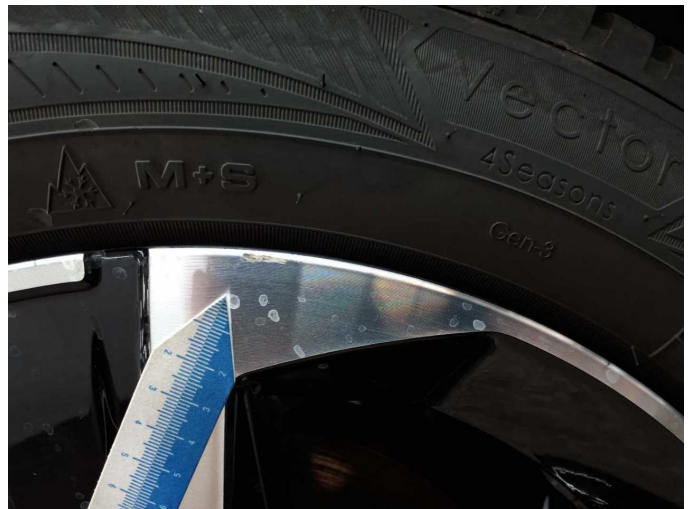
| No. | Component group | Description |
|---|---|---|
| 4 | Wheel / tyres | Alloy rim - rear right side - Scratch(es) - Loss in value |

**Damage 4:** Wheel / tyres: Alloy rim - rear right side - Scratch(es) - Loss in value

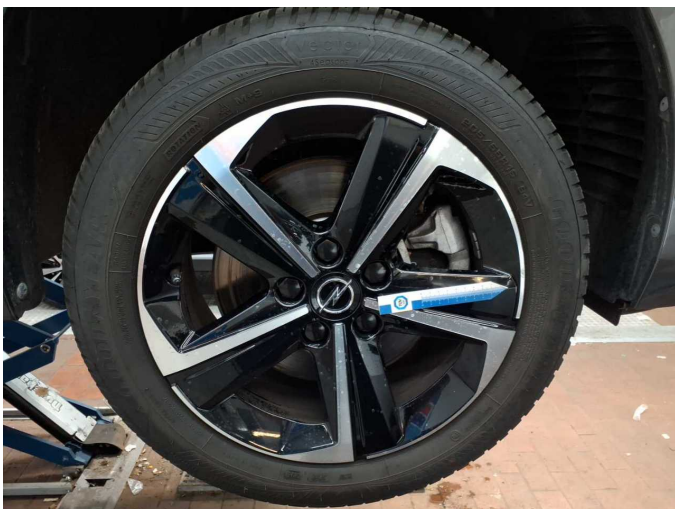
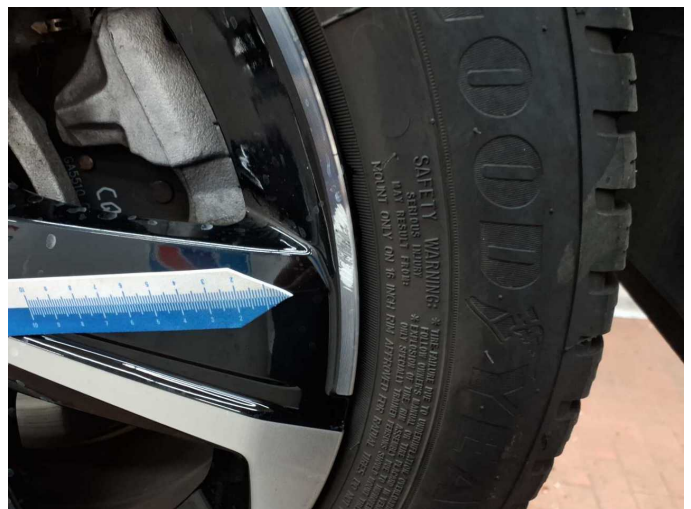
| No. | Component group | Description |
|---|---|---|
| 5 | Wheel / tyres | Alloy rim - front right side - Scratch(es) - Loss in value |

**Damage 5:** Wheel / tyres: Alloy rim - front right side - Scratch(es) - Loss in value

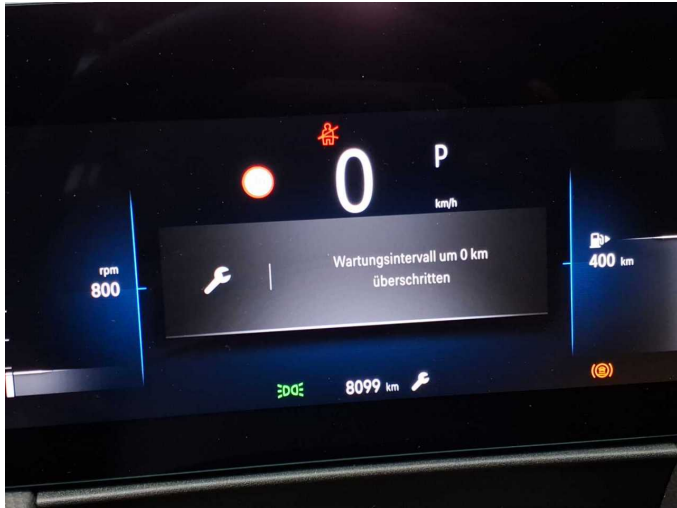
| No. | Component group | Description |
|---|---|---|
| 6 | Misc. | Inspection / maintenance - Due - Replace |

**Damage 6:** Misc.: Inspection / maintenance - Due - Replace

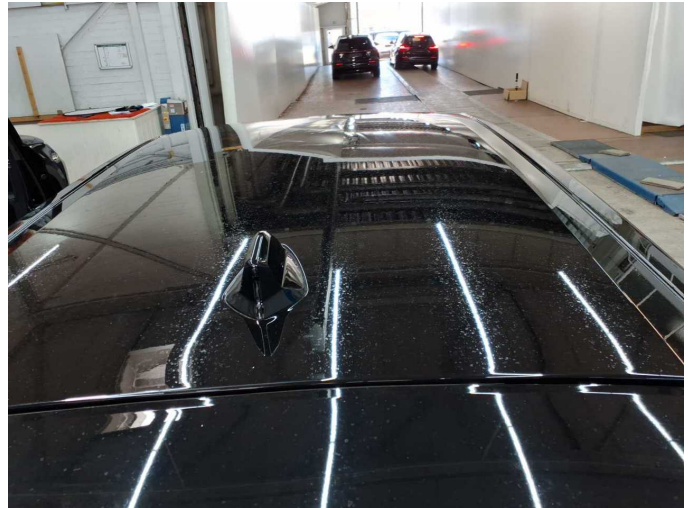
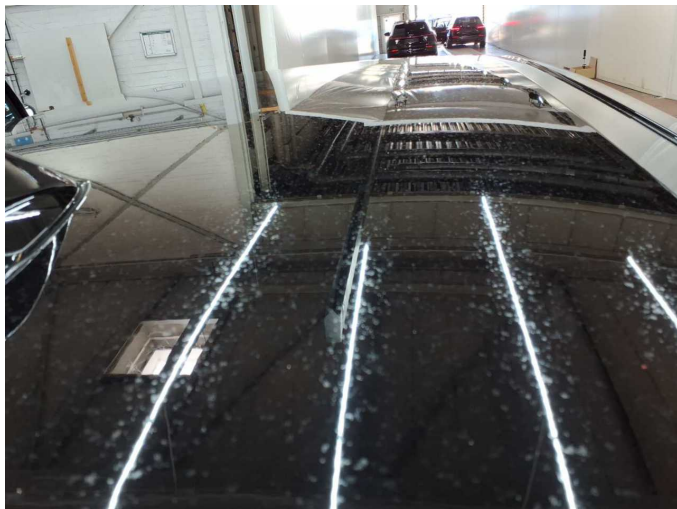
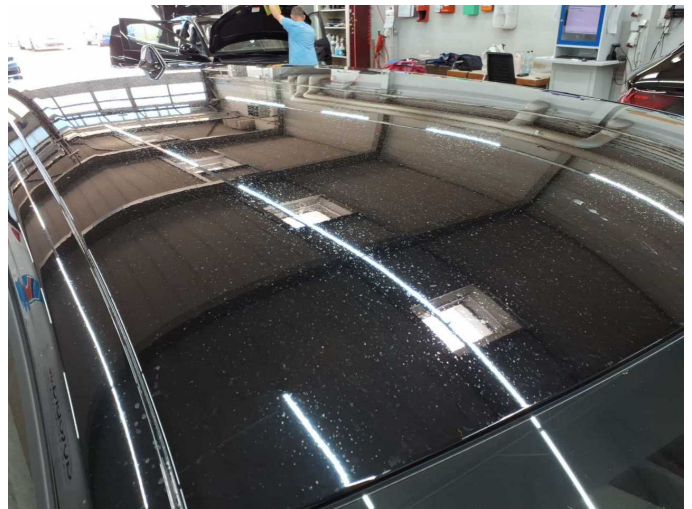
| No. | Component group | Description |
|---|---|---|
| 7 | Roof | Roof (Anhaftung verätzung hartz) - Paint defect - Paint |

**Damage 7:** Roof: Roof (Anhaftung verätzung hartz) - Paint defect - Paint
