Expertise

Protocol number: 46361010  
Order No. / Reference: 26571081  
Inspection date: 7 Jul 2026

Model: Mokka-e Elegance

Opel Mokka-e Elegance

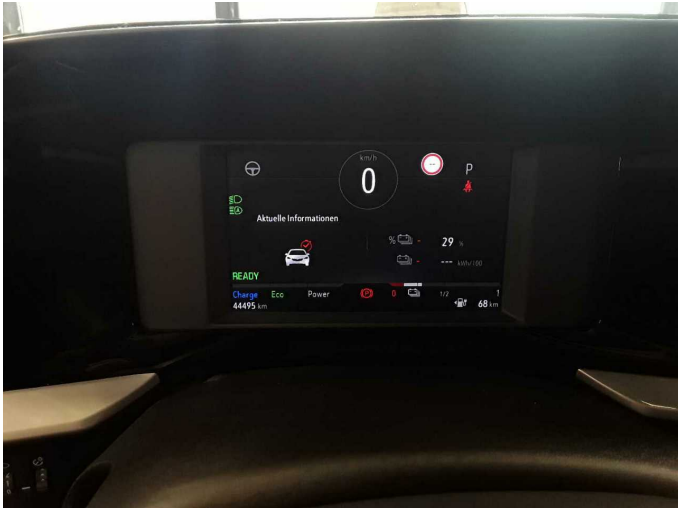
Figure 7: Instrument cluster

Mileage (Read) 44,495 km

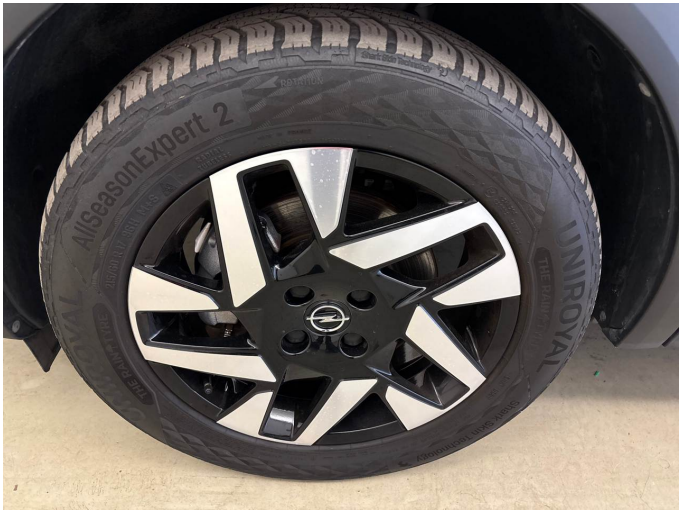
Figure 12: Mounted tyres

| # | Tyre size | Type of tyre | Manufacturer | Tread depth |
|---|---|---|---|---|
| 1) | 215/60 R17 96H | All-season tyres on Light alloy | Uniroyal | 3mm / 3mm |
| 2) | 215/60 R17 96H | All-season tyres on Light alloy | Uniroyal | 5mm / 5mm |

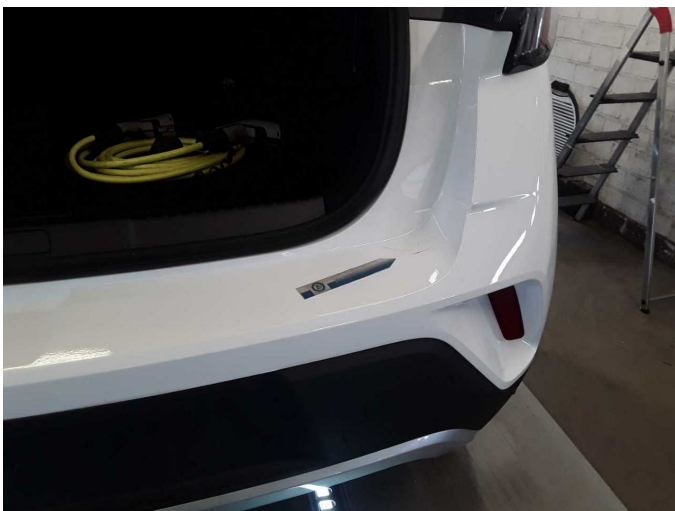
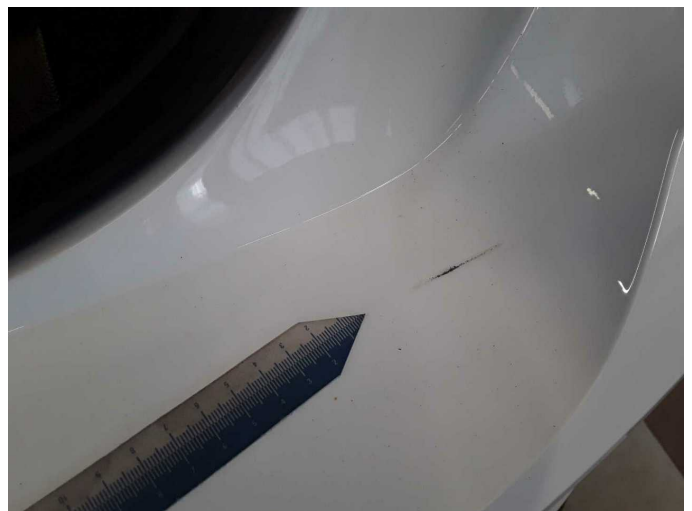
Damage 1: Rear bumper: Rear bumper - Scratch(es) - Smart repair

| No. | Component group | Description |
|---|---|---|
| 1 | Rear bumper | Rear bumper - Scratch(es) - Smart repair |

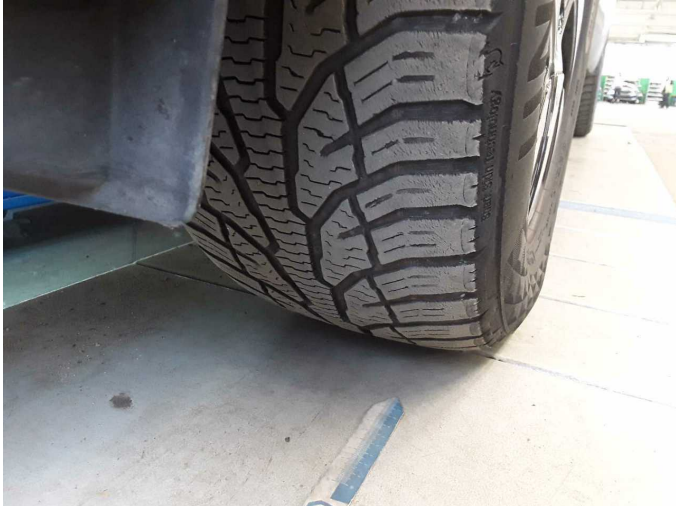
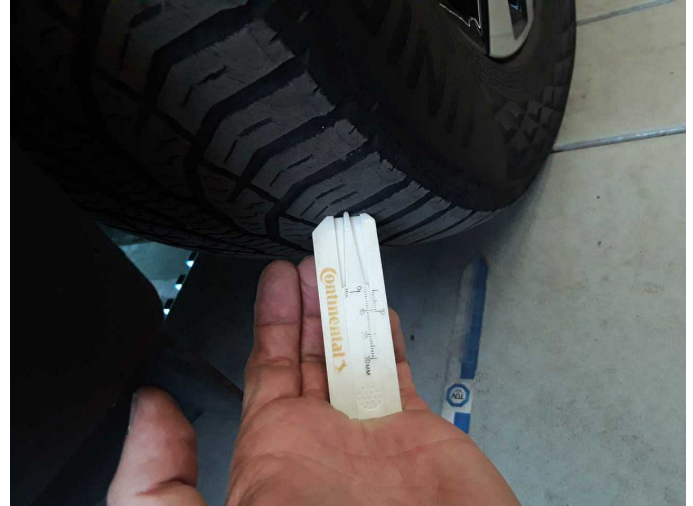
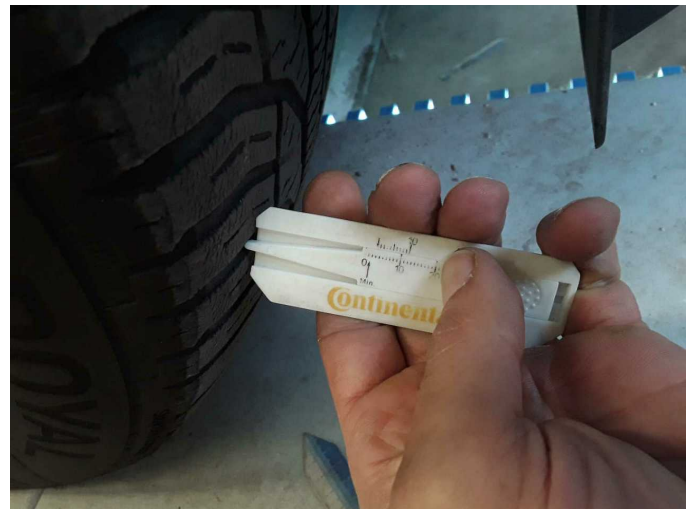
**Damage 2:** Wheel / tyres: Tyre - front - Does not meet the leasing specifications - Replace

| No. | Component group | Description |
|---|---|---|
| 2 | Wheel / tyres | Tyre - front - Does not meet the leasing specifications - Replace |

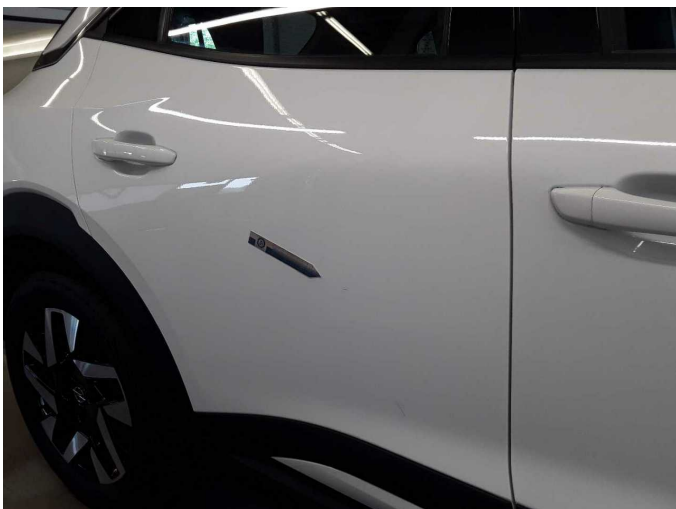
**Damage 3:** Door - rear right side: Door - Scratch(es) - Paint

| No. | Component group | Description |
|---|---|---|
| 3 | Door - rear right side | Door - Scratch(es) - Paint |

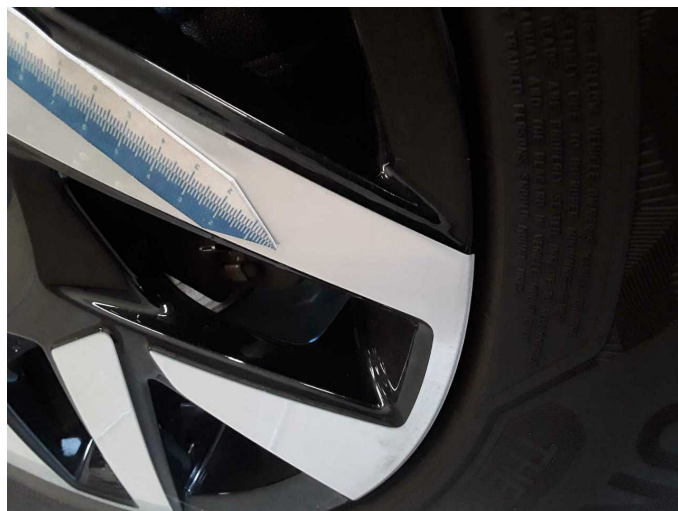
**Wear and tear 1:** Wheel / tyres: Alloy rim - front right side - Scratch(es) - No deduction

| No. | Component group | Description |
|---|---|---|
| 1 | Wheel / tyres | Alloy rim - front right side - Scratch(es) - No deduction |
