Expertise

Protocol number: 46159816  
Order No. / Reference: 26466095  
Inspection date: 24 Jun 2026

Manufacturer: Skoda  
VIN: TMBJH7NP4P7054947

Model: Superb Combi 2.0 TDI DSG Ambition

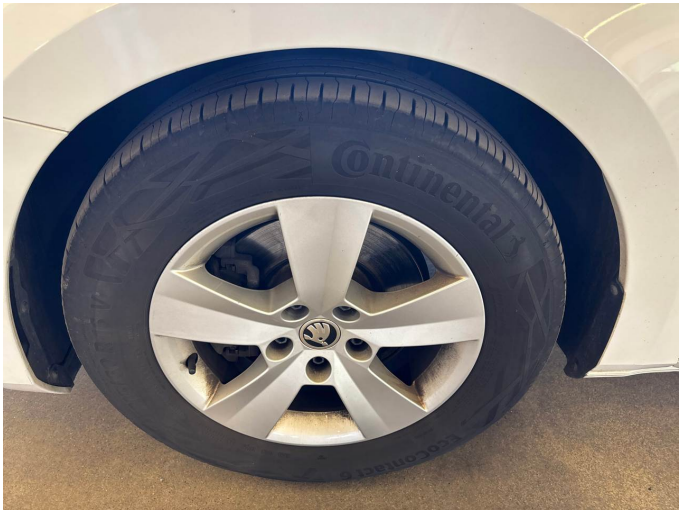
| # | Tyre size | Type of tyre | Manufacturer | Tread depth |
|---|---|---|---|---|
| 1) | 215/60 R16 95V | Summer tyres on Light alloy | Continental | 4mm / 4mm |
| 2) | 215/60 R16 95V | Summer tyres on Light alloy | Continental | 4mm / 4mm |

Figure 12: Mounted tyres

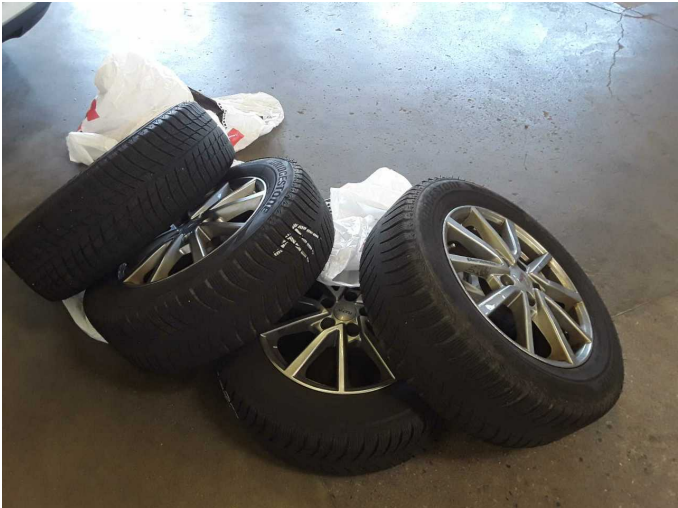
| # | Tyre size | Type of tyre | Manufacturer | Tread depth |
|---|---|---|---|---|
| 1) | 215/60 R16 99H | Winter tyres on Light alloy | Bridgestone | 3mm / 3mm |
| 2) | 215/60 R16 99H | Winter tyres on Light alloy | Bridgestone | 4mm / 4mm |

Figure 16: Additional tyres

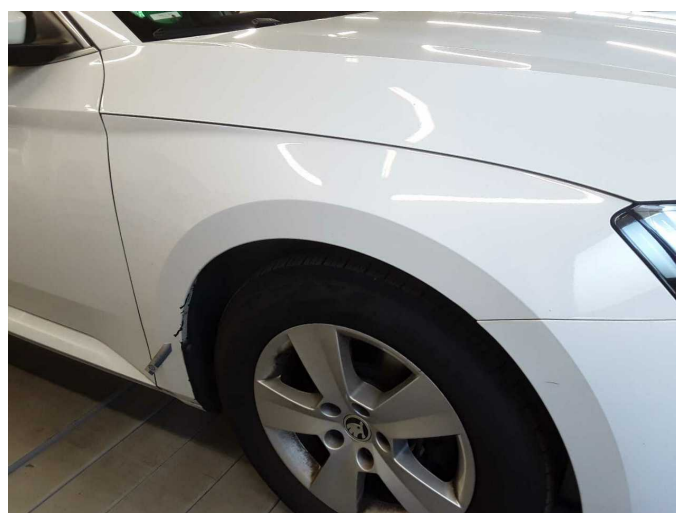
| No. | Component group | Description |
|---|---|---|
| 2 | Mudguard - right side | Mudguard - right side - Paint defect - Smart repair |

**Damage 2:** Mudguard - right side: Mudguard - right side - Paint defect - Smart repair

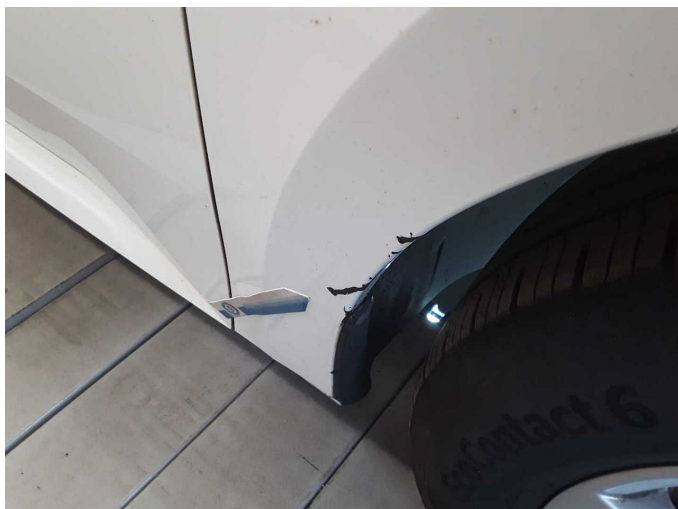
**Damage 2:** Mudguard - right side: Mudguard - right side - Paint defect - Smart repair

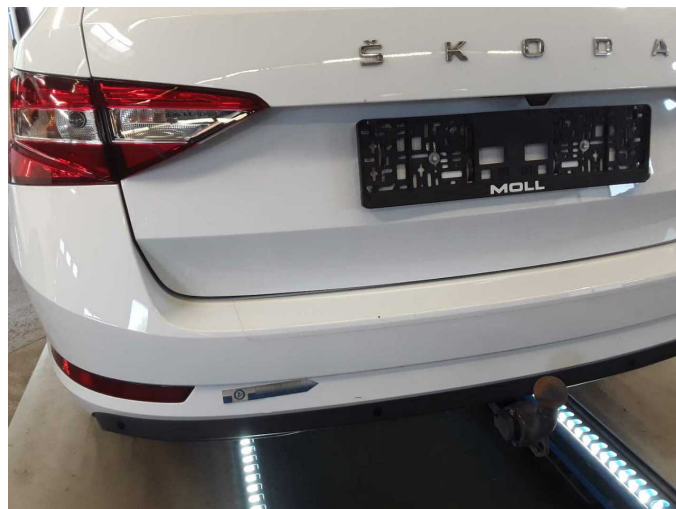
| No. | Component group | Description |
|---|---|---|
| 3 | Rear bumper | Rear bumper - Scratch(es) - Smart repair |

**Damage 3:** Rear bumper: Rear bumper - Scratch(es) - Smart repair

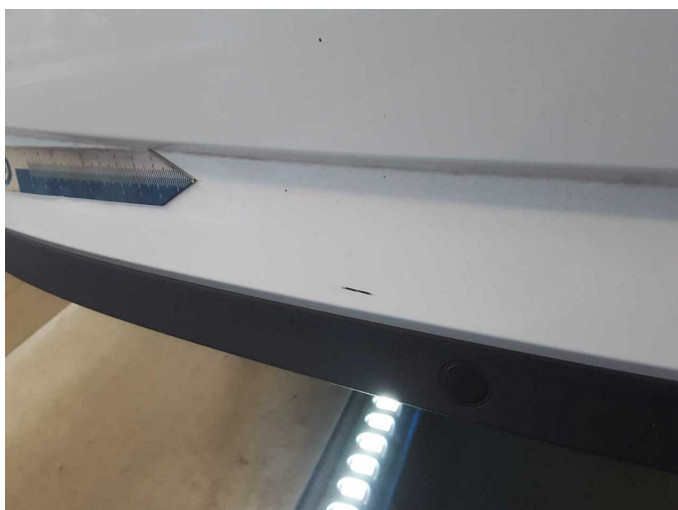
**Damage 3:** Rear bumper: Rear bumper - Scratch(es) - Smart repair

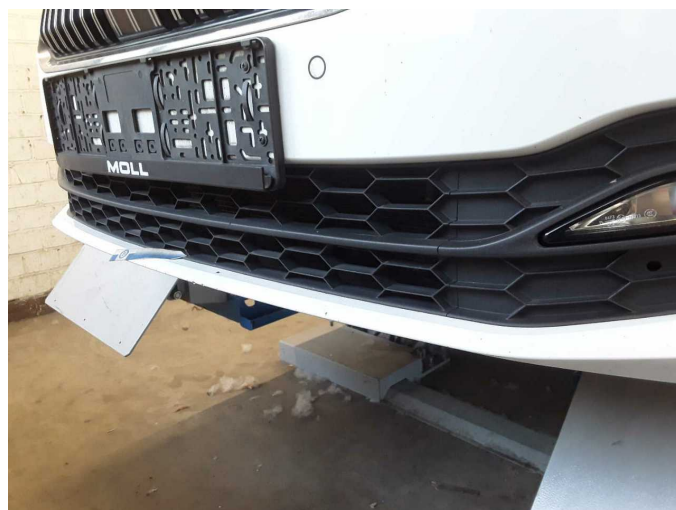
| No. | Component group | Description |
|---|---|---|
| 4 | Front bumper | Front bumper - Scratch(es) - Smart repair |

**Damage 4:** Front bumper: Front bumper - Scratch(es) - Smart repair

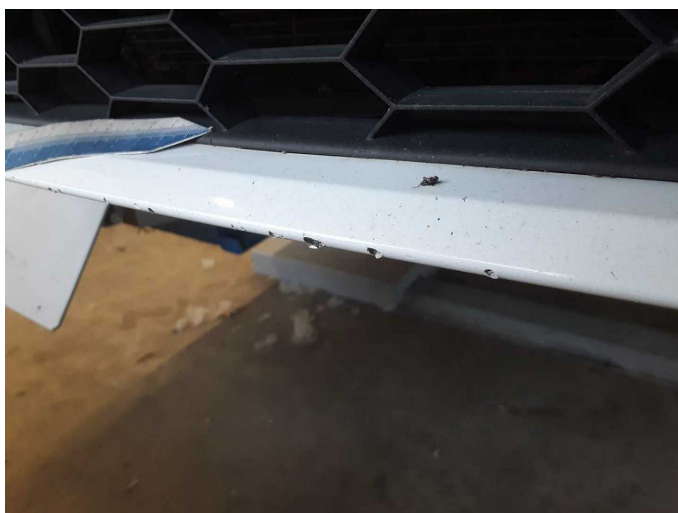
**Damage 4:** Front bumper: Front bumper - Scratch(es) - Smart repair

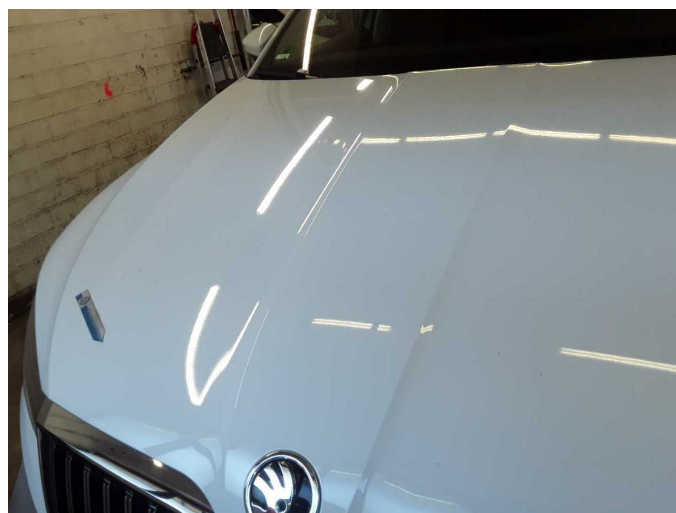
| No. | Component group | Description |
|---|---|---|
| 5 | Bonnet | Bonnet - Dent / paintcoat damage - Repair and paint |

**Damage 5:** Bonnet: Bonnet - Dent / paintcoat damage - Repair and paint

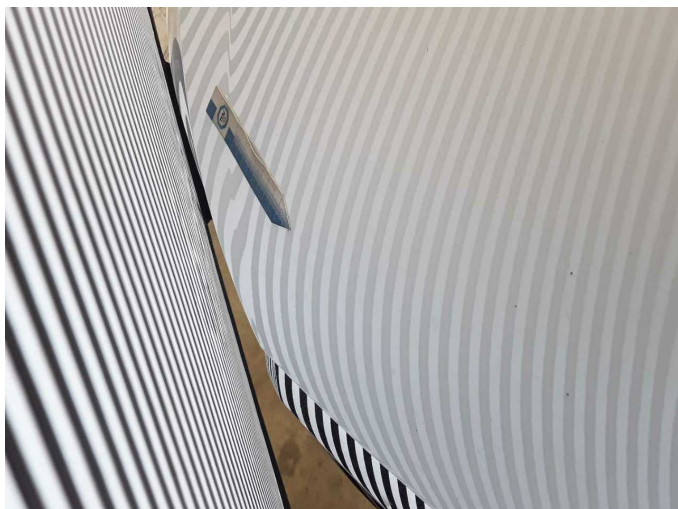
**Damage 5:** Bonnet: Bonnet - Dent / paintcoat damage - Repair and paint

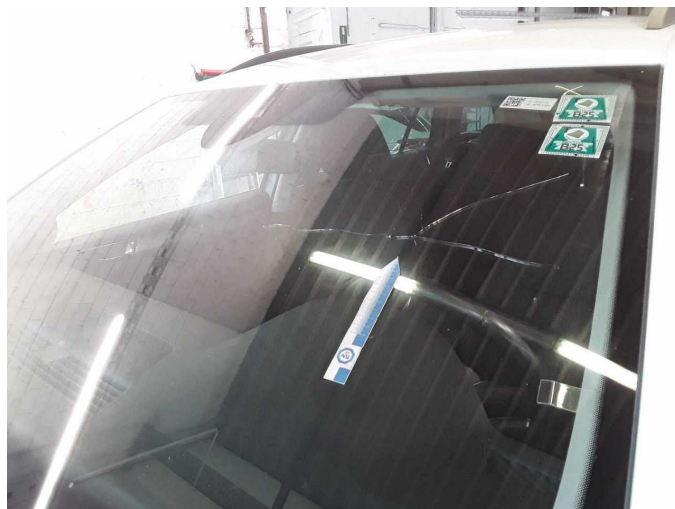
| No. | Component group | Description |
|---|---|---|
| 6 | Vehicle glazing | Windscreen (Rissbildung) - Stone chips - Replace |

**Damage 6:** Vehicle glazing: Windscreen (Rissbildung) - Stone chips - Replace

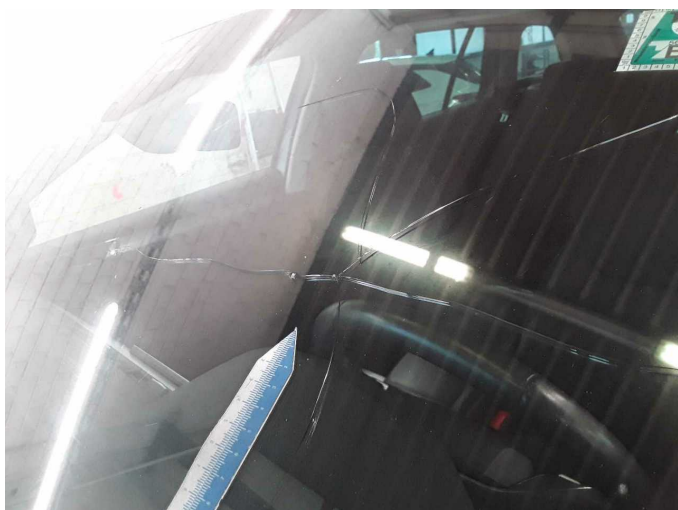
**Damage 6:** Vehicle glazing: Windscreen (Rissbildung) - Stone chips - Replace

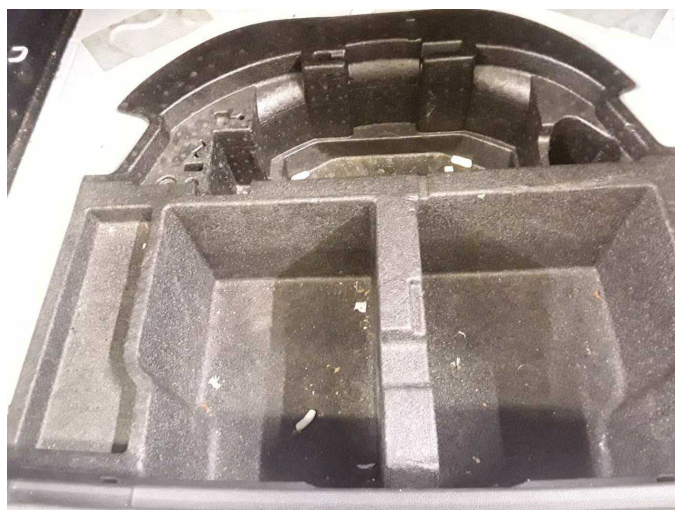
Equipment - Tirefit complete

**Missing part 1:** Equipment: Tirefit complete - Missing - Replace

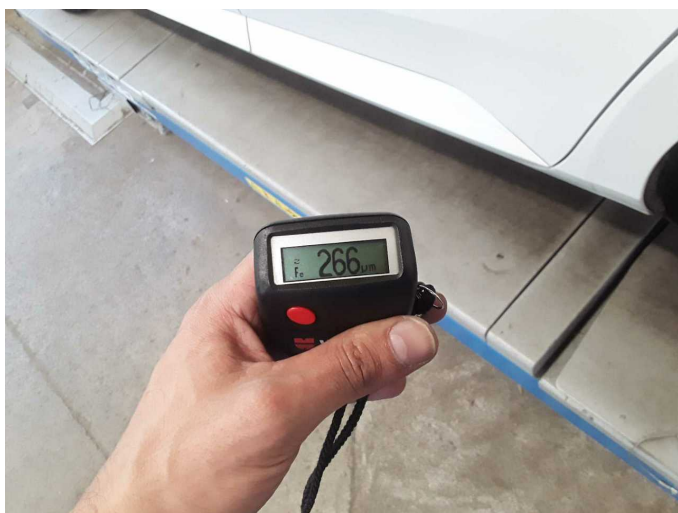
| 1 | Side panel - rear left side, Professionally carried out, Invoice of repair done Non-existent |

| Side panel - rear left side | 266 µm |

**Repainting 1:** Side panel - rear left side

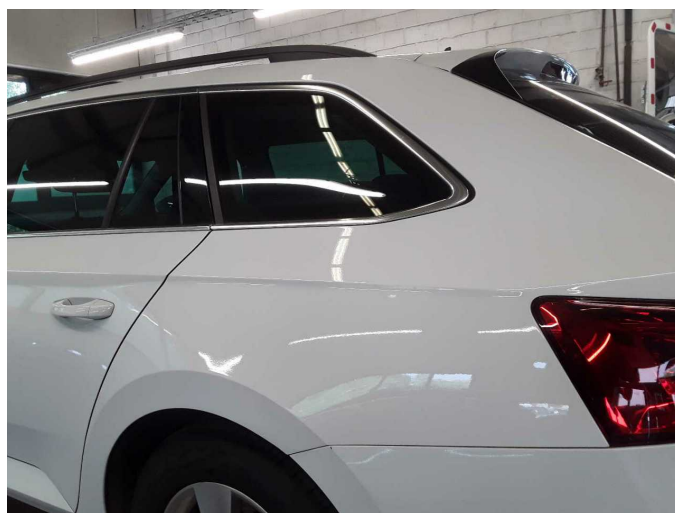
**Repainting 1:** Side panel - rear left side
