Expertise

Protocol number: 46534416  
Order No. / Reference: 26642407  
Inspection date: 15 Jul 2026

Manufacturer: Ford

Model: Transit Connect 230 L2 Trend

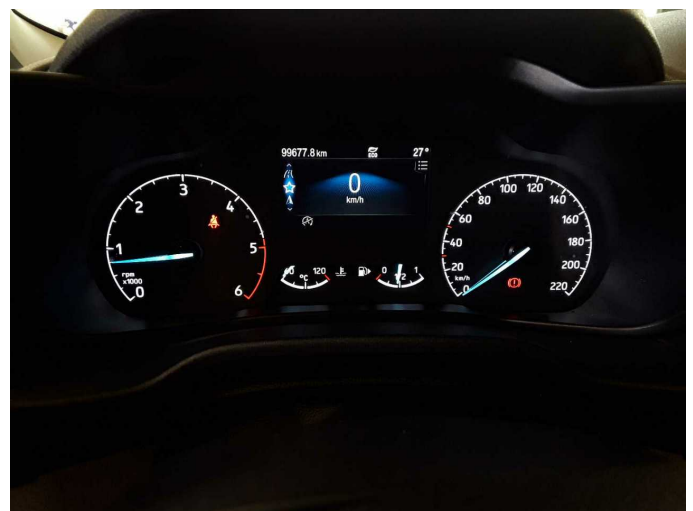
Figure 6: Instrument cluster

Mileage (Read) 99,677 km

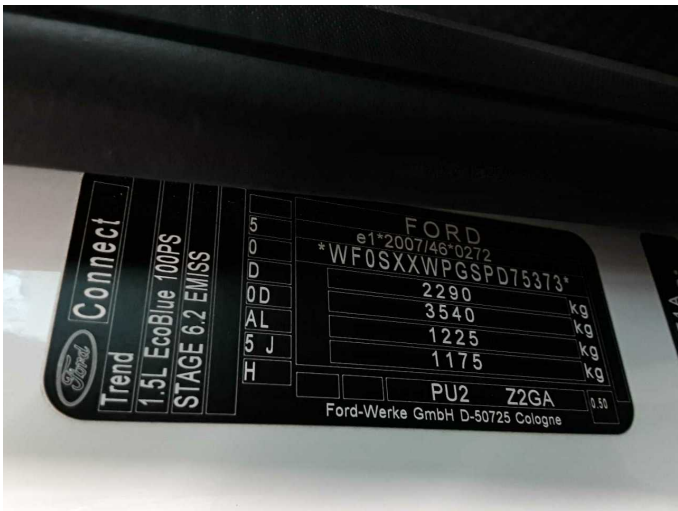
Figure 10: VIN

| VIN comparison | The vehicle identification number (VIN) was read from the vehicle and its conformity with the submitted documents was confirmed by the undersigned during the inspection. |

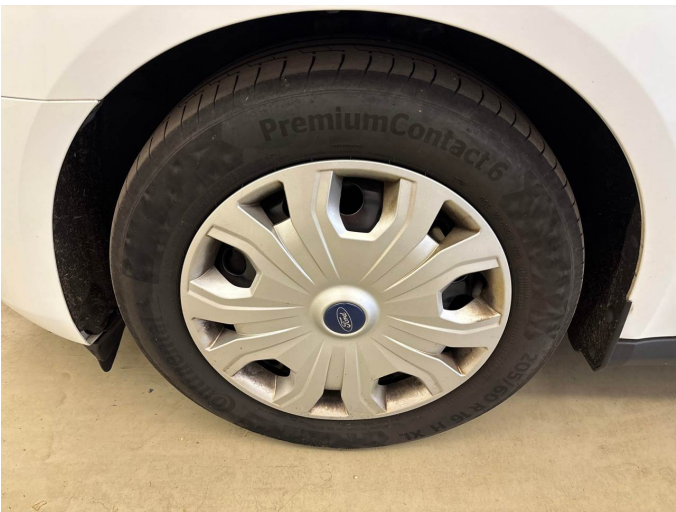
Figure 11: Mounted tyres

| # | Tyre size | Type of tyre | Manufacturer | Tread depth |
|---|---|---|---|---|
| 1) | 205/60 R16 96H | Summer tyres on Steel rim with wheel cover | Continental | 3mm / 3mm |
| 2) | 205/60 R16 96H | Summer tyres on Steel rim with wheel cover | Continental | 4mm / 4mm |

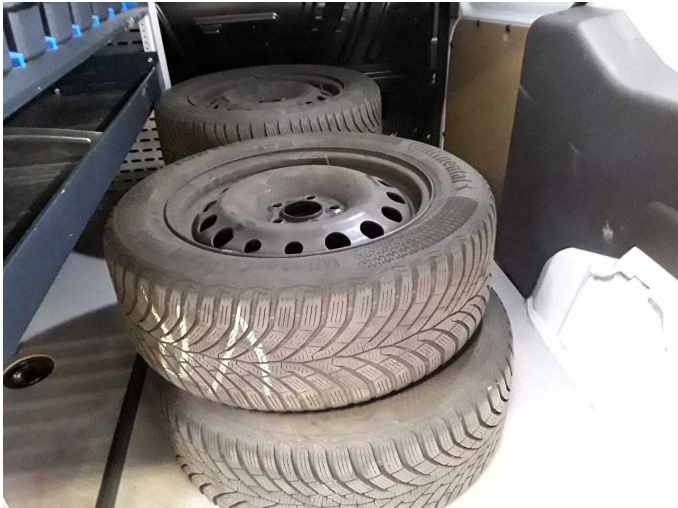
Figure 14: Additional tyres

| # | Tyre size | Type of tyre | Manufacturer | Tread depth |
|---|---|---|---|---|
| 1) | 215/55 R16 97H | Winter tyres on Steel | Continental | 4mm / 4mm |
| 2) | 215/55 R16 97H | Winter tyres on Steel | Continental | 5mm / 5mm |

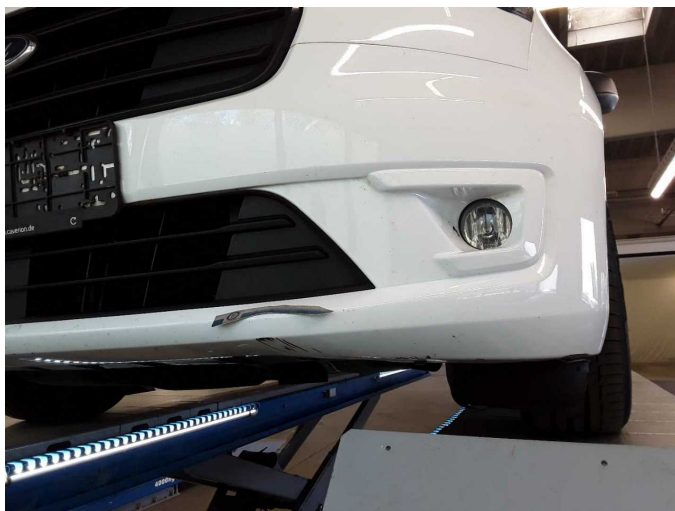
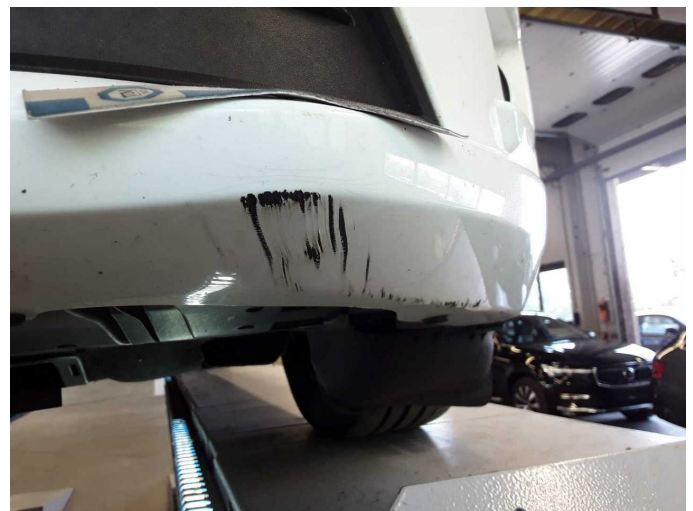
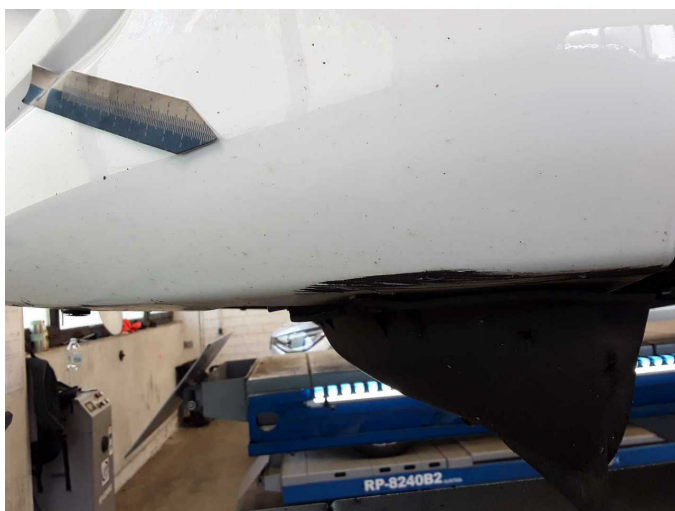
| No. | Component group | Description |
|---|---|---|
| 1 | Front bumper | Front bumper - Scratch(es) - Smart repair |

Damage 1: Front bumper: Front bumper - Scratch(es) - Smart repair

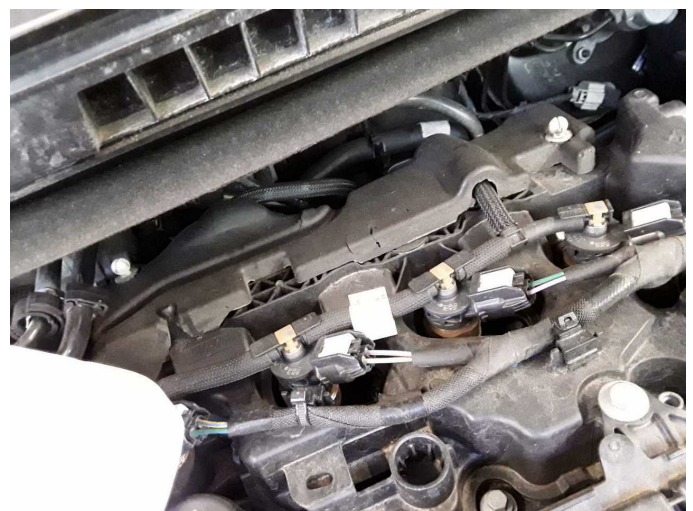
| No. | Component group | Description |
|---|---|---|
| 2 | Engine | Engine cover - Damaged - Replace |

Damage 2: Engine: Engine cover - Damaged - Replace

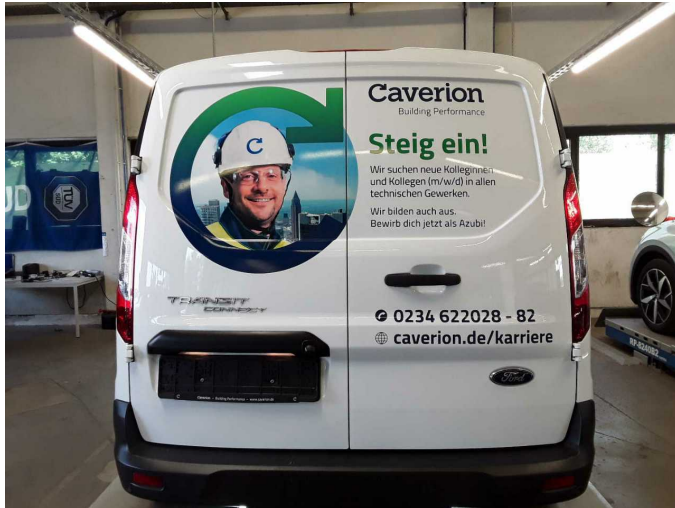
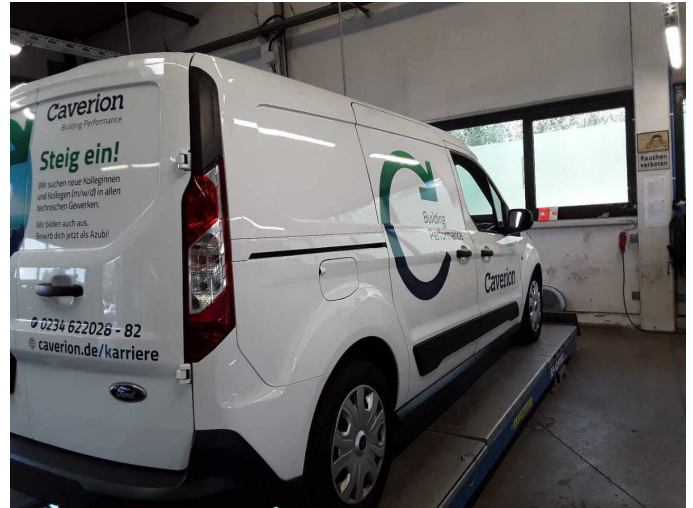
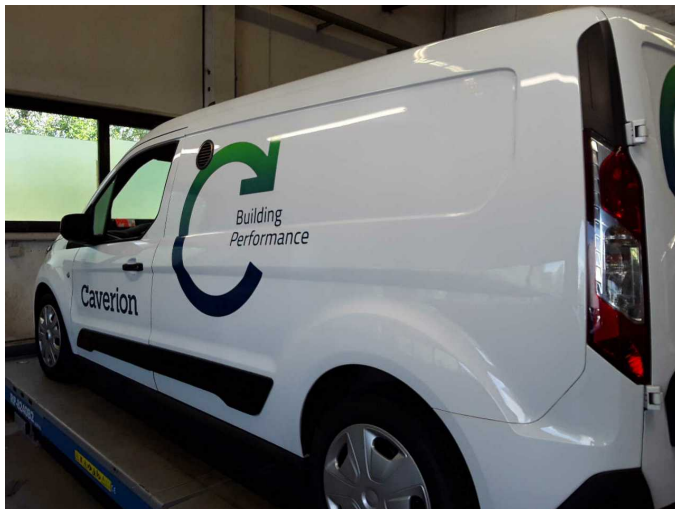
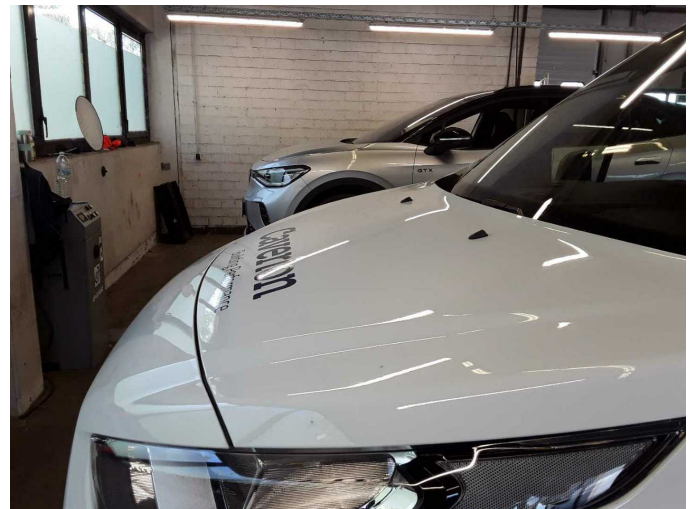
| No. | Component group | Description |
|---|---|---|
| 3 | Body | Body - Glued / labelled - De-glue / neutralise |

**Damage 3:** Body: Body - Glued / labelled - De-glue / neutralise

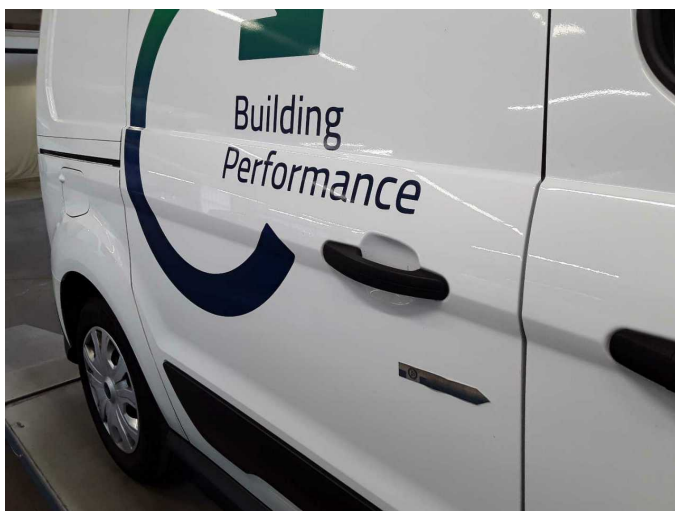
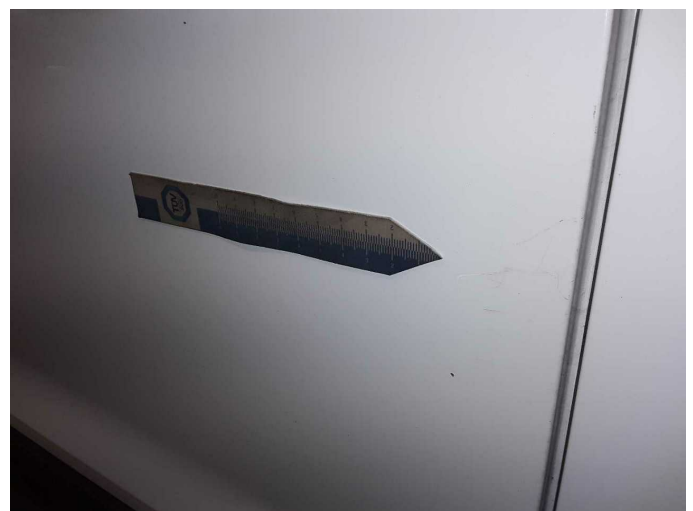
| No. | Component group | Description |
|---|---|---|
| 4 | Door - rear right side | Door - Scratch(es) - Paint |

**Damage 4:** Door - rear right side: Door - Scratch(es) - Paint

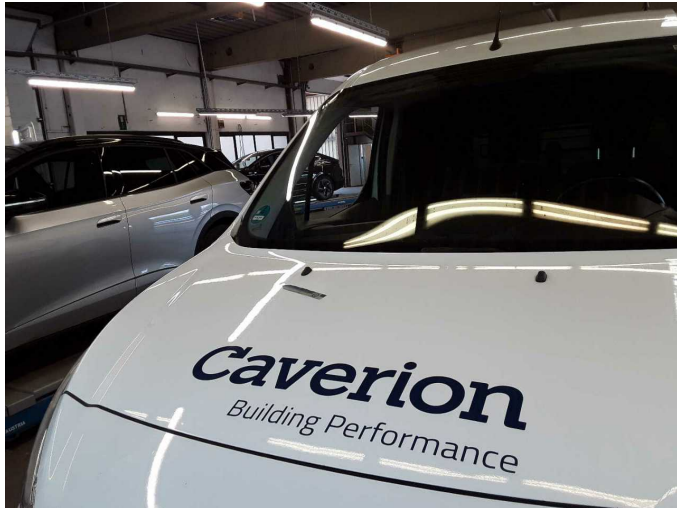
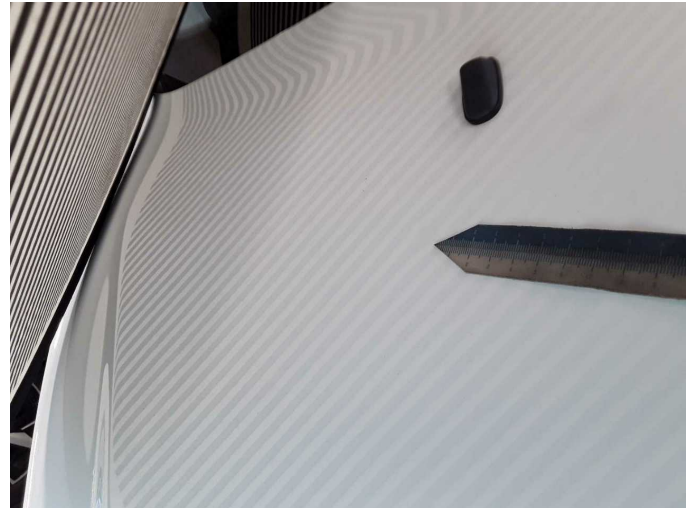
| No. | Component group | Description |
|---|---|---|
| 6 | Bonnet | Bonnet - dent(s) - No deduction |

**Wear and tear 6:** Bonnet: Bonnet - dent(s) - No deduction
