Expertise

Protocol number: 46787665  
Order No. / Reference: 26529969  
Inspection date: 28 Jul 2026

Manufacturer: Volvo

Model: C40 Recharge Twin Motor Ultimate

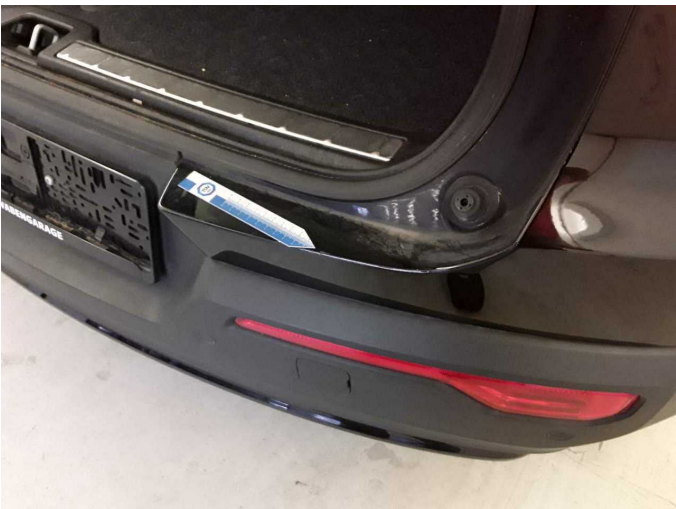
Damage 1: Rear bumper: Rear bumper - Scratched - Smart repair

| No. | Component group | Description |
|---|---|---|
| 1 | Rear bumper | Rear bumper - Scratched - Smart repair |

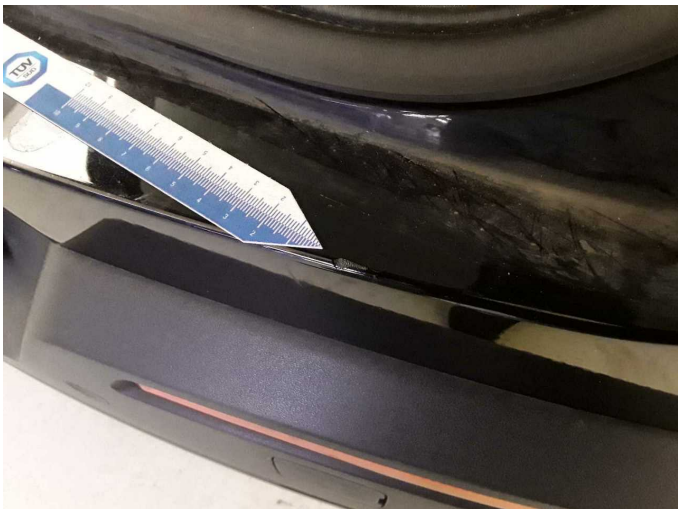
Damage 1: Rear bumper: Rear bumper - Scratched - Smart repair

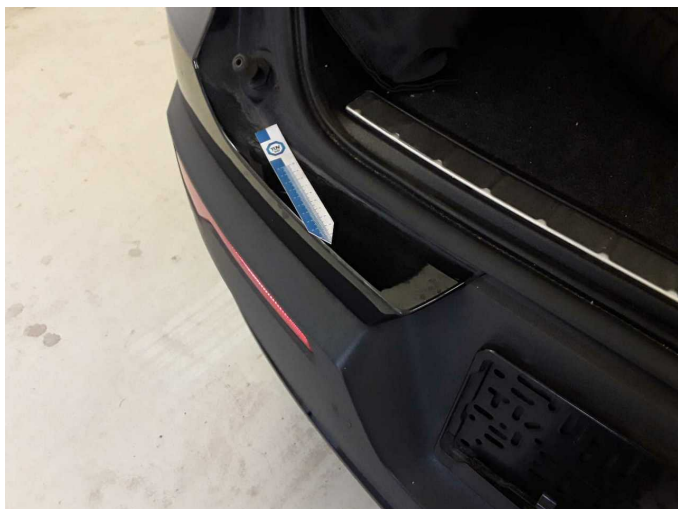
**Damage 1:** Rear bumper: Rear bumper - Scratched - Smart repair

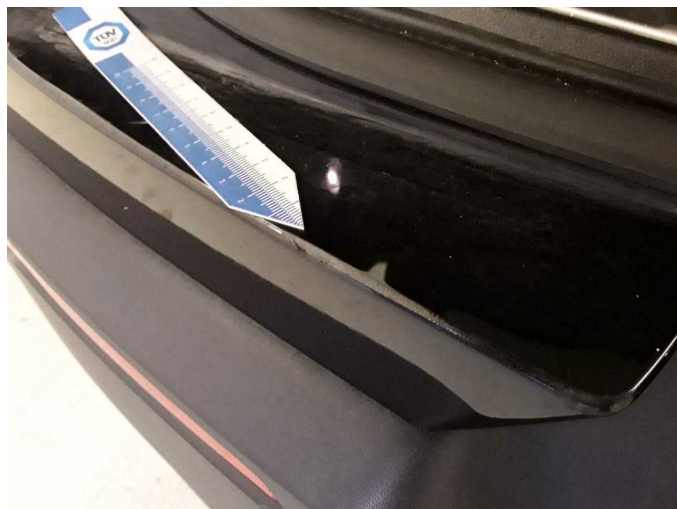
**Damage 1:** Rear bumper: Rear bumper - Scratched - Smart repair

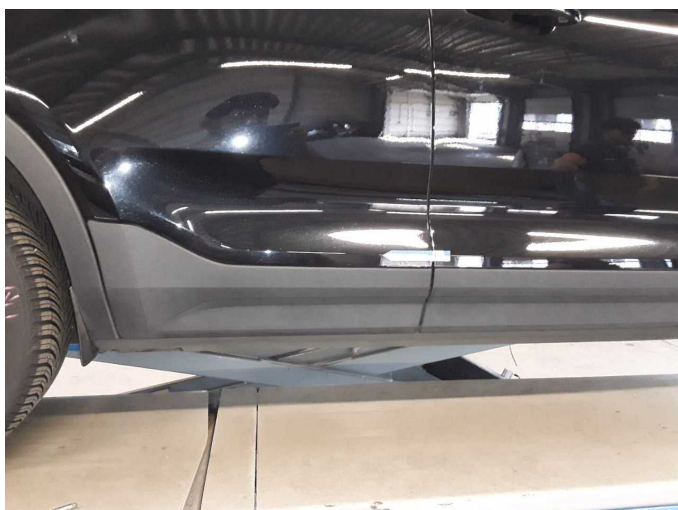
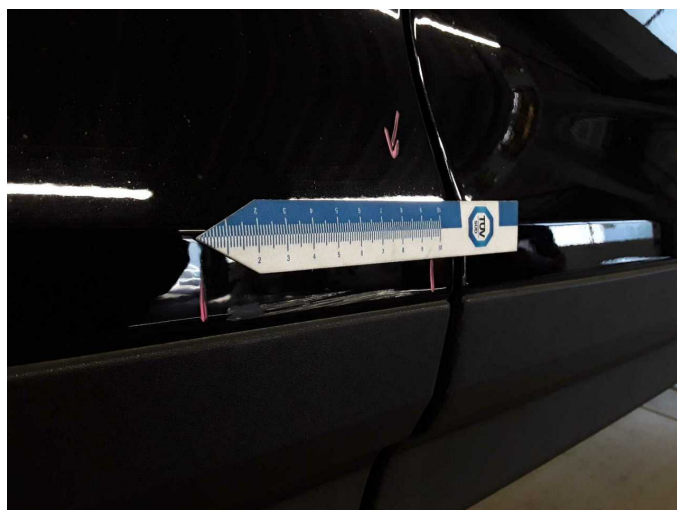
**Damage 3:** Door - rear right side: Door - Scratched - Smart repair

| No. | Component group | Description |
|---|---|---|
| 3 | Door - rear right side | Door - Scratched - Smart repair |

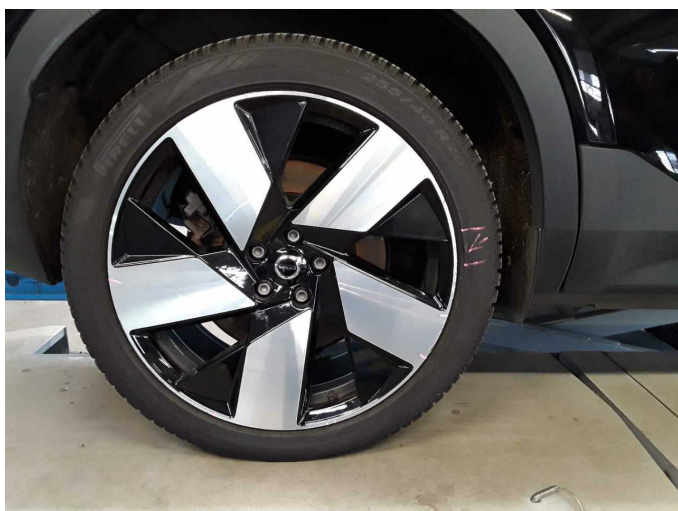
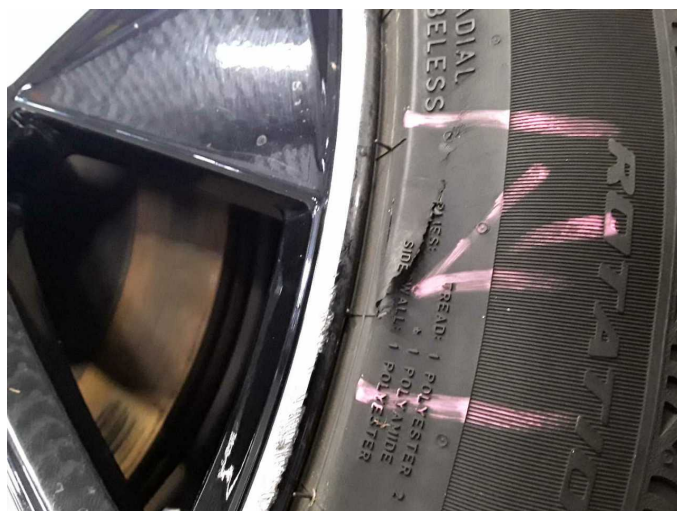
**Damage 4:** Wheel / tyres: Tyre - rear right side (nicht fahrbereit) - Broken / torn - Replace

| No. | Component group | Description |
|---|---|---|
| 4 | Wheel / tyres | Tyre - rear right side (nicht fahrbereit) - Broken / torn - Replace |

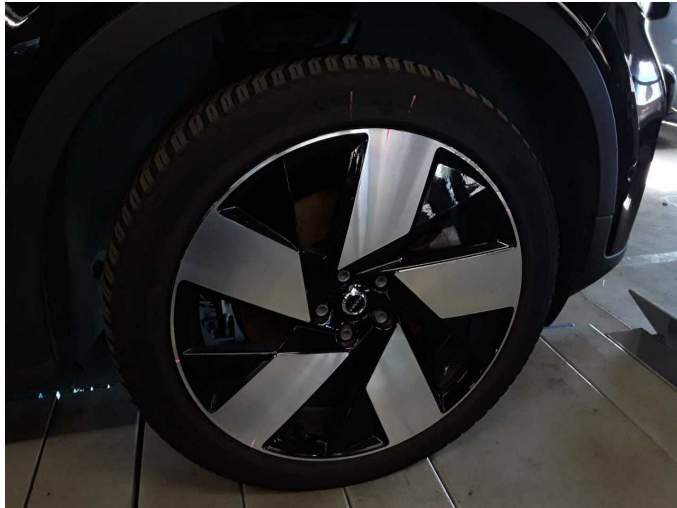
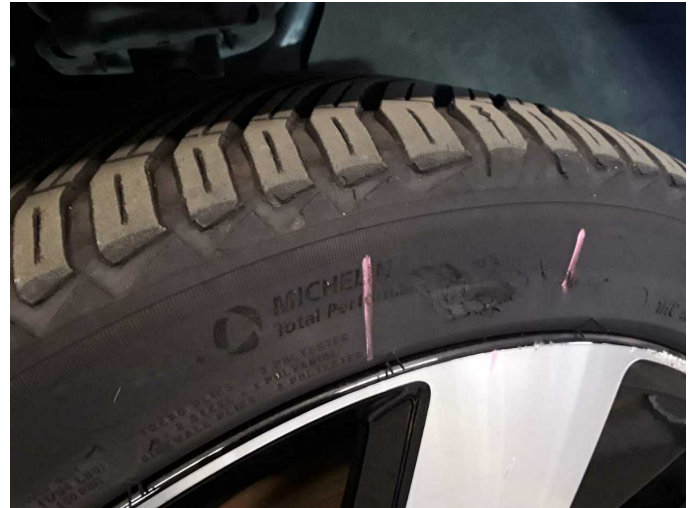
**Damage 5:** Wheel / tyres: Tyre - front right side (nicht fahrbereit) - Broken / torn - Replace

| No. | Component group | Description |
|---|---|---|
| 5 | Wheel / tyres | Tyre - front right side (nicht fahrbereit) - Broken / torn - Replace |

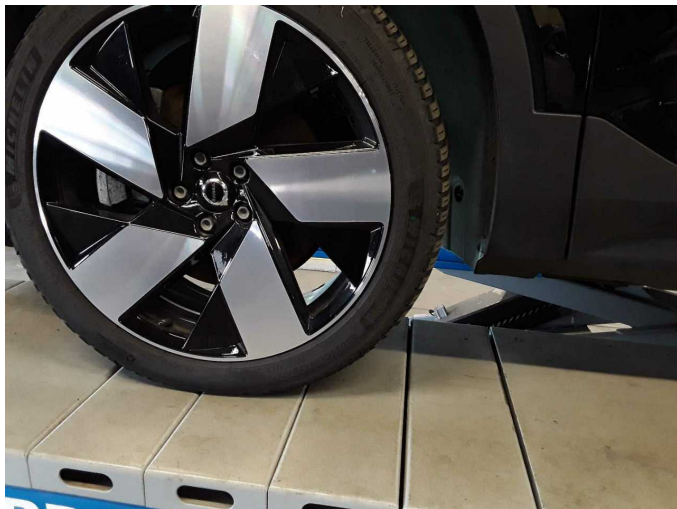
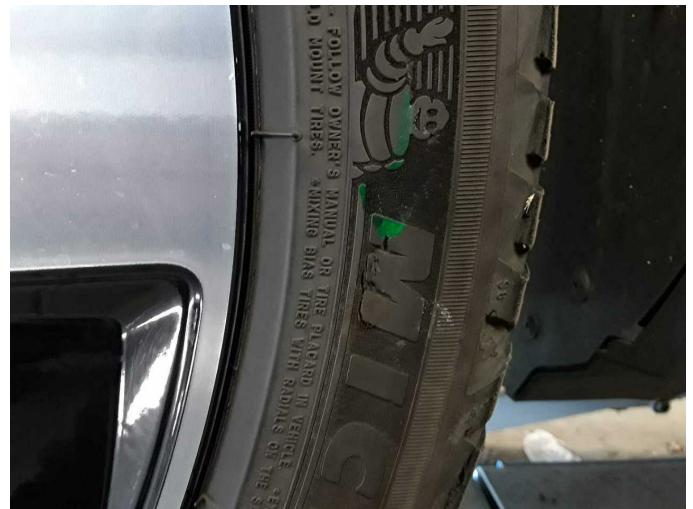
**Damage 6:** Wheel / tyres: Tyre - front left side (nicht fahrbereit) - Broken / torn - Replace

| No. | Component group | Description |
|---|---|---|
| 6 | Wheel / tyres | Tyre - front left side (nicht fahrbereit) - Broken / torn - Replace |

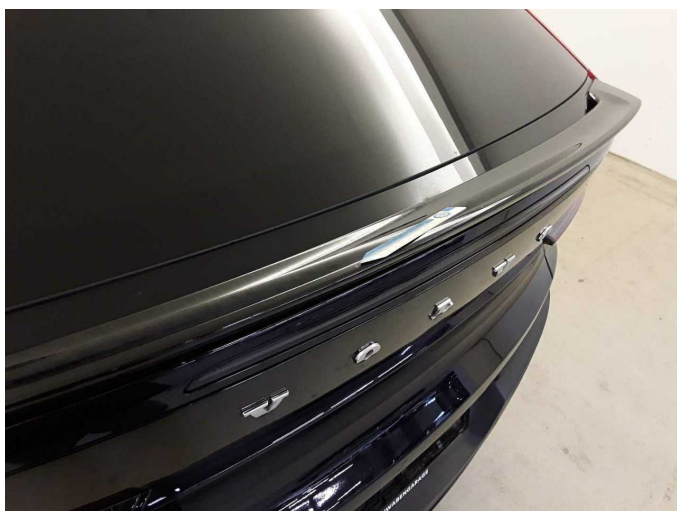
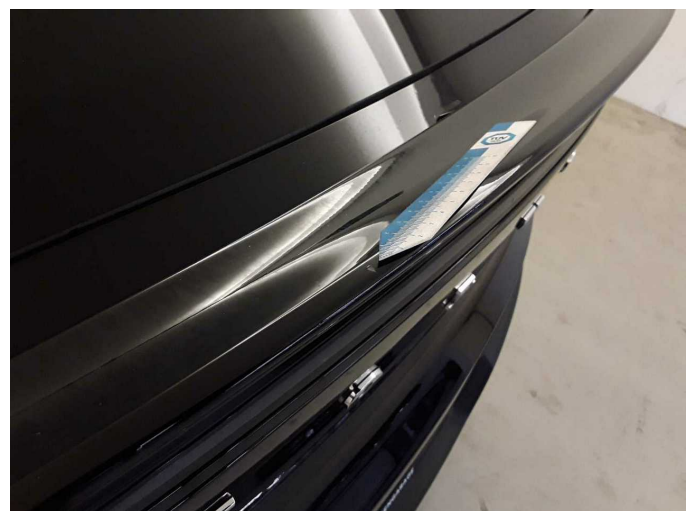
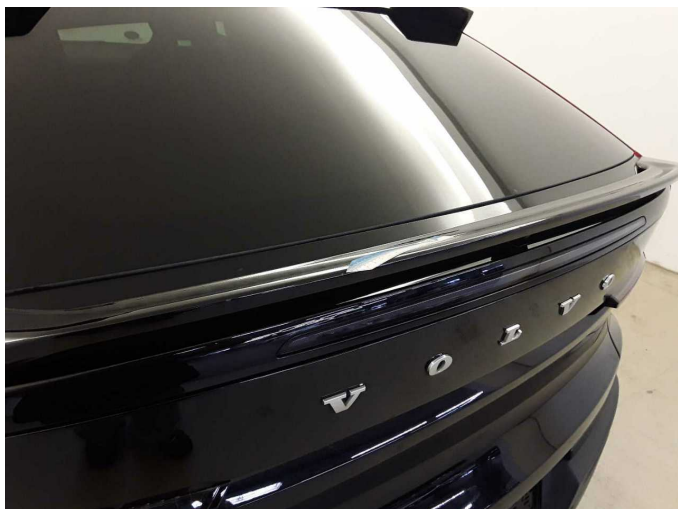
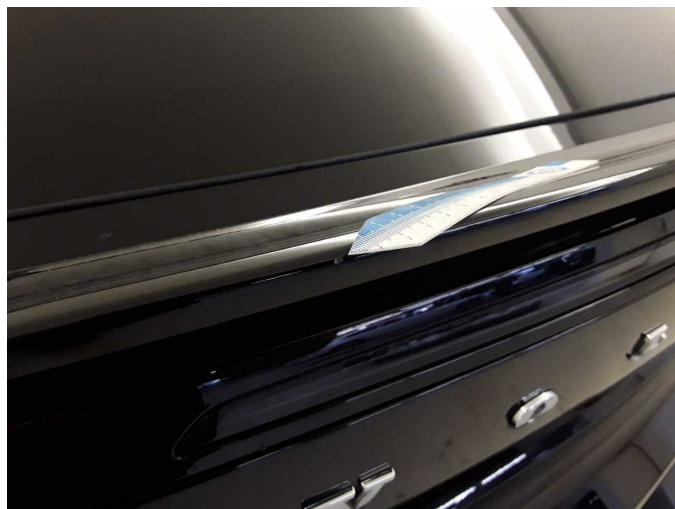
**Damage 7:** Boot lid / rear door: Rear spoiler - Stone chips - Paint

| No. | Component group | Description |
|---|---|---|
| 7 | Boot lid / rear door | Rear spoiler - Stone chips - Paint |

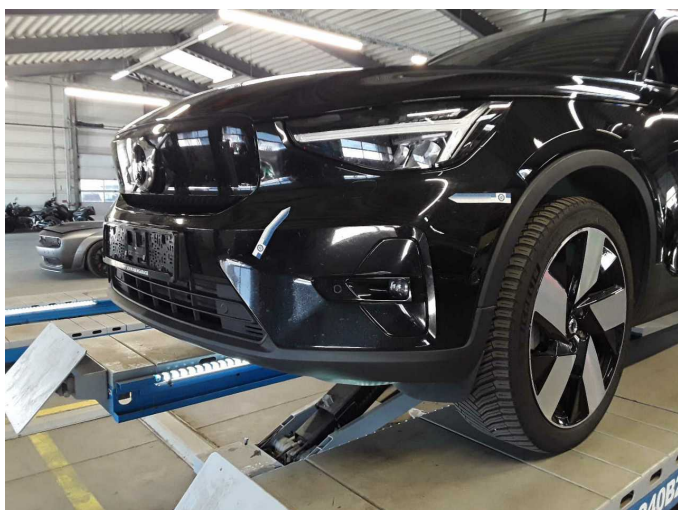
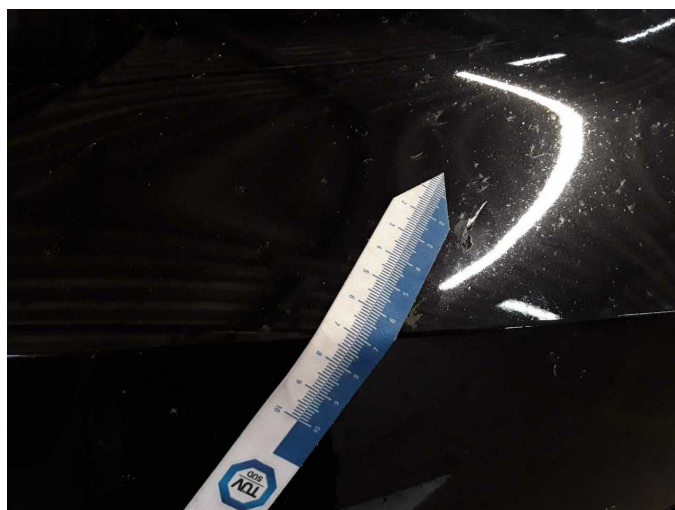
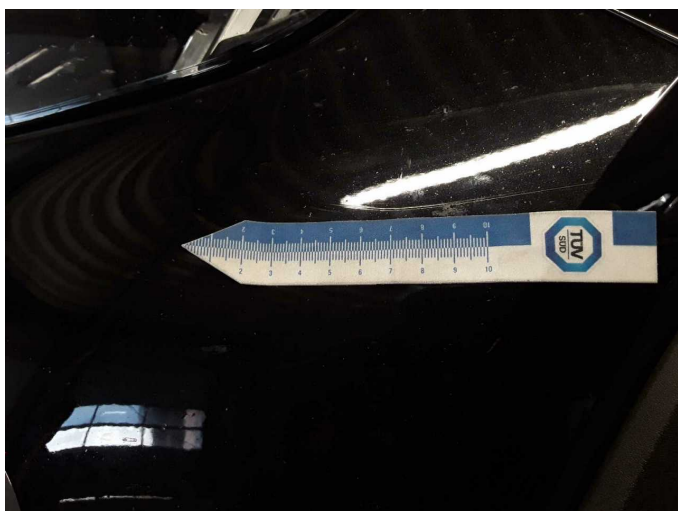
**Damage 8:** Front bumper: Front bumper - Scratch(es) - Paint

| No. | Component group | Description |
|---|---|---|
| 8 | Front bumper | Front bumper - Scratch(es) - Paint |

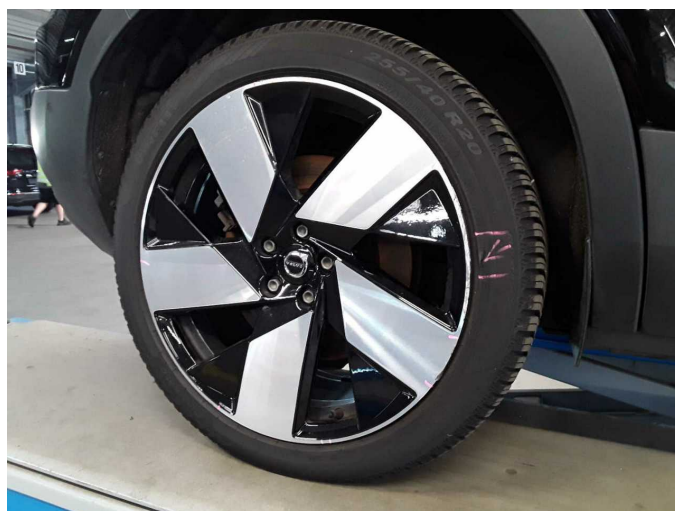
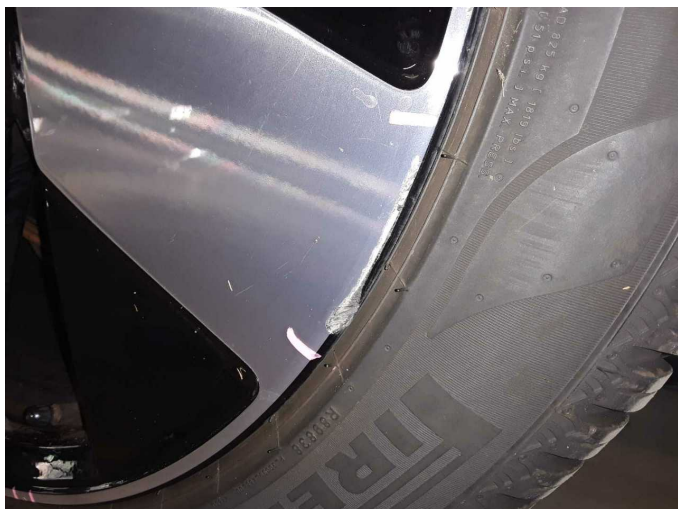
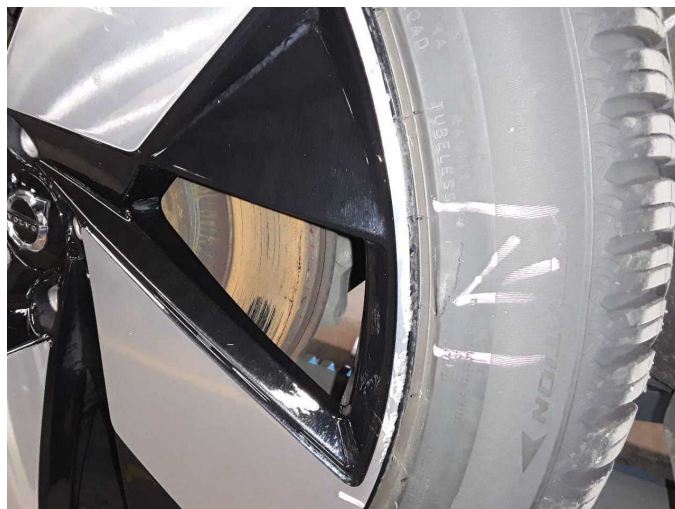
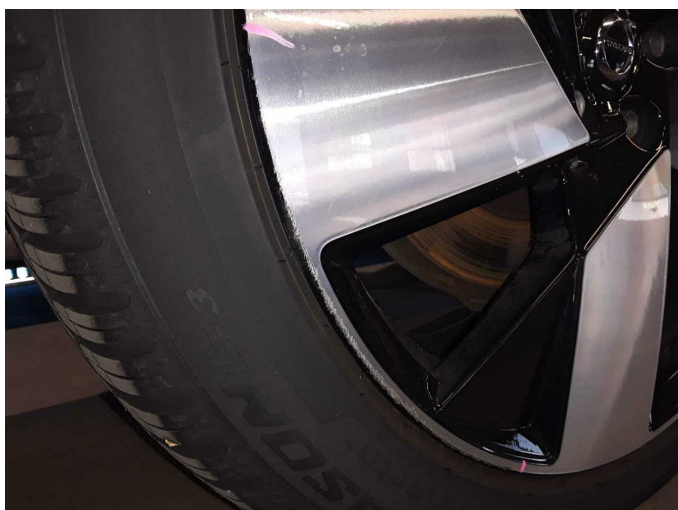
**Damage 9:** Wheel / tyres: Alloy rim - rear right side (Materialabtrag) - Scratched - Replace

| No. | Component group | Description |
|---|---|---|
| 9 | Wheel / tyres | Alloy rim - rear right side (Materialabtrag) - Scratched - Replace |

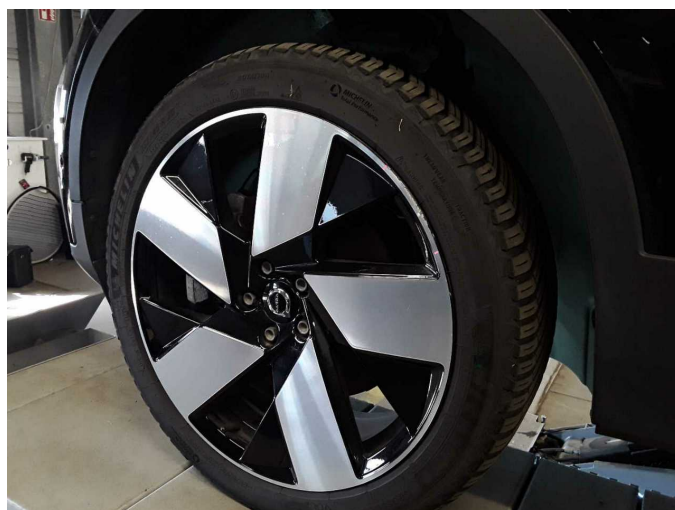
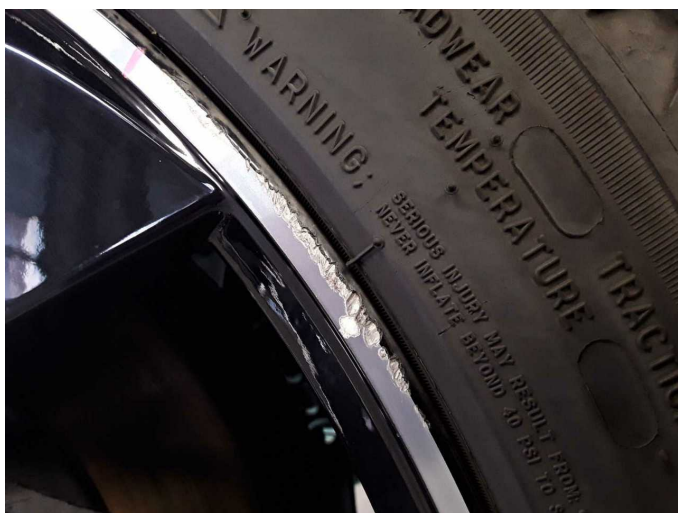
**Damage 10:** Wheel / tyres: Alloy rim - front left side (Materialabtrag) - Scratched - Replace

| No. | Component group | Description |
|---|---|---|
| 10 | Wheel / tyres | Alloy rim - front left side (Materialabtrag) - Scratched - Replace |

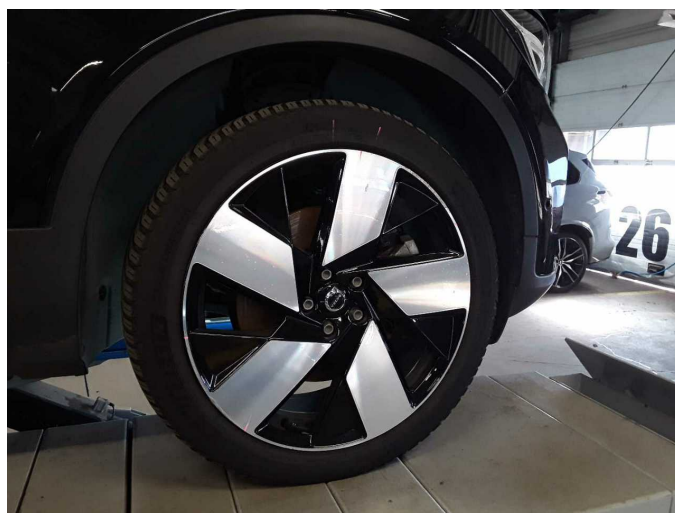
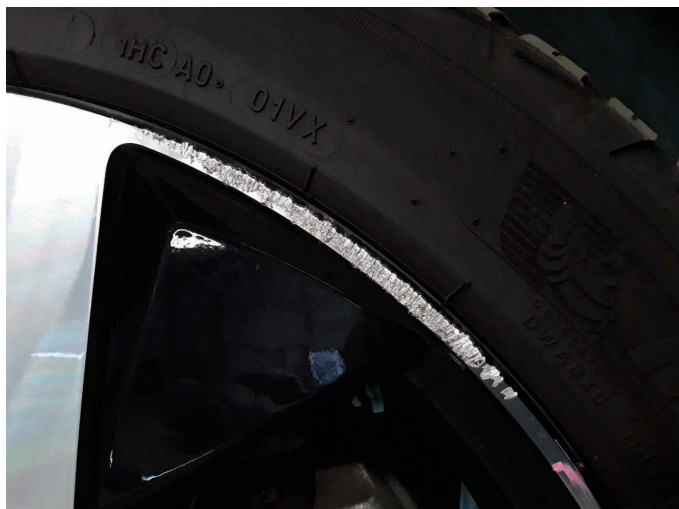
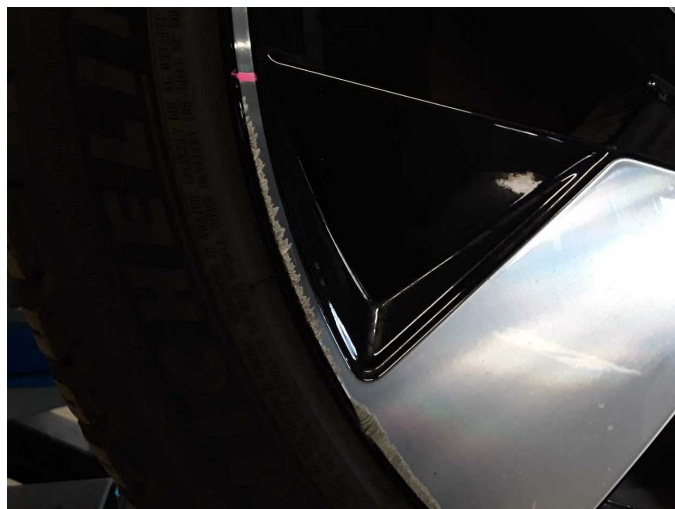
**Damage 11:** Wheel / tyres: Alloy rim - front right side (Materialabtrag) - Scratched - Replace

| No. | Component group | Description |
|---|---|---|
| 11 | Wheel / tyres | Alloy rim - front right side (Materialabtrag) - Scratched - Replace |

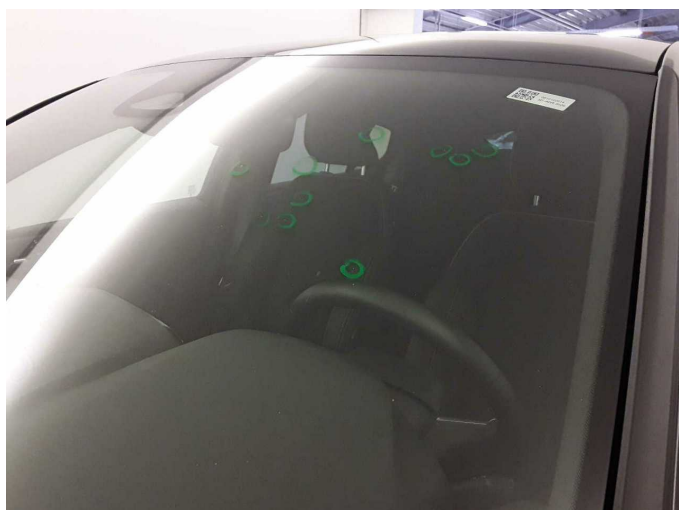
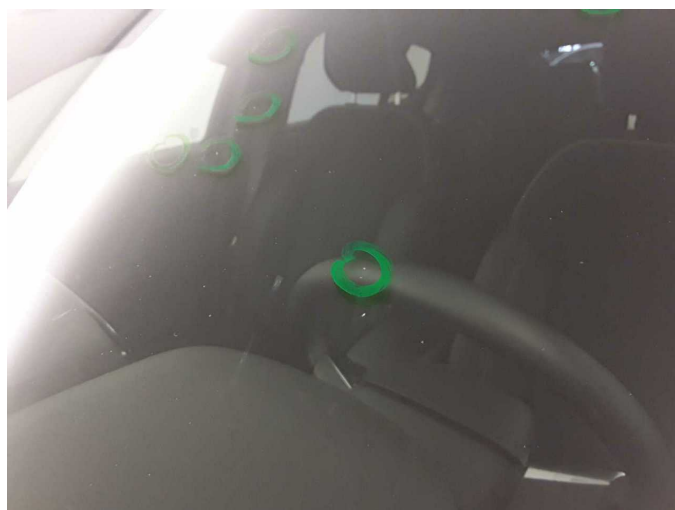
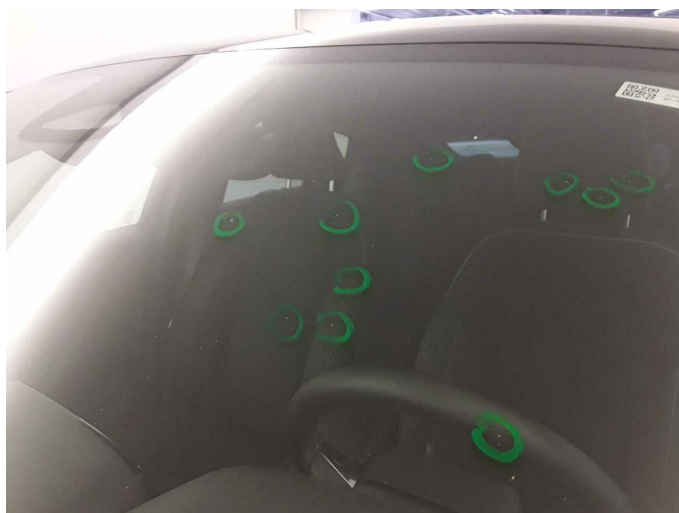
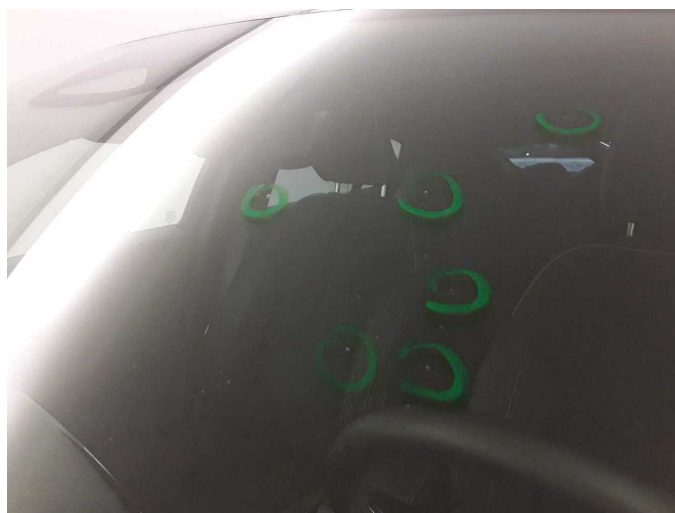
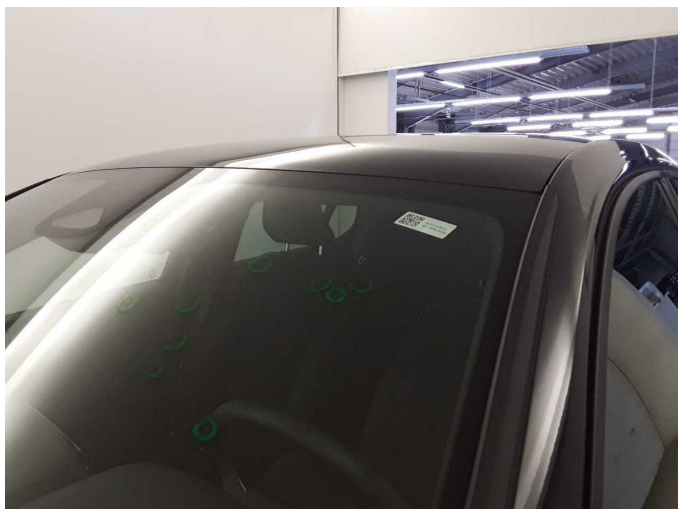
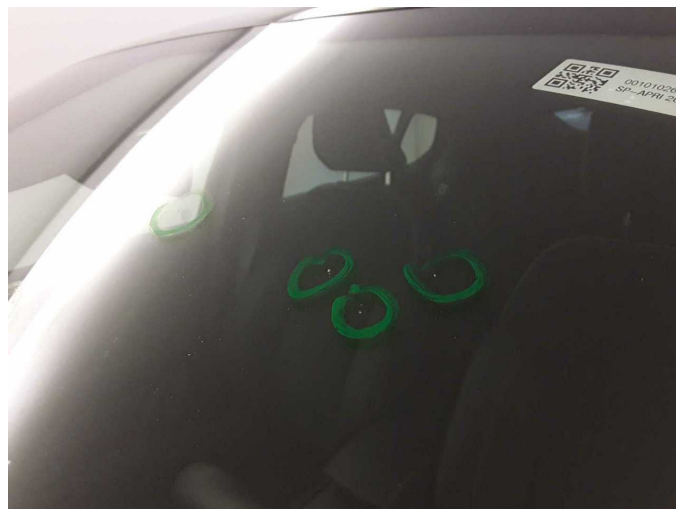
**Damage 12:** Vehicle glazing: Windscreen (kein Staubschutz) - Stone chips - Replace

| No. | Component group | Description |
|---|---|---|
| 12 | Vehicle glazing | Windscreen (kein Staubschutz) - Stone chips - Replace |

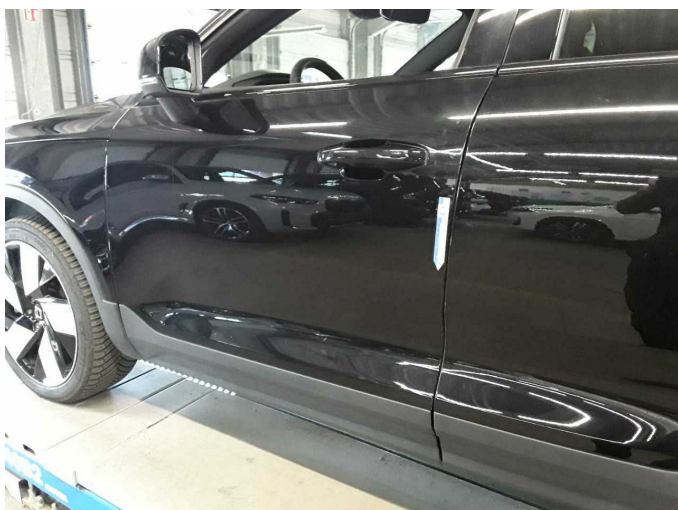
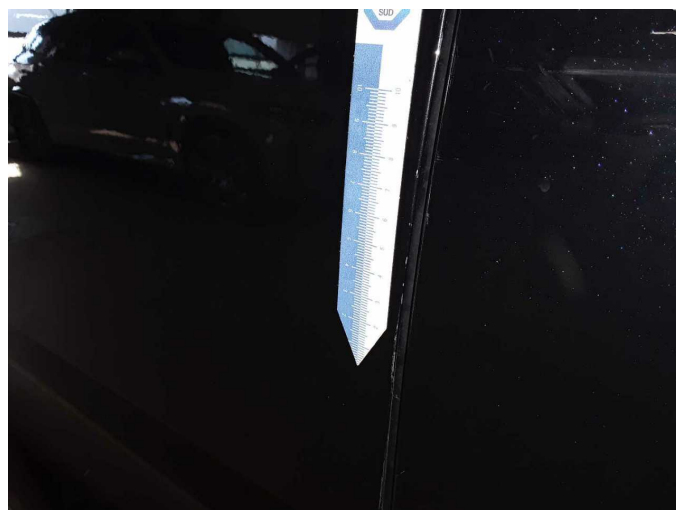
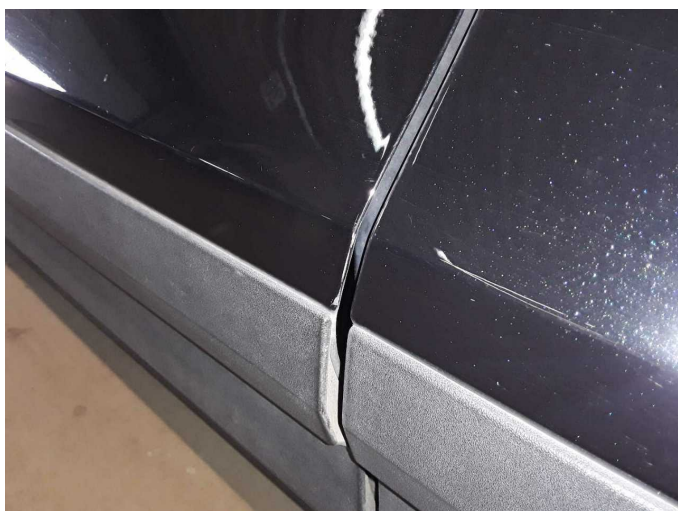
**Wear and tear 5:** Door - front left side: Door edge - Scratch(es) - Cover / polish

| No. | Component group | Description |
|---|---|---|
| 5 | Door - front left side | Door edge - Scratch(es) - Cover / polish |

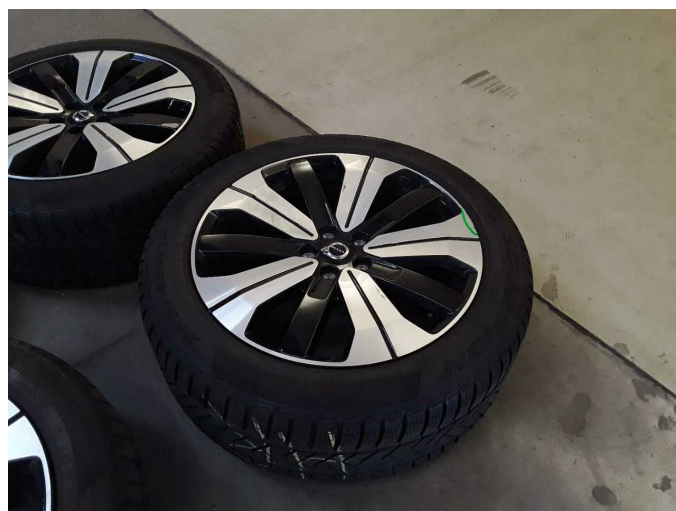
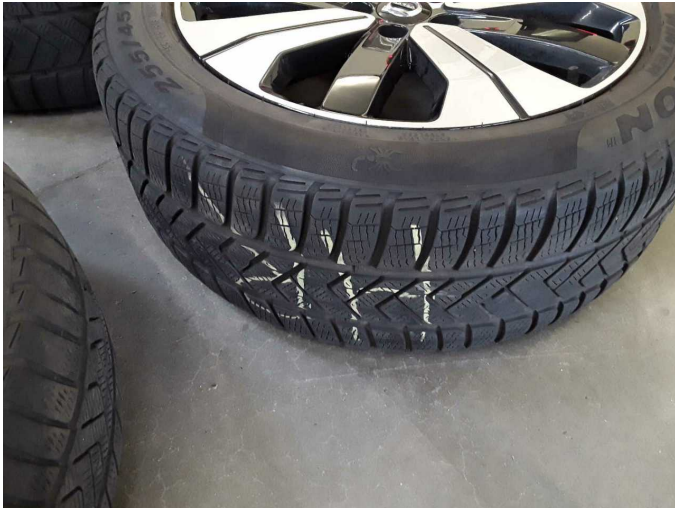
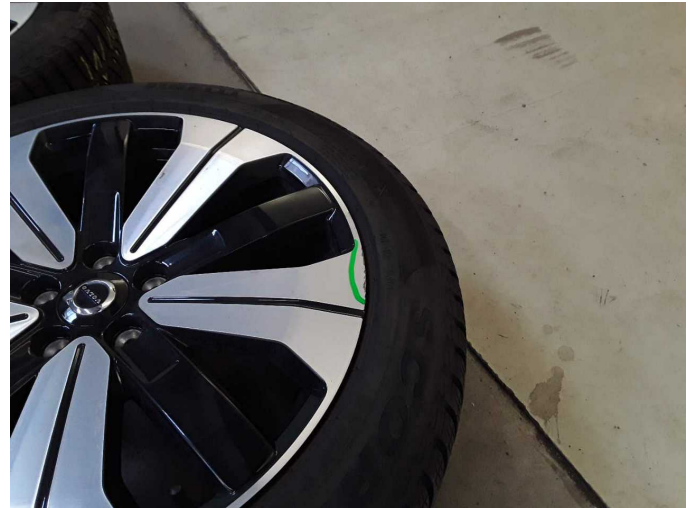
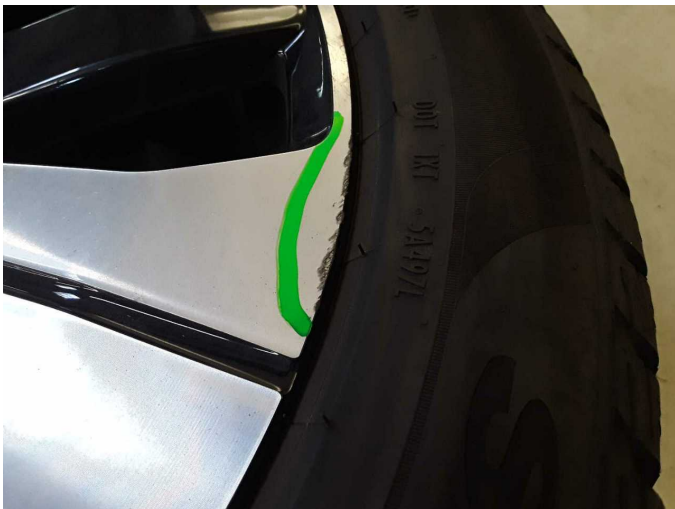
**Wear and tear 6:** 2nd wheel set: 1 alloy rim (gehört nicht zur Ausstattung) - Scratched - No deduction

| No. | Component group | Description |
|---|---|---|
| 6 | 2nd wheel set | 1 alloy rim (gehört nicht zur Ausstattung) - Scratched - No deduction |
