Expertise

Protocol number: 46638759  
Order No. / Reference: 26685691  
Inspection date: 22 Jul 2026

Manufacturer: Audi

Model: A6 Avant 45 TFSI quattro S tronic design

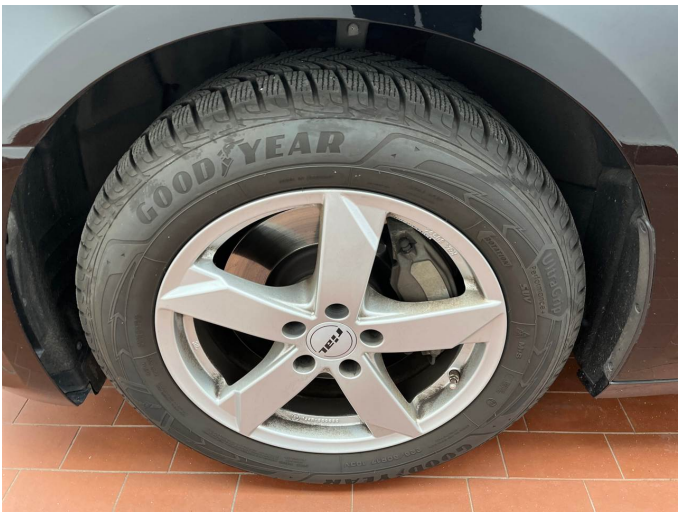
Figure 12: Mounted tyres

| Tyres | | | | |
|---|---|---|---|---|
| 1) | 225/60 R18 103V | Winter tyres on Light alloy | Goodyear | 7mm / 7mm |
| 2) | 225/60 R18 103V | Winter tyres on Light alloy | Goodyear | 7mm / 7mm |

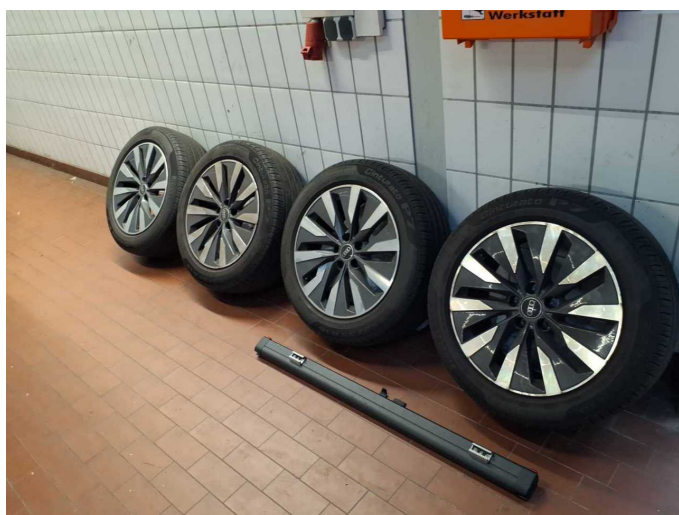
Figure 15: Additional tyres

| Tyres | | | | |
|---|---|---|---|---|
| 1) | 225/55 R18 102Y | Summer tyres on Light alloy | Pirelli | 4mm / 4mm |
| 2) | 225/55 R18 102Y | Summer tyres on Light alloy | Pirelli | 5mm / 5mm |

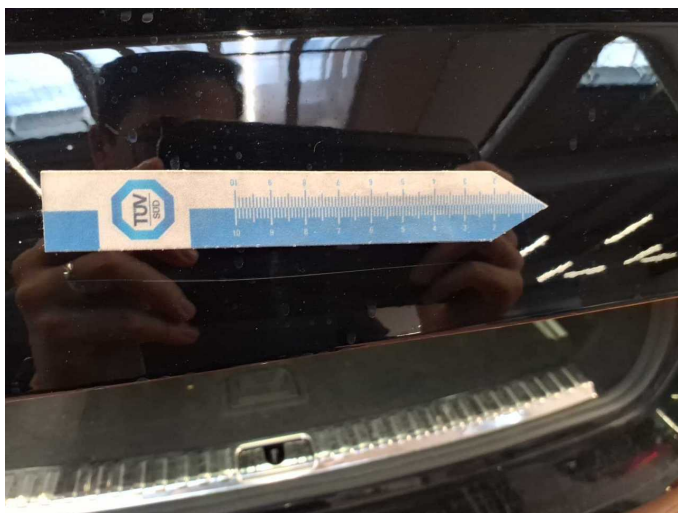
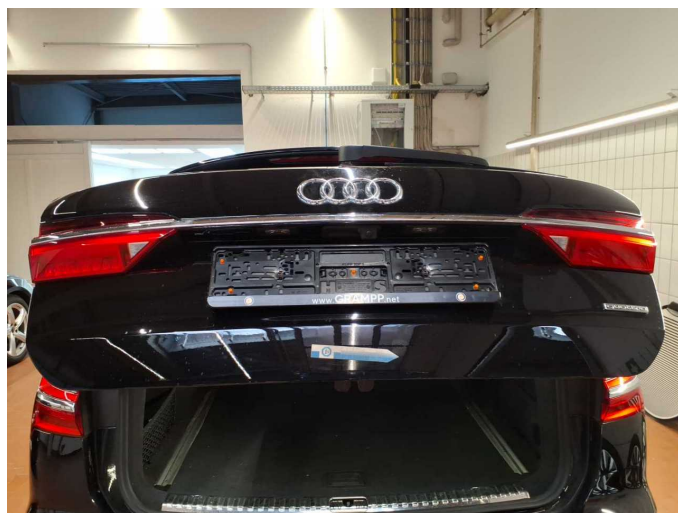
| No. | Component group | Description |
|---|---|---|
| 1 | Boot lid / rear door | Boot lid - Scratch(es) - Smart repair |

Damage 1: Boot lid / rear door: Boot lid - Scratch(es) - Smart repair

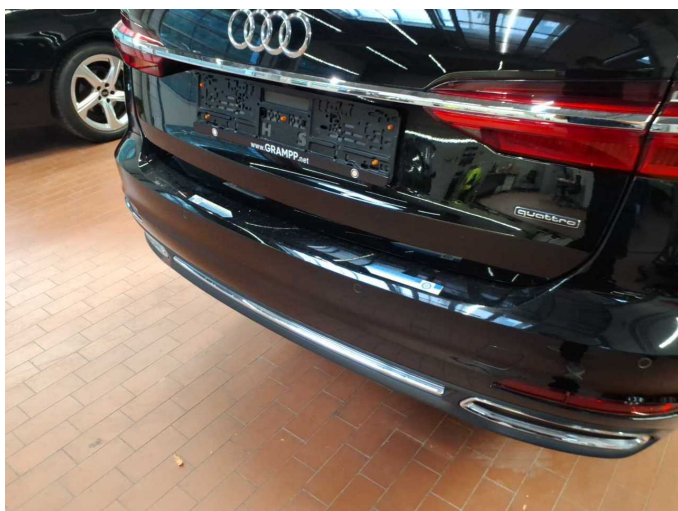
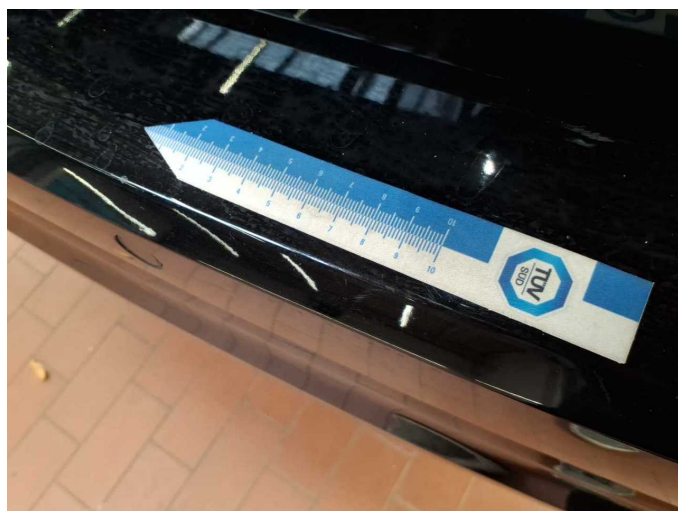
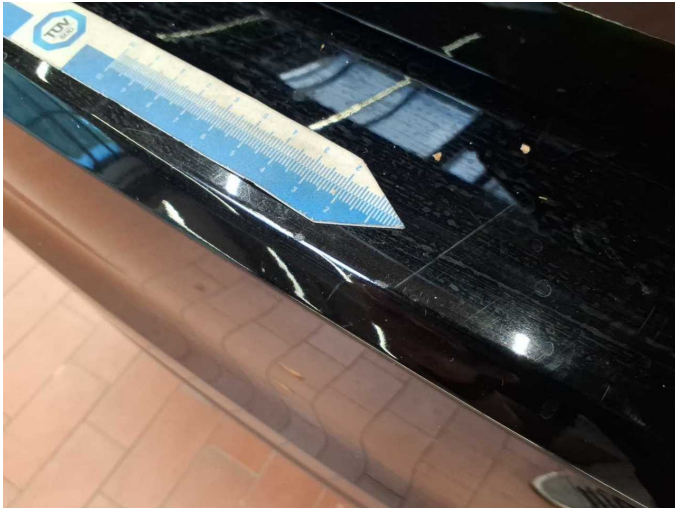
| No. | Component group | Description |
|---|---|---|
| 2 | Rear bumper | Rear bumper - Scratch(es) - Smart repair |

Damage 2: Rear bumper: Rear bumper - Scratch(es) - Smart repair

**Damage 2:** Rear bumper: Rear bumper - Scratch(es) - Smart repair

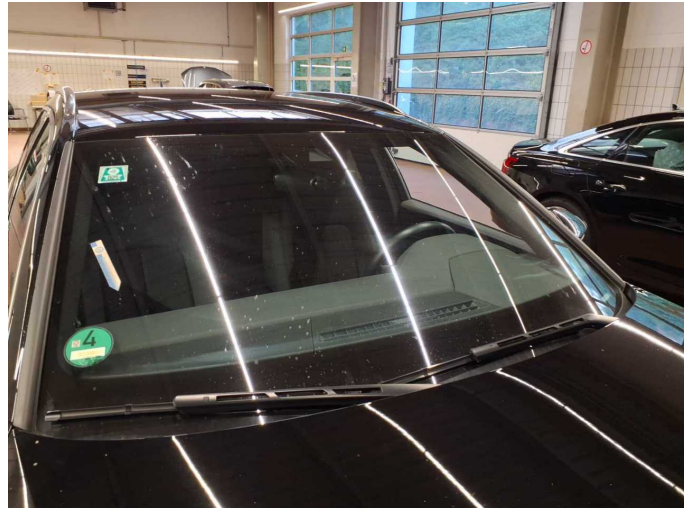
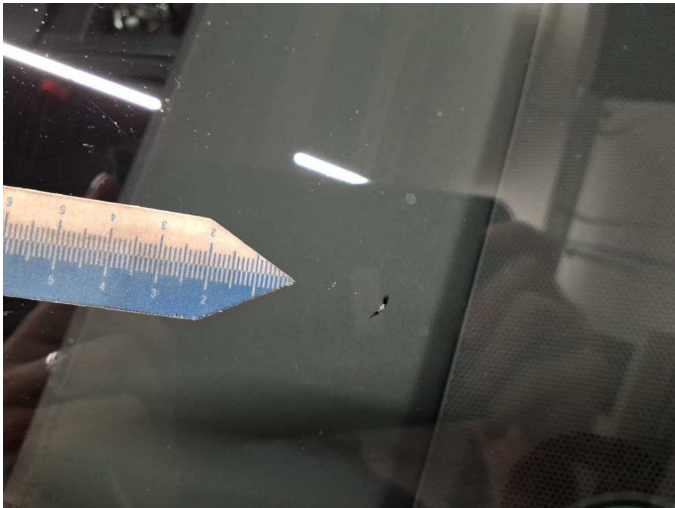
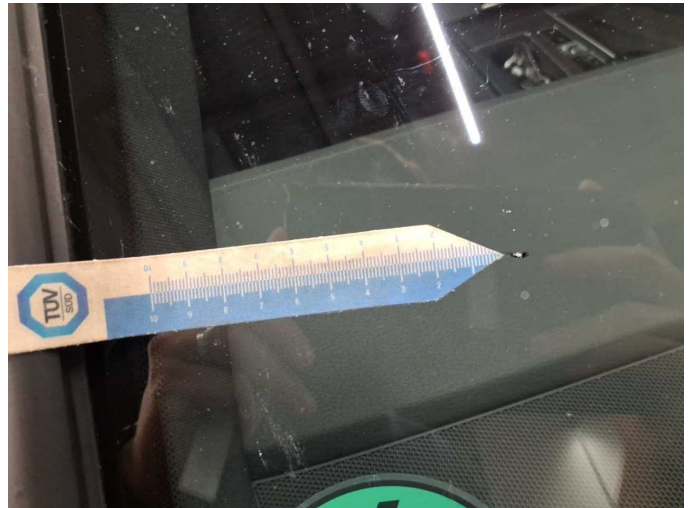
| No. | Component group | Description |
|---|---|---|
| 3 | Vehicle glazing | Windscreen - Stone chips - Smart repair |

**Damage 3:** Vehicle glazing: Windscreen - Stone chips - Smart repair

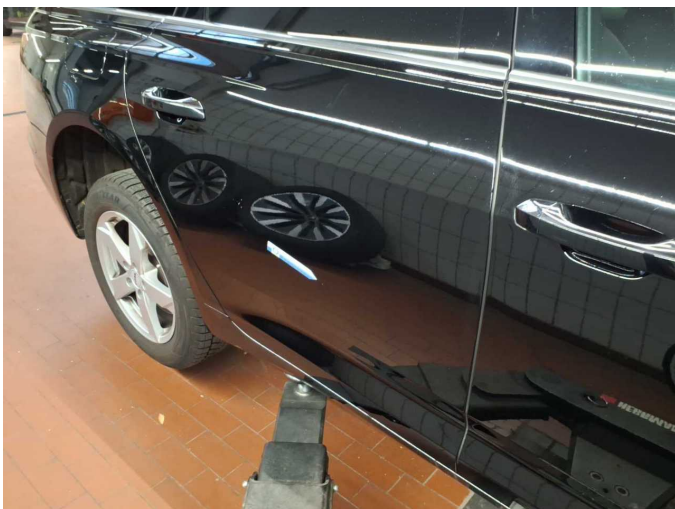
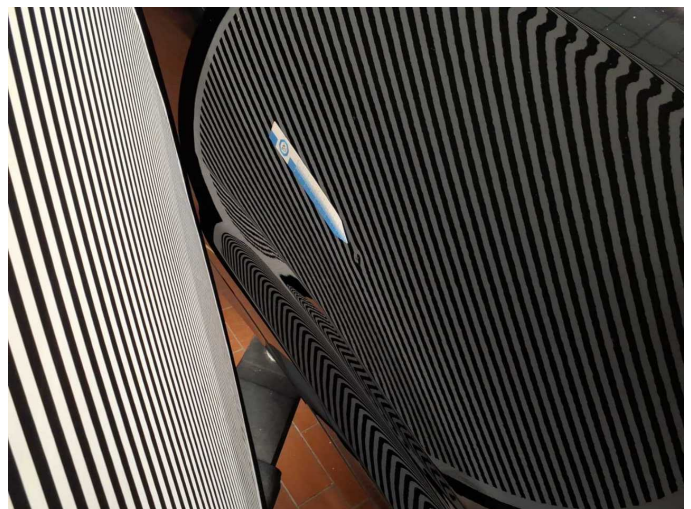
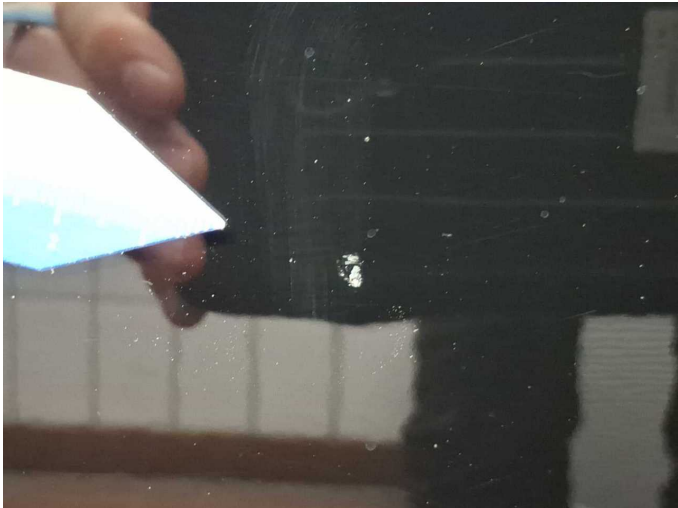
| No. | Component group | Description |
|---|---|---|
| 4 | Door - rear right side | Door - Dent / paintcoat damage - Smart repair |

**Damage 4:** Door - rear right side: Door - Dent / paintcoat damage - Smart repair

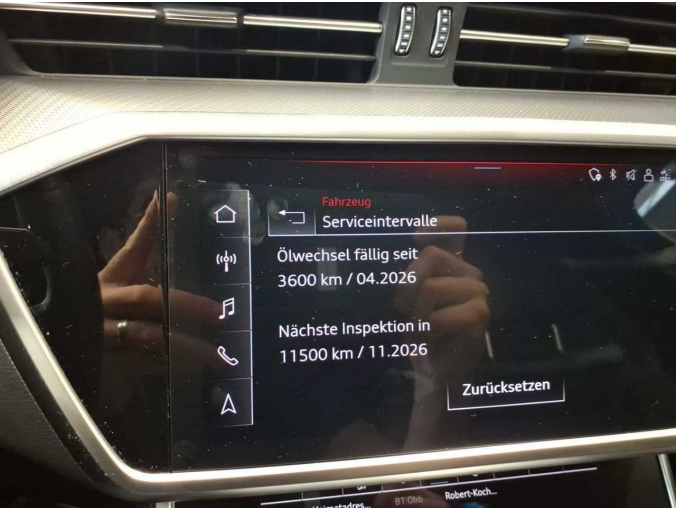
| No. | Component group | Description |
|---|---|---|
| 5 | Misc. | Inspection / maintenance - Due - Perform |

**Damage 5:** Misc.: Inspection / maintenance - Due - Perform

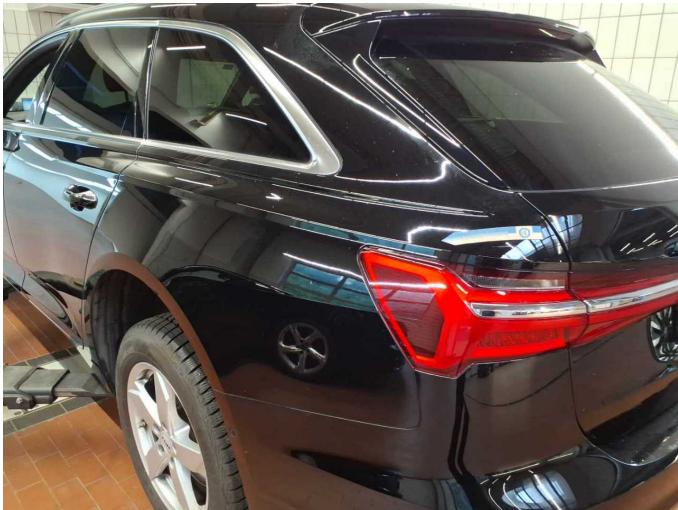
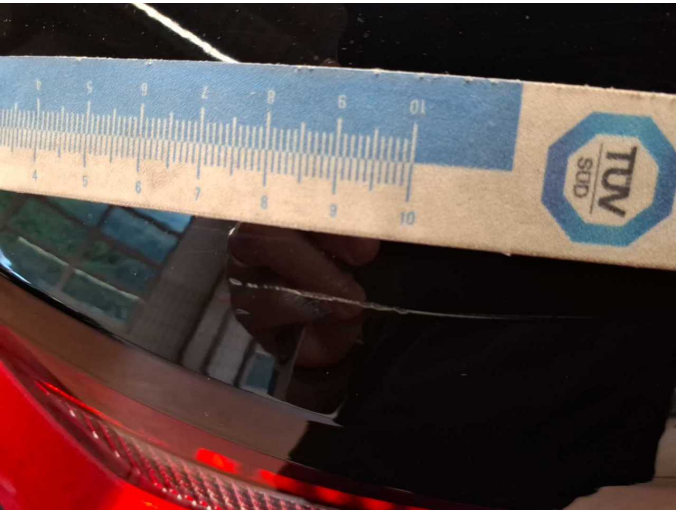
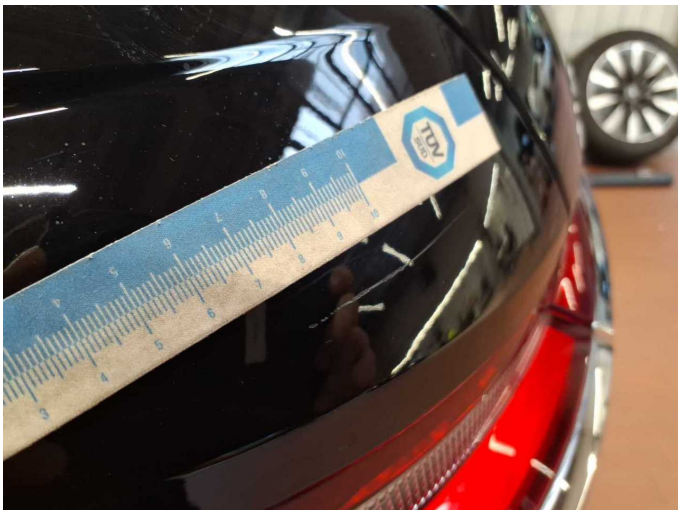
| No. | Component group | Description |
|---|---|---|
| 6 | Side panel - rear left side | Side panel - Scratch(es) - Paint |

**Damage 6:** Side panel - rear left side: Side panel - Scratch(es) - Paint
