Expertise

Protocol number: 45982141  
Order No. / Reference: 26384605  
Inspection date: 16 Jun 2026

Model: Tiguan Allspace 2.0 TDI SCR 4Motion DSG Elegance

VIN: WVGZZZ5NZNM049413

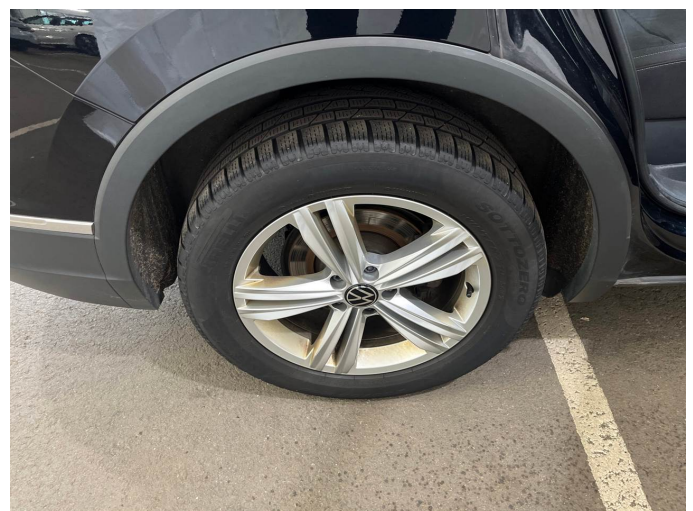
Figure 12: Mounted tyres

| # | Tyre size | Type of tyre | Manufacturer | Tread depth |
|---|---|---|---|---|
| 1) | 235/55 R18 104H | Winter tyres on Light alloy | Pirelli | 4mm / 5mm |
| 2) | 235/55 R18 104H | Winter tyres on Light alloy | Pirelli | 6mm / 6mm |

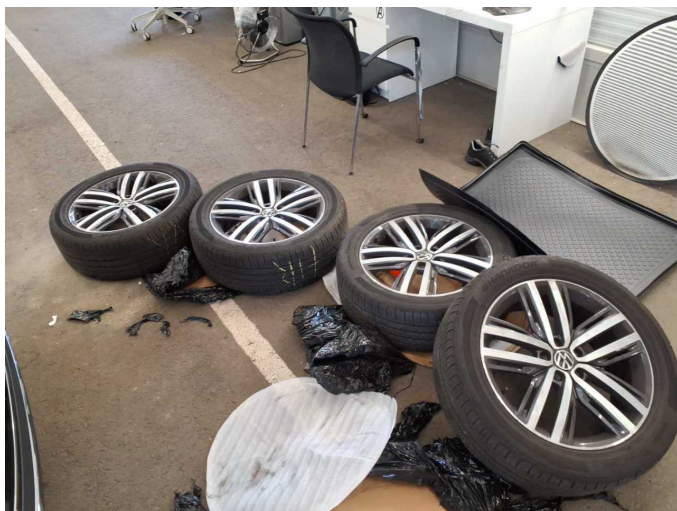
Figure 17: Additional tyres

| # | Tyre size | Type of tyre | Manufacturer | Tread depth |
|---|---|---|---|---|
| 1) | 235/50 R19 99V | Summer tyres on Light alloy | Hankook | 6mm / 6mm |
| 2) | 235/50 R19 99V | Summer tyres on Light alloy | Hankook | 5mm / 5mm |

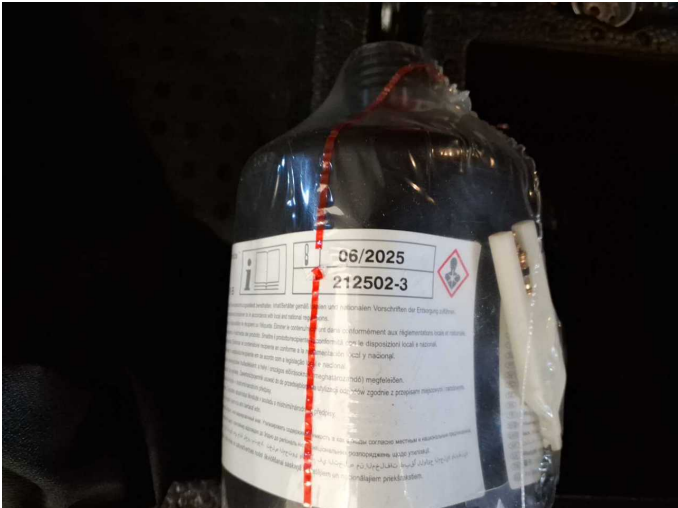
| No. | Component group | Description |
|---|---|---|
| 1 | Equipment | Tirefit filler - Expired - Replace |

Damage 1: Equipment: Tirefit filler - Expired - Replace

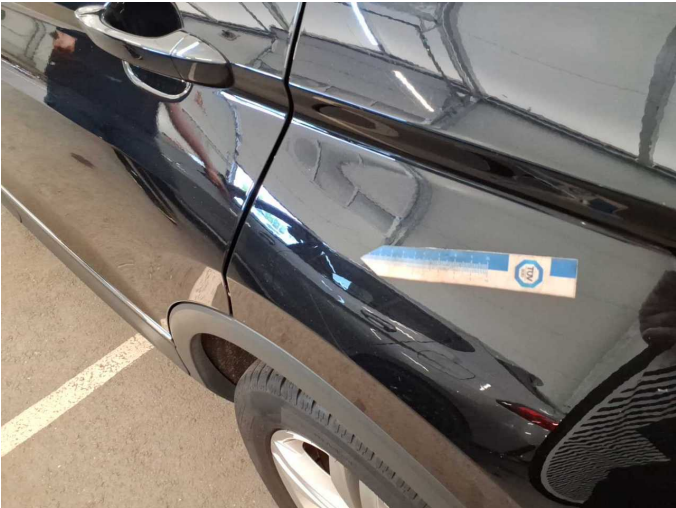
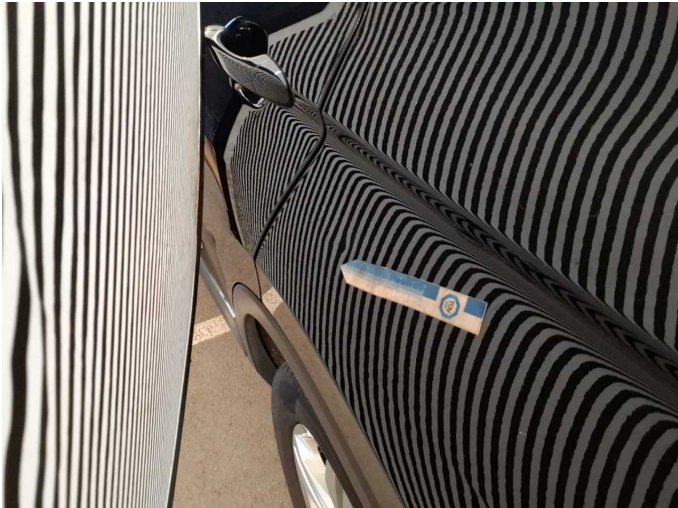
| No. | Component group | Description |
|---|---|---|
| 2 | Side panel - rear left side | Side panel - dent(s) - Smooth repair work |

Damage 2: Side panel - rear left side: Side panel - dent(s) - Smooth repair work

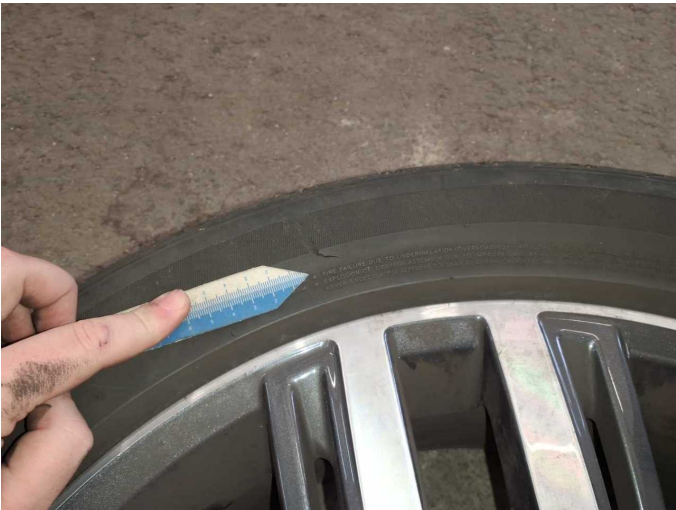
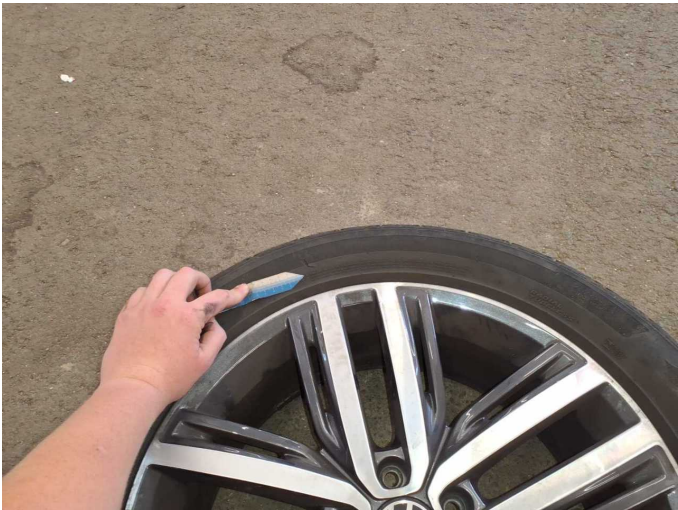
| No. | Component group | Description |
|---|---|---|
| 3 | 2nd wheel set | 1 tyre - Broken / torn - Replace |

Damage 3: 2nd wheel set: 1 tyre - Broken / torn - Replace

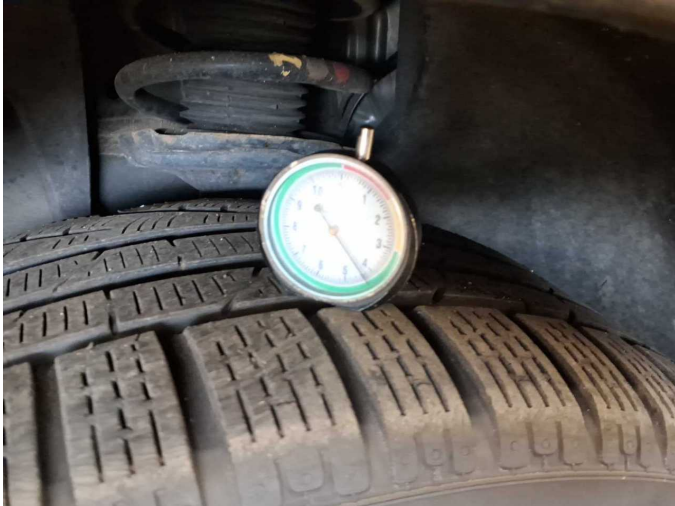
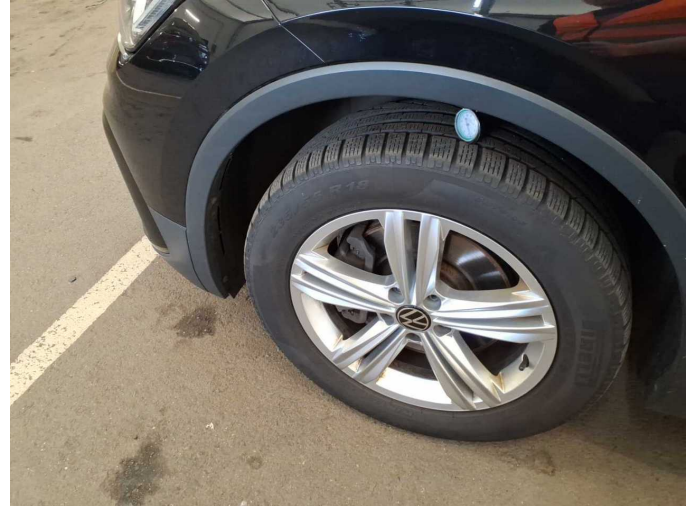
| No. | Component group | Description |
|---|---|---|
| 4 | Wheel / tyres | Tyre - front left side - Does not meet the leasing specifications - Replace |

**Damage 4:** Wheel / tyres: Tyre - front left side - Does not meet the leasing specifications - Replace

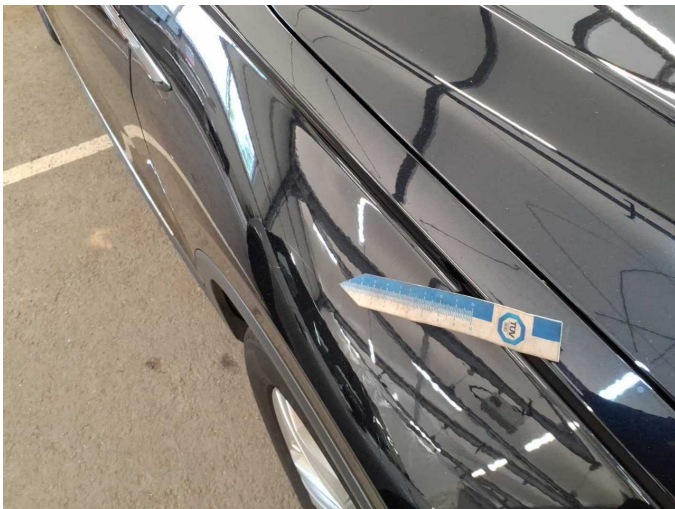
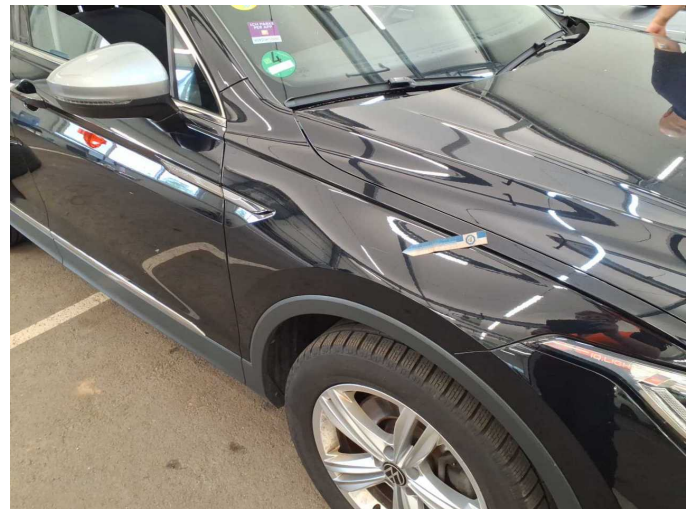
| No. | Component group | Description |
|---|---|---|
| 5 | Mudguard - right side | Mudguard - right side - Scratch(es) - Paint |

**Damage 5:** Mudguard - right side: Mudguard - right side - Scratch(es) - Paint

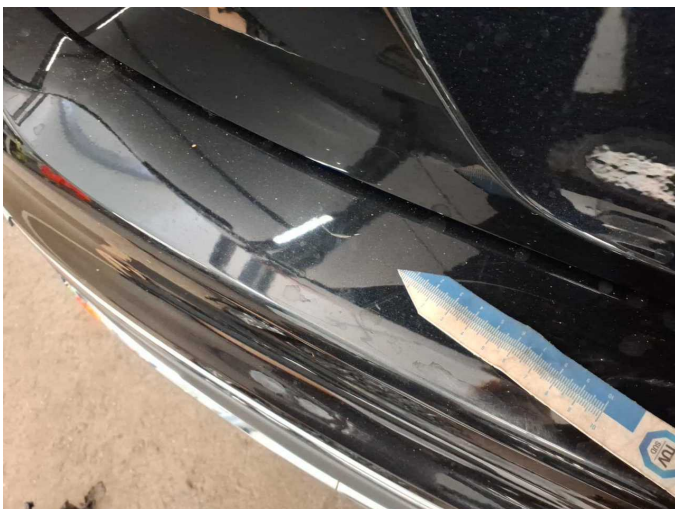
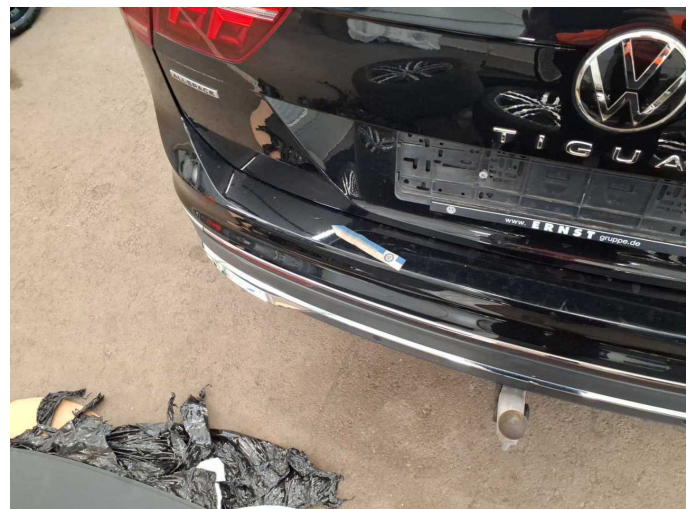
| No. | Component group | Description |
|---|---|---|
| 6 | Rear bumper | Rear bumper - Scratch(es) - Paint |

**Damage 6:** Rear bumper: Rear bumper - Scratch(es) - Paint

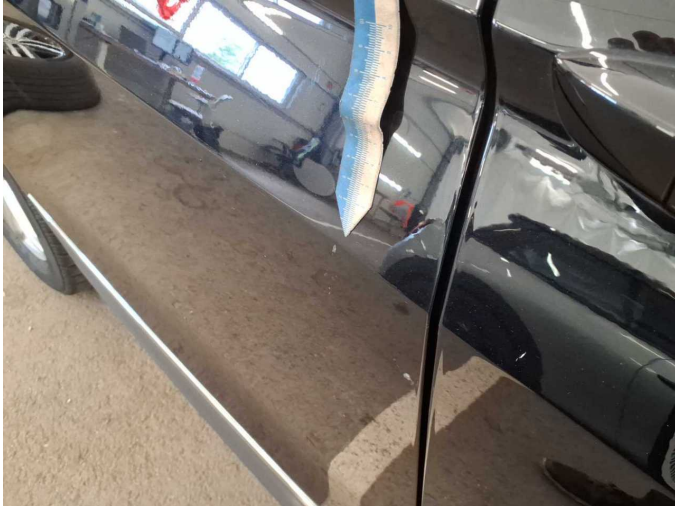
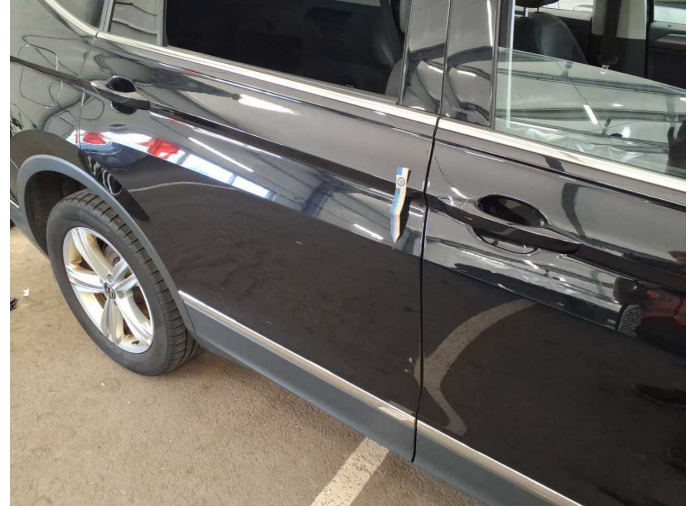
| No. | Component group | Description |
|---|---|---|
| 7 | Door - rear right side | Door - Scratch(es) - Paint |

**Damage 7:** Door - rear right side: Door - Scratch(es) - Paint

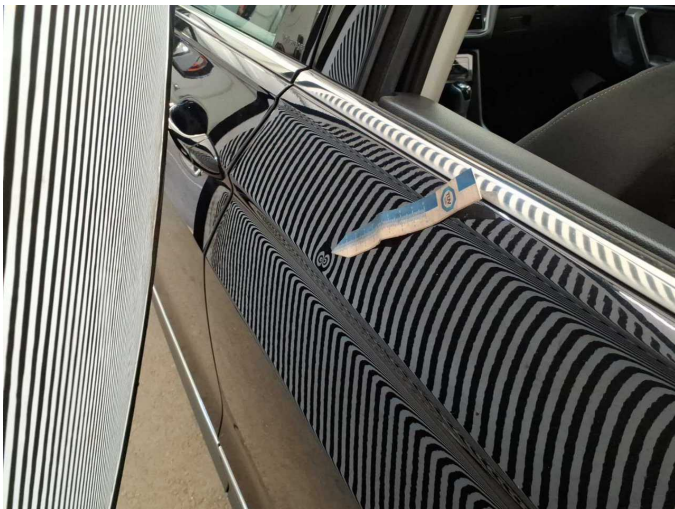
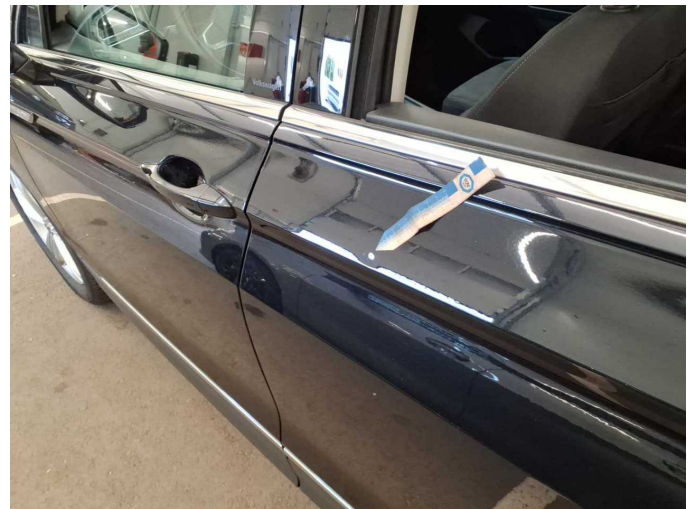
| No. | Component group | Description |
|---|---|---|
| 8 | Door - rear left side | Door - Dent / paintcoat damage - Repair and paint |

**Damage 8:** Door - rear left side: Door - Dent / paintcoat damage - Repair and paint
