Expertise

Protocol number: 46121644  
Order No. / Reference: 26443239  
Inspection date: 23 Jun 2026

Manufacturer: Ford

Model: S-Max 2.0 EcoBlue Aut. TITANIUM

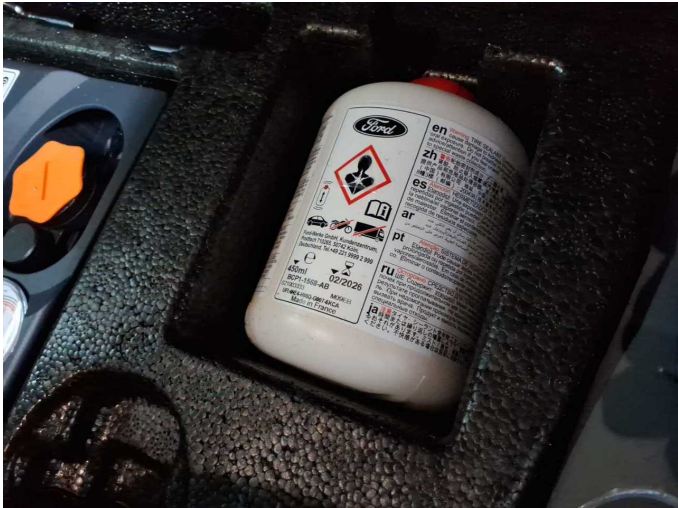
| No. | Component group | Description |
|---|---|---|
| 1 | Equipment | Tirefit filler - Expired - Replace |

Damage 1: Equipment: Tirefit filler - Expired - Replace

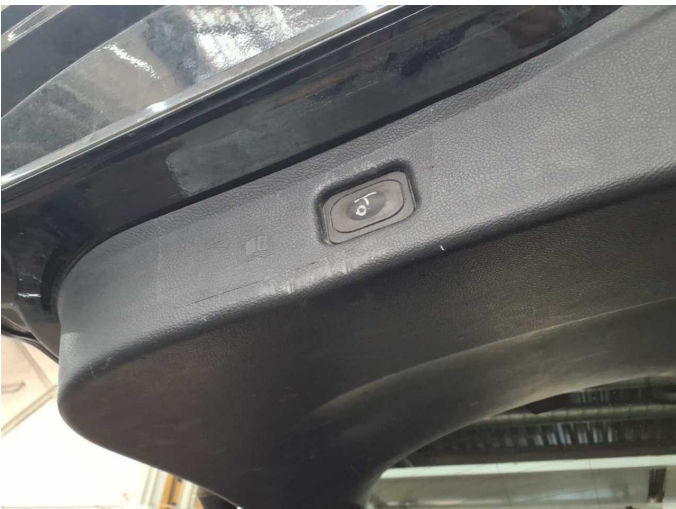
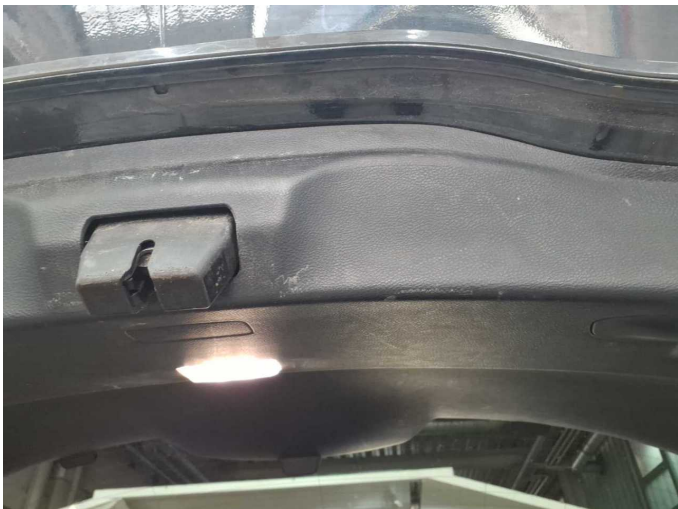
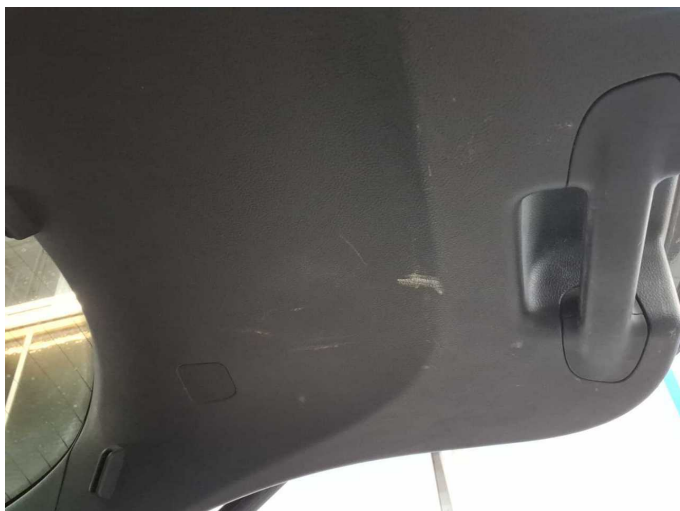
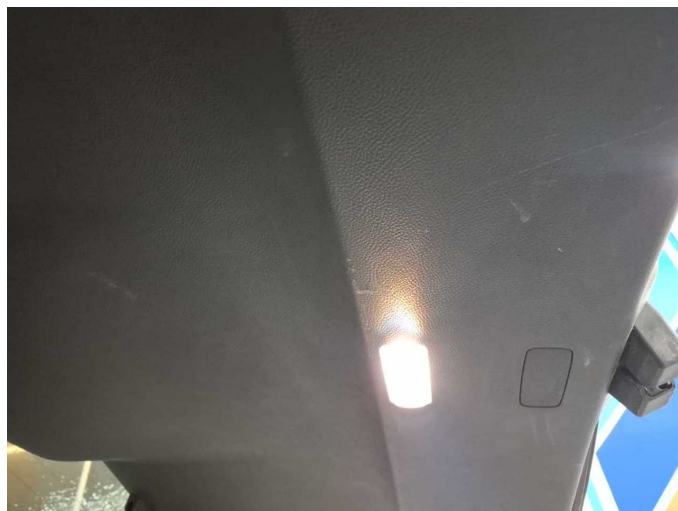
| No. | Component group | Description |
|---|---|---|
| 2 | Trim / covers | Boot lid - interior trim - Scratch(es) - Loss in value |

Damage 2: Trim / covers: Boot lid - interior trim - Scratch(es) - Loss in value

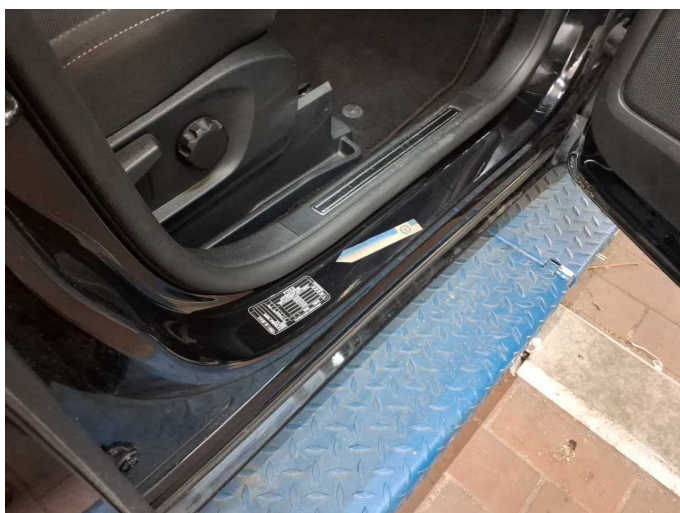
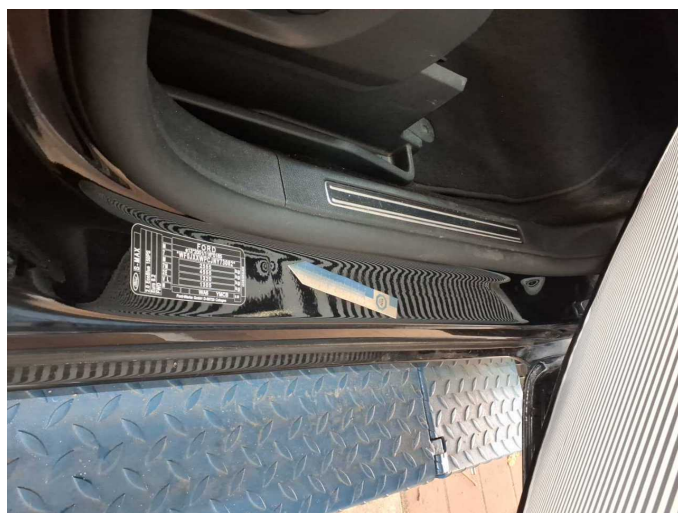
| No. | Component group | Description |
|---|---|---|
| 3 | Sill - right side | Sill - dent(s) - Smart repair |

**Damage 3:** Sill - right side: Sill - dent(s) - Smart repair

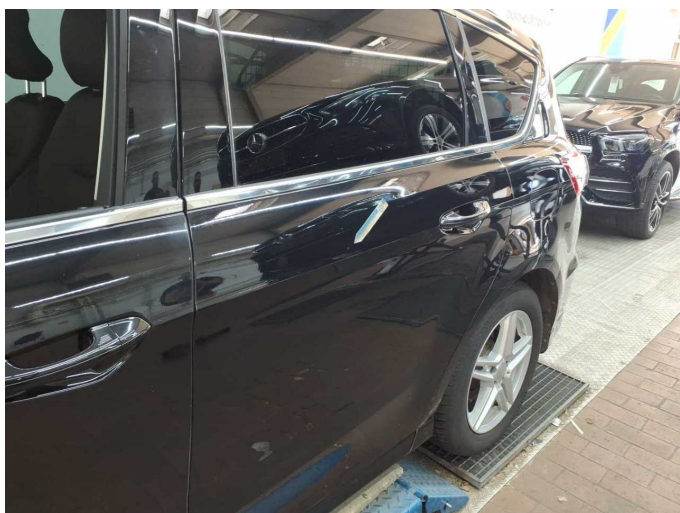
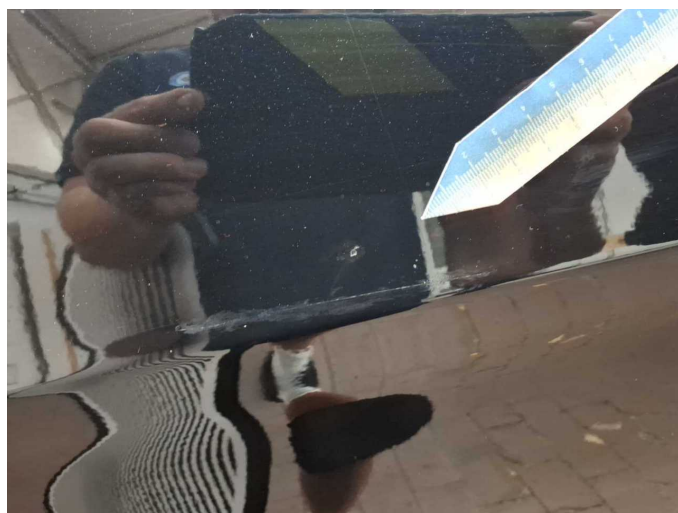
| No. | Component group | Description |
|---|---|---|
| 4 | Door - rear left side | Door - Scratch(es) - Smart repair |

**Damage 4:** Door - rear left side: Door - Scratch(es) - Smart repair

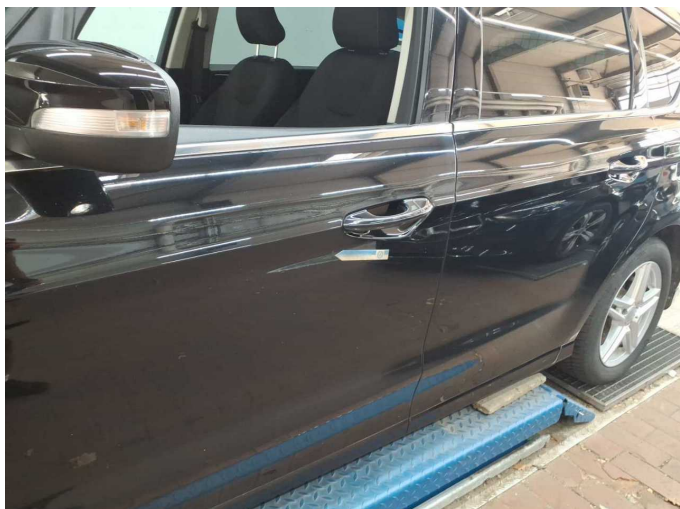
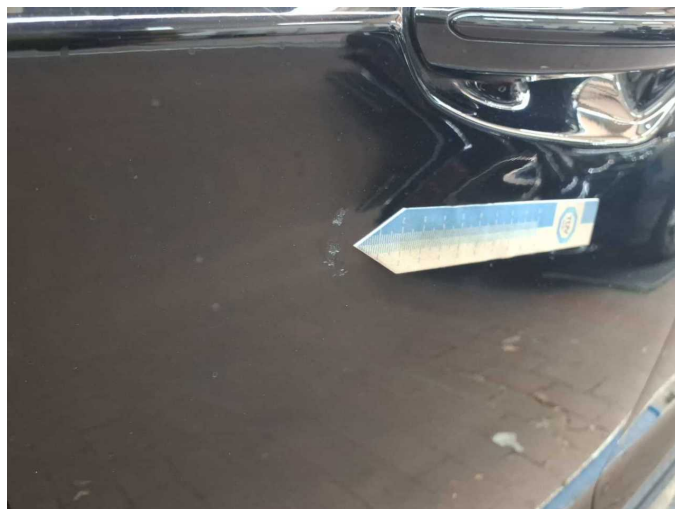
| No. | Component group | Description |
|---|---|---|
| 5 | Door - front left side | Door - Scratch(es) - Smart repair |

**Damage 5:** Door - front left side: Door - Scratch(es) - Smart repair

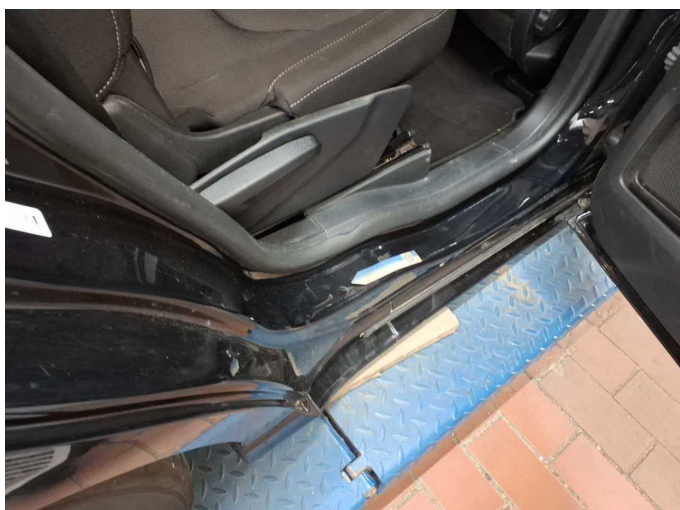
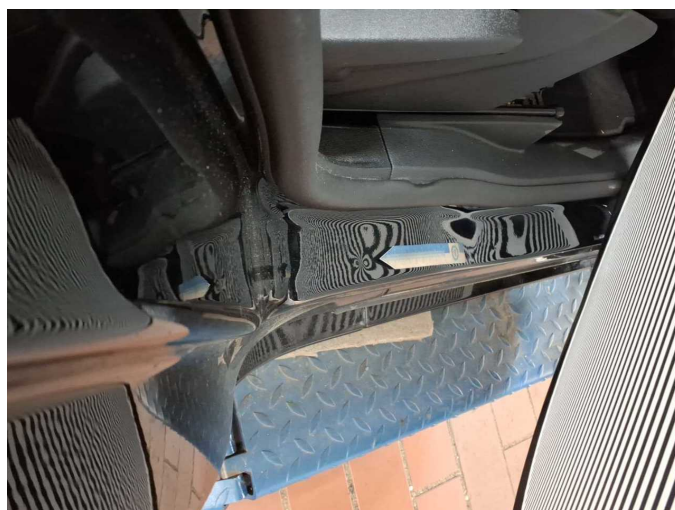
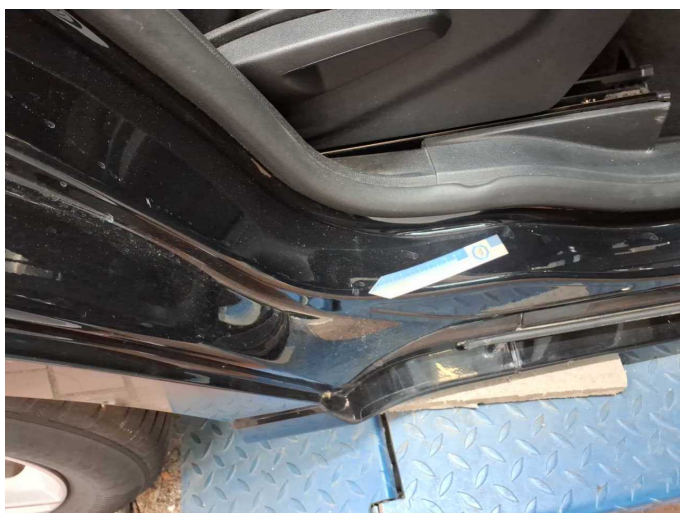
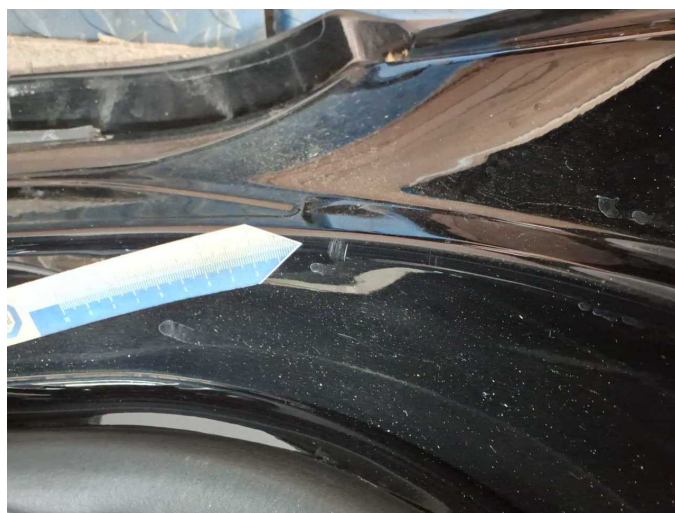
| No. | Component group | Description |
|---|---|---|
| 6 | Side panel - rear right side | Sill - Dent / paintcoat damage - Smart repair |

**Damage 6:** Side panel - rear right side: Sill - Dent / paintcoat damage - Smart repair

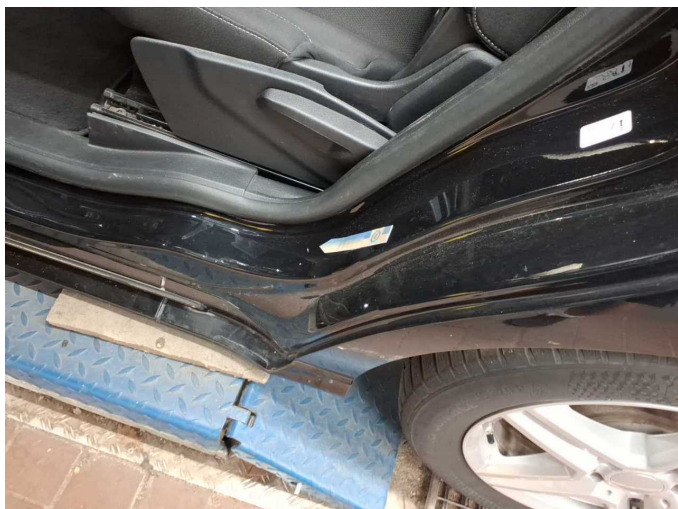
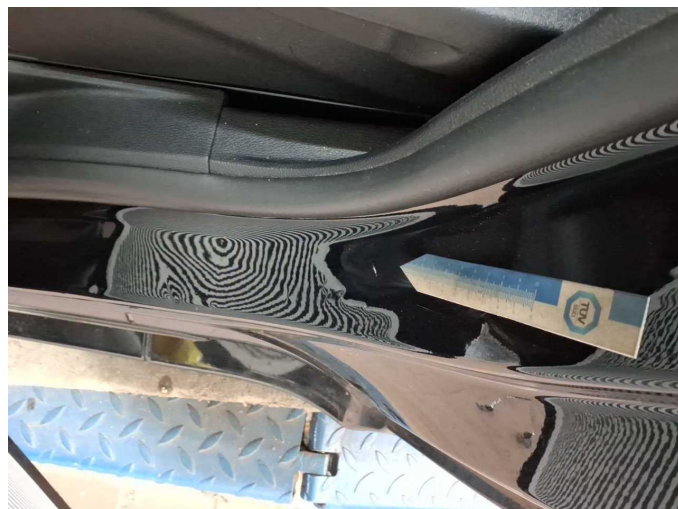
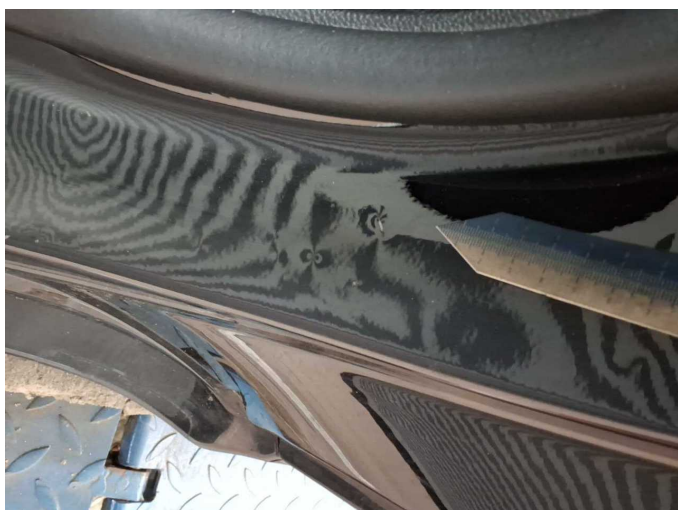
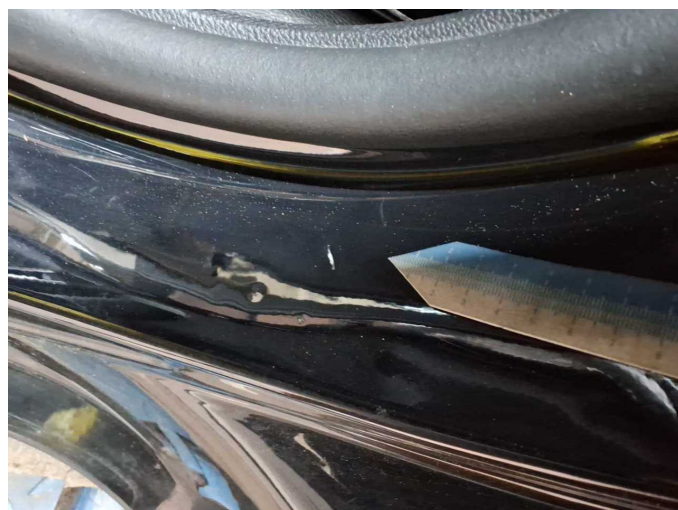
| No. | Component group | Description |
|---|---|---|
| 7 | Side panel - rear left side | Sill - Dent / paintcoat damage - Smart repair |

**Damage 7:** Side panel - rear left side: Sill - Dent / paintcoat damage - Smart repair

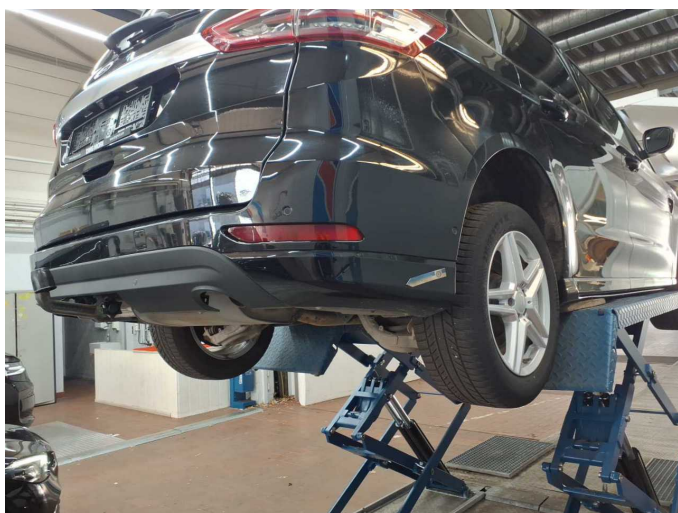
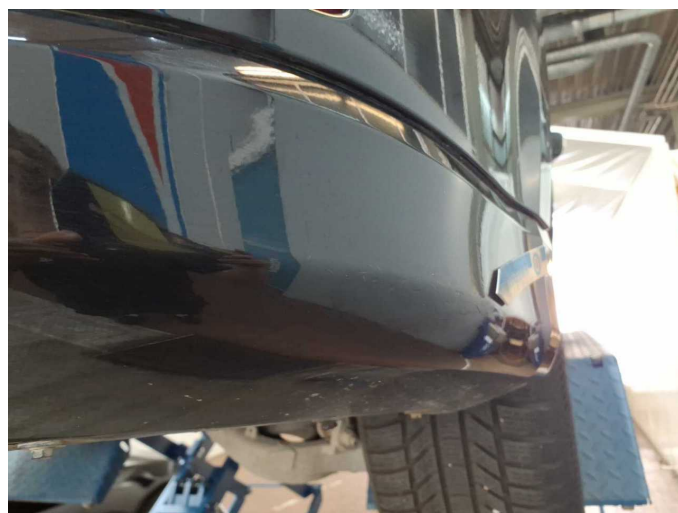
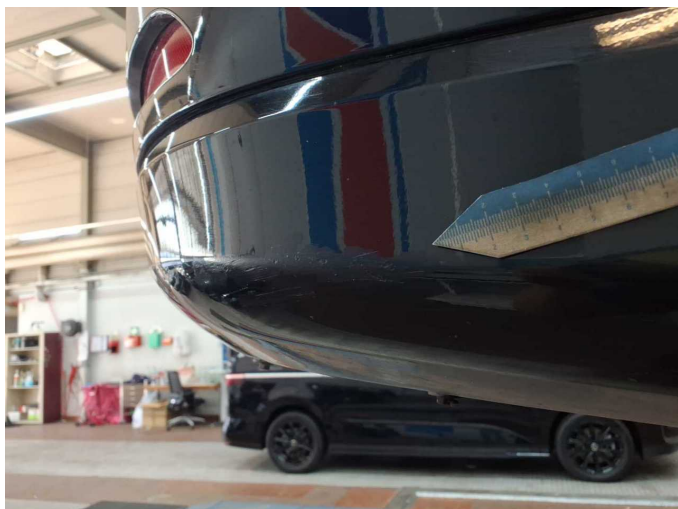
| No. | Component group | Description |
|---|---|---|
| 8 | Rear bumper | Spoiler (Rechts) - Scratch(es) - Smart repair |

**Damage 8:** Rear bumper: Spoiler (Rechts) - Scratch(es) - Smart repair

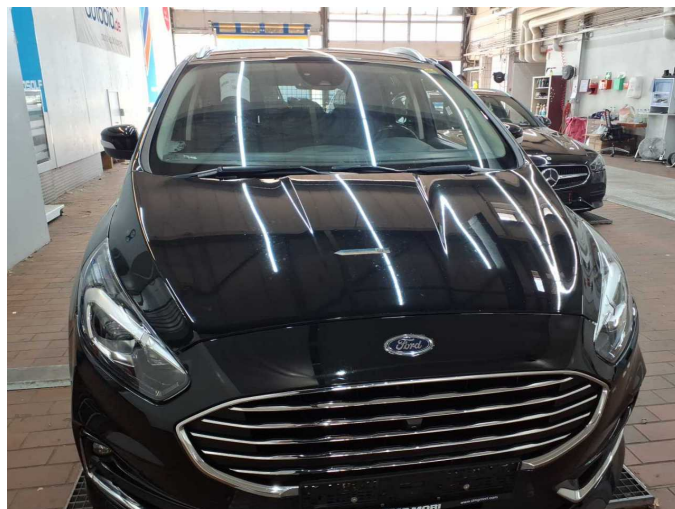
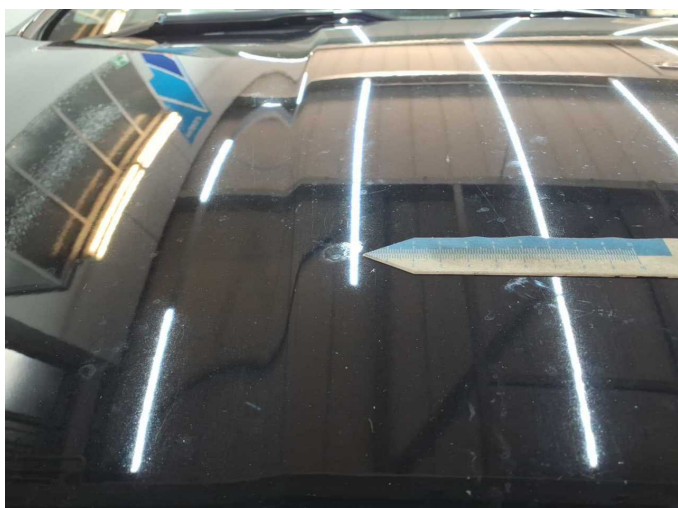
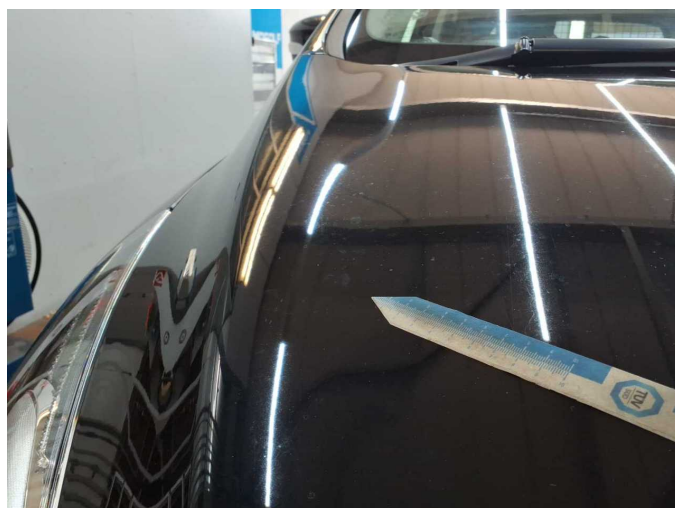
| No. | Component group | Description |
|---|---|---|
| 9 | Bonnet | Bonnet (Verätzungen-Mehrkosten möglich) - Paint defect - Conditioning |

| Boot lid / rear door | 108 µm | Bonnet | 97 µm |

**Damage 9:** Bonnet: Bonnet (Verätzungen-Mehrkosten möglich) - Paint defect - Conditioning

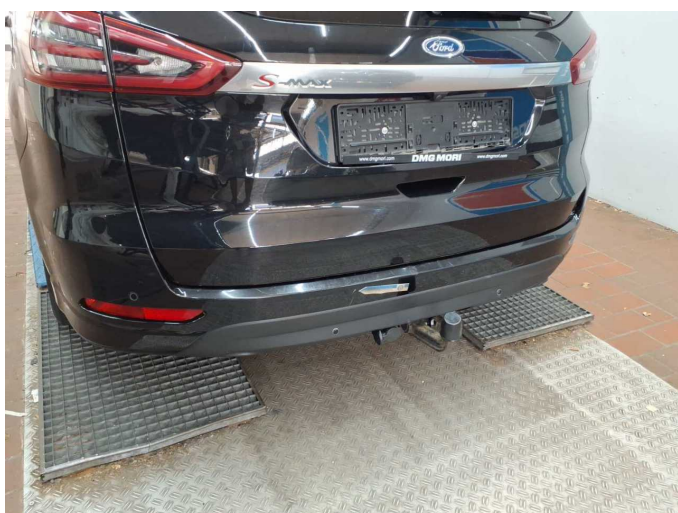
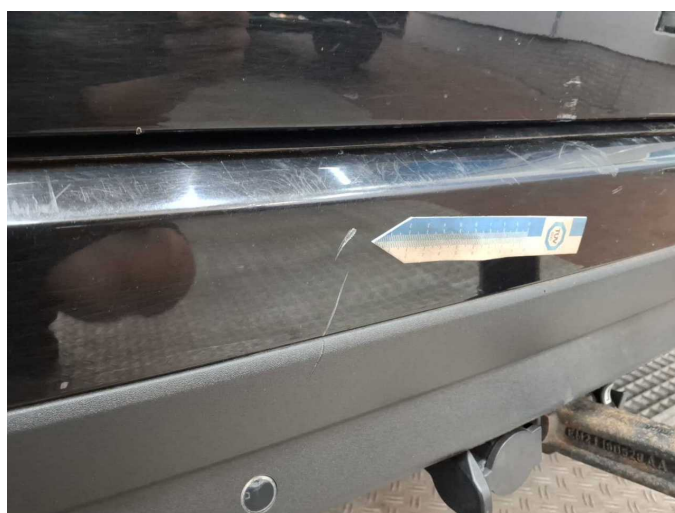
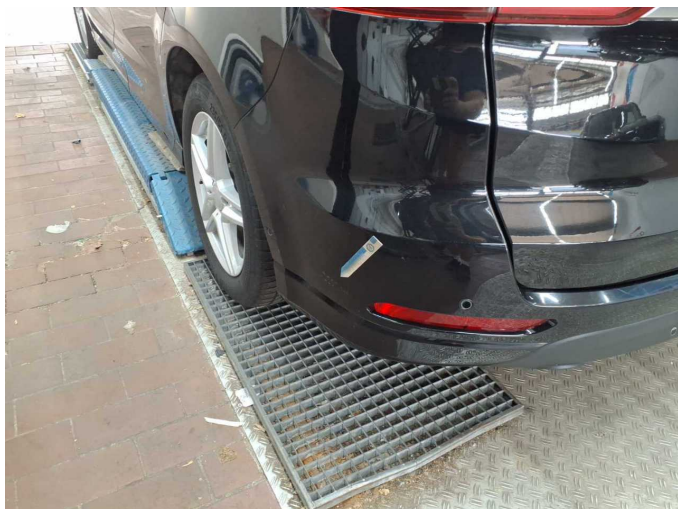
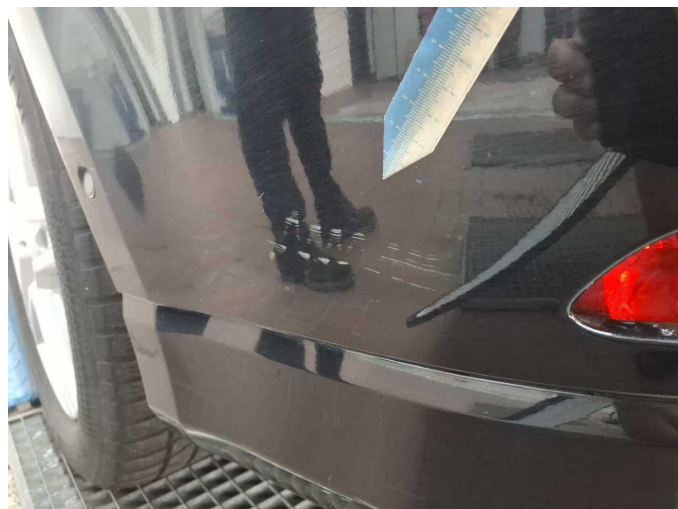
| No. | Component group | Description |
|---|---|---|
| 10 | Rear bumper | Rear bumper - Scratch(es) - Paint |

**Damage 10:** Rear bumper: Rear bumper - Scratch(es) - Paint

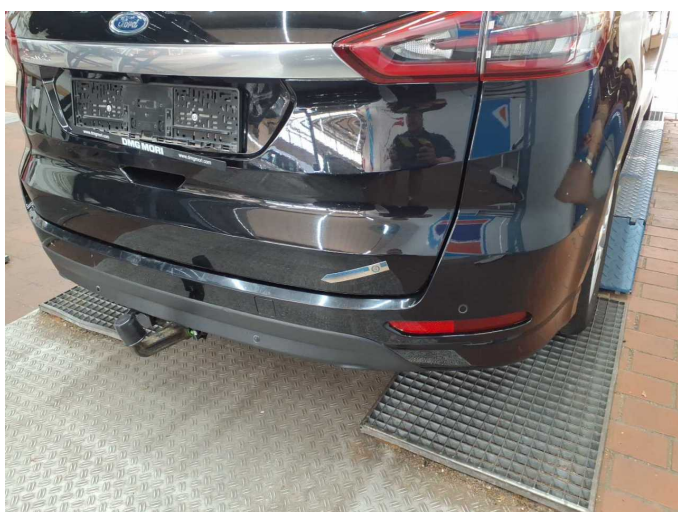
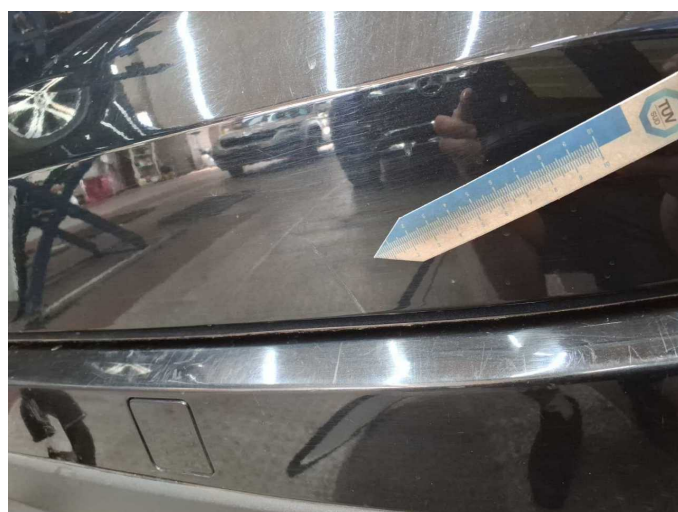
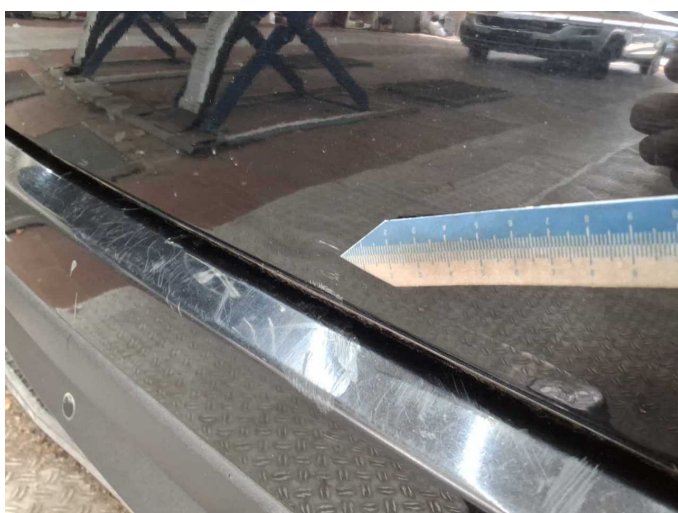
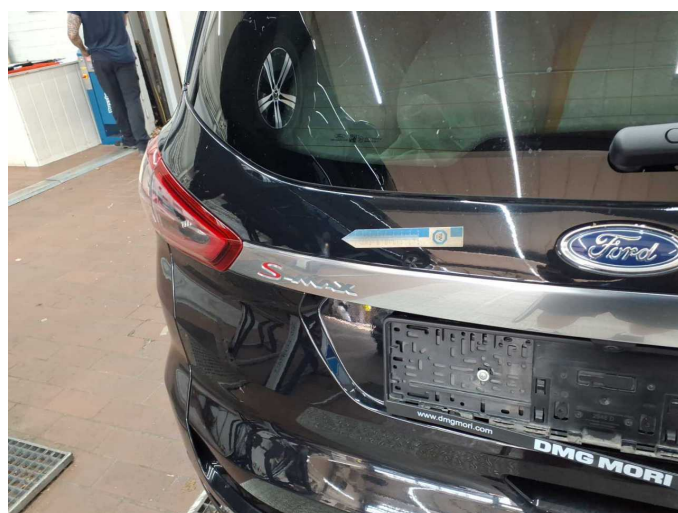
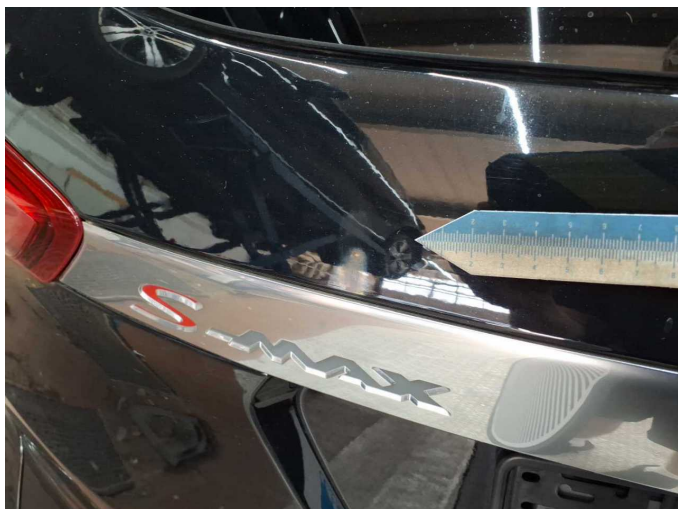
| No. | Component group | Description |
|---|---|---|
| 11 | Boot lid / rear door | Boot lid (+ Korrosion an Heckklappe) - Scratch(es) - Paint |

**Damage 11:** Boot lid / rear door: Boot lid (+ Korrosion an Heckklappe) - Scratch(es) - Paint

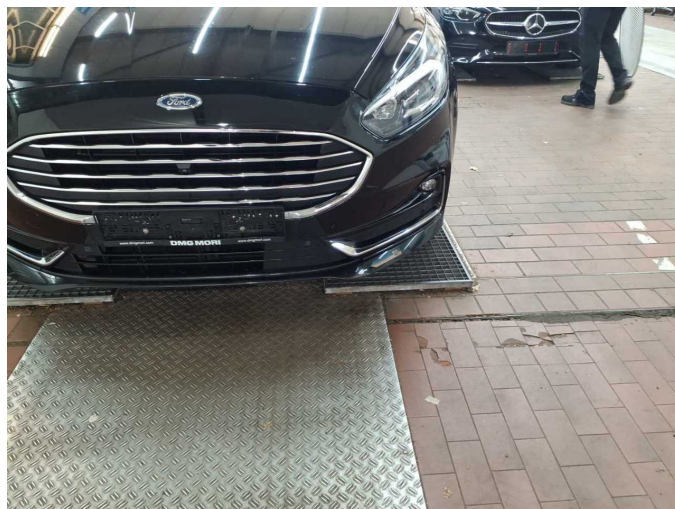
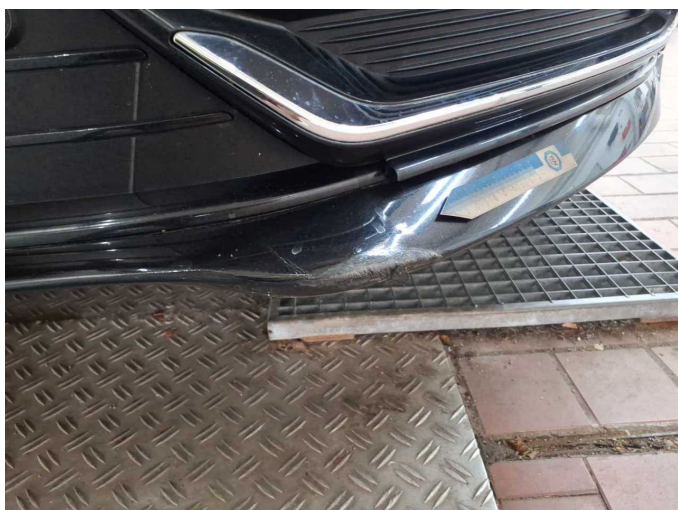
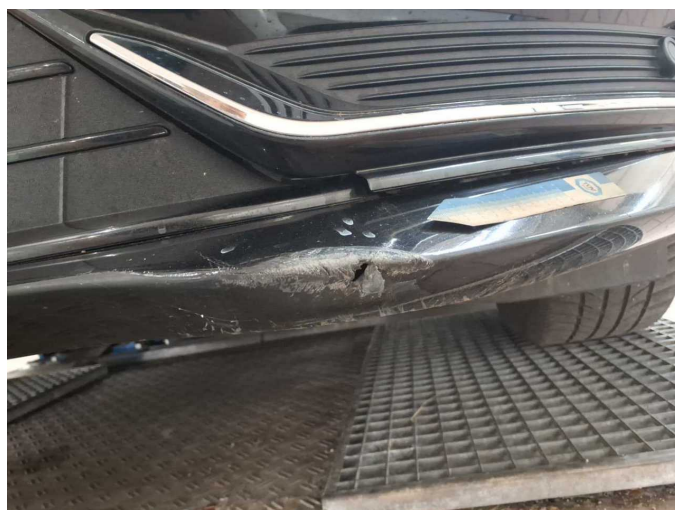
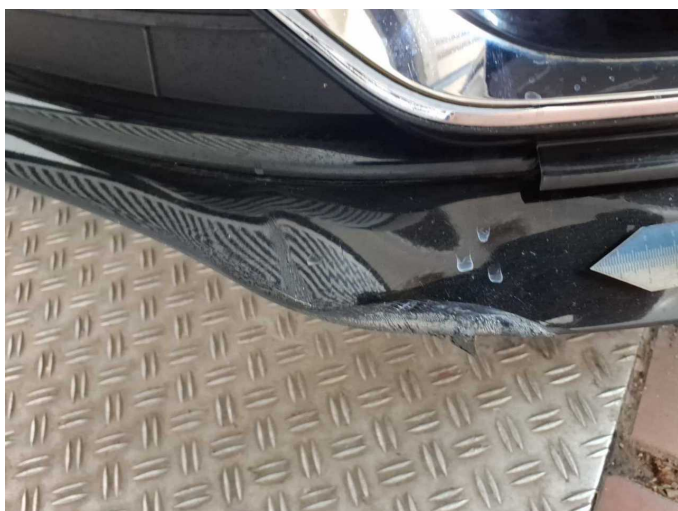
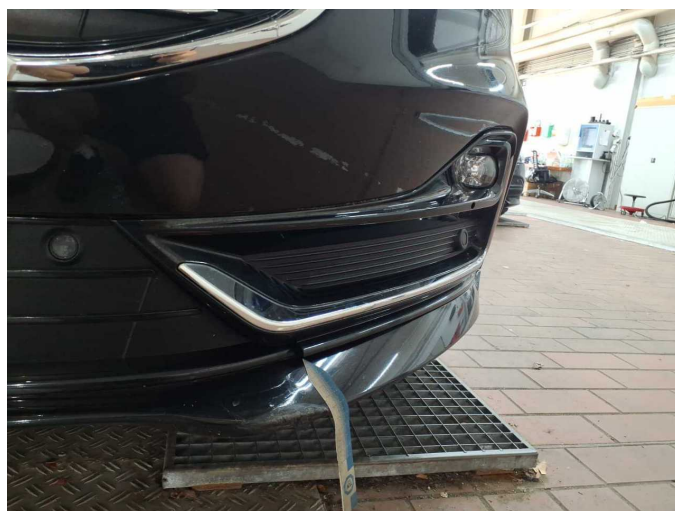
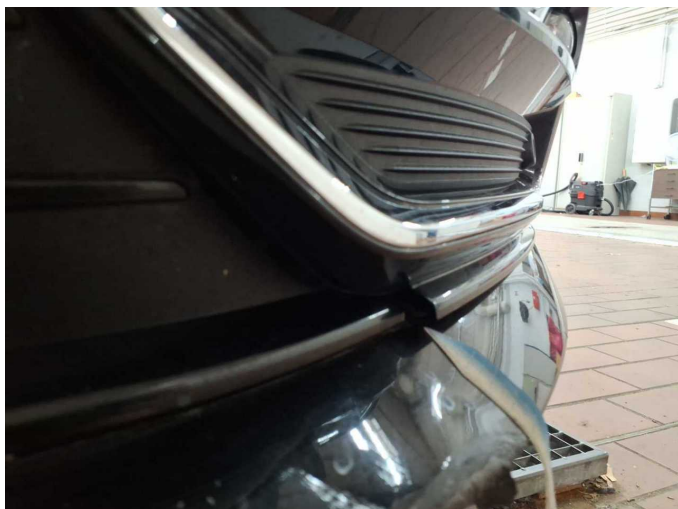
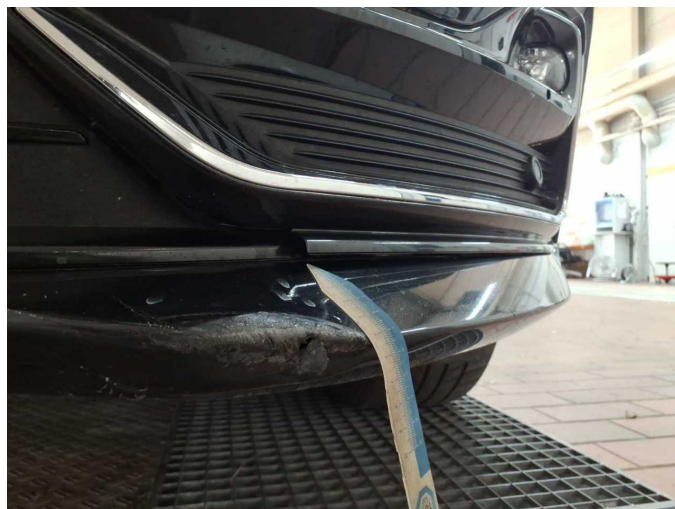
| No. | Component group | Description |
|---|---|---|
| 12 | Front bumper | Spoiler (Mit Blende / Loch) - Deformed - repair according to calculation |

**Damage 12:** Front bumper: Spoiler (Mit Blende / Loch) - Deformed - repair according to calculation

Die beigefügte Reparaturkostenkalkulation wurde nach bestem Wissen und Gewissen unter eingeschränkten Besichtigungsbedingung im demontagefreien Zustand erstellt. Es können aufgrund verdeckter Beschädigung, Mehrkosten und somit Abweichung der für die Stoßstange ausgewiesenen Reparaturkosten nicht ausgeschlossen werden.

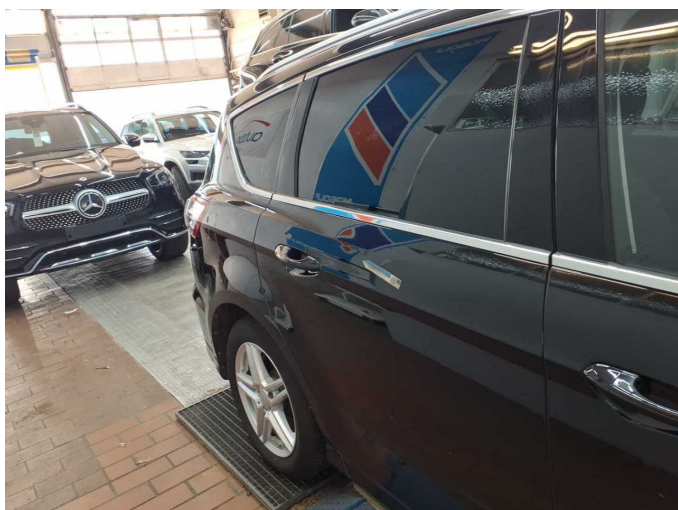
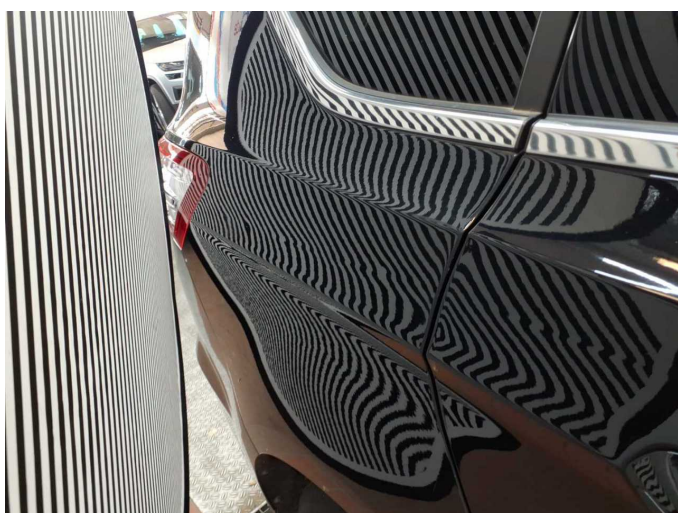
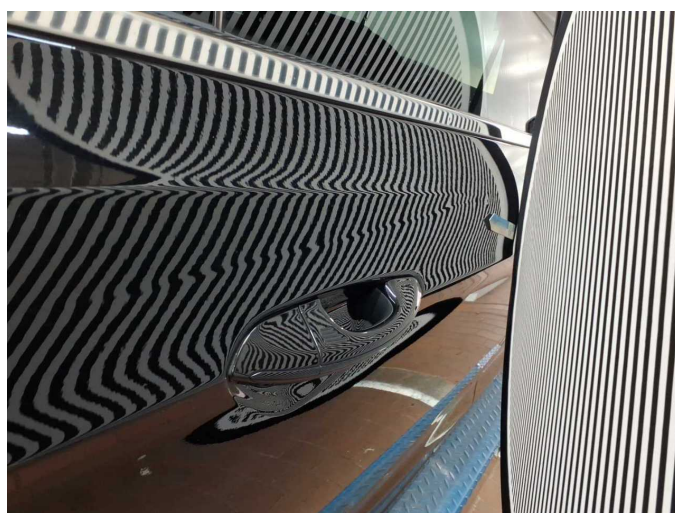
| No. | Accident |
|---|---|
| 1 | Side right |

**Accident 1:** Side right

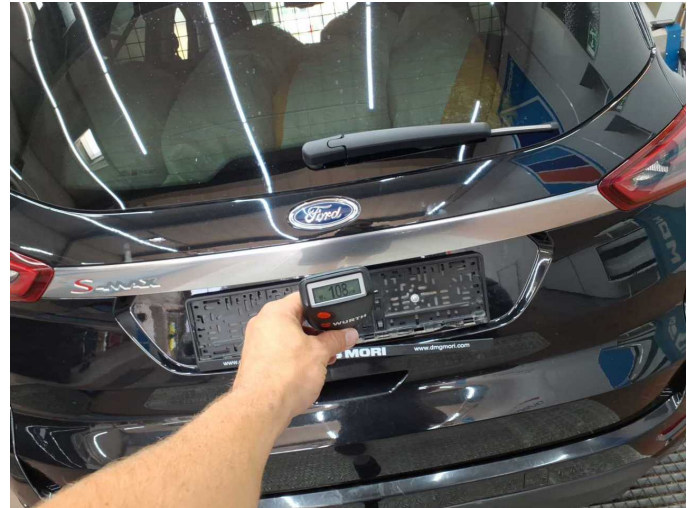
| No. | Previous damage | Extent of damage (Net) |
|---|---|---|
| 1 | Rear, Provided by user / customer, from 12 Nov 2022 | 2.686,93 € |

**Previous damage 1: Rear**

Non-repaired previous damages were found at the vehicle. The necessary repair costs are listed in the expert report or if necessary, are listed in detail in a separately enclosed repair cost calculation.

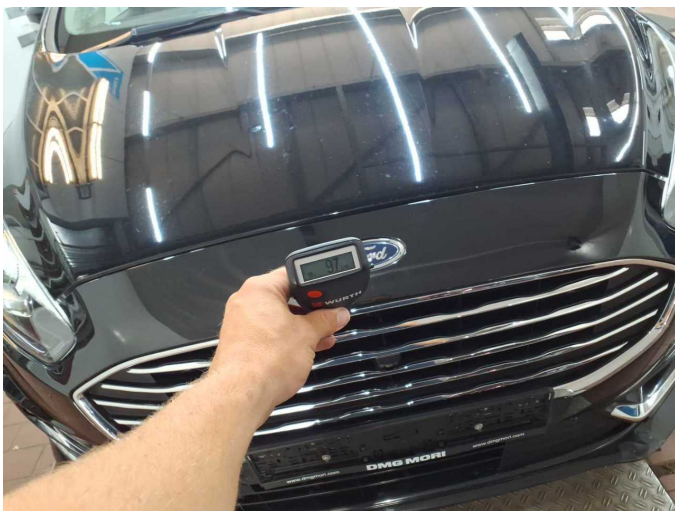
| No. | Previous damage | Extent of damage (Net) |
|---|---|---|
| 2 | Front, Provided by user / customer, from 20 Nov 2022 | 5.481,63 € |

**Previous damage 2: Front**
