Expertise

Protocol number: 46172633  
Order No. / Reference: 26550786  
Inspection date: 26 Jun 2026

Manufacturer: Volkswagen  
VIN: WVGZZZCDZNW008018

Model: Golf 2.0 TDI SCR DSG Life

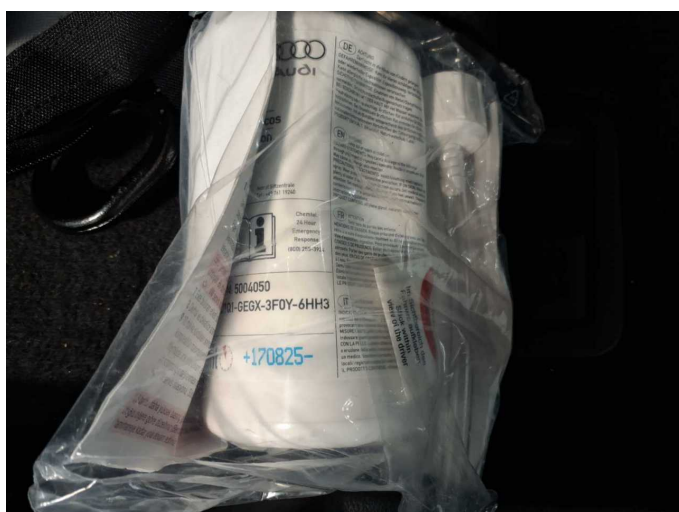
| No. | Component group | Description |
|---|---|---|
| 2 | Equipment | Tirefit filler - Expired - Replace |

Damage 2: Equipment: Tirefit filler - Expired - Replace

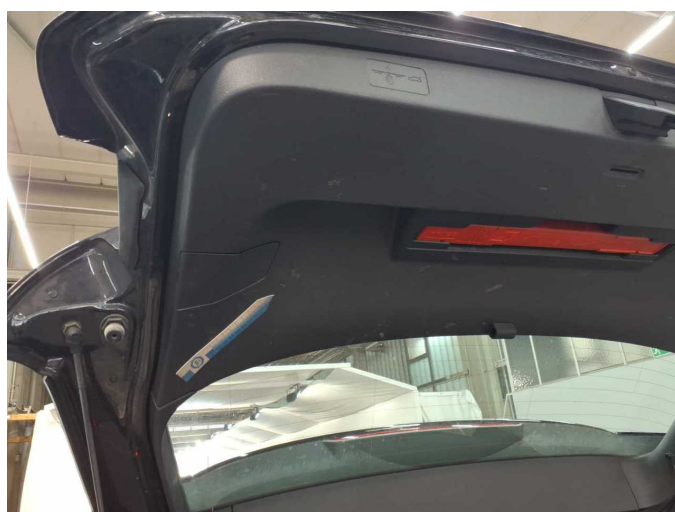
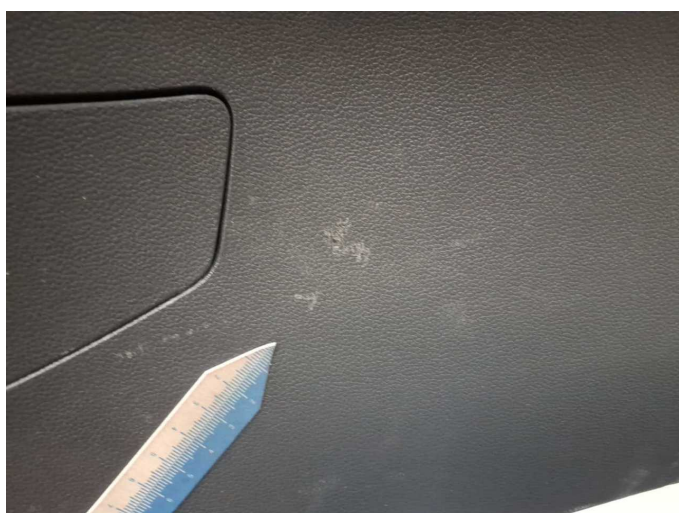
| No. | Component group | Description |
|---|---|---|
| 3 | Trim / covers | Boot lining - Scratch(es) - Loss in value |

Damage 3: Trim / covers: Boot lining - Scratch(es) - Loss in value

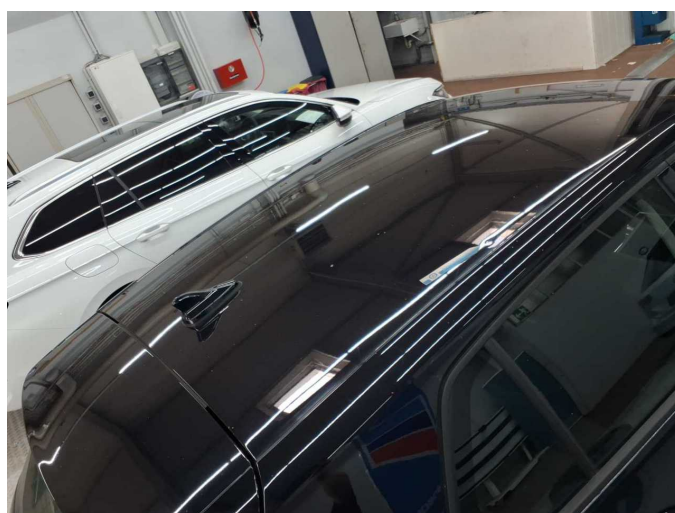
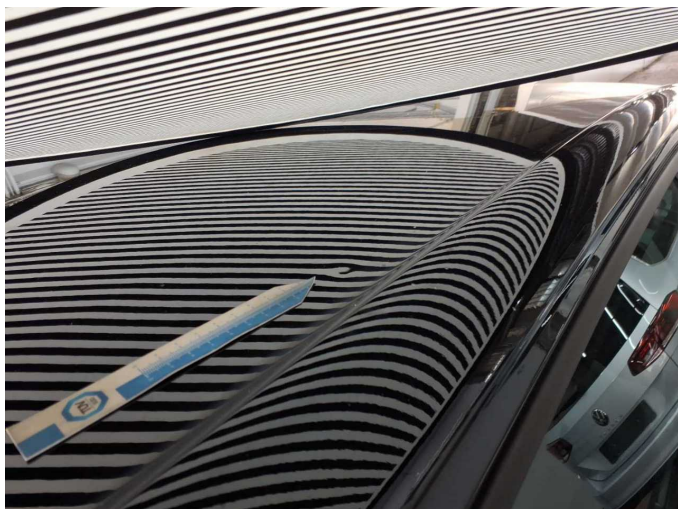
| No. | Component group | Description |
|---|---|---|
| 4 | Roof | Roof - dent(s) - Smooth repair work |

Damage 4: Roof: Roof - dent(s) - Smooth repair work

**Damage 4:** Roof: Roof - dent(s) - Smooth repair work

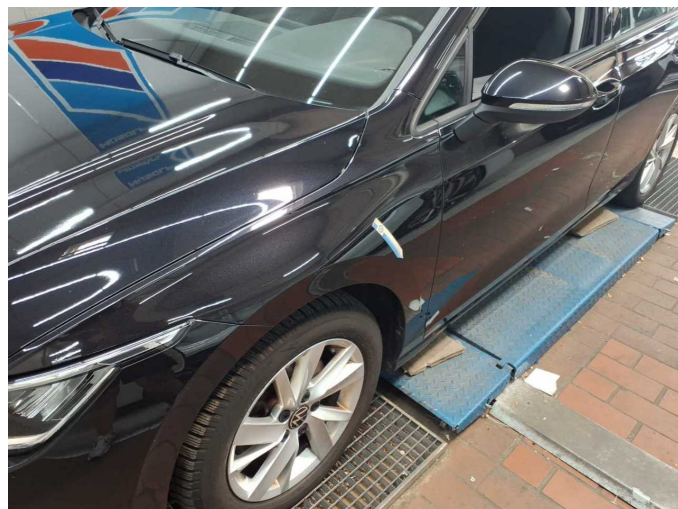
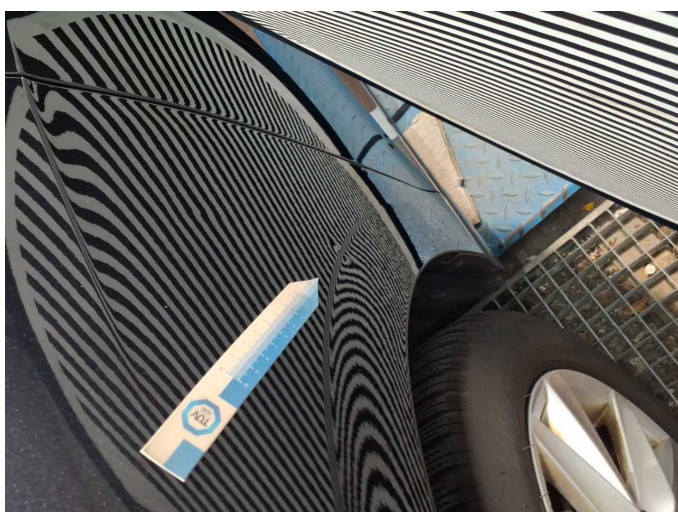
| No. | Component group | Description |
|---|---|---|
| 5 | Mudguard - left side | Mudguard - left side - dent(s) - Smooth repair work |

**Damage 5:** Mudguard - left side: Mudguard - left side - dent(s) - Smooth repair work

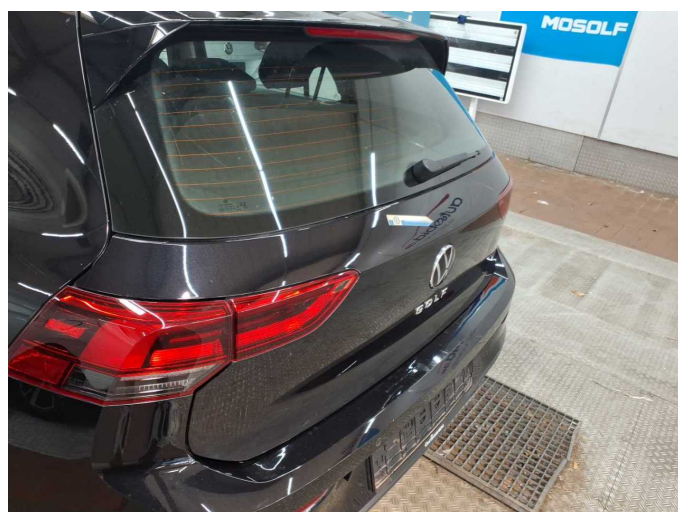
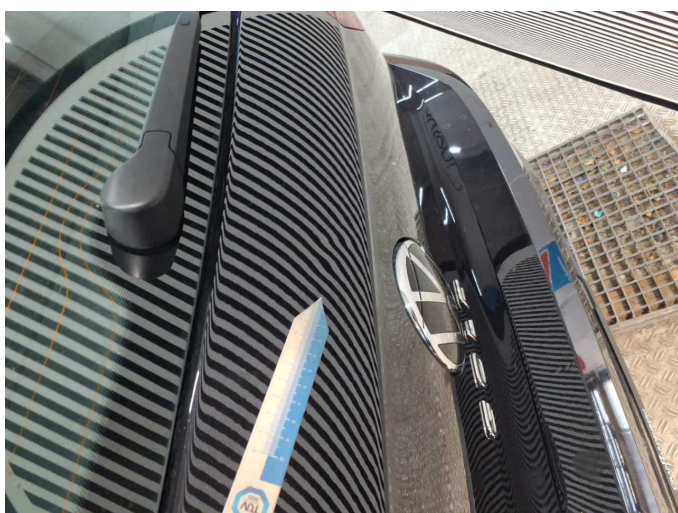
| No. | Component group | Description |
|---|---|---|
| 6 | Boot lid / rear door | Boot lid - dent(s) - Smooth repair work |

**Damage 6:** Boot lid / rear door: Boot lid - dent(s) - Smooth repair work

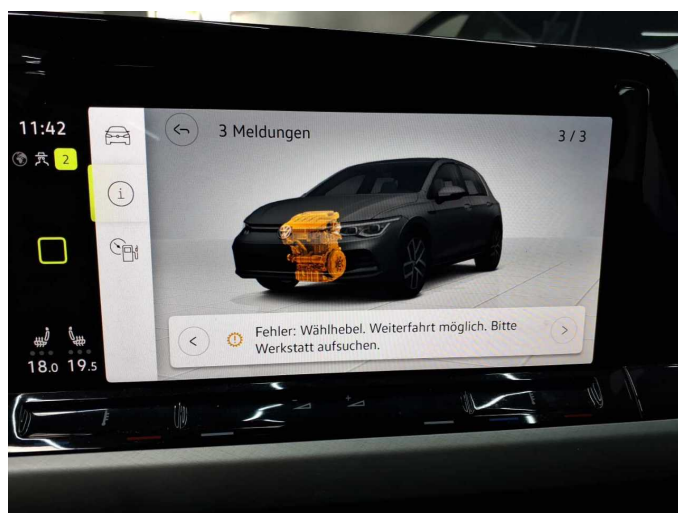
| No. | Component group | Description |
|---|---|---|
| 7 | Instrument panel | Indicator light (Getriebe) - on - Perform diagnosis |

**Damage 7:** Instrument panel: Indicator light (Getriebe) - on - Perform diagnosis

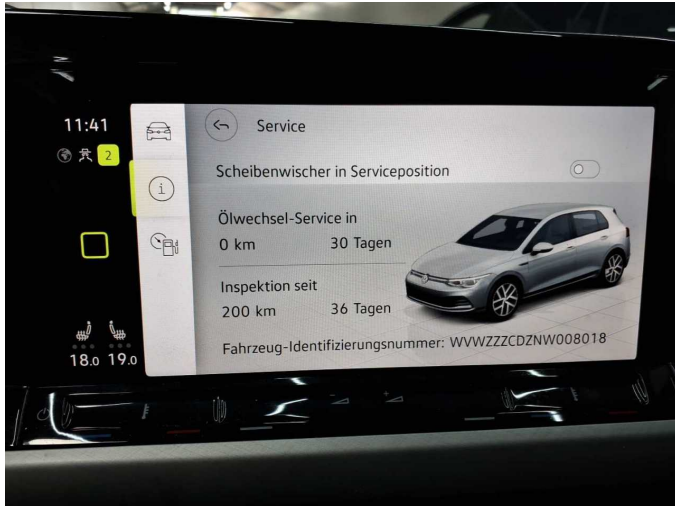
| No. | Component group | Description |
|---|---|---|
| 8 | Misc. | Inspection / maintenance - Due - Replace |

**Damage 8:** Misc.: Inspection / maintenance - Due - Replace

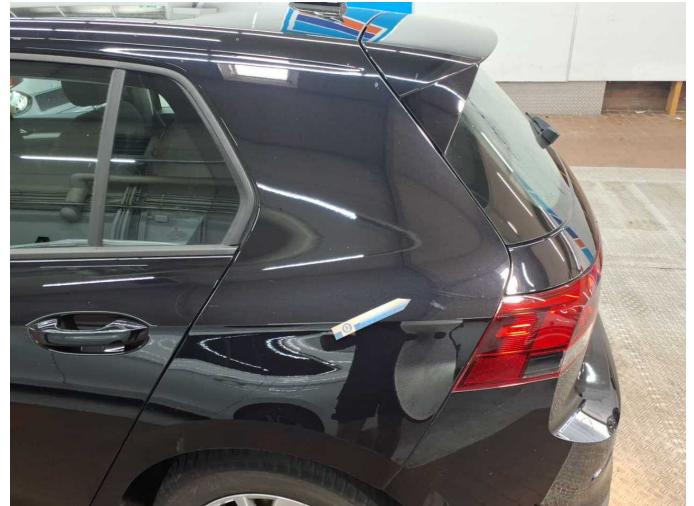
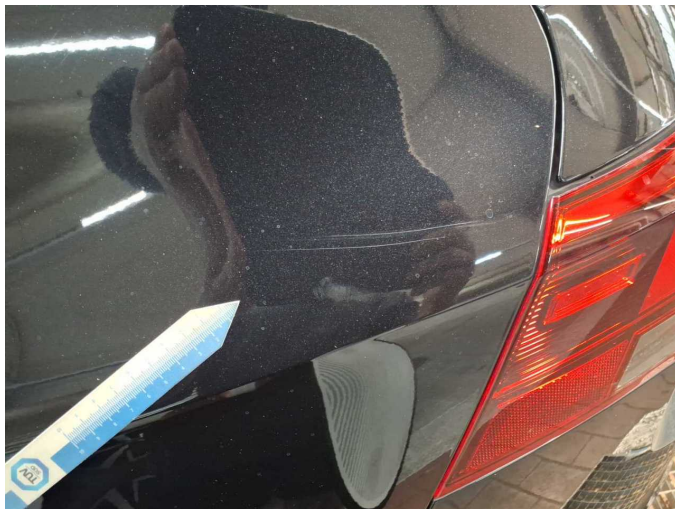
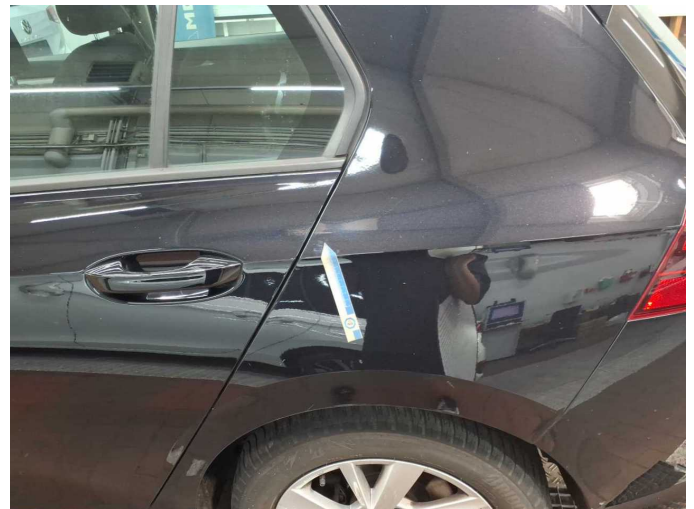
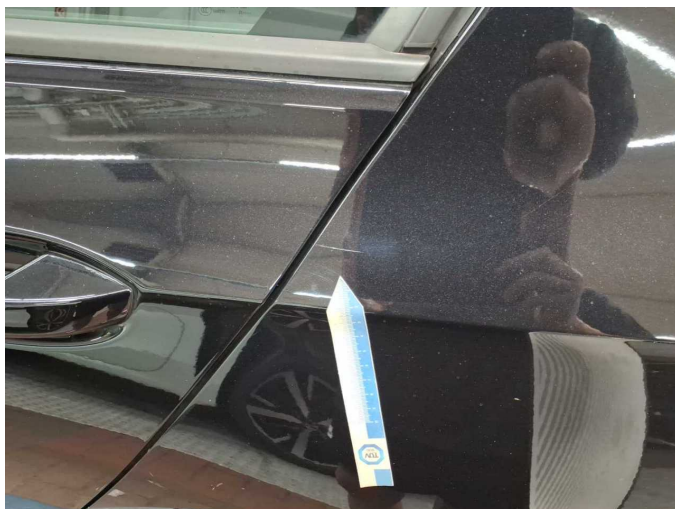
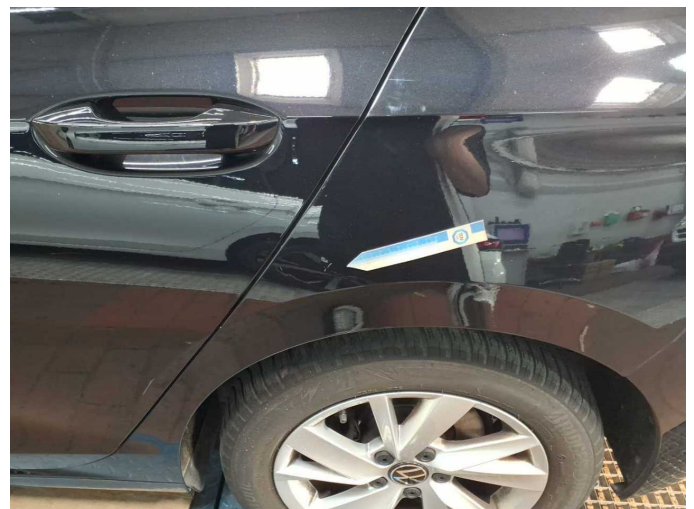
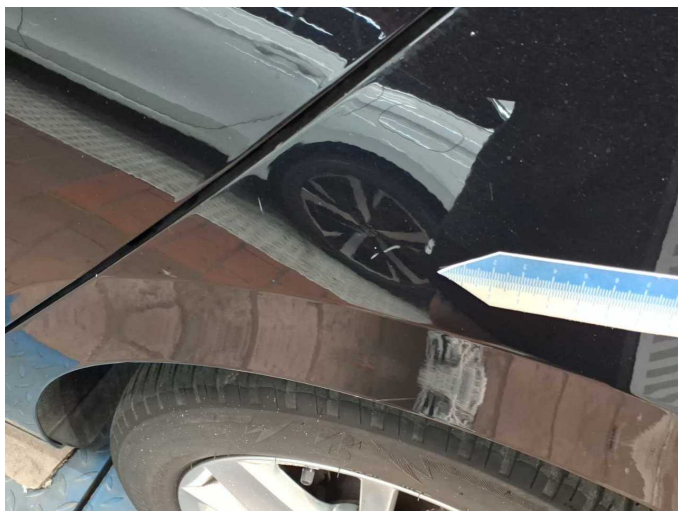
| No. | Component group | Description |
|---|---|---|
| 9 | Side panel - rear left side | Side panel - Scratch(es) - Paint |

**Damage 9:** Side panel - rear left side: Side panel - Scratch(es) - Paint

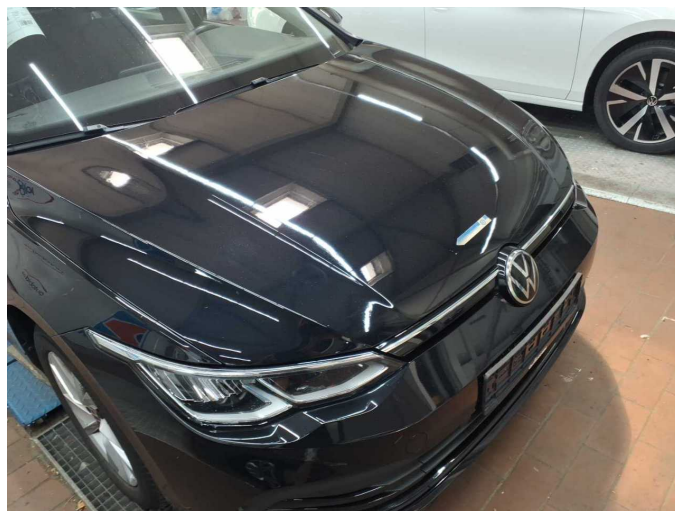
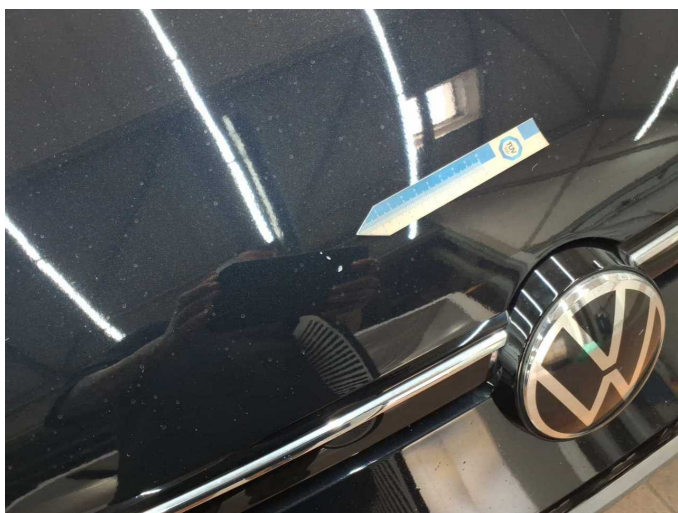
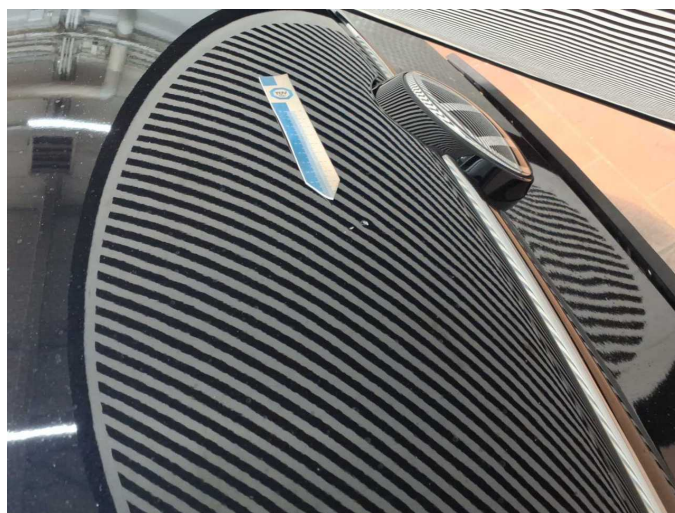
| No. | Component group | Description |
|---|---|---|
| 10 | Bonnet | Bonnet - Dent / paintcoat damage - Paint |

| Bonnet | 239 µm |

**Damage 10:** Bonnet: Bonnet - Dent / paintcoat damage - Paint

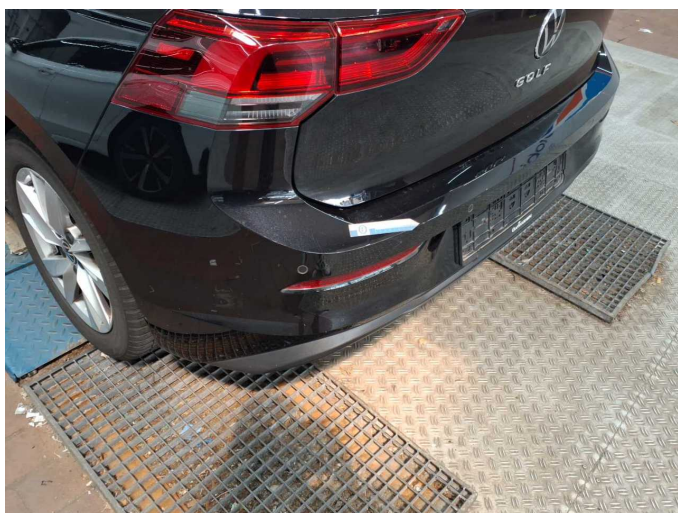
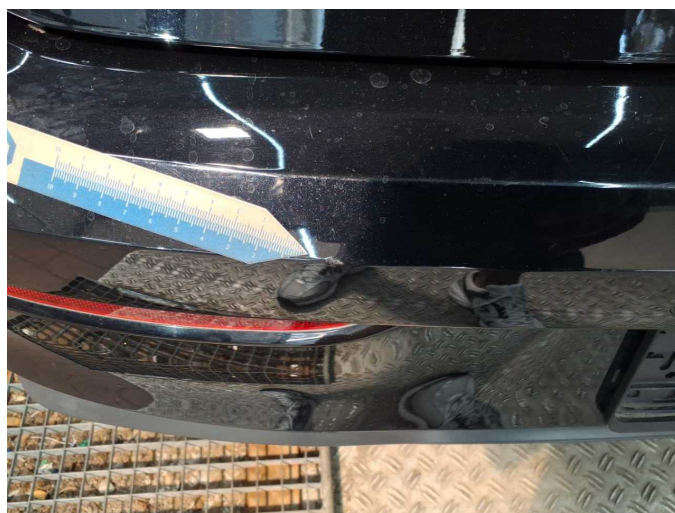
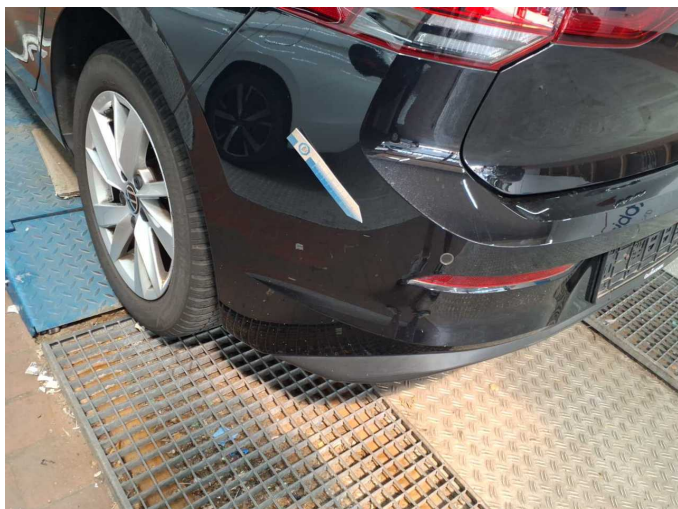
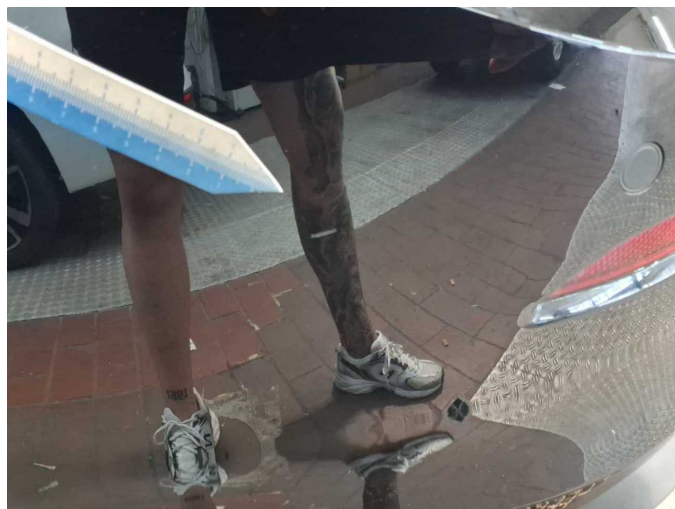
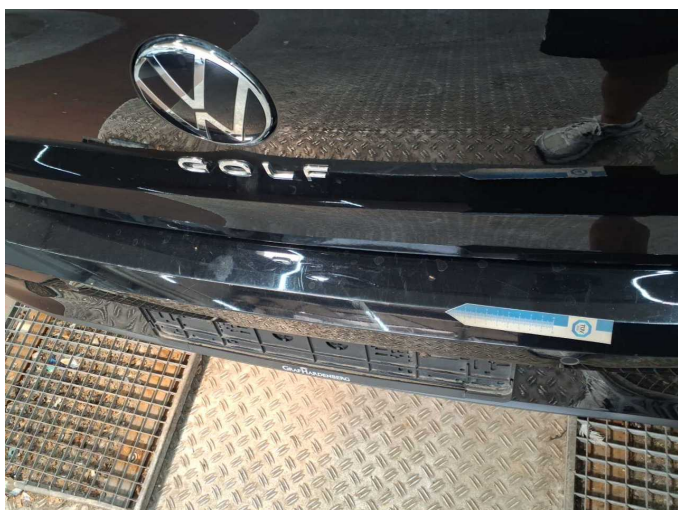
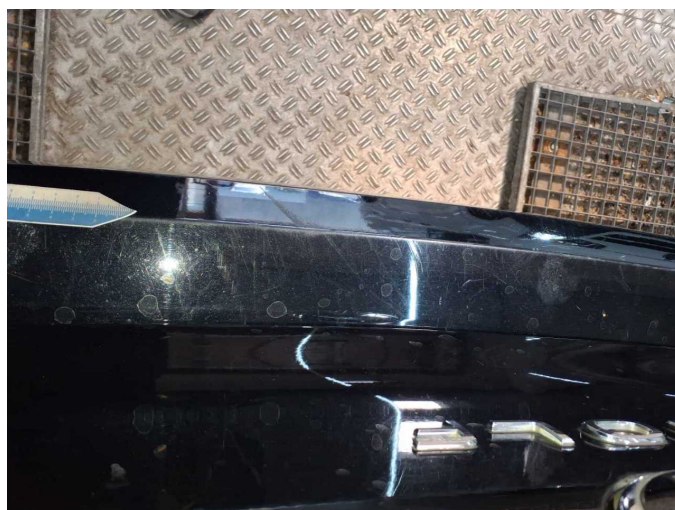
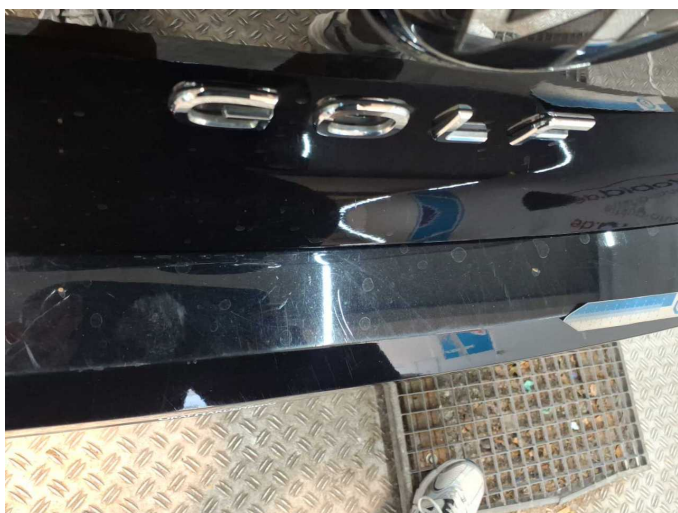
| No. | Component group | Description |
|---|---|---|
| 11 | Rear bumper | Rear bumper - Scratch(es) - Paint |

**Damage 11:** Rear bumper: Rear bumper - Scratch(es) - Paint

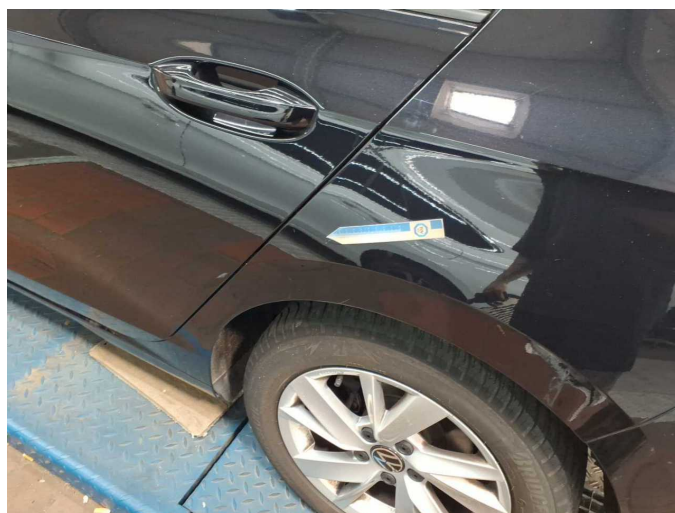
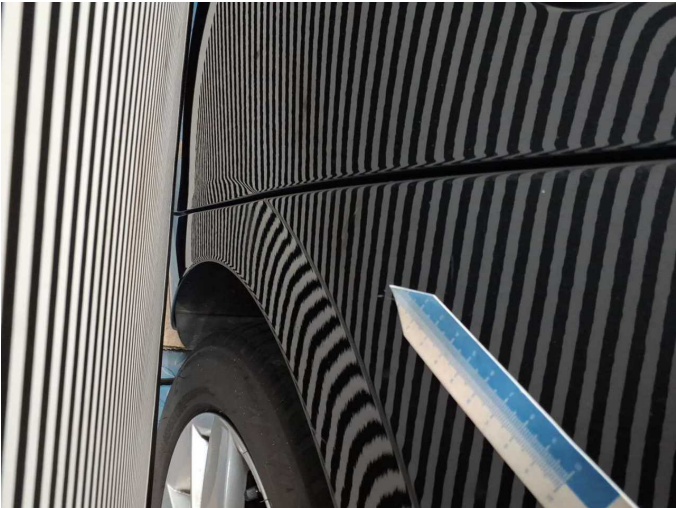
| No. | Component group | Description |
|---|---|---|
| 3 | Side panel - rear left side | Side panel - dent(s) - Smooth repair work |

**Wear and tear 3:** Side panel - rear left side: Side panel - dent(s) - Smooth repair work

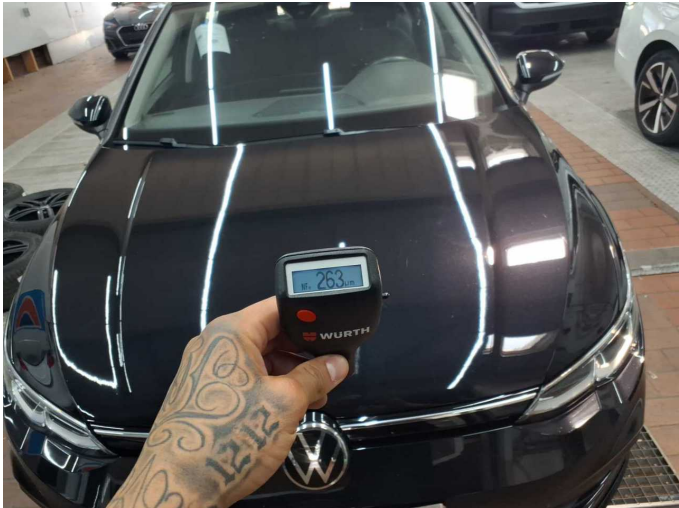
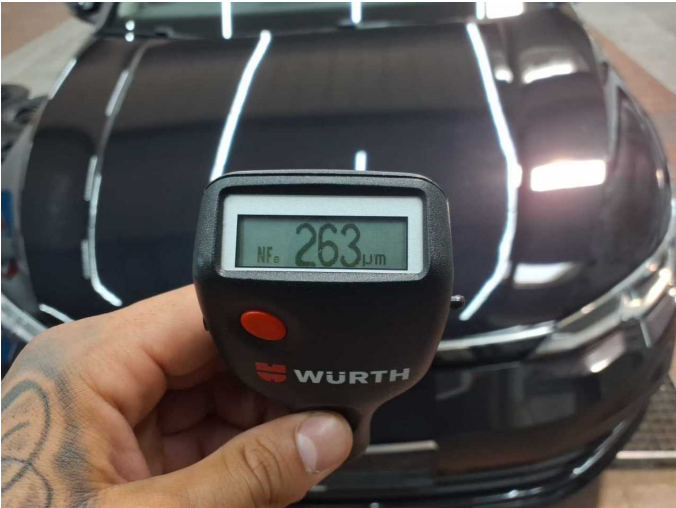
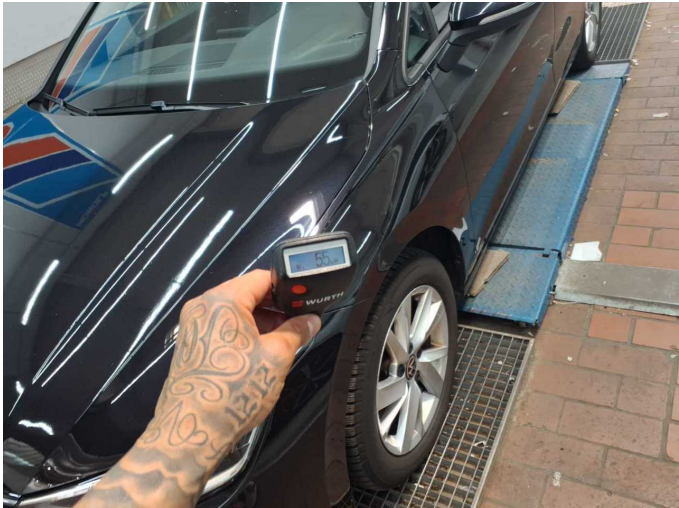
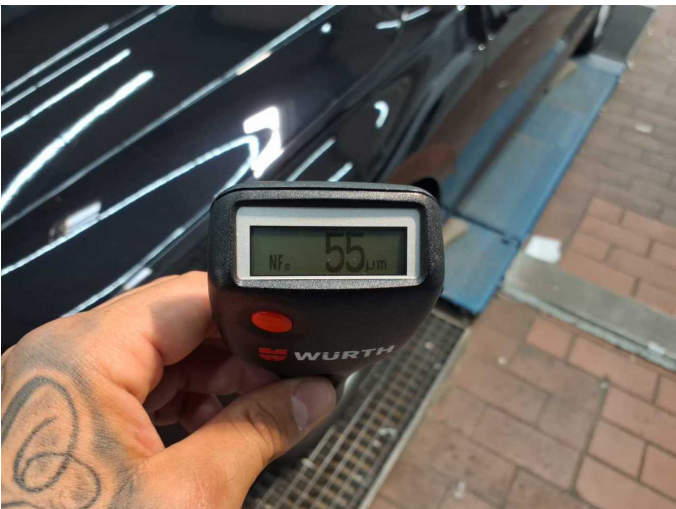
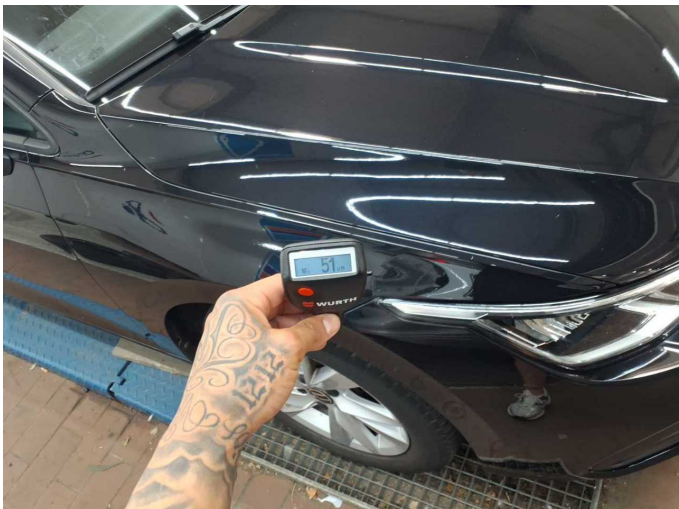
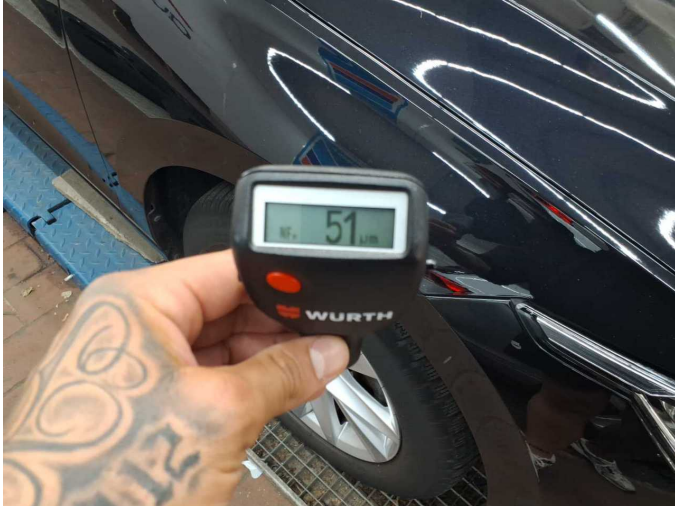
| No. | Previous damage | Extent of damage (Net) |
|---|---|---|
| 1 | Front, Provided by user / customer, from 12 Aug 2024 | 1.055,60 € |

According to available information previous damages were repaired at the vehicle. Traces of repairs, which allow conclusions about the area of repair, were not recognizable during the inspection.

**Previous damage 1:** Front

**Previous damage 1: Front**

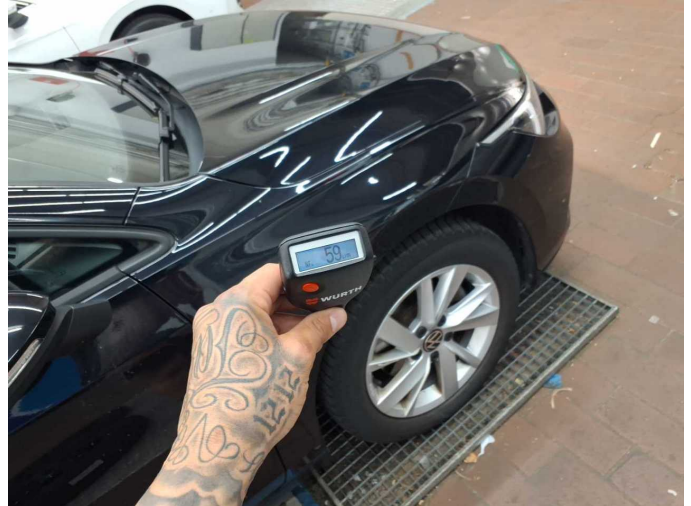
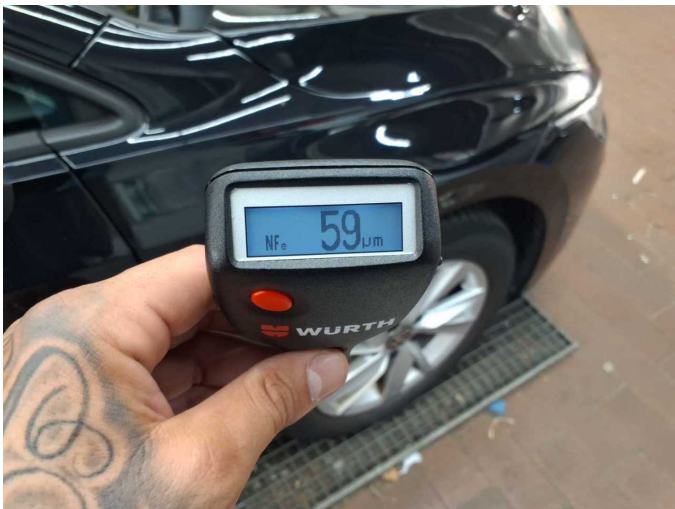
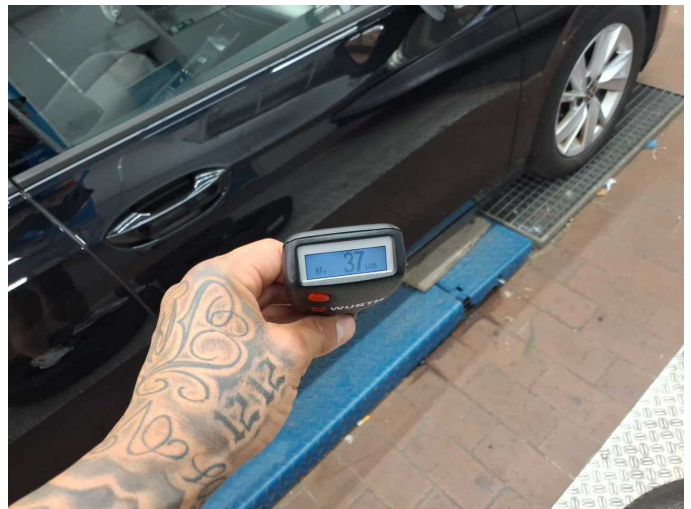
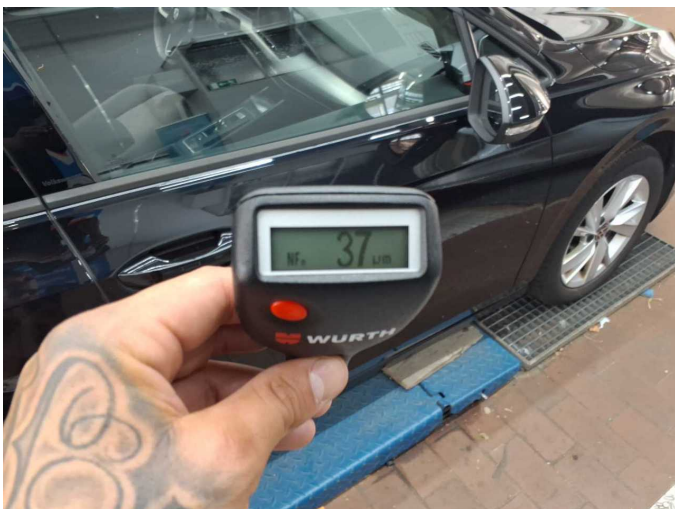
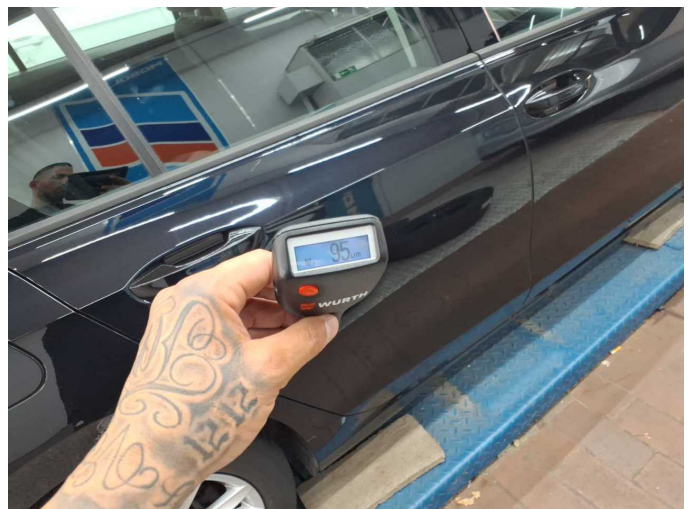
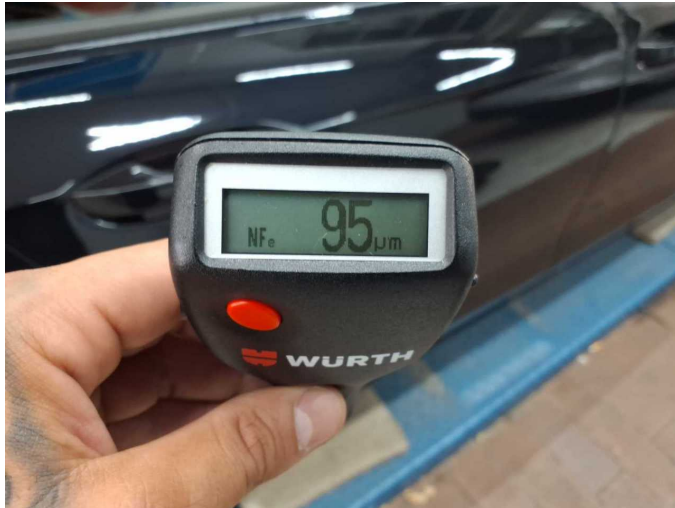
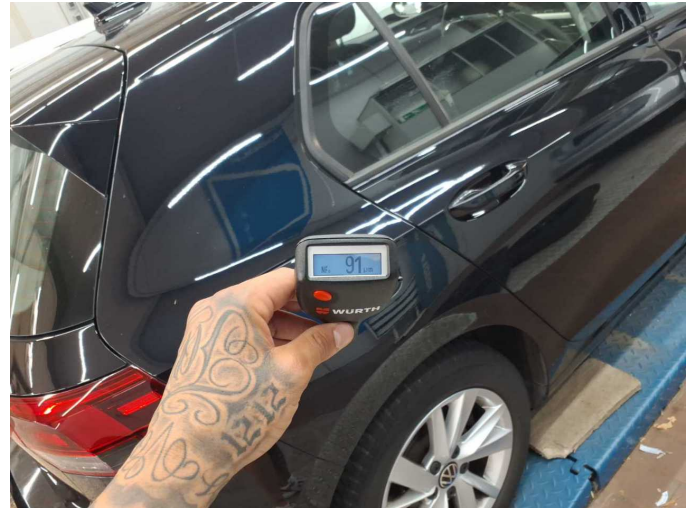
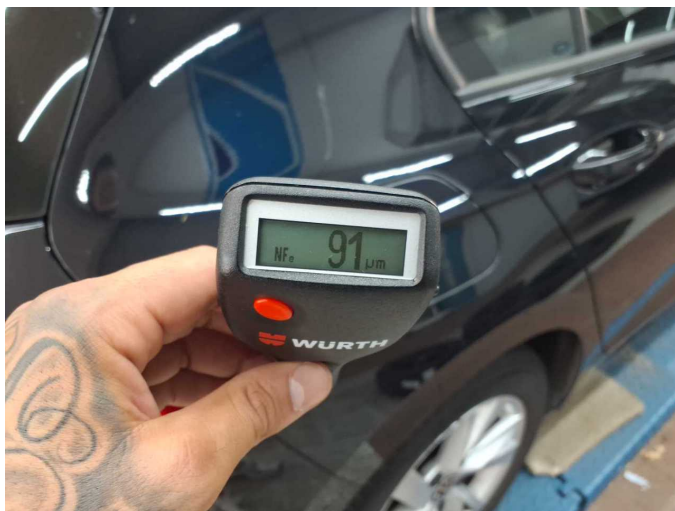
| No. | Previous damage | Extent of damage (Net) |
|---|---|---|
| 2 | Side right, Provided by user / customer, from 24 Aug 2024 | 1.374,28 € |

**Previous damage 2: Side right**

Previous damage 2: Side right

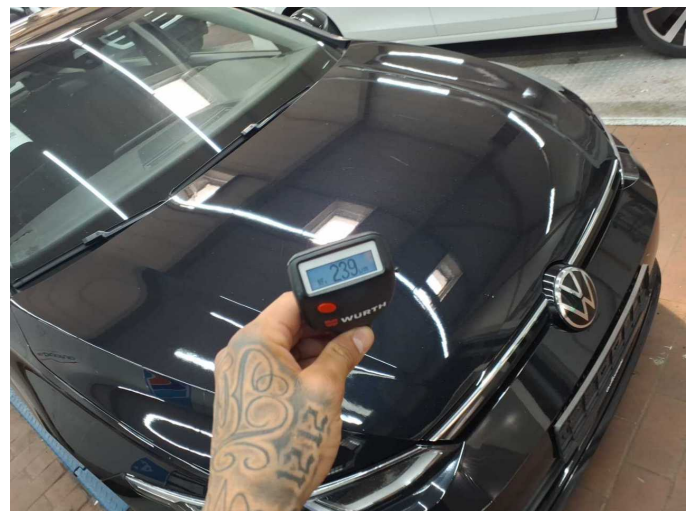
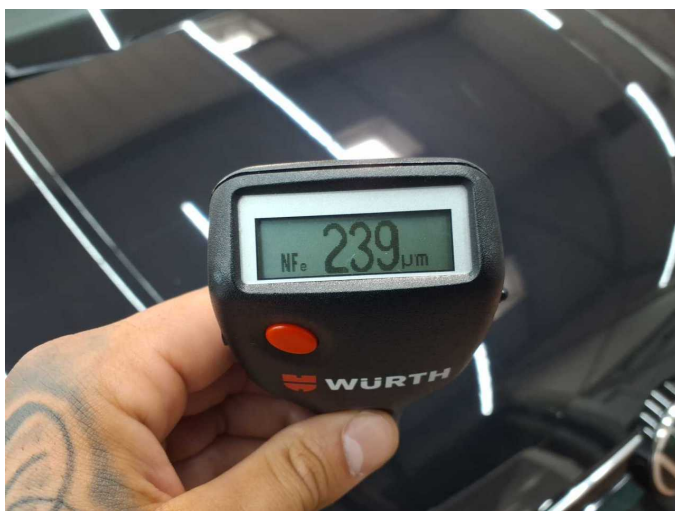
| No. | Repainting |
|---|---|
| 1 | Bonnet, Professionally carried out |

Repainting 1: Bonnet
